Subject: Due Diligence Geotechnical Investigation and Geologic Hazard Evaluation
Hannah Ridge (AKA Feathergrass)
El Paso County, Colorado
CTL|T Project No. CS19005-115

This letter presents the results of our Due Diligence Geotechnical Investigation and Geologic Hazard Evaluation for the Hannah Ridge (AKA Feathergrass) parcel. The site is located on the east and west side of Hannah Ridge Drive, south of the intersection of Hannah Ridge Drive and Constitution Avenue, in El Paso County Colorado (Fig. 1).

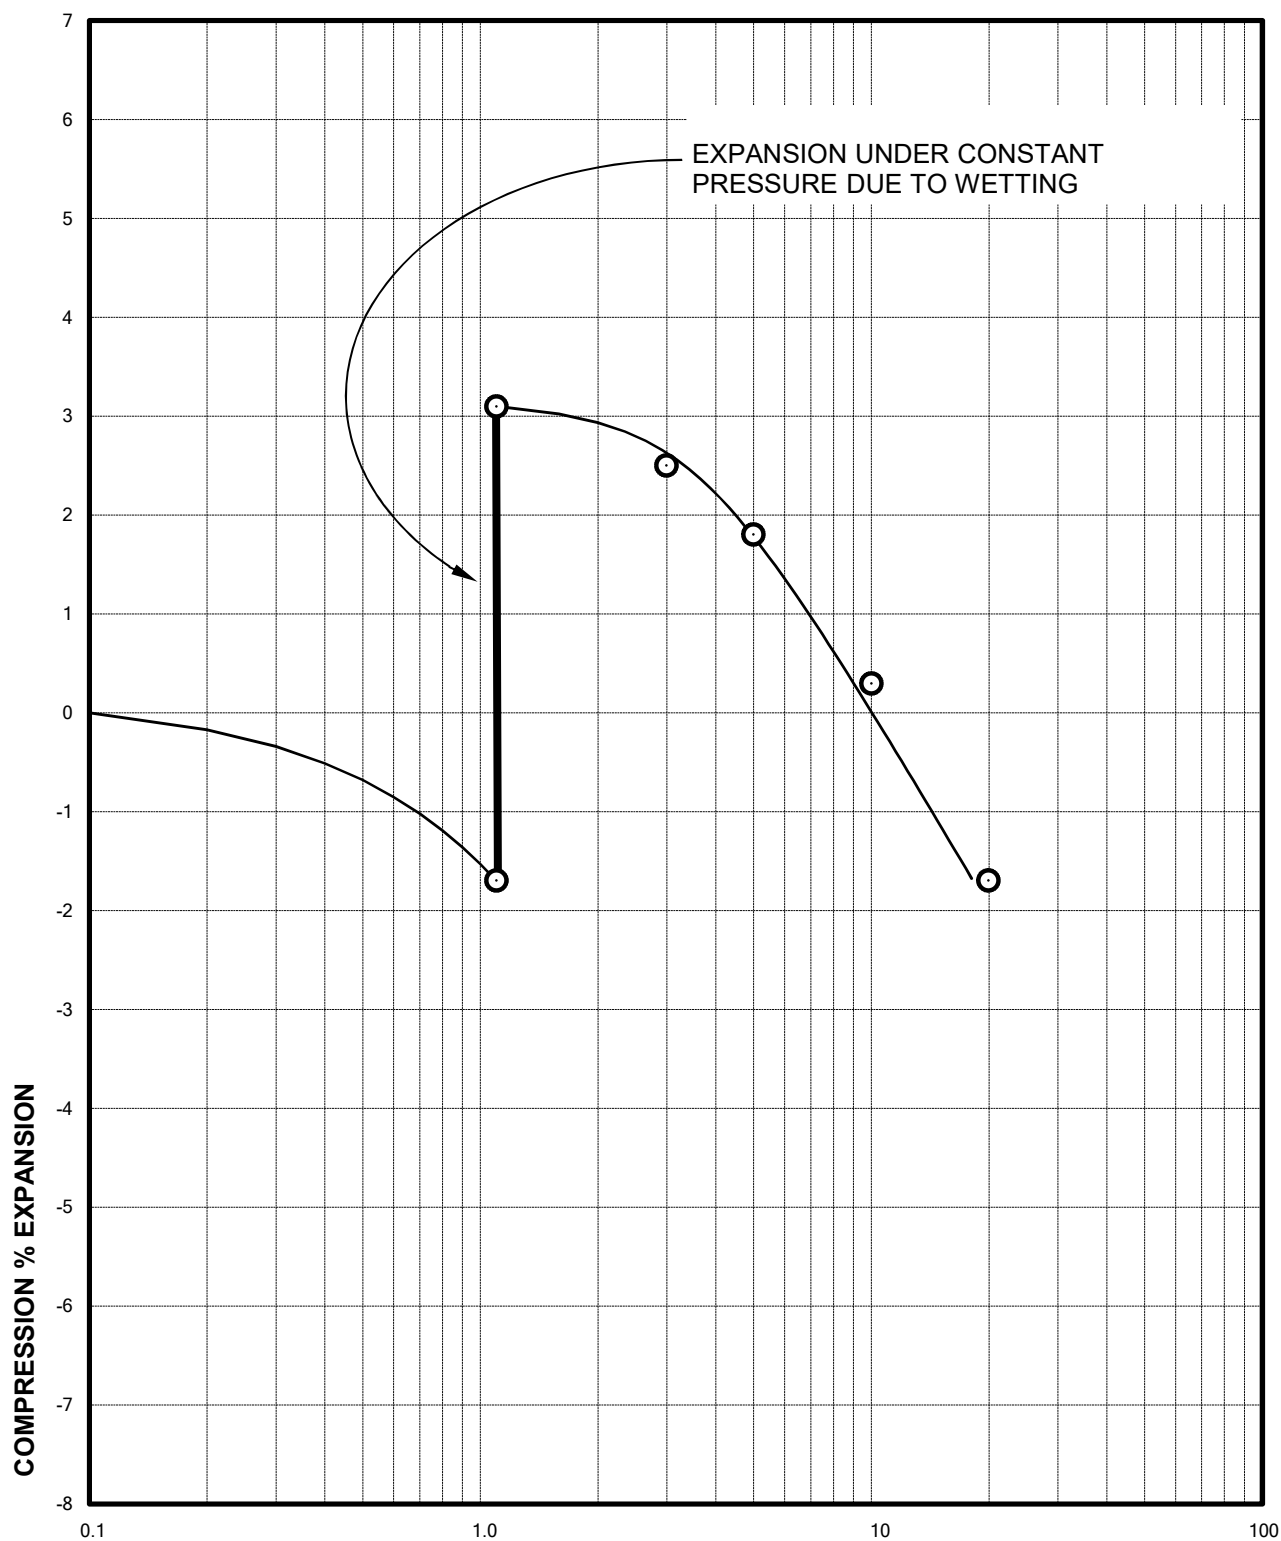
APPLIED PRESSURE - KSF
Sample of CLAYSTONE, WEATHERED
From TH-10 AT 9 FEET

DRY UNIT WEIGHT= 101 PCF
MOISTURE CONTENT= 22.3 %

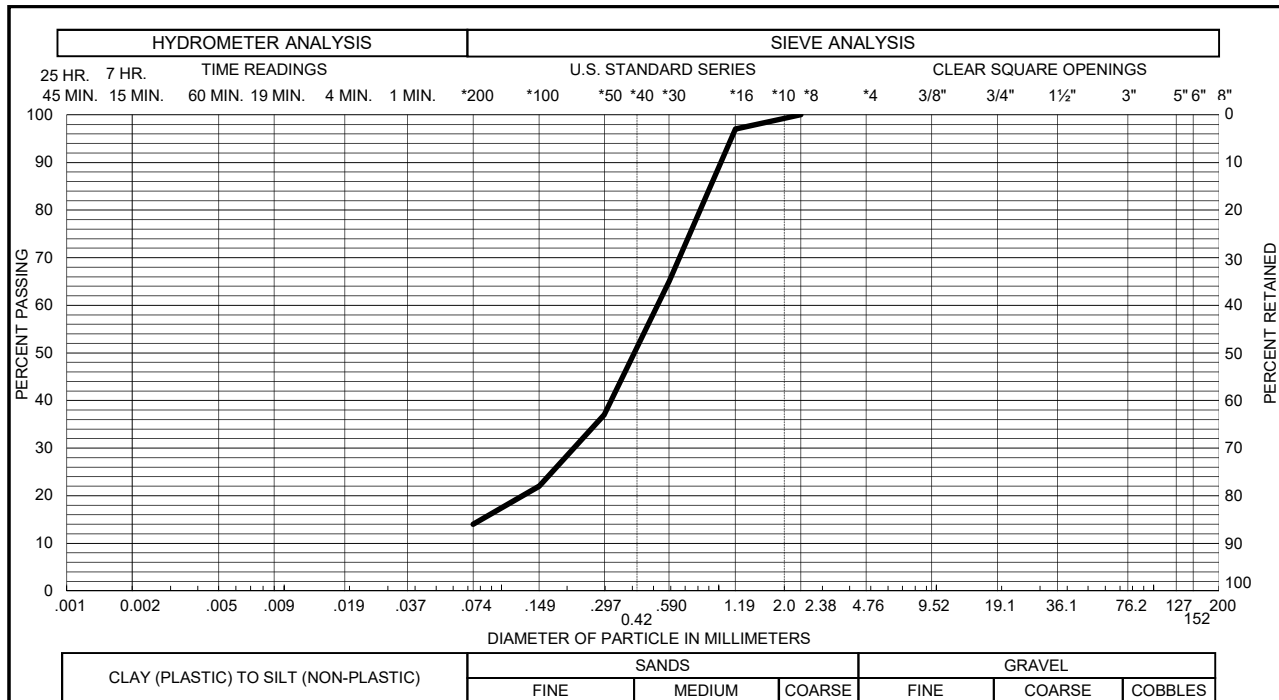
Sample of SAND, CLAYEY (SC)
From TH - 1 AT 9 FEET

GRAVEL 0 % SAND 86 %
SILT & CLAY 14 % LIQUID LIMIT %
PLASTICITY INDEX %
