## SOIL AND GEOLOGY STUDY

**Currently Addressed as: 18050 Quarterhorse Lane  
Lot 6, Blk 1, Willow Springs Estates  
El Paso County, Colorado**

**JOB NO. 201954**

**June 8, 2026**

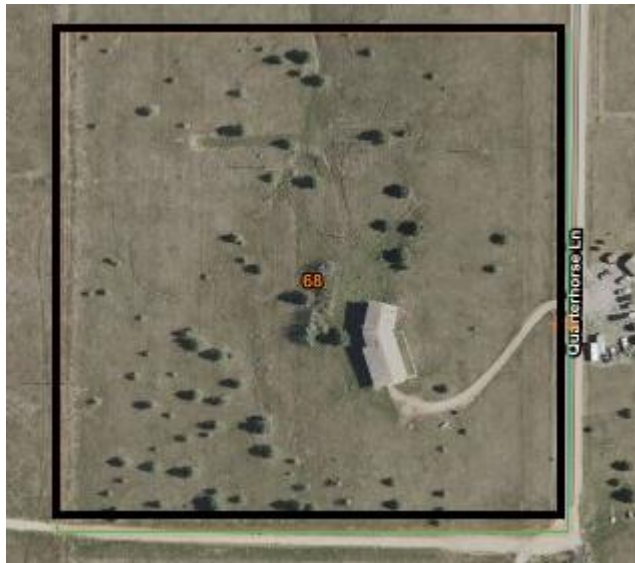
- **68 – Peyton-Pring complex, 3 to 8 percent slopes.** The Peyton-Pring complex was mapped by the USDA to encompass the entire property. Properties of the Peyton-Pring complex include, well-drained soils, depth of the water table is anticipated to be greater than 6.5 feet, runoff is anticipated to be low, frequency of flooding and ponding is none, and landforms include hills.

The USDA Soil Survey Map is presented below.

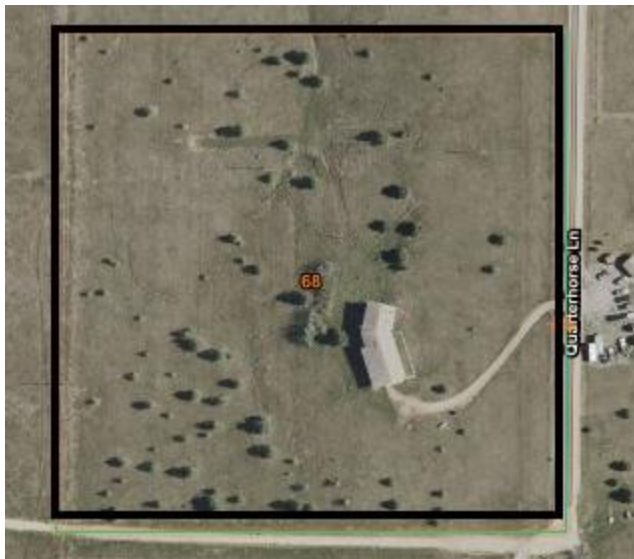
than 6.5 feet, runoff is anticipated to be low, frequency of flooding and ponding is none, and landforms include hills.

The USDA Soil Survey Map is presented below.
