GEOLOGIC HAZARDS EVALUATION AND PRELIMINARY GEOTECHNICAL INVESTIGATION

3819 JANITELL ROAD
COLORADO SPRINGS, COLORADO

Project No. CS20080-105

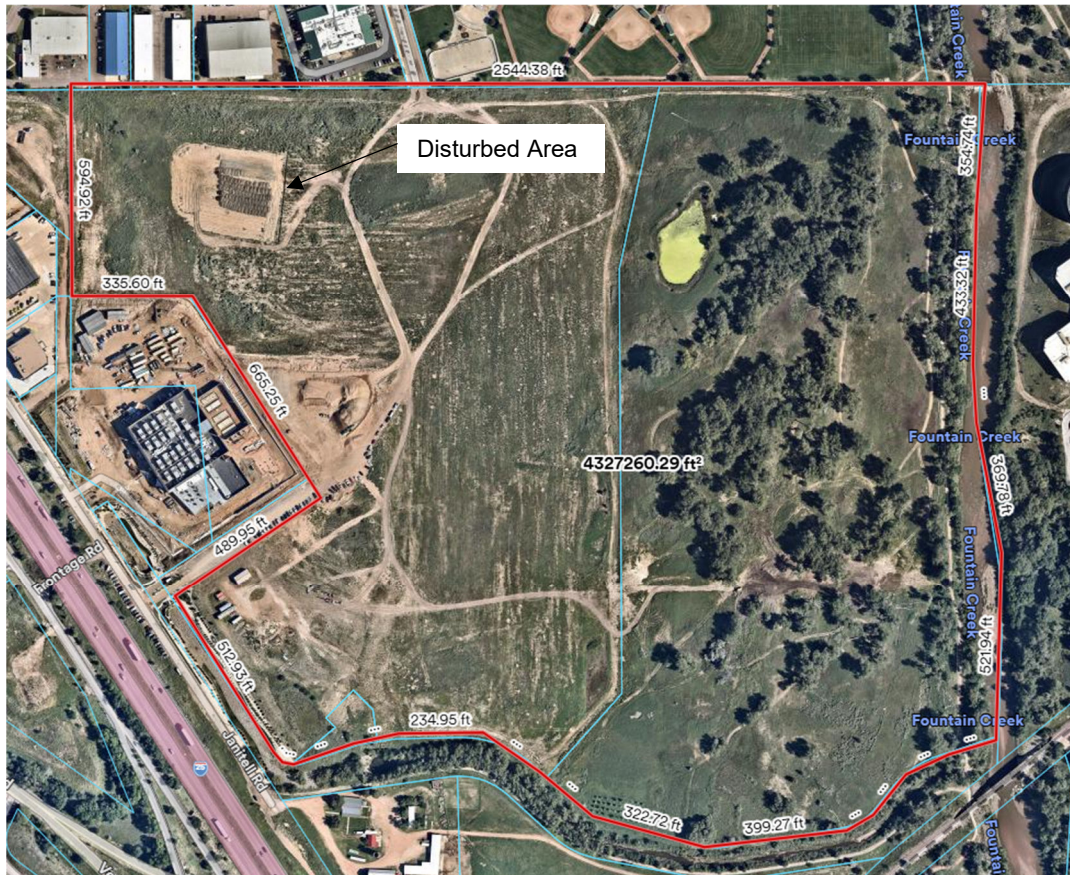
As shown below in the August 2017 aerial image, an area in the northwestern portion of the site was disturbed around the time of construction of the existing building to the west.

Nearmap Aerial Image of the Site – August 2017

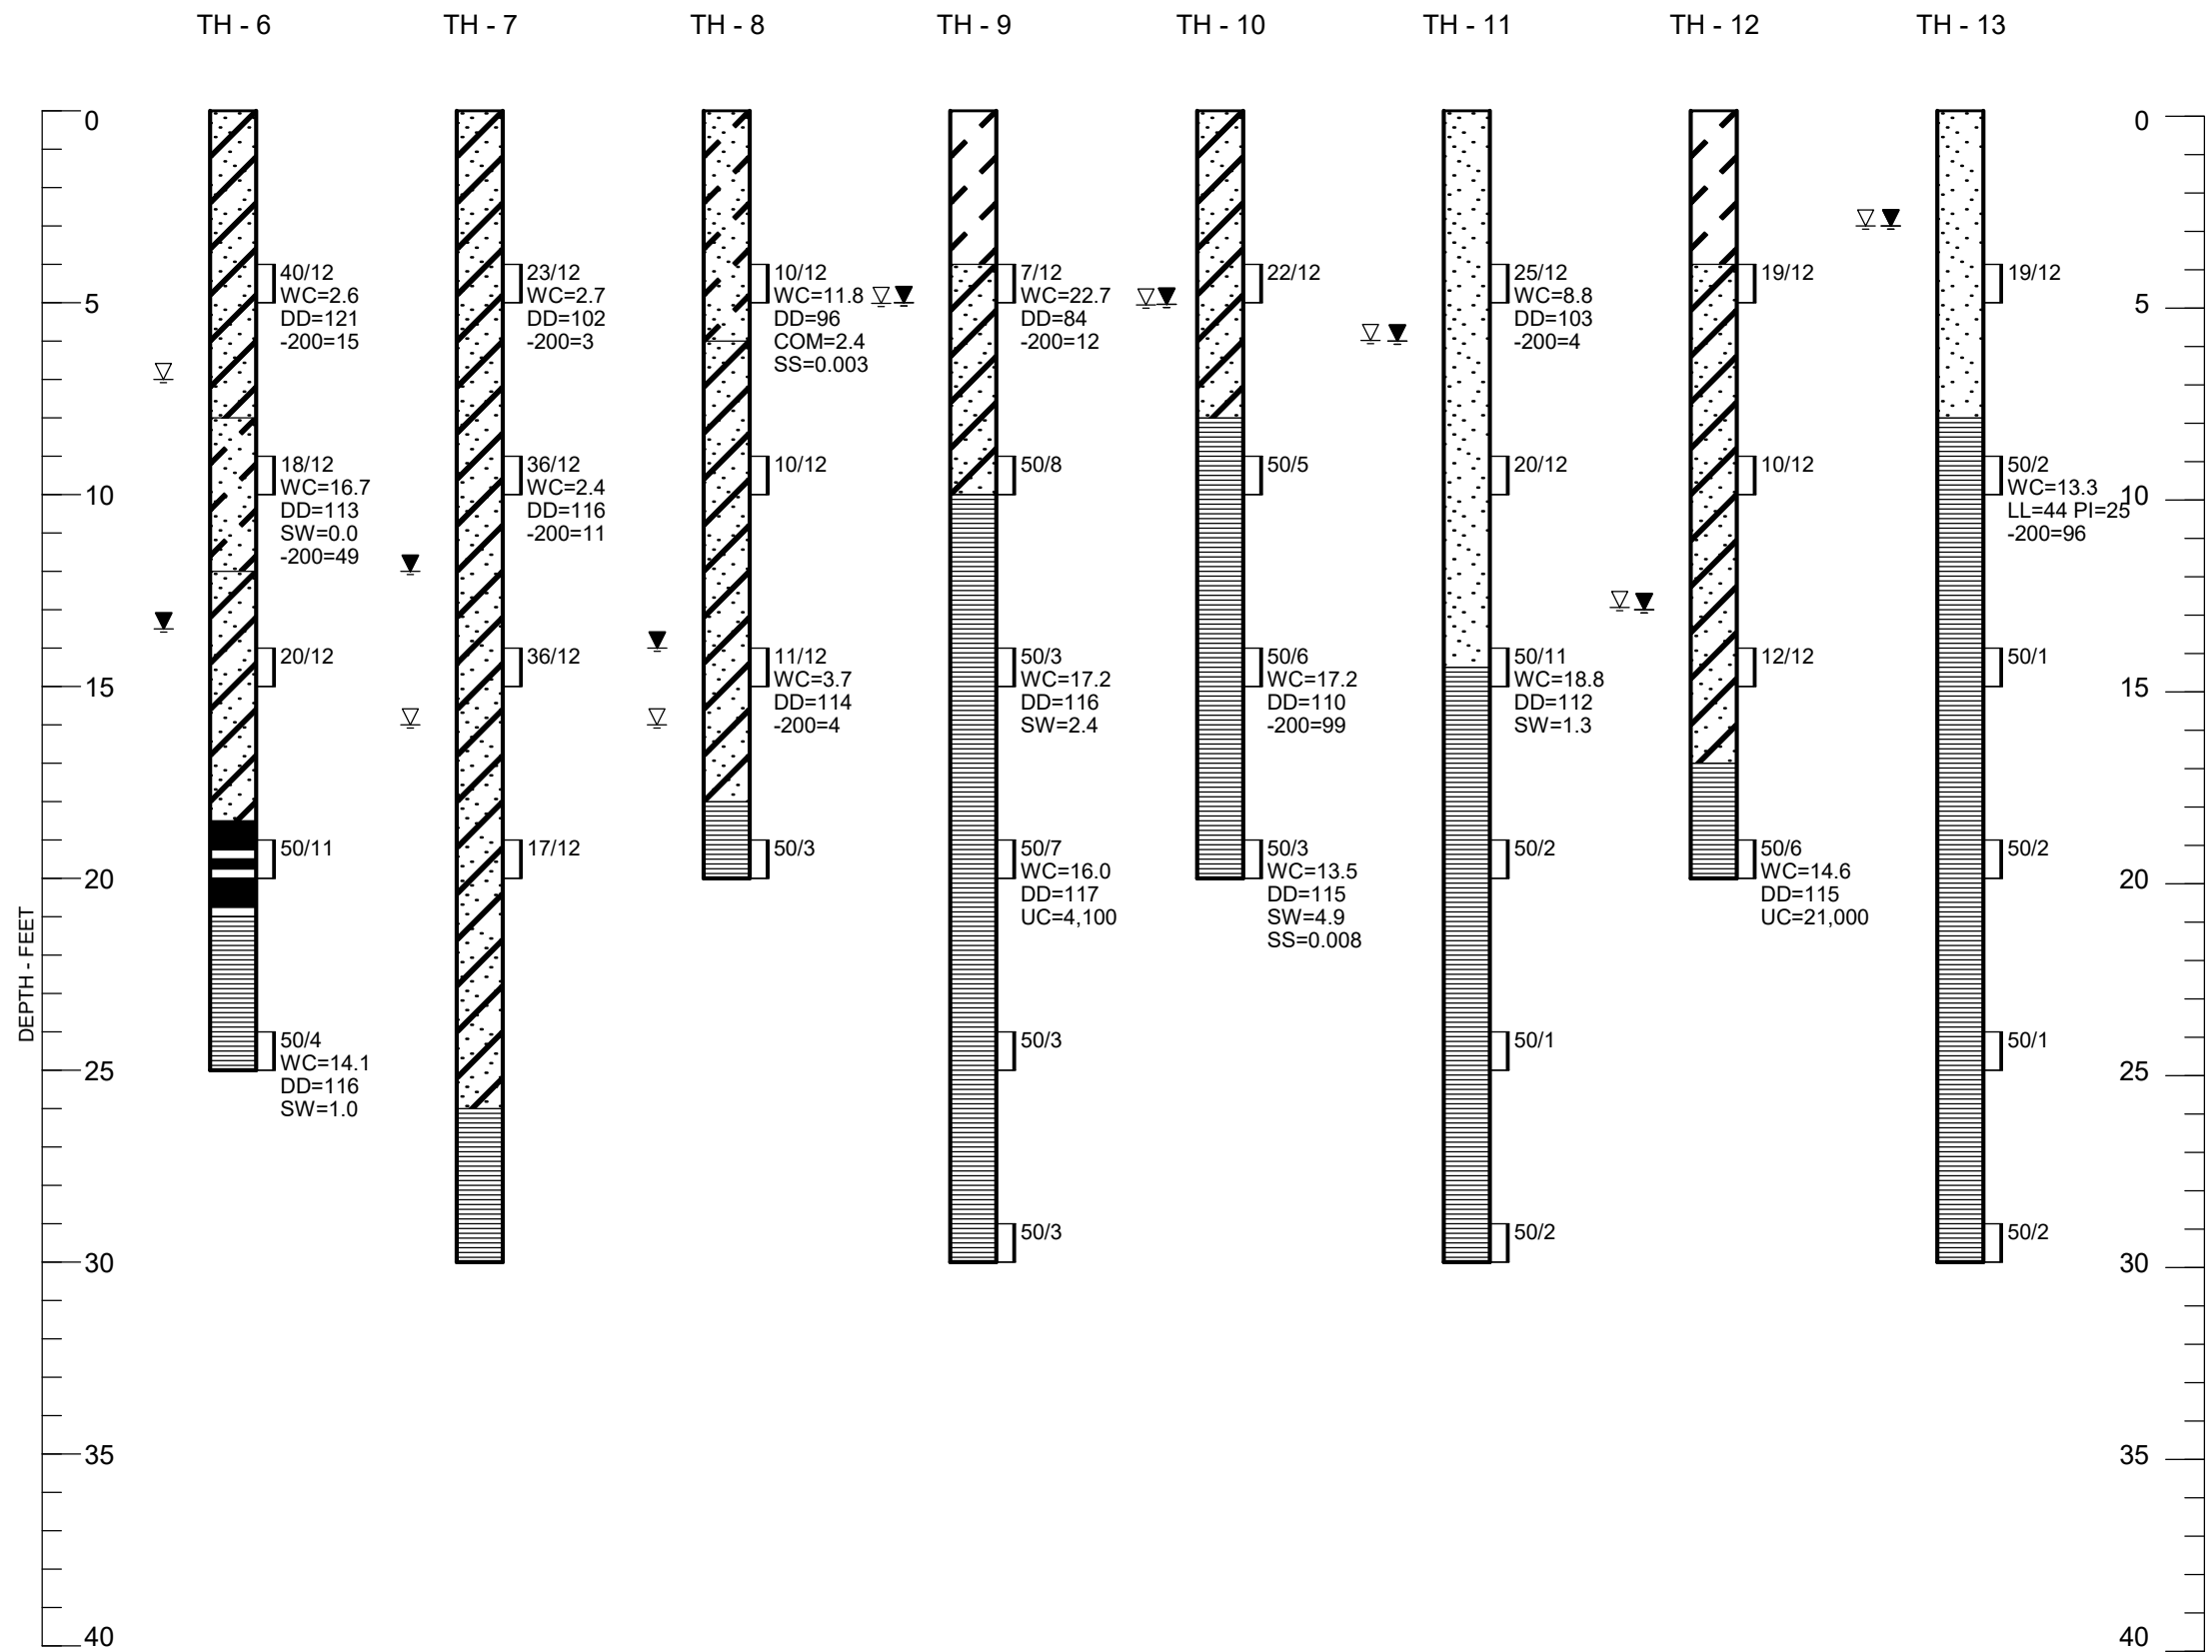
SUMMARY LOGS OF EXPLORATORY BORINGS

- CLAY, VERY SOFT TO STIFF, MOIST, DARK BROWN. (CL)
- SAND, GRAVEL, MEDIUM DENSE, MOIST TO WET, DARK BROWN. (SP)
- SAND, SLIGHTLY SILTY TO SILTY, OCASSIONAL GRAVEL, LOOSE TO VERY DENSE, MOIST TO WET, DARK BROWN. (SM, SP-SM, SW-SM)
- SAND, CLAYEY, LOOSE TO MEDIUM DENSE, MOIST, DARK BROWN. (SC)
- BEDROCK. CLAYSTONE, HARD, MOIST DARK GRAY.
- SHALE, HARD TO VERY HARD, MOIST, DARK GRAY.
- DRIVE SAMPLE. THE SYMBOL 11/12 INDICATES 11 BLOWS OF A 140-POUND HAMMER FALLING 30 INCHES WERE REQUIRED TO DRIVE A 2.5-INCH O.D. SAMPLER 12 INCHES.
- WATER LEVEL MEASURED AT TIME OF DRILLING.
- WATER LEVEL MEASURED ONE TO THREE DAYS AFTER DRILLING.

Slightly silty to silty and clayey to very clayey sand containing varying percentages of gravel was encountered at the ground surface or below the clay in all thirteen of the borings. The granular soils were generally loose to very dense. Two samples exhibited compression (0.2 and 2.4 percent) when wetted. The sand samples tested contained between 3 and 49 percent fines (silt and clay-size particles).

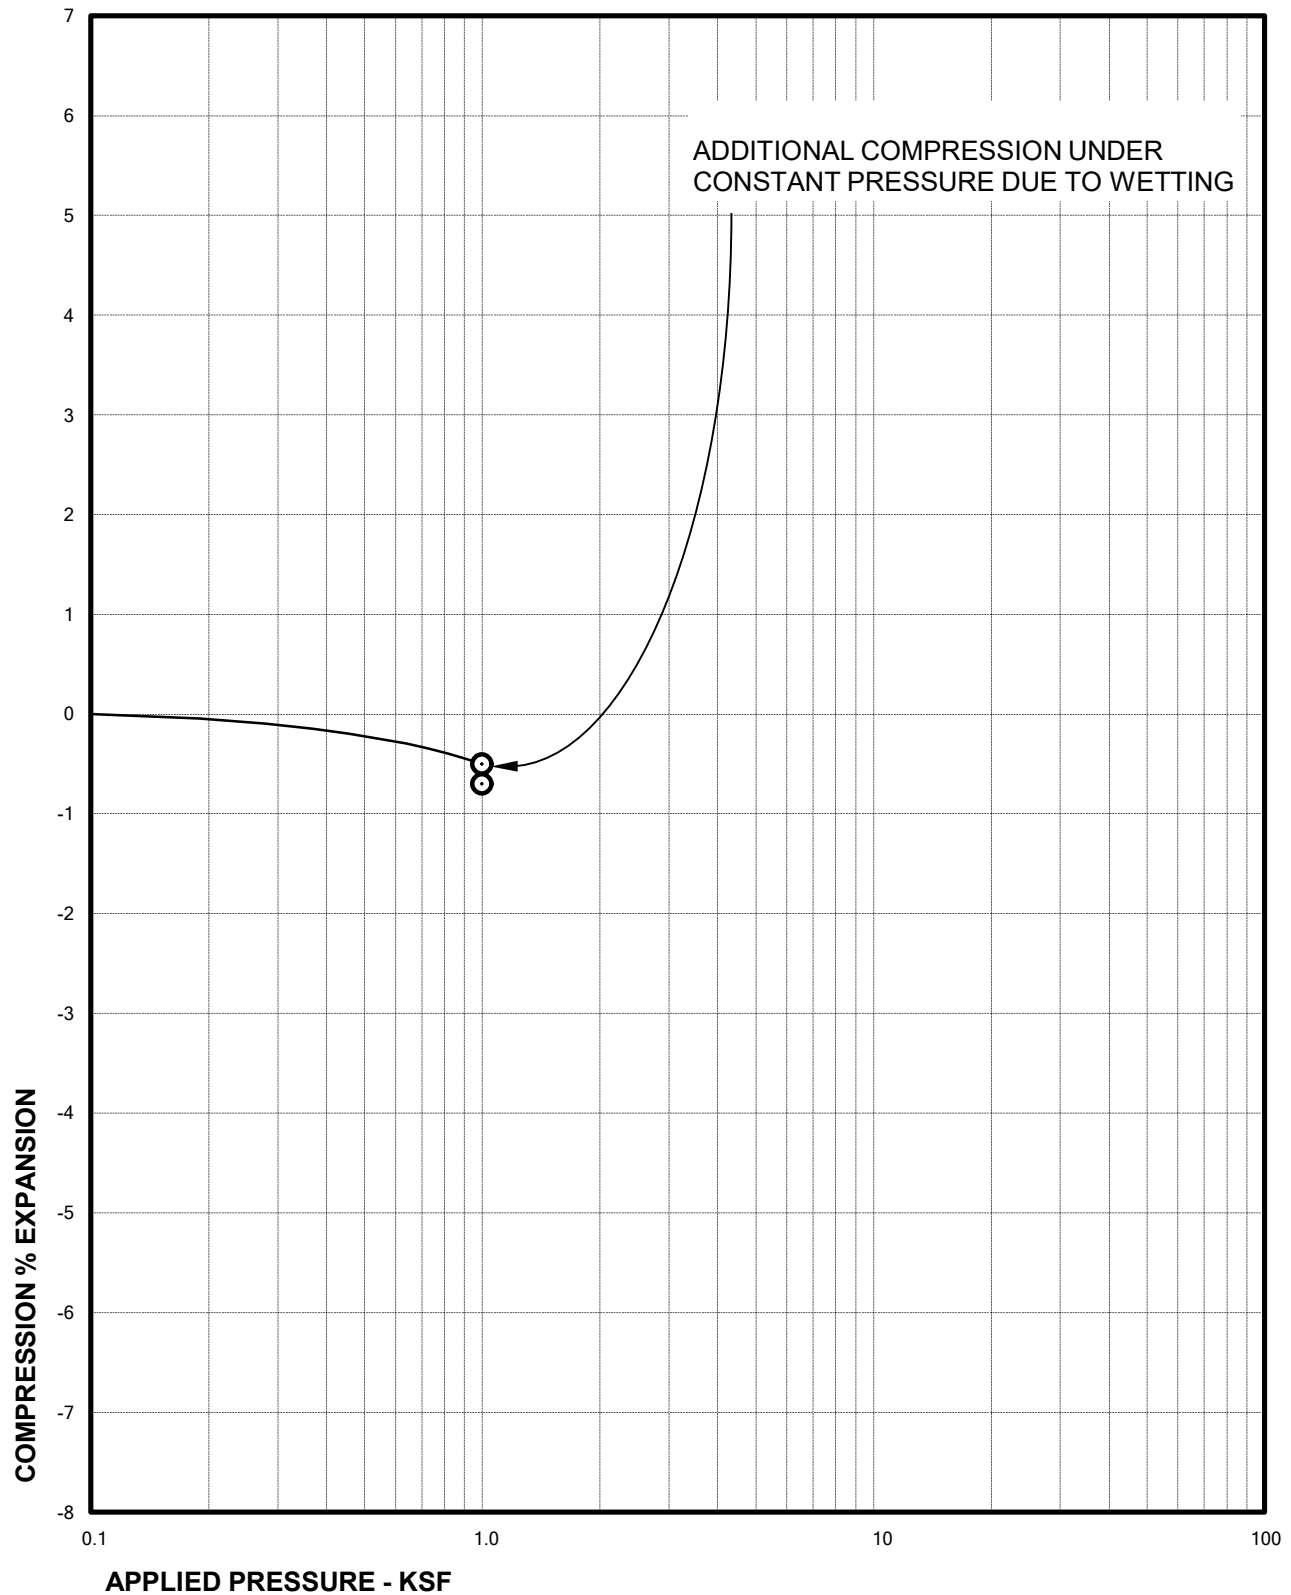
Swell Consolidation Test Results

Sample of SAND, SILTY (SM)
From TH-1 AT 19 FEET

DRY UNIT WEIGHT= 112 PCF
MOISTURE CONTENT= 7.7 %

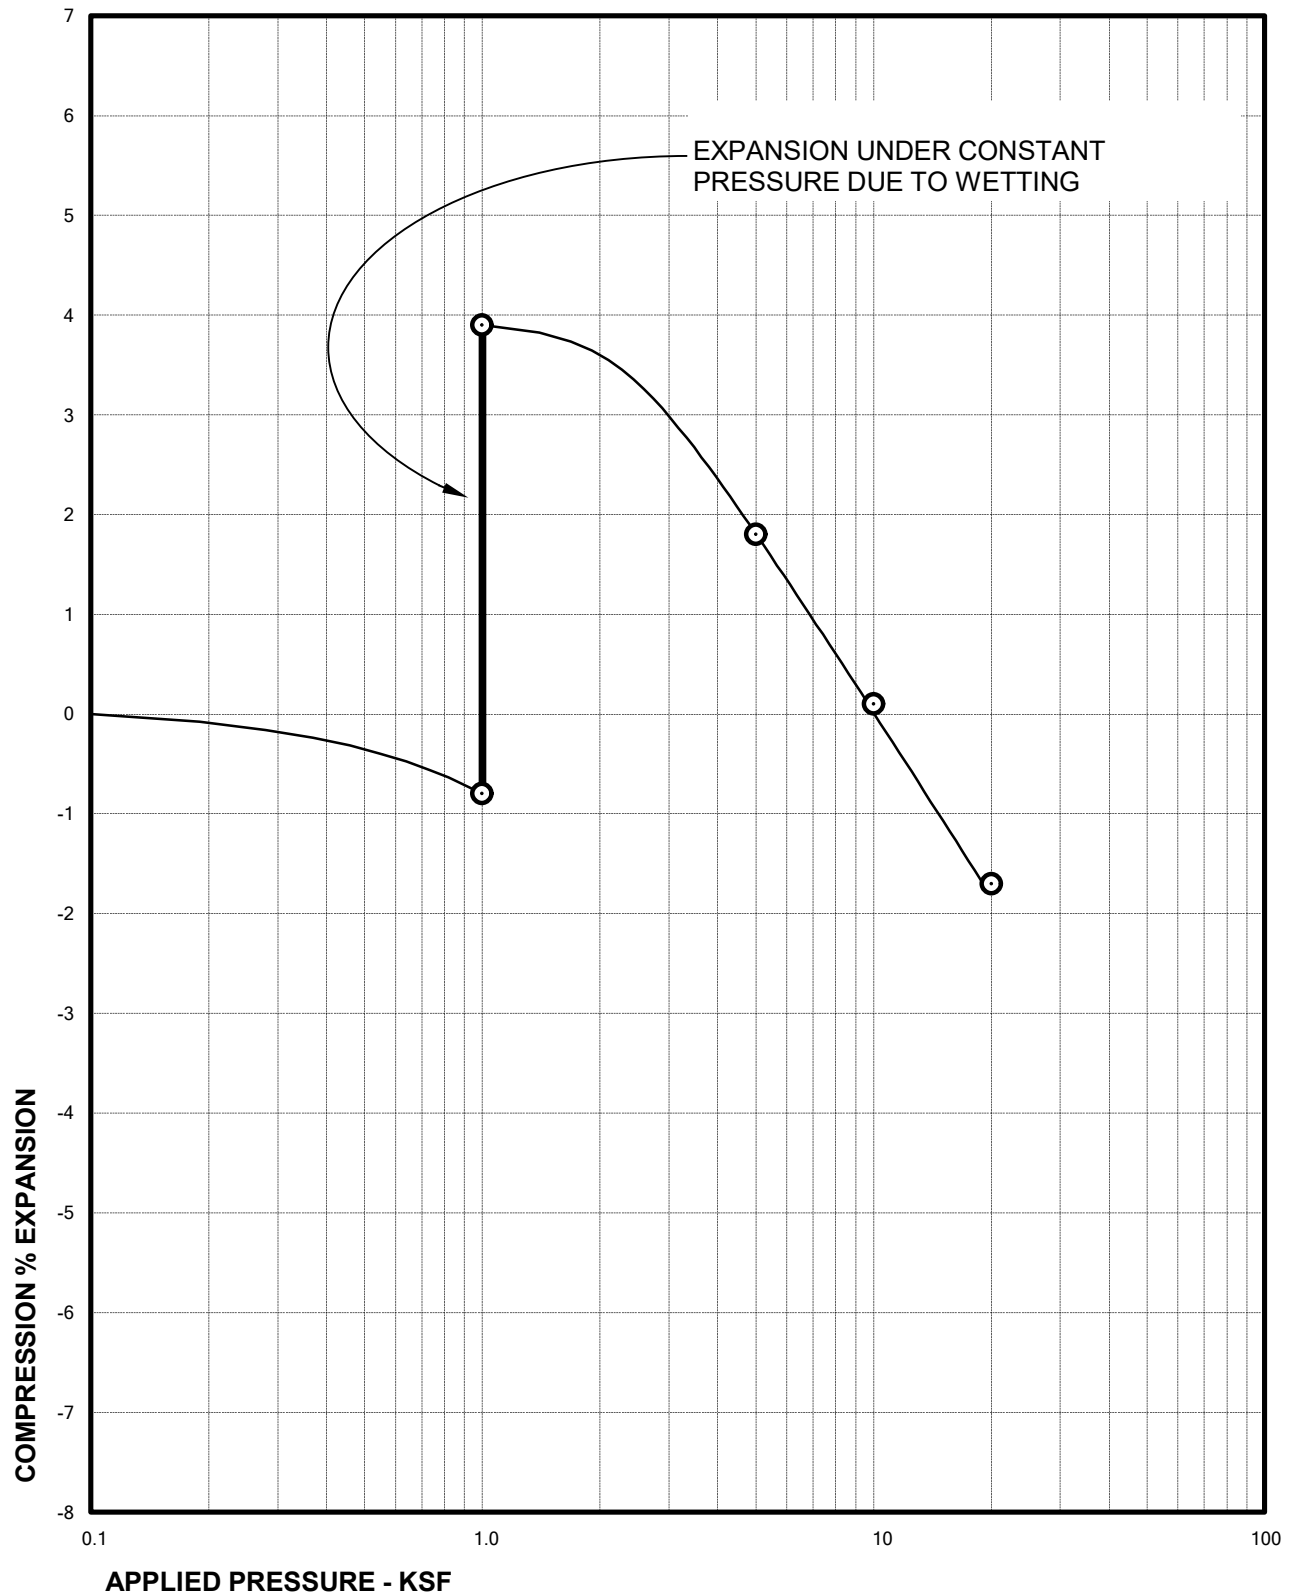
Swell Consolidation Test Results

Sample of SHALE
From TH-3 AT 29 FEET

DRY UNIT WEIGHT= 123 PCF
MOISTURE CONTENT= 11.5 %

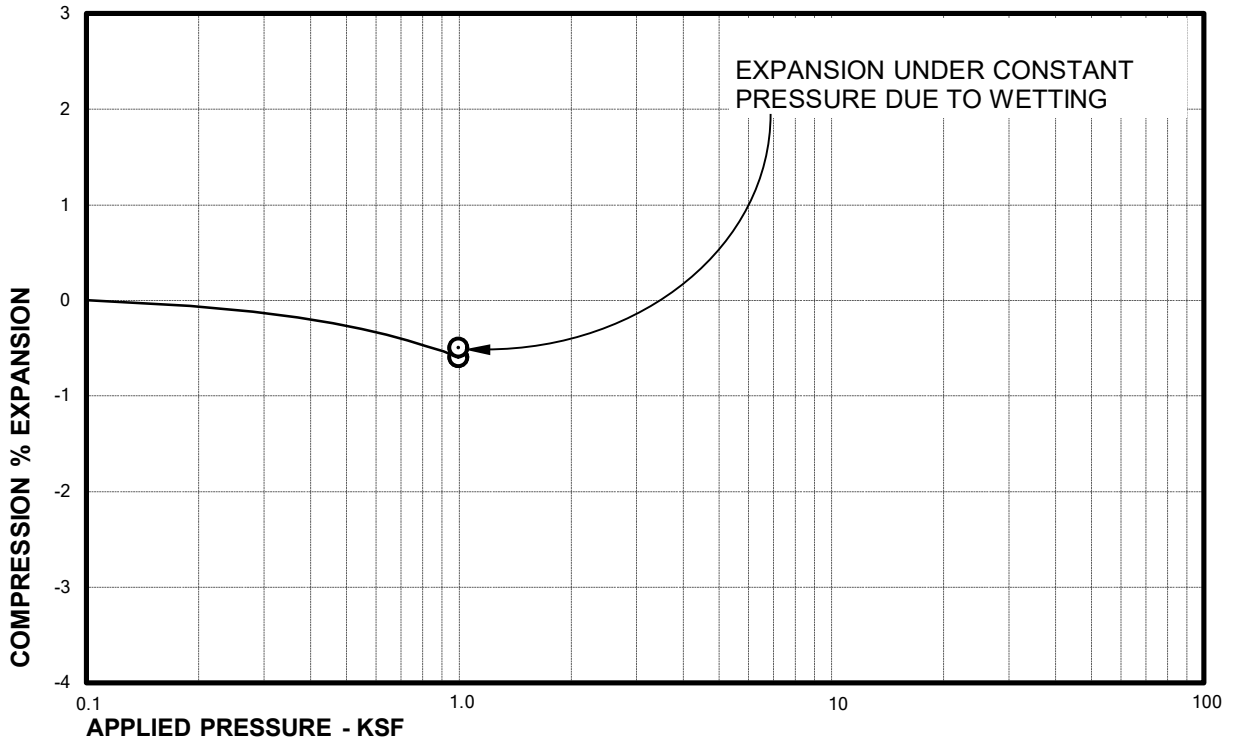
Sample of SAND, CLAYEY (SC)
From TH-4 AT 4 FEET

DRY UNIT WEIGHT= 107 PCF
MOISTURE CONTENT= 11.4 %

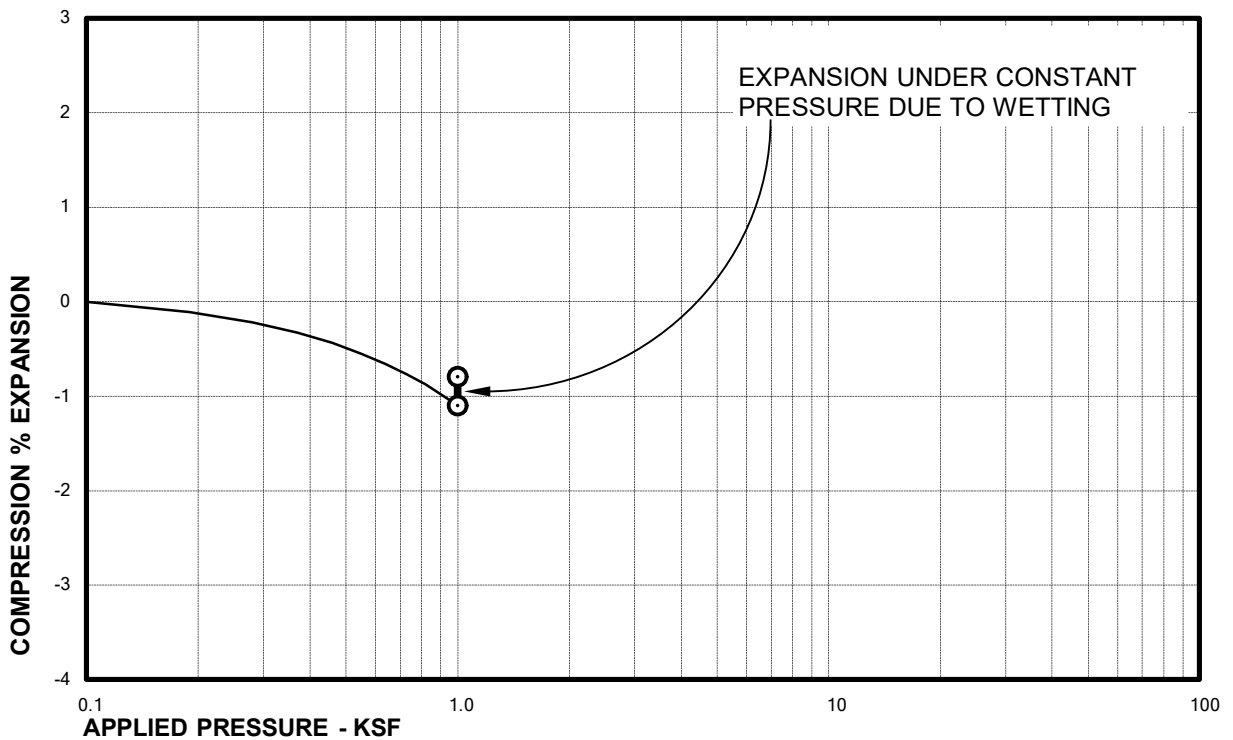
Sample of CLAY (CL)
From TH-5 AT 4 FEET

DRY UNIT WEIGHT= 103 PCF
MOISTURE CONTENT= 23.2 %

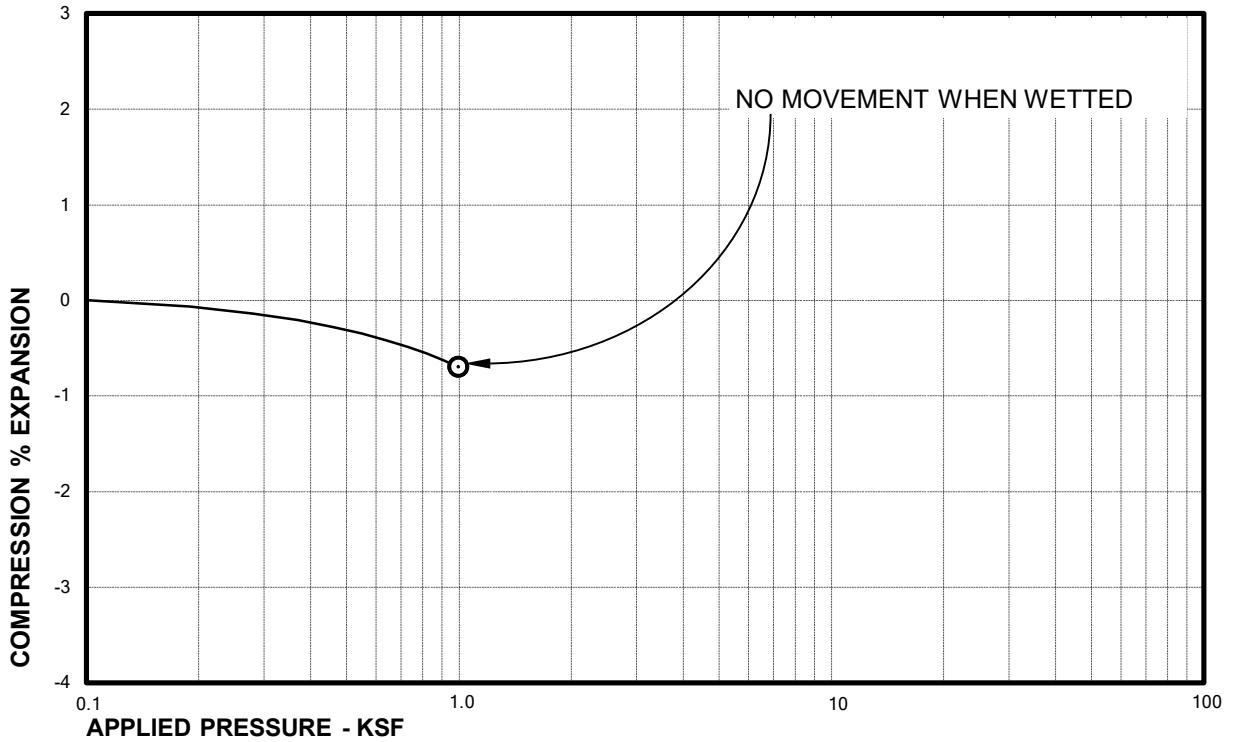
Sample of SAND, VERY CLAYEY (SC)
From TH-6 AT 9 FEET

DRY UNIT WEIGHT= 113 PCF
MOISTURE CONTENT= 16.7 %

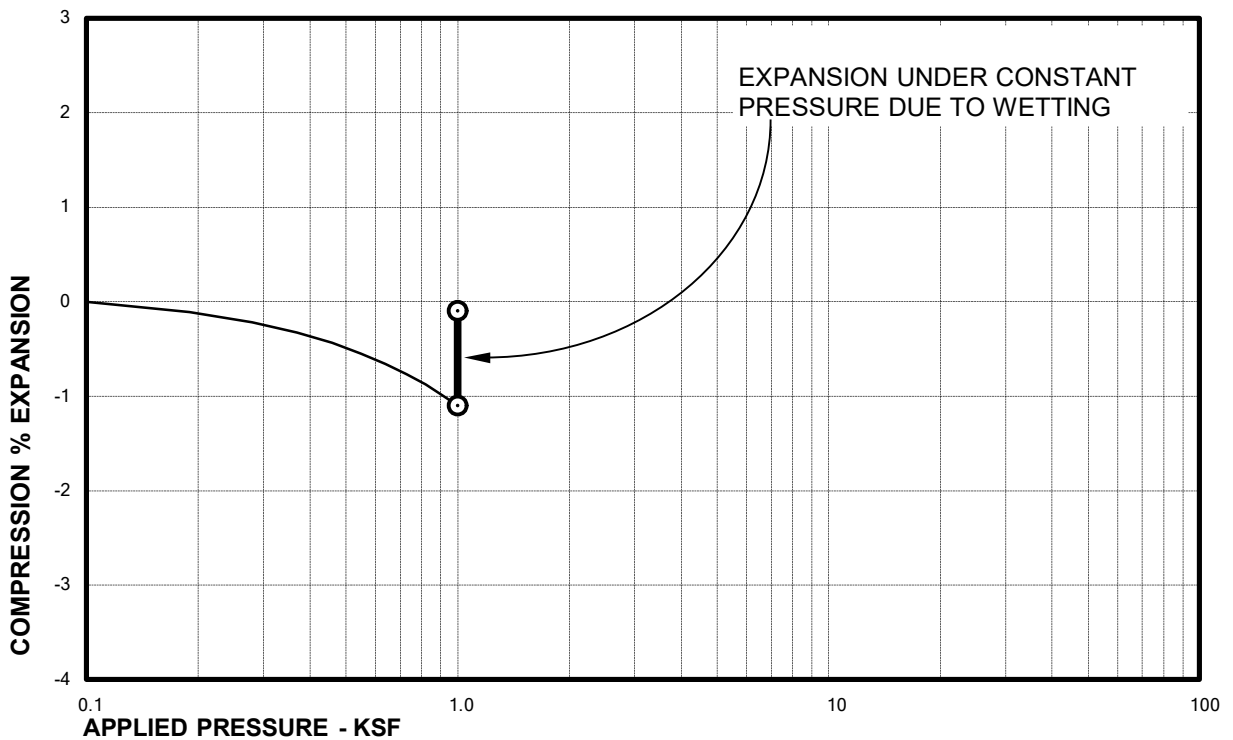
Sample of SHALE
From TH-6 AT 24 FEET

DRY UNIT WEIGHT= 116 PCF
MOISTURE CONTENT= 14.1 %

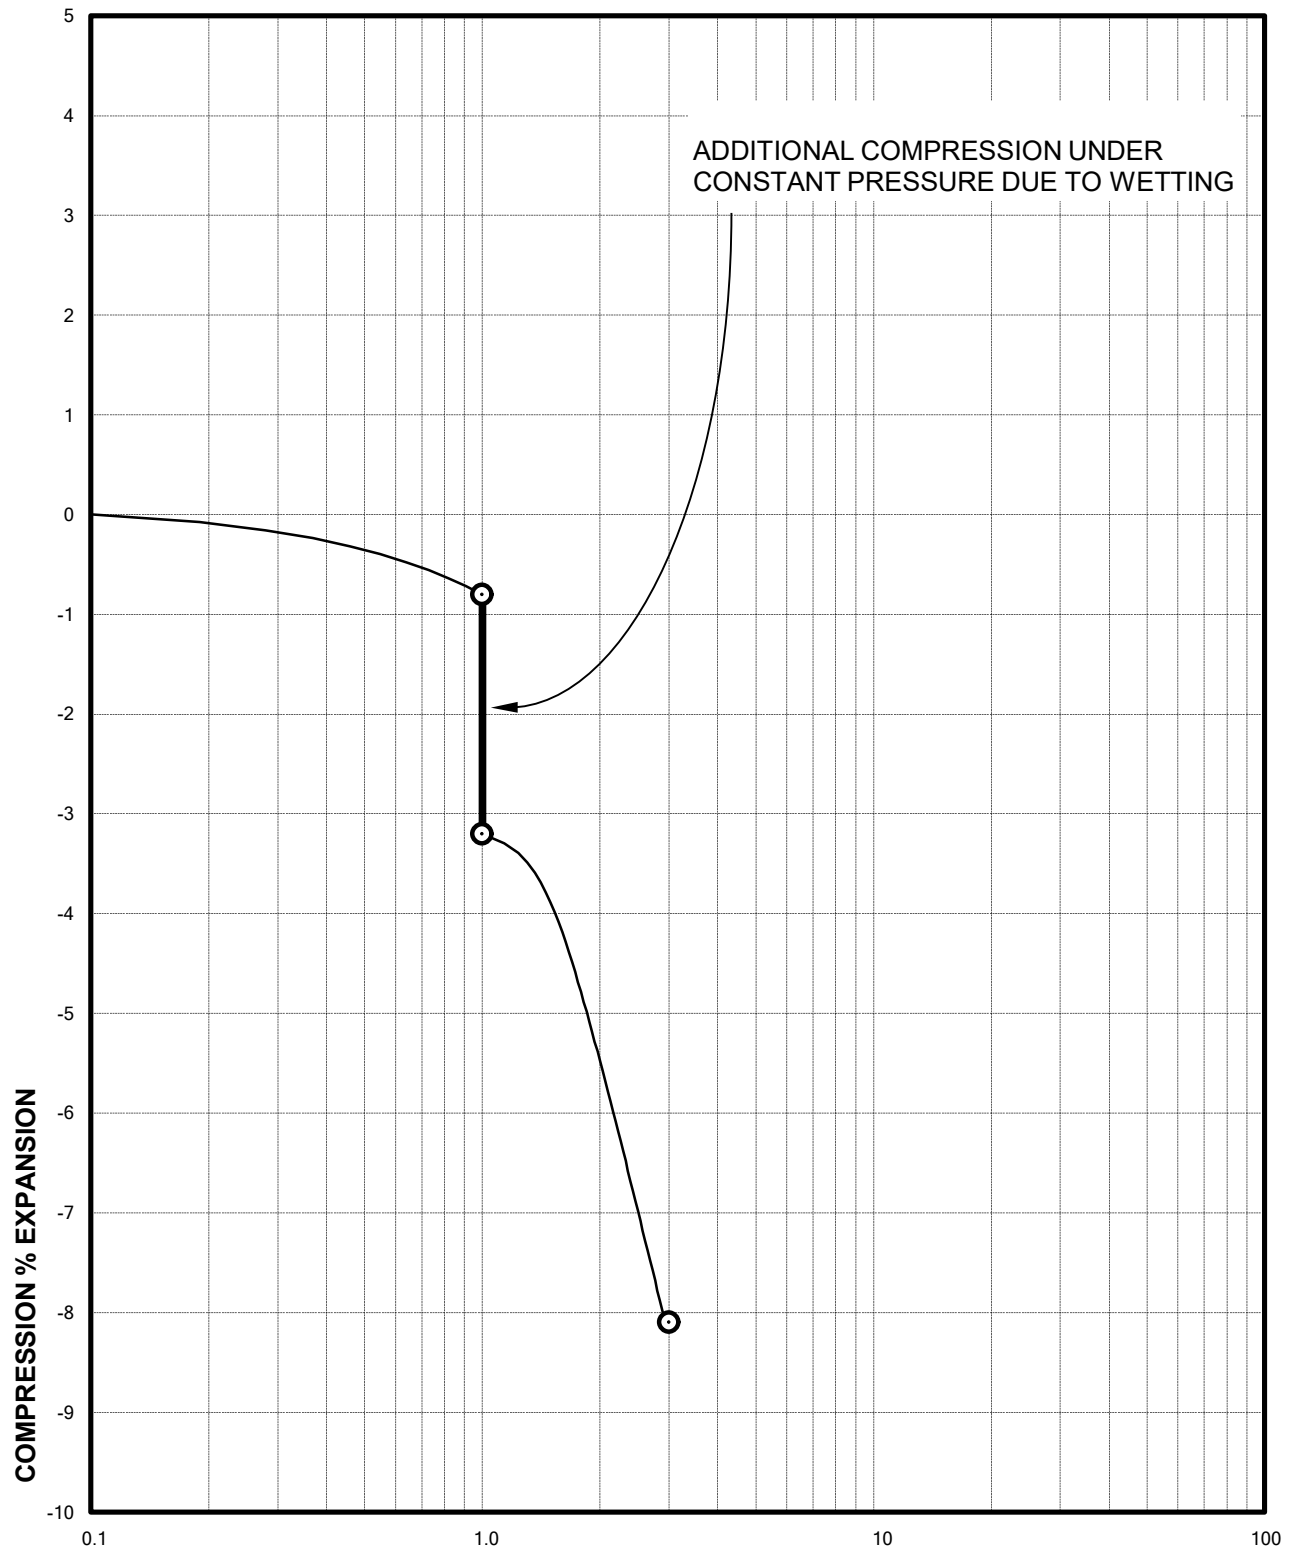
Swell Consolidation Test Results

APPLIED PRESSURE - KSF
Sample of SAND, CLAYEY (SC)
From TH-8 AT 4 FEET

DRY UNIT WEIGHT= 96 PCF
MOISTURE CONTENT= 11.8 %

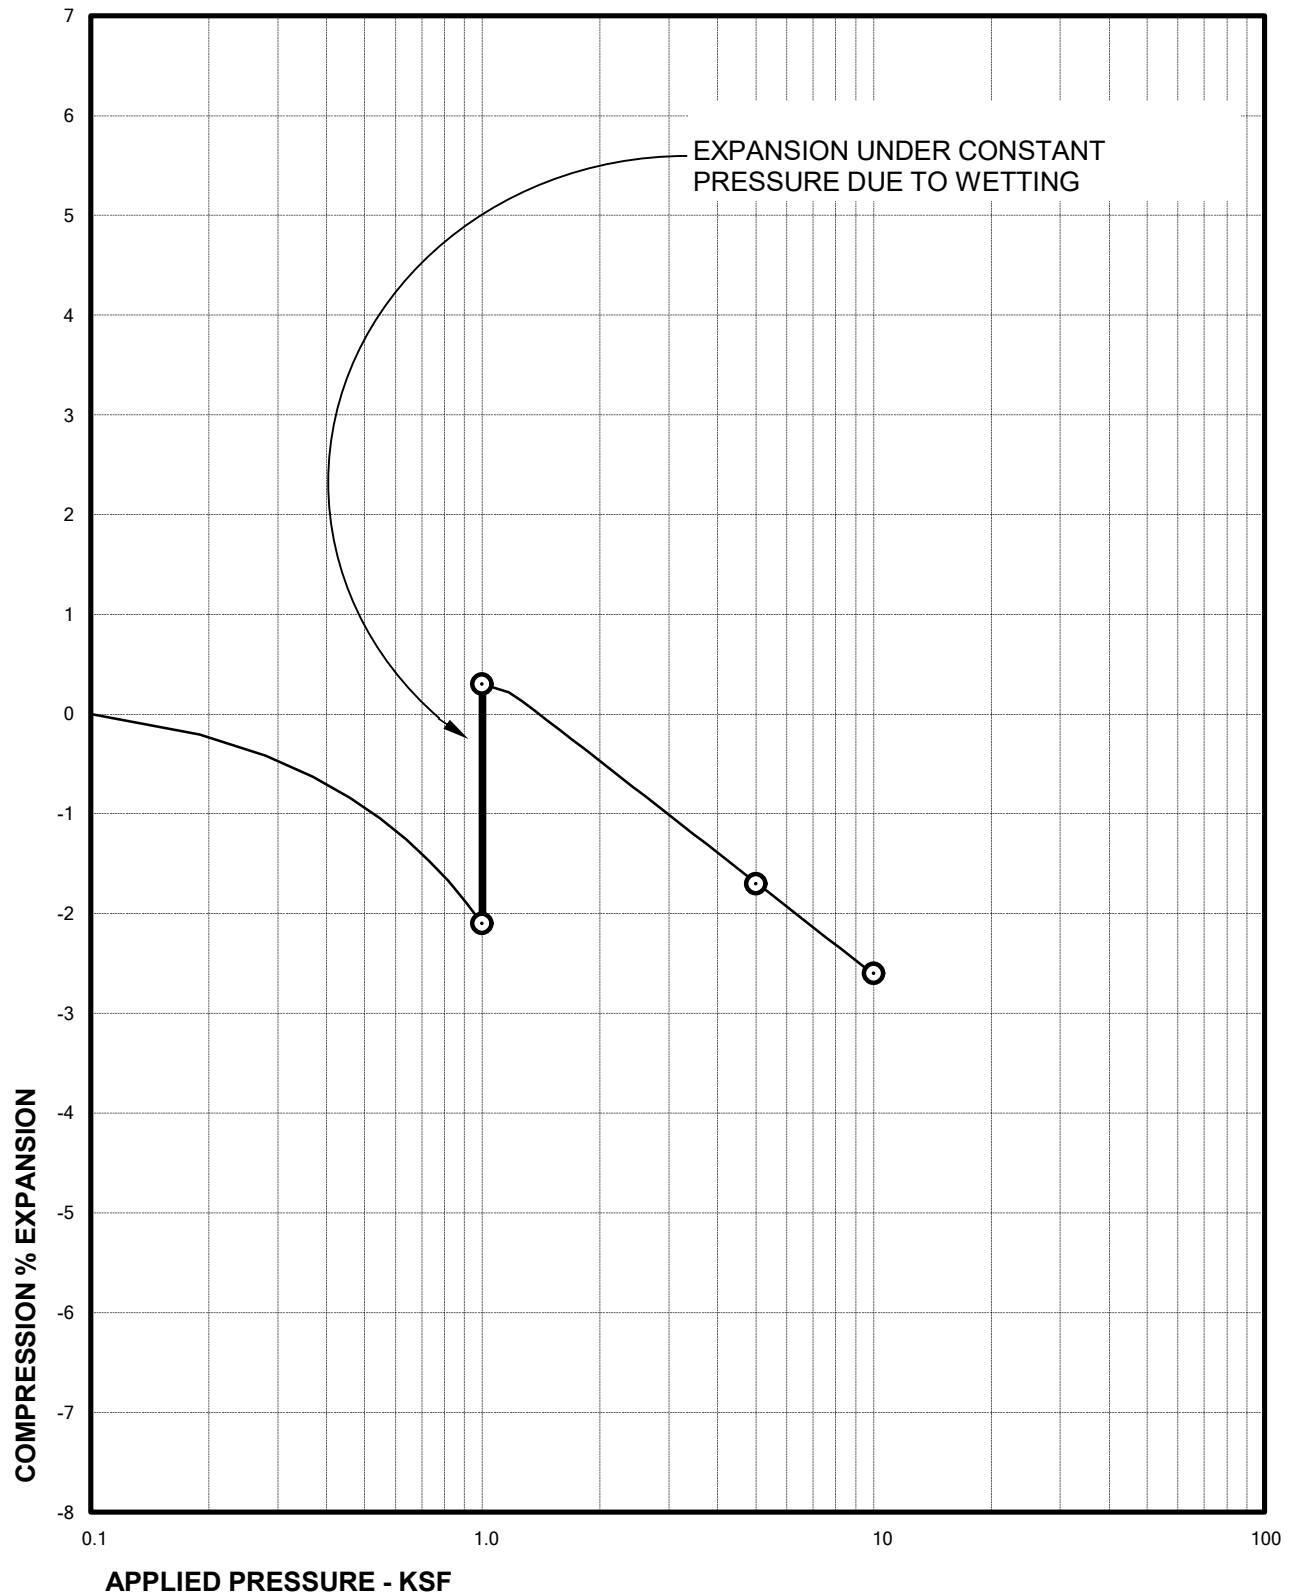
Swell Consolidation Test Results

Sample of SHALE
From TH-9 AT 14 FEET

DRY UNIT WEIGHT= 116 PCF
MOISTURE CONTENT= 17.2 %

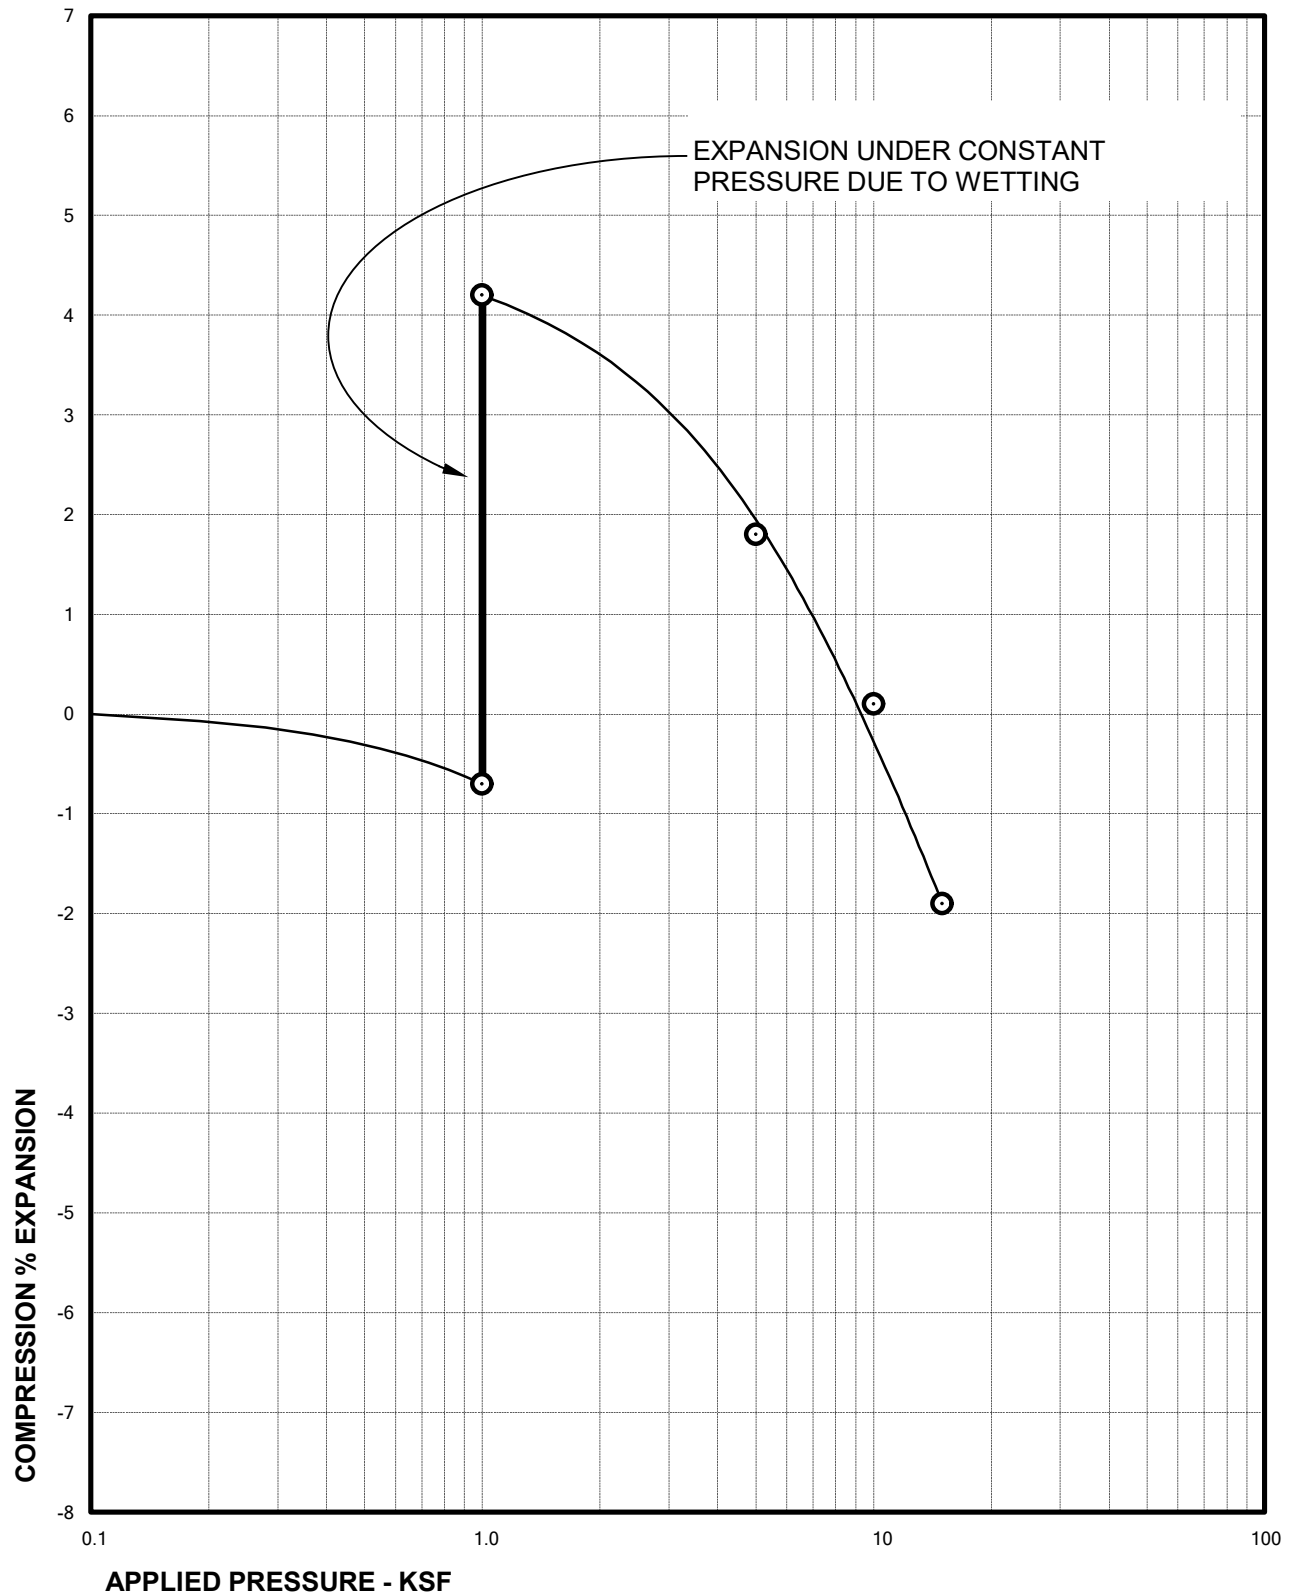
Swell Consolidation Test Results

Sample of SHALE
From TH-10 AT 19 FEET

DRY UNIT WEIGHT= 115 PCF
MOISTURE CONTENT= 17.5 %

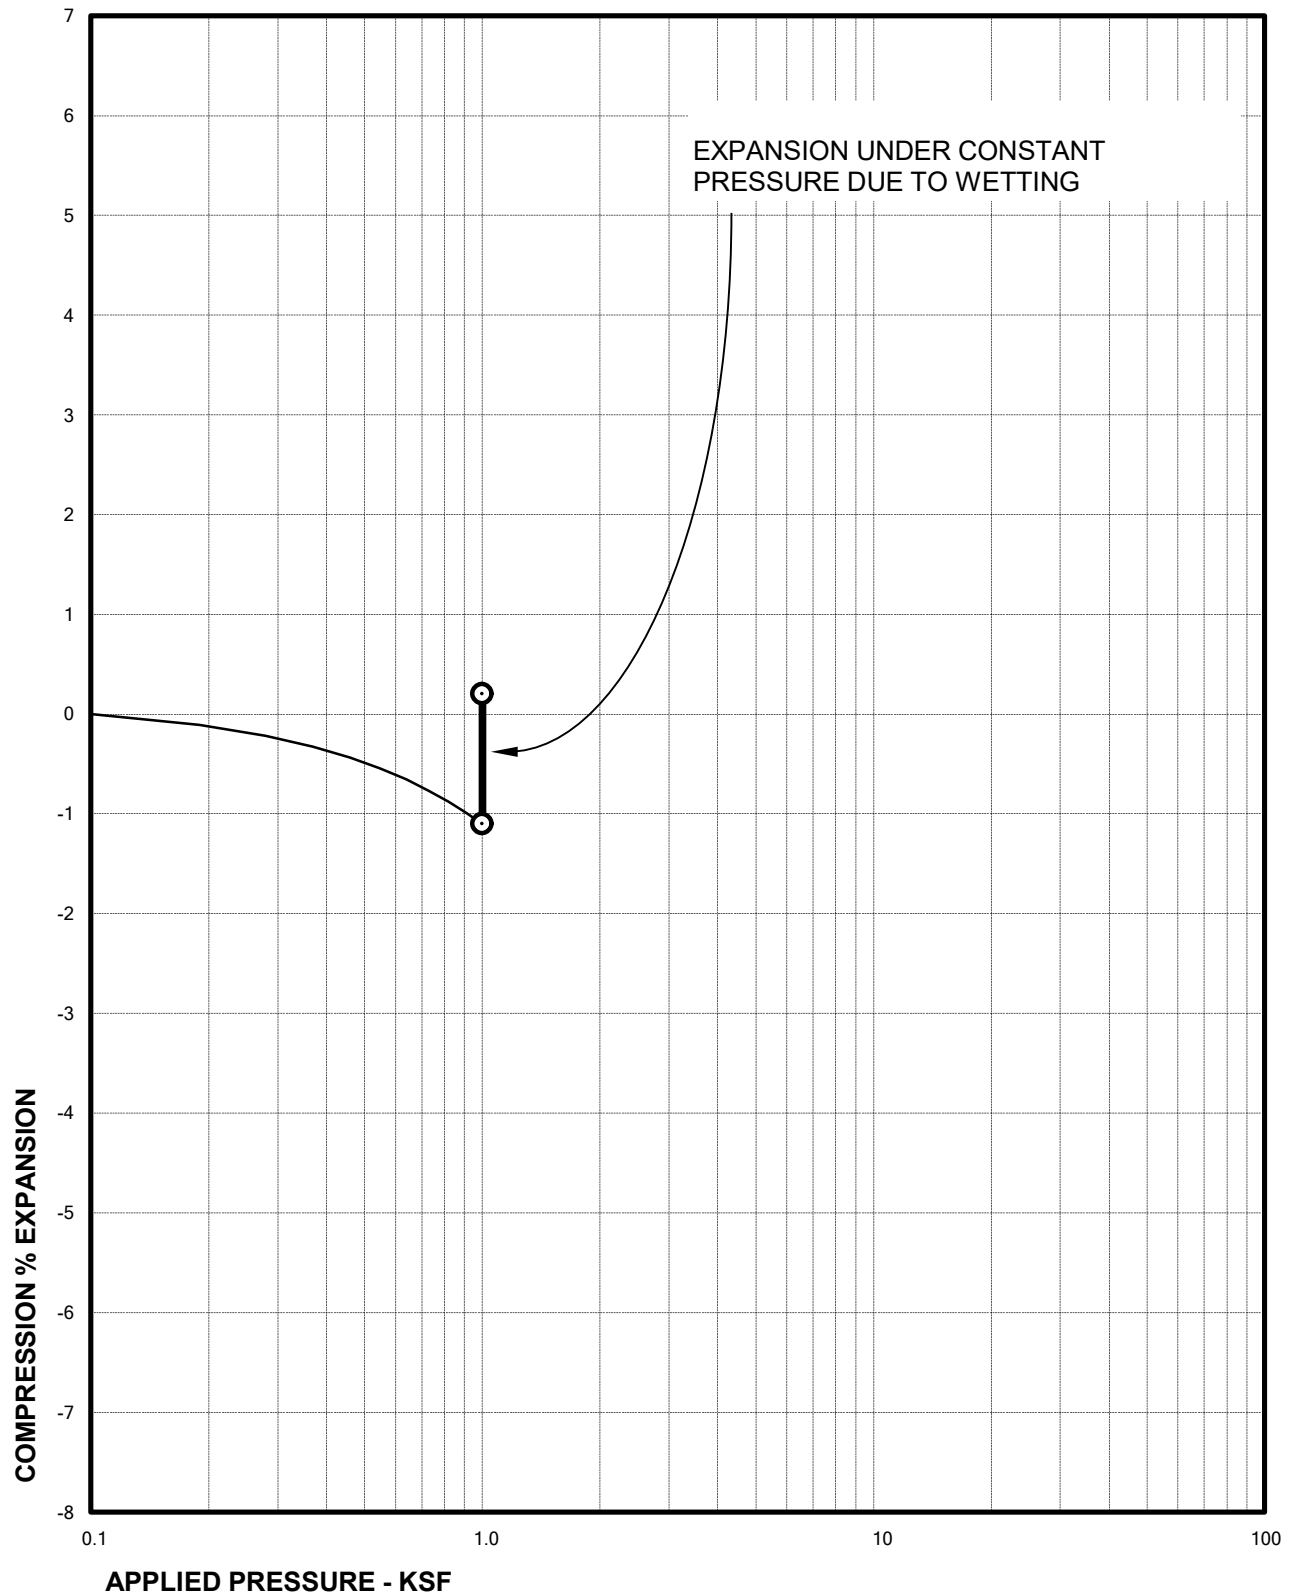
Swell Consolidation Test Results

Sample of SHALE
From TH-11 AT 14 FEET

DRY UNIT WEIGHT= 112 PCF
MOISTURE CONTENT= 18.8 %

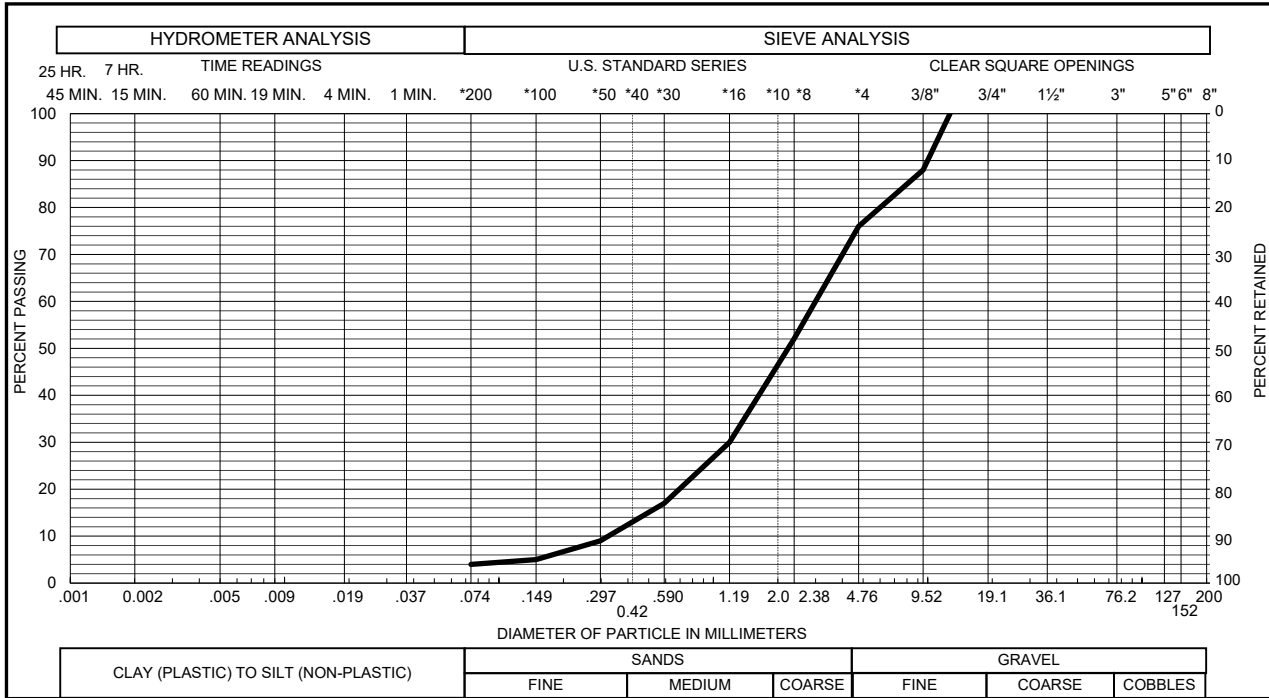
Sample of SAND, SLIGHTLY SILTY (SW-SM) GRAVEL 24 % SAND 72 %
 From TH - 11 AT 4 FEET SILT & CLAY 4 % LIQUID LIMIT _____ %
 PLASTICITY INDEX _____ %
