ENTECH
ENGINEERING, INC.

**WASTEWATER STUDY
ROLLIN RIDGE ESTATES
HODGEN ROAD AND HIGHWAY 83 – SOUTHWEST CORNER
EL PASO COUNTY, COLORADO**

November 12, 2019
Revised February 19, 2020

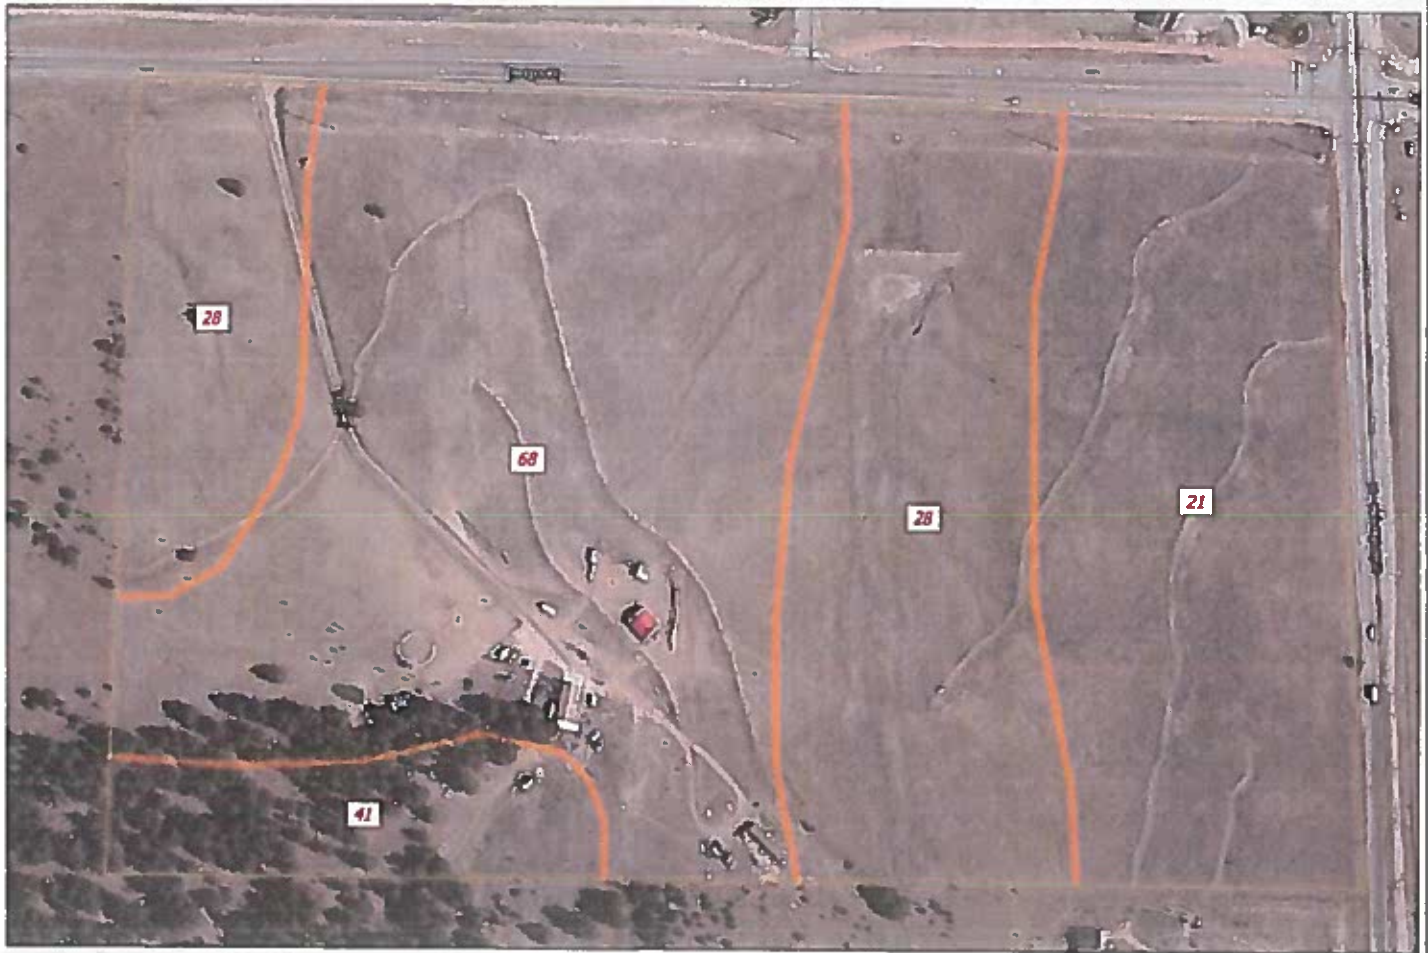
FIG NO:
4

SCS MAP
ROLLIN RIDGE ESTATES
HODGEN ROAD AND HIGHWAY 83
EL PASO COUNTY, CO.
FOR: CARL TURSE

Figure 4: Soil Survey Map

Complete descriptions of each soil type are presented in Appendix D. The soils have generally been described to typically have moderate to moderately rapid permeabilities. Roads may need to be designed to minimize frost-heave potential. Possible hazards with soil erosion are present on the site. The erosion potential can be controlled with vegetation. The majority of the soils have been described to have slight to moderate erosion hazards.

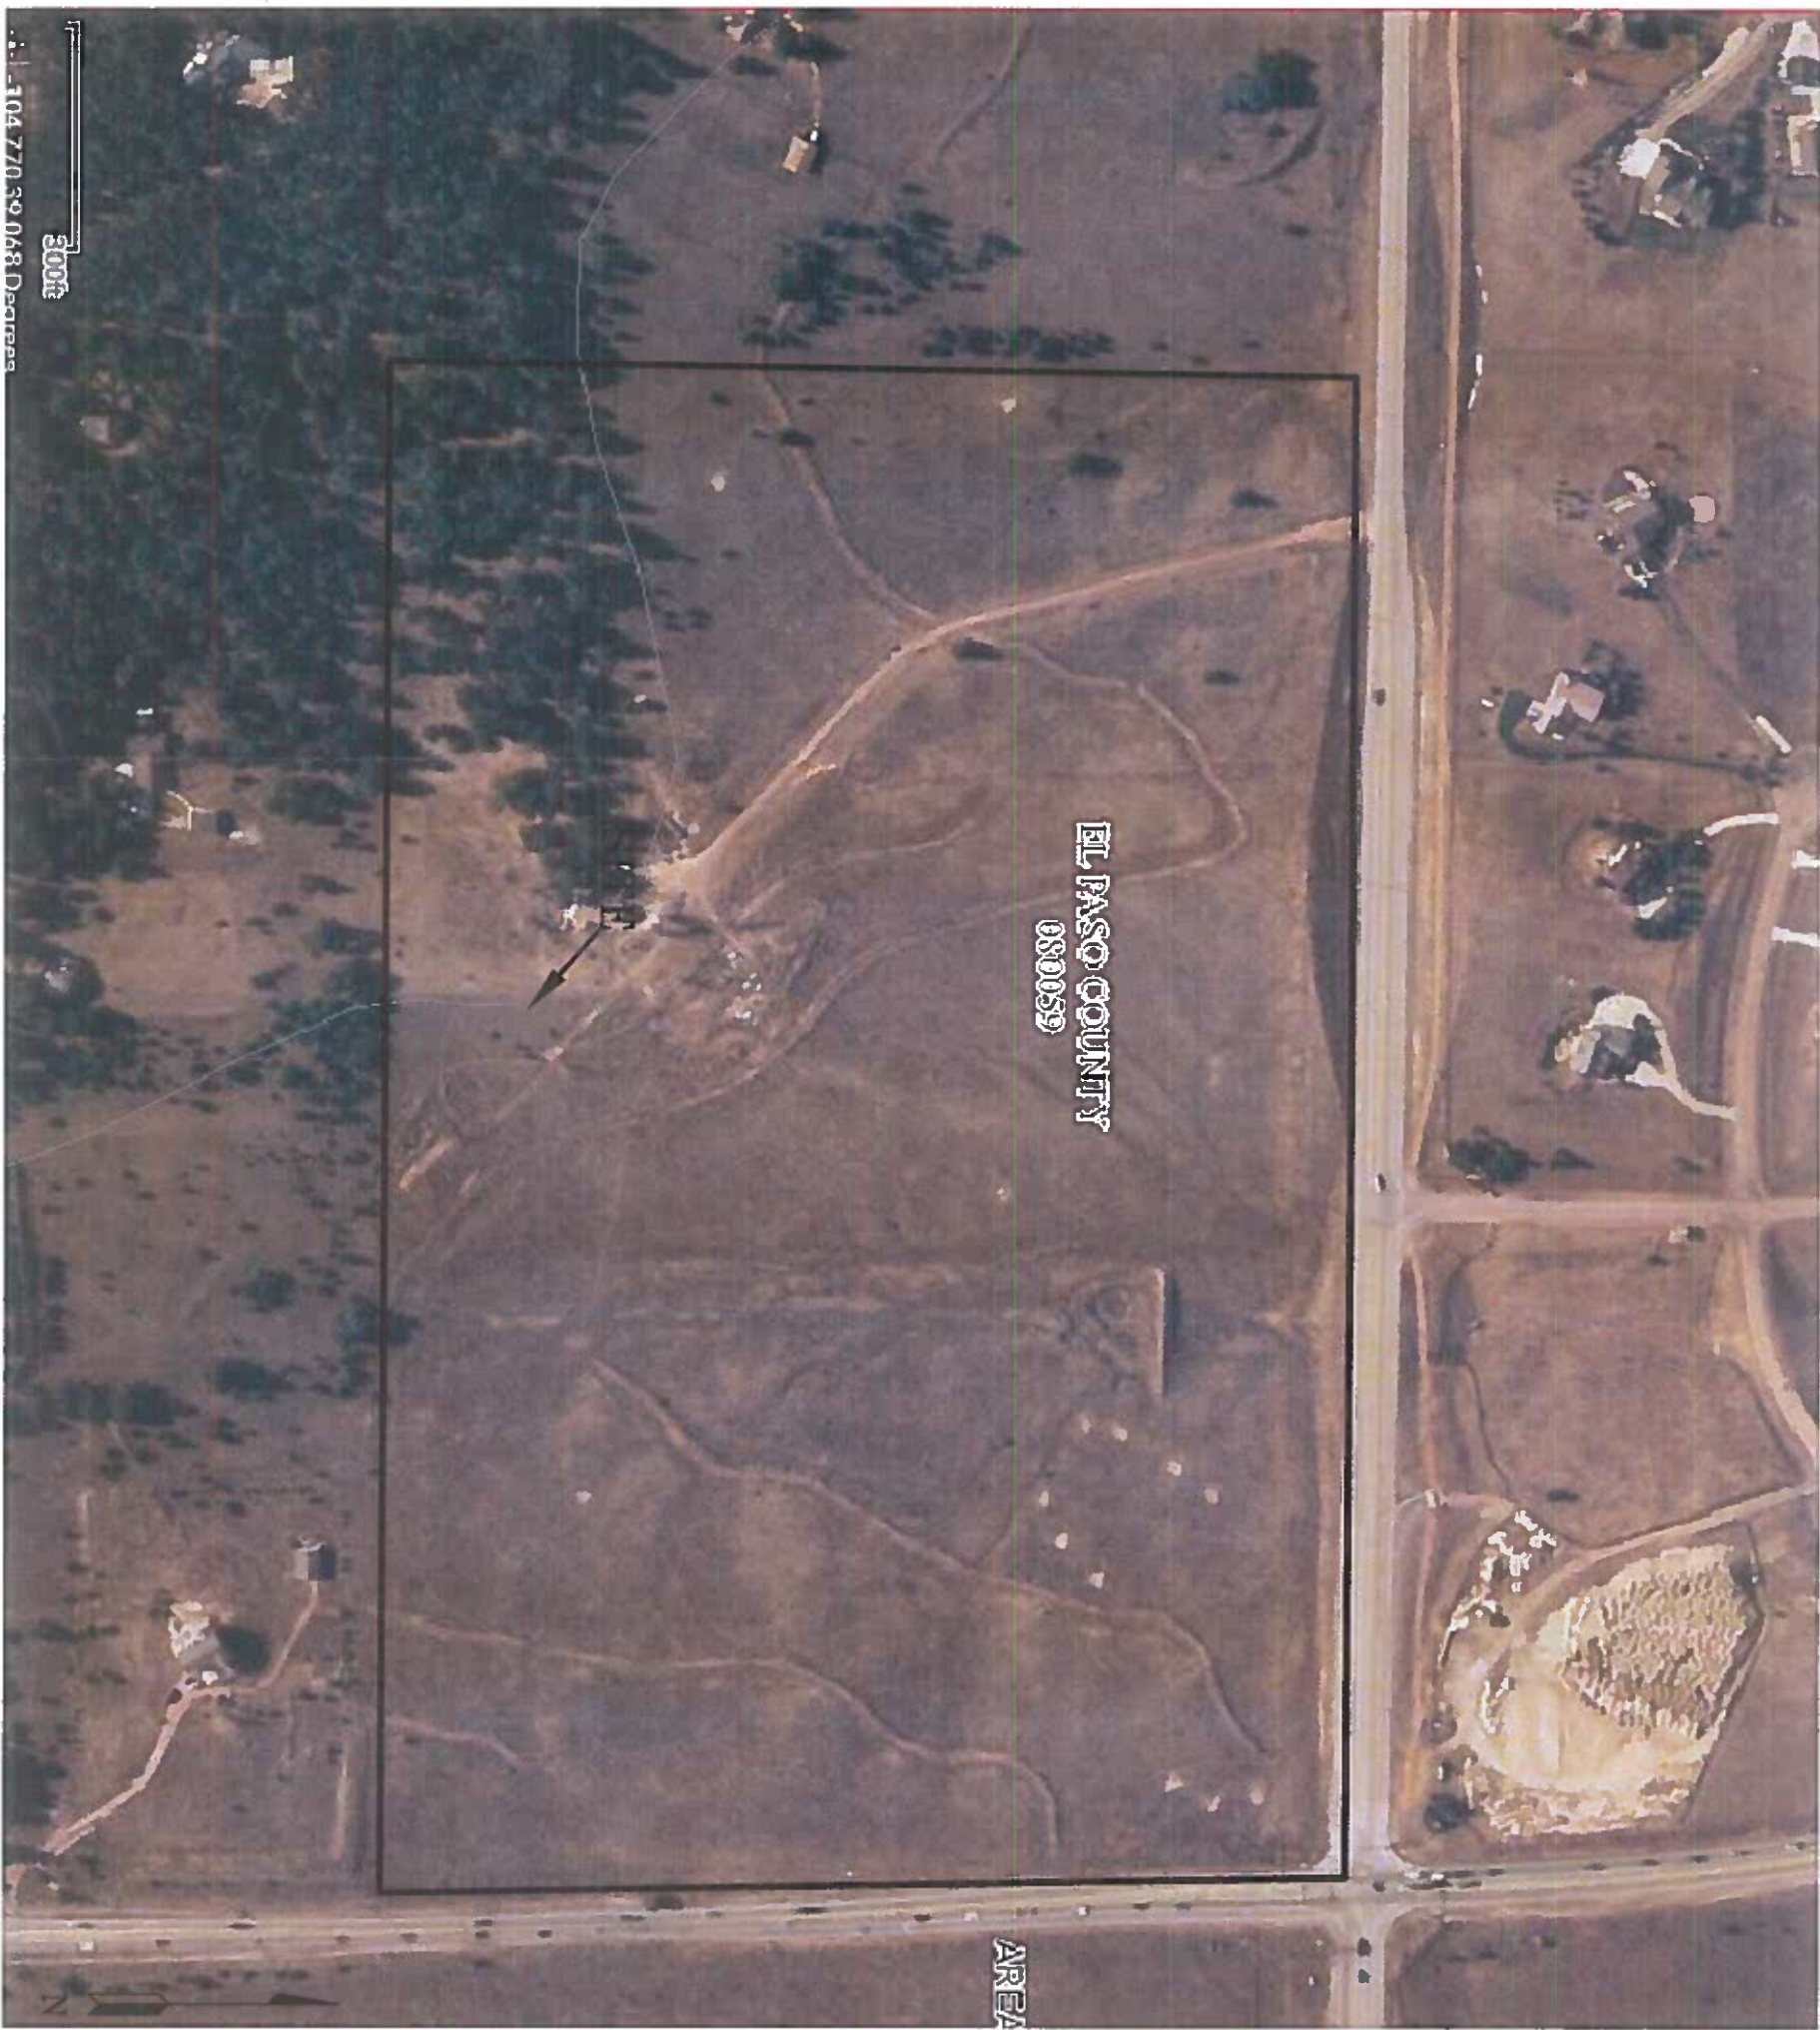
FLOODPLAIN MAP
ROLLIN RIDGE ESTATES
HODGEN ROAD AND HIGHWAY 83
EL PASO COUNTY, CO.
FOR: CARL TURSE

Figure 7: Floodplain Map

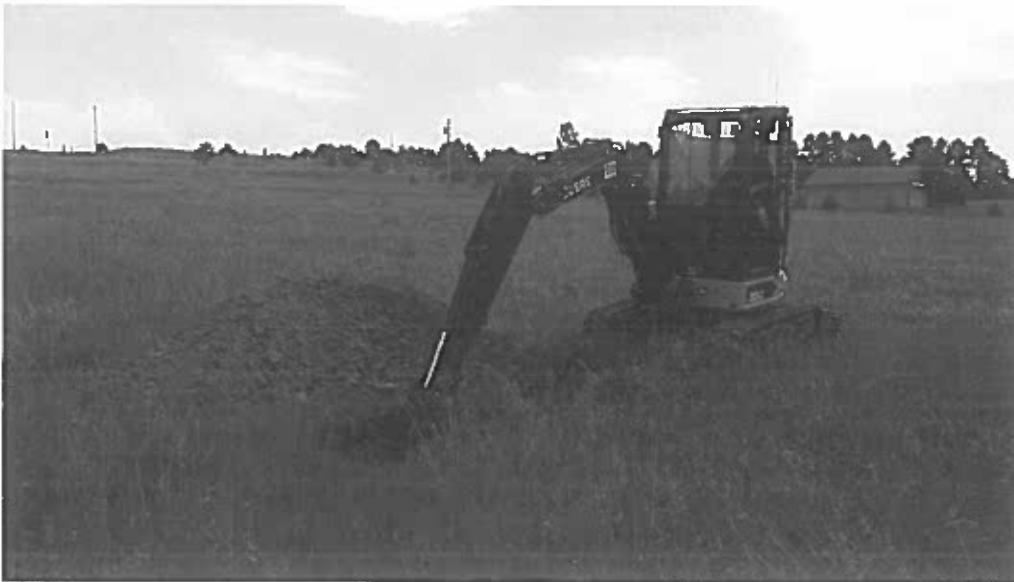
Looking southeast from Test Pit No. 1 in the southeastern portion of the site.

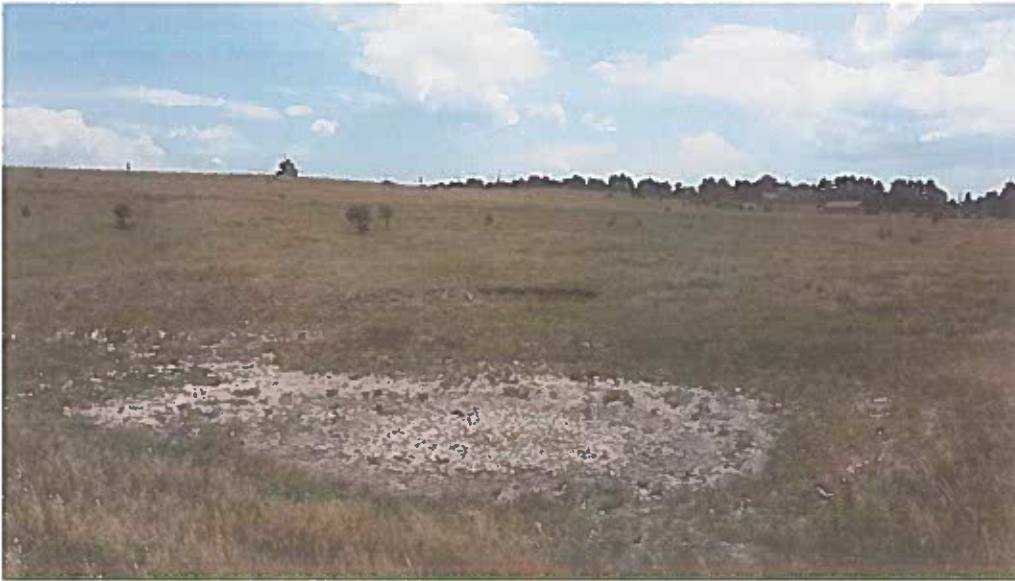
**Looking southeast
from the pond in the
northeastern portion of
the site.**

Areas of seasonal shallow groundwater and potentially seasonal shallow groundwater were encountered on site. A pond and earthen dam are located in the northeastern portion of the site. Water was not observed in the pond or drainages on-site. Due to the size of the lots and the proposed development, these areas can be avoided by construction on the residential lots. Structures should not block drainages. Septic fields should not be located in these areas due to the potential for periodic high groundwater conditions.
