**ENTECH**  
ENGINEERING, INC.

**SOIL, GEOLOGY, & GEOLOGIC HAZARD STUDY  
ROLLIN RIDGE ESTATES  
HODGEN ROAD AND HIGHWAY 83 – SOUTHWEST CORNER  
EL PASO COUNTY, COLORADO**

November 12, 2019  
Revised February 19, 2020

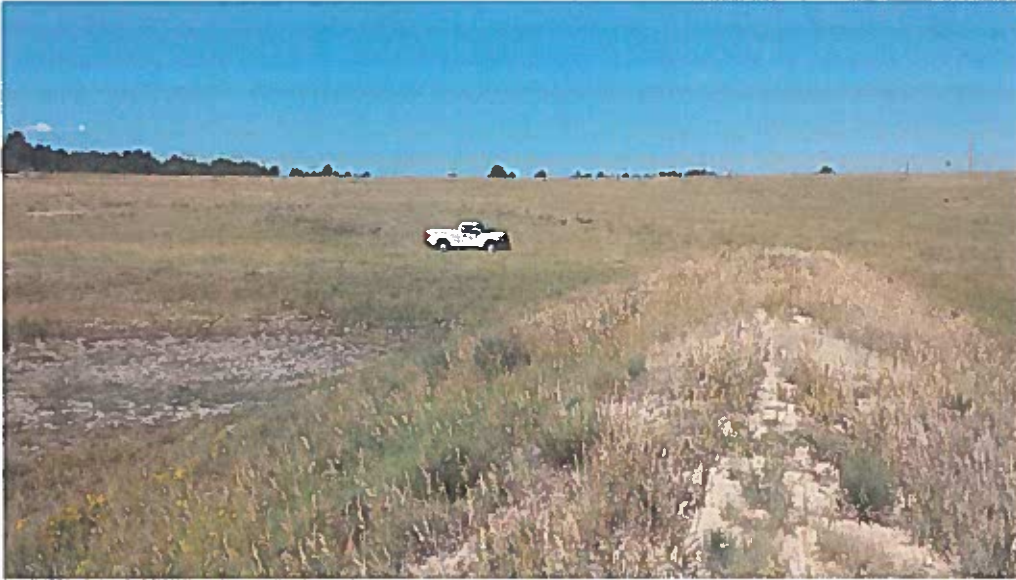
**Looking west along  
the dam located in the  
northeastern portion of  
the site.**
