**ENTECH**  
ENGINEERING, INC.

**SOIL, GEOLOGY, & GEOLOGIC HAZARD STUDY  
ROLLIN RIDGE ESTATES  
HODGEN ROAD AND HIGHWAY 83 – SOUTHWEST CORNER  
EL PASO COUNTY, COLORADO**

November 12, 2019

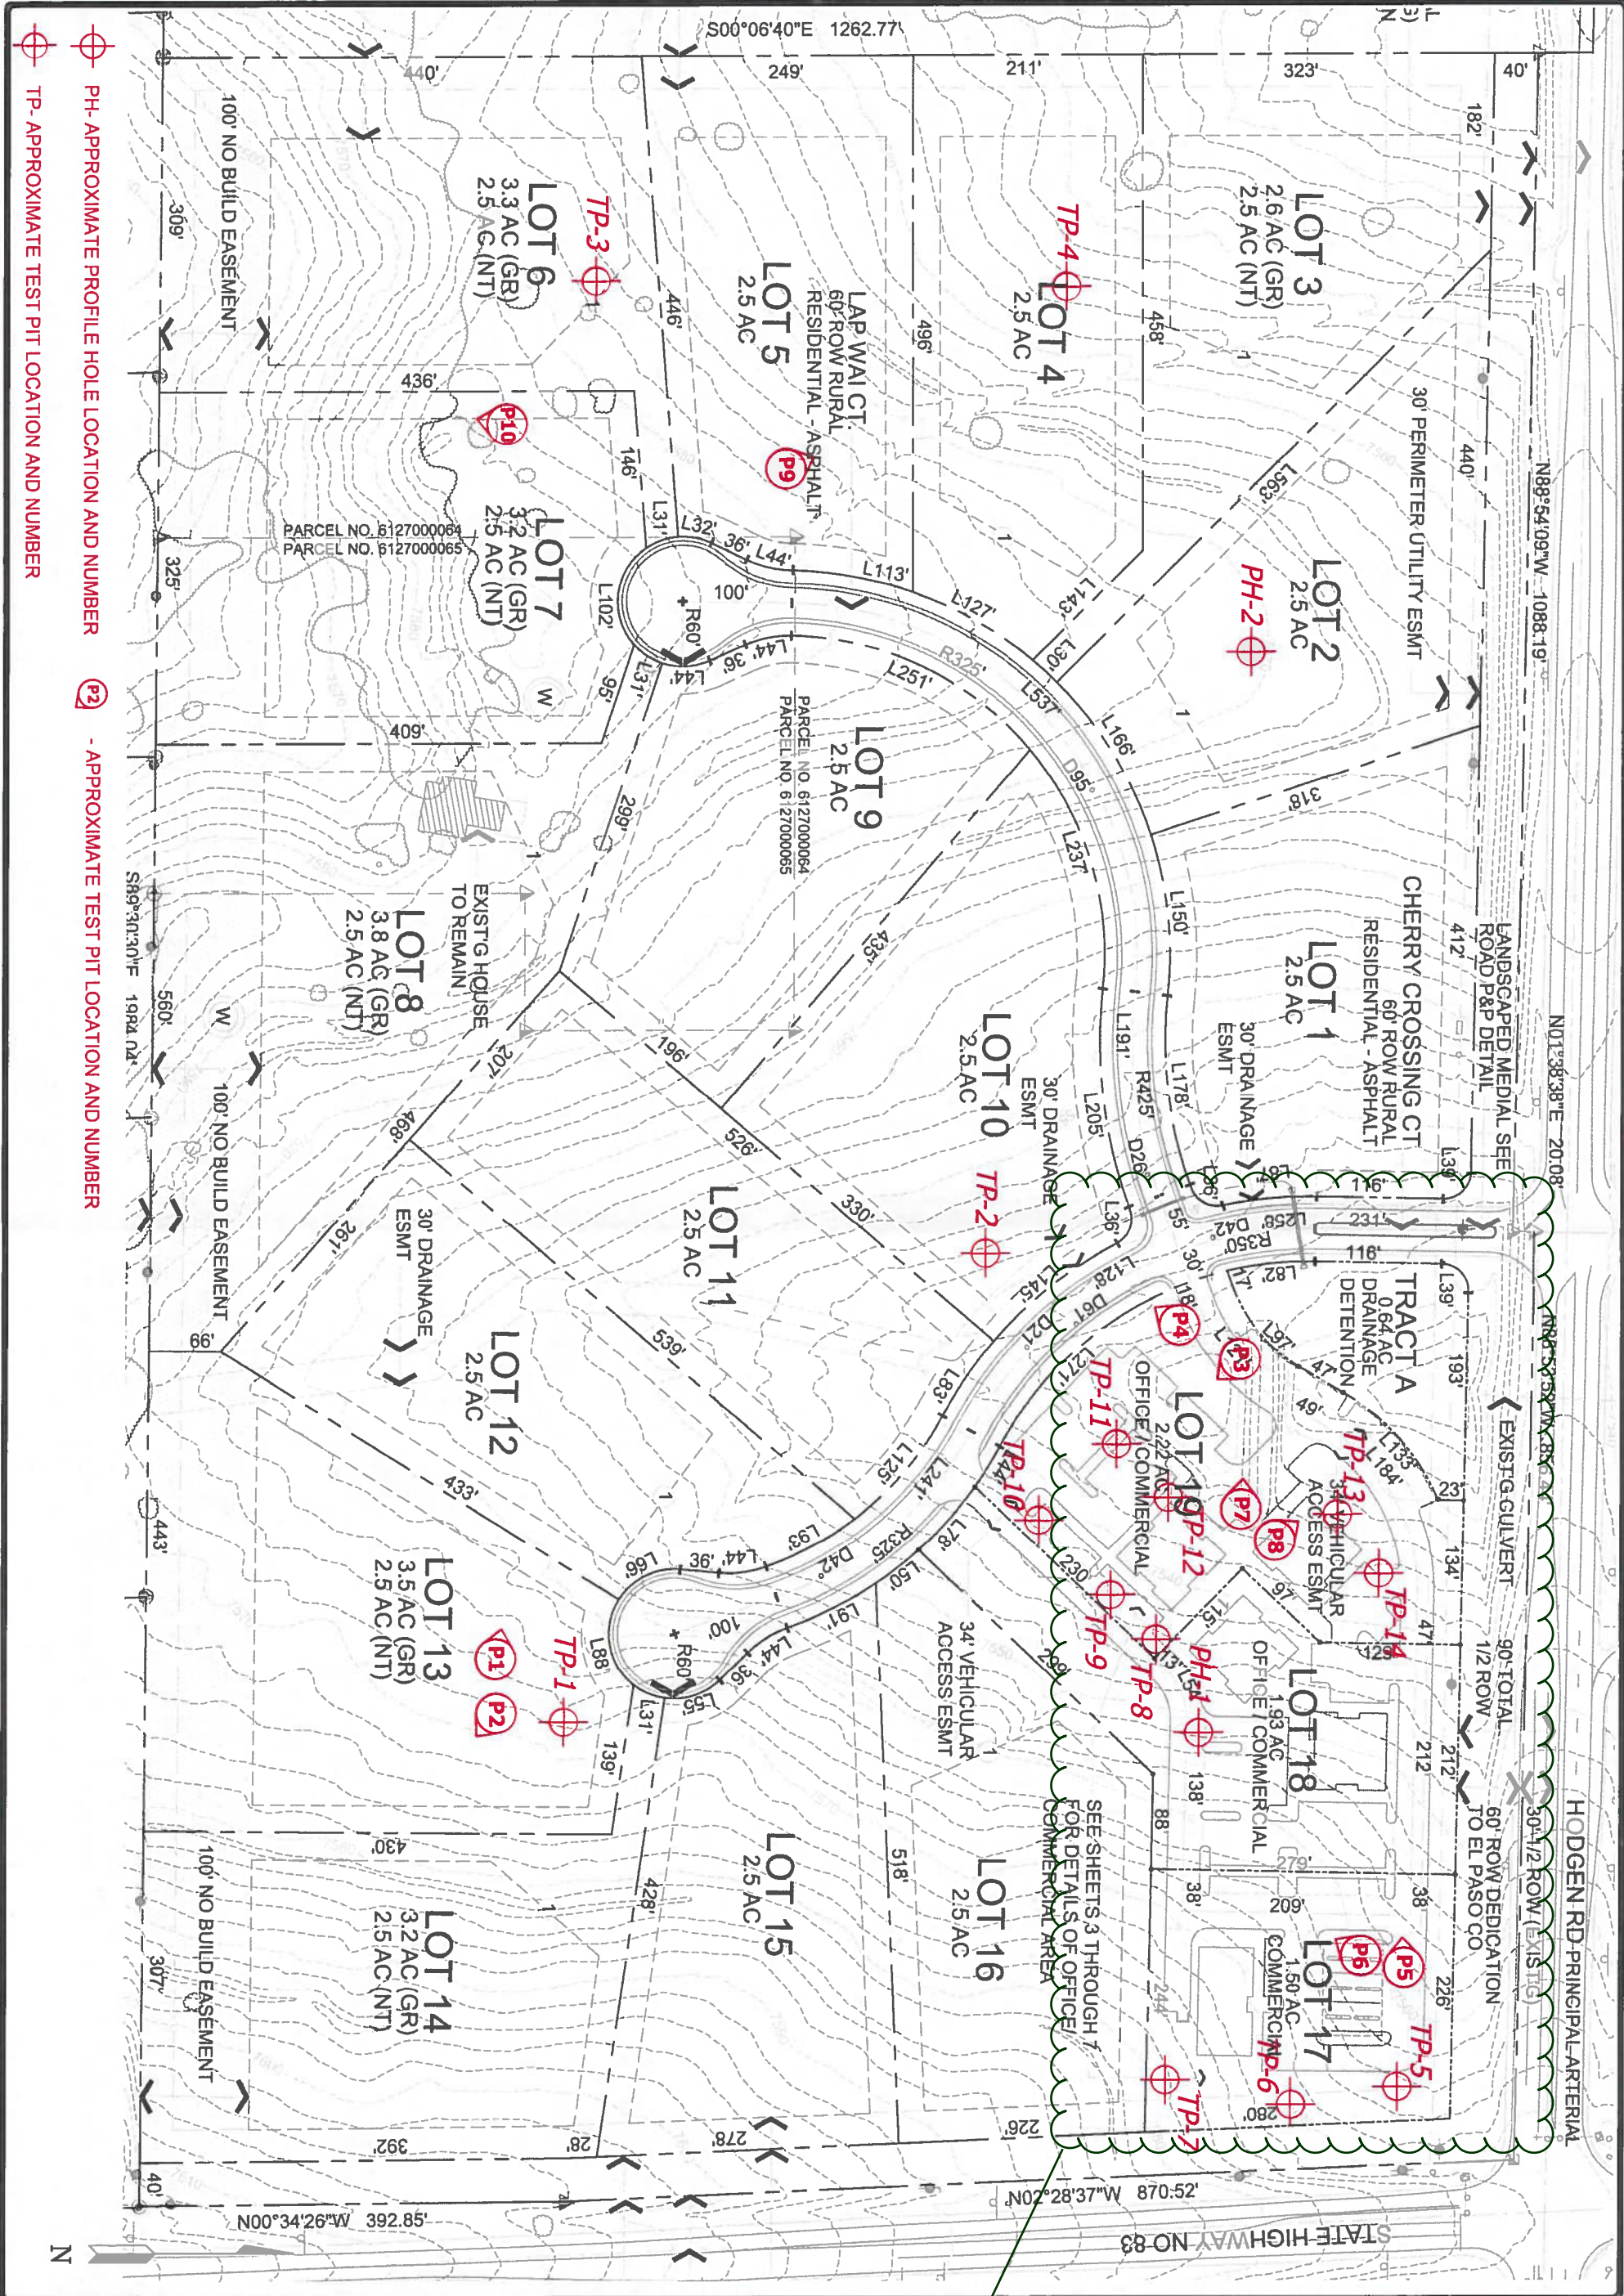
PH- APPROXIMATE PROFILE HOLE LOCATION AND NUMBER  
TP- APPROXIMATE TEST PIT LOCATION AND NUMBER

P2 - APPROXIMATE TEST PIT LOCATION AND NUMBER

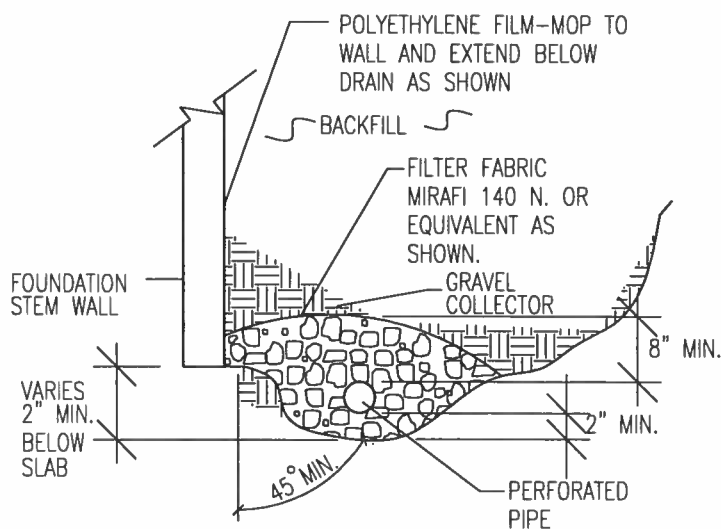
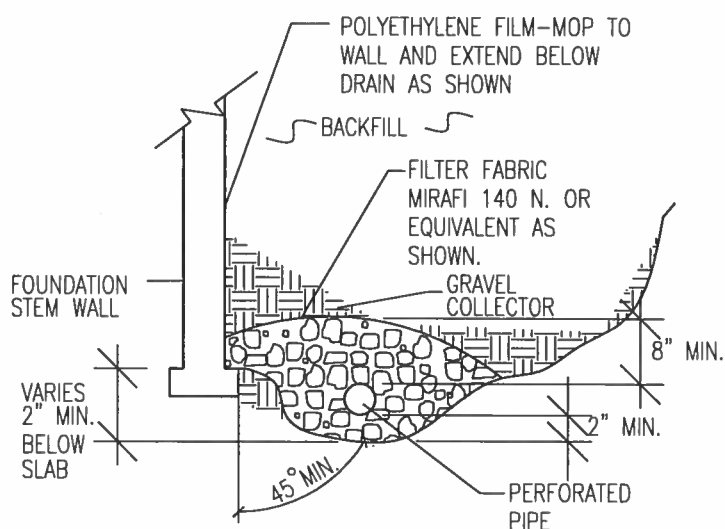
#### NOTES:

-GRAVEL SIZE IS RELATED TO DIAMETER OF PIPE PERFORATIONS-85% GRAVEL GREATER THAN 2x PERFORATION DIAMETER.

Mitigation: Foundations must have a minimum 30-inch depth for frost protection. In areas where high subsurface moisture conditions are anticipated periodically, subsurface perimeter drains are recommended to help prevent the intrusion of water into areas below grade. Typical drain details are presented in Figure 8. Any grading in these areas should be done to direct surface flow around construction to avoid areas of ponded water. All organic material would be completely removed prior to any fill placement. Specific drainage studies are beyond the scope of this report.

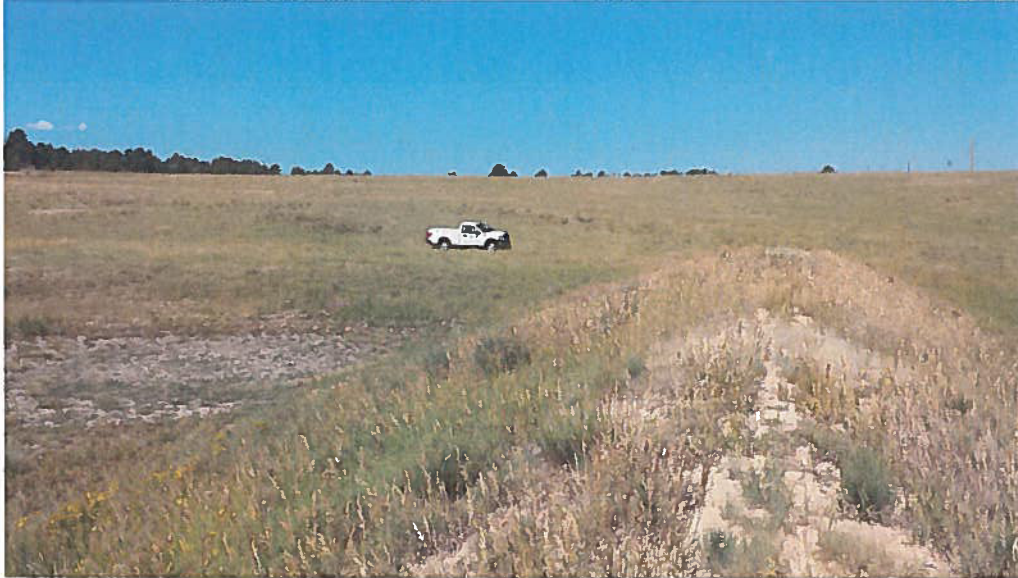
**Looking west along  
the dam located in the  
northeastern portion of  
the site.**

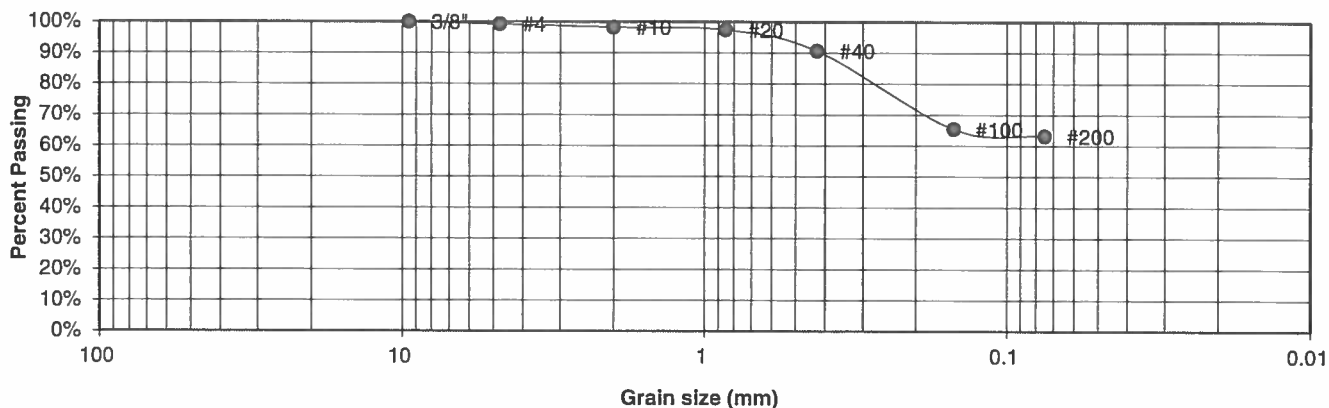
<u>UNIFIED CLASSIFICATION</u>	CL	<u>CLIENT</u>	CARL TURSE
<u>SOIL TYPE #</u>	1	<u>PROJECT</u>	ROLLIN RIDGE ESTATES
<u>TEST BORING #</u>	TP-3	<u>JOB NO.</u>	170837
<u>DEPTH (FT)</u>	2-3	<u>TEST BY</u>	BL

<u>U.S. Sieve #</u>	<u>Percent Finer</u>
3"	
1 1/2"	
3/4"	
1/2"	
3/8"	100.0%
4	99.3%
10	98.3%
20	97.4%
40	90.6%
100	65.4%
200	63.2%

Soil Type 1 is a very sandy to sandy clay and silty clay loam (CL, ML). This material was encountered in both of the profile holes and in six of the test pits. The clay and silt soils were encountered at the existing surface and extended to depths ranging from 3 to 10 feet bgs. These soils were encountered at soft to firm states and at dry to moist conditions. Samples tested had 55 to 73 percent passing the No. 200 Sieve. FHA Swell Testing on a sample of sandy clay resulted in an expansion pressure of 430 psf, which is in the low expansion range.

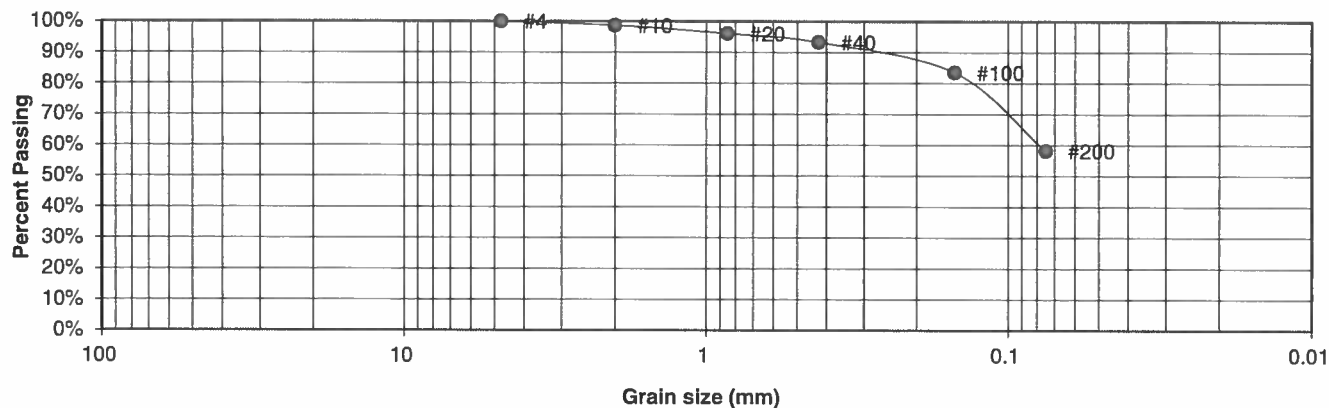
<u>UNIFIED CLASSIFICATION</u>	CL	<u>CLIENT</u>	CARL TURSE
<u>SOIL TYPE #</u>	1	<u>PROJECT</u>	ROLLIN RIDGE ESTATES
<u>TEST BORING #</u>	TP-5	<u>JOB NO.</u>	170837
<u>DEPTH (FT)</u>	2-3	<u>TEST BY</u>	BL

<u>U.S. Sieve #</u>	<u>Percent Finer</u>
3"	
1 1/2"	
3/4"	
1/2"	
3/8"	
4	100.0%
10	98.7%
20	96.1%
40	93.3%
100	83.6%
200	58.2%

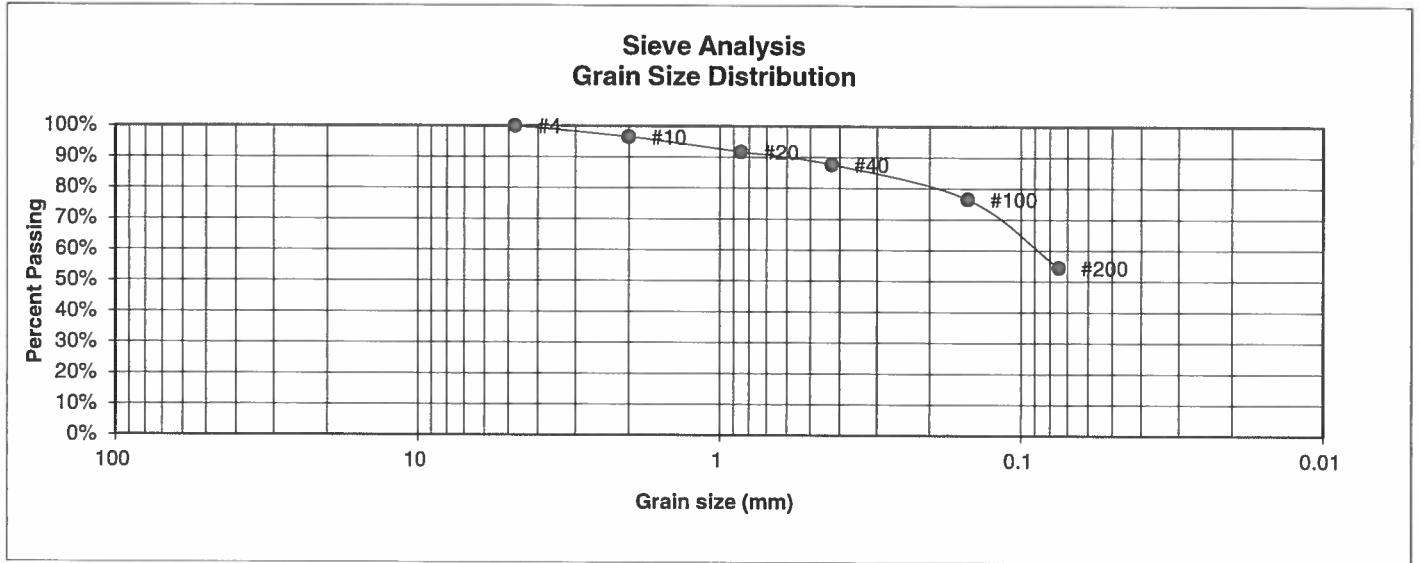
<u>UNIFIED CLASSIFICATION</u>	CL	<u>CLIENT</u>	CARL TURSE
<u>SOIL TYPE #</u>	1	<u>PROJECT</u>	ROLLIN RIDGE ESTATES
<u>TEST BORING #</u>	TP-10	<u>JOB NO.</u>	170837
<u>DEPTH (FT)</u>	6-8	<u>TEST BY</u>	BL

<u>U.S. Sieve #</u>	<u>Percent Finer</u>
3"	
1 1/2"	
3/4"	
1/2"	
3/8"	
4	100.0%
10	96.5%
20	91.7%
40	87.7%
100	76.5%
200	54.5%

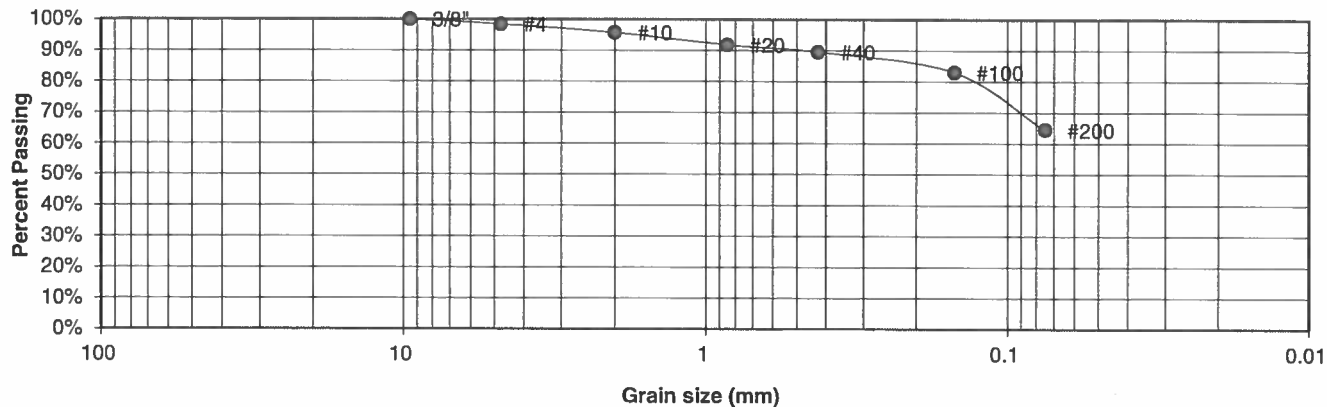
UNIFIED CLASSIFICATION	CL	CLIENT	CARL TURSE
SOIL TYPE #	1	PROJECT	ROLLIN RIDGE ESTATES
TEST BORING #	TP-14	JOB NO.	170837
DEPTH (FT)	3-4	TEST BY	BL

U.S. Sieve #	Percent Finer
3"	
1 1/2"	
3/4"	
1/2"	
3/8"	100.0%
4	98.5%
10	95.7%
20	91.8%
40	89.6%
100	83.0%
200	64.5%

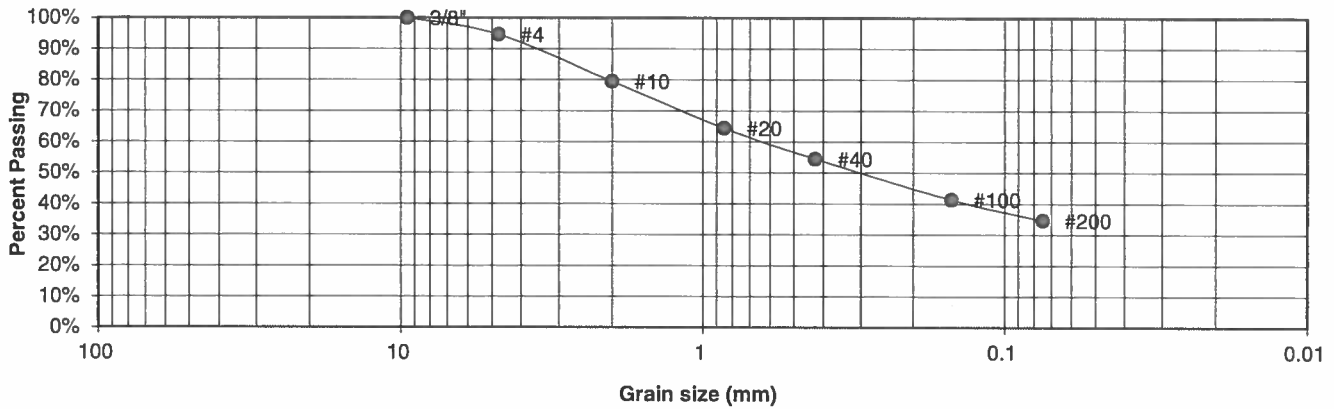
CLIENT	CARL TURSE
PROJECT	ROLLIN RIDGE ESTATES
JOB NO.	170837
TEST BY	BL

U.S. Sieve #	Percent Finer
3"	
1 1/2"	
3/4"	
1/2"	
3/8"	100.0%
4	94.7%
10	79.5%
20	64.4%
40	54.5%
100	41.4%
200	34.6%

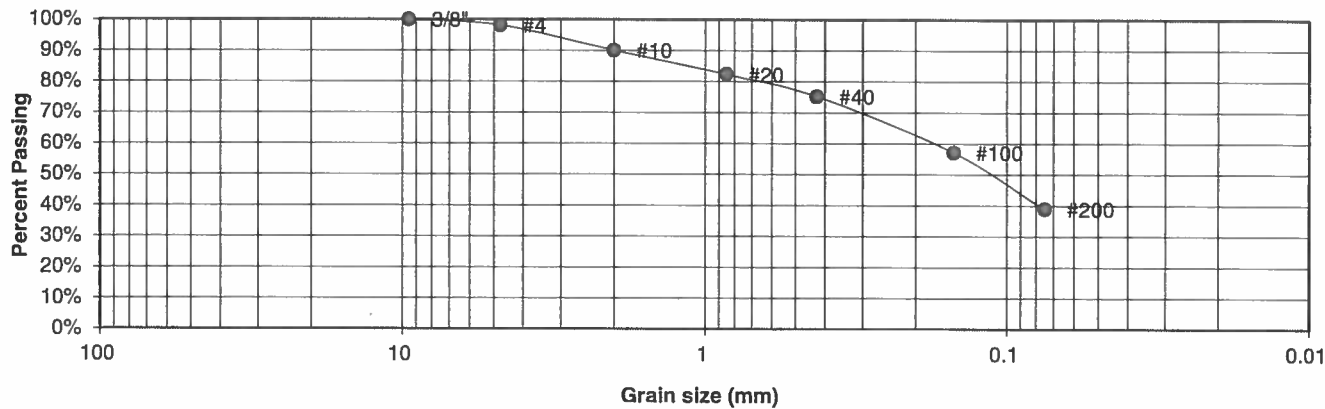
UNIFIED CLASSIFICATION	SC	CLIENT	CARL TURSE
SOIL TYPE #	2	PROJECT	ROLLIN RIDGE ESTATES
TEST BORING #	TP-4	JOB NO.	170837
DEPTH (FT)	5-6	TEST BY	BL

U.S. Sieve #	Percent Finer
3"	
1 1/2"	
3/4"	
1/2"	
3/8"	100.0%
4	98.2%
10	90.1%
20	82.3%
40	75.2%
100	57.1%
200	38.9%

Soil Type 2 is a clayey sand, sandy loam, and slightly silty to silty sand (SC, SM-SW). This material was encountered in Profile Hole No. 1 and in eight of the test pits. The sands were encountered at depths ranging from the existing surface grade to 3 feet and extended to depths ranging from 5 to 12 feet. The sands were encountered at medium dense to states and dry to moist conditions. Samples tested had 6 to 40 percent passing the No. 200 sieve. FHA Swell Testing on a sample of clayey sand resulted in an expansion pressure of 556 psf, which is in the low expansion range.

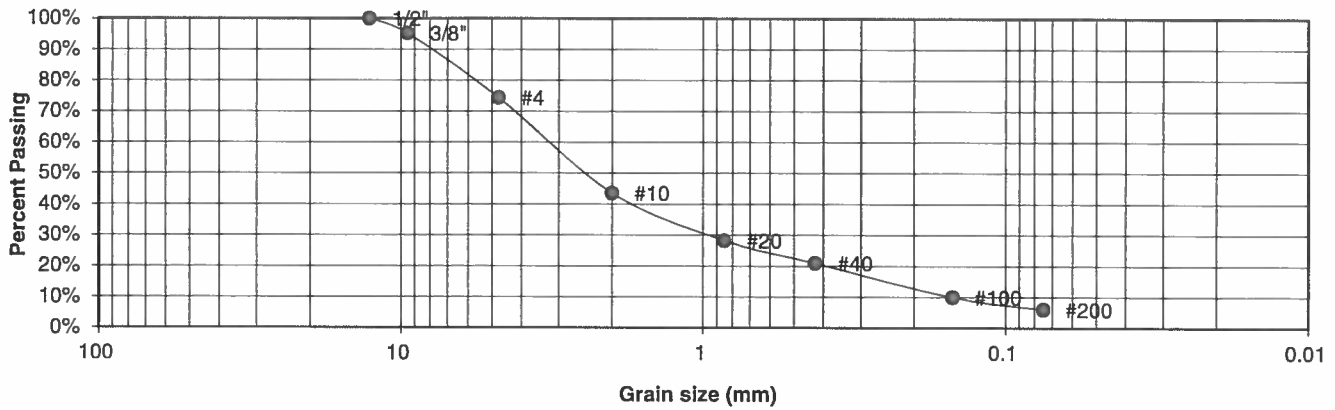
**Sieve Analysis  
Grain Size Distribution**

<u>UNIFIED CLASSIFICATION</u>	SM-SW	<u>CLIENT</u>	CARL TURSE
<u>SOIL TYPE #</u>	2	<u>PROJECT</u>	ROLLIN RIDGE ESTATES
<u>TEST BORING #</u>	TP-5	<u>JOB NO.</u>	170837
<u>DEPTH (FT)</u>	6-8	<u>TEST BY</u>	BL

<u>U.S. Sieve #</u>	<u>Percent Finer</u>
3"	
1 1/2"	
3/4"	
1/2"	100.0%
3/8"	95.2%
4	74.4%
10	43.6%
20	28.2%
40	20.9%
100	10.0%
200	6.0%

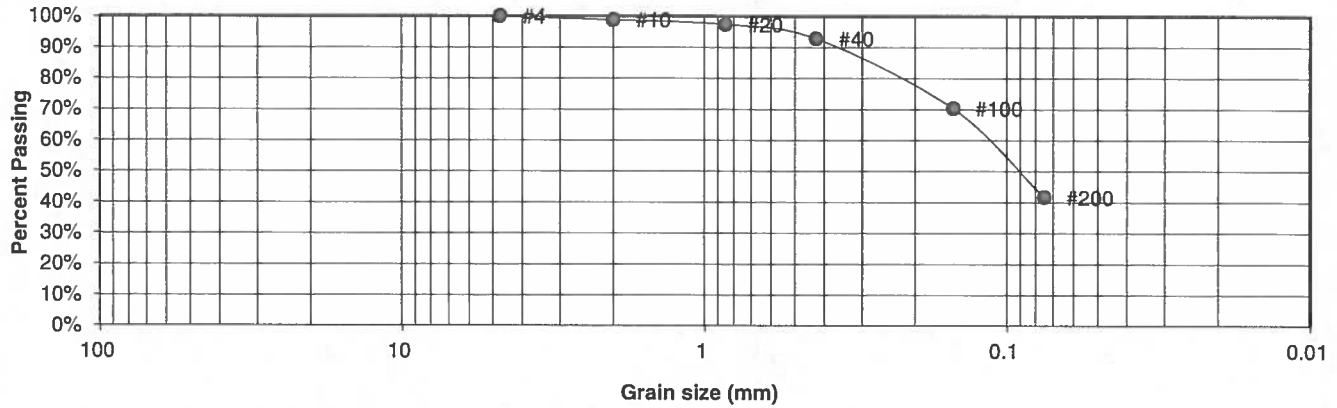
**Sieve Analysis  
Grain Size Distribution**

UNIFIED CLASSIFICATION	SC	CLIENT	CARL TURSE
SOIL TYPE #	2	PROJECT	ROLLIN RIDGE ESTATES
TEST BORING #	TP-6	JOB NO.	170837
DEPTH (FT)	3-8	TEST BY	BL

U.S. Sieve #	Percent Finer
3"	
1 1/2"	
3/4"	
1/2"	
3/8"	
4	100.0%
10	98.9%
20	97.4%
40	92.8%
100	70.3%
200	41.7%

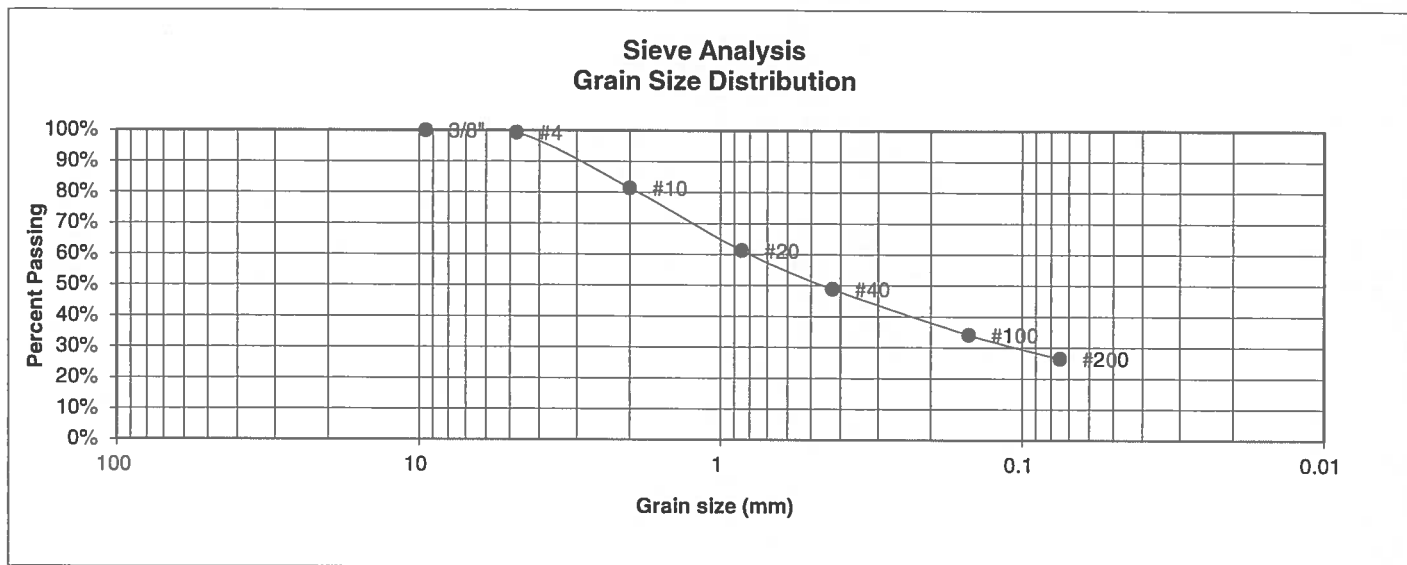
FIG NO.:  
C-12

<u>UNIFIED CLASSIFICATION</u>	SM	<u>CLIENT</u>	CARL TURSE
<u>SOIL TYPE #</u>	2	<u>PROJECT</u>	ROLLIN RIDGE ESTATES
<u>TEST BORING #</u>	TP-11	<u>JOB NO.</u>	170837
<u>DEPTH (FT)</u>	4-6	<u>TEST BY</u>	BL

<u>U.S. Sieve #</u>	<u>Percent Finer</u>
3"	
1 1/2"	
3/4"	
1/2"	
3/8"	100.0%
4	99.2%
10	81.5%
20	61.3%
40	48.8%
100	34.2%
200	26.4%

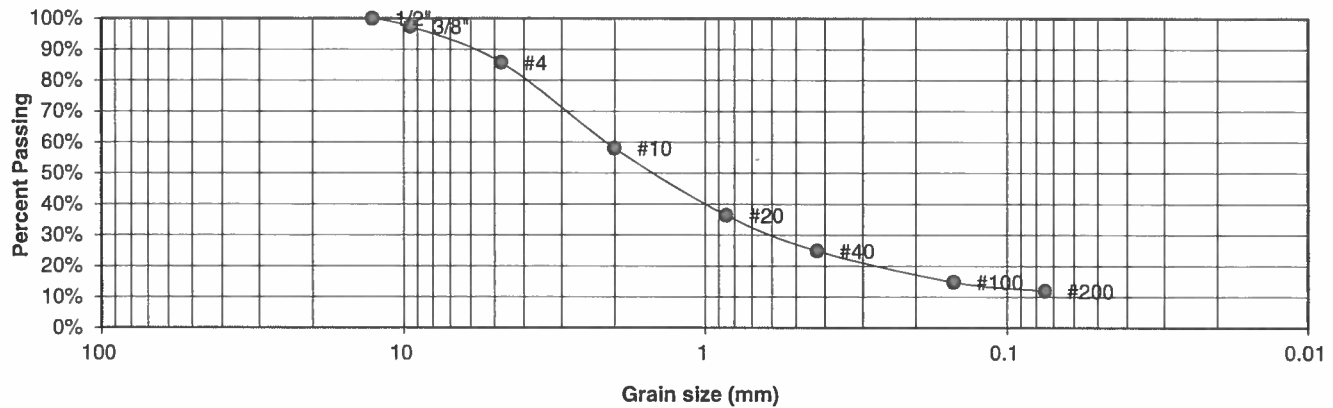
### Sieve Analysis Grain Size Distribution

UNIFIED CLASSIFICATION	SM	CLIENT	CARL TURSE
SOIL TYPE #	3	PROJECT	ROLLIN RIDGE ESTATES
TEST BORING #	2	JOB NO.	170837
DEPTH (FT)	15	TEST BY	BL

U.S. Sieve #	Percent Finer
3"	
1 1/2"	
3/4"	
1/2"	100.0%
3/8"	97.4%
4	85.8%
10	58.1%
20	36.4%
40	24.9%
100	14.8%
200	11.9%

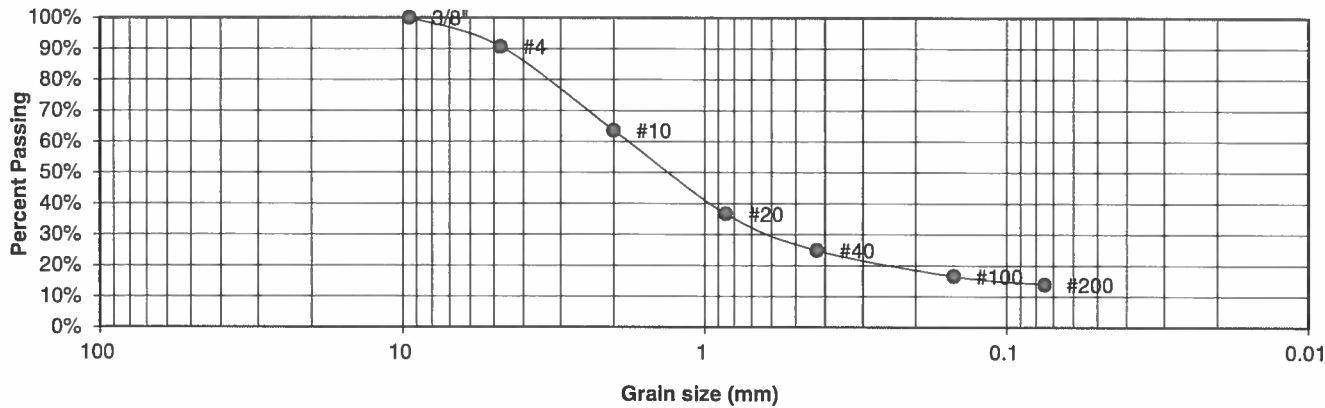
Sieve Analysis  
Grain Size Distribution

<u>UNIFIED CLASSIFICATION</u>	SM	<u>CLIENT</u>	CARL TURSE
<u>SOIL TYPE #</u>	3	<u>PROJECT</u>	ROLLIN RIDGE ESTATES
<u>TEST BORING #</u>	TP-3	<u>JOB NO.</u>	170837
<u>DEPTH (FT)</u>	5-6	<u>TEST BY</u>	BL

<u>U.S. Sieve #</u>	<u>Percent Finer</u>	<u>Atterberg Limits</u>
3"		Plastic Limit
1 1/2"		Liquid Limit
3/4"		Plastic Index
1/2"		
3/8"	100.0%	
4	90.7%	
10	63.6%	
20	36.7%	
40	24.9%	
100	16.6%	
200	13.9%

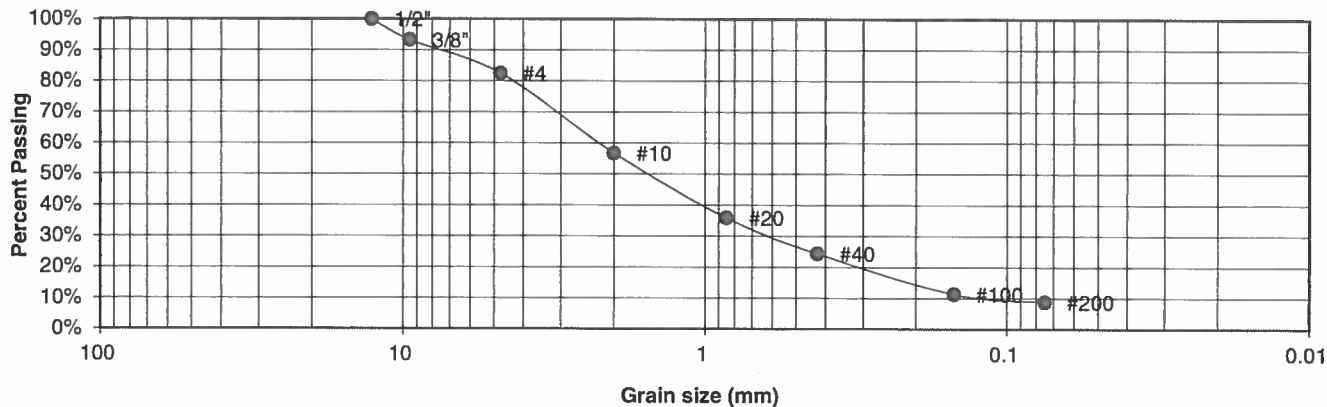
### Sieve Analysis Grain Size Distribution

UNIFIED CLASSIFICATION	SM-SW	CLIENT	CARL TURSE
SOIL TYPE #	3	PROJECT	ROLLIN RIDGE ESTATES
TEST BORING #	TP-7	JOB NO.	170837
DEPTH (FT)	6-8	TEST BY	BL

U.S. Sieve #	Percent Finer
3"	
1 1/2"	
3/4"	
1/2"	100.0%
3/8"	93.2%
4	82.5%
10	56.8%
20	35.9%
40	24.3%
100	11.3%
200	8.8%

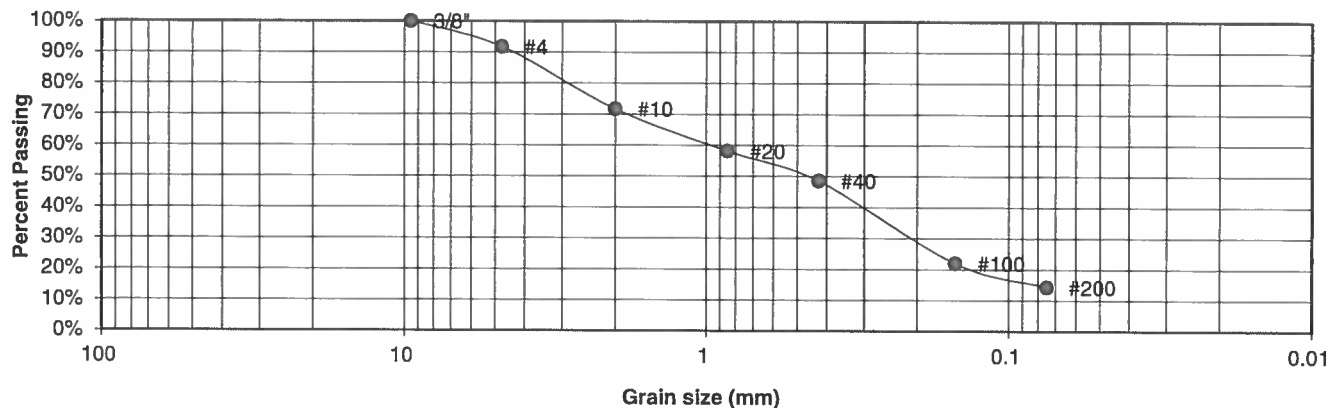
**Sieve Analysis  
Grain Size Distribution**

<u>UNIFIED CLASSIFICATION</u>	SM	<u>CLIENT</u>	CARL TURSE
<u>SOIL TYPE #</u>	3	<u>PROJECT</u>	ROLLIN RIDGE ESTATES
<u>TEST BORING #</u>	TP-8	<u>JOB NO.</u>	170837
<u>DEPTH (FT)</u>	6-8	<u>TEST BY</u>	BL

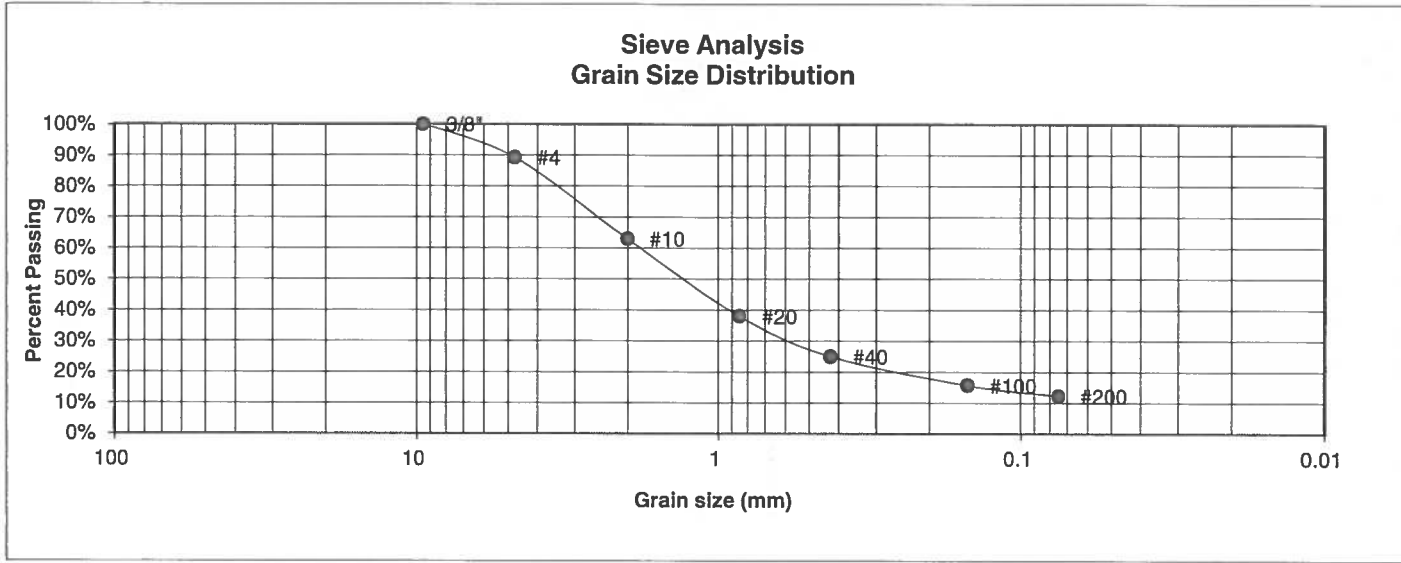
FIG NO.:  
C-17

<u>UNIFIED CLASSIFICATION</u>	SM	<u>CLIENT</u>	CARL TURSE
<u>SOIL TYPE #</u>	3	<u>PROJECT</u>	ROLLIN RIDGE ESTATES
<u>TEST BORING #</u>	TP-12	<u>JOB NO.</u>	170837
<u>DEPTH (FT)</u>	5-6	<u>TEST BY</u>	BL

<u>U.S. Sieve #</u>	<u>Percent Finer</u>	<u>Atterberg Limits</u>
3"		Plastic Limit
1 1/2"		Liquid Limit
3/4"		Plastic Index
1/2"		
3/8"	100.0%	
4	89.2%	<u>Swell</u>
10	62.9%	Moisture at start
20	38.0%	Moisture at finish
40	25.0%	Moisture increase
100	15.7%	Initial dry density (pcf)
200	12.2%	Swell (psf)

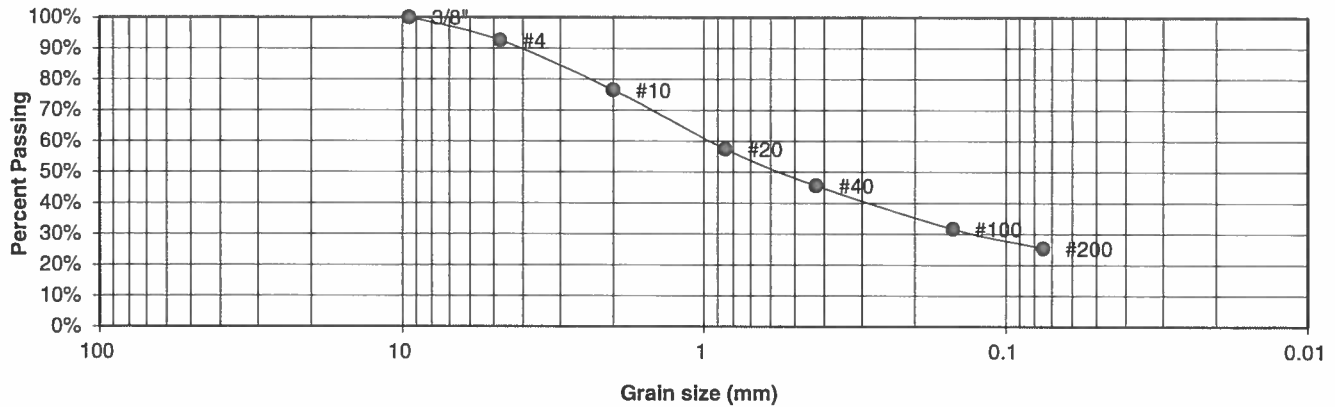
### Sieve Analysis Grain Size Distribution

UNIFIED CLASSIFICATION	SM	CLIENT	CARL TURSE
SOIL TYPE #	3	PROJECT	ROLLIN RIDGE ESTATES
TEST BORING #	TP-13	JOB NO.	170837
DEPTH (FT)	1.5-8	TEST BY	BL
