Subject: Supplement to Preliminary Soil, Geology and Geologic Hazard Study
By Entech Engineering, Inc.
Proposed Academy Station
Northwest of I-25 and Academy Boulevard
El Paso County, Colorado
Project Number 87953

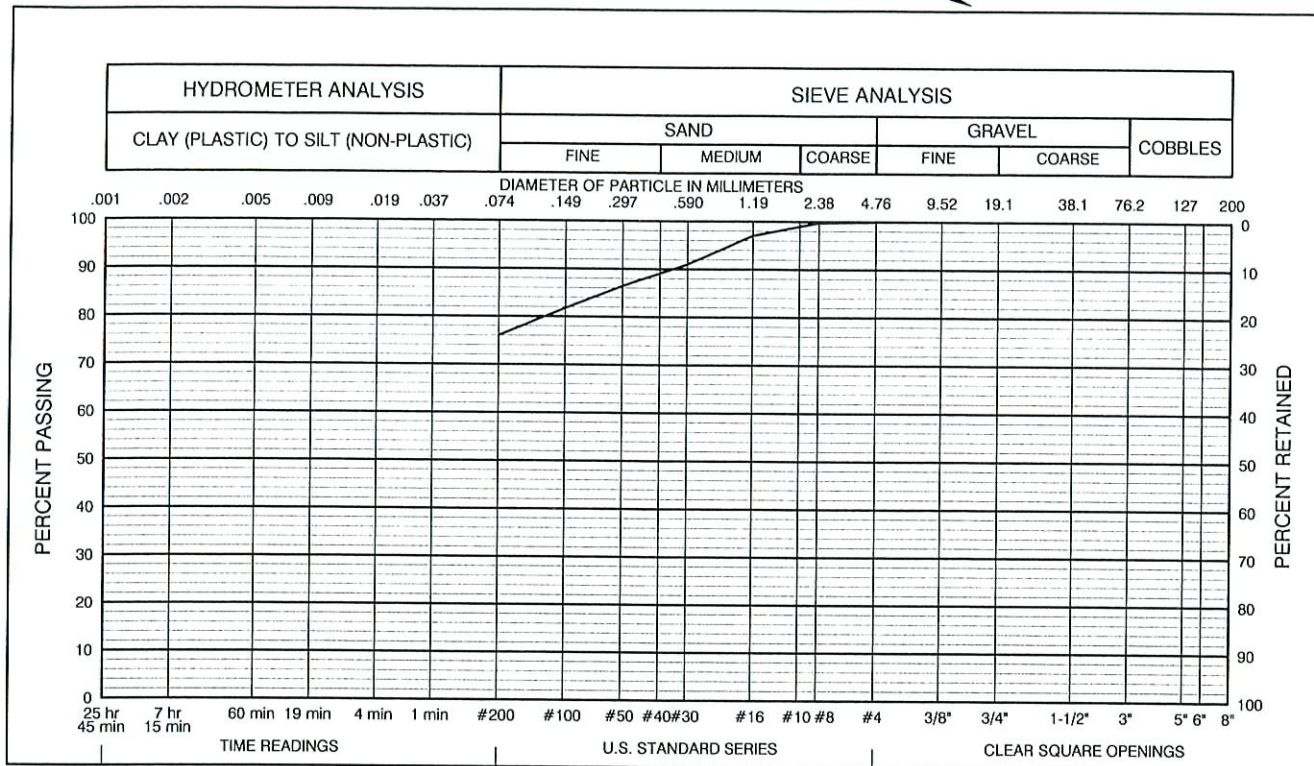
LOCATION TEST BORING NO. 1 @ DEPTH OF 29' GRAVEL 0 % LIQUID LIMIT 55
 SAMPLE DESCRIPTION CLAYSTONE / CLAY SHALE, SANDY (CH) SAND 24 % PLASTICITY INDEX 32
 CLASSIFICATION AASHTO A-7-6 (25) SILT & CLAY 76 %

LOCATION TEST BORING NO. 2 @ DEPTH OF 9' GRAVEL 19 % LIQUID LIMIT NV
 SAMPLE DESCRIPTION SAND, GRAVELLY (SP) SAND 78 % PLASTICITY INDEX NP
 CLASSIFICATION AASHTO A-1-b (0) SILT & CLAY 3 %

GRADATION TEST RESULTS

The samples obtained during drilling were returned to our laboratory where they were visually classified by a geotechnical engineer. Laboratory testing was then assigned to specific samples to evaluate their engineering properties. The laboratory tests included three swell-consolidation tests to evaluate the effect of wetting and loading on the selected samples. The results of the swell tests are presented on Figures 5 and 6. Two gradation analysis and Atterberg limits tests were conducted to evaluate grain size distribution and plasticity. These results are presented on Figure 7.
