**FINAL DRAINAGE REPORT
FOR
A-1 CHIPSEAL
LOT 36 AND 37 CLAREMONT BUSINESS PARK FIL NO 2
7245 COLE VIEW
COLORADO SPRINGS, COLORADO**

MAY 2022

TNE Job No. 2173.00
County Job No. COM-22-014

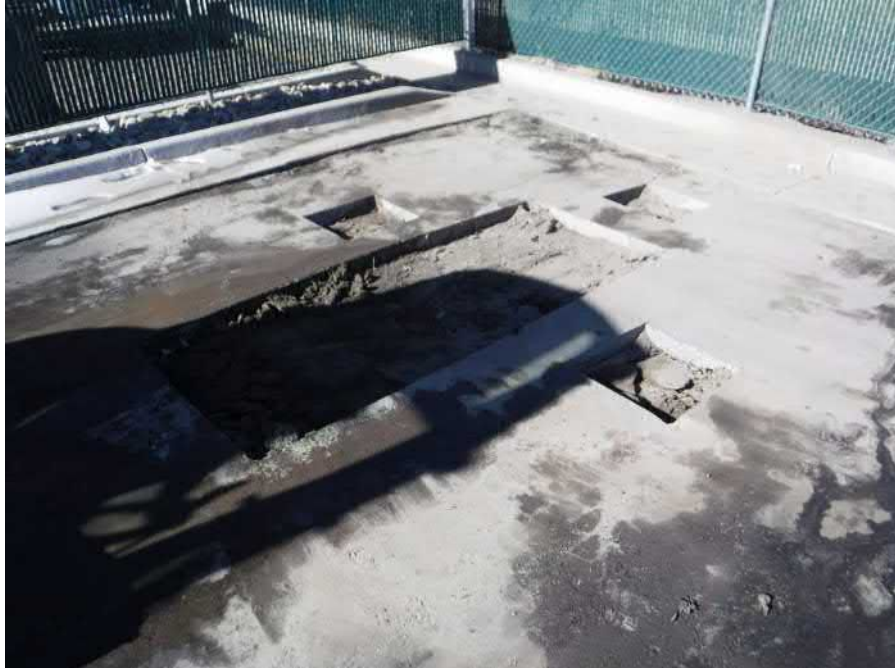
General Test Location Layout

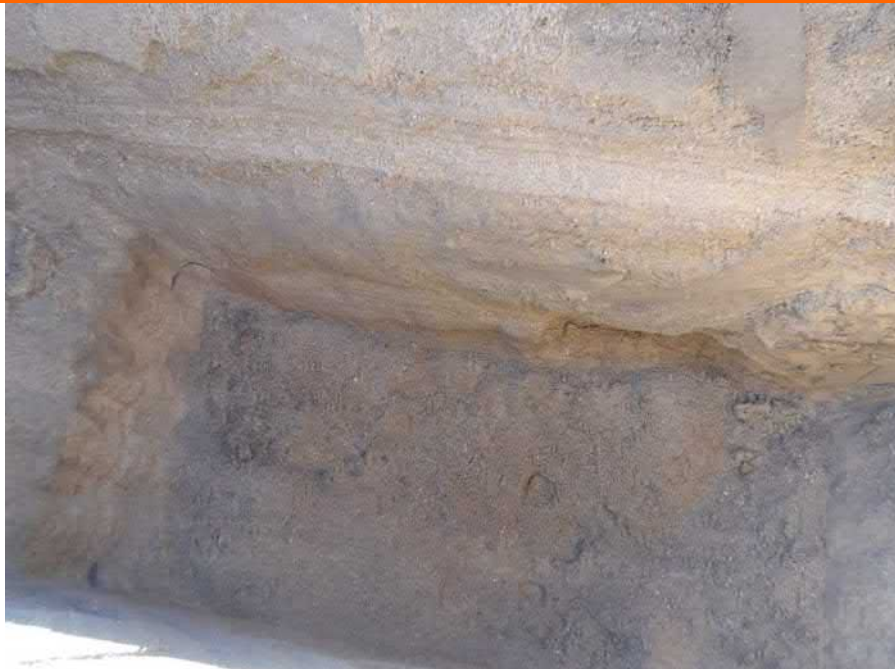
Sidewall and Bottom of Test Pit

A-1 Chipseal excavated a test pit on Tuesday March 1, 2022. A Terracon representative observed the excavation and visually logged the subsurface material. The test pit was terminated at a depth of 7 feet. We understand that A-1 Chipseal backfilled the test pit on the same working day. Documentation of the testpit backfill was beyond the scope of our services and was not performed.

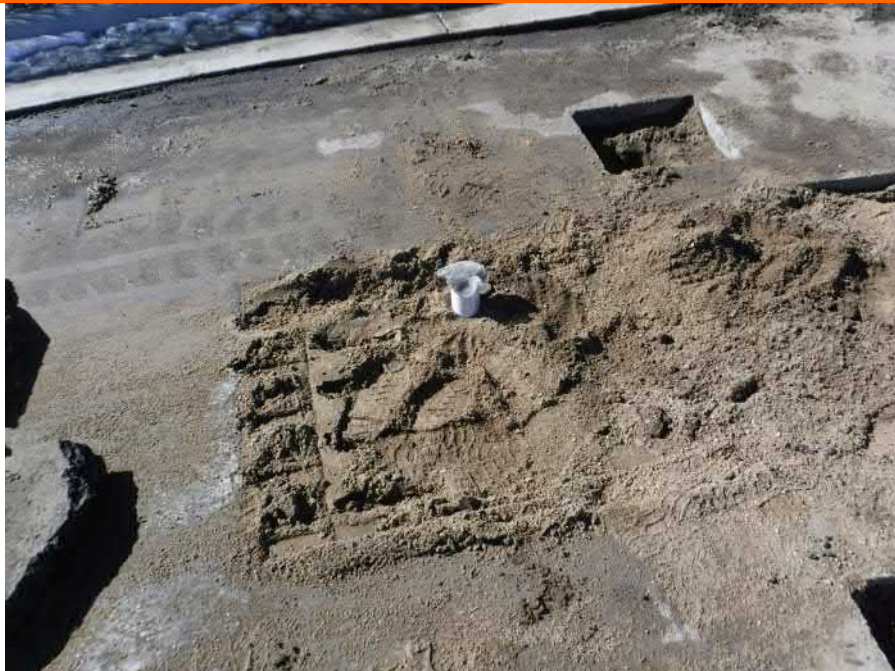
Percolation Test Location P-1

A-1 Chipseal removed asphalt pavement and base stone in three locations immediately adjacent to the test pit. On March 2, 2022 Terracon performed percolation testing at two of the three provided locations. Materials directly below the pavements in the area of percolation hole P-1 could not be excavated using hand methods. Therefore P-1 was relocated to the backfilled test pit. A Terracon representative then performed percolation testing in general accordance with the City of Colorado Springs policy clarification “Infiltration Testing Using Percolation Test Method,” dated January 9, 2017.

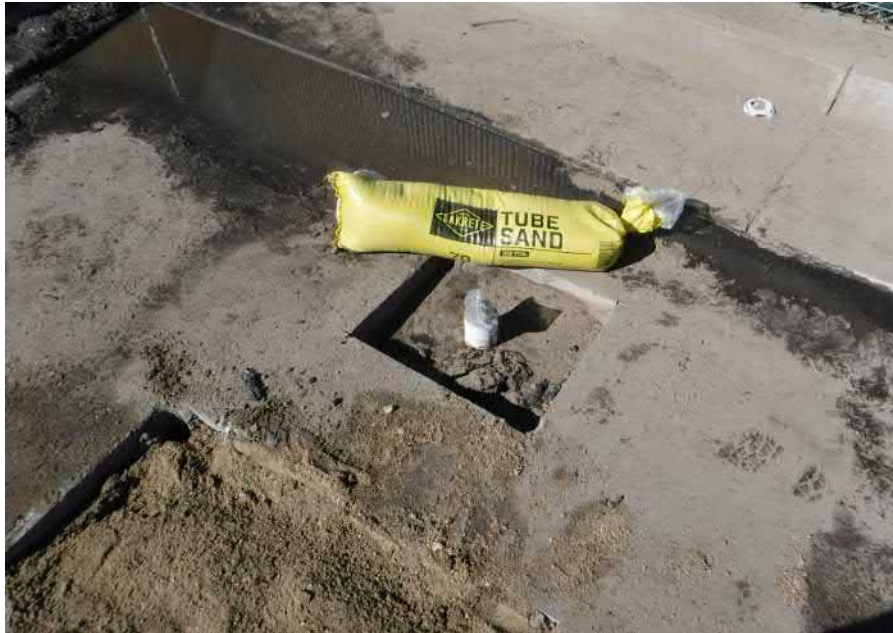
Percolation Test Location P-3

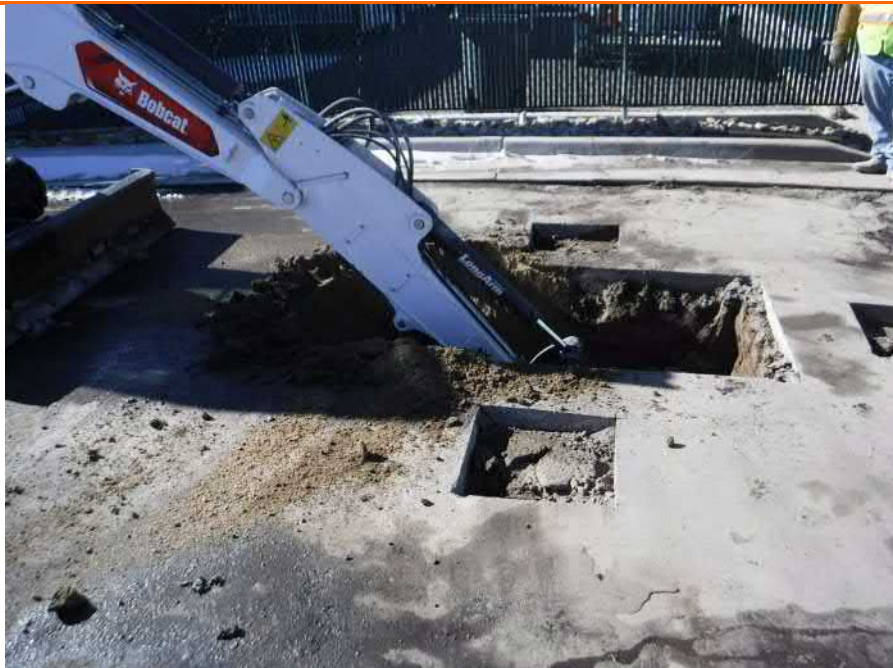
Test Pit During Excavation
