ENTECH
ENGINEERING, INC.

**PRELIMINARY SOIL, GEOLOGY, GEOLOGIC HAZARD,
AND WASTEWATER STUDY,
GRANDVIEW RESERVE
PARCEL NO. 42000-00-396
0 EASTONVILLE ROAD
EL PASO COUNTY, COLORADO**

January 15, 2019

Entech Job No. 181951

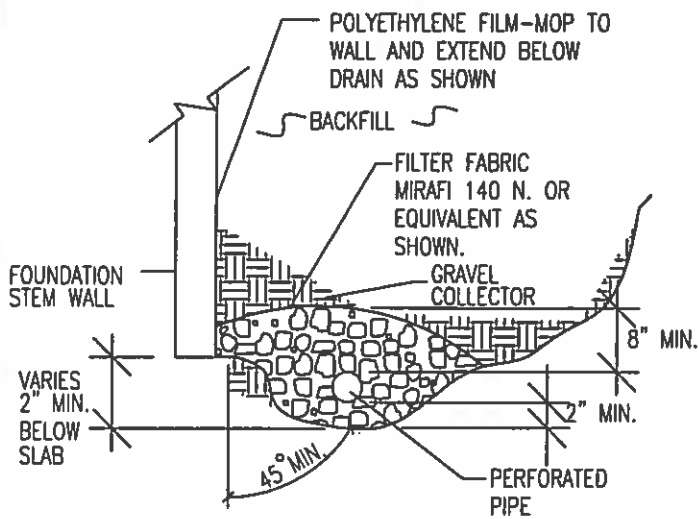
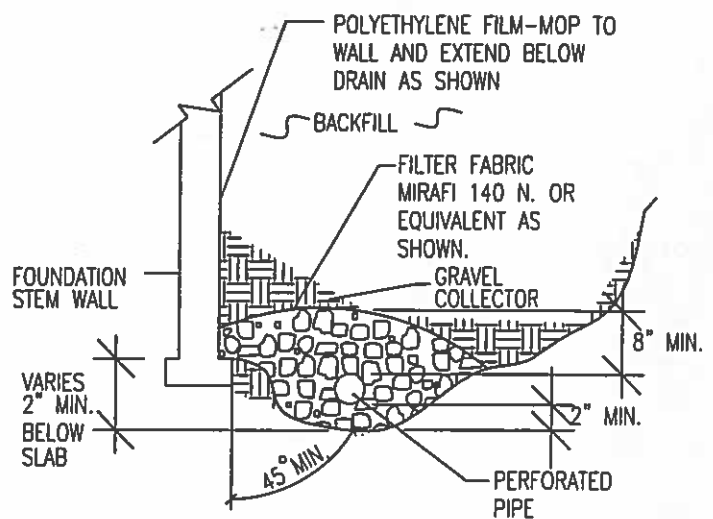
NOTES:

-GRAVEL SIZE IS RELATED TO DIAMETER OF PIPE PERFORATIONS-85% GRAVEL GREATER THAN 2x PERFORATION DIAMETER.

Mitigation: Foundations must have a minimum 30-inch depth for frost protection. In areas where high subsurface moisture conditions are anticipated periodically, subsurface perimeter drains are recommended to help prevent the intrusion of water into areas below grade. Typical drain details are presented in Figure 8. Some of the minor drainage swales can be avoided or regraded. The main drainage that bisects the site is designated as open space and will be avoided. Any grading in these areas should be done to direct surface flow around construction to avoid areas of ponded water. Finished floors must be located at least one foot above floodplain levels. Specific drainage studies and exact floodplain locations are beyond the scope of this report.

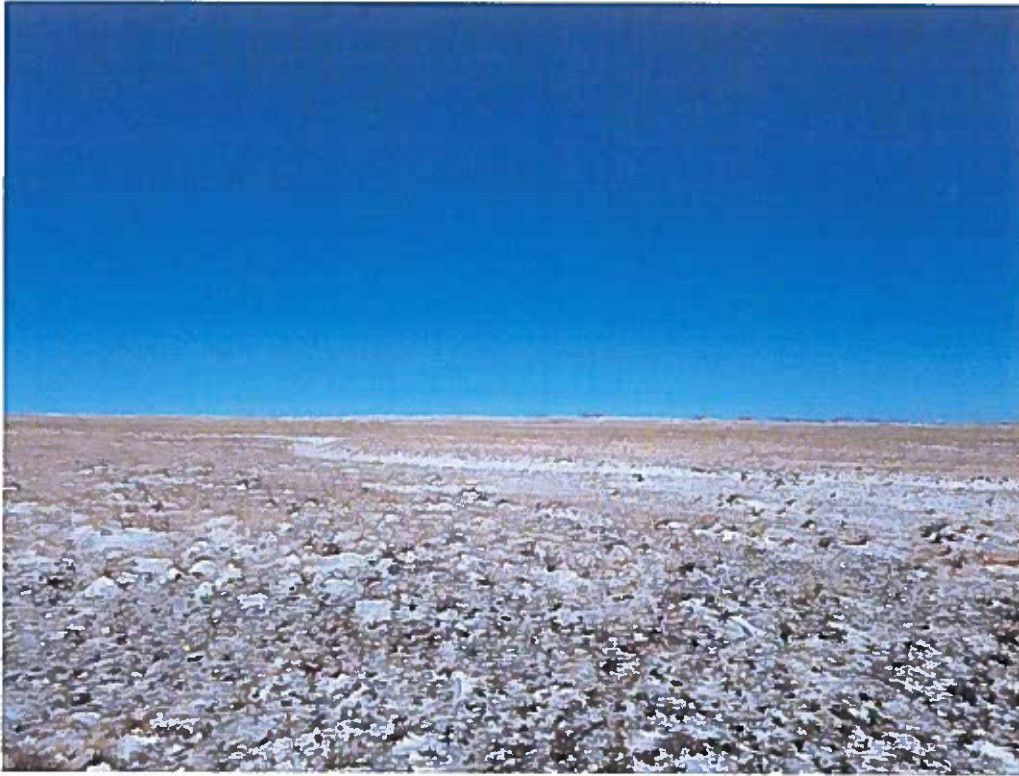
**Looking northwest
along drainage in
eastern portion of the
site.**

The area identified with this hazard is located along a portion of a minor drainage where cut banks have created unstable slopes. Considerable care must be exercised in these areas not to create a condition which would tend to activate instability.

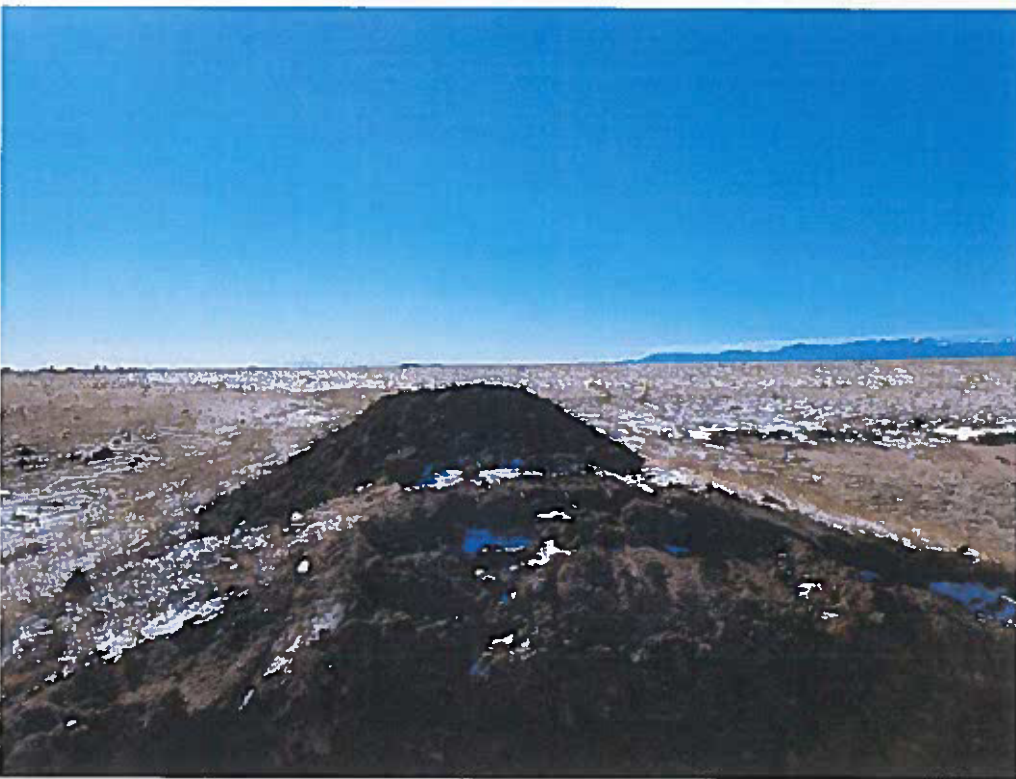
**Looking southwest
along man-made dam
in the central portion
of the site.**

Mitigation: Berms were observed along Eastonville Road that can be avoided or easily removed or penetrated by foundations. The earthen dams lie within areas designated as open space and will be avoided by development. Should any uncontrolled fill be encountered beneath foundations, removal and recompaction at 95 percent of its maximum Modified Proctor Dry Density, ASTM D-1557 will be required.

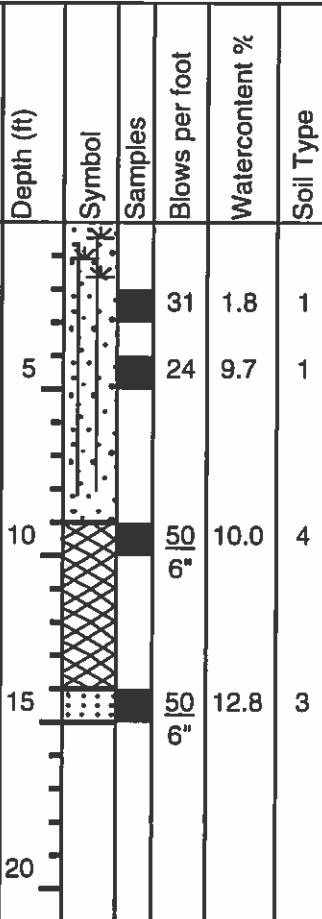
CLAYSTONE, VERY SANDY, BLUE
 GRAY, HARD, MOIST

SANDSTONE, CLAYEY, FINE TO
 COARSE GRAINED, GRAY, VERY
 DENSE, WET

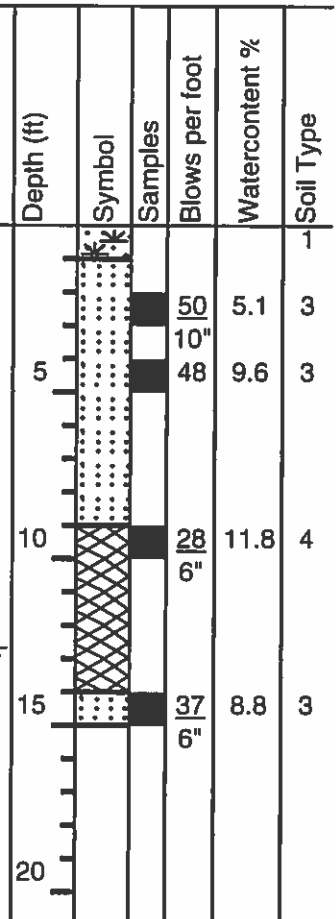
CLAYSTONE, SANDY, GRAY
 BROWN, HARD, MOIST

SANDSTONE, SILTY, FINE TO
 COARSE GRAINED, BROWN,
 VERY DENSE, MOIST

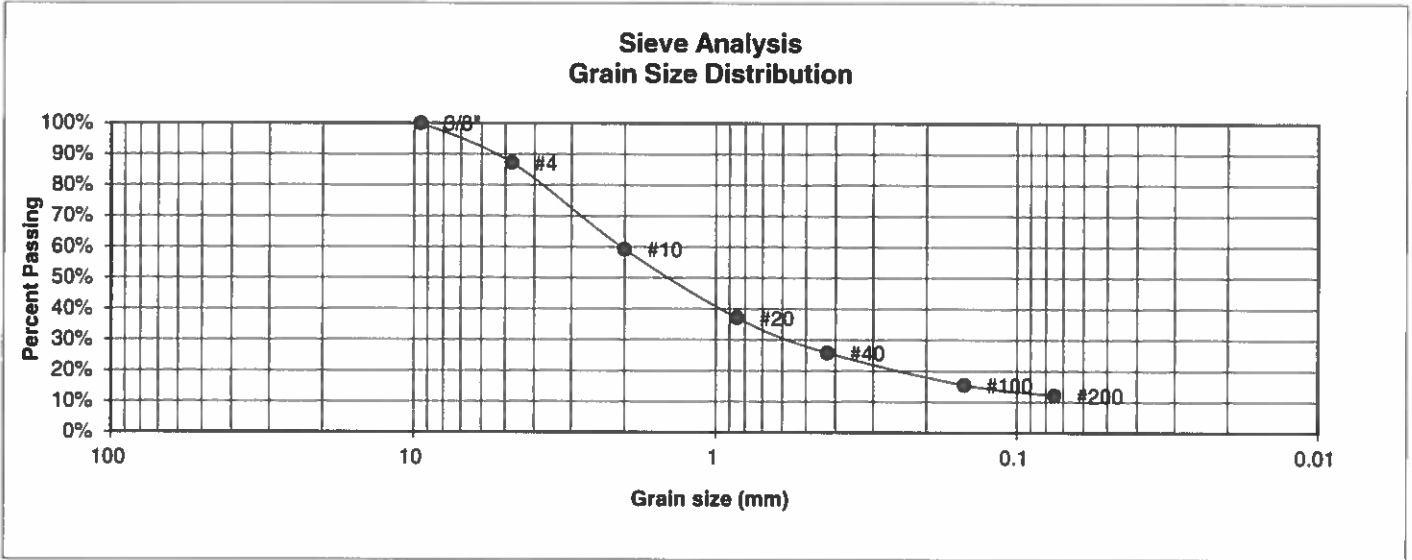
FIG NO:
C-1

UNIFIED CLASSIFICATION	SM	CLIENT	4 SITE INVESTMENTS, LLC
SOIL TYPE #	1	PROJECT	GRANDVIEW RESERVE
TEST BORING #	1	JOB NO.	181951
DEPTH (FT)	5	TEST BY	BL

U.S. Sieve #	Percent Finer
3"	
1 1/2"	
3/4"	
1/2"	
3/8"	100.0%
4	87.2%
10	59.3%
20	37.1%
40	25.9%
100	15.5%
200	12.1%

Soil Type 1 is well-graded, slightly silty to silty and clayey sand (SW, SM-SW, SM, SC, SC-SM-SW). This material was encountered in all of the test borings and in six of the test pits. The sand was encountered at the existing surface and extended to depths ranging from 1 to 9 feet in the test borings and 2 feet to the termination of the test pits (8 feet). These soils were encountered at medium dense to dense states and at dry to very moist conditions. Samples tested had 5 to 40 percent of the soil size particles passing the No. 200 Sieve. Atterberg Limits Testing resulted in a liquid limit of 17 and a plastic index of 5. FHA Swell Testing on samples of the sand resulted in expansion pressures of 110 and 130 psf, indicating low expansion potential.

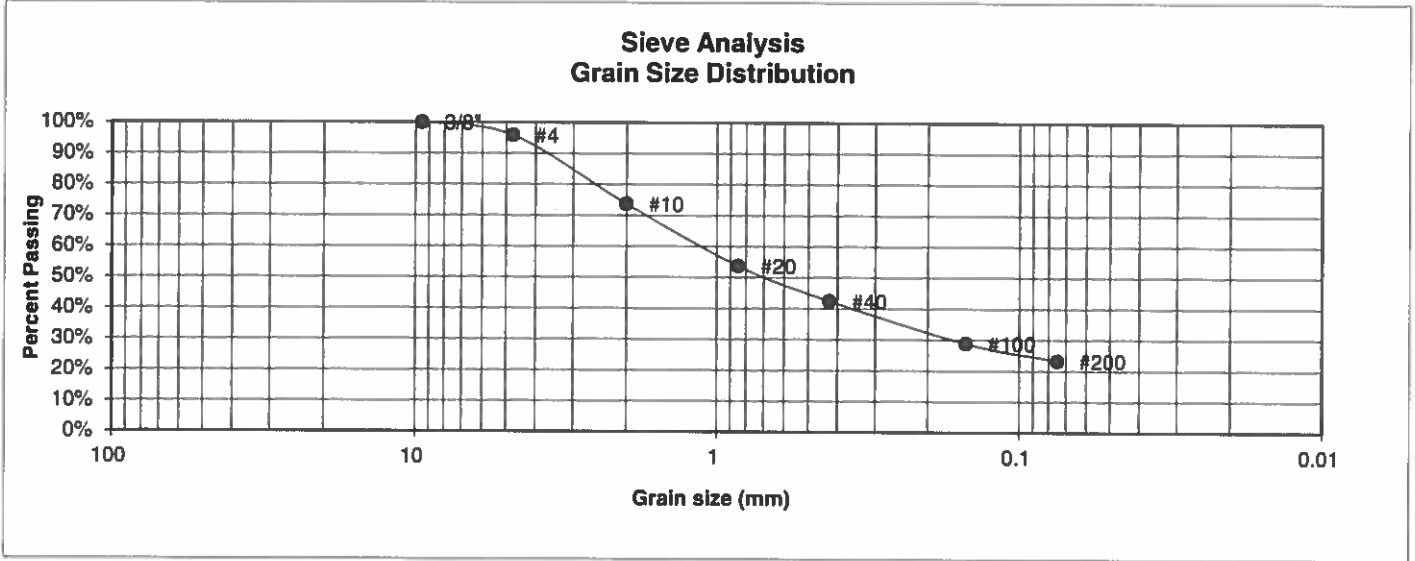
FIG NO.:
C-2

UNIFIED CLASSIFICATION	SM	CLIENT	4 SITE INVESTMENTS, LLC
SOIL TYPE #	1	PROJECT	GRANDVIEW RESERVE
TEST BORING #	3	JOB NO.	181951
DEPTH (FT)	2-3	TEST BY	BL

U.S. Sieve #	Percent Finer
3"	
1 1/2"	
3/4"	
1/2"	
3/8"	100.0%
4	95.9%
10	73.7%
20	53.8%
40	42.4%
100	28.8%
200	23.3%

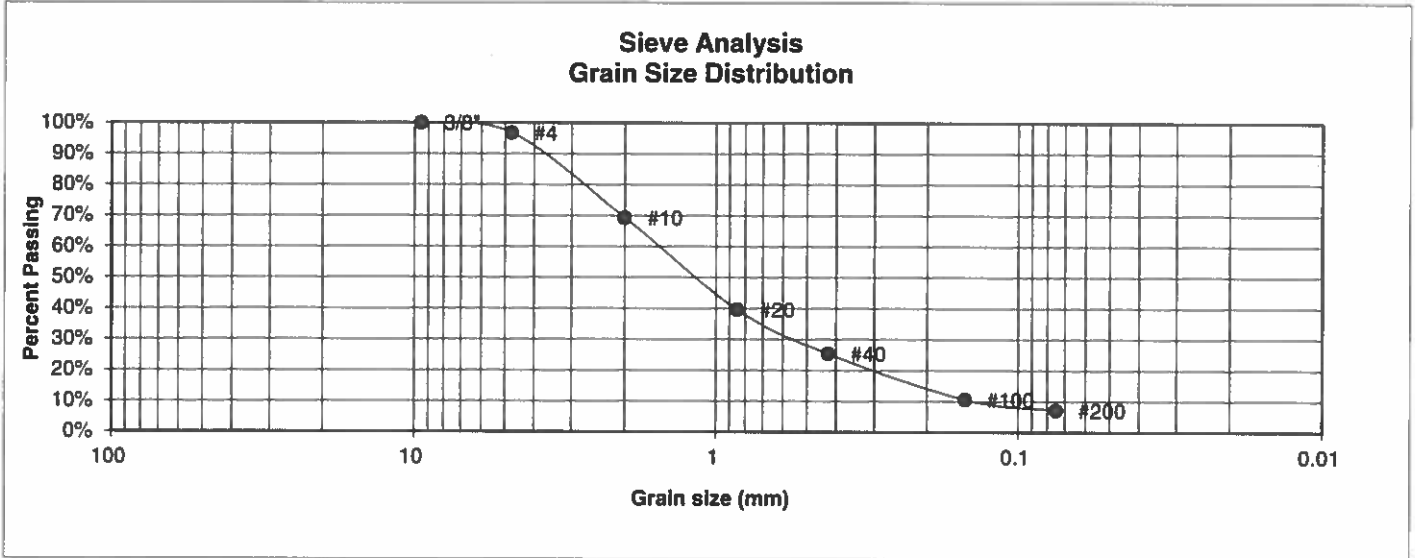
FIG NO.:
0-3

UNIFIED CLASSIFICATION	SM-SW	CLIENT	4 SITE INVESTMENTS, LLC
SOIL TYPE #	1	PROJECT	GRANDVIEW RESERVE
TEST BORING #	4	JOB NO.	181951
DEPTH (FT)	2-3	TEST BY	BL

U.S. Sieve #	Percent Finer
3"	
1 1/2"	
3/4"	
1/2"	
3/8"	100.0%
4	96.8%
10	69.3%
20	39.6%
40	25.4%
100	10.6%
200	7.1%

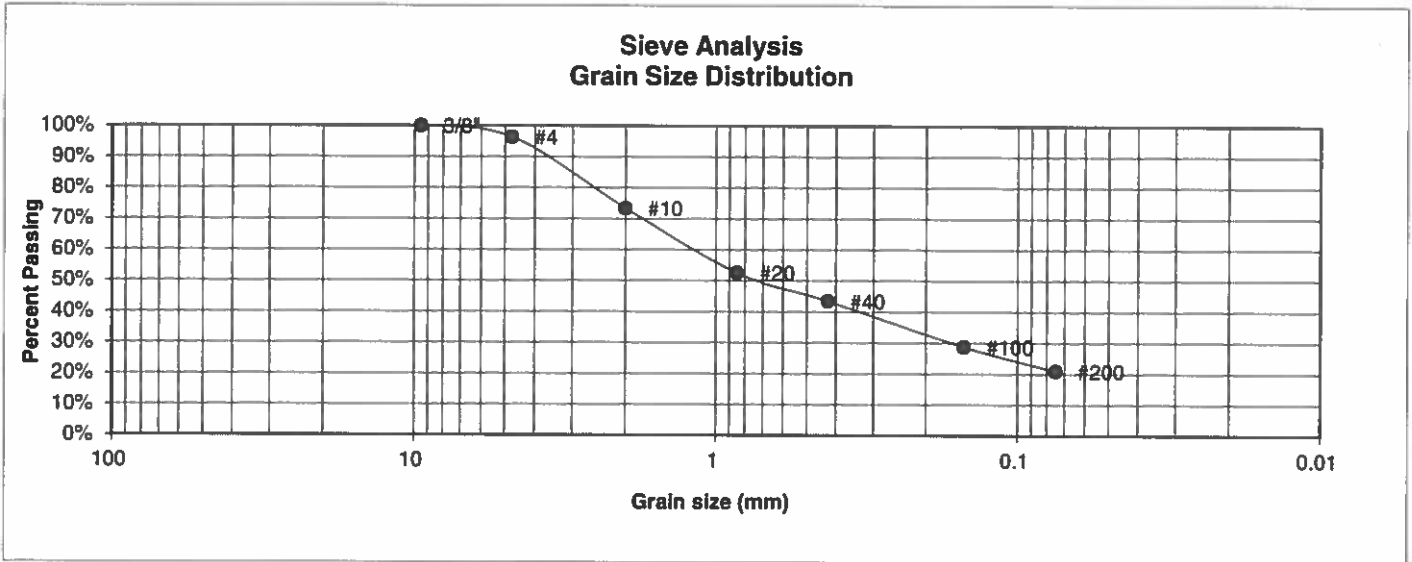
FIG NO:
C-5

UNIFIED CLASSIFICATION	SM	CLIENT	4 SITE INVESTMENTS, LLC
SOIL TYPE #	1	PROJECT	GRANDVIEW RESERVE
TEST BORING #	6	JOB NO.	181951
DEPTH (FT)	5	TEST BY	BL

U.S. Sieve #	Percent Finer
3"	
1 1/2"	
3/4"	
1/2"	
3/8"	100.0%
4	96.4%
10	73.4%
20	52.6%
40	43.4%
100	28.8%
200	20.9%

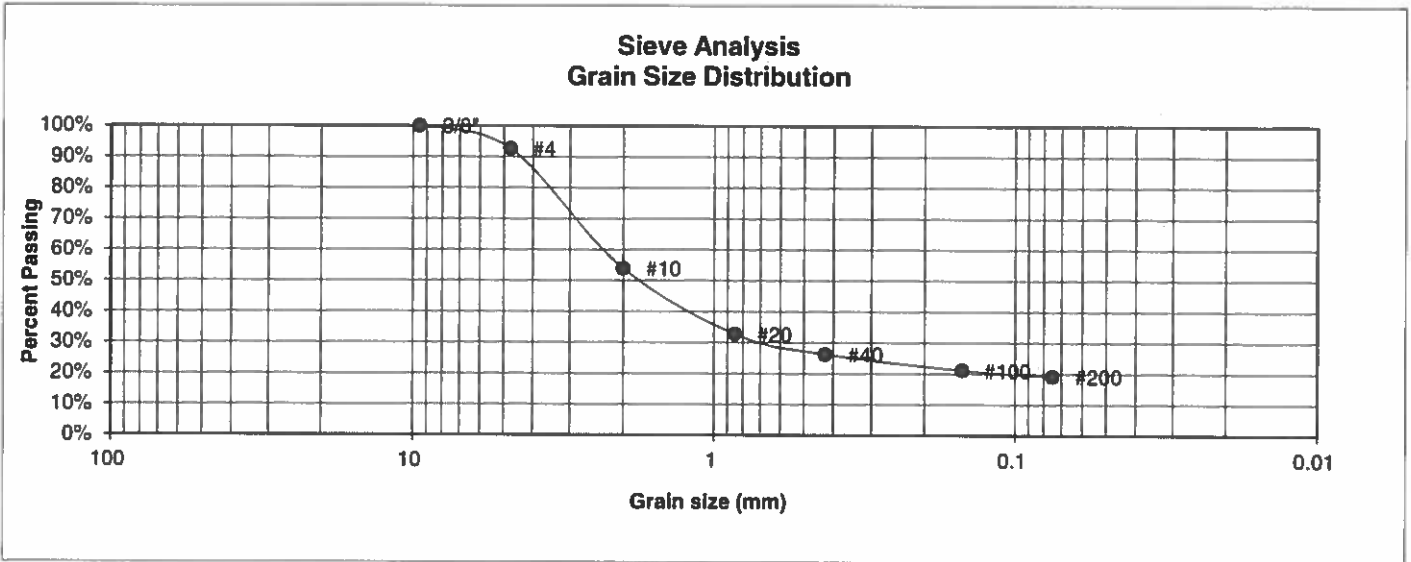
FIG NO:
C-6

UNIFIED CLASSIFICATION	SM	CLIENT	4 SITE INVESTMENTS, LLC
SOIL TYPE #	1	PROJECT	GRANDVIEW RESERVE
TEST BORING #	8	JOB NO.	181951
DEPTH (FT)	5	TEST BY	BL

U.S. Sieve #	Percent Finer
3"	
1 1/2"	
3/4"	
1/2"	
3/8"	100.0%
4	92.6%
10	53.9%
20	32.7%
40	26.3%
100	21.1%
200	19.2%

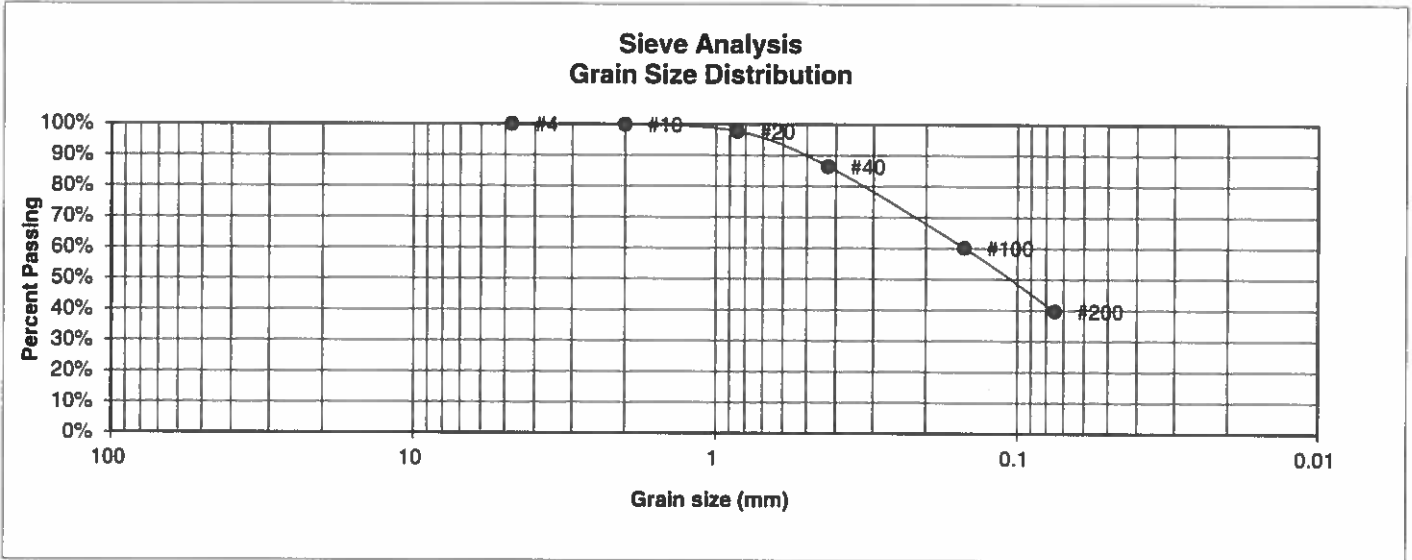
UNIFIED CLASSIFICATION	SM	CLIENT	4 SITE INVESTMENTS, LLC
SOIL TYPE #	1	PROJECT	GRANDVIEW RESERVE
TEST BORING #	9	JOB NO.	181951
DEPTH (FT)	5	TEST BY	BL

U.S. Sieve #	Percent Finer
3"	
1 1/2"	
3/4"	
1/2"	
3/8"	
4	100.0%
10	99.9%
20	97.8%
40	86.5%
100	60.2%
200	39.8%

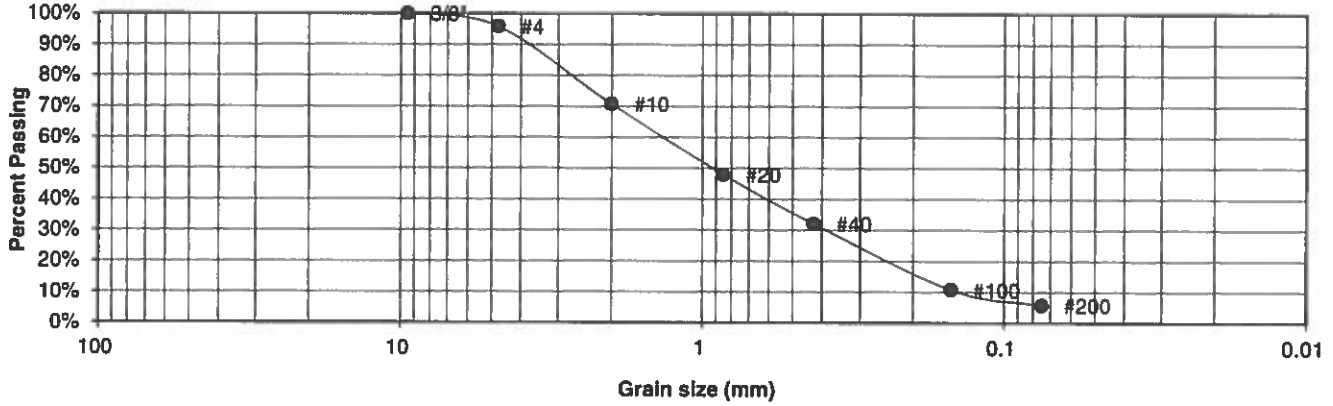
UNIFIED CLASSIFICATION	SM-SW	CLIENT	4 SITE INVESTMENTS, LLC
SOIL TYPE #	1	PROJECT	GRANDVIEW RESERVE
TEST BORING #	TP-2	JOB NO.	181951
DEPTH (FT)	2-3	TEST BY	BL

**Sieve Analysis
Grain Size Distribution**

<u>U.S. Sieve #</u>	<u>Percent Finer</u>
3"	
1 1/2"	
3/4"	
1/2"	
3/8"	100.0%
4	95.8%
10	70.7%
20	48.0%
40	32.0%
100	10.7%
200	5.8%

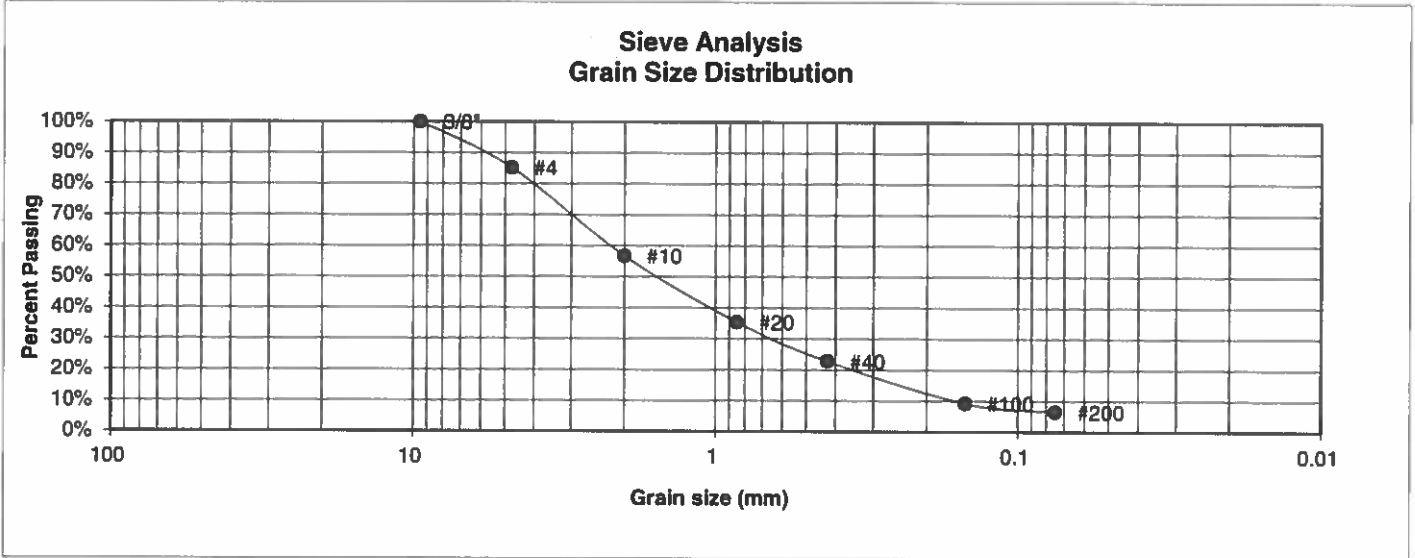
FIG NO.:
C-8

UNIFIED CLASSIFICATION	SM-SW	CLIENT	4 SITE INVESTMENTS, LLC
SOIL TYPE #	1	PROJECT	GRANDVIEW RESERVE
TEST BORING #	TP-3	JOB NO.	181951
DEPTH (FT)	2-3	TEST BY	BL

U.S. Sieve #	Percent Finer
3"	
1 1/2"	
3/4"	
1/2"	
3/8"	100.0%
4	85.2%
10	56.8%
20	35.4%
40	22.8%
100	9.2%
200	6.5%

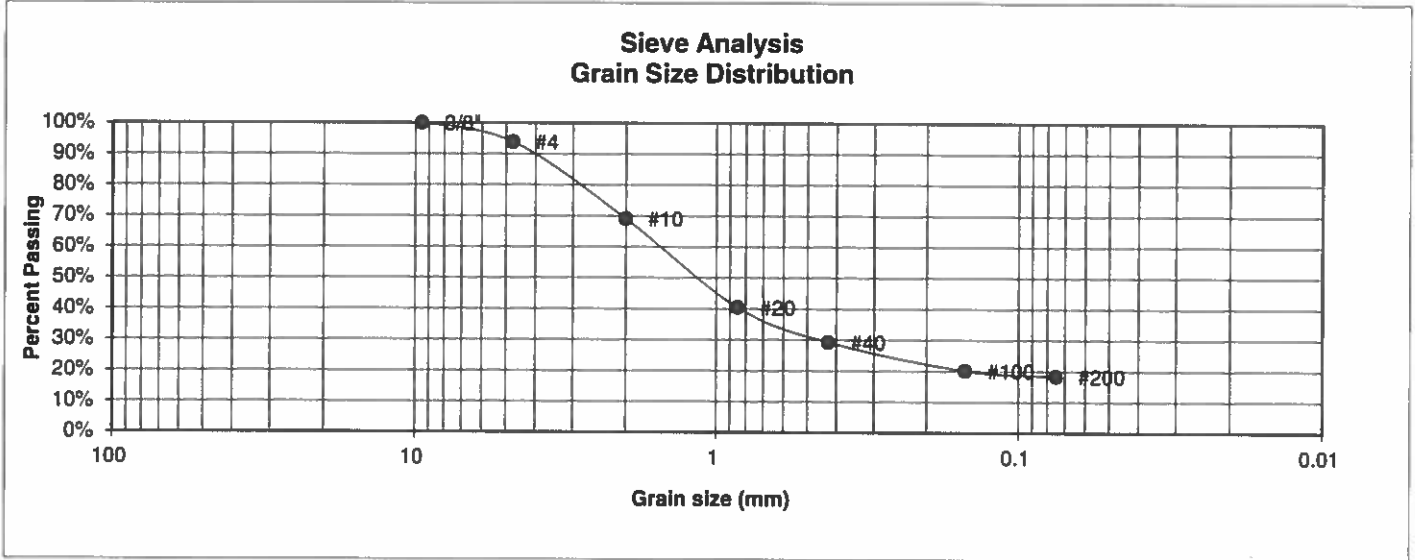
FIG NO.: C-9

UNIFIED CLASSIFICATION	SC	CLIENT	4 SITE INVESTMENTS, LLC
SOIL TYPE #	1	PROJECT	GRANDVIEW RESERVE
TEST BORING #	TP-3	JOB NO.	181951
DEPTH (FT)	8-9	TEST BY	BL

U.S. Sieve #	Percent Finer
3"	
1 1/2"	
3/4"	
1/2"	
3/8"	100.0%
4	93.9%
10	69.1%
20	40.4%
40	29.3%
100	20.1%
200	18.4%

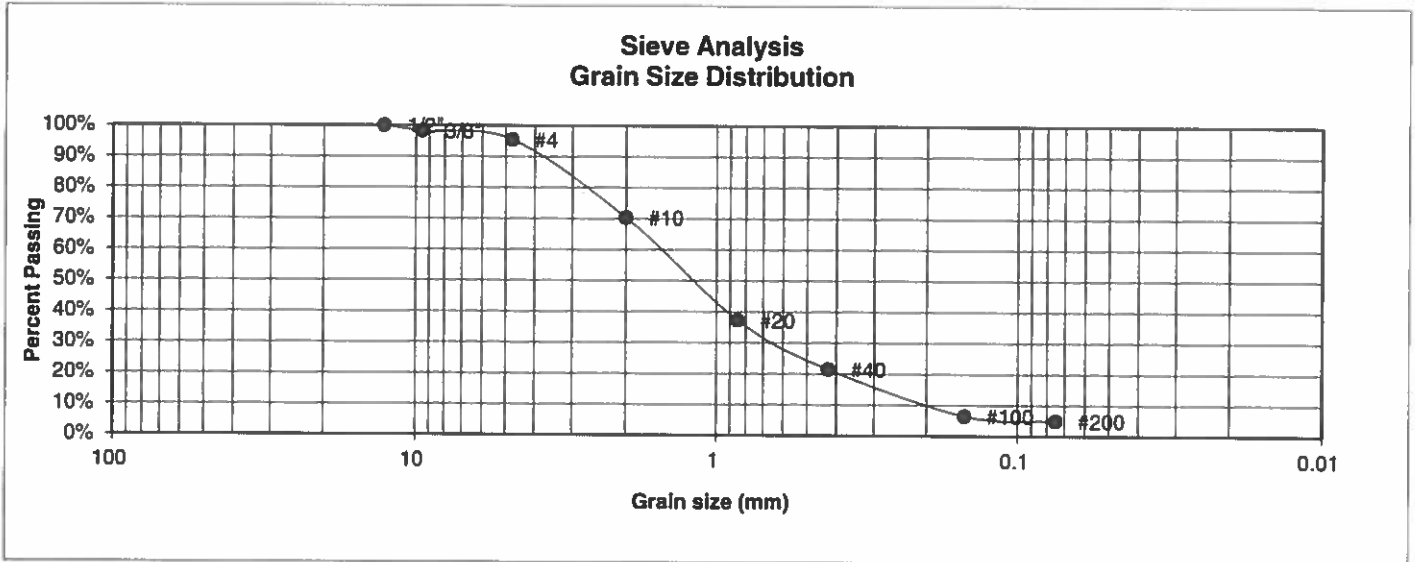
FIG NO.:
C-10

UNIFIED CLASSIFICATION	SW	CLIENT	4 SITE INVESTMENTS, LLC
SOIL TYPE #	1	PROJECT	GRANDVIEW RESERVE
TEST BORING #	TP-4	JOB NO.	181951
DEPTH (FT)	5-6	TEST BY	BL

U.S. Sieve #	Percent Finer
3"	
1 1/2"	
3/4"	
1/2"	100.0%
3/8"	98.3%
4	95.5%
10	70.4%
20	37.3%
40	21.5%
100	6.5%
200	4.9%

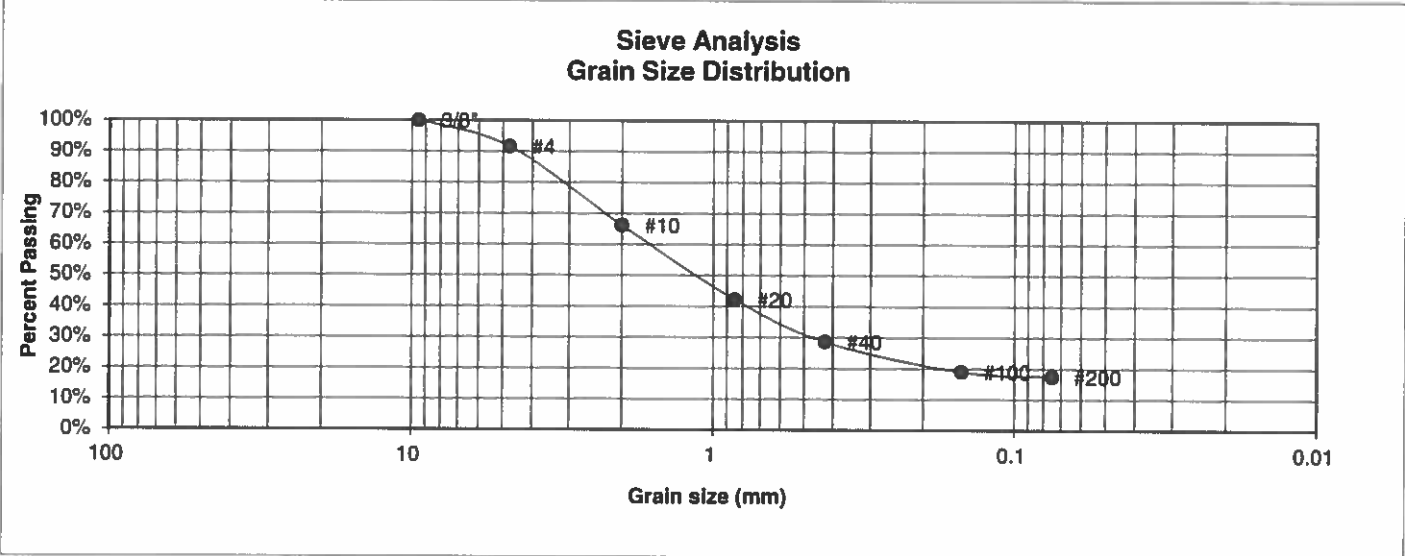
FIG NO:
C-11

UNIFIED CLASSIFICATION	SM	CLIENT	4 SITE INVESTMENTS, LLC
SOIL TYPE #	1	PROJECT	GRANDVIEW RESERVE
TEST BORING #	TP-7	JOB NO.	181951
DEPTH (FT)	5-6	TEST BY	BL

U.S. Sieve #	Percent Finer
3"	
1 1/2"	
3/4"	
1/2"	
3/8"	100.0%
4	91.6%
10	66.2%
20	42.2%
40	28.6%
100	18.9%
200	17.5%

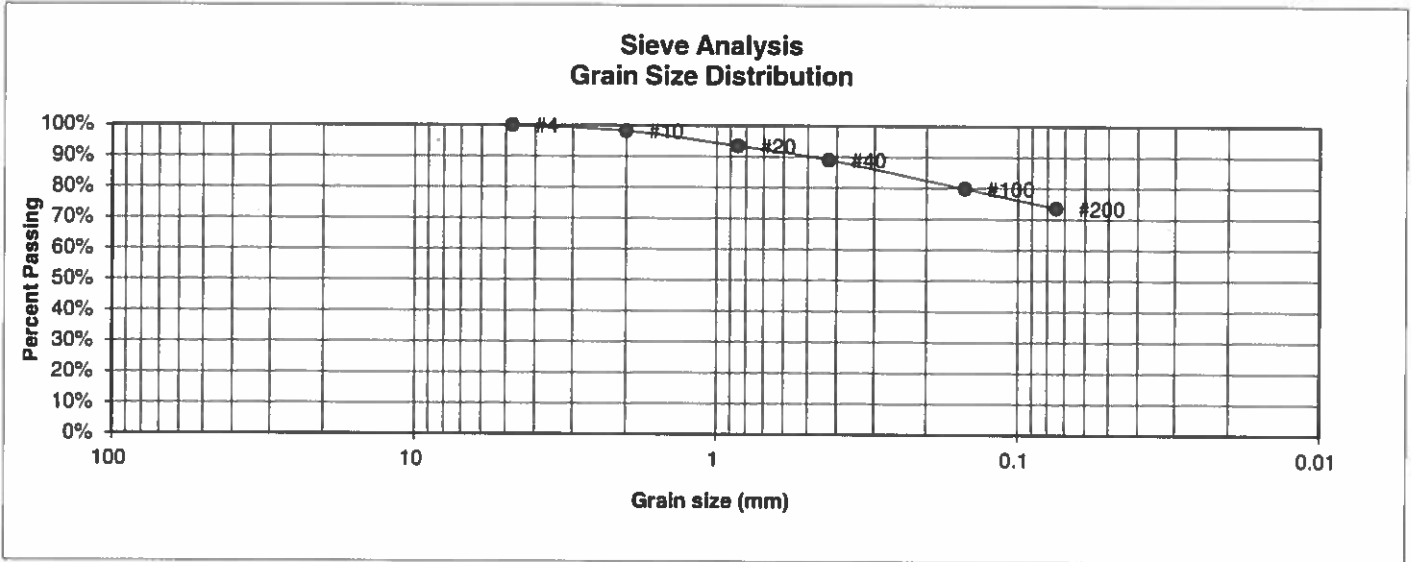
FIG NO.:
C-12

UNIFIED CLASSIFICATION	CL	CLIENT	4 SITE INVESTMENTS, LLC
SOIL TYPE #	2	PROJECT	GRANDVIEW RESERVE
TEST BORING #	10	JOB NO.	181951
DEPTH (FT)	10	TEST BY	BL

U.S. Sieve #	Percent Finer
3"	
1 1/2"	
3/4"	
1/2"	
3/8"	
4	100.0%
10	98.2%
20	93.4%
40	89.0%
100	79.9%
200	73.6%

Atterberg Limits	
Plastic Limit	22
Liquid Limit	44
Plastic Index	22

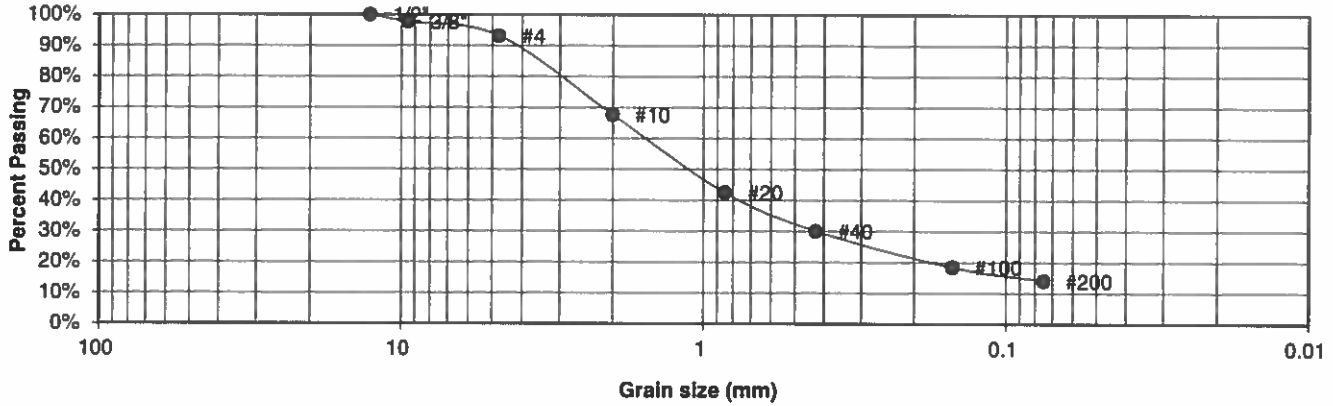
**Sieve Analysis
Grain Size Distribution**

U.S. Sieve #	Percent Finer
3"	
1 1/2"	
3/4"	
1/2"	100.0%
3/8"	97.7%
4	93.2%
10	67.7%
20	42.5%
40	30.1%
100	18.4%
200	14.0%

Atterberg Limits	
Plastic Limit	13
Liquid Limit	28
Plastic Index	15

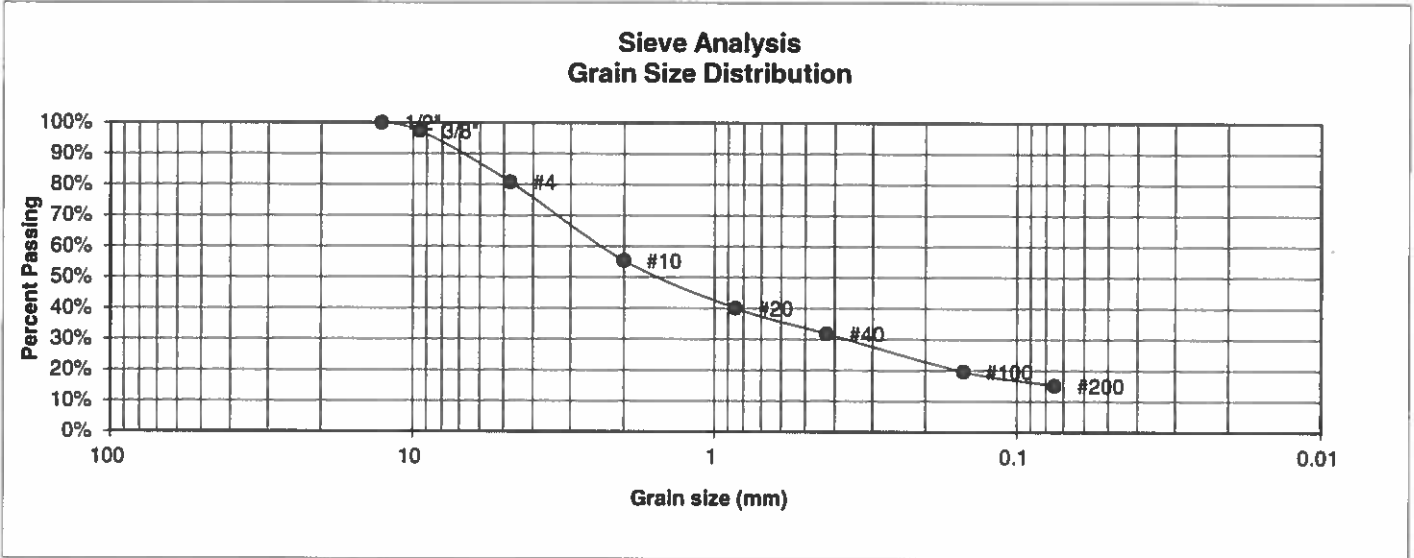
FIG NO:
C-15

UNIFIED CLASSIFICATION	SM	CLIENT	4 SITE INVESTMENTS, LLC
SOIL TYPE #	3	PROJECT	GRANDVIEW RESERVE
TEST BORING #	3	JOB NO.	181951
DEPTH (FT)	10	TEST BY	BL

U.S. Sieve #	Percent Finer
3"	
1 1/2"	
3/4"	
1/2"	100.0%
3/8"	97.4%
4	80.8%
10	55.4%
20	40.1%
40	31.9%
100	19.6%
200	15.2%

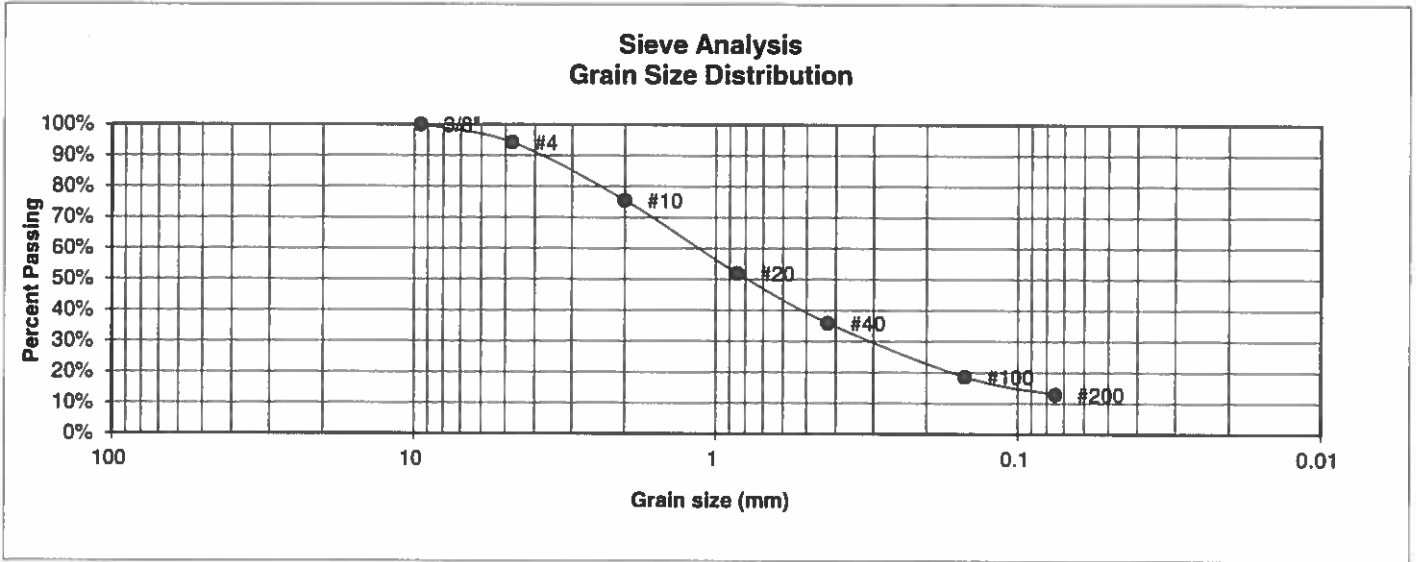
FIG NO.:
C-16

UNIFIED CLASSIFICATION	SM	CLIENT	4 SITE INVESTMENTS, LLC
SOIL TYPE #	3	PROJECT	GRANDVIEW RESERVE
TEST BORING #	4	JOB NO.	181951
DEPTH (FT)	15	TEST BY	BL

U.S. Sieve #	Percent Finer
3"	
1 1/2"	
3/4"	
1/2"	
3/8"	100.0%
4	94.2%
10	75.6%
20	52.0%
40	35.9%
100	18.6%
200	12.9%

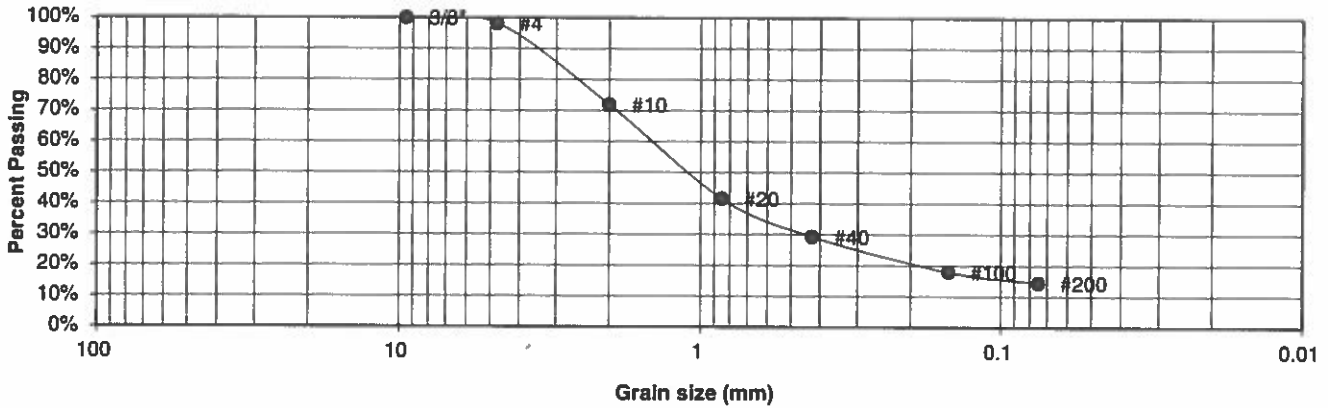
**Sieve Analysis
Grain Size Distribution**

U.S. Sieve #	Percent Finer
3"	
1 1/2"	
3/4"	
1/2"	
3/8"	100.0%
4	98.2%
10	71.9%
20	41.5%
40	29.3%
100	17.9%
200	14.4%

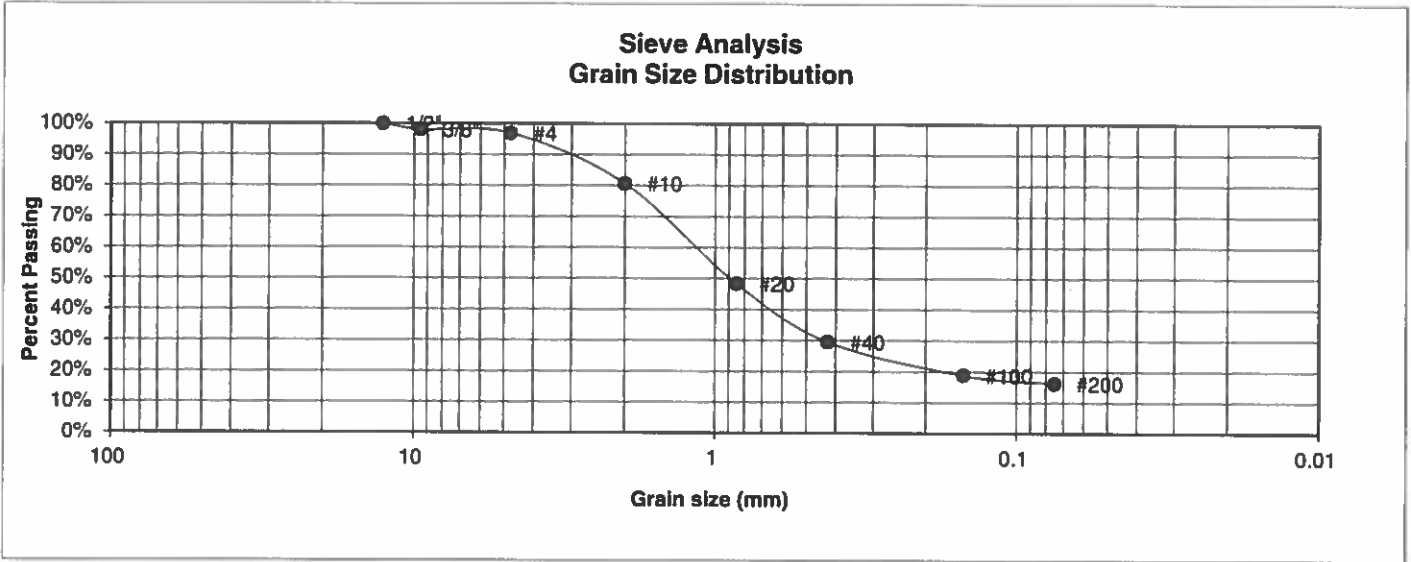
FIG NO.: C-19

UNIFIED CLASSIFICATION	SM	CLIENT	4 SITE INVESTMENTS, LLC
SOIL TYPE #	3	PROJECT	GRANDVIEW RESERVE
TEST BORING #	TP-1	JOB NO.	181951
DEPTH (FT)	4-5	TEST BY	BL

U.S. Sieve #	Percent Finer
3"	
1 1/2"	
3/4"	
1/2"	100.0%
3/8"	98.1%
4	96.9%
10	80.7%
20	48.3%
40	29.5%
100	18.8%
200	16.2%

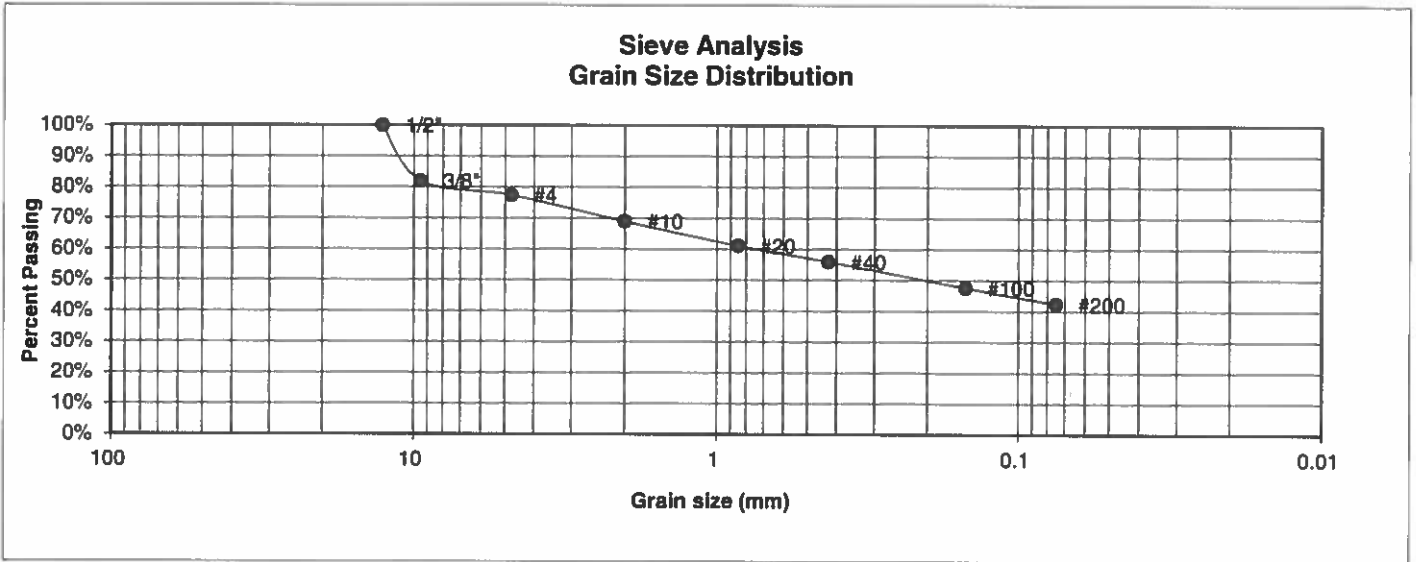
FIG NO.:
C-20

UNIFIED CLASSIFICATION	SC	CLIENT	4 SITE INVESTMENTS, LLC
SOIL TYPE #	3	PROJECT	GRANDVIEW RESERVE
TEST BORING #	TP-5	JOB NO.	181951
DEPTH (FT)	4-5	TEST BY	BL

U.S. Sieve #	Percent Finer
3"	
1 1/2"	
3/4"	
1/2"	100.0%
3/8"	82.0%
4	77.4%
10	69.0%
20	61.1%
40	55.9%
100	47.6%
200	42.3%

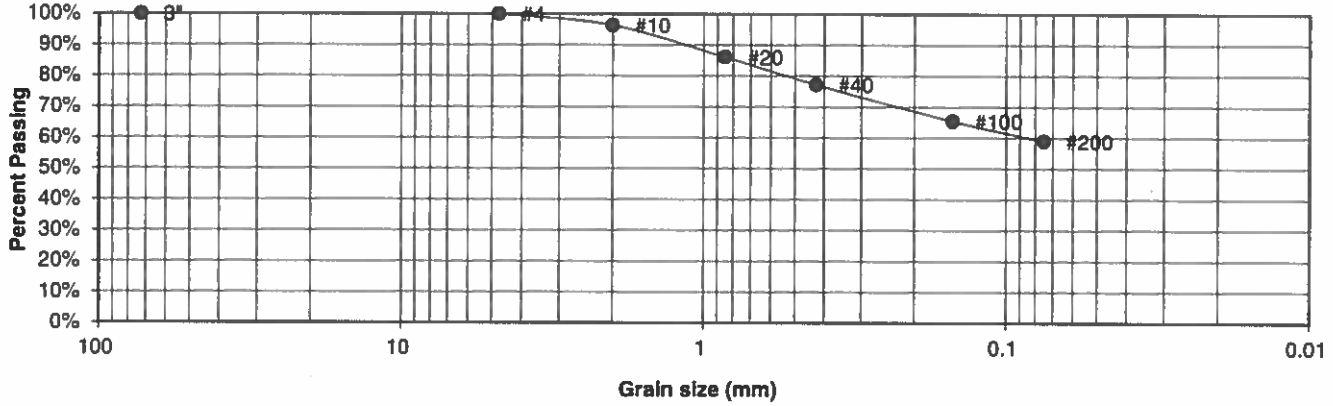
**Sieve Analysis
Grain Size Distribution**

U.S. Sieve #	Percent Finer
3"	100.0%
1 1/2"	
3/4"	
1/2"	
3/8"	
4	100.0%
10	96.4%
20	86.1%
40	77.2%
100	65.4%
200	59.0%

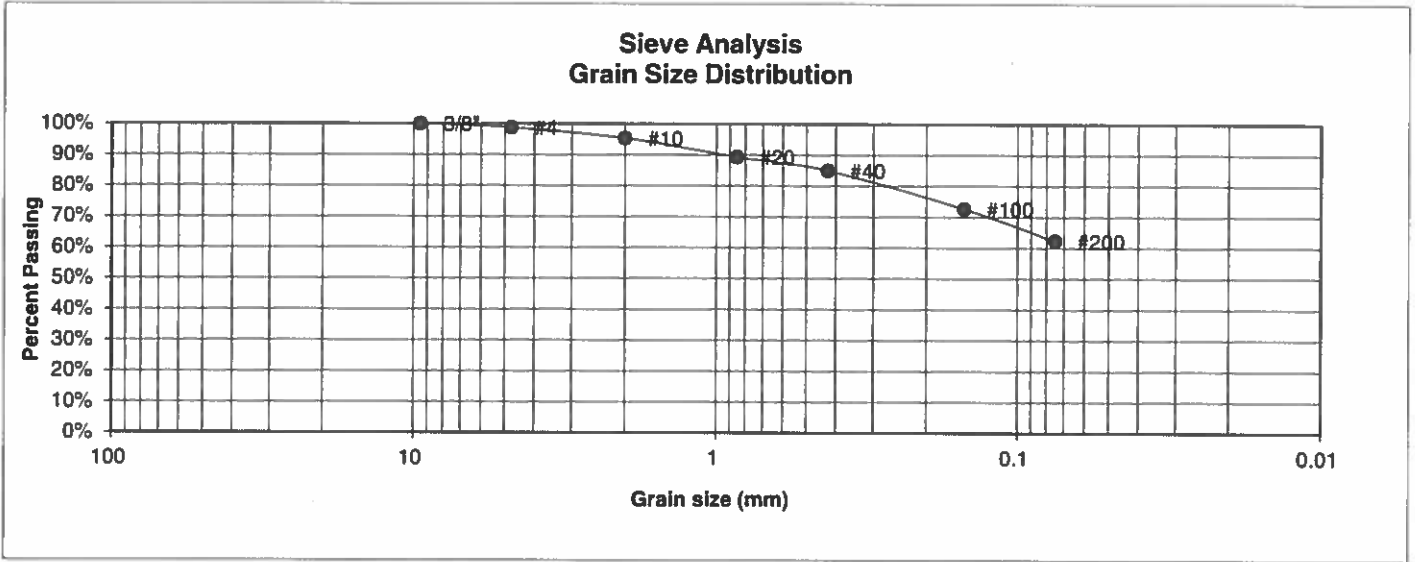
FIG NO.:
C-22

UNIFIED CLASSIFICATION	CL	CLIENT	4 SITE INVESTMENTS, LLC
SOIL TYPE #	4	PROJECT	GRANDVIEW RESERVE
TEST BORING #	2	JOB NO.	181951
DEPTH (FT)	10	TEST BY	BL

U.S. Sieve #	Percent Finer
3"	
1 1/2"	
3/4"	
1/2"	
3/8"	100.0%
4	98.8%
10	95.4%
20	89.3%
40	85.0%
100	72.6%
200	62.3%

Atterberg Limits	
Plastic Limit	14
Liquid Limit	35
Plastic Index	21

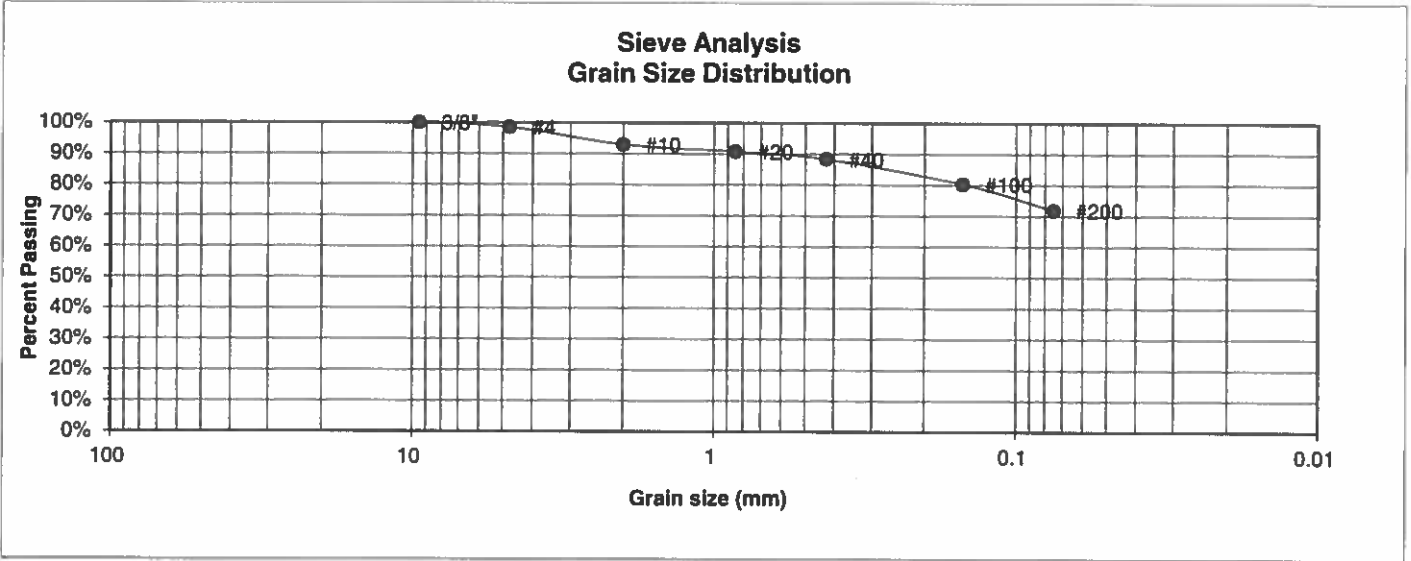
FIG NO.:
C-23

UNIFIED CLASSIFICATION	CL	CLIENT	4 SITE INVESTMENTS, LLC
SOIL TYPE #	4	PROJECT	GRANDVIEW RESERVE
TEST BORING #	9	JOB NO.	181951
DEPTH (FT)	15	TEST BY	BL

U.S. Sieve #	Percent Finer
3"	
1 1/2"	
3/4"	
1/2"	
3/8"	100.0%
4	98.5%
10	93.0%
20	90.8%
40	88.3%
100	80.3%
200	71.9%

Swell
 Moisture at start 7.9%
 Moisture at finish 15.7%
 Moisture increase 7.8%
 Initial dry density (pcf) 99
 Swell (psf) 1580

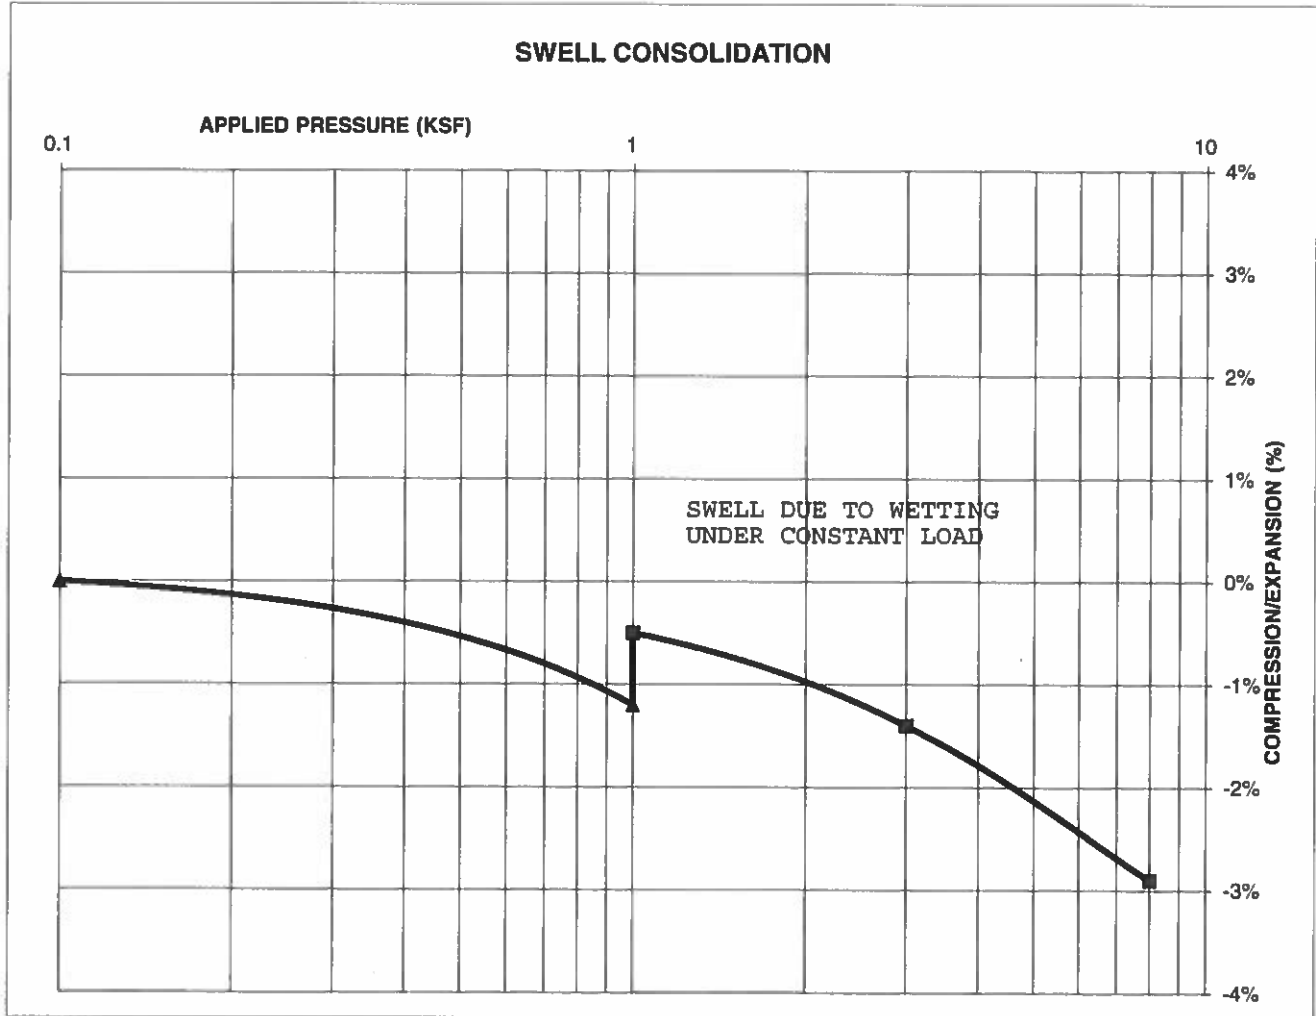
TEST BORING #	3	DEPTH(ft)	15
DESCRIPTION	CL	SOIL TYPE	4
NATURAL UNIT DRY WEIGHT (PCF)	113		
NATURAL MOISTURE CONTENT	12.8%		
SWELL/CONSOLIDATION (%)	0.7%
