**GEOLOGIC HAZARD EVALUATION AND
PRELIMINARY GEOTECHNICAL INVESTIGATION
GRANDVIEW RESERVE, FILING 1
EASTONVILLE ROAD AND U.S. HIGHWAY 24
FALCON, COLORADO**

D.R. HORTON
9555 S. Kingston Court
Englewood, Colorado

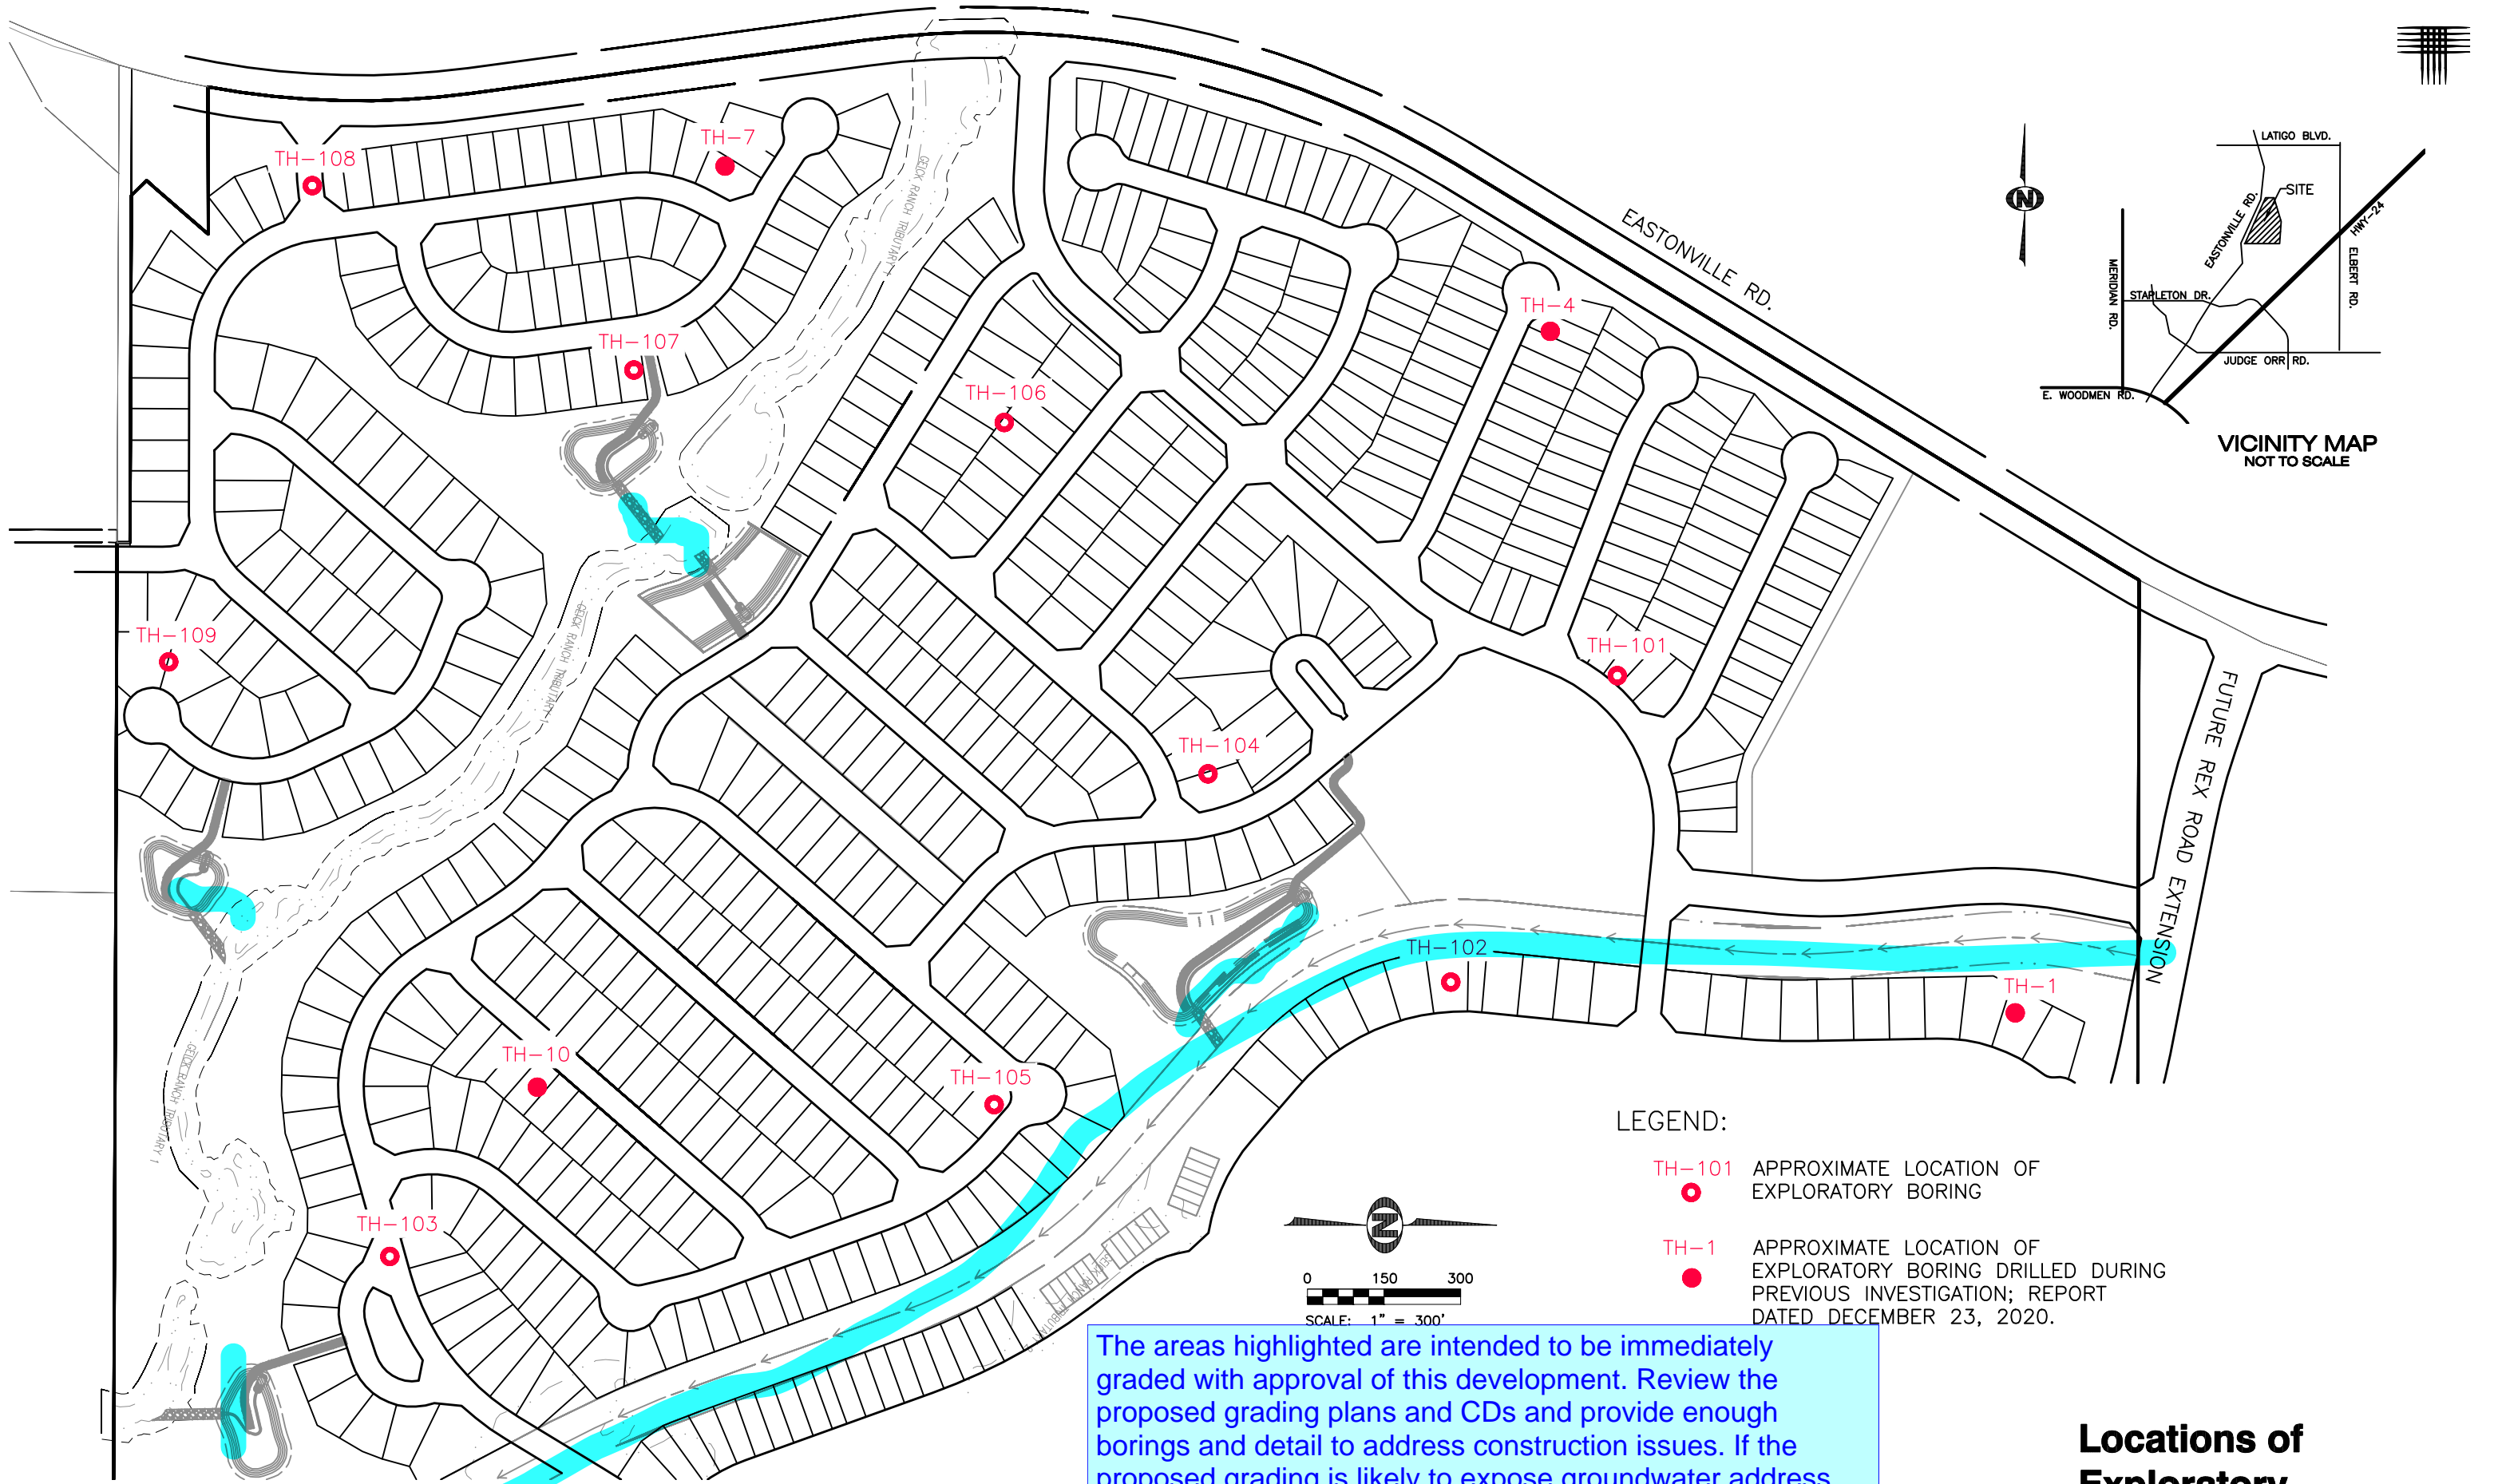
FIG. 1 – LOCATIONS OF EXPLORATORY BORINGS

The areas highlighted are intended to be immediately graded with approval of this development. Review the proposed grading plans and CDs and provide enough borings and detail to address construction issues. If the proposed grading is likely to expose groundwater address mitigation measures.

- LEGEND:
- TH-101 APPROXIMATE LOCATION OF EXPLORATORY BORING
 - TH-1 APPROXIMATE LOCATION OF EXPLORATORY BORING DRILLED DURING PREVIOUS INVESTIGATION; REPORT DATED DECEMBER 23, 2020.

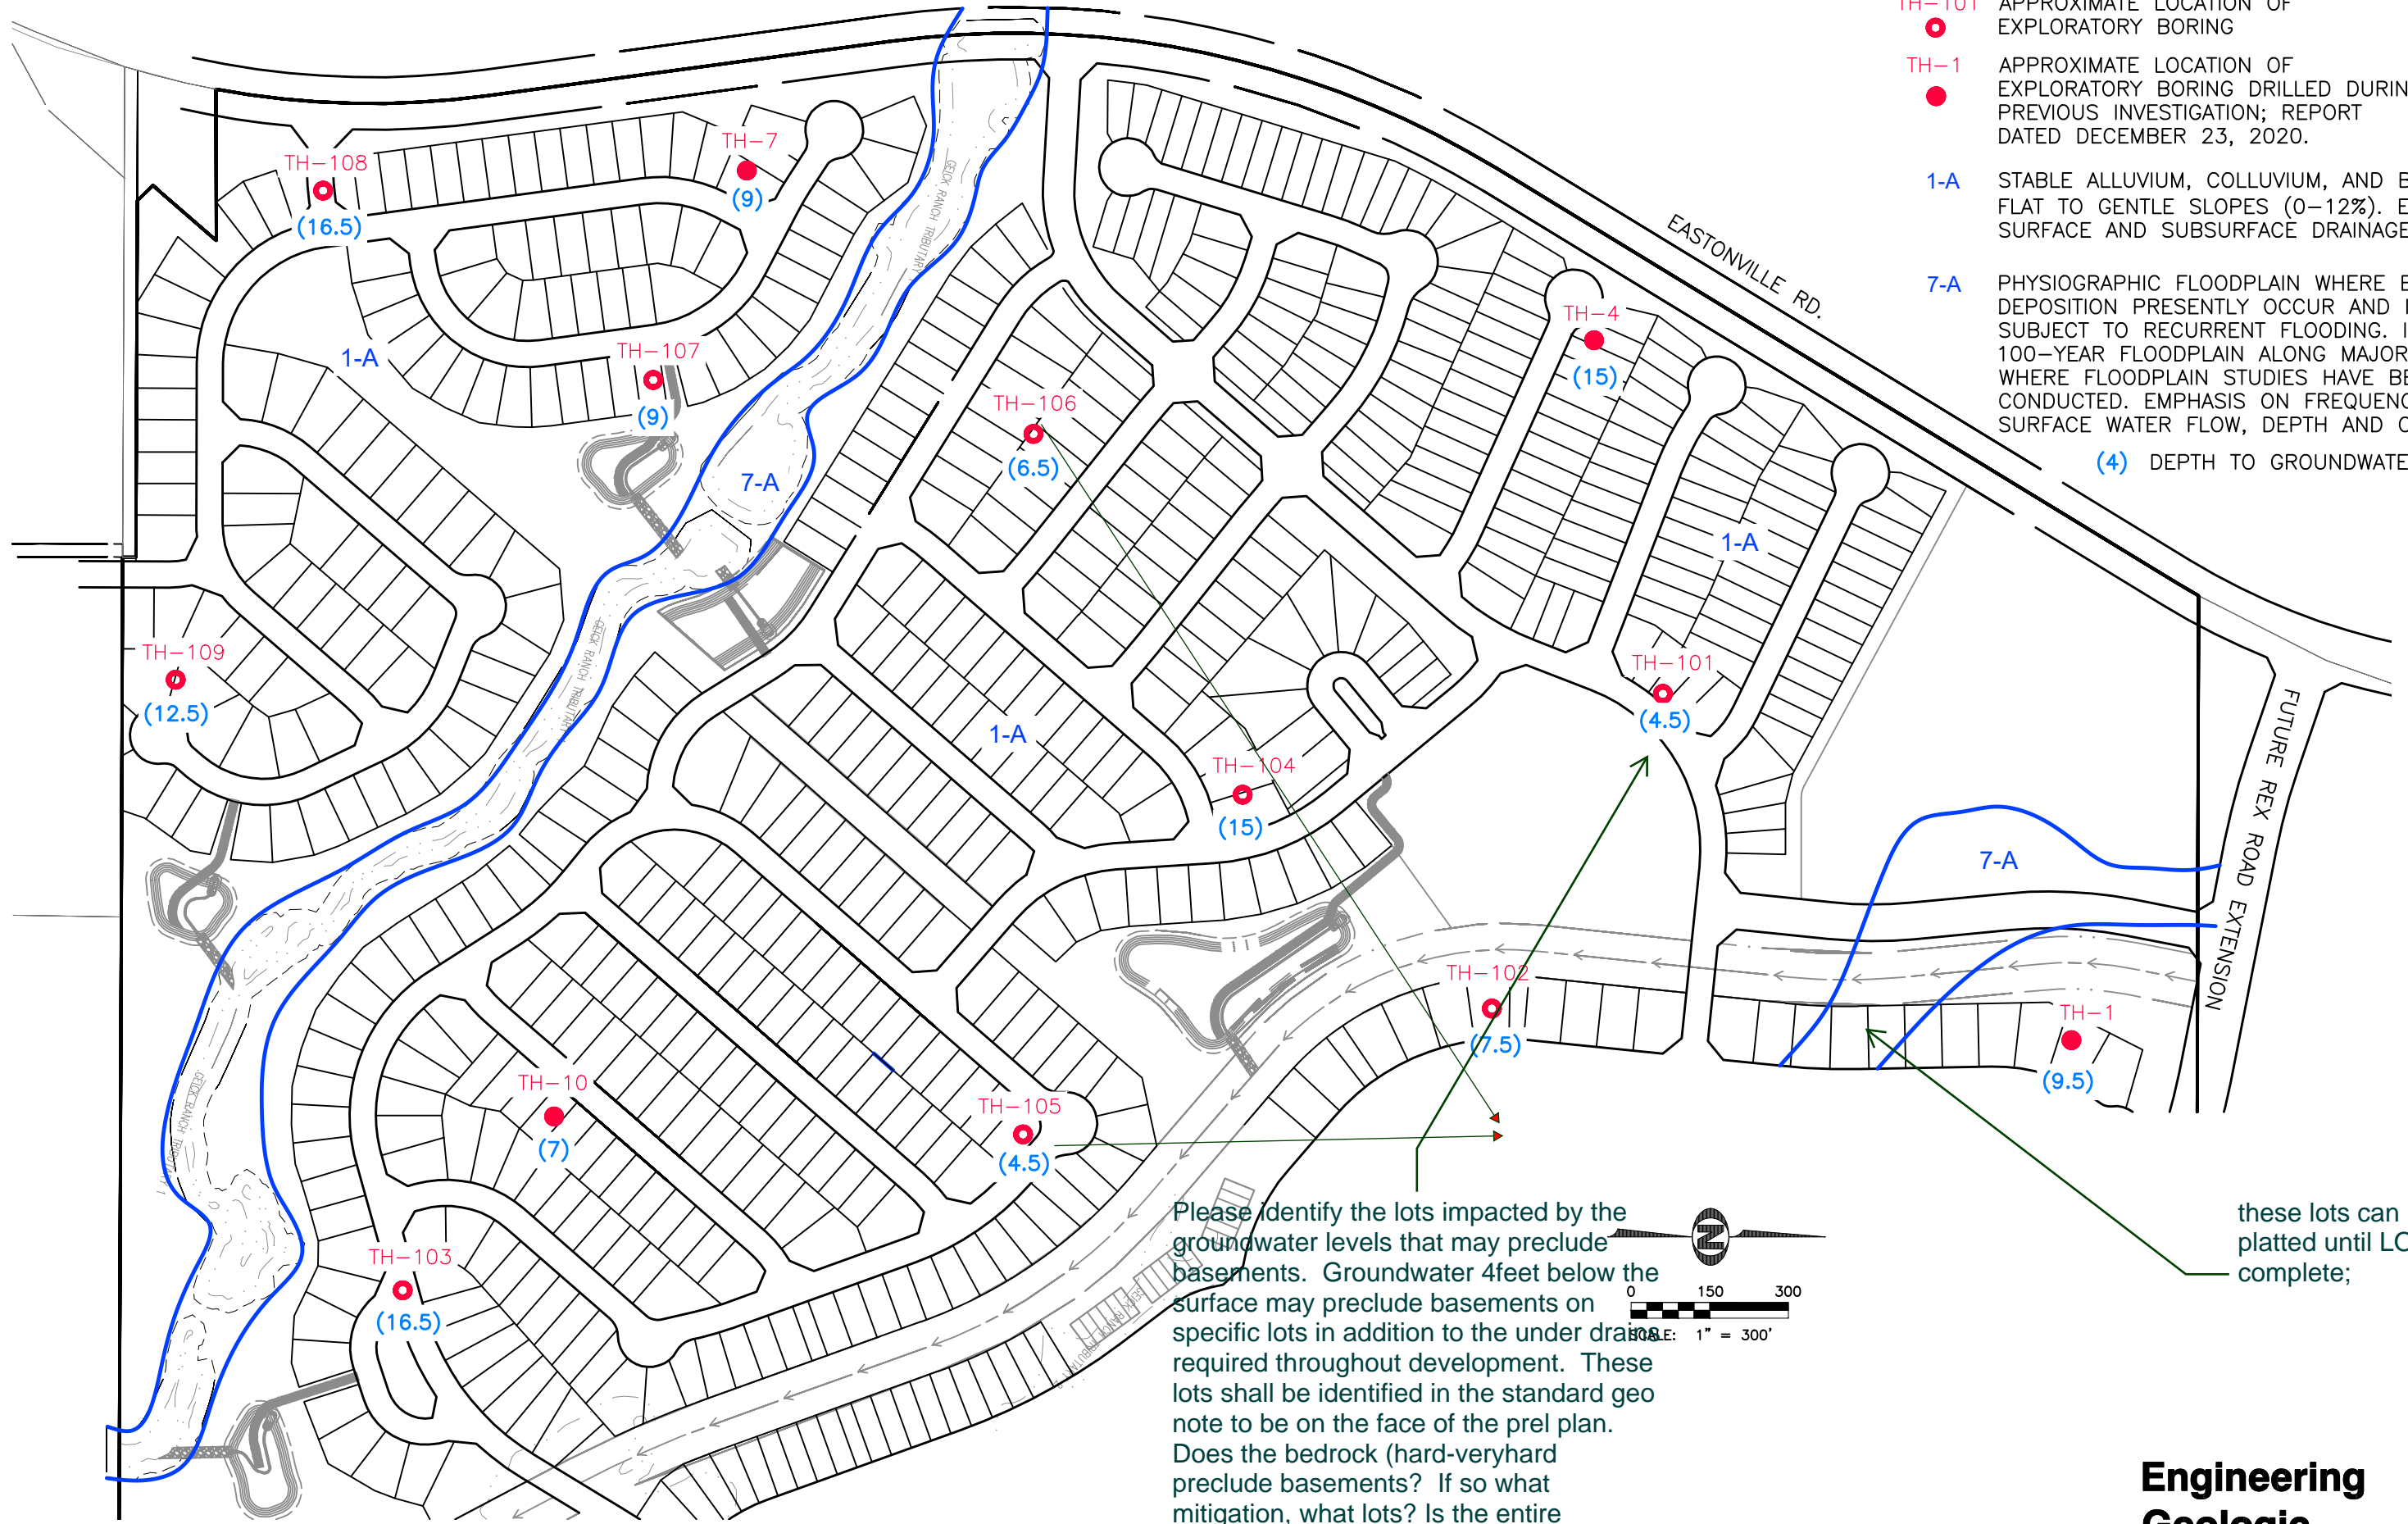
FIG. 2 – ENGINEERING GEOLOGIC CONDITIONS

- TH-101 APPROXIMATE LOCATION OF EXPLORATORY BORING
- TH-1 APPROXIMATE LOCATION OF EXPLORATORY BORING DRILLED DURING PREVIOUS INVESTIGATION; REPORT DATED DECEMBER 23, 2020.
- 1-A STABLE ALLUVIUM, COLLUVIUM, AND BEDROCK ON FLAT TO GENTLE SLOPES (0-12%). EMPHASIS ON SURFACE AND SUBSURFACE DRAINAGE.
- 7-A PHYSIOGRAPHIC FLOODPLAIN WHERE EROSION AND DEPOSITION PRESENTLY OCCUR AND IS GENERALLY SUBJECT TO RECURRENT FLOODING. INCLUDES 100-YEAR FLOODPLAIN ALONG MAJOR STREAMS WHERE FLOODPLAIN STUDIES HAVE BEEN CONDUCTED. EMPHASIS ON FREQUENCY OF SURFACE WATER FLOW, DEPTH AND CONTROL.
- (4) DEPTH TO GROUNDWATER (FEET)

Please identify the lots impacted by the groundwater levels that may preclude basements. Groundwater 4feet below the surface may preclude basements on specific lots in addition to the under drains required throughout development. These lots shall be identified in the standard geo note to be on the face of the prel plan. Does the bedrock (hard-veryhard preclude basements? If so what mitigation, what lots? Is the entire development subject to heave or just some lots? Please clarify graphicly and via Geo note on prelim plan

The presence of shallow groundwater can impact basement level construction. Current groundwater depths indicate proximity of groundwater to basement level foundation systems may be a concern, particularly near drainages. This condition can be mitigated through use of foundation drains, active underdrains (if allowed and installed by the developer), or cut-off drains. The depth to groundwater will also be impacted by proposed grading and depth of foundations. This condition should be further evaluated at the time of lot-specific Soils and Foundation Investigations.
