Geotechnical Engineering Services Report

**Falcon Marketplace Roadways  
East Woodmen Road & Meridian Road  
Falcon, Colorado**

September 29, 2020  
Revised January 8, 2021

PSI Project No. 05322095

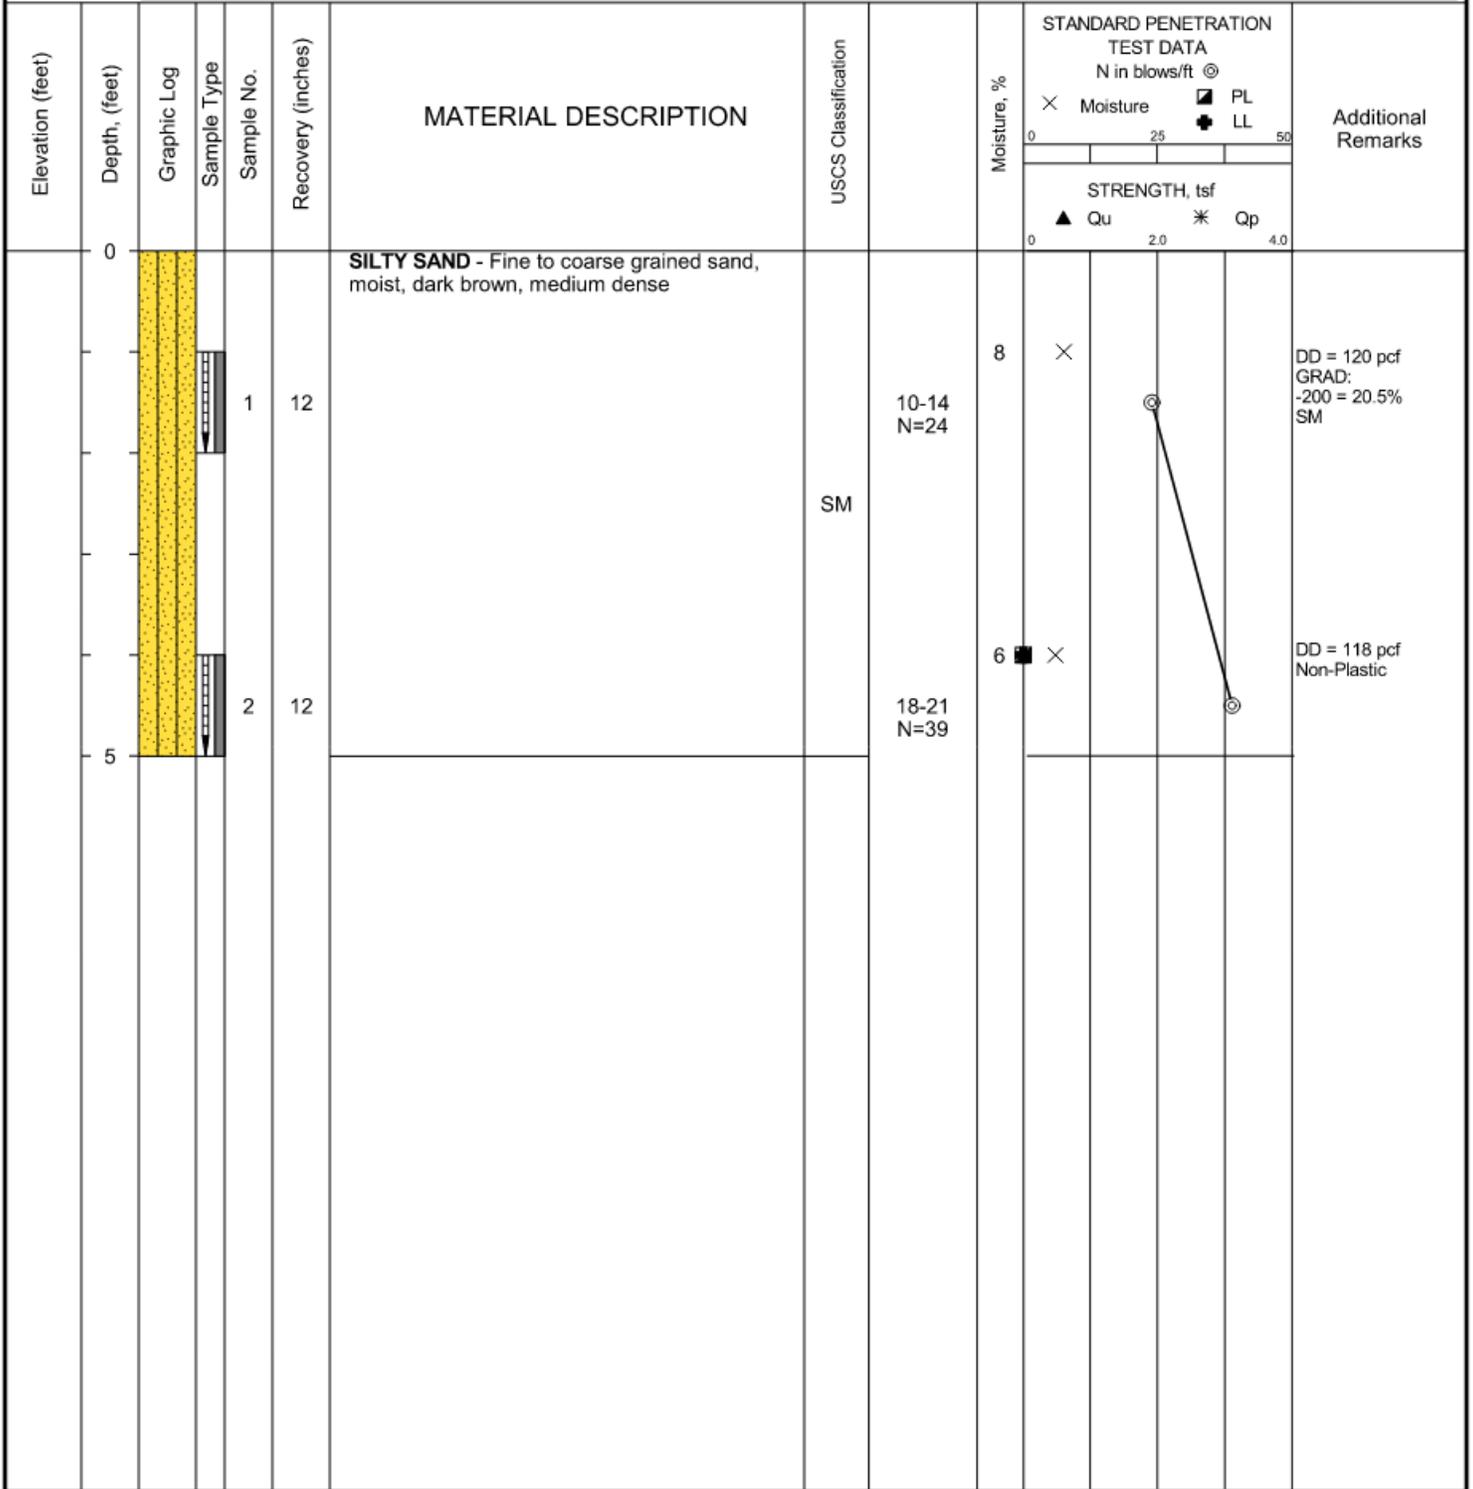
FIGURE: 6

DATE STARTED: 9/15/20	DRILL COMPANY: Dakota Drilling	<b>BORING B 4</b>
DATE COMPLETED: 9/15/20	DRILLER: RR      LOGGED BY: BP	
COMPLETION DEPTH: 5.0 ft	DRILL RIG: CME-55	<b>Water</b> <input type="checkbox"/> While Drilling      Not Observed <input type="checkbox"/> Upon Completion      Not Observed <input type="checkbox"/> Delay      N/A
BENCHMARK: N/A	DRILLING METHOD: Solid Stem Auger	<b>BORING LOCATION:</b> See Figure 2
ELEVATION: N/A	SAMPLING METHOD: Modified California	
LATITUDE: 38.9418°	HAMMER TYPE: Manual	
LONGITUDE: -104.6093°	EFFICIENCY: N/A	
STATION: N/A      OFFSET: N/A	REVIEWED BY: KD	
REMARKS:

The stratification lines represent approximate boundaries. The transition may be gradual.

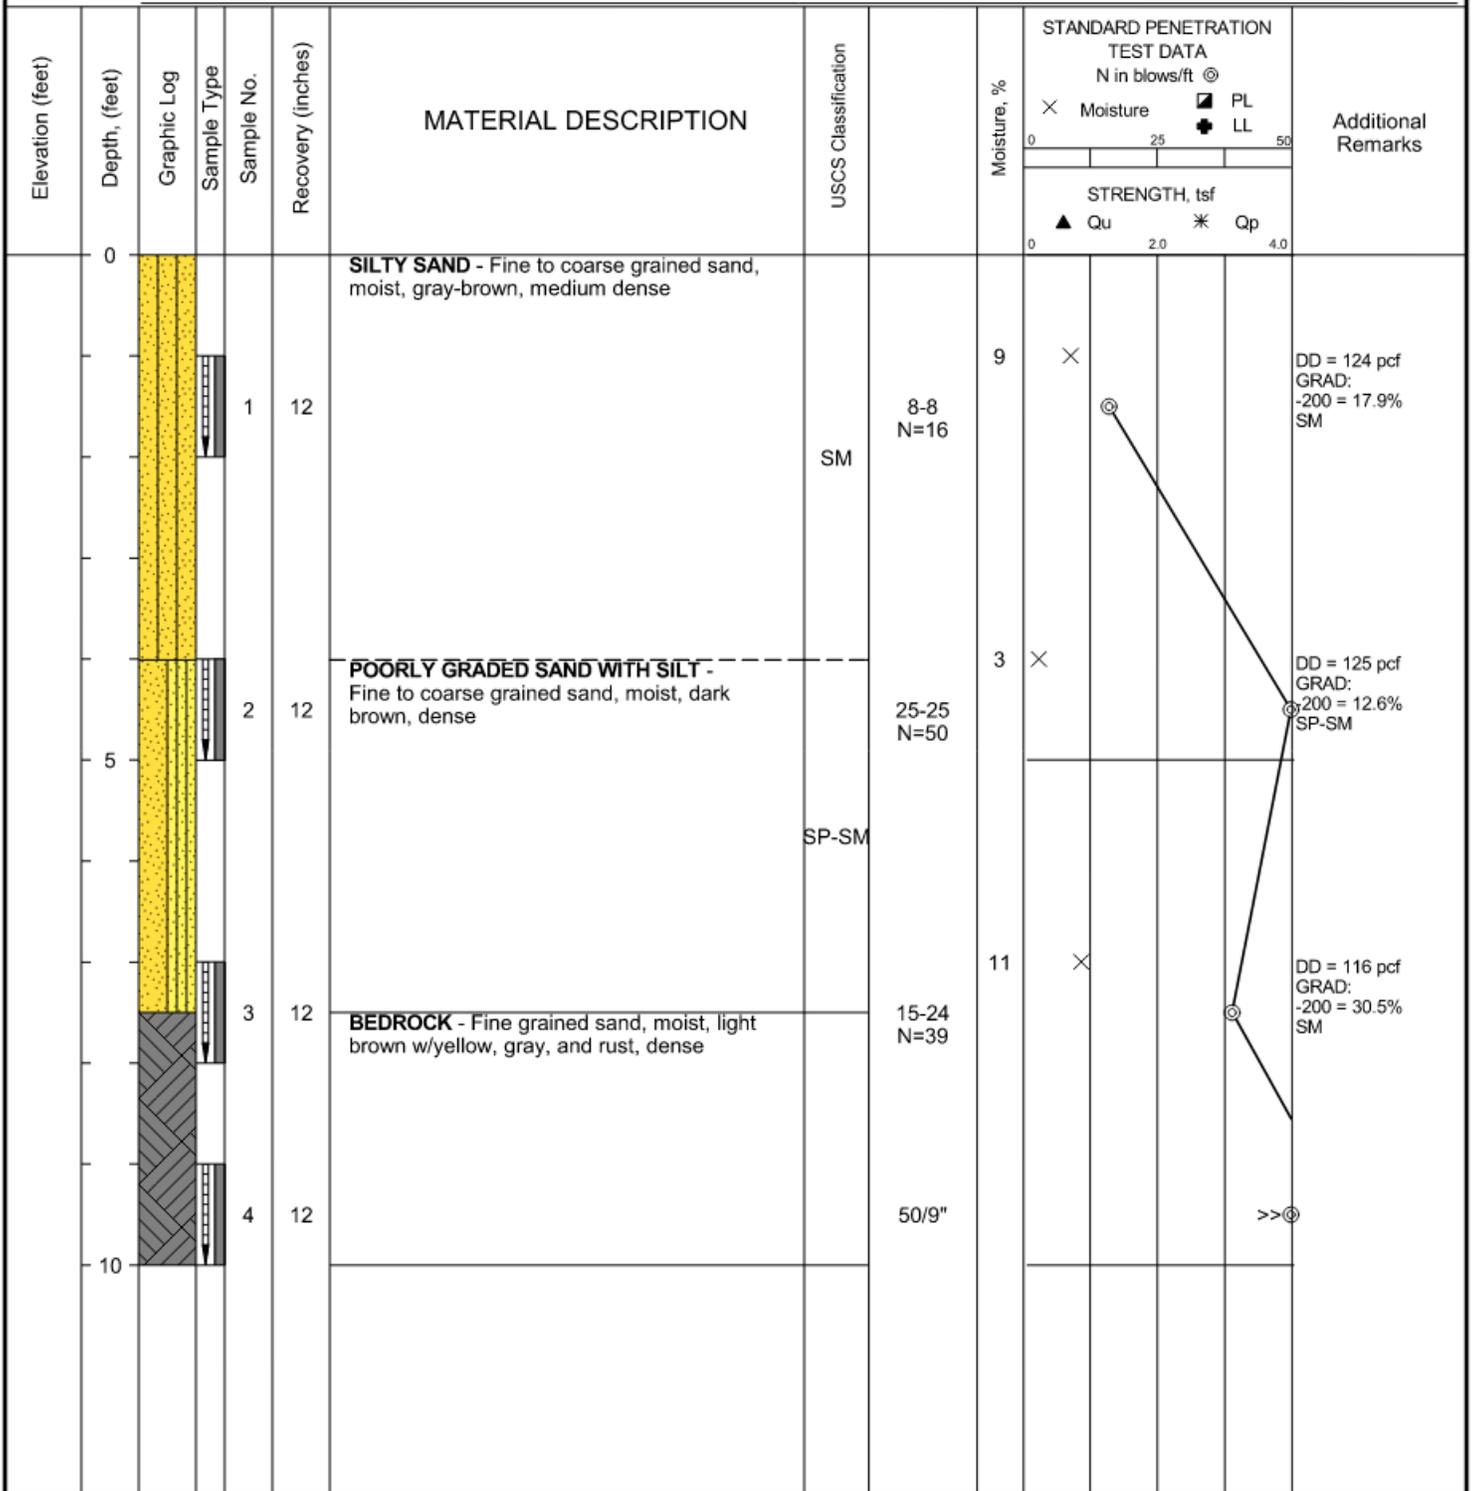
FIGURE: 8

DATE STARTED: 9/15/20	DRILL COMPANY: Dakota Drilling	<b>BORING B 6</b>
DATE COMPLETED: 9/15/20	DRILLER: RR      LOGGED BY: BP	
COMPLETION DEPTH: 10.0 ft	DRILL RIG: CME-55	<b>Water</b> <input type="checkbox"/> While Drilling      Not Observed <input type="checkbox"/> Upon Completion      Not Observed <input type="checkbox"/> Delay      N/A
BENCHMARK: N/A	DRILLING METHOD: Solid Stem Auger	<b>BORING LOCATION:</b> See Figure 2
ELEVATION: N/A	SAMPLING METHOD: Modified California	
LATITUDE: 38.9418°	HAMMER TYPE: Manual	
LONGITUDE: -104.6093°	EFFICIENCY: N/A	
STATION: N/A      OFFSET: N/A	REVIEWED BY: KD	
REMARKS:

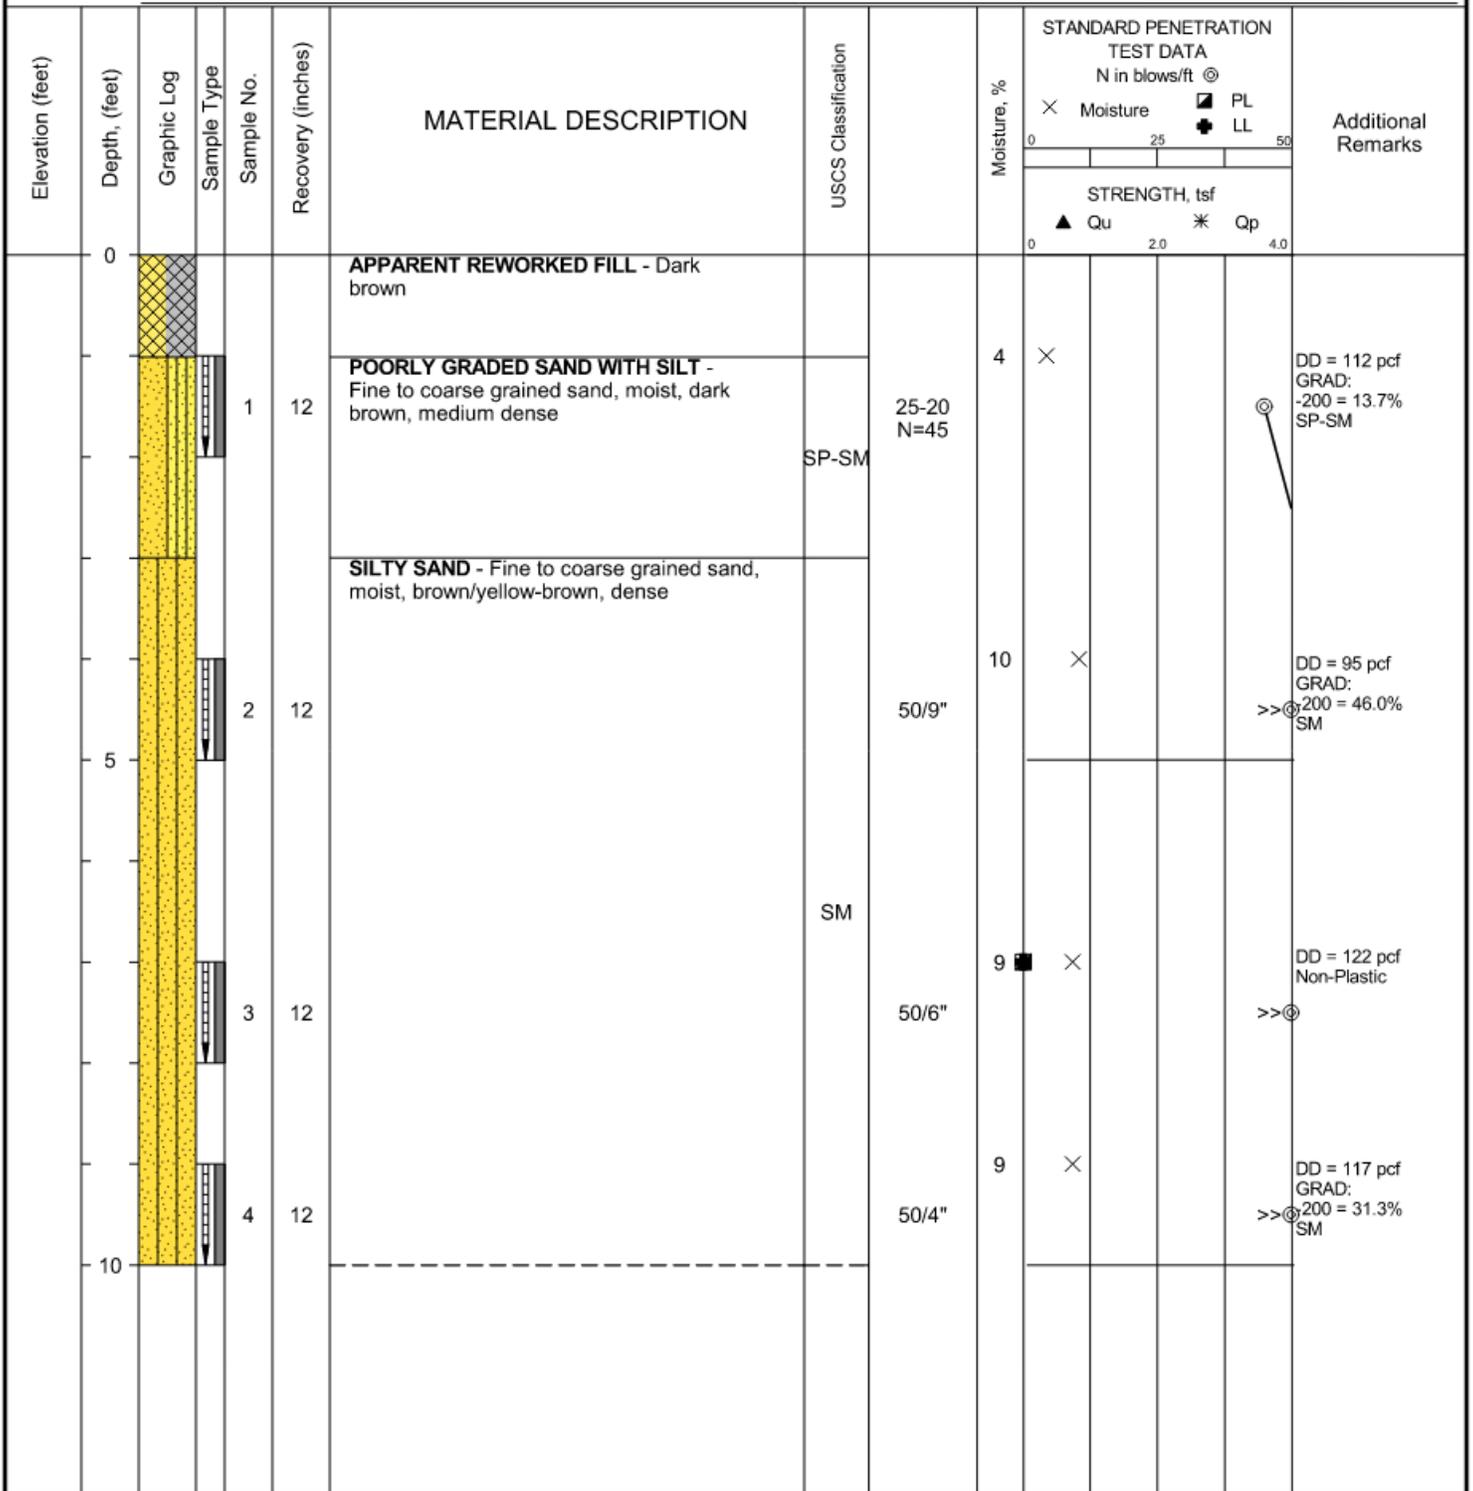
FIGURE: 11

DATE STARTED: 9/15/20	DRILL COMPANY: Dakota Drilling	<b>BORING B 9</b>
DATE COMPLETED: 9/15/20	DRILLER: RR    LOGGED BY: BP	
COMPLETION DEPTH: 10.0 ft	DRILL RIG: CME-55	Water <input type="checkbox"/> While Drilling    Not Observed
BENCHMARK: N/A	DRILLING METHOD: Solid Stem Auger	<input type="checkbox"/> Upon Completion    Not Observed
ELEVATION: N/A	SAMPLING METHOD: Modified California	<input type="checkbox"/> Delay    N/A
LATITUDE: 38.9418°	HAMMER TYPE: Manual	<b>BORING LOCATION:</b>
LONGITUDE: -104.6093°	EFFICIENCY: N/A	See Figure 2
STATION: N/A    OFFSET: N/A	REVIEWED BY: KD	
REMARKS:

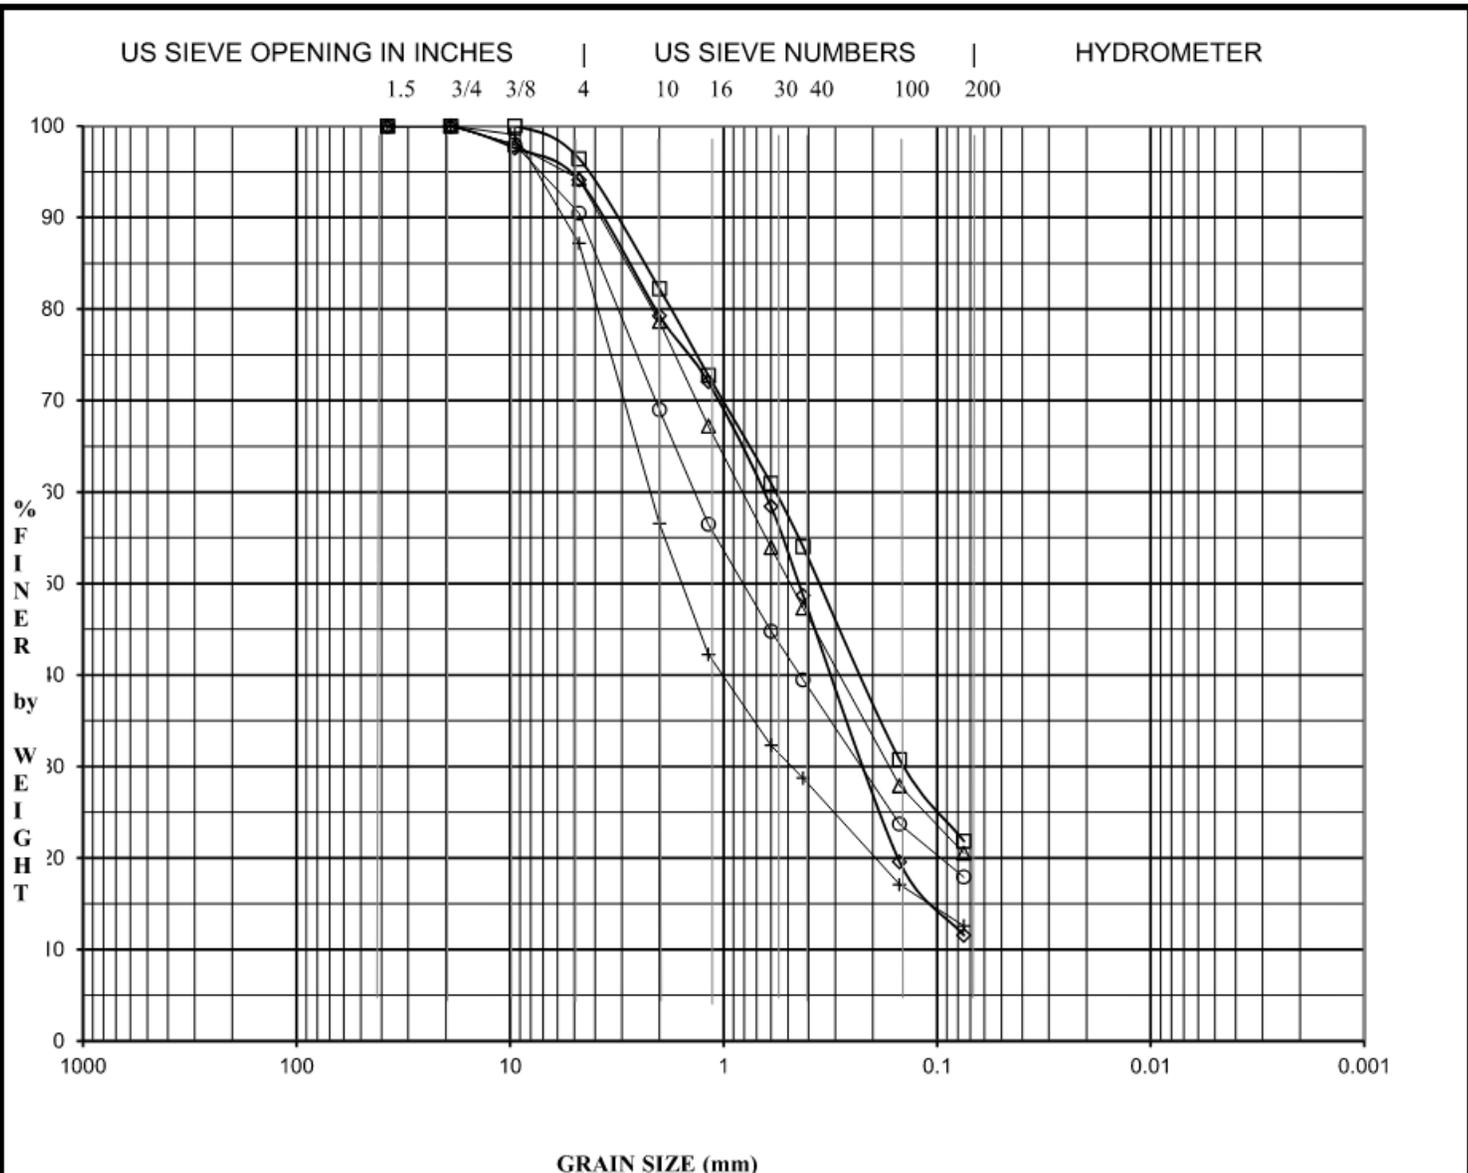
Falcon Marketplace	JOB NO. 5322095
	GRADATION CURVES	FIGURE NO. A1

Specimen I.D.	Description	USCS	AASHTO	Group Index	LL	PI	PL
◇ B1 @ 4 FEET	Poorly Graded Sand with Silt	SP-SM	A-1-b	0	NP	NP	NP
□ B3 @ 1 FEET	Silty Sand	SM	A-2-4	0	NP	NP	NP
△ B4 @ 1 FEET	Silty Sand	SM	A-1-b	0	NP	NP	NP
○ B6 @ 1 FEET	Silty Sand	SM	A-1-b	0	NP	NP	NP
+ B6 @ 4 FEET	Silty Sand	SM	A-1-b	0	NP	NP	NP

Specimen I.D.	D100	D60	D30	D10	Cc	Cu	%Gravel	%Sand	%Silt&Clay
◇ B1 @ 4 FEET	19.00	0.67	0.248				6	83	12
□ B3 @ 1 FEET	9.50	0.58	0.144				4	75	22
△ B4 @ 1 FEET	19.00	0.86	0.180				6	74	21
○ B6 @ 1 FEET	19.00	1.41	0.260				10	73	18
+ B6 @ 4 FEET	19.00	2.31	0.487				13	75	13

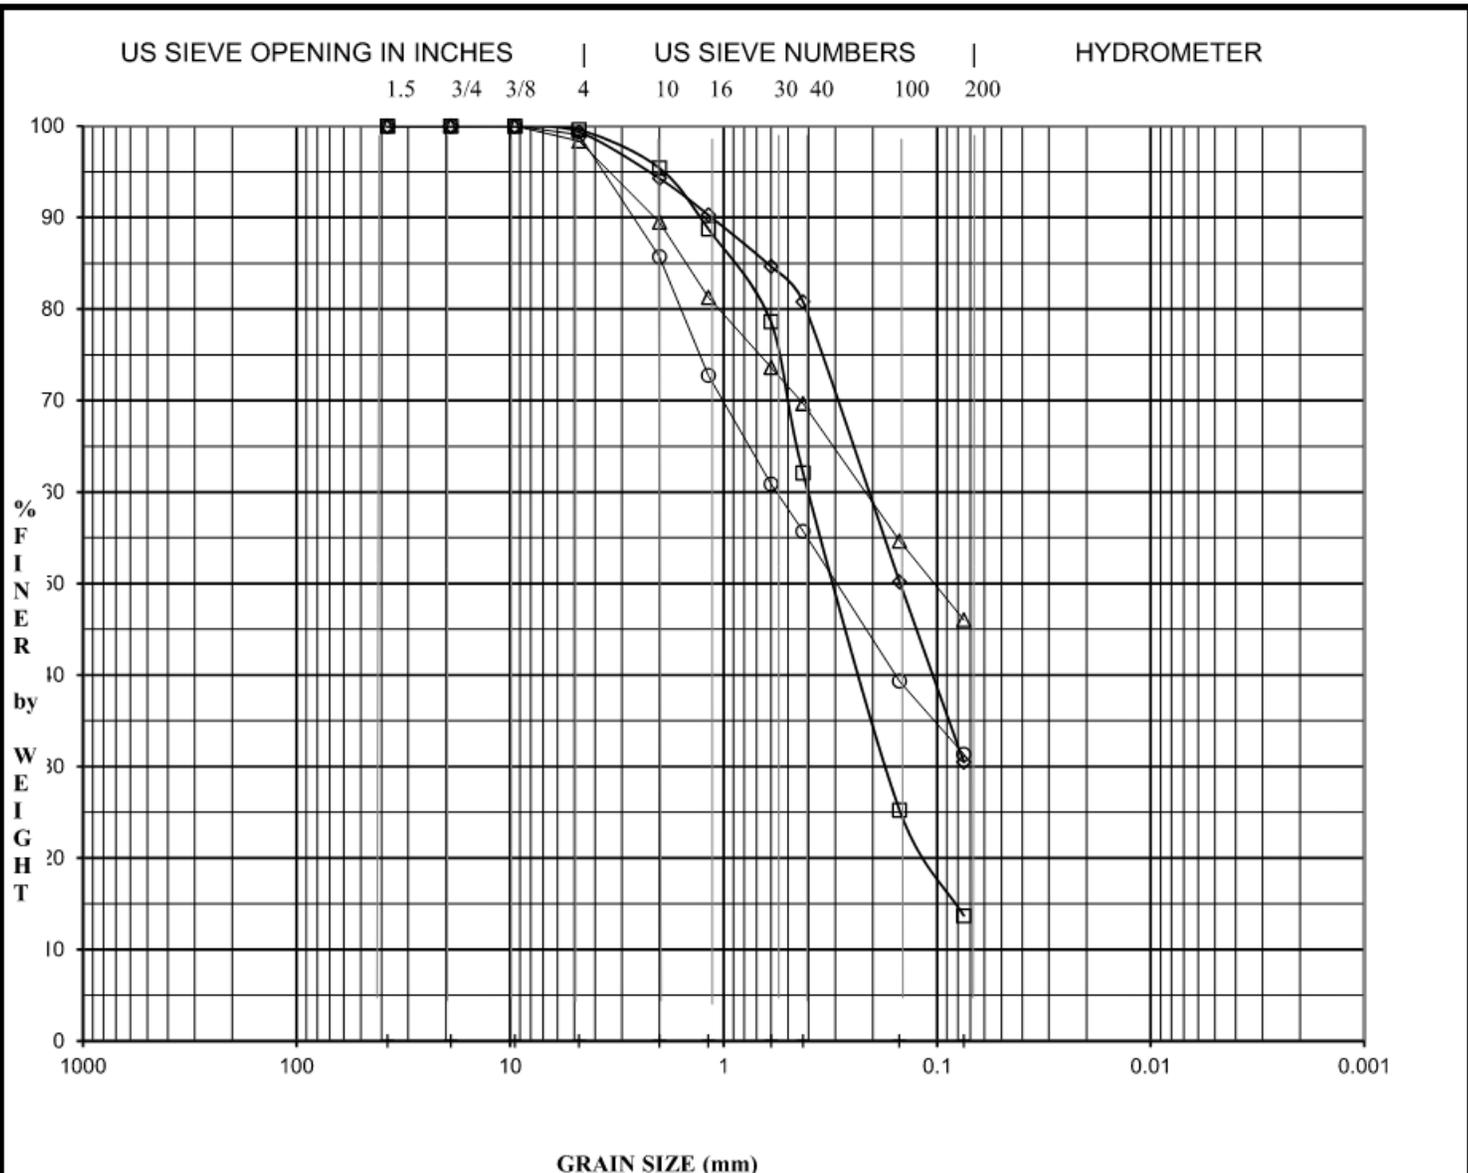
Specimen I.D.	Description	USCS	AASHTO	Group Index	LL	PI	PL
◇ B6 @ 7 FEET	Silty Sand	SM	A-2-4	0	NP	NP	NP
□ B9 @ 1 FEET	Silty Sand	SM	A-2-4	0	NP	NP	NP
△ B9 @ 4 FEET	Silty Sand	SM	A-4	0	NP	NP	NP
○ B9 @ 10 FEET	Silty Sand	SM	A-2-4	0	NP	NP	NP
+

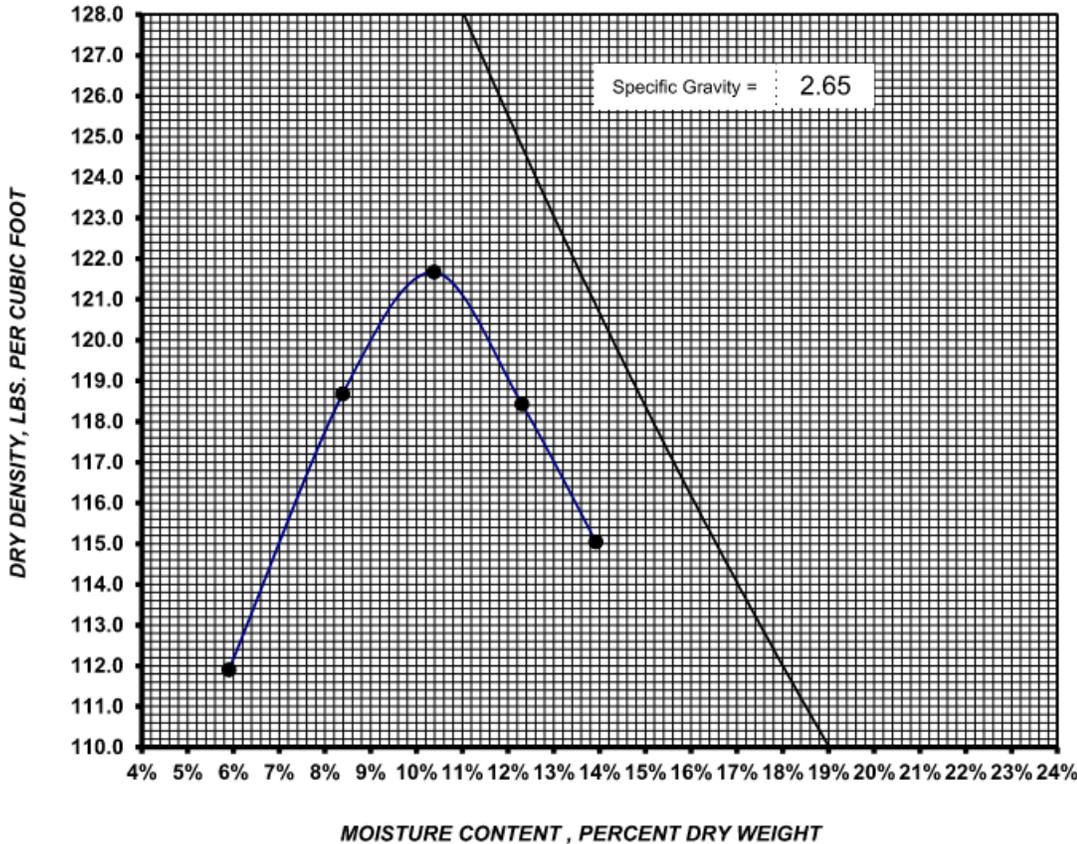
**REPORT OF MOISTURE DENSITY RELATIONSHIP OF SOIL**

Optimum Moisture Content (%): 10.4

Sieve Size	Percent Passing
3"	100
3"	100
1 1/2"	100
3/4"	100
1/2"	100
3/8"	100
No. 4	98
No. 8	89
No. 10	84
No. 16	79
No. 30	67
No. 40	59
No. 50	51
No. 100	34
No. 200	25
