**STORMWATER MANAGEMENT FACILITY  
OPERATION AND MAINTENANCE (O&M) MANUAL**

**MONUMENT STEEL STRUCTURES  
LOT 2 OF GREATER EUROPE MISSION SUBDIVISION FILING NUMBER 1  
18910 BASE CAMP ROAD  
EL PASO COUNTY, COLORADO**

Prepared By:  
Terra Forma Solutions

April, 2019

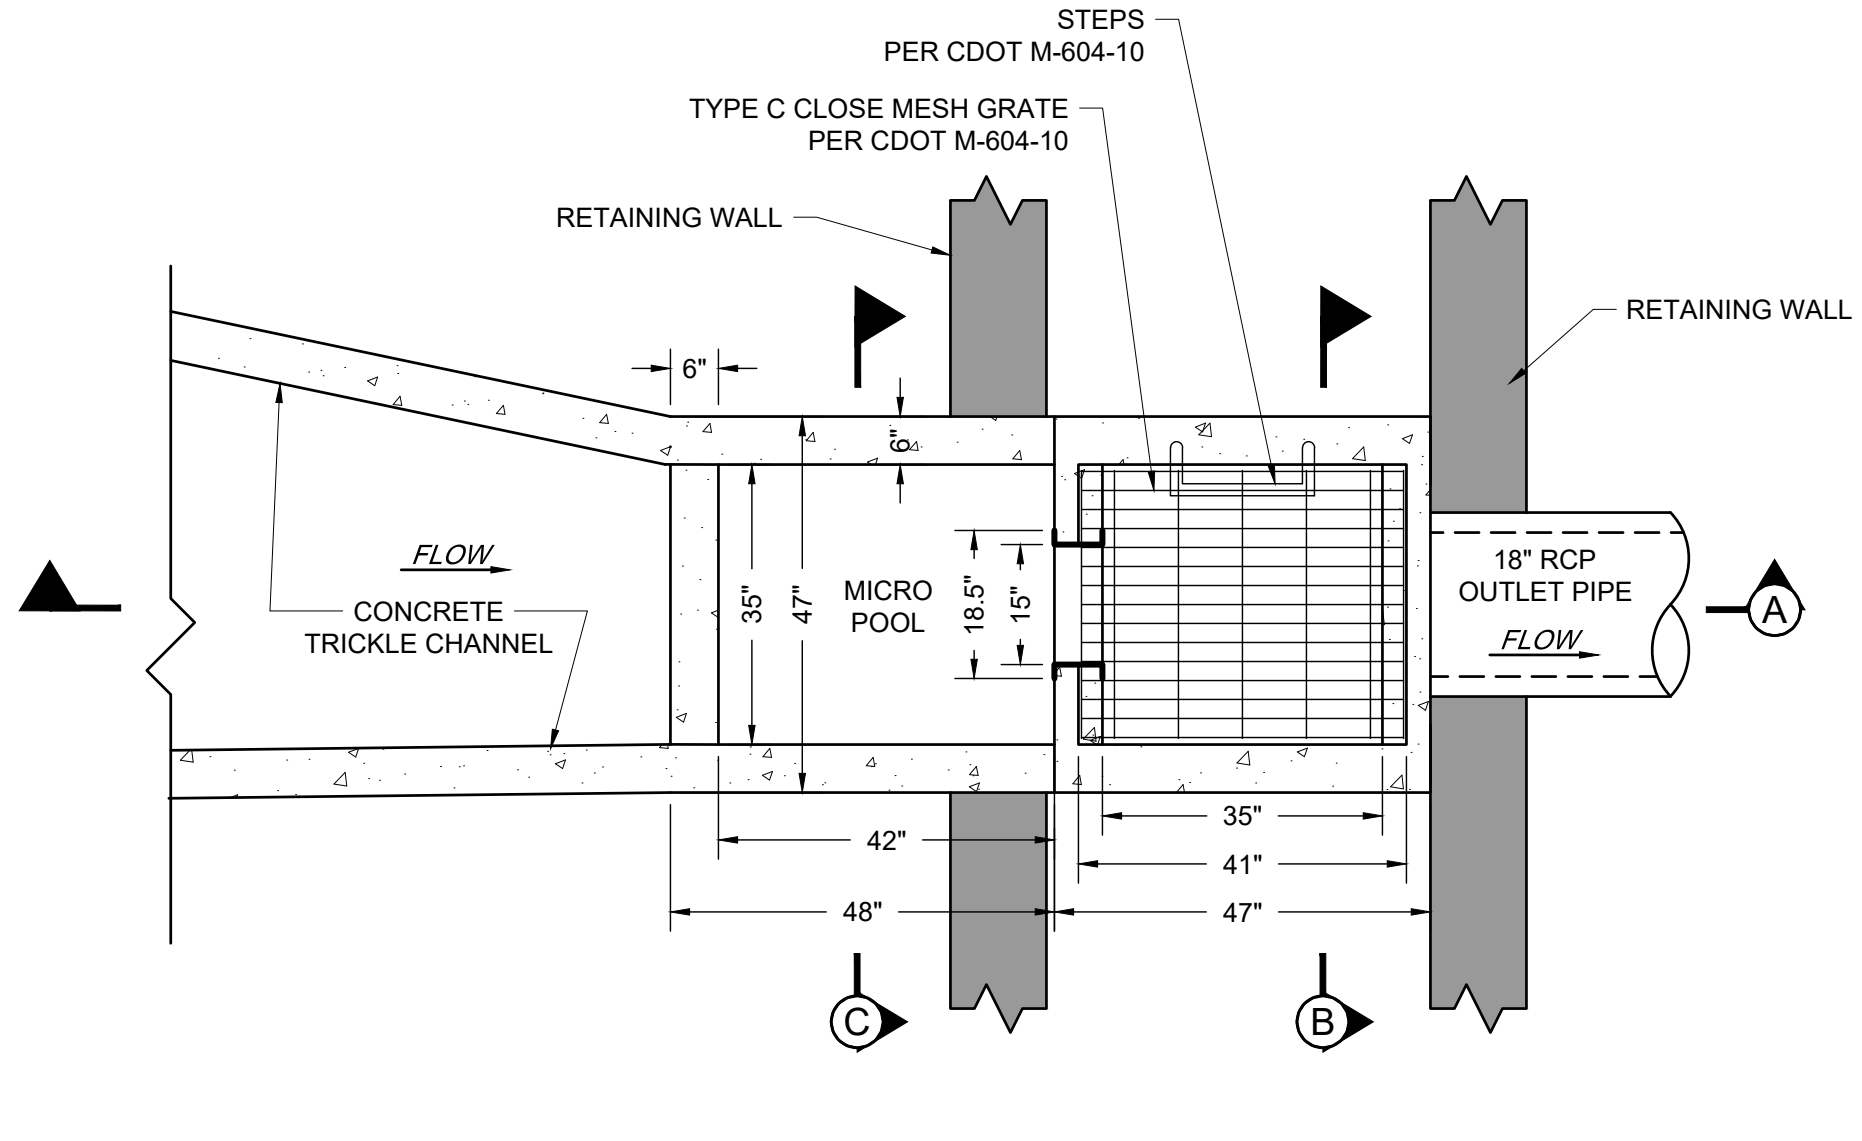
**DETENTION POND OUTLET STRUCTURE MODIFIED TYPE C**  
SCALE: 1"=2"

**NOTE:**  
CONTRACTOR MUST COMPLETE DETENTION POND GRADING AND PROVIDE DETENTION POND CERTIFICATION TO ENGINEER PRIOR TO CONSTRUCTING ANY OUTFALL STRUCTURE (WATER QUALITY PLATE, BOX INLET, WEIR, ETC). DETENTION POND CERTIFICATION NEEDS TO BE DONE AFTER THE SOD IS IN PLACE.
