## **SOIL AND GEOLOGY STUDY**

**Triple H Ranch  
North and East of Jones Road and Murr Road  
EPC Schedule No. 3300000168 and 3300000388  
El Paso County, Colorado**

**JOB NO. 193940**

**September 15, 2023  
Amended July 24, 2026  
PCD File SP254**

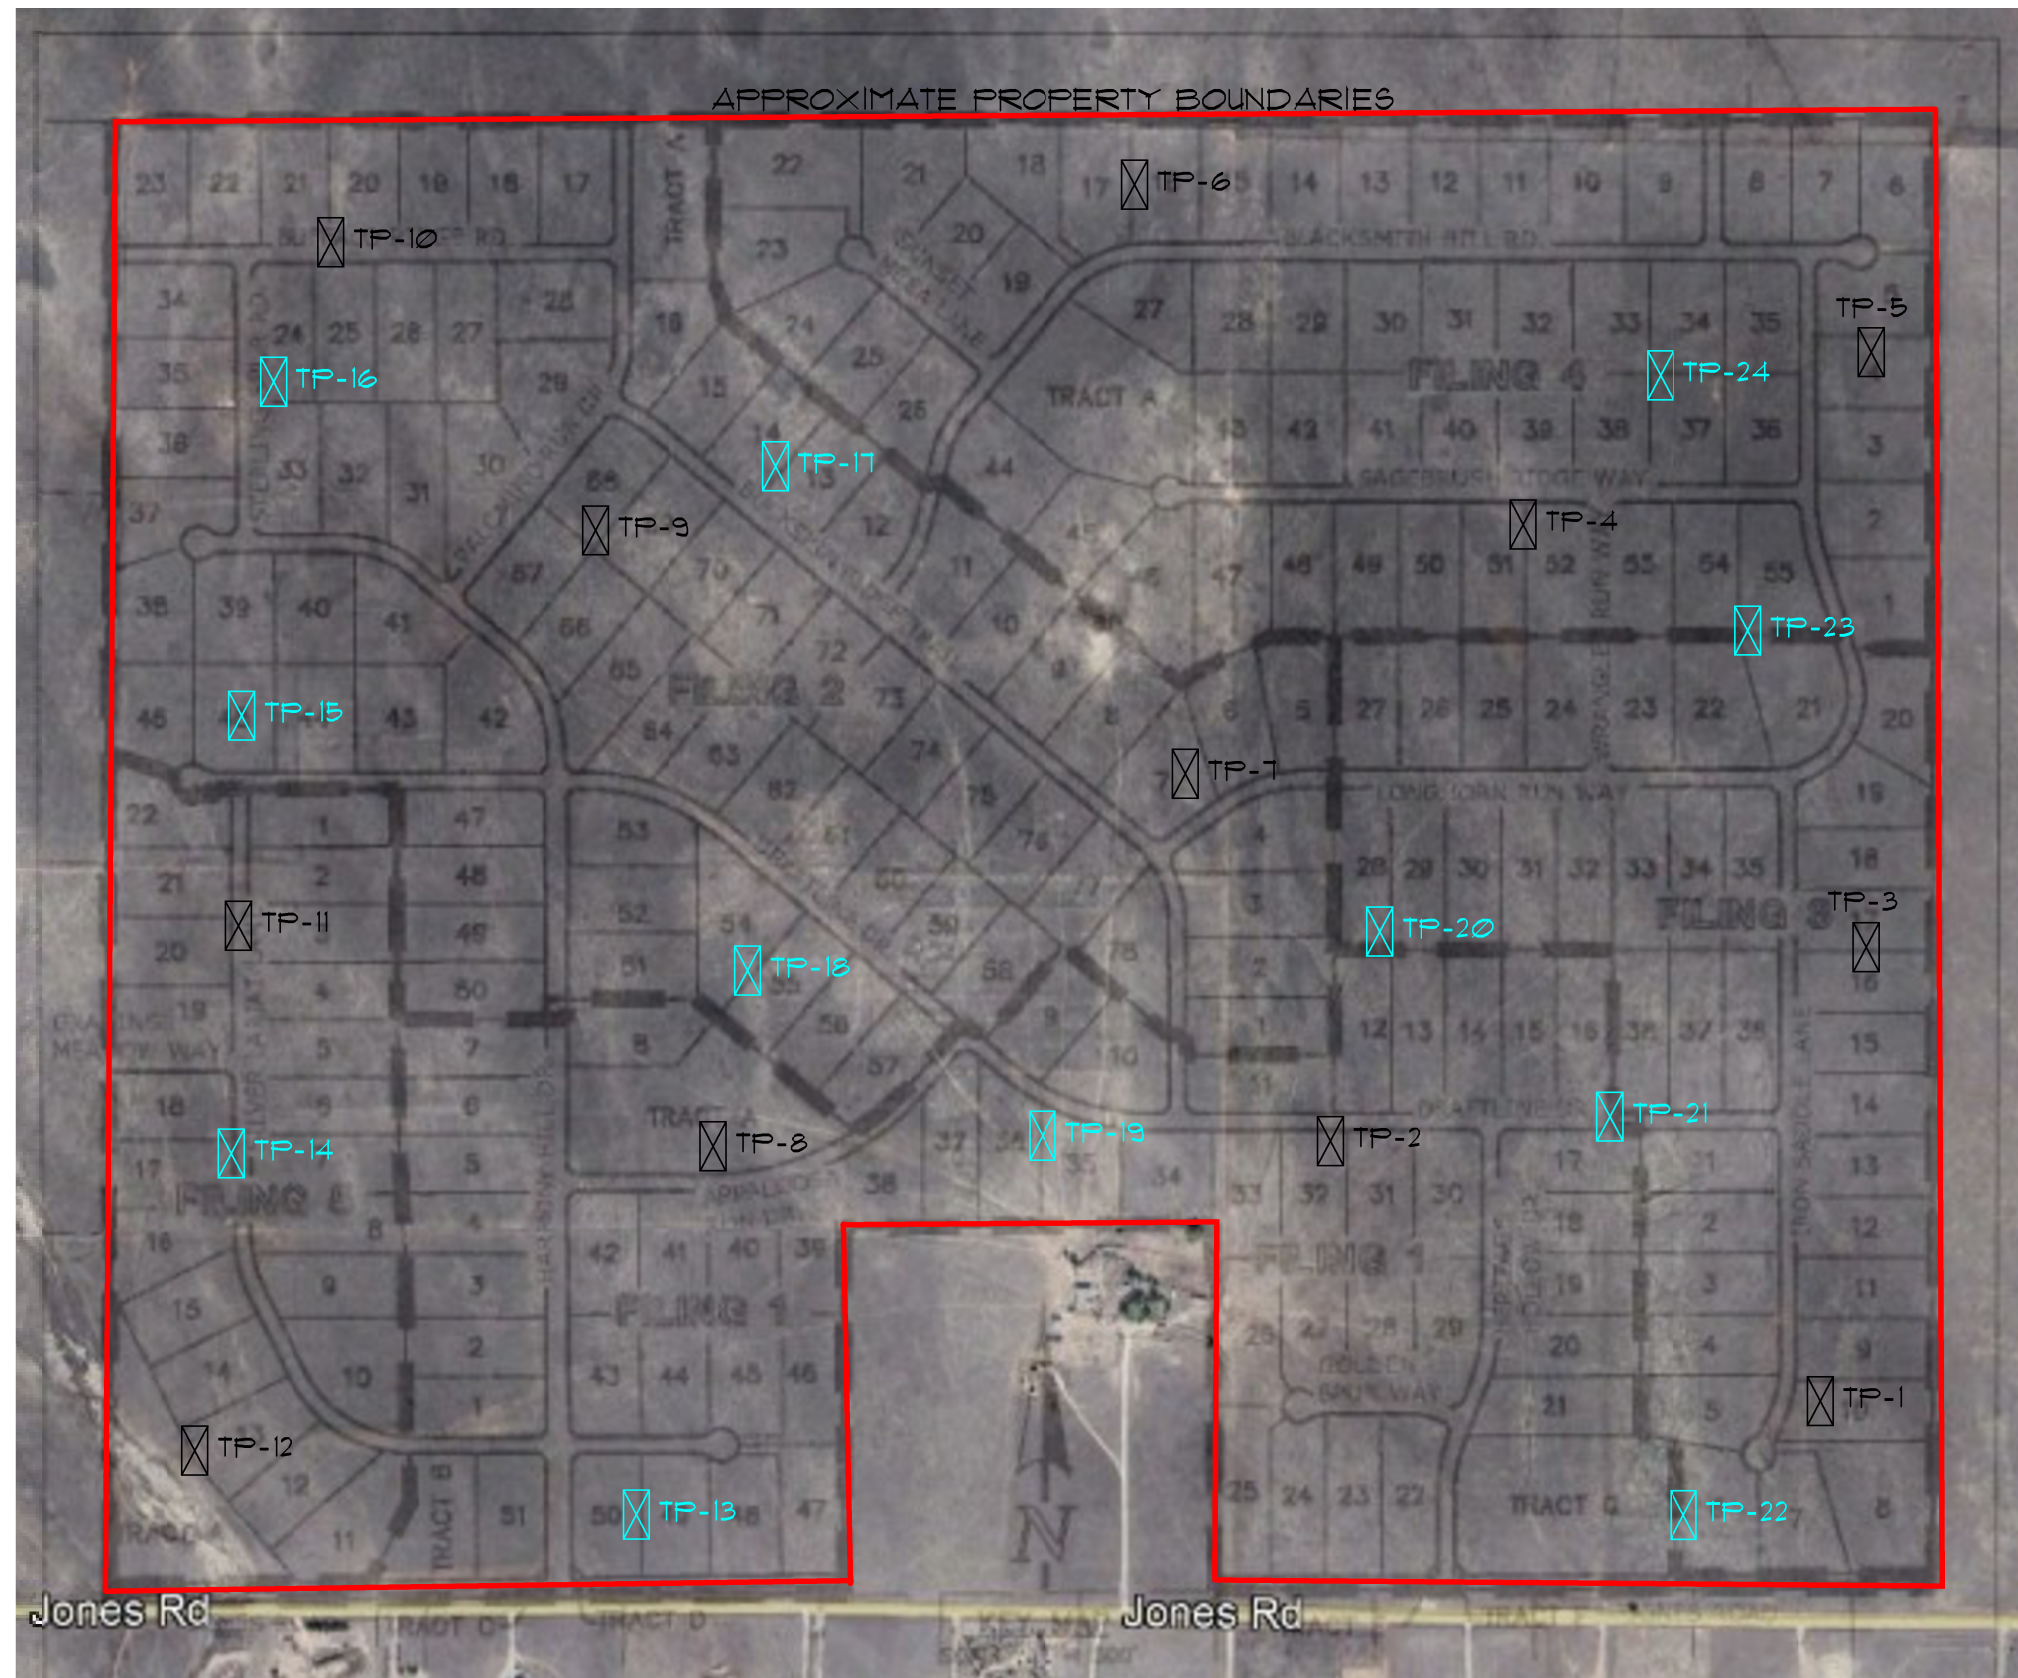
DENOTES APPROXIMATE LOCATIONS  
OF TEST PITS PERFORMED FOR THE  
INVESTIGATION COMPLETED 2023

The test borings and test pits were spaced to provide preliminary soil information across the site for future residential foundations and on-site wastewater treatment systems. The Test Boring/Test Pit Layout Plan is presented in Figure 3.

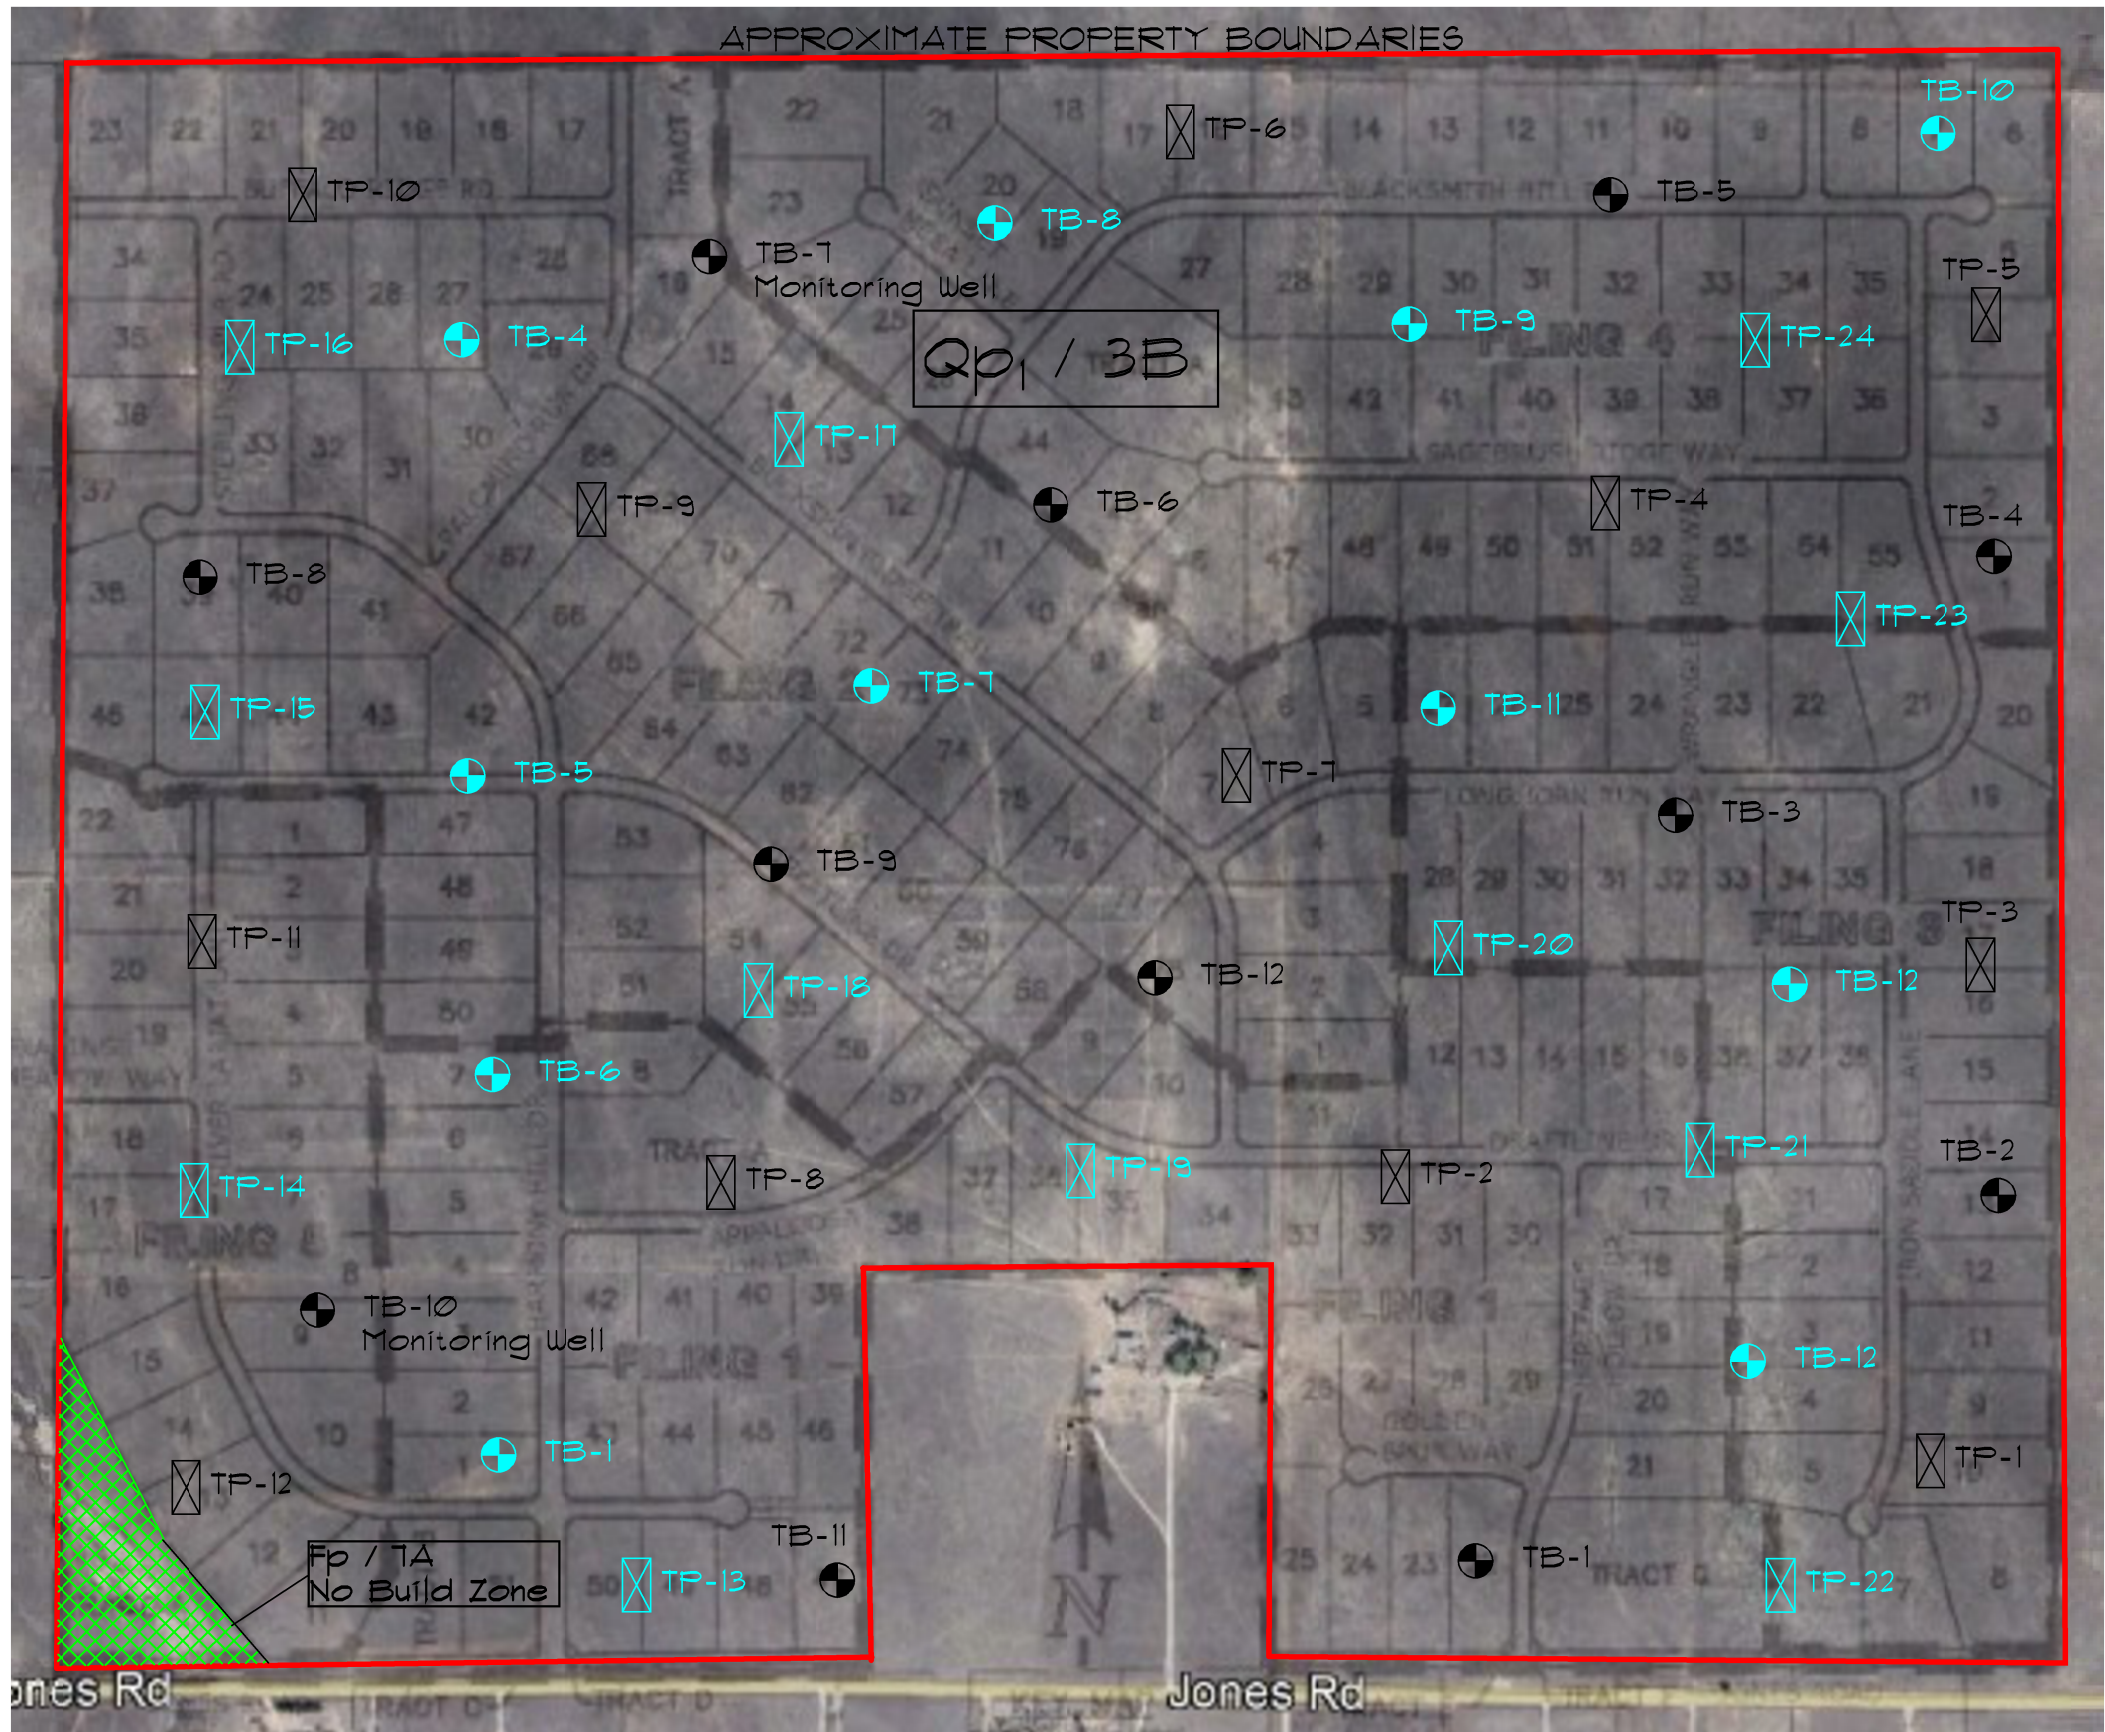
⊠ DENOTES APPROXIMATE LOCATIONS OF TEST BORINGS/PITS PERFORMED FOR THE INVESTIGATION COMPLETED 2023

⊕ DENOTES APPROXIMATE LOCATIONS OF TEST BORINGS/PITS PERFORMED FOR THE INVESTIGATION COMPLETED 2026

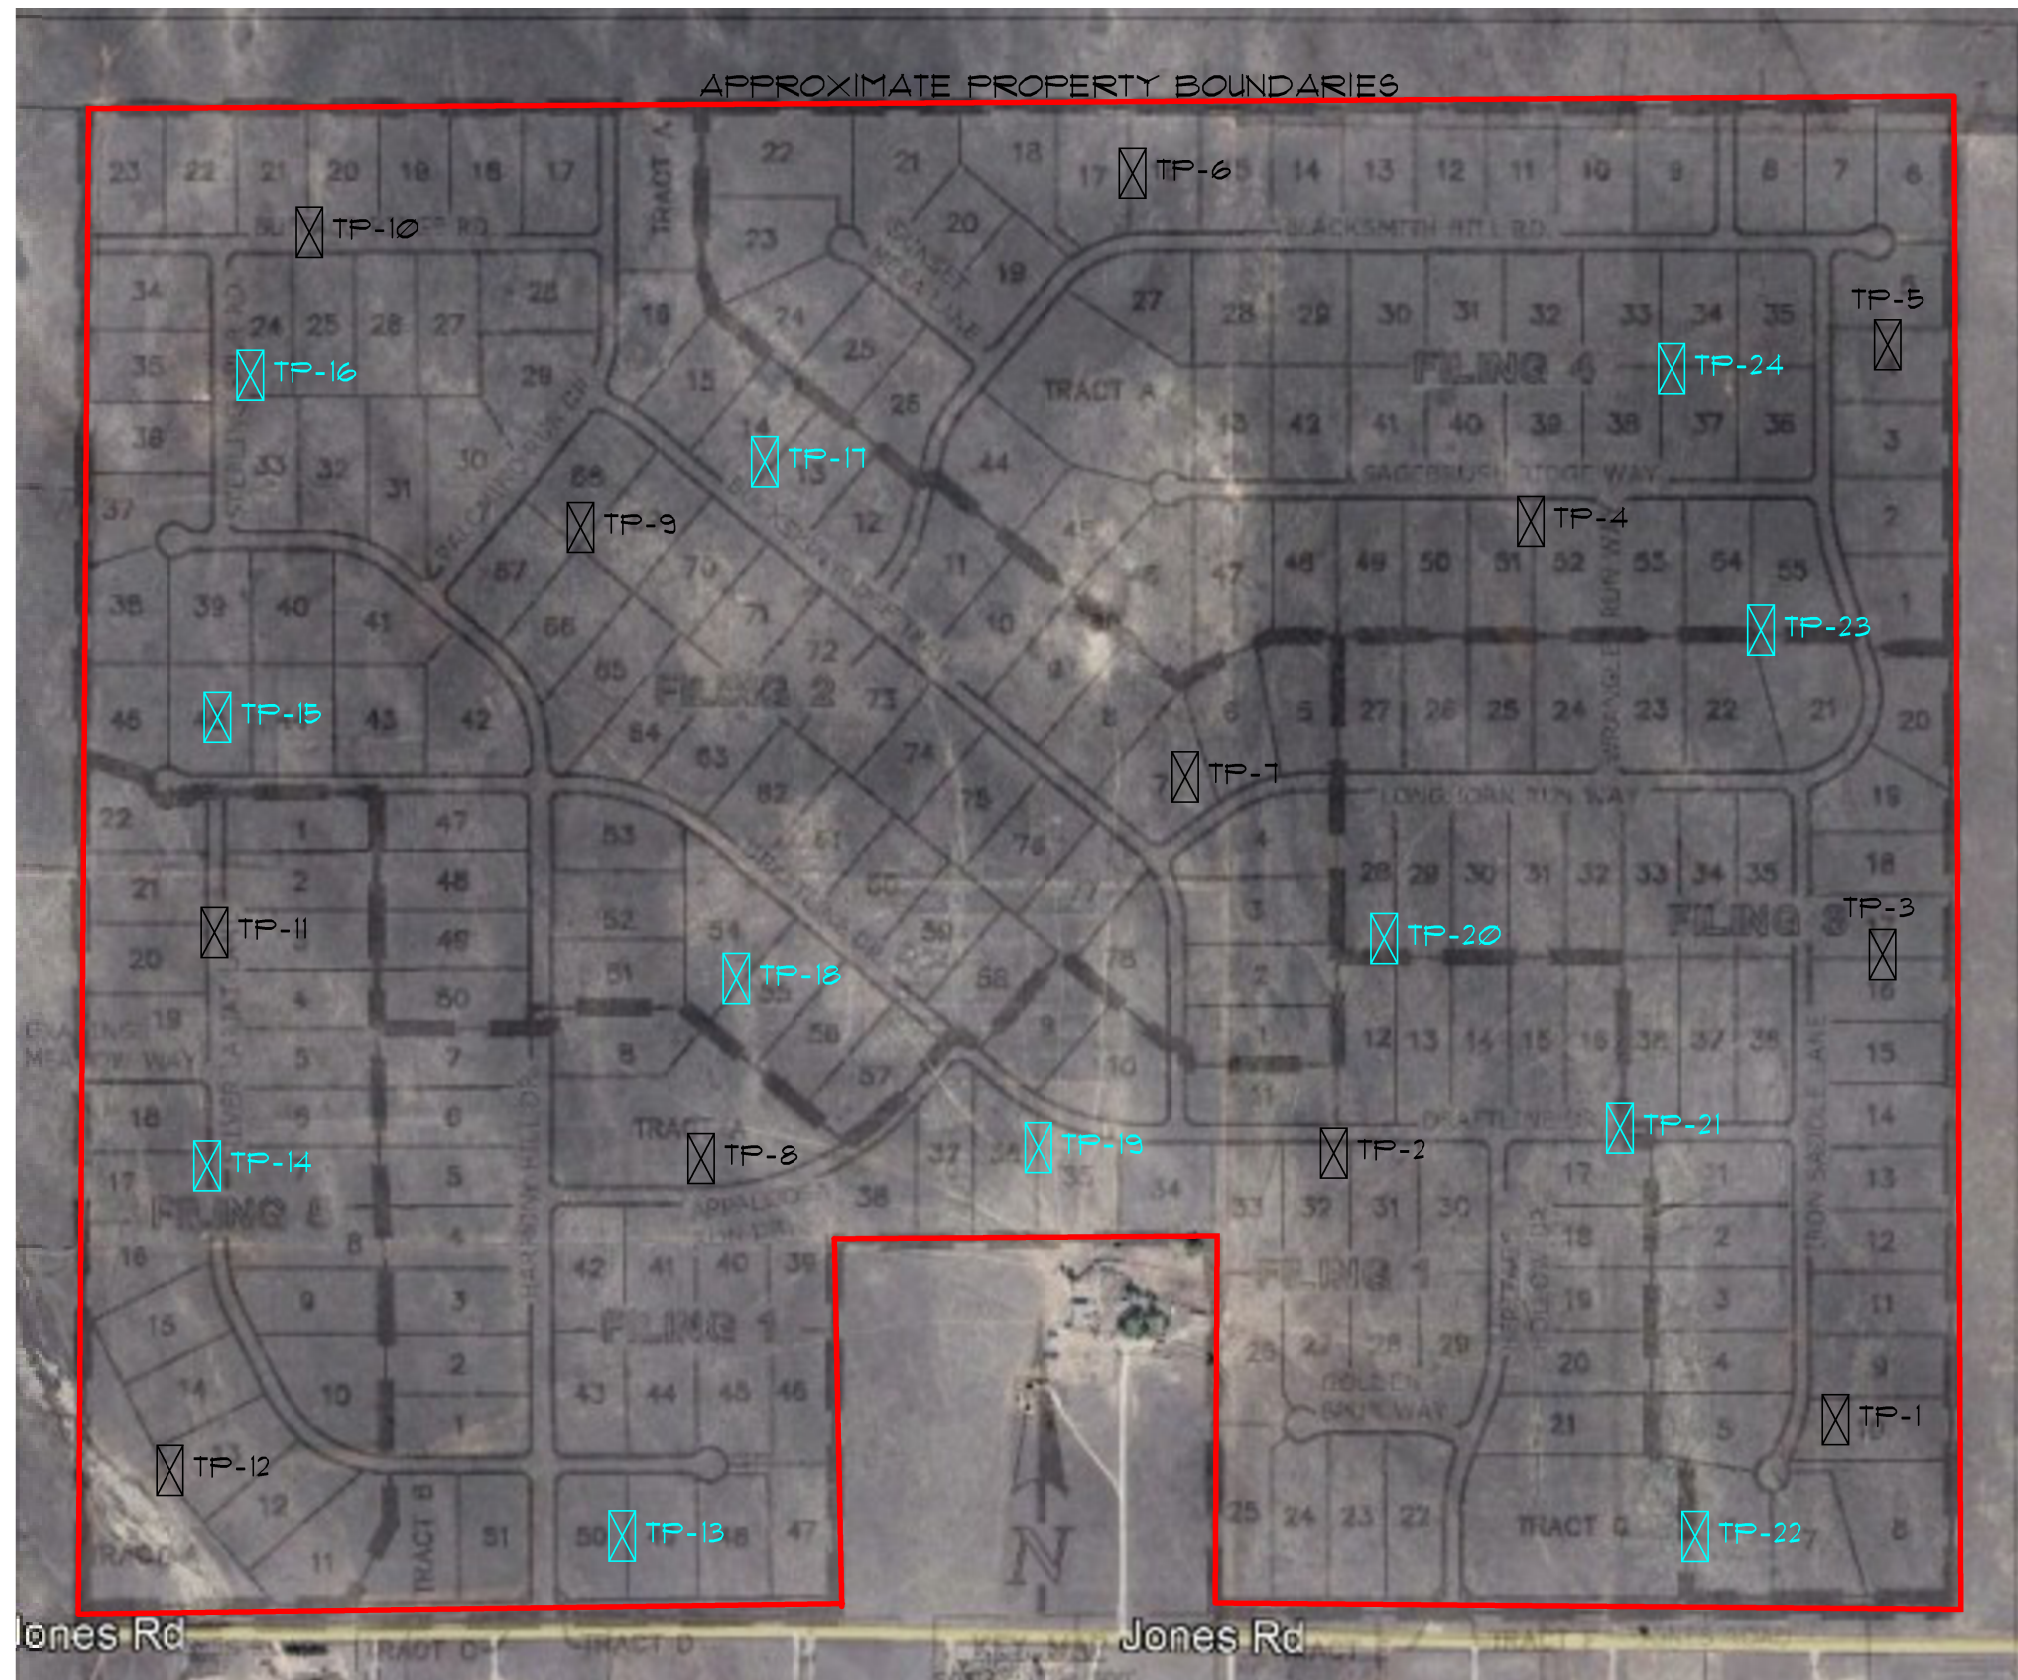
DENOTES APPROXIMATE LOCATIONS  
OF TEST PITS PERFORMED FOR THIS  
INVESTIGATION

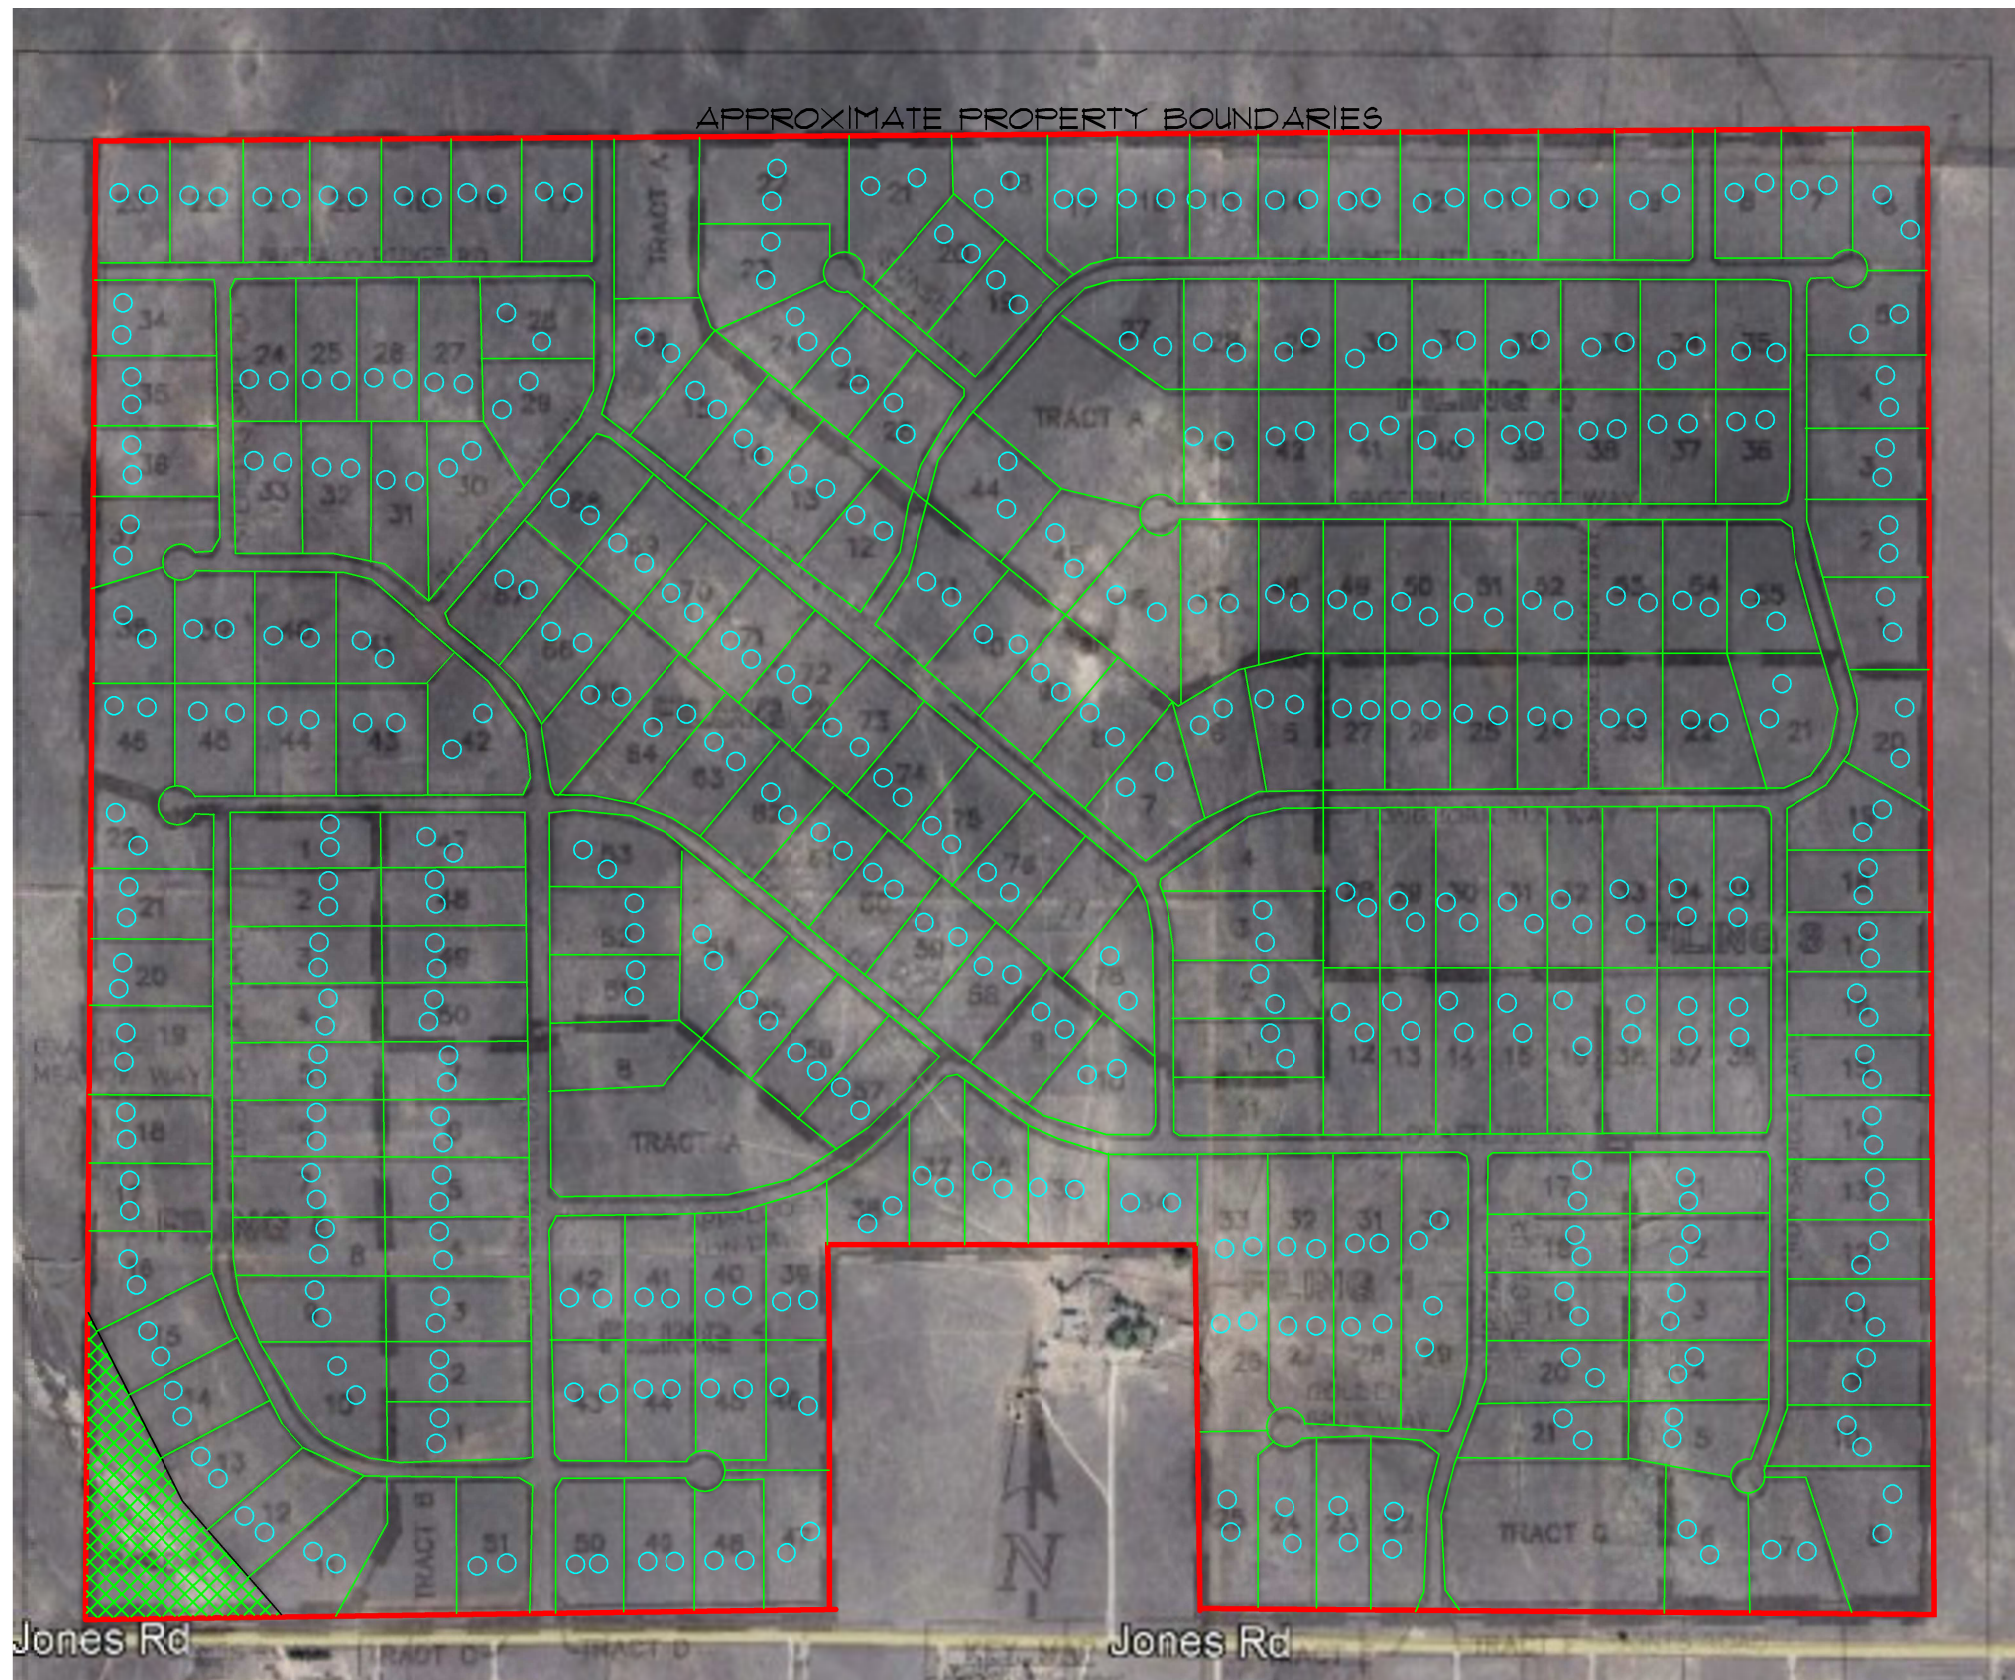
○ DENOTES APPROXIMATE LOCATIONS  
FOR PROPOSED OWS SYSTEMS
