**ENTECH**  
ENGINEERING, INC.

**SOIL, GEOLOGY AND  
GEOLOGIC HAZARD STUDY  
BANNING LEWIS RANCH  
VILLAGES A, B, C, AND D  
COLORADO SPRINGS, COLORADO**

**Oakwood Homes**  
1290 North Newport Road  
Colorado Springs, Colorado 80916

May 1, 2020  
Revised June 17, 2020

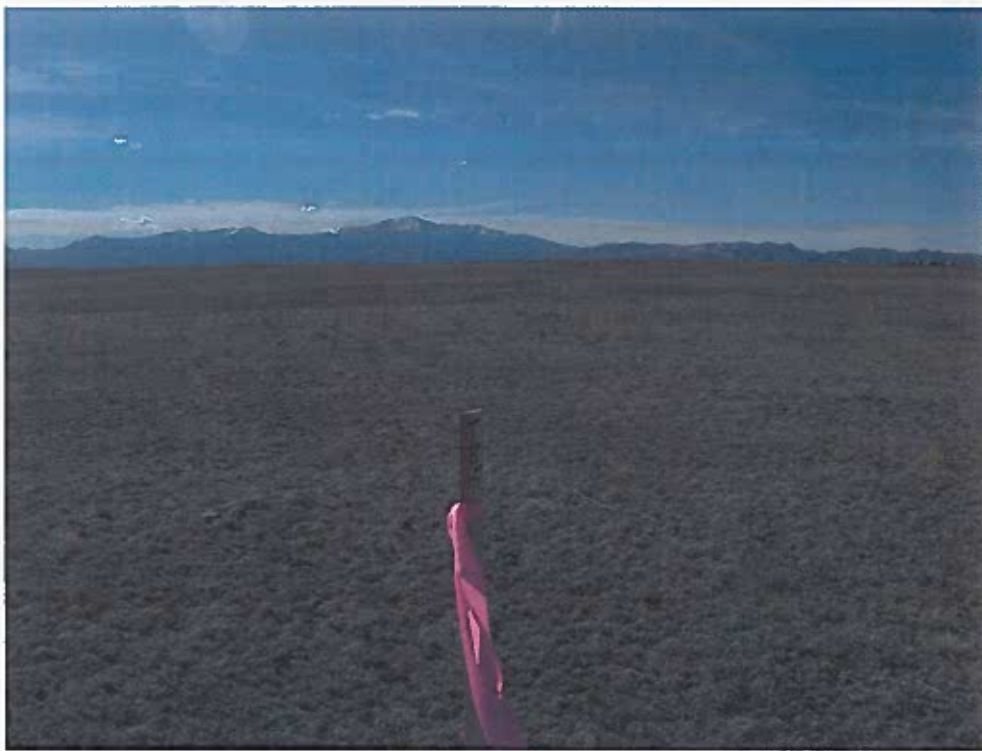
**Looking south towards fill in the western portion of the site.**

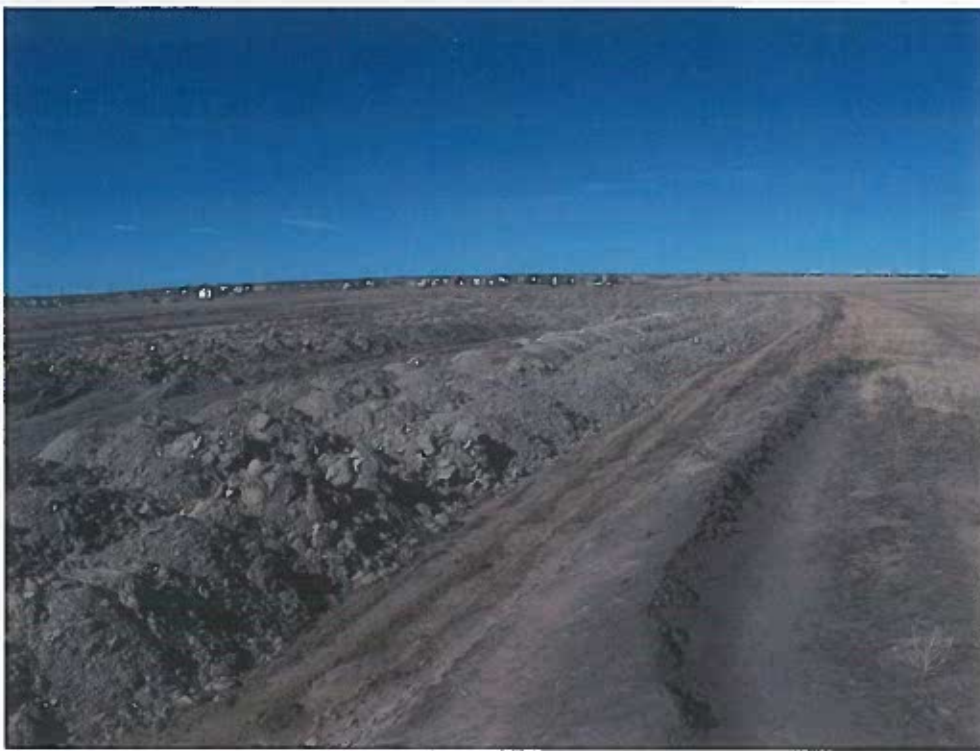
**Looking west towards  
fill in southwestern  
portion of the site.**

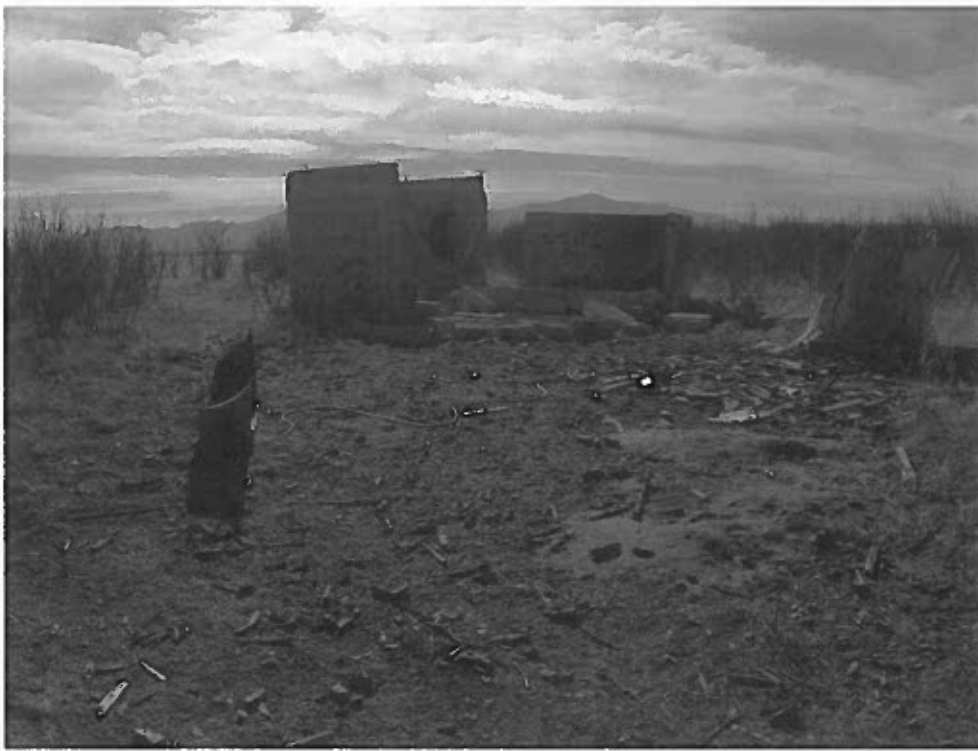
**Looking north towards  
fill in southwestern  
portion of the site.**
