SOIL AND GEOLOGY STUDY

Greaves Subdivision, Filing No. 1
Replat of Lot 13, Wildwood Ranch Estates, Filing No. 7
El Paso County, Colorado

JOB NO. 196053

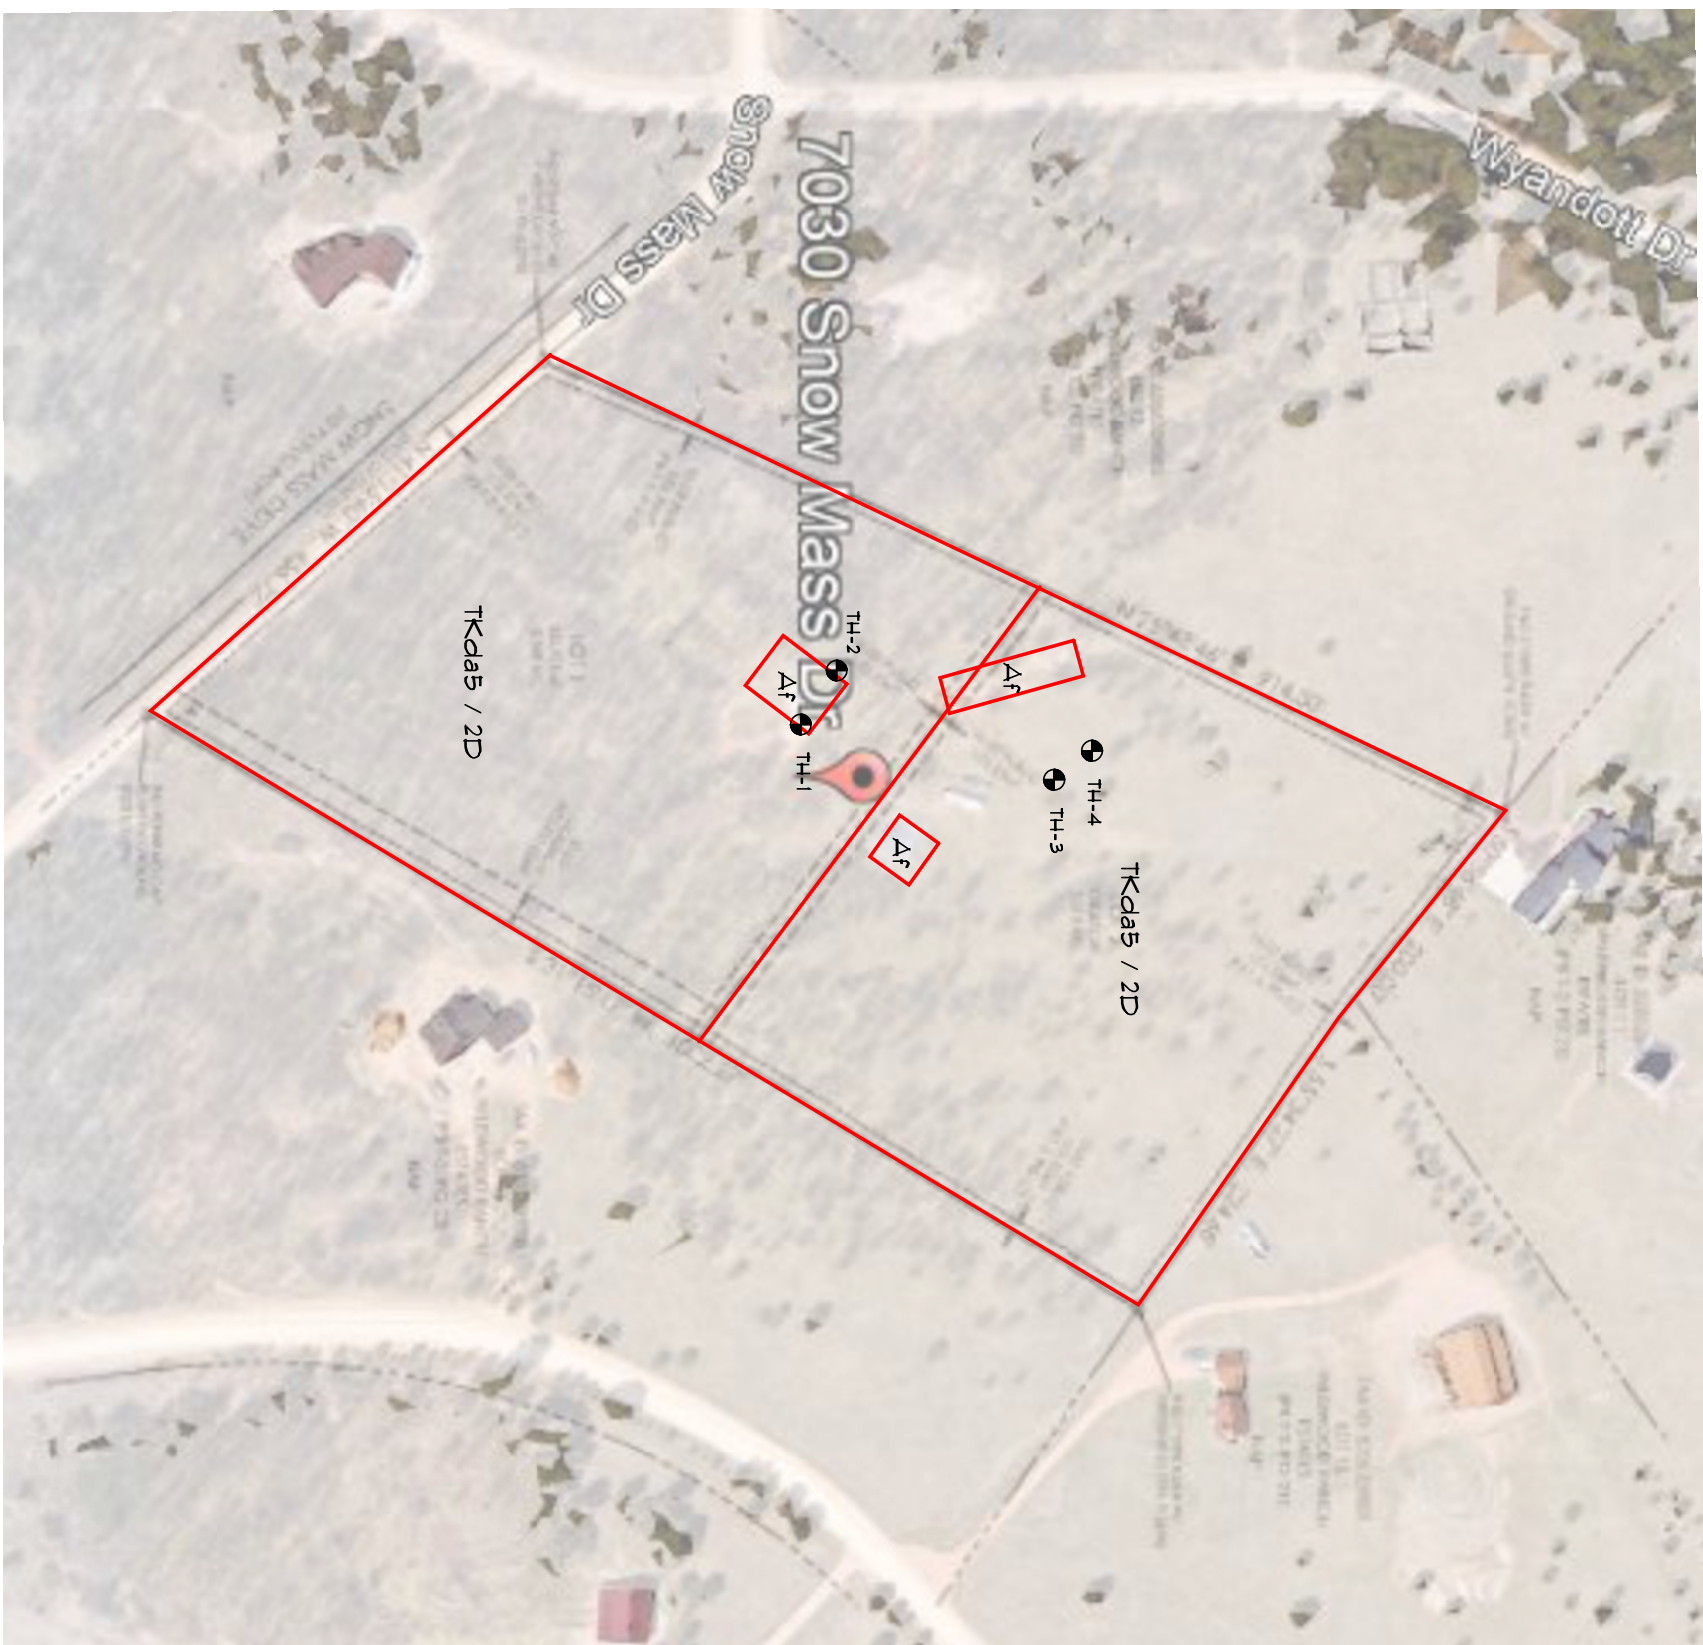
FIG-3

Geologic

- *TKda5 - Dawson formation, facies unit five* - The Dawson is known to contain occasional interbedded sandy claystone. Estimated thickness is around 500 feet. The Dawson sandstone was not encountered in the test holes performed by others.
- *Af - Artificial Fill* - fill that may remain from the demolition of the previous residence and detached garage and/or areas of recent ground modifications (test pits).

Four test borings were reportedly performed by A Better Soil Solution on each new lot to explore the subsurface soil conditions and provide recommendations for design and construction of the proposed foundations. The test borings extended to depths of approximately 15 feet below the existing ground surface. The results of their investigation are presented in the referenced report, attached and included in Appendix B. The approximate locations of the A Better Soil Solution test borings are presented on the Engineering and Geology Map, Figure 3.

Based on review of relevant geologic maps, we identified the geologic conditions (listed below) affecting the development, as shown on the Engineering and Geology Map, Figure 3.

One engineering geology unit was mapped at the site and is shown on the Engineering and Geology Map, Figure 3.

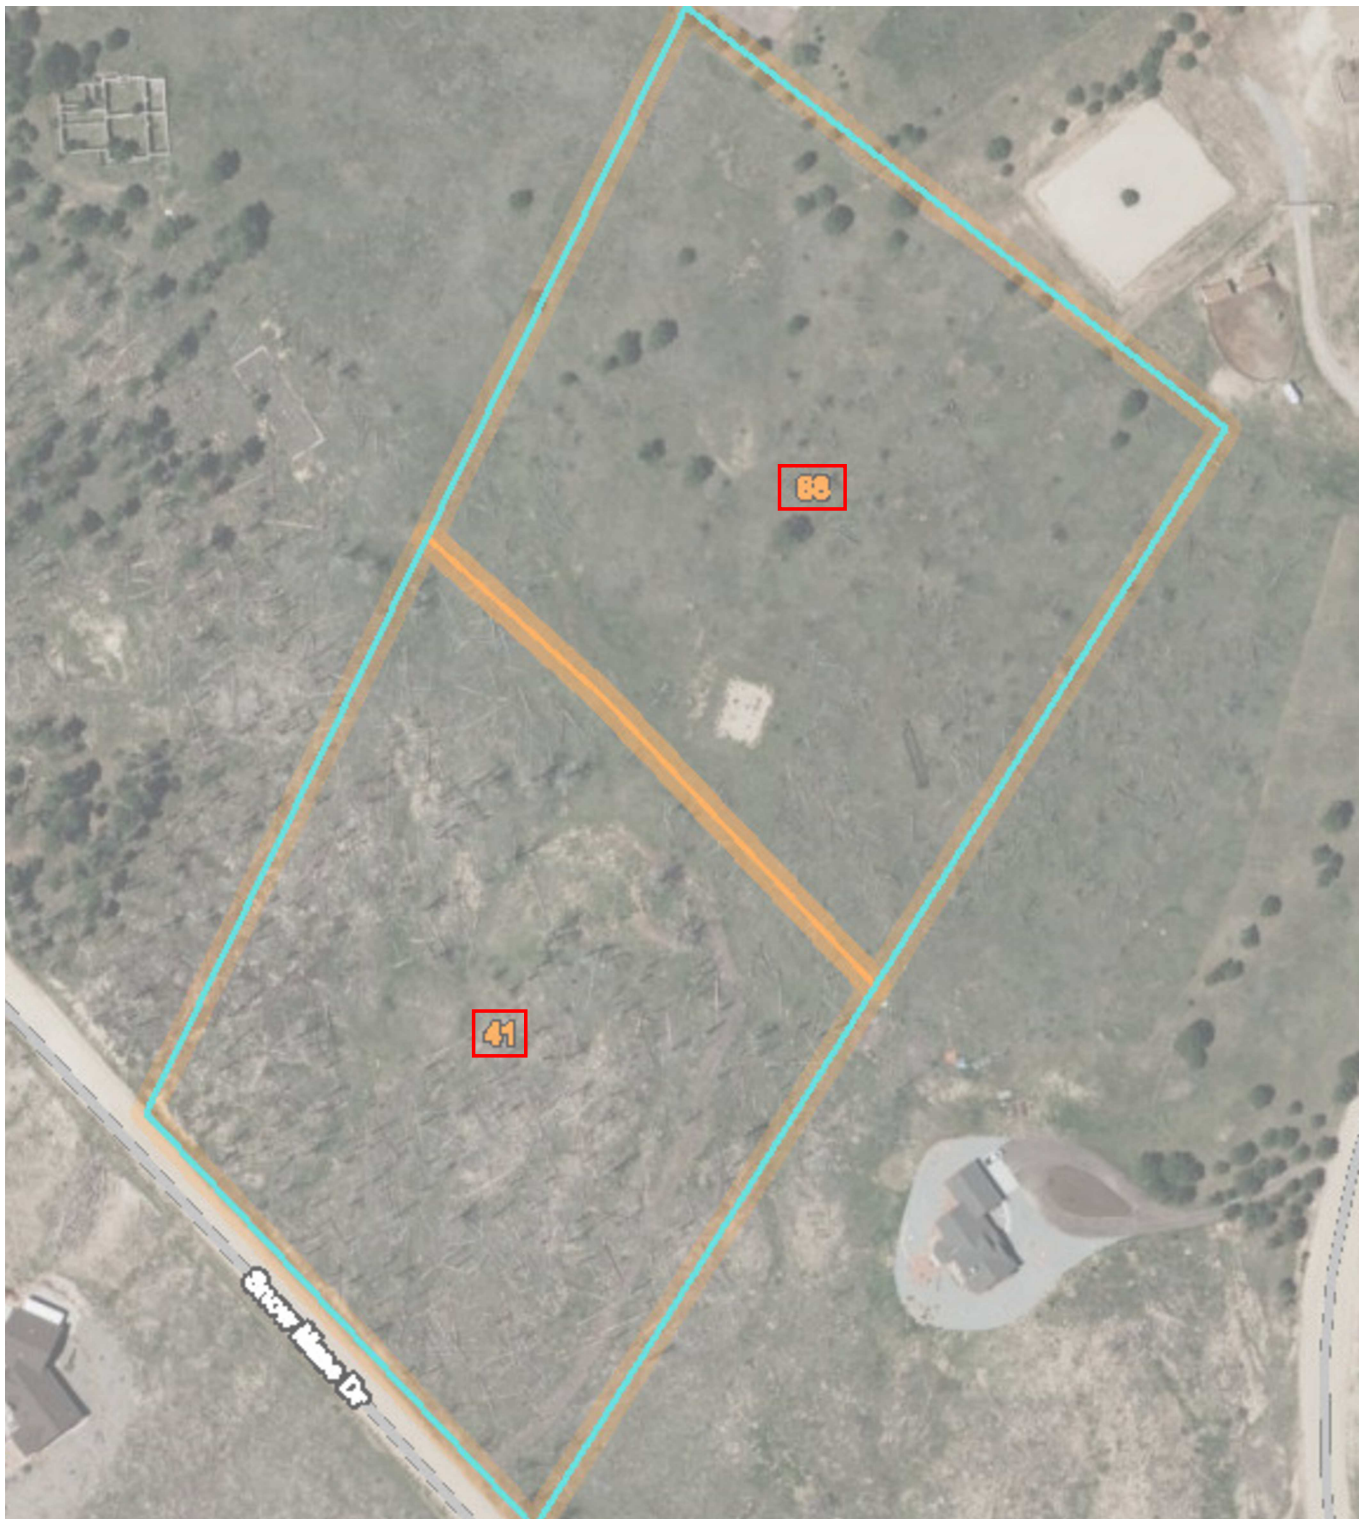
41 - Kettle gravelly loamy sand,
8 to 40% slopes

68 - Peyton-Pring complex,
3 to 8% slopes
