**GEOLOGIC HAZARDS EVALUATION AND  
PRELIMINARY GEOTECHNICAL INVESTIGATION  
FOREST LAKES SUBDIVISION (FILINGS 5, 6 & 7)  
FOREST LAKES ROAD & WEST BAPTIST ROAD  
EL PASO COUNTY, COLORADO**

CTL|T Project No. CS18916-105

July 18, 2018  
Revised: December 11, 2018  
Revised: February 18, 2019

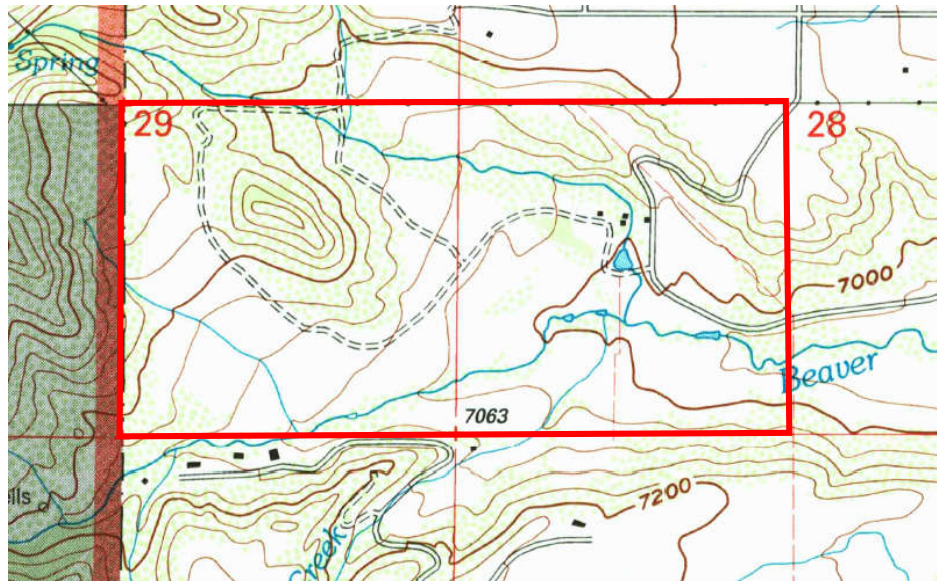
Excerpt from 1994 USGS Topographic Map of the Palmer Lake Quadrangle.

The planned, single-family residential development shown in Fig. 1 is situated generally on uplands west of the confluence of North Beaver Creek and Beaver Creek. Slopes within proposed development areas are typically gentle to moderate to the east. A local mesa dominates the west portion of the parcel and contains steeper slopes that will not be developed. The North Beaver Creek drainage gradient flattens along the north border of the parcel. Past floods have left abandoned channels and debris deposits. The main Beaver Creek channel along the south side is at a lower slope, is more defined, and shows less evidence for geologically recent overbank flows. The parcel has been used for agriculture in the past. An excerpt of the 1994 USGS topographic map of the Palmer Lake Quadrangle is reproduced below, with the project area outlined in red.

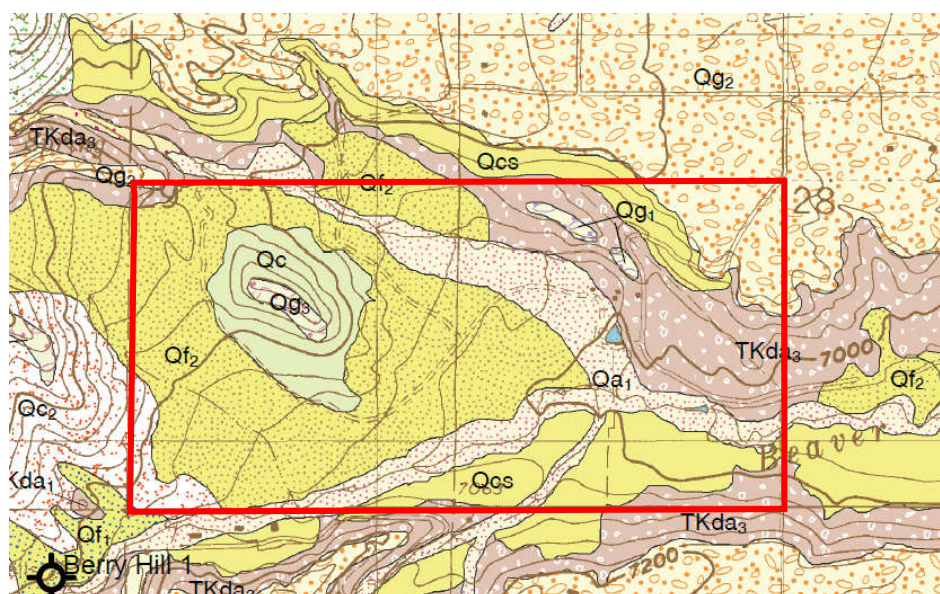
Excerpt from the 2007 "Geologic Map of the Palmer Lake Quadrangle" by Colorado Geological Survey. Site area shown outlined in red. Our field observations generally concur with CGS' mapping. Our borings show the Dawson Formation (Map Symbol TKda<sub>3</sub>) is overlain by 4 to more than 50 feet of slopewash colluvium or stream alluvium.

The locality is at the foot of the Front Range of the Rocky Mountains, less than ½-mile east of the Rampart Range Fault, an inactive reverse fault that places Pre-Cambrian crystalline metamorphic and igneous rocks against much younger sedimentary rocks of the Late Cretaceous and Eocene Dawson Formation, which underlie the subject site. Geologic processes of the last several million years have carved drainages and divides, leaving alluvial fan and colluvial-slopewash deposits chiefly composed of sand and gravel. An excerpt from the 2007 “Geologic Map of the Palmer Lake Quadrangle” by Colorado Geological Survey is presented below.

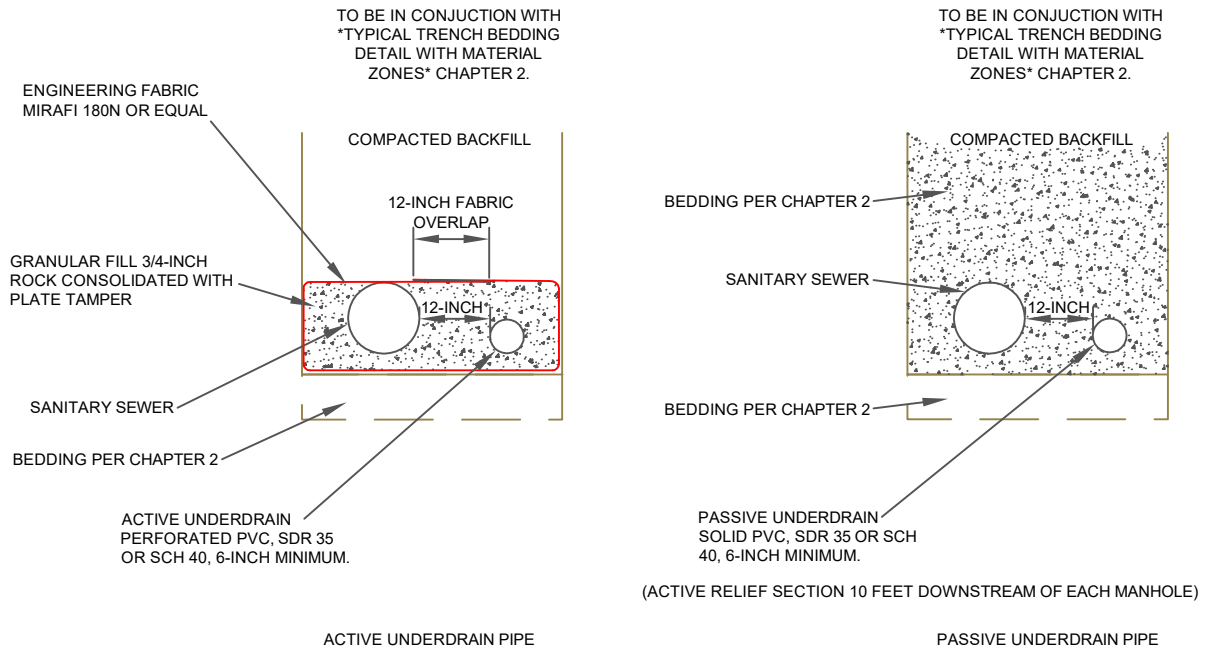
**FIG. 5 – ALTERNATE 2 UNDERDRAIN TRENCH DETAILS**

- POINT OF DISCHARGE TO PUBLIC SYSTEM REQUIRED.
- UNDERDRAIN SERVICE LINE CONNECTIONS SHALL BE 3" SCH 40.

1. MINIMUM UNDERDRAIN SIZE OF MAINLINE PIPE TO BE SIX (6") INCHES.
2. TO BE READ IN CONJUNCTION WITH COLORADO SPRINGS UTILITIES WASTEWATER CHAPTER 13 - UNDERDRAINS.
3. BEDDING MATERIAL SPECIFICATIONS CLASS I, II OR III FOR PIPE SLOPE GREATER THAN 1.04 PERCENT FOR SLOPE OF 1.04 PERCENT OR FLATTER.

If high moisture conditions or groundwater is encountered in the sanitary sewer trench, we recommend an active underdrain system with perforated or slotted pipe for these areas. Active underdrains could help to lower the shallow groundwater elevation found in portions of the development. A cutoff collar should be constructed around the sewer pipe and underdrain pipe immediately downstream of the point where the underdrain pipe exits the sewer trench or changes from active to passive. Solid pipe should be used down-gradient of this cutoff collar to the point of discharge. The underdrain should be maintained at least 3 to 5 feet below the lowest nearby foundation elevation. Conceptual drain details are presented in Figs. 4 and 5.

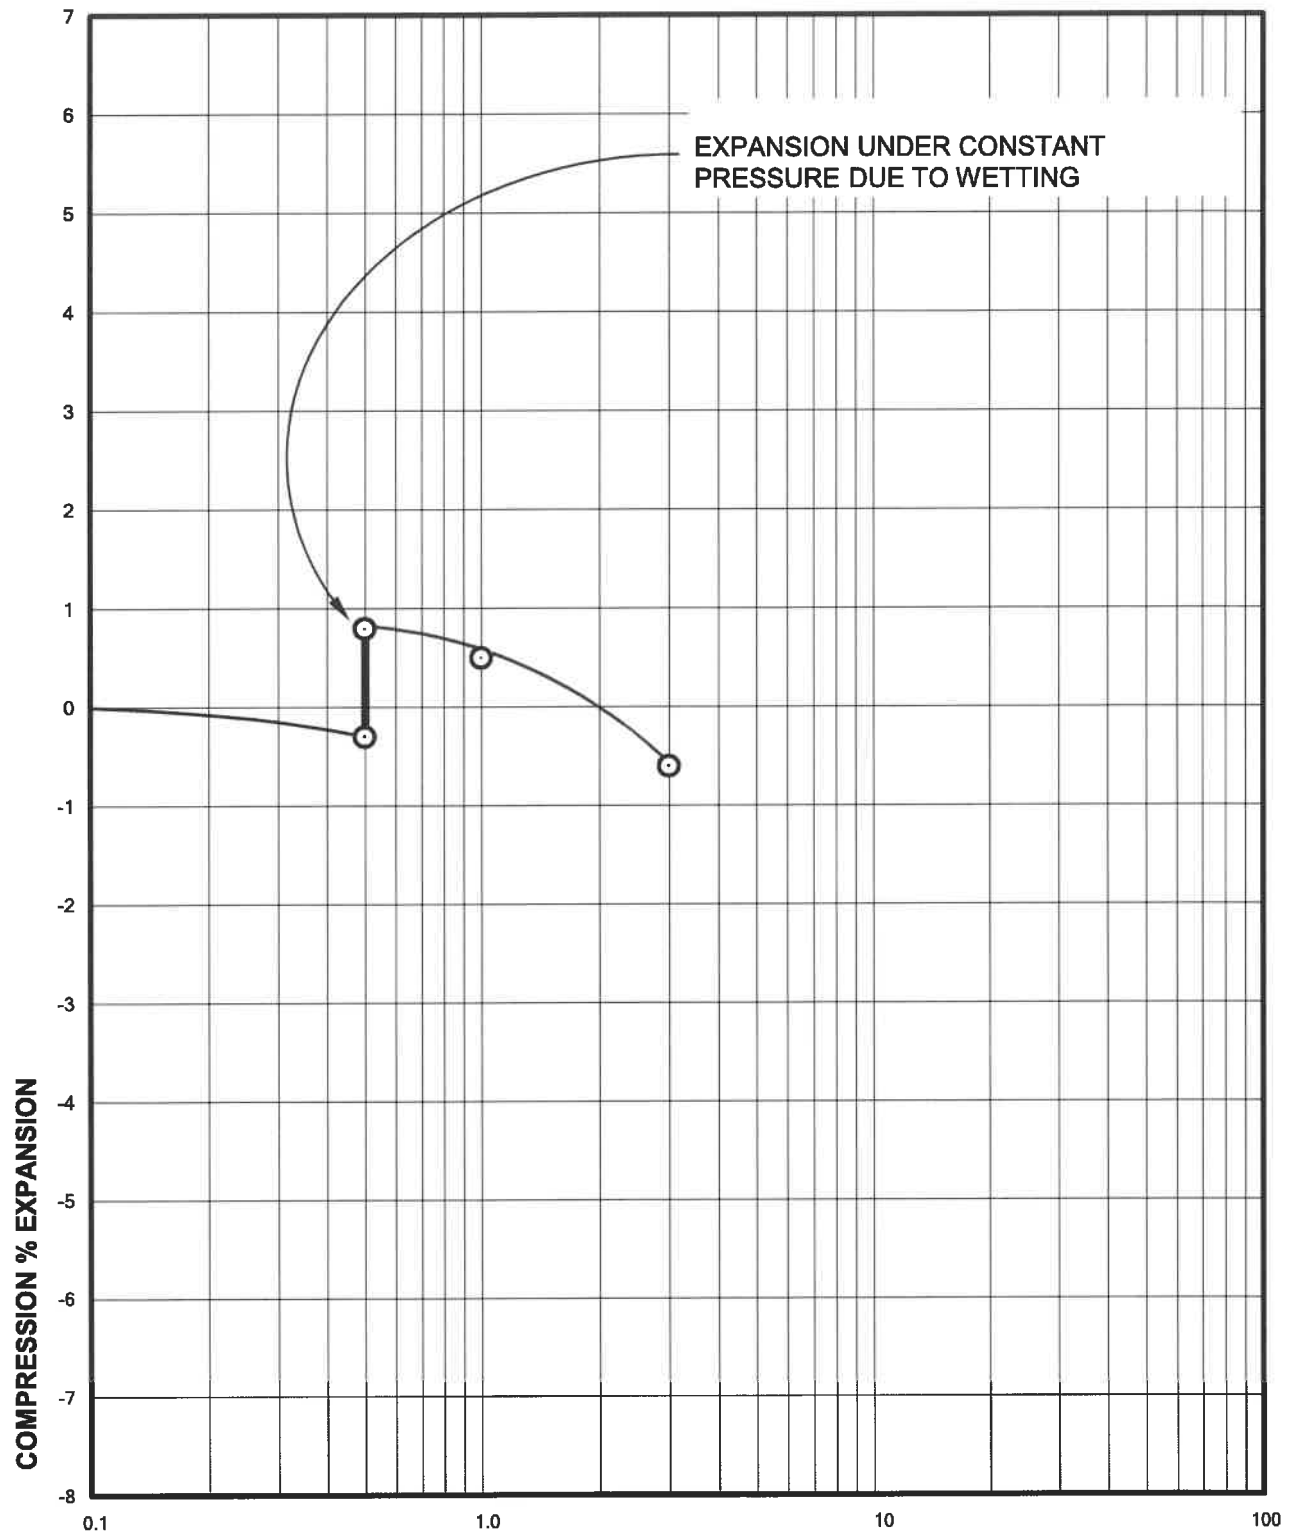
**APPLIED PRESSURE - KSF**  
Sample of SAND, VERY CLAYEY (SC)  
From TH-101 AT 4 FEET

DRY UNIT WEIGHT= 107 PCF  
MOISTURE CONTENT= 4.5 %

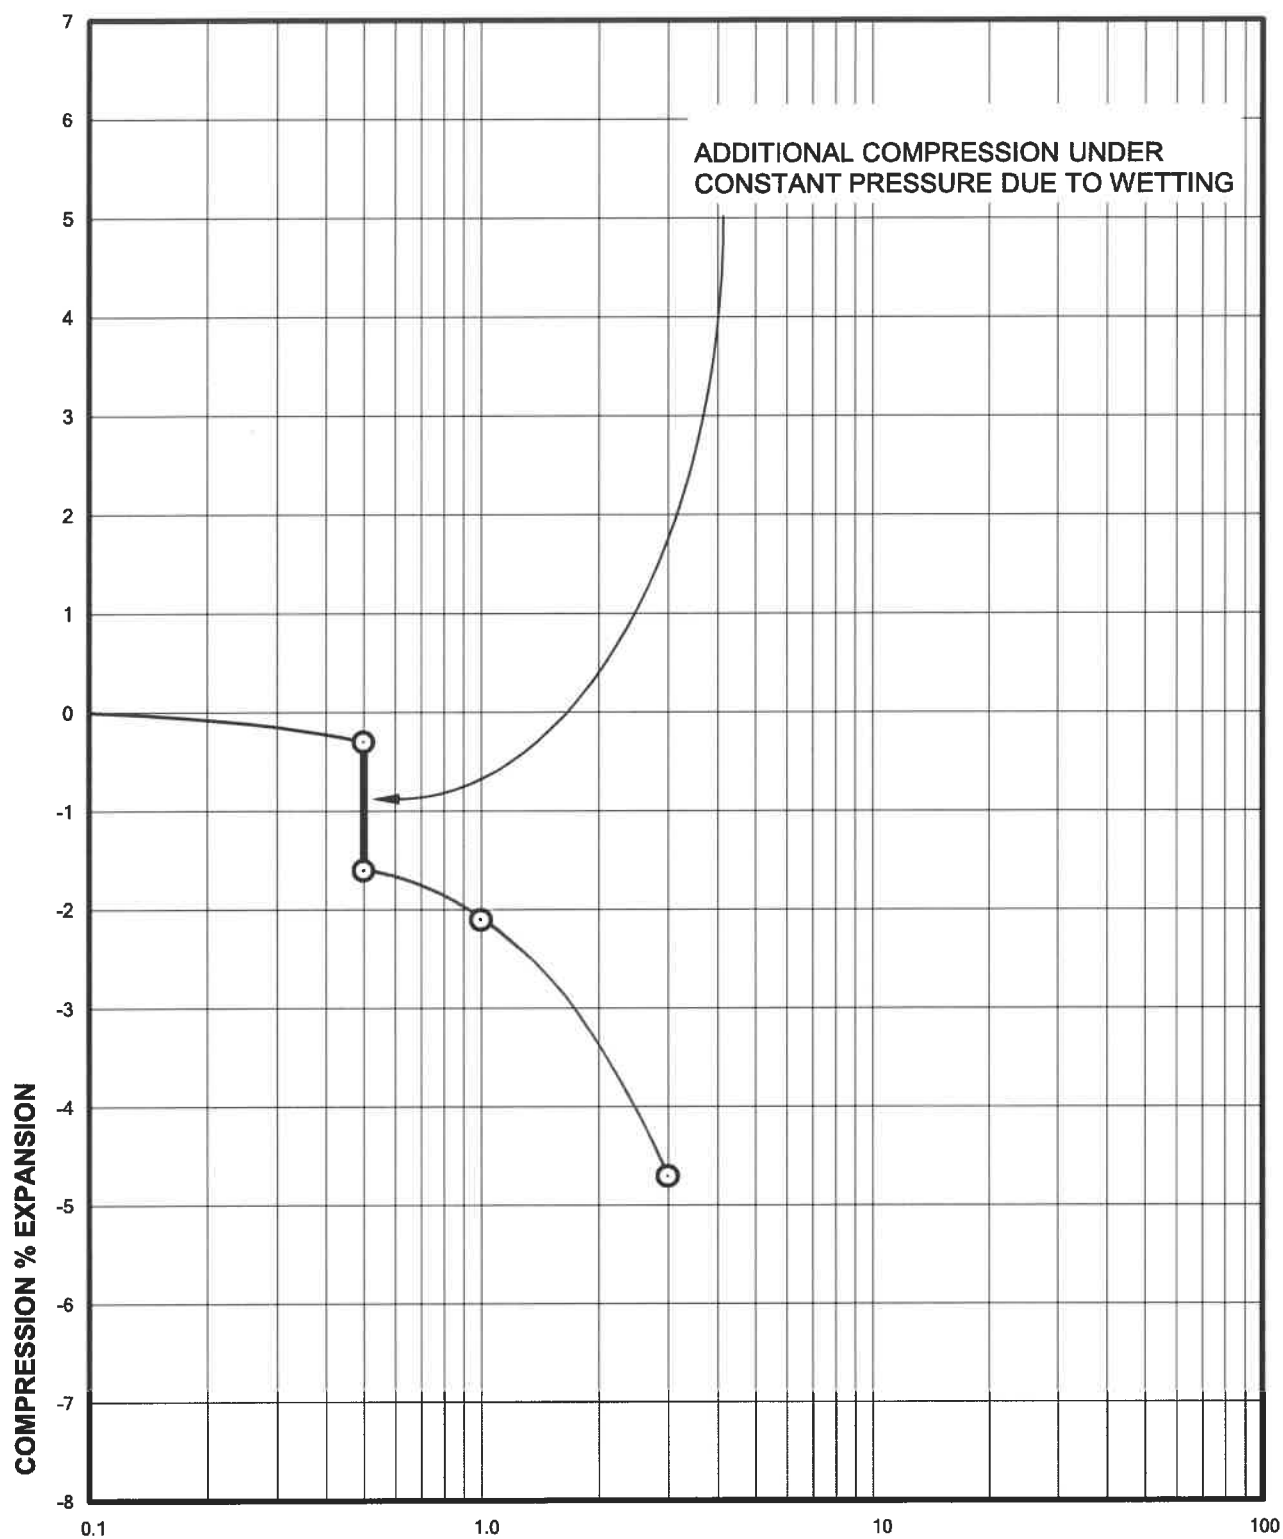
**APPLIED PRESSURE - KSF**  
Sample of SAND, SILTY (SM)  
From TH-104 AT 4 FEET

DRY UNIT WEIGHT= 108 PCF  
MOISTURE CONTENT= 2.3 %

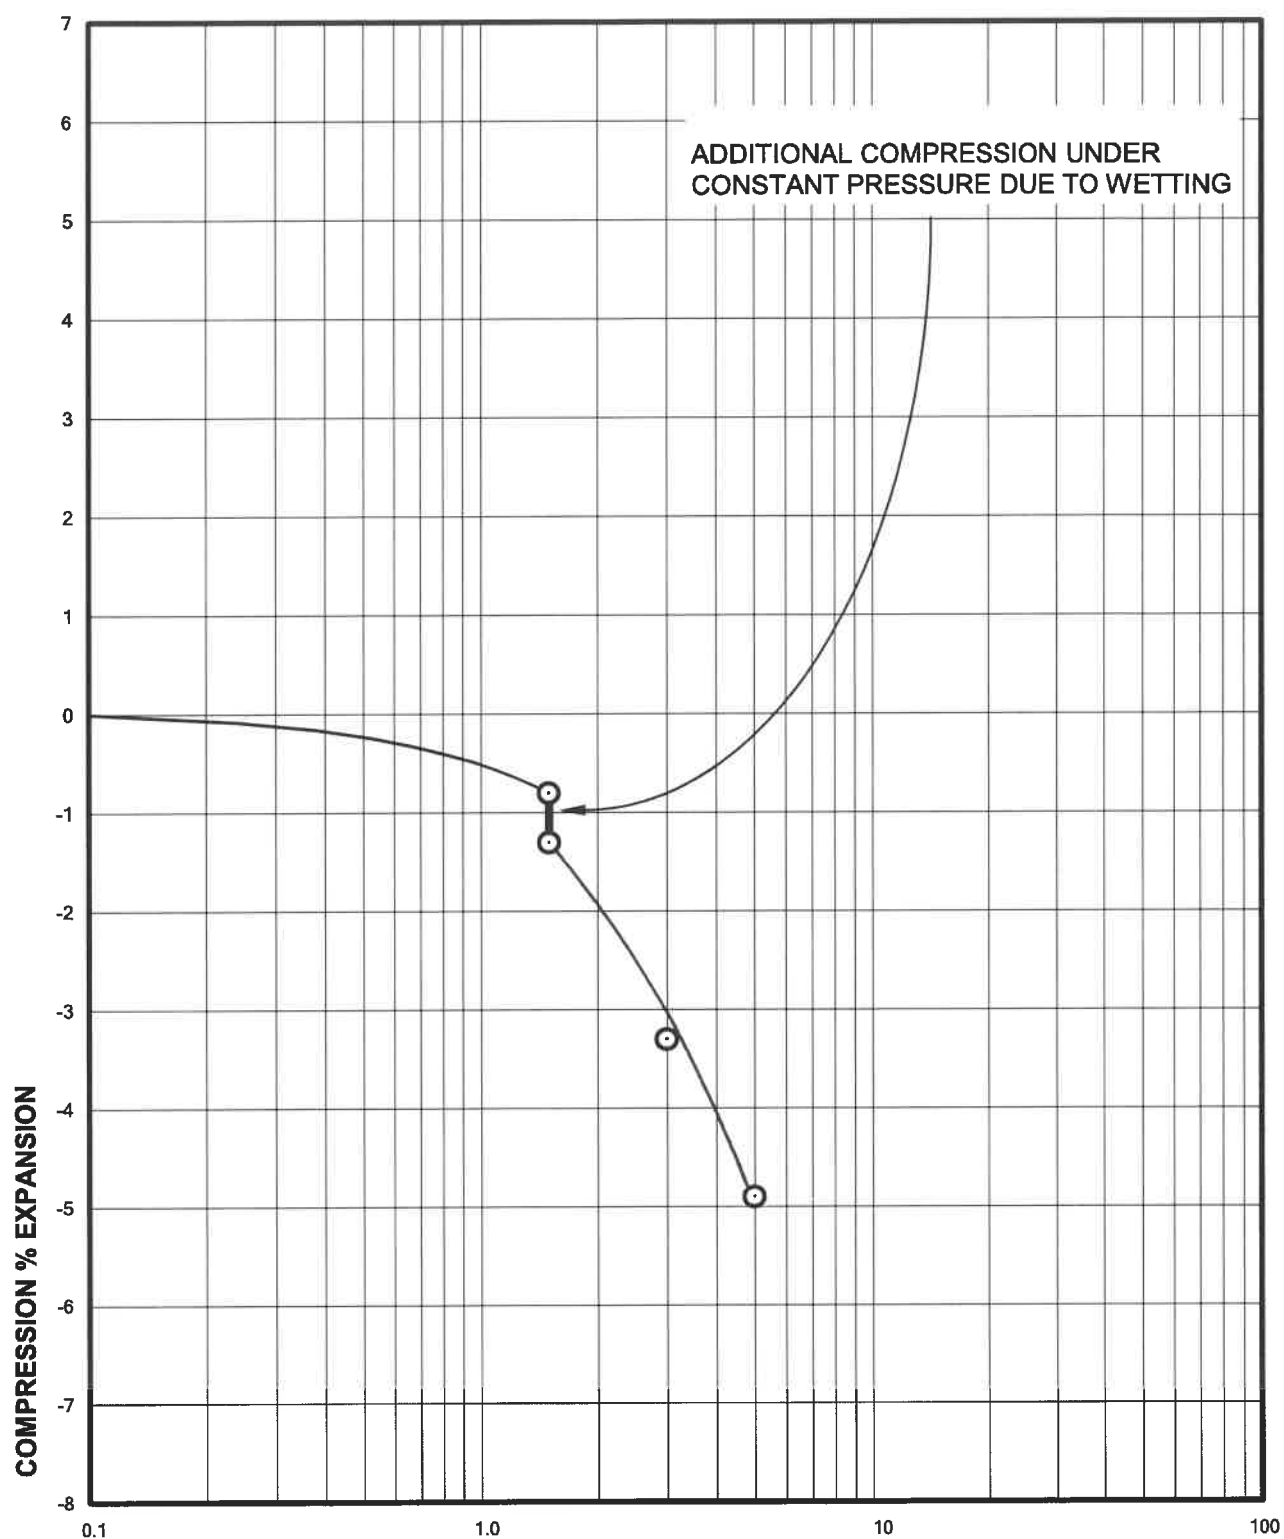
**APPLIED PRESSURE - KSF**  
Sample of SAND, CLAYEY (SC)  
From TH-104 AT 9 FEET

DRY UNIT WEIGHT= 117 PCF  
MOISTURE CONTENT= 3.9 %

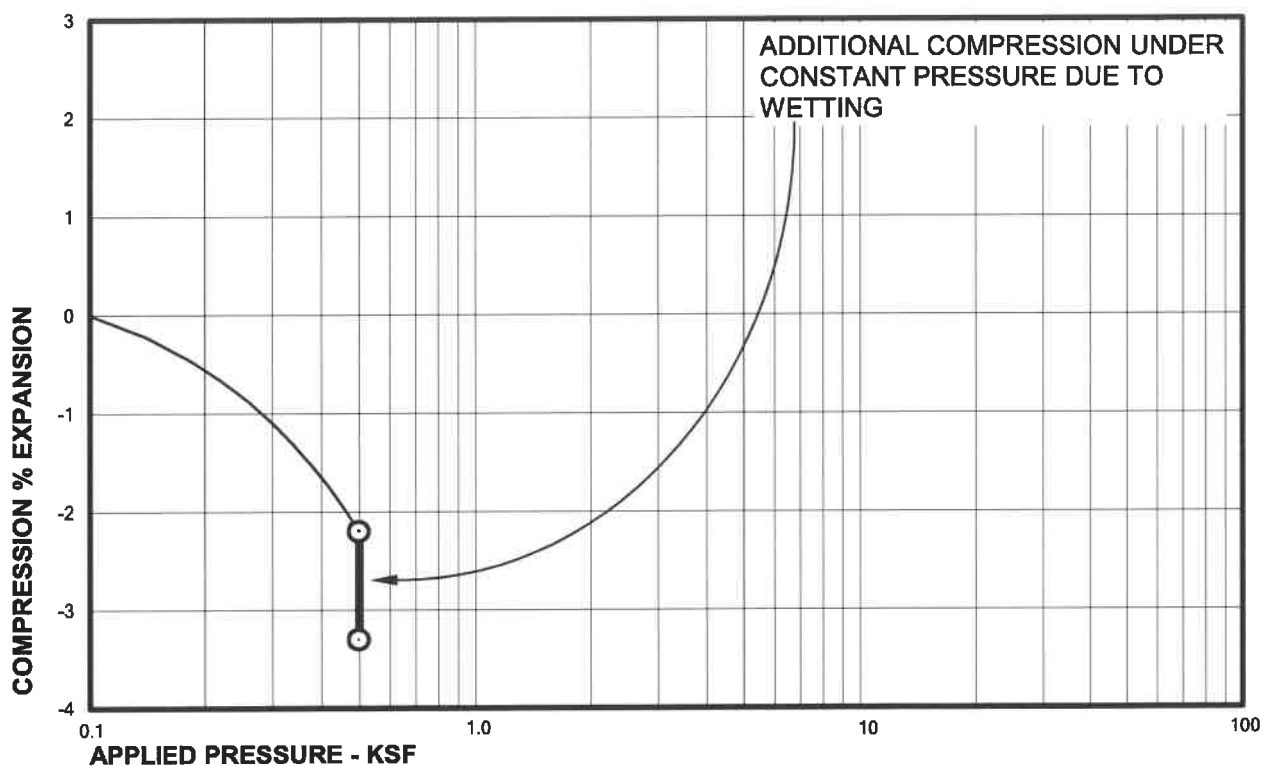
Sample of SAND, SILTY (SM)  
From TH-105 AT 4 FEET

DRY UNIT WEIGHT= 112 PCF  
MOISTURE CONTENT= 3.2 %

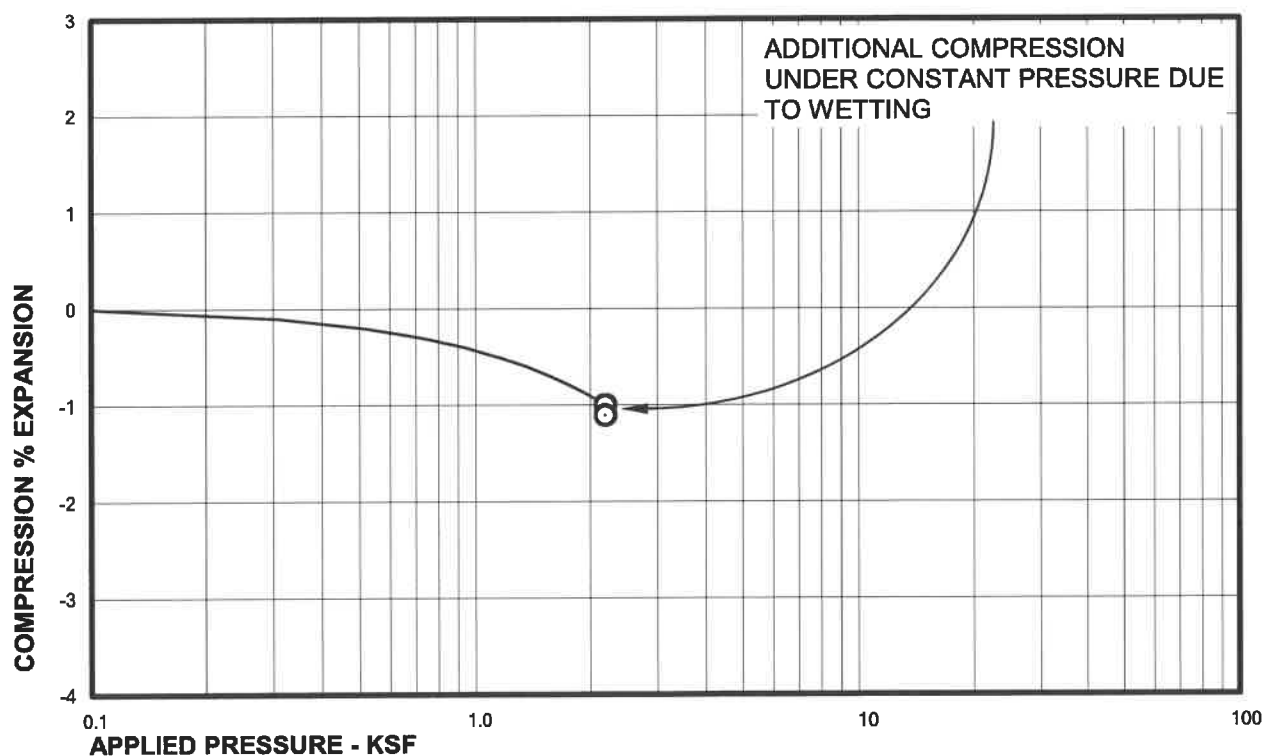
Sample of SAND, VERY CLAYEY (SC)  
From TH-105 AT 19 FEET

DRY UNIT WEIGHT= 120 PCF  
MOISTURE CONTENT= 11.6 %

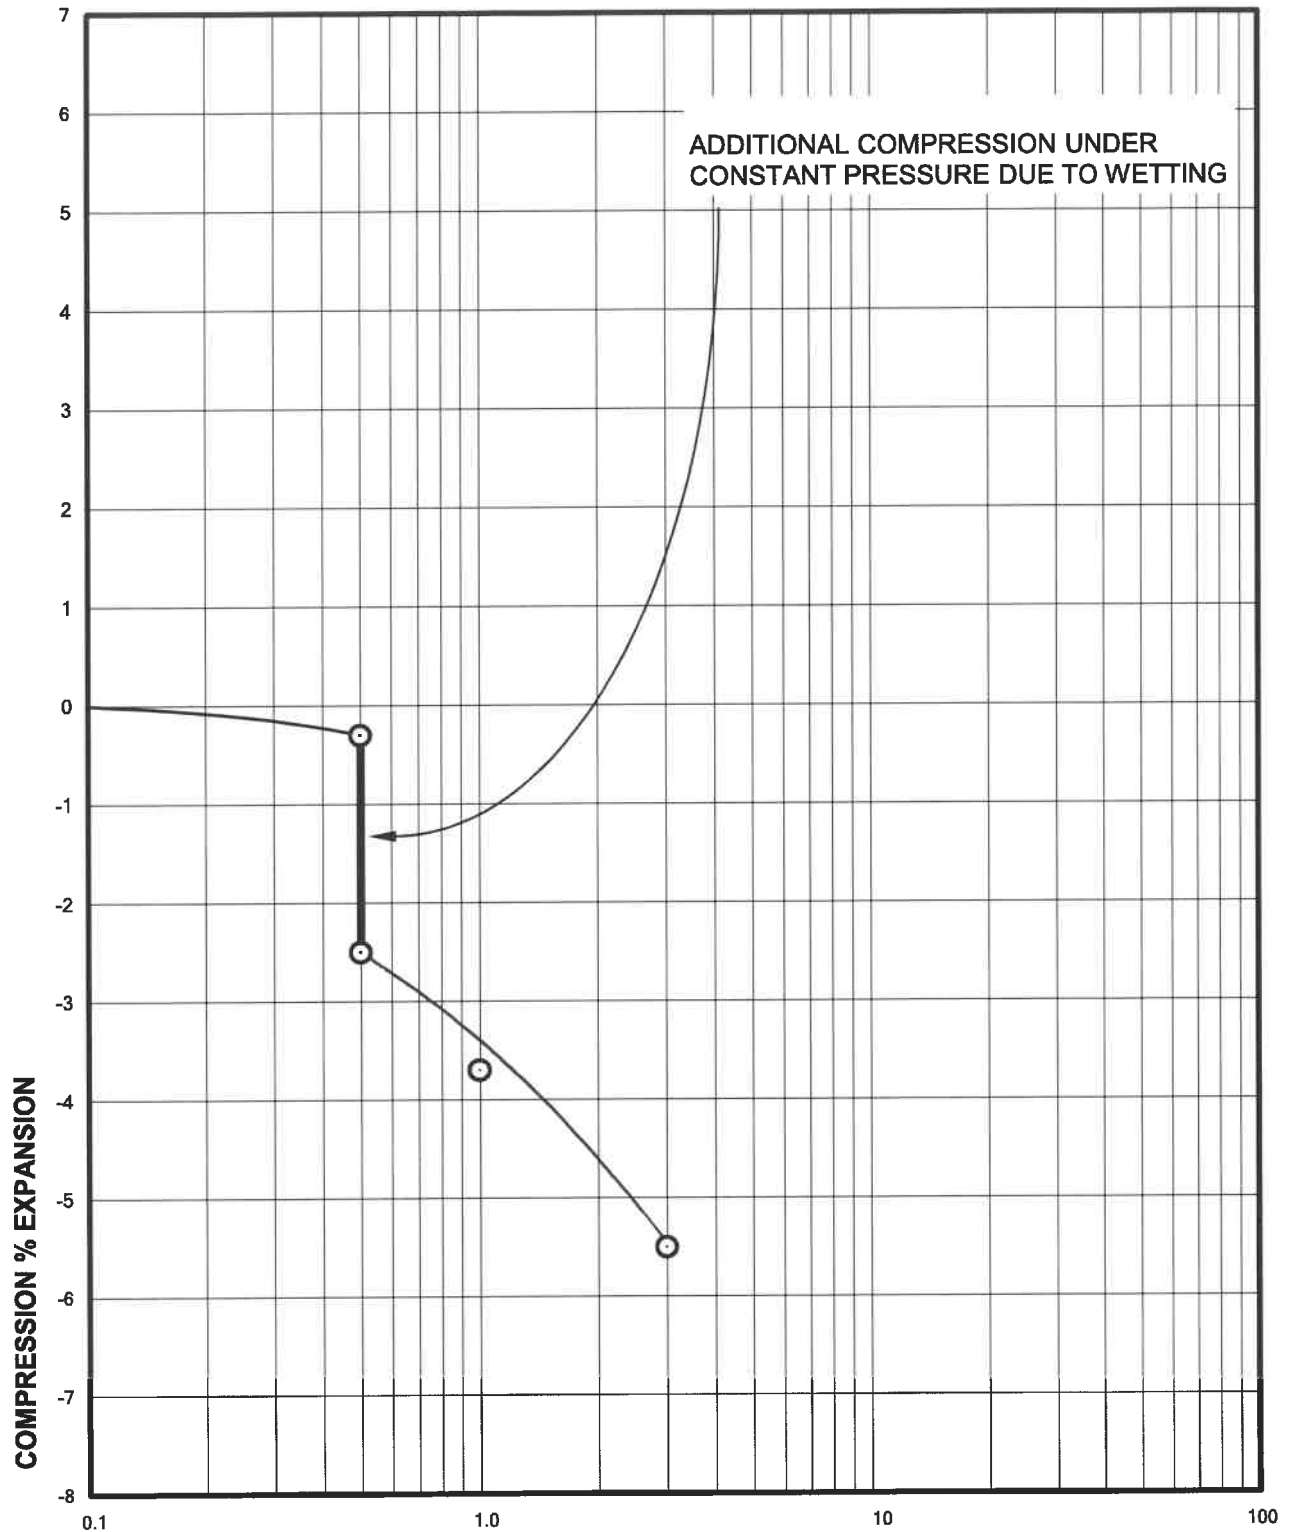
Sample of SAND, SILTY (SM)  
From TH-108 AT 4 FEET

DRY UNIT WEIGHT= 103 PCF  
MOISTURE CONTENT= 4.5 %

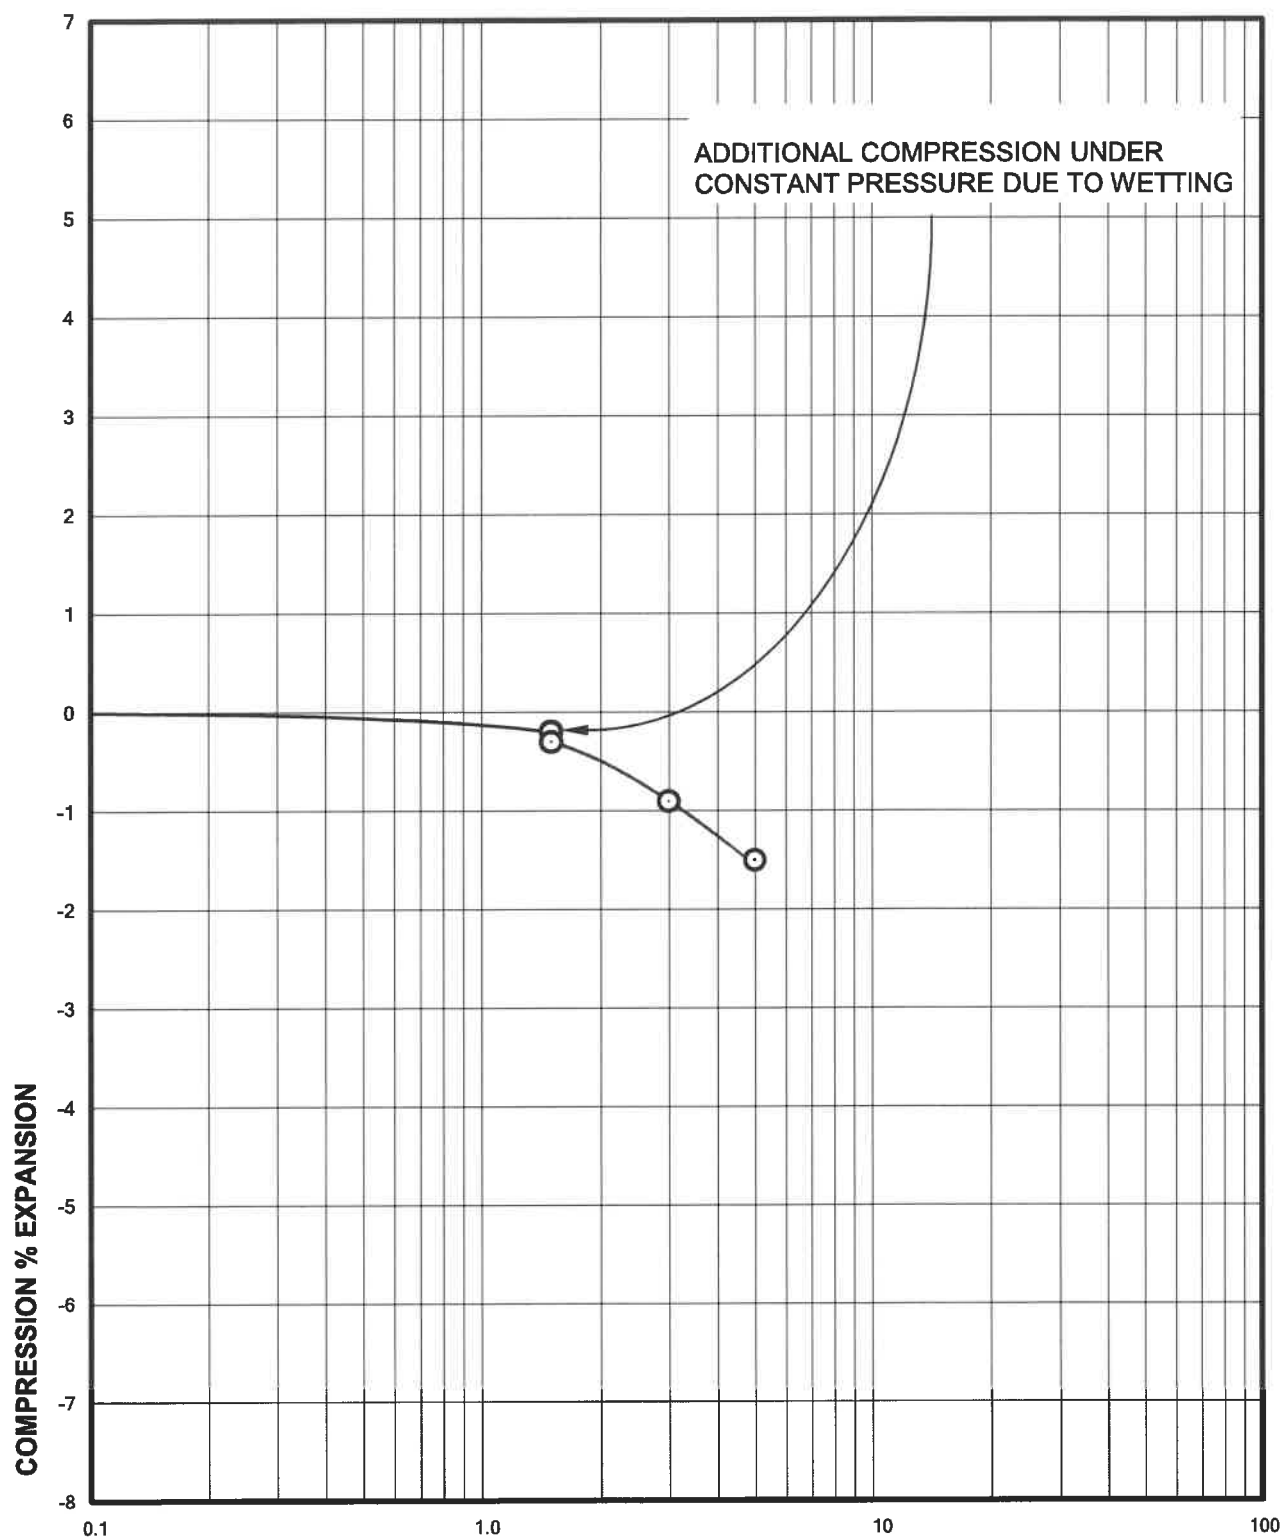
Sample of SAND, GRAVELLY, SILTY (SM)  
From TH-109 AT 9 FEET

DRY UNIT WEIGHT= 112 PCF  
MOISTURE CONTENT= 4.2 %

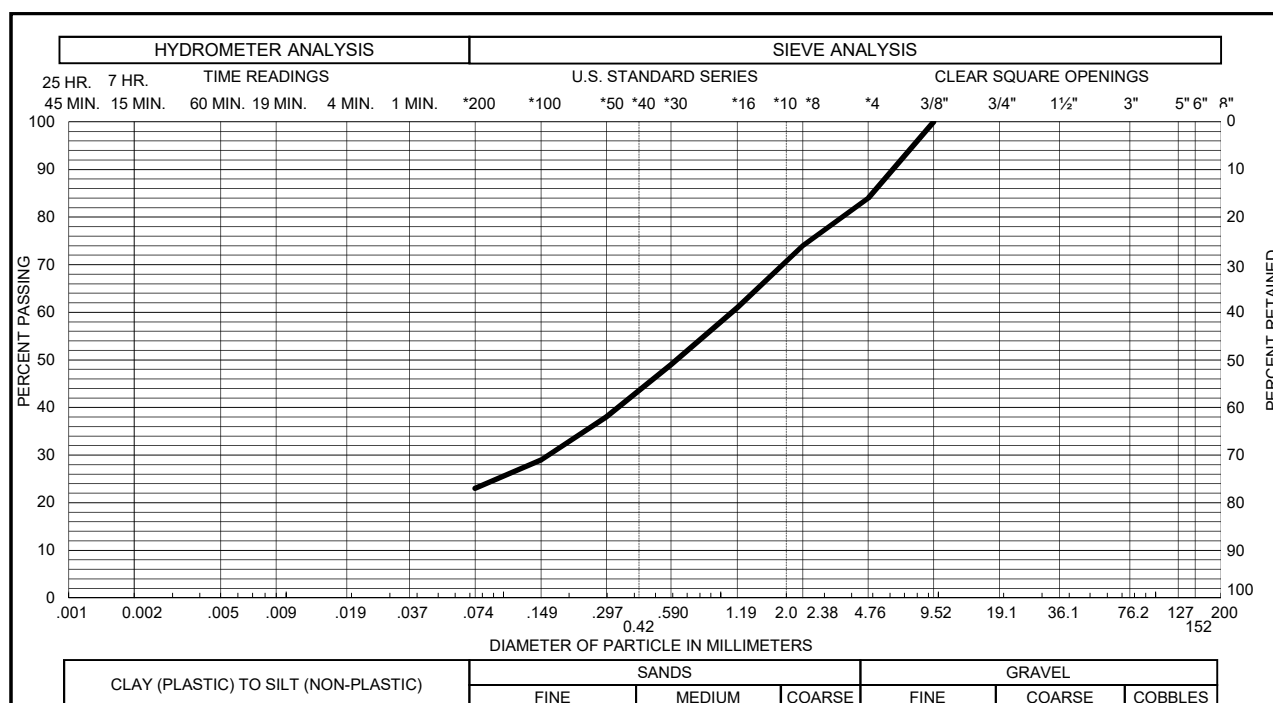
Sample of **SAND, SILTY, GRAVELLY (SM)** GRAVEL 16 % SAND 61 %  
From **TH - 101 AT 14 FEET** SILT & CLAY 23 % LIQUID LIMIT %  
PLASTICITY INDEX %

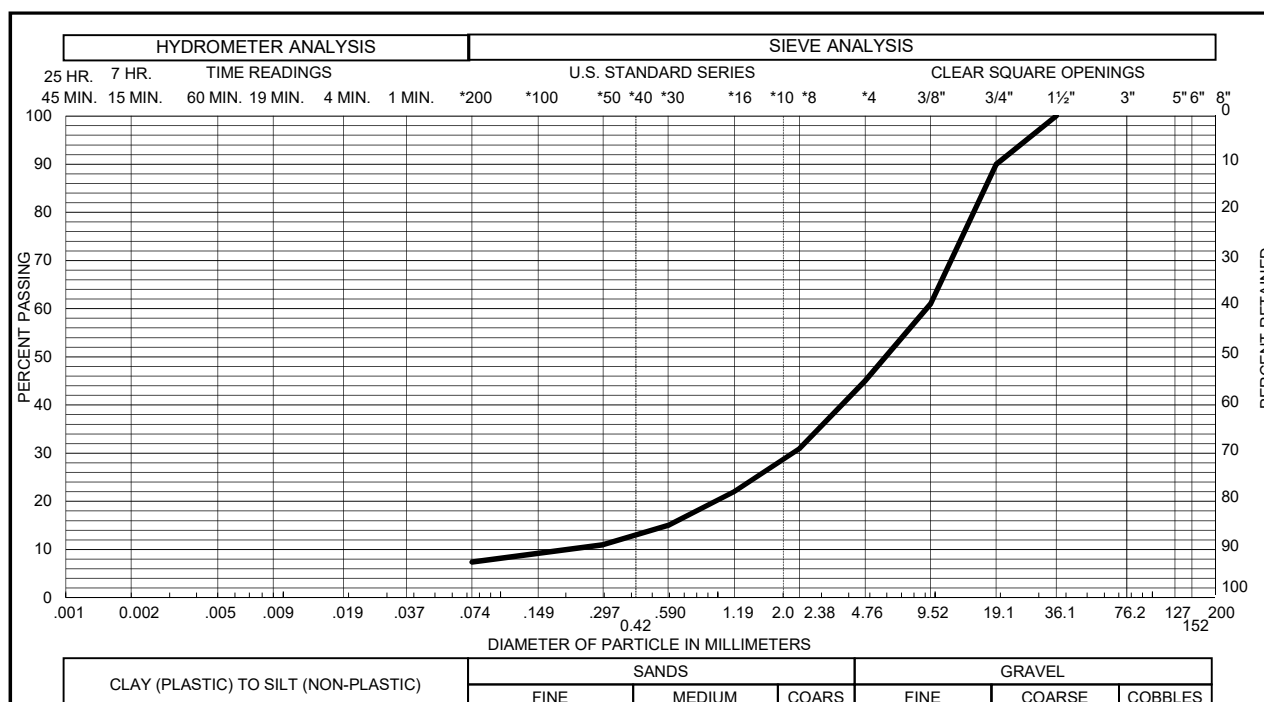
Sample of **GRAVEL, V. SANDY, SLT. SILTY (GW-GM)** GRAVEL 55 % SAND 38 %  
From **TH - 102 AT 14 FEET** SILT & CLAY 7 % LIQUID LIMIT %  
PLASTICITY INDEX %

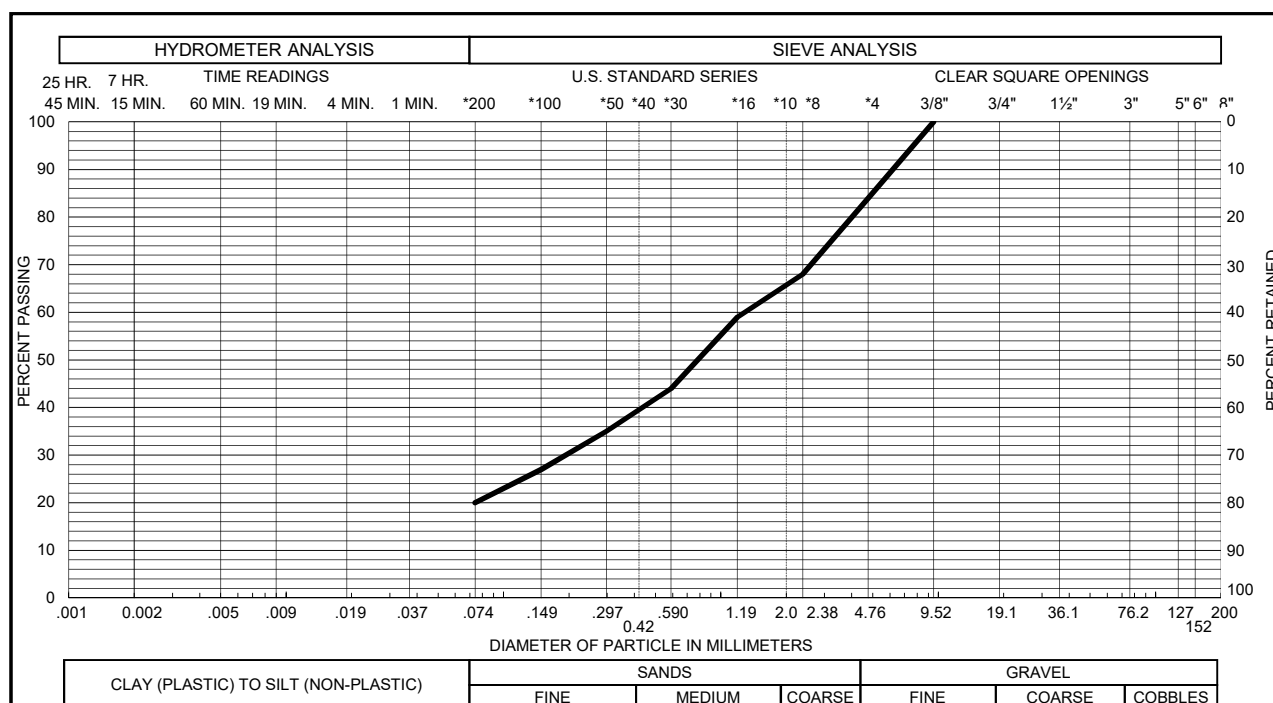
Sample of **SAND, GRAVELLY, SILTY (SM)** GRAVEL 16 % SAND 64 %  
From **TH - 104 AT 19 FEET** SILT & CLAY 20 % LIQUID LIMIT %  
PLASTICITY INDEX %

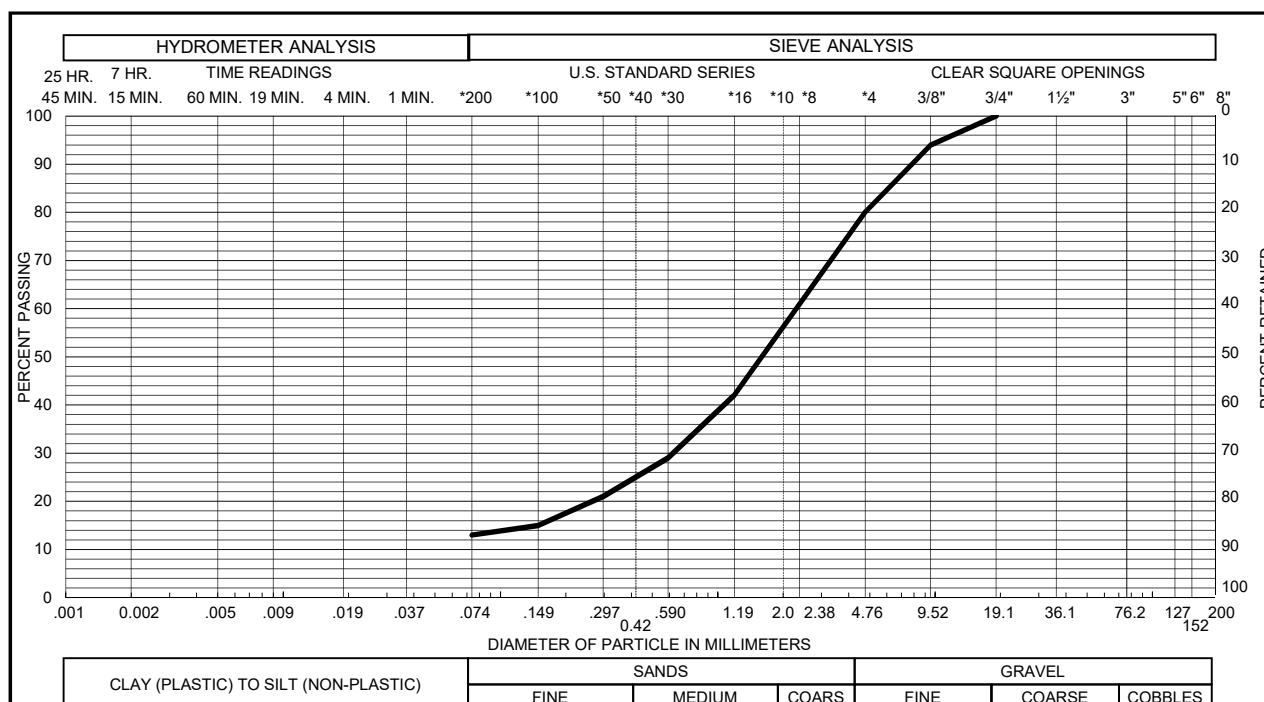
Sample of **SAND, GRAVELLY, SILTY (SM)** GRAVEL 20 % SAND 67 %  
From **TH - 106 AT 9 FEET** SILT & CLAY 13 % LIQUID LIMIT %  
PLASTICITY INDEX %

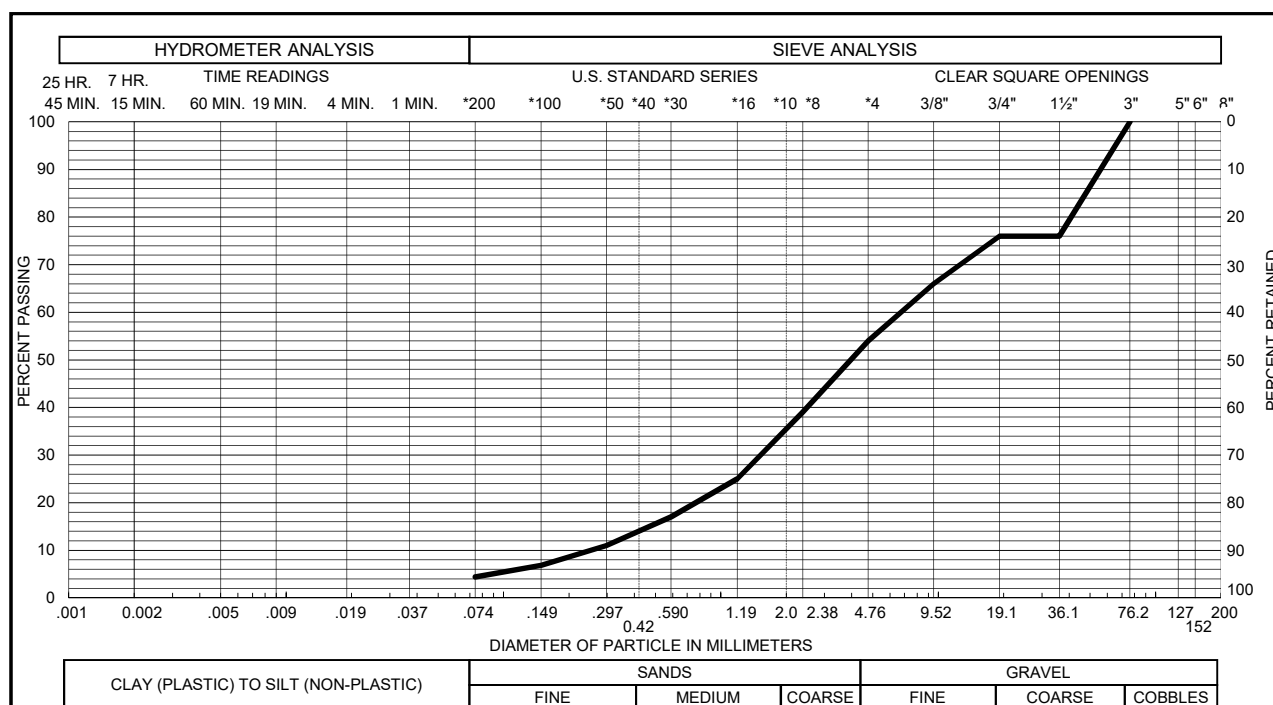
Sample of **SAND, VERY GRAVELLY (SP)** GRAVEL 46 % SAND 50 %  
From **TH - 106 AT 19 FEET** SILT & CLAY 4 % LIQUID LIMIT %  
PLASTICITY INDEX %

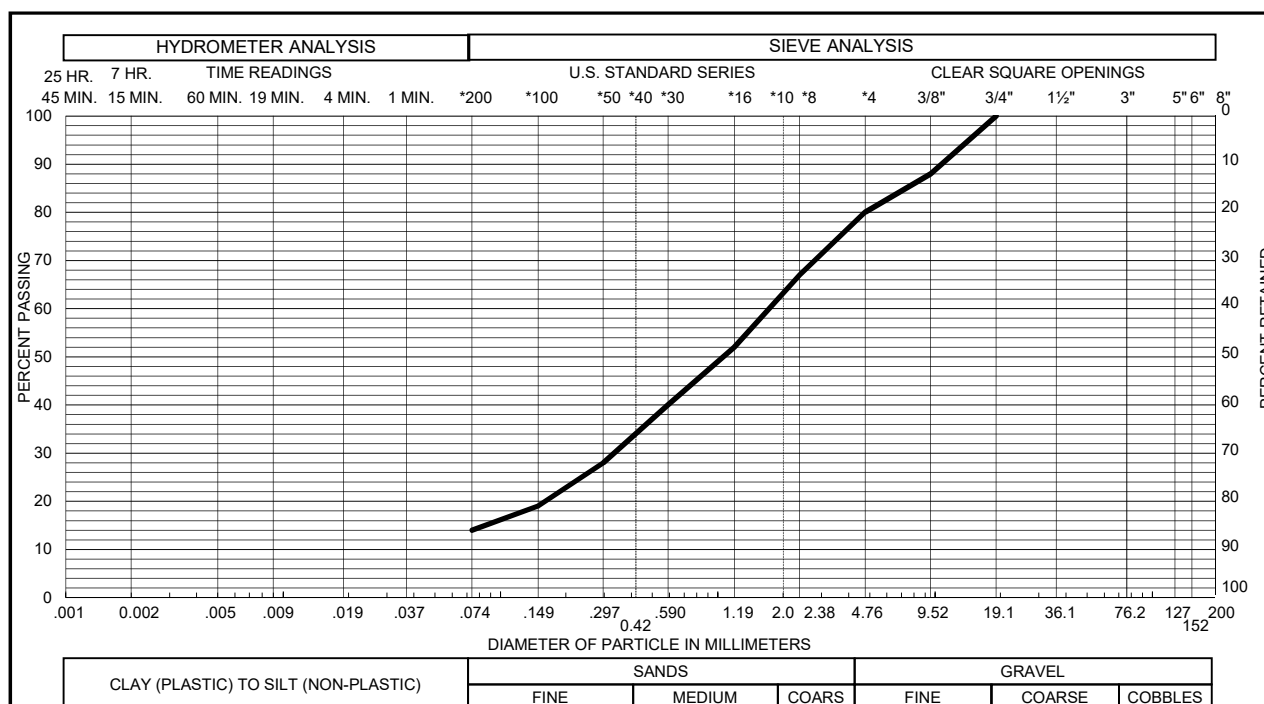
Sample of **SAND, GRAVELLY, SILTY (SM)** GRAVEL 20 % SAND 66 %  
From **TH - 107 AT 9 FEET** SILT & CLAY 14 % LIQUID LIMIT %  
PLASTICITY INDEX %

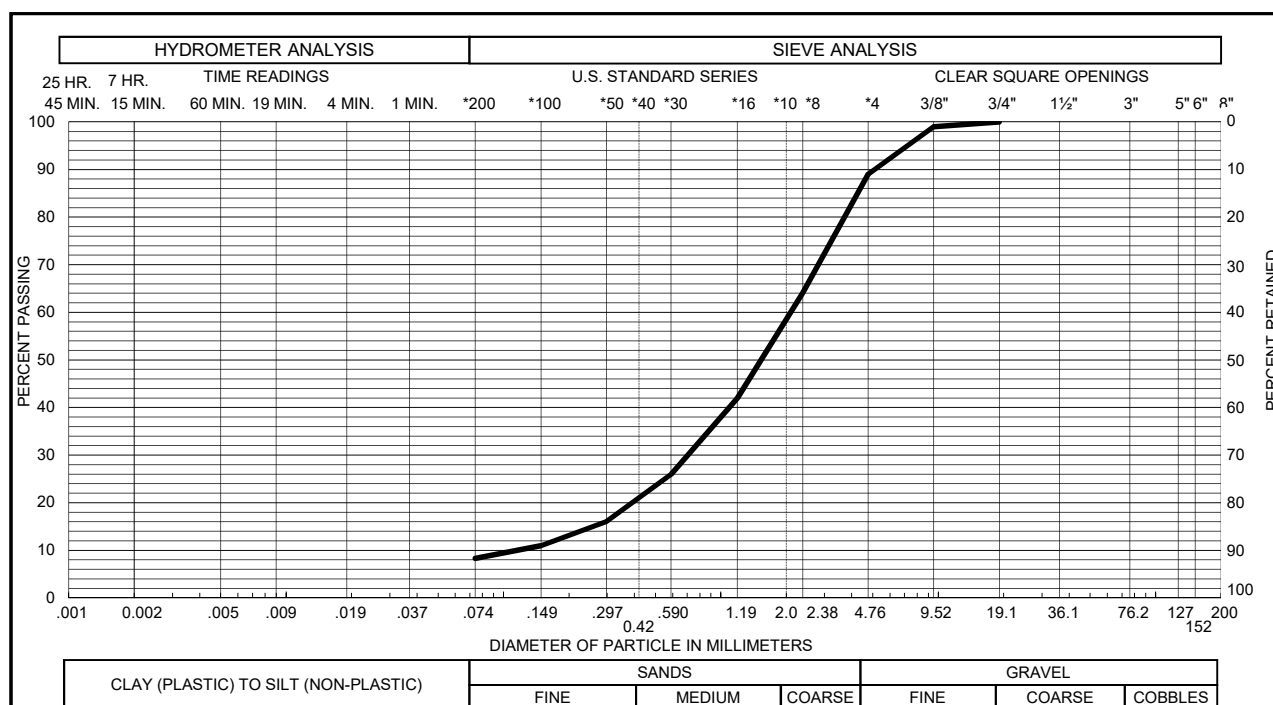
Sample of **SAND, SLIGHTLY SILTY (SW-SM)** GRAVEL 11 % SAND 81 %  
From **TH - 108 AT 9 FEET** SILT & CLAY 8 % LIQUID LIMIT %  
PLASTICITY INDEX %

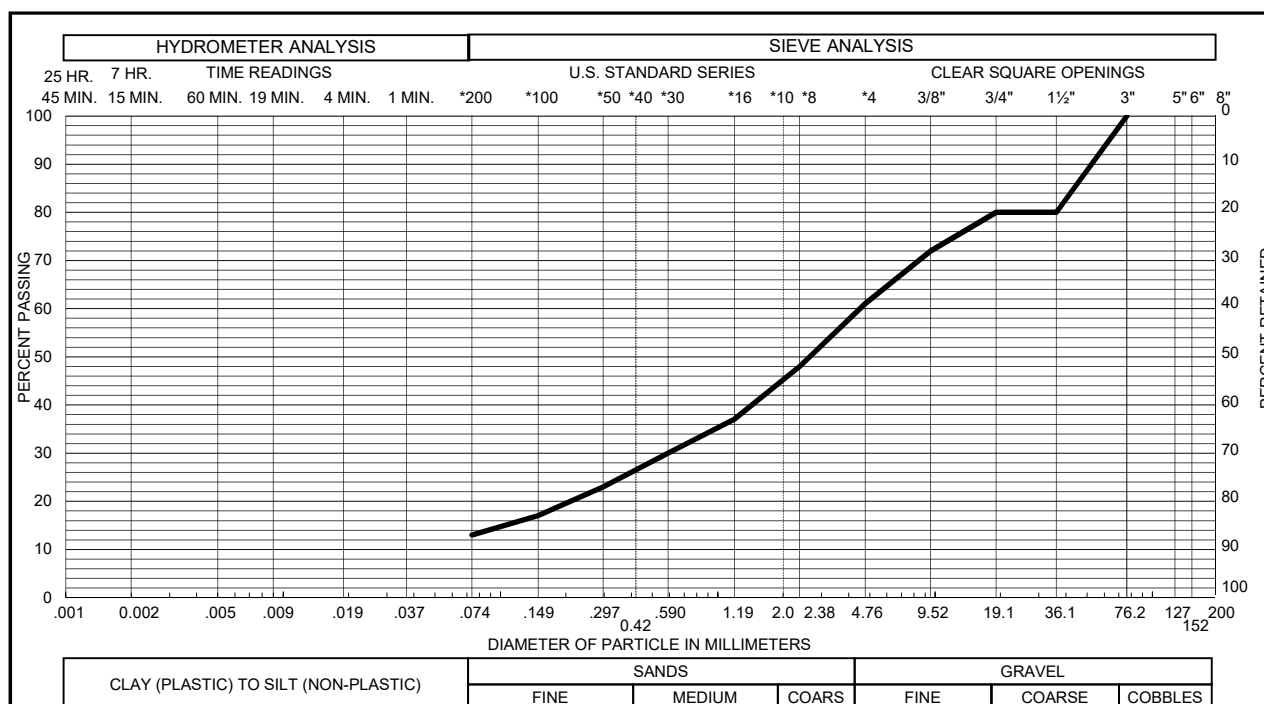
Sample of **SAND, V. GRAVELLY, SILTY (SM)** GRAVEL 39 % SAND 48 %  
From **TH - 108 AT 14 FEET** SILT & CLAY 13 % LIQUID LIMIT %  
PLASTICITY INDEX %

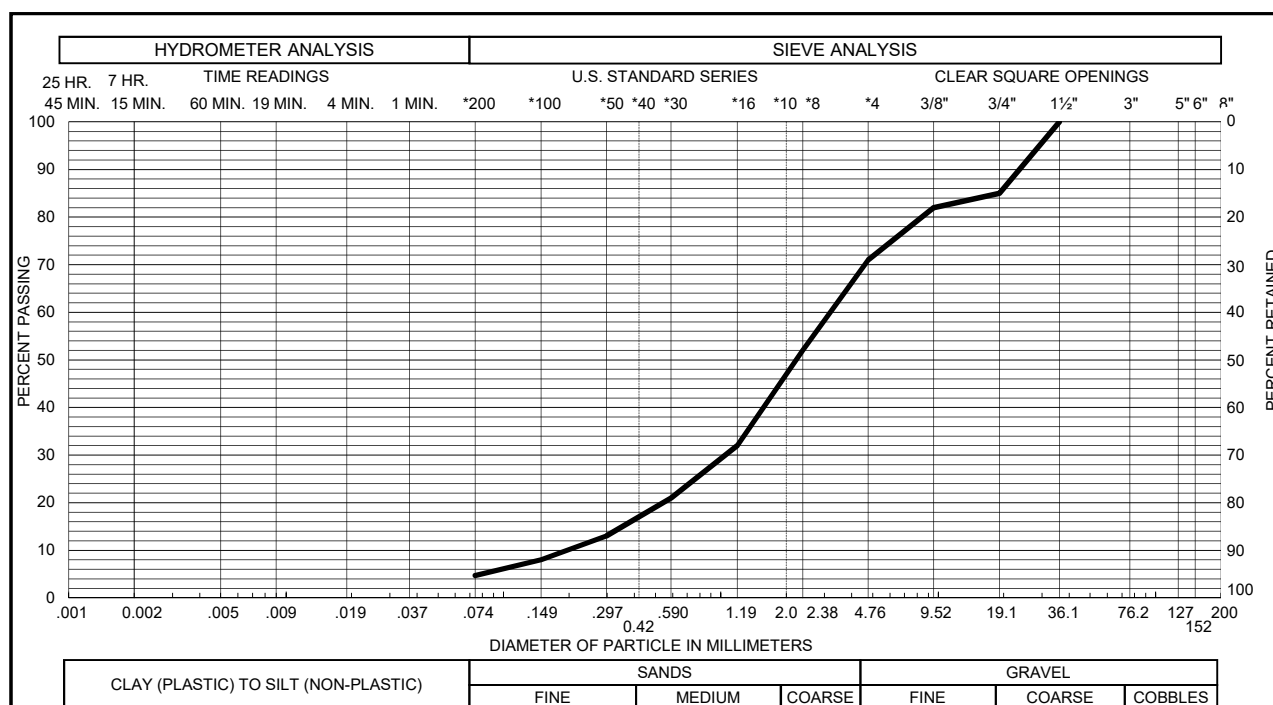
Sample of SAND, GRAVELLY, SLT. SILTY (SW-SM) GRAVEL 29 % SAND 66 %  
From TH - 110 AT 4 FEET SILT & CLAY 5 % LIQUID LIMIT %  
PLASTICITY INDEX %
