**GEOLOGIC HAZARDS EVALUATION AND  
PRELIMINARY GEOTECHNICAL INVESTIGATION  
FOREST LAKES SUBDIVISION (FILINGS 5, 6 & 7)  
FOREST LAKES ROAD & WEST BAPTIST ROAD  
EL PASO COUNTY, COLORADO**

CTL|T Project No. CS18916-105

July 18, 2018  
Revised: December 11, 2018  
Revised: February 18, 2019

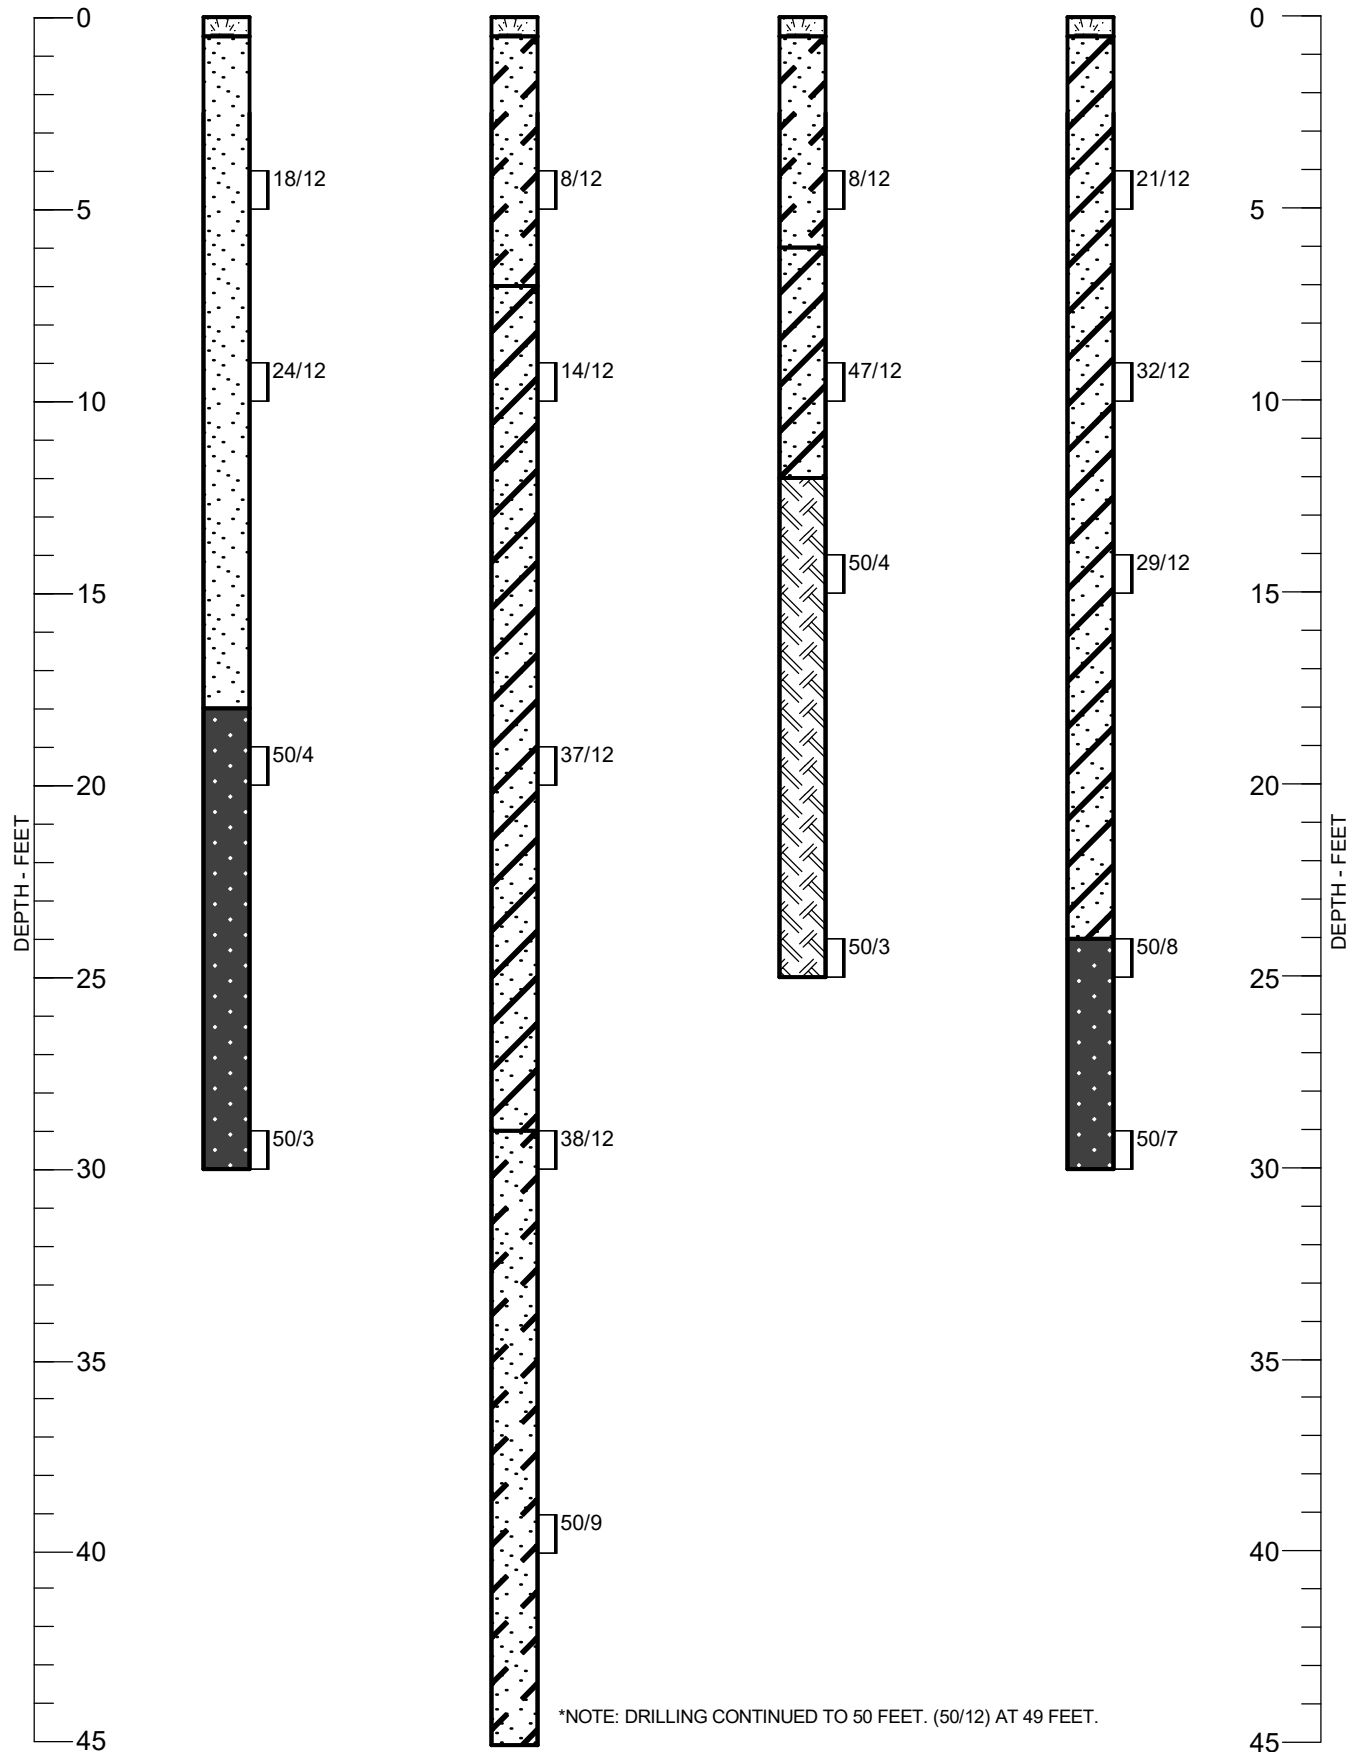
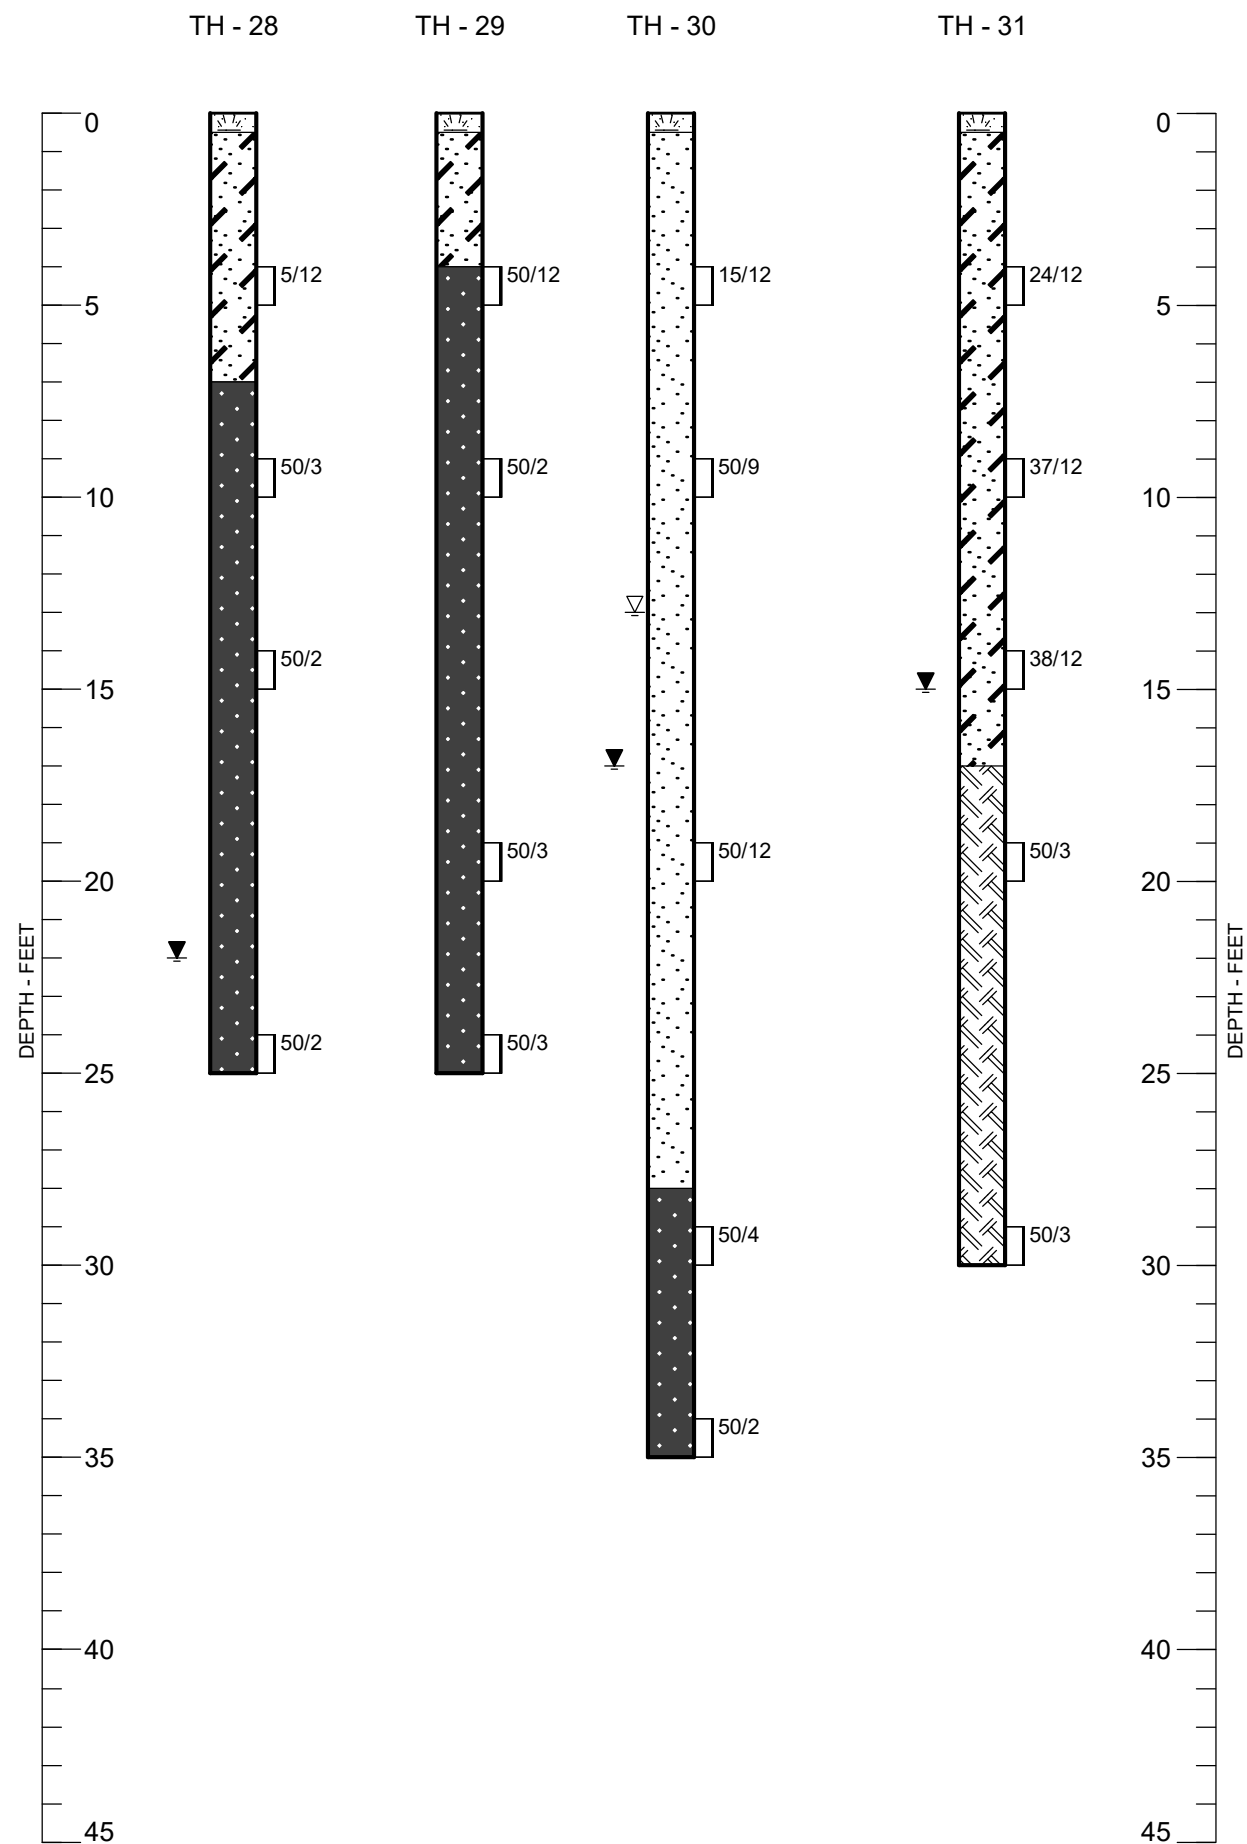
SUMMARY LOGS OF EXPLORATORY BORINGS  
(CTL | T JOB NO. CS-10,585; DATED AUGUST 15, 2001)

1. THE BORINGS WERE DRILLED FEBRUARY 18 AND MARCH 6, 2000 USING A 4-INCH DIAMETER, CONTINUOUS-FLIGHT, TRUCK-MOUNTED, POWER AUGER.
2. THESE LOGS ARE SUBJECT TO THE EXPLANATIONS, LIMITATIONS, AND CONCLUSIONS AS CONTAINED IN THIS REPORT.
