Job No. 198337

Re: Response to Review Comments
PUDSP255 Antelope Ridge at Bull Hill, Phase 1
Bradley Rd
El Paso County, Colorado

RMG Engineers (RMG) prepared the *Soils and Geology Study* (RMG Job No. 198337, last dated March 14, 2025) for the proposed development comprising 471 single-family residential lots located approximately 1 mile east of the intersection of Marksheffel Road and Bradley Road. The report was reviewed by personnel of the Colorado Geological Survey (CGS) and the El Paso County Planning Department. The CGS comments (last dated July 18, 2024) were provided to us by personnel of Matrix Design on October 8, 2025.

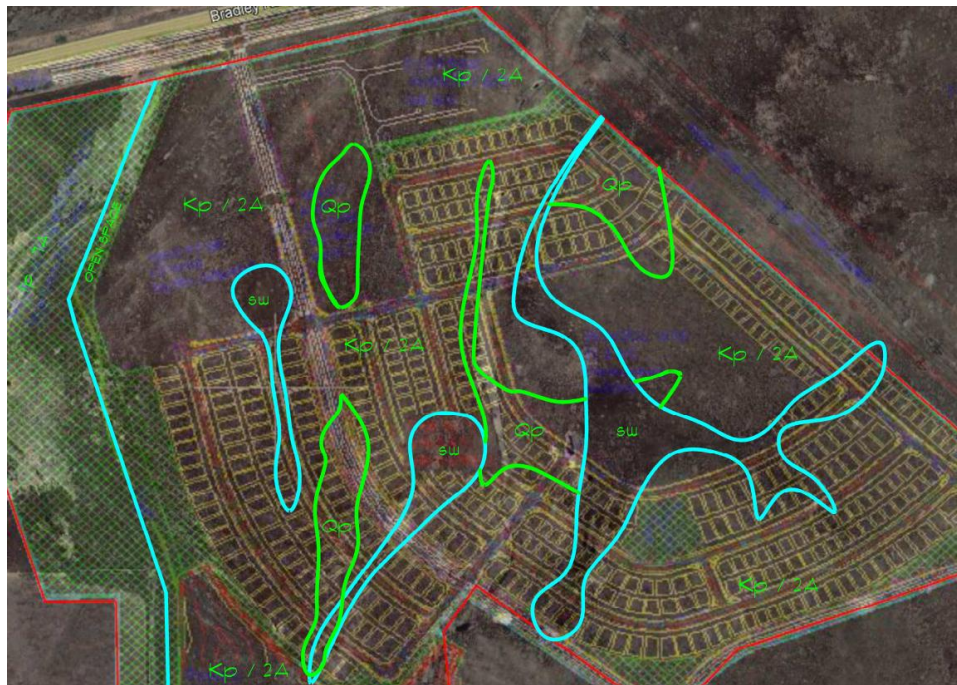
Figure 11, Engineering and Geology Map was included in our report last dated March 14, 2025 and shown below. It is uncertain if the Figure was missed or insufficient. If insufficient we would request further explanation as to what is needed.

General Geology

- *sw* - *seasonally wet areas* - low lying areas that may collect surface water during heavy precipitation events (rain or snowfall). These areas are likely to be regraded during the land development.
- *fp* - *floodplain*, as designated by FEMA -Improvements are proposed for JCC to contain the tributary to a designated channel. No construction is proposed within this area.
- *Qp* - *Piney Creek Alluvium* - Alluvial and pond or bog deposits. Mostly clayey sandy silt and silty sand; very clayey in pond and bog deposits, gravelly along main stream. Thickness is generally 5 to 15 feet, maximum of 50 feet possible.
- *Kp* - *Pierre Shale*, Main part of formation - Shale, minor siltstone and sandstone beds, and thin concretionary limestone beds. Poorly exposed in general. Total formation thickness is about 5,000 feet.

The Engineering and Geology Map specific to Antelope Ridge at Bull Hill, is included in Figure 11.

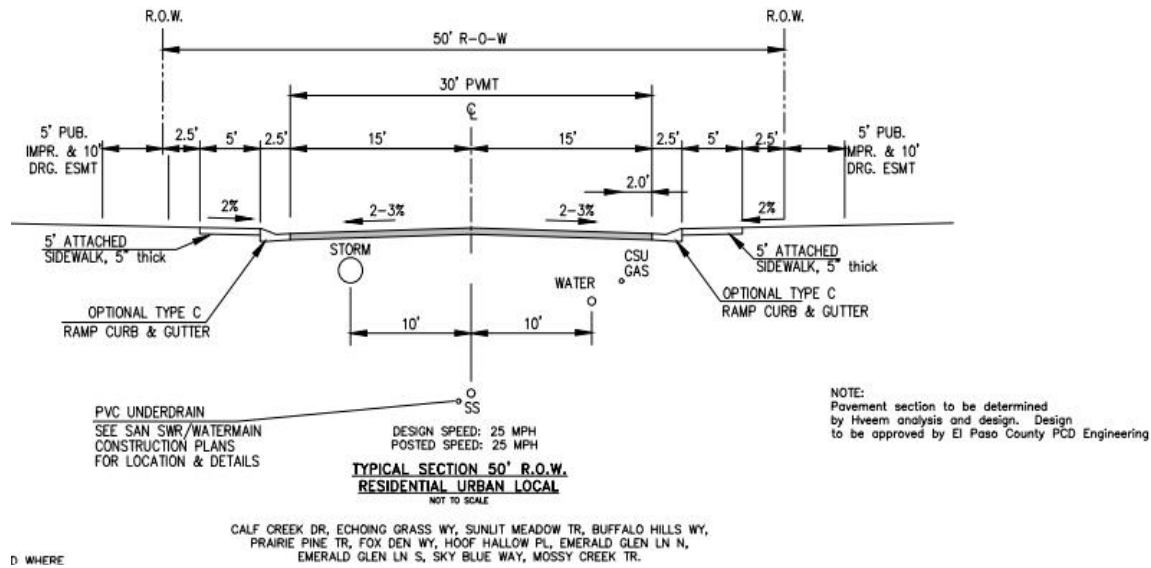
Core Engineering Group has provided the construction plans for the passive underdrain system for Antelope Ridge, at Bull Hill, Phase 1. It is our understanding the passive underdrain system is to be located 1-foot below the sanitary and stub out to every lot. The outlets for the underdrain system daylight into the E. Tributary, south of the project. Below is a snippet of the Street / Storm Typical Sections as presented in Core Engineering Group's detail (Project No.100.302, sheet C1-3, dated

8-1-25). Rolling Meadows/Bull Hill Metro District No. 1 is responsible for the underdrain maintenance outside the lot limits.
