Job No. 198337

Re: Response to Review Comments
Antelope Ridge at Bull Hill, Phase 1
Bradley Rd
El Paso County, Colorado

RMG Engineers (RMG) prepared the *Soils and Geology Study* (RMG Job No. 198337, last dated March 14, 2025) for the proposed development comprising 471 single-family residential lots located approximately 1 mile east of the intersection of Marksheffel Road and Bradley Road. The report was reviewed by personnel of the Colorado Geological Survey (CGS) and the El Paso County Planning Department. The CGS comments (last dated July 18, 2024) were provided to us by personnel of Matrix Design on October 8, 2025.

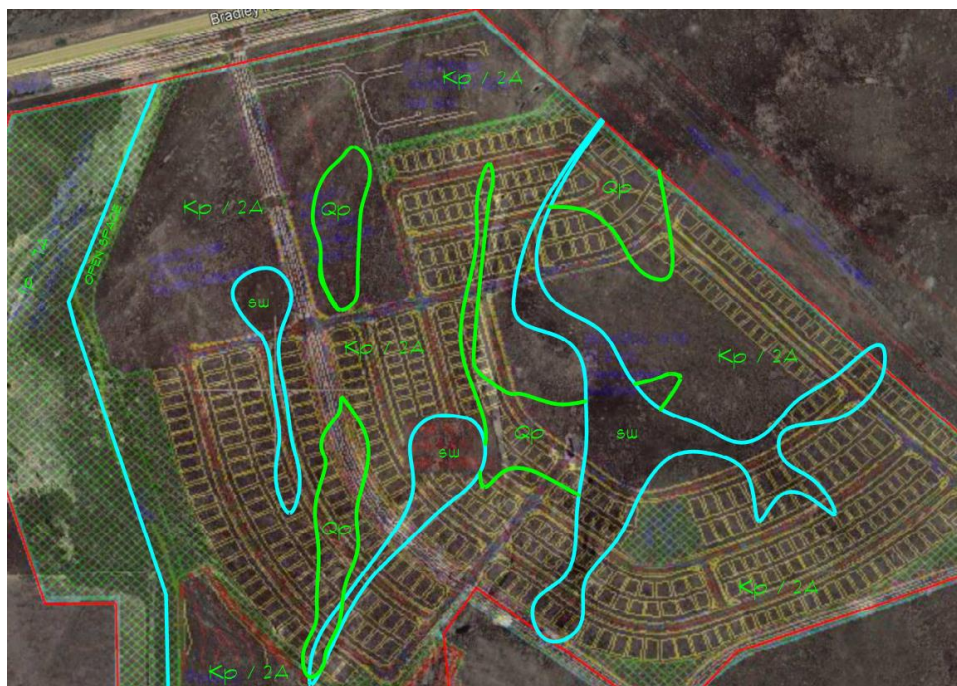
Figure 11, Engineering and Geology Map was included in our report last dated March 14, 2025 and shown below. It is uncertain if the Figure was missed or insufficient. If insufficient we would request further explanation as to what is needed.

- *sw* - *seasonally wet areas* - low lying areas that may collect surface water during heavy precipitation events (rain or snowfall). These areas are likely to be regraded during the land development.
- *fp* - *floodplain*, as designated by FEMA -Improvements are proposed for JCC to contain the tributary to a designated channel. No construction is proposed within this area.
- *Qp* - *Piney Creek Alluvium* - Alluvial and pond or bog deposits. Mostly clayey sandy silt and silty sand; very clayey in pond and bog deposits, gravelly along main stream. Thickness is generally 5 to 15 feet, maximum of 50 feet possible.
- *Kp* - *Pierre Shale*, Main part of formation - Shale, minor siltstone and sandstone beds, and thin concretionary limestone beds. Poorly exposed in general. Total formation thickness is about 5,000 feet.

The Engineering and Geology Map specific to Antelope Ridge at Bull Hill, is included in Figure 11.

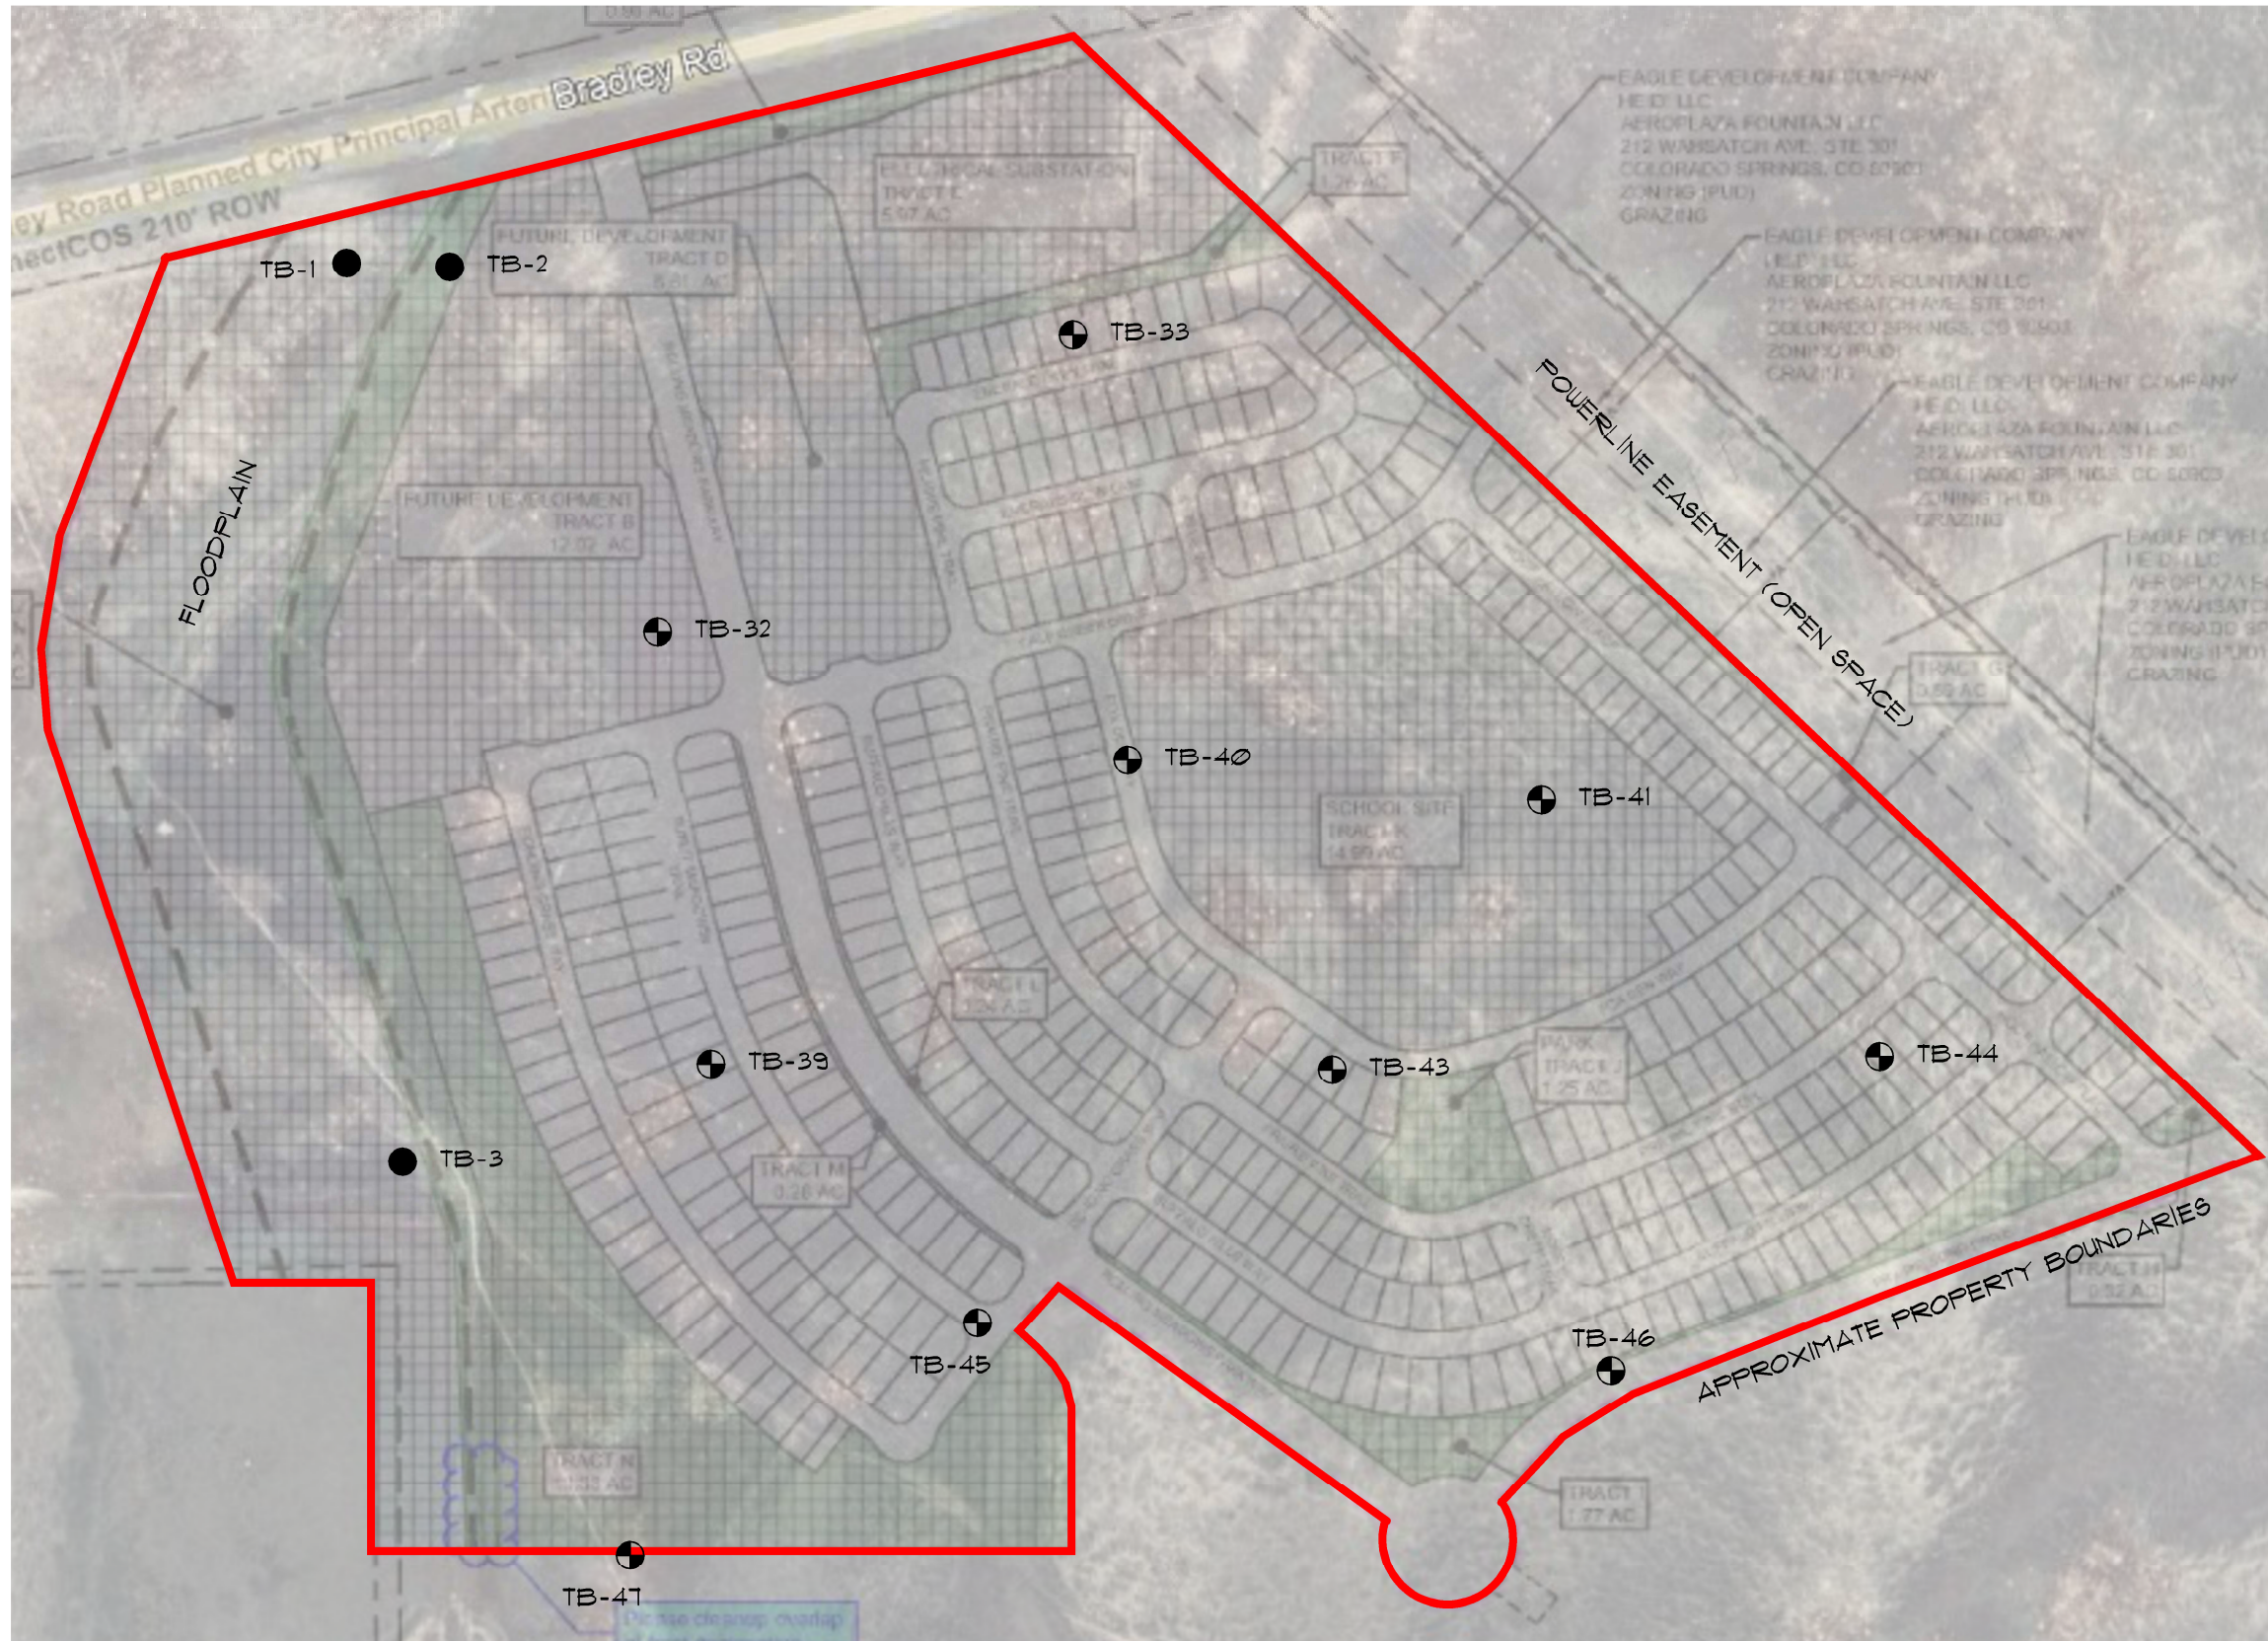
● DENOTES APPROXIMATE LOCATION OF TEST BORINGS PERFORMED FOR THIS STUDY

⊕ DENOTES APPROXIMATE LOCATION OF TEST BORINGS PERFORMED FOR THE OVERALL PROPOSED DEVELOPMENT, RMG JOB NO. 181146, LAST DATED JANUARY 24, 2024

The subsurface conditions within the property were explored by drilling three (3) exploratory borings across the site on January 15, 2025, extending to depths of approximately 20 to 30 feet below the existing ground surface. The test boring locations were selected by Matrix Design, who were provided guidance from the structural engineers that are to complete the culvert design. It is our understanding they needed additional material properties to design the culvert.

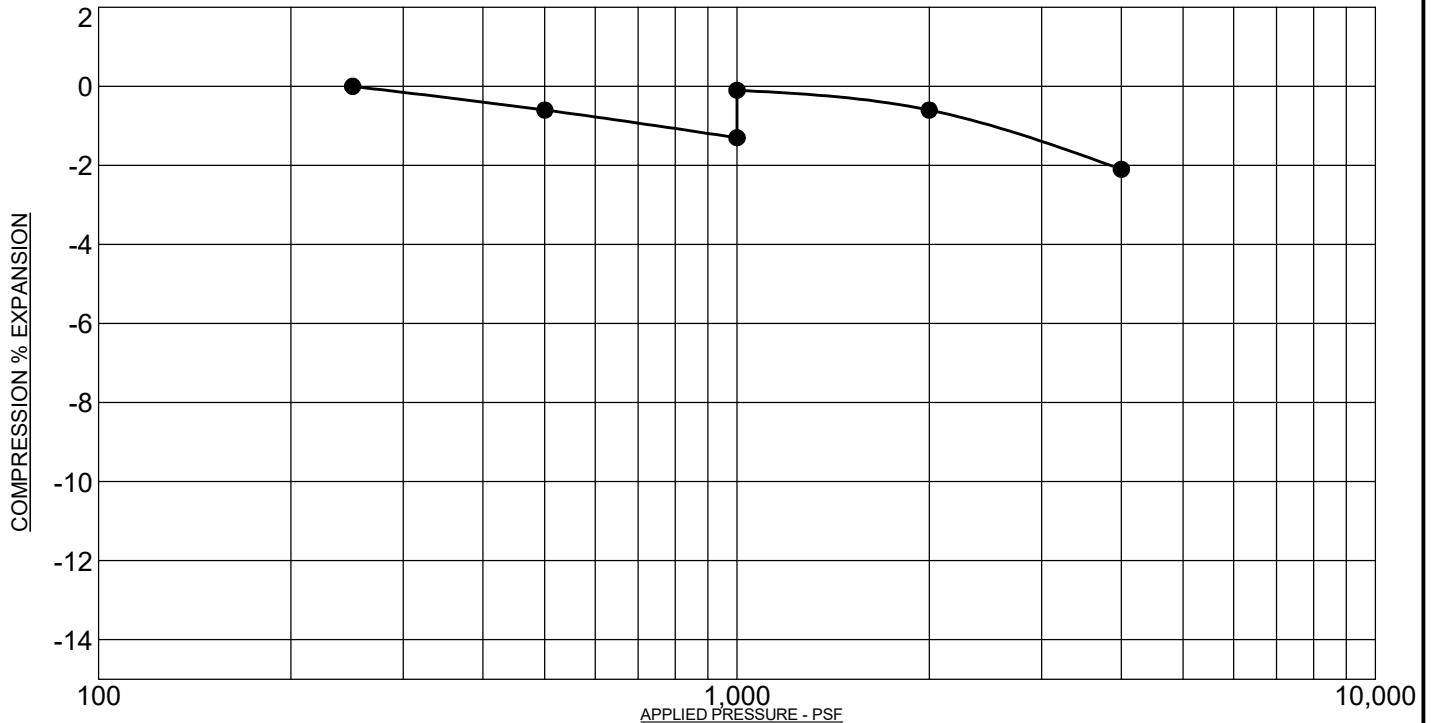
PROJECT: **Antelope Ridge at Bull Hill El Paso County, Colorado**
 SAMPLE DESCRIPTION: **CLAY, SANDY**
 NOTE: **SAMPLE WAS INUNDATED WITH WATER AT 1,000 PSF**

SAMPLE LOCATION: **2 @ 14 FT**
 NATURAL DRY UNIT WEIGHT: **98.0 PCF**
 NATURAL MOISTURE CONTENT: **24.9%**
 PERCENT SWELL/COMPRESSION: **1.2**

Soil laboratory testing was performed as part of this investigation. The laboratory tests included moisture content, dry density, grain-size analyses, Atterberg Limits and Swell/Consolidation tests. A Summary of Laboratory Test Results is presented in Figure 7. Soils Classification Data is presented in Figure 8. Swell/Consolidation Test Results are presented in Figures 9 and 10.

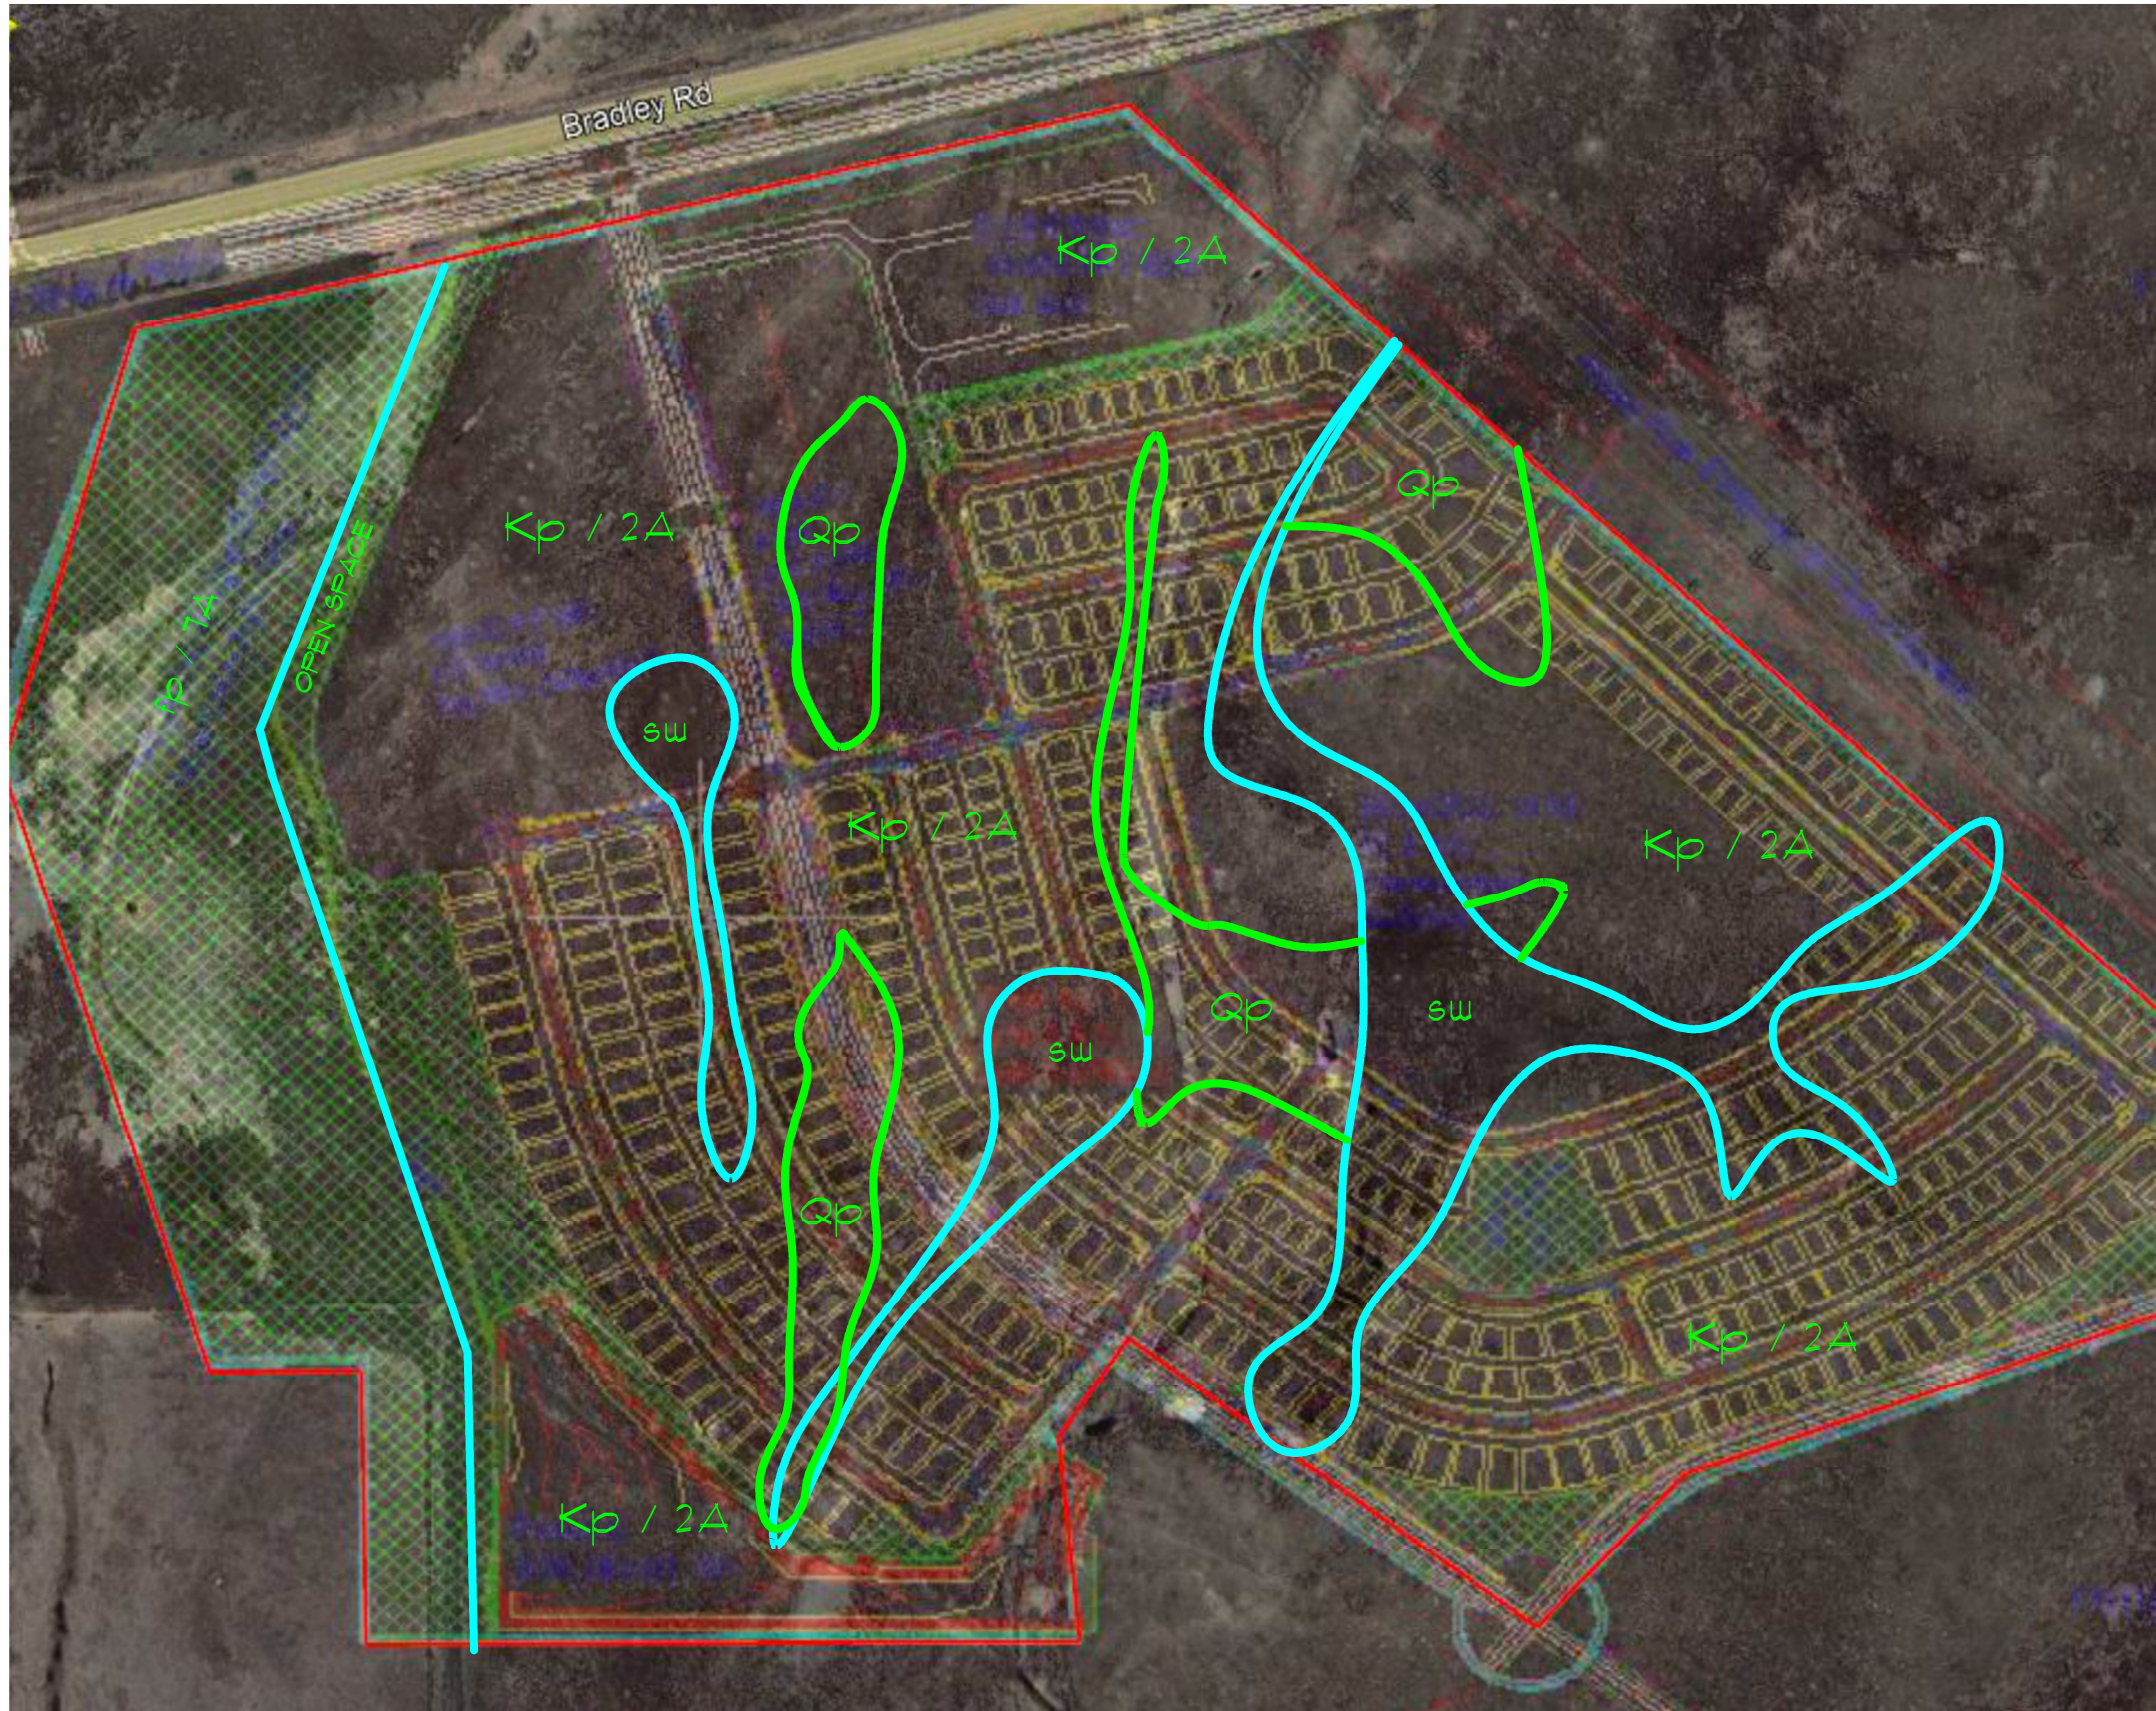
SHEET No.
FIG-11

General Geology

- *sw - seasonally wet areas* - low lying areas that may collect surface water during heavy precipitation events (rain or snowfall). These areas are likely to be regraded during the land development.
- *fp - floodplain*, as designated by FEMA -Improvements are proposed for JCC to contain the tributary to a designated channel. No construction is proposed within this area.
- *Qp - Piney Creek Alluvium* - Alluvial and pond or bog deposits. Mostly clayey sandy silt and silty sand; very clayey in pond and bog deposits, gravelly along main stream. Thickness is generally 5 to 15 feet, maximum of 50 feet possible.
- *Kp - Pierre Shale, Main part of formation* - Shale, minor siltstone and sandstone beds, and thin concretionary limestone beds. Poorly exposed in general. Total formation thickness is about 5,000 feet.
