Standard Operation Procedures
for
Inspection and Maintenance
of
Extended Detention Basin(s)

Kum & Go #2232 – Gas & C-Store

O&M Manual

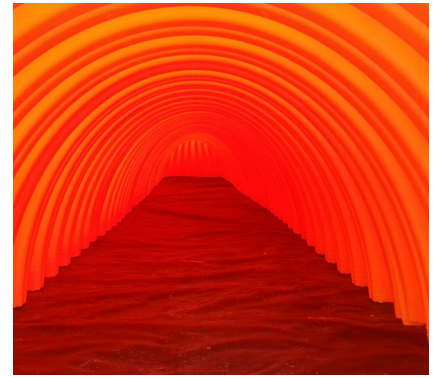
Looking down the Isolator Row PLUS from the manhole opening, ADS PLUS Fabric is shown between the chamber and stone base.

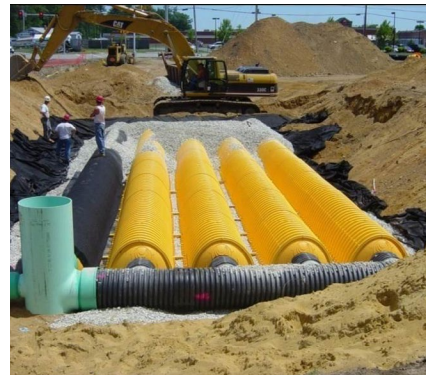
StormTech Isolator Row PLUS with Overflow Spillway (not to scale)

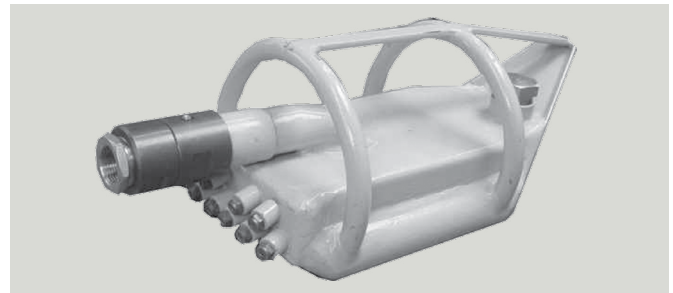
StormTech Isolator Row PLUS (not to scale)

Note: Non-woven fabric is only required over the inlet pipe connection into the end cap for SC-160LP, DC-780, MC-3500 and MC-7200 chamber models and is not required over the entire Isolator Row PLUS.

Maintenance is accomplished with the JetVac process. The JetVac process utilizes a high pressure water nozzle to propel itself down the Isolator Row Plus while scouring and suspending sediments. As the nozzle is retrieved, the captured pollutants are flushed back into the manhole for vacuuming. Most sewer and pipe maintenance companies have vacuum/JetVac combination vehicles. Selection of an appropriate JetVac nozzle will improve maintenance efficiency. Fixed nozzles designed for culverts or large diameter pipe cleaning are preferable. Rear facing jets with an effective spread of at least 45" are best. StormTech recommends a maximum nozzle pressure of 2000 psi be utilized during cleaning. JetVac reels can vary in length. For ease of maintenance, ADS recommends Isolator Row Plus lengths up to 200' (61 m). **The JetVac process shall only be performed on StormTech Isolator Row Plus that have ADS Plus Fabric (as specified by StormTech) over their angular base stone.**

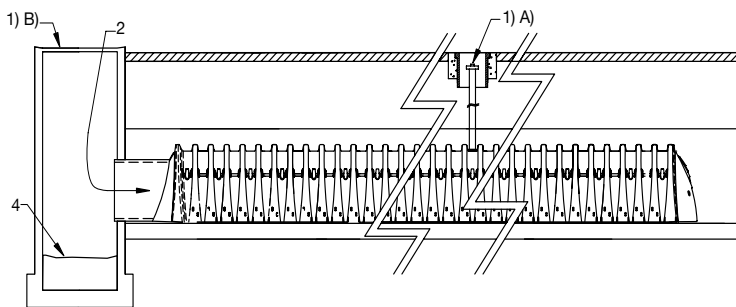
Sample Maintenance Log

Date	Stadia Rod Readings		Sedi-ment Depth (1)-(2)	Observations/Actions	Inspector
	Fixed point to chamber bottom (1)	Fixed point to top of sediment (2)			
3/15/11	6.3 ft	none		New installation. Fixed point is CI frame at grade	DJM
9/24/11		6.2	0.1 ft	Some grit felt	SM
6/20/13		5.8	0.5 ft	Mucky feel, debris visible in manhole and in Isolator Row PLUS, maintenance due	NV
7/7/13	6.3 ft		0	System jetted and vacuumed	DJM
