**SOILS AND GEOLOGY STUDY
SADDLEHORN RANCH – FILING NO. 4
CURTIS ROAD & JUDGE ORR ROAD
EL PASO COUNTY, COLORADO**

December 5, 2022
Revised October 3, 2023

PCD File No. SF236

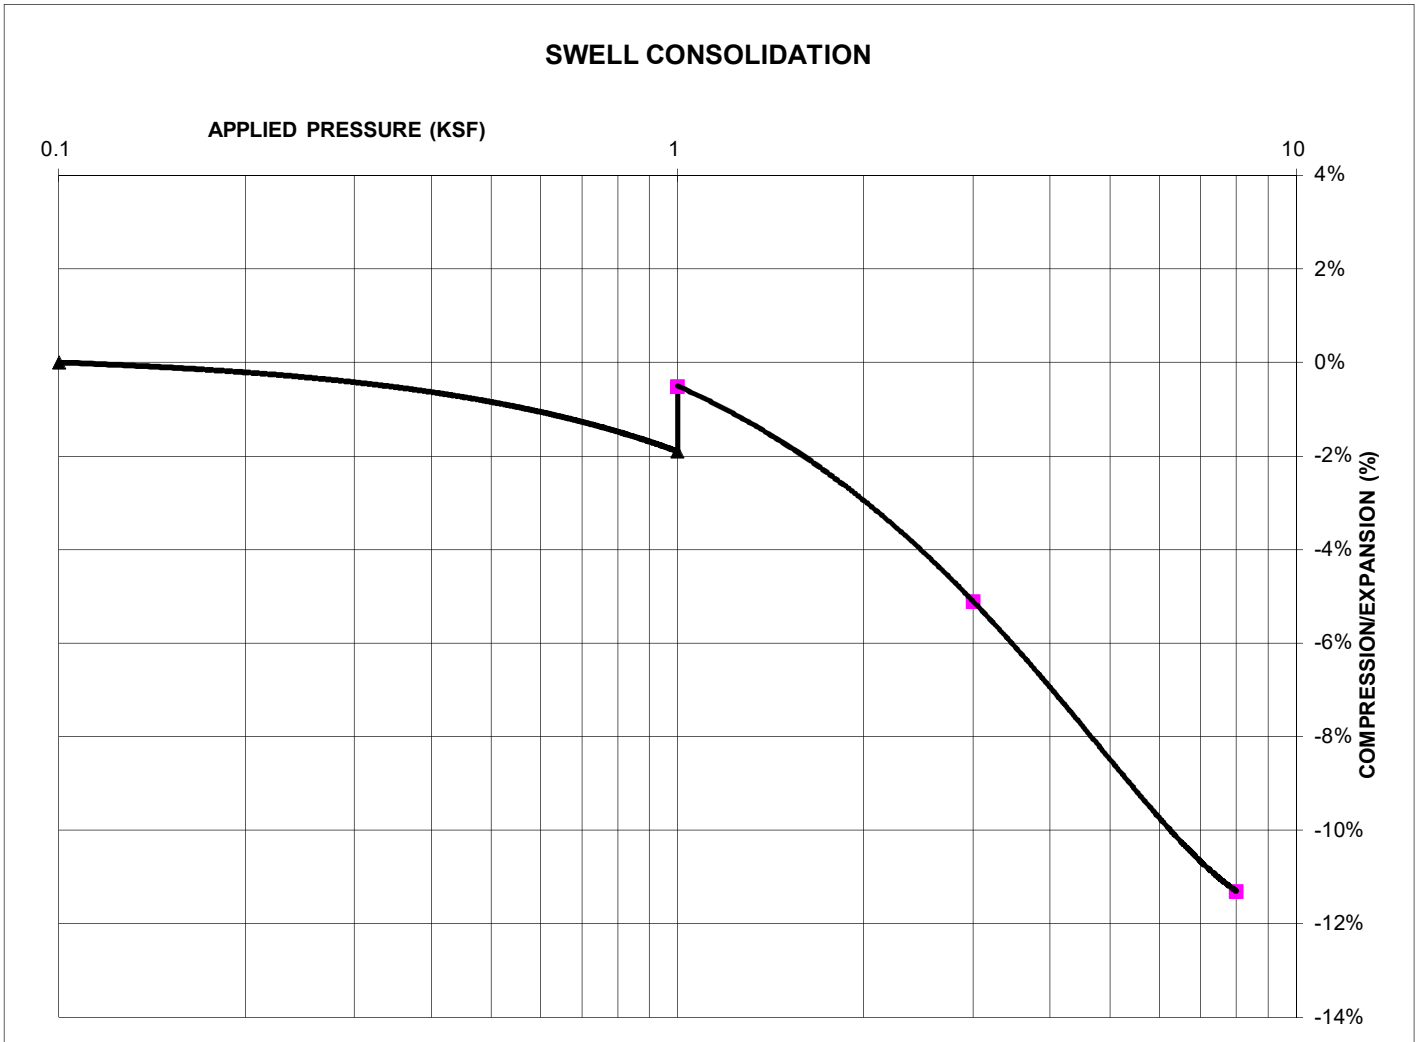
TEST BORING 4
DEPTH (FT) 20

SOIL DESCRIPTION SILTSTONE, (SILT, SANDY)
SOIL TYPE 4

SWELL/CONSOLIDATION TEST RESULTS

NATURAL UNIT DRY WEIGHT (PCF): 77
NATURAL MOISTURE CONTENT: 31.1%
SWELL/CONSOLIDATION (%): 1.4%
