**COMBINED PRELIMINARY AND FINAL DRAINAGE
REPORT**

**OHANA SUBDIVISION
EL PASO COUNTY, COLORADO**

October 28, 2021

**Allison Engineering
4245 Log Road
Peyton, CO 80831**

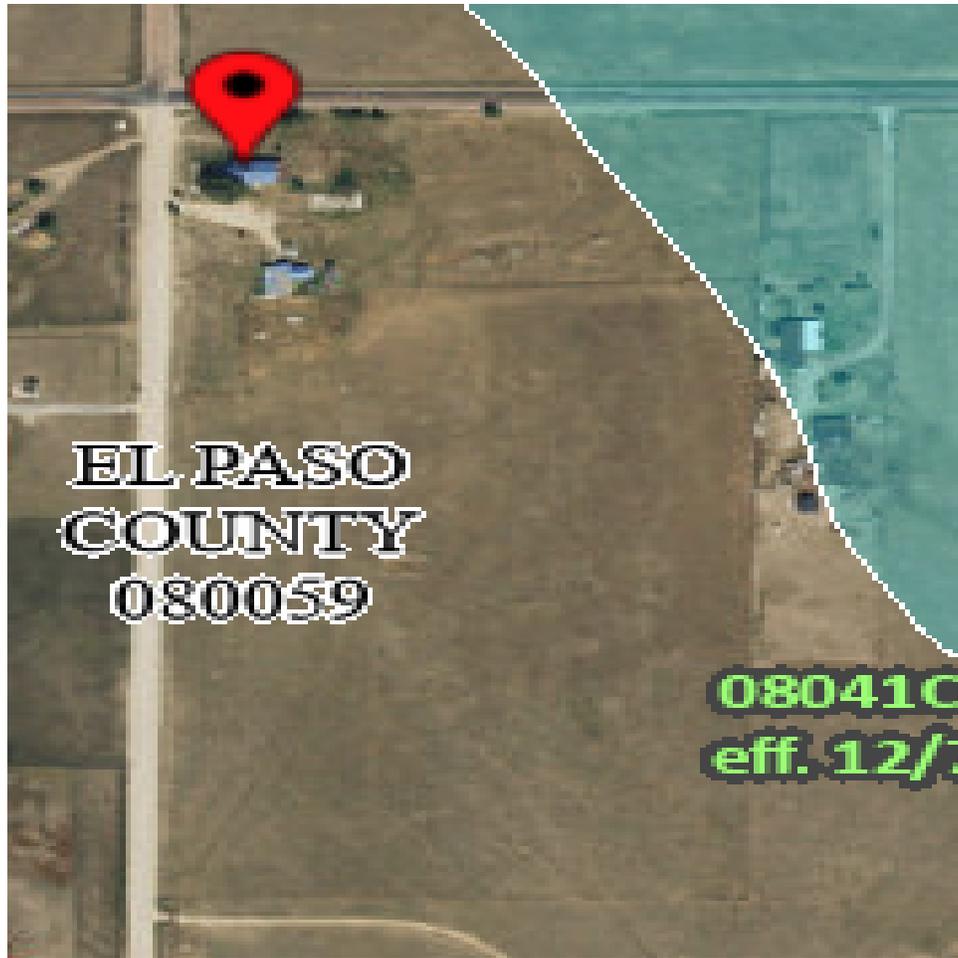
Figure 1: Zoomed view of FIRM including proposed subdivision.

According to the Federal Emergency Management Agency (FEMA) Flood Insurance Rate Map (FIRM) Panel No. 08041C0590 G with an effective date of December 7, 2018; encompassing the entirety of the proposed subdivision, Zone A clips the northwest corner of proposed Lot 1. This is shown in Figure 1, which is a focus on that part of the FIRM encompassing the proposed subdivision. The spatial extent of this zone is a triangular area with dimensions of 170-feet along the north boundary and 256-feet along the east boundary. The total area of zone A in proposed Lot 1 is 21,760 square feet or slightly less than 1/2-acre. No revisions are recorded for his FIRM.

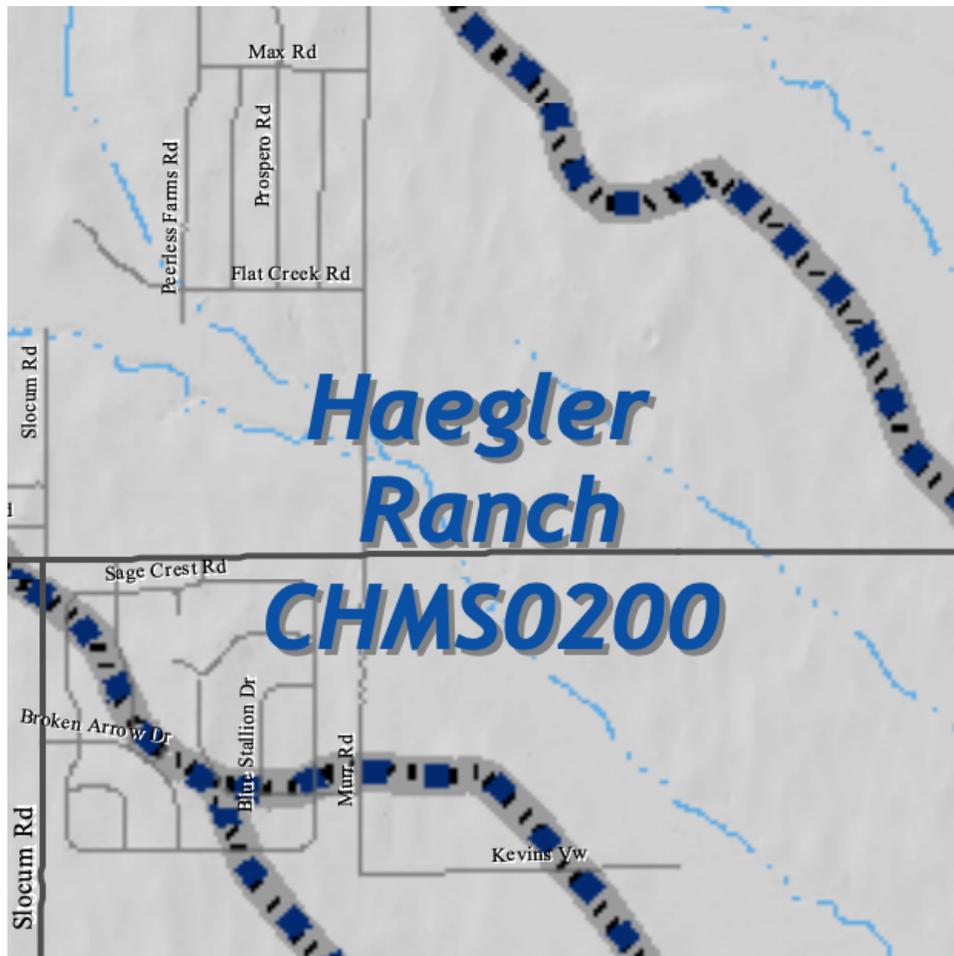
Figure 2: Context map of Haegler Basin including proposed subdivision.

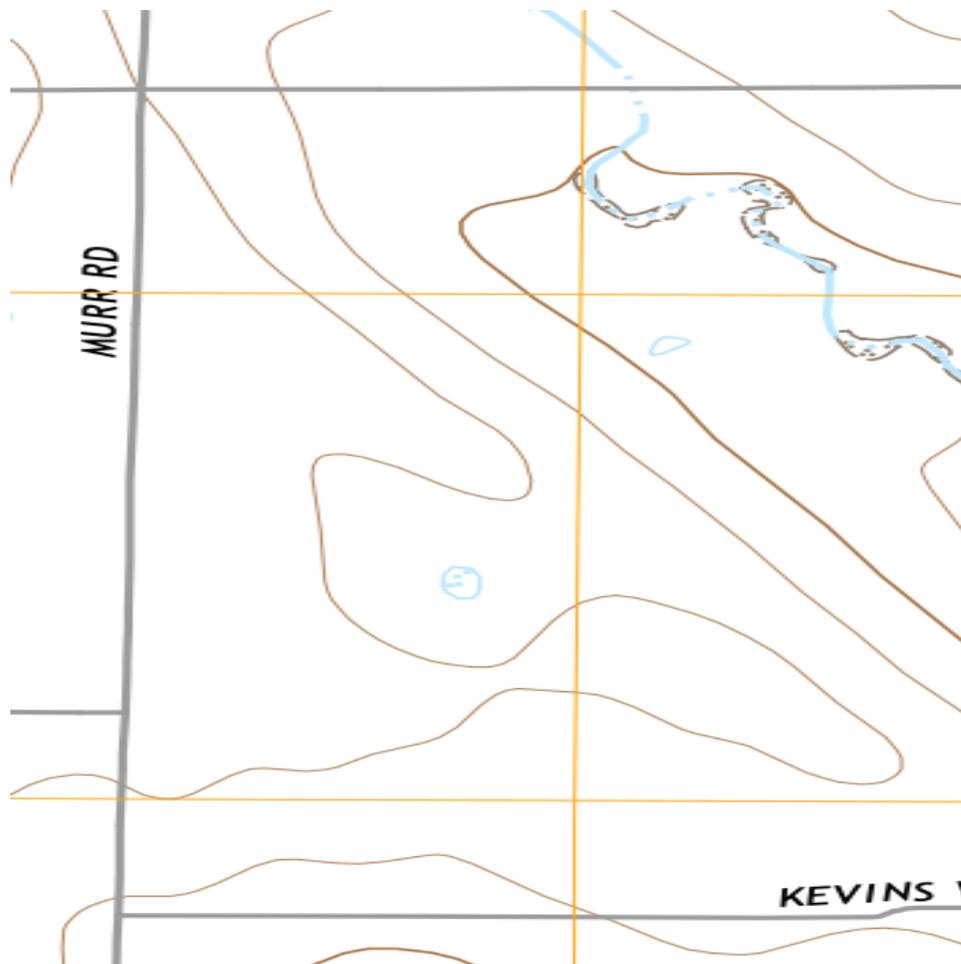
Figure 3: Context map from USGS Quad map.

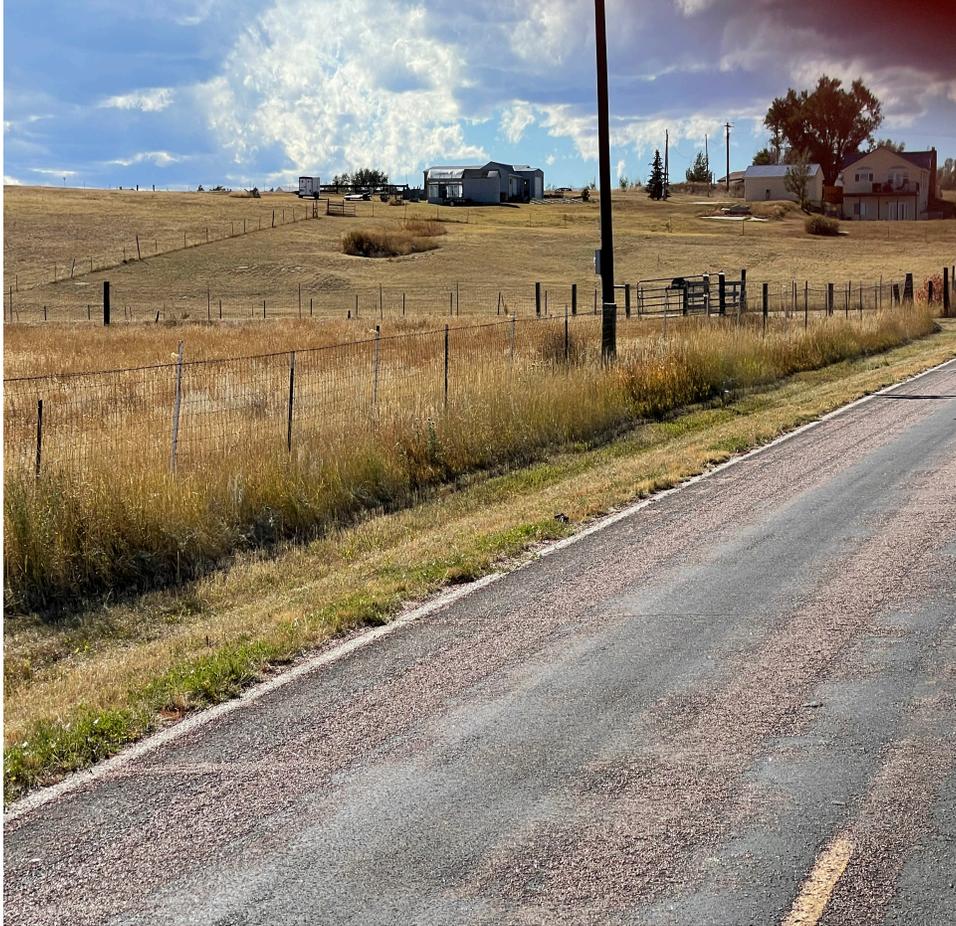
Figure 4: View from east of proposed subdivision showing no erosion scars.

Existing site native grade slopes downward to the east towards the Haegler Ranch drainage way. The grade in its descent does not exceed 10% and is unbroken by erosion, cliffs, escarpments or any other feature which would indicate recent erosion or lack of conservation care as shown in Figure 4.
