**PRELIMINARY GEOTECHNICAL INVESTIGATION
AND GEOLOGIC HAZARDS EVALUATION
LATIGO TRAILS FILINGS 9 AND 10, 78 LOTS
SOUTHWEST OF EASTONVILLE ROAD
AND LATIGO BOULEVARD
EL PASO COUNTY, COLORADO**

Project No. CS19409-115

August 3, 2021
Revised March 31, 2022
Revised June 16, 2022
Revised August 19, 2022
Final October 6, 2022

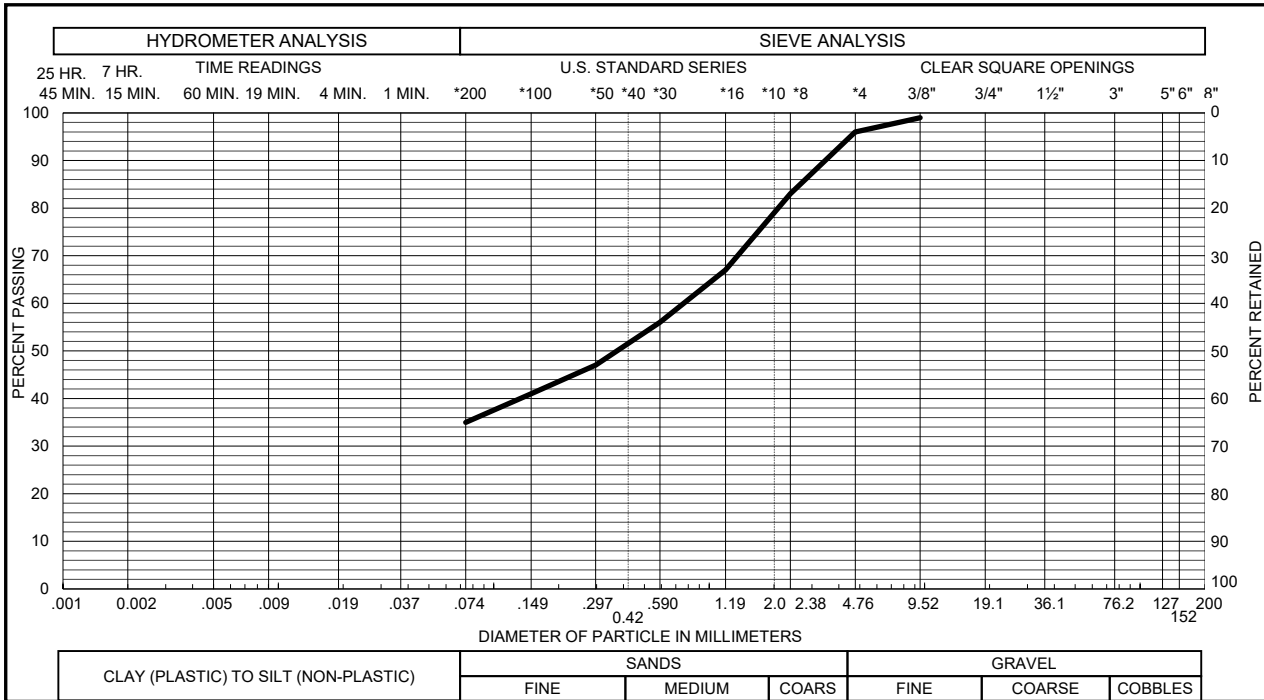
Sample of SANDSTONE, SILTY GRAVEL 4 % SAND 61 %
 From TH - 2 AT 9 FEET SILT & CLAY 35 % LIQUID LIMIT %
 PLASTICITY INDEX %
