**PRELIMINARY GEOTECHNICAL INVESTIGATION  
AND GEOLOGIC HAZARDS EVALUATION  
LATIGO TRAILS FILINGS 9 AND 10, 78 LOTS  
SOUTHWEST OF EASTONVILLE ROAD  
AND LATIGO BOULEVARD  
EL PASO COUNTY, COLORADO**

Project No. CS19409-115

August 3, 2021  
Revised March 31, 2022

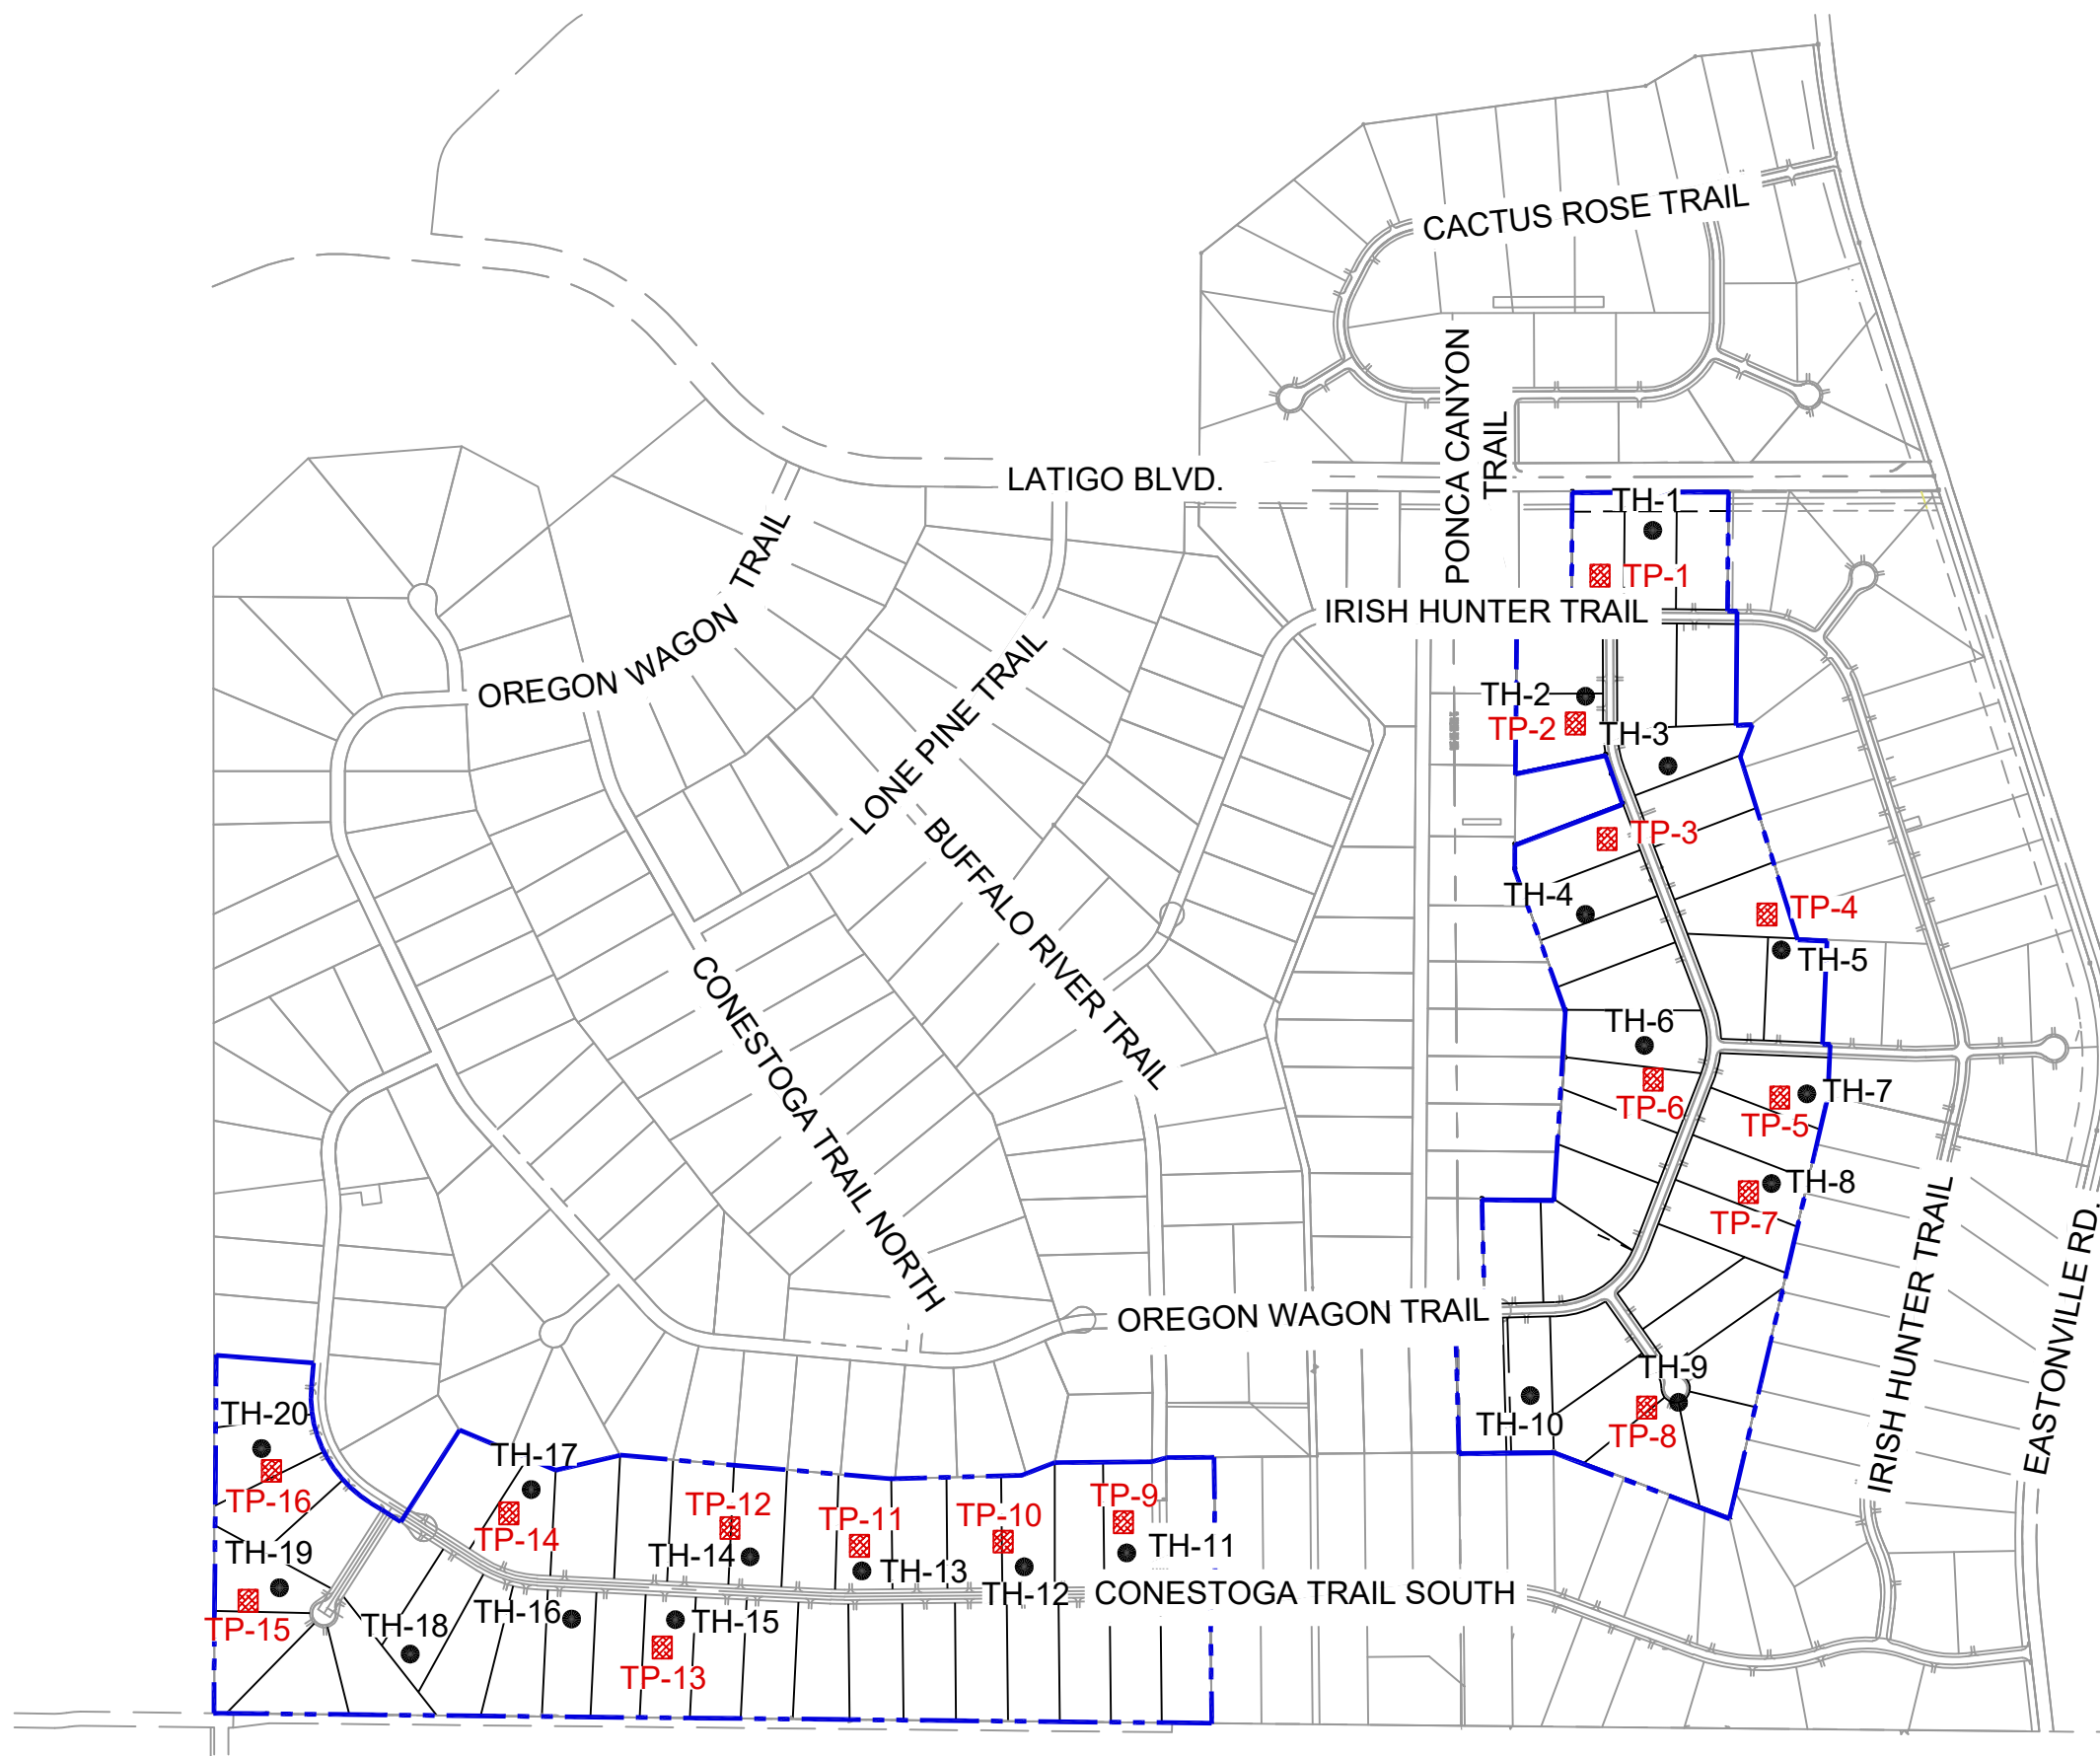
**LOCATION OF EXPLORATORY BORINGS AND SOIL PROFILE TEST PITS**

- LEGEND:**
- TH-1 APPROXIMATE LOCATION OF EXPLORATORY BORING.
  - TP-1 APPROXIMATE LOCATION OF SOIL PROFILE TEST PIT.
  - - - PROJECT BOUNDARY

FIG. 1 – LOCATIONS OF EXPLORATORY BORINGS

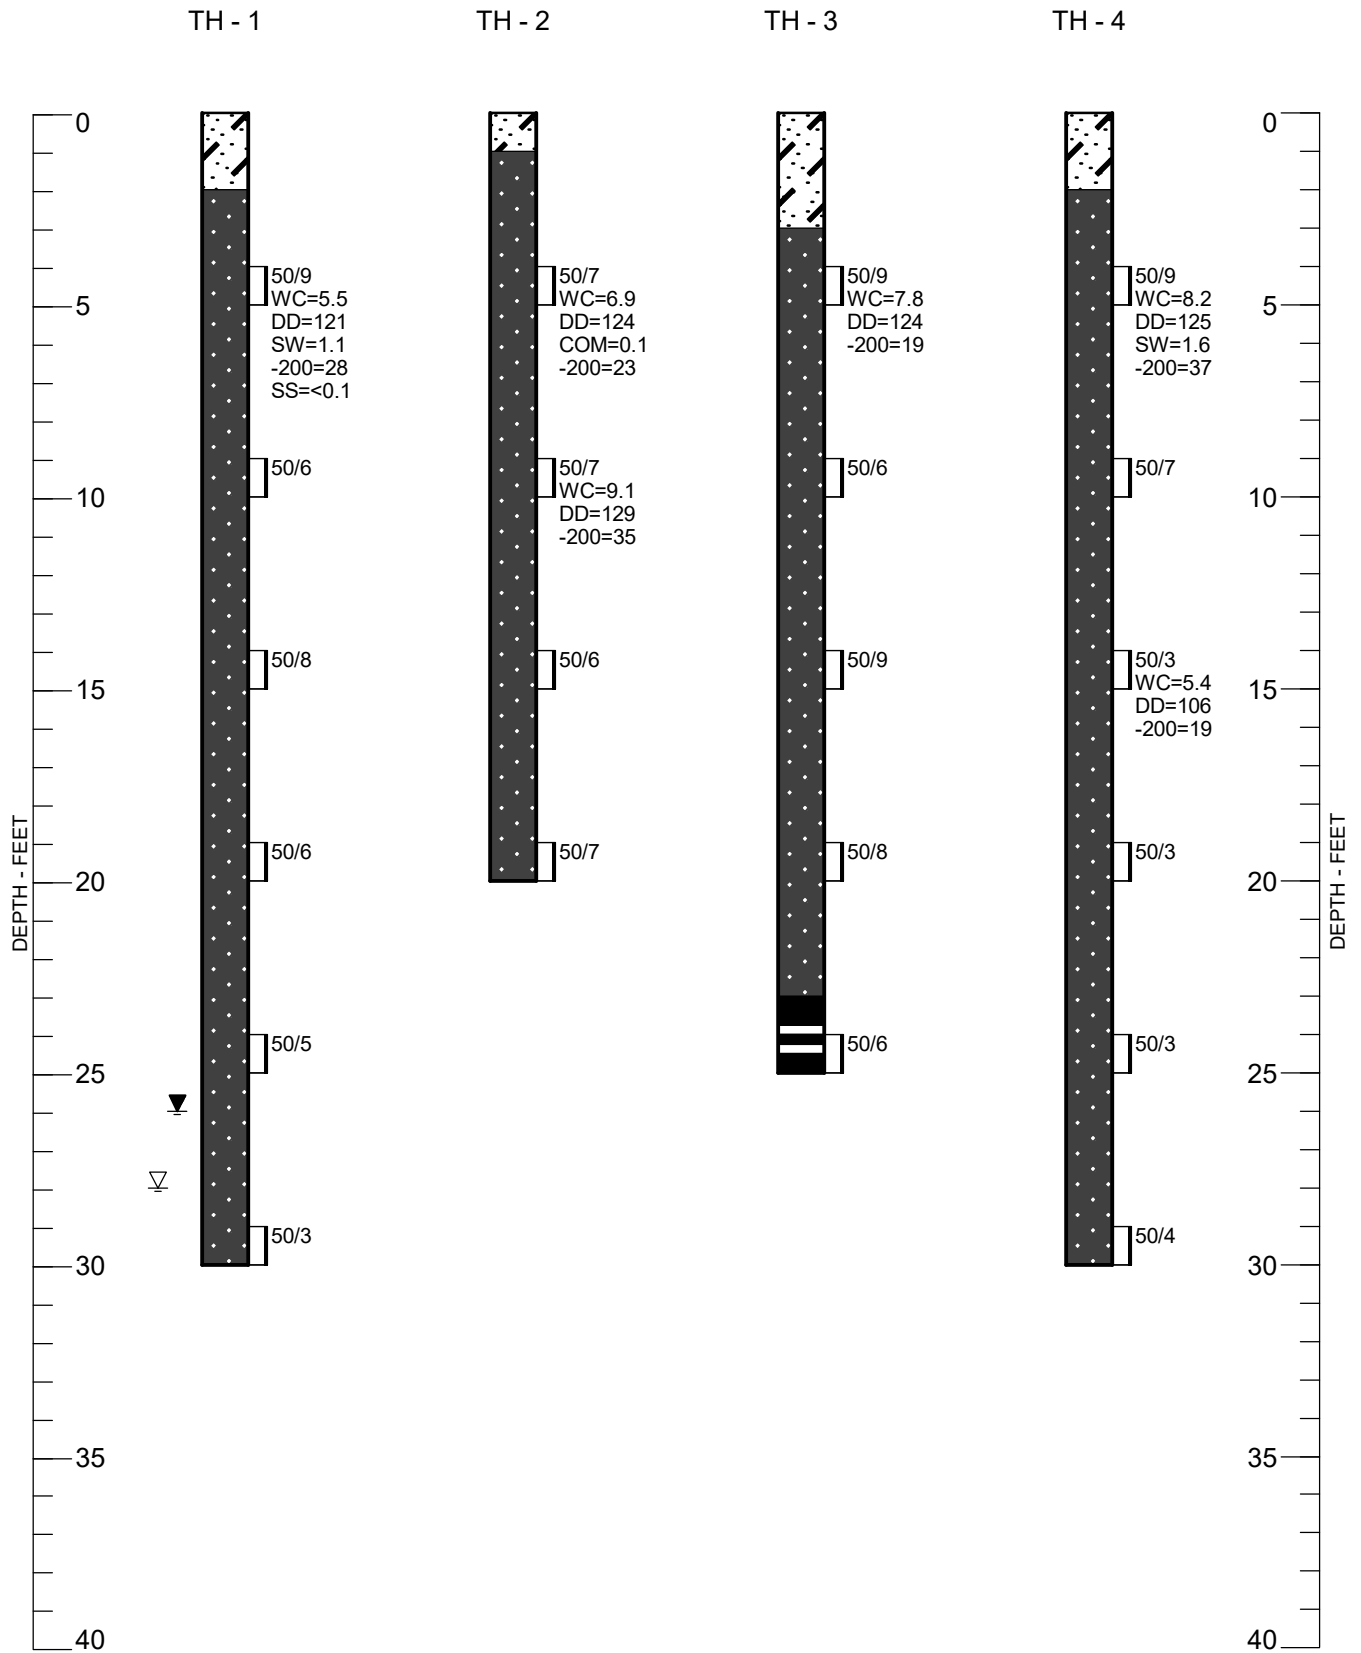
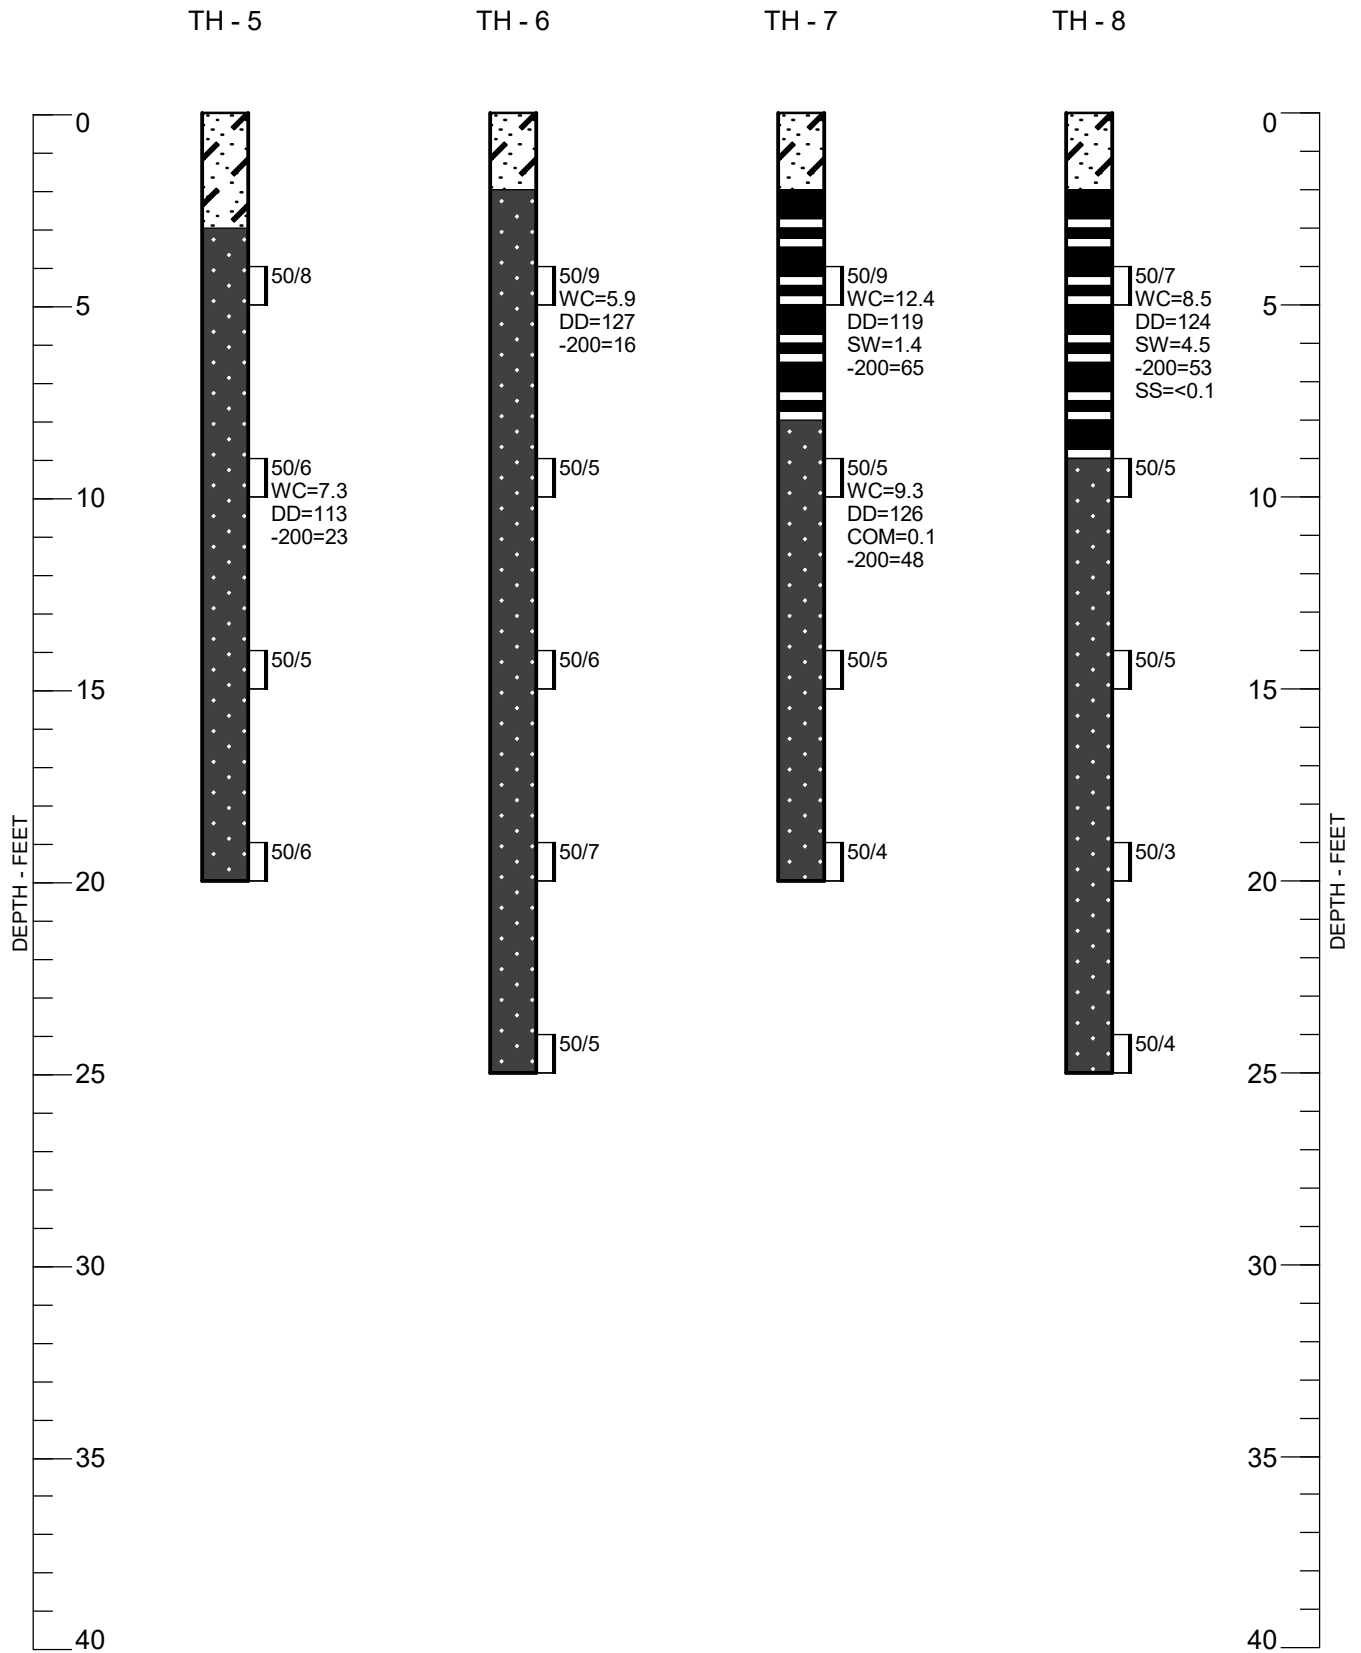
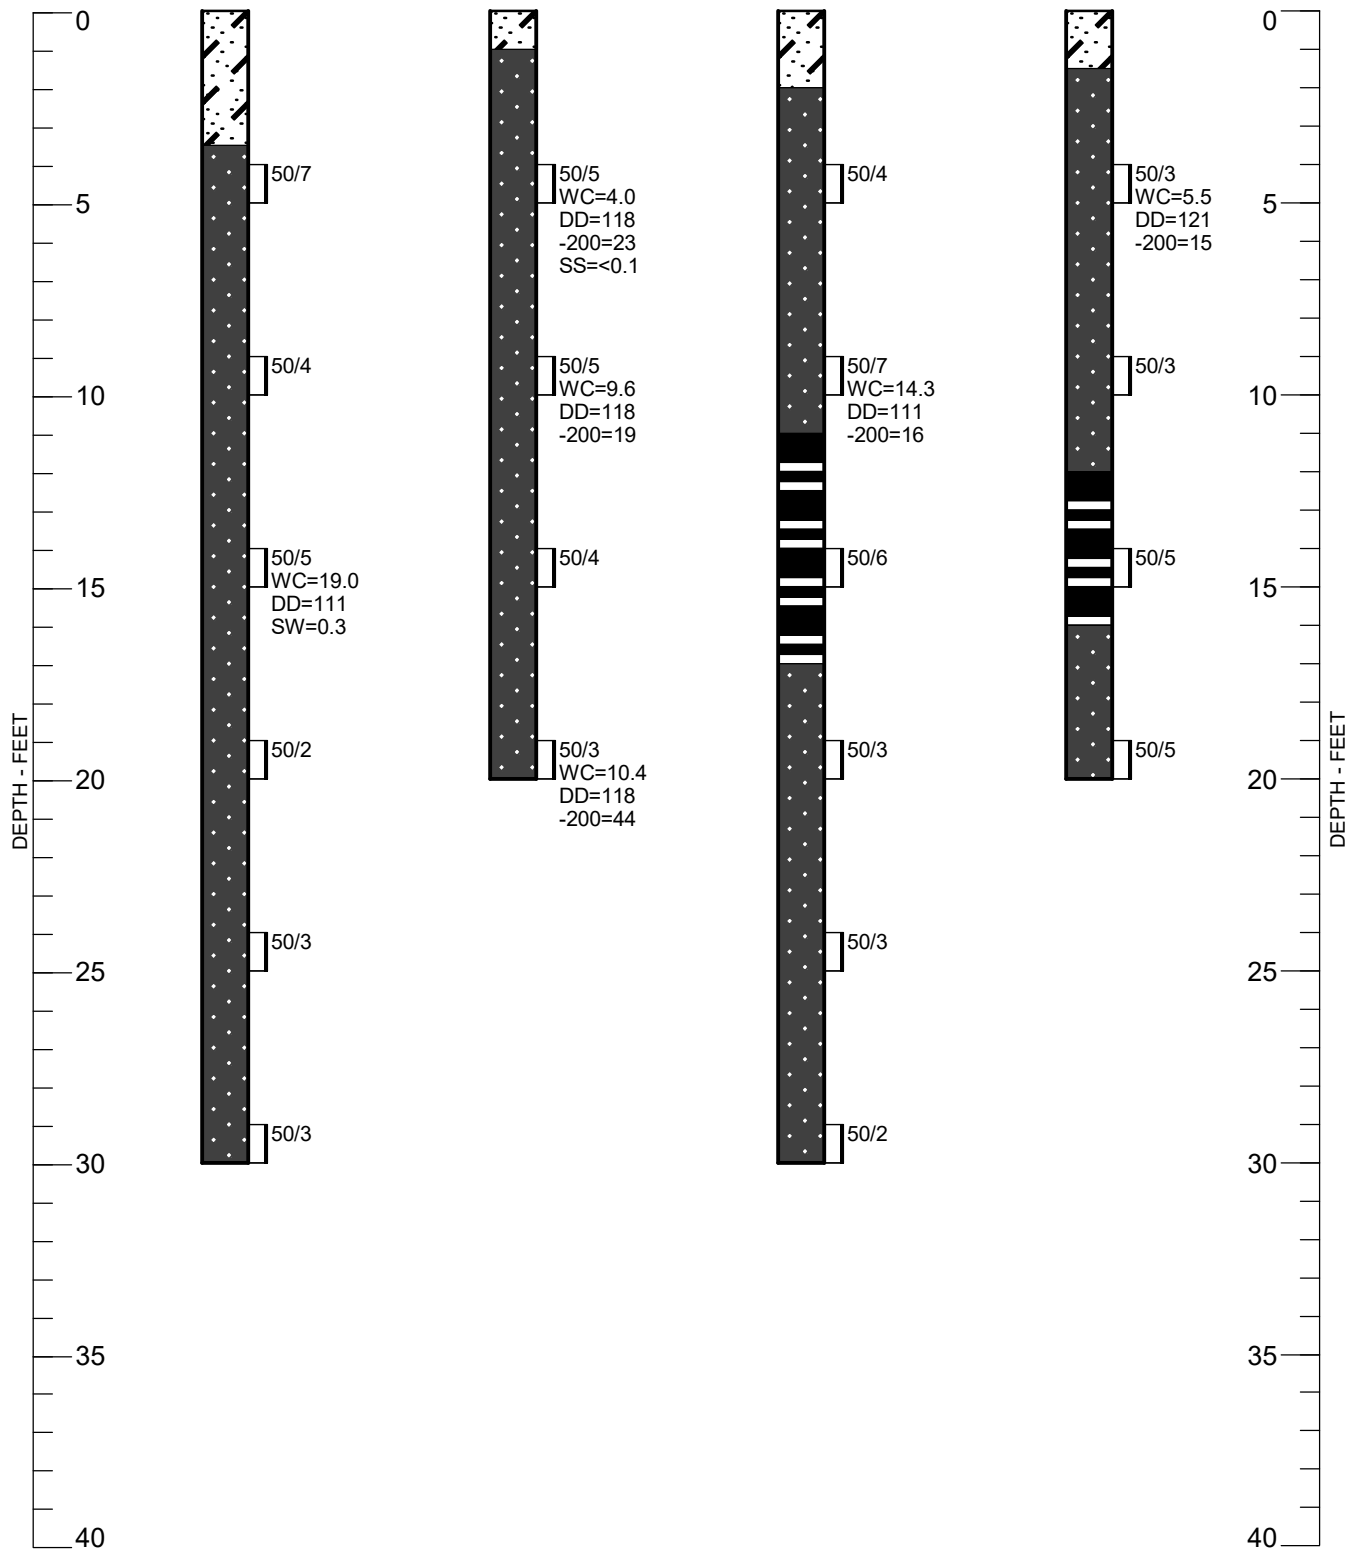
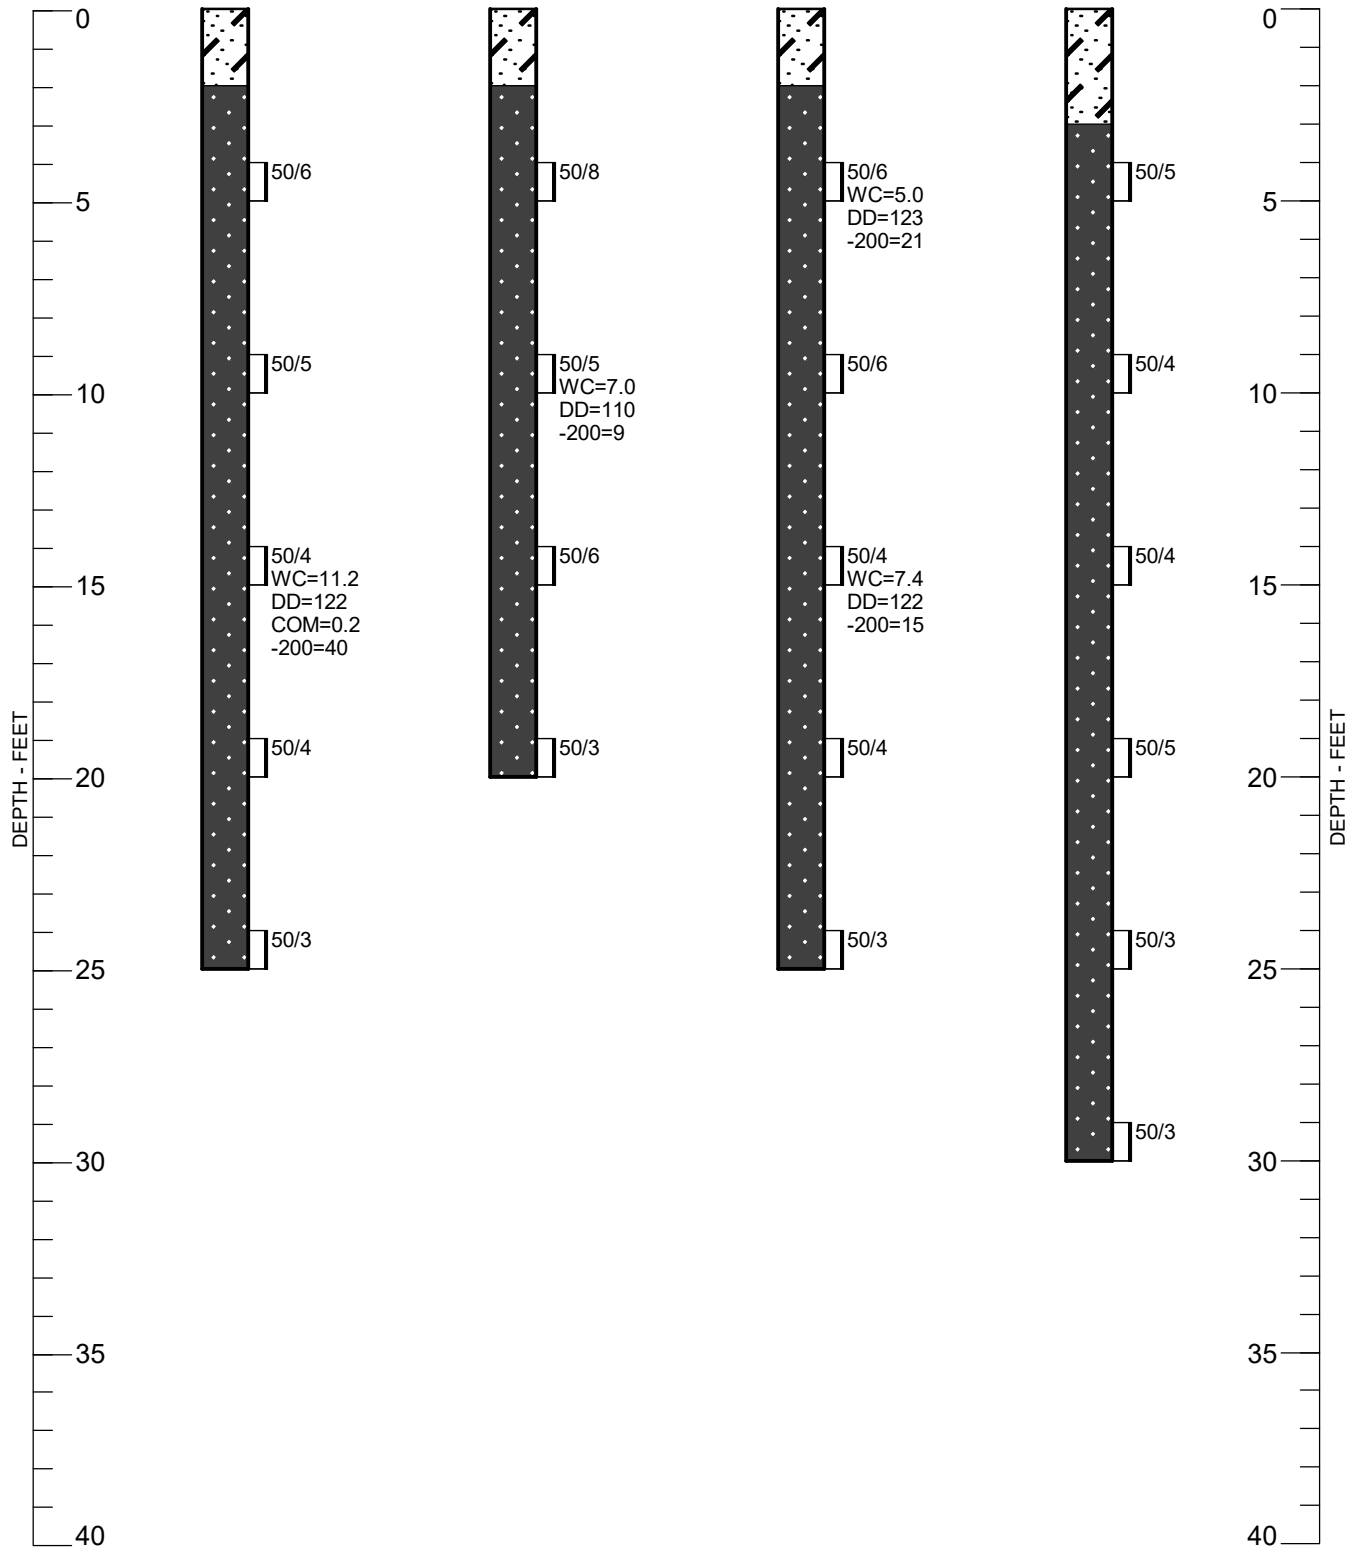
### **SUMMARY LOGS OF EXPLORATORY BORINGS**

- CLAY, SAND, SLIGHTLY MOIST TO MOIST, LIGHT BROWN TO BROWN (SC).
- SANDSTONE, SLIGHTLY SILTY TO VERY SILTY, CLAYEY TO VERY CLAYEY, HARD TO VERY HARD, DRY TO MOIST VARIOUS SHADES OF BROWN AND GRAY.
- CLAYSTONE, SANDY TO VERY SANDY, VERY HARD, SLIGHTLY MOIST TO MOIST, GRAY TO BROWN.

APPENDIX A – SUMMARY LOGS OF EXPLORATORY BORINGS

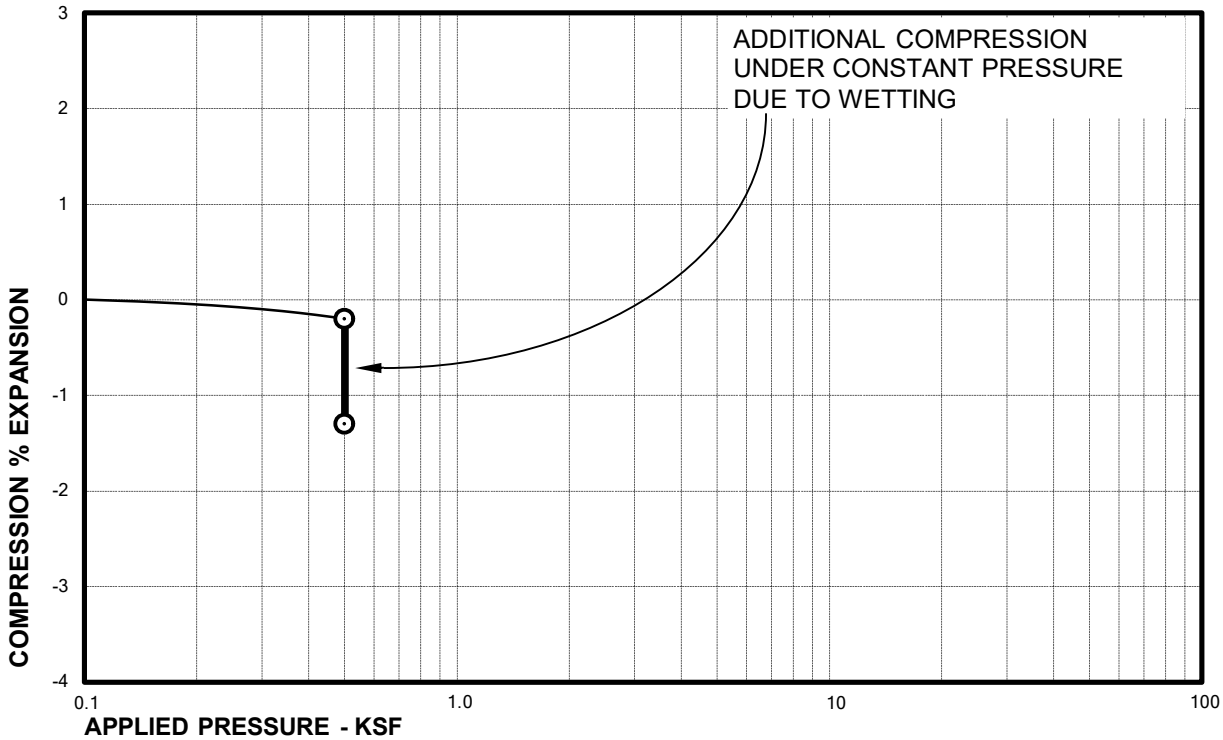
Sample of SANDSTONE, CLAYEY  
From TH-1 AT 4 FEET

DRY UNIT WEIGHT= 121 PCF  
MOISTURE CONTENT= 5.5 %

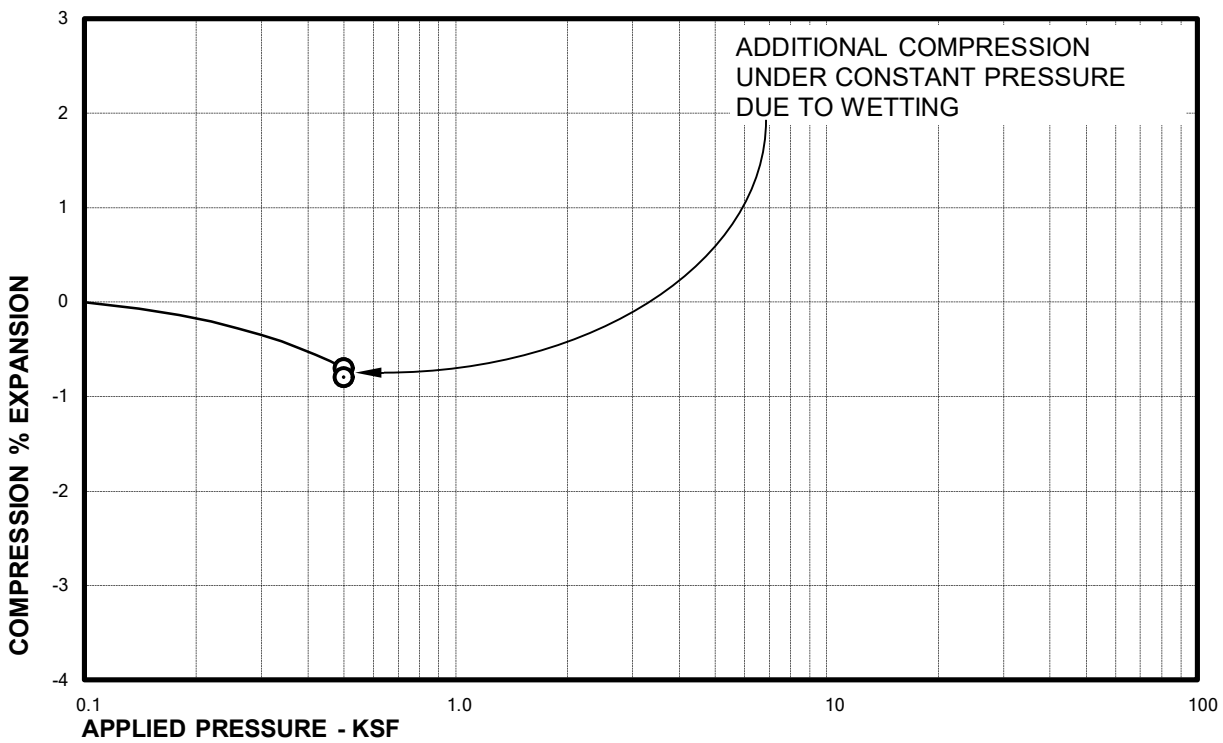
Sample of SANDSTONE, SILTY  
From TH-2 AT 4 FEET

DRY UNIT WEIGHT= 124 PCF  
MOISTURE CONTENT= 6.9 %

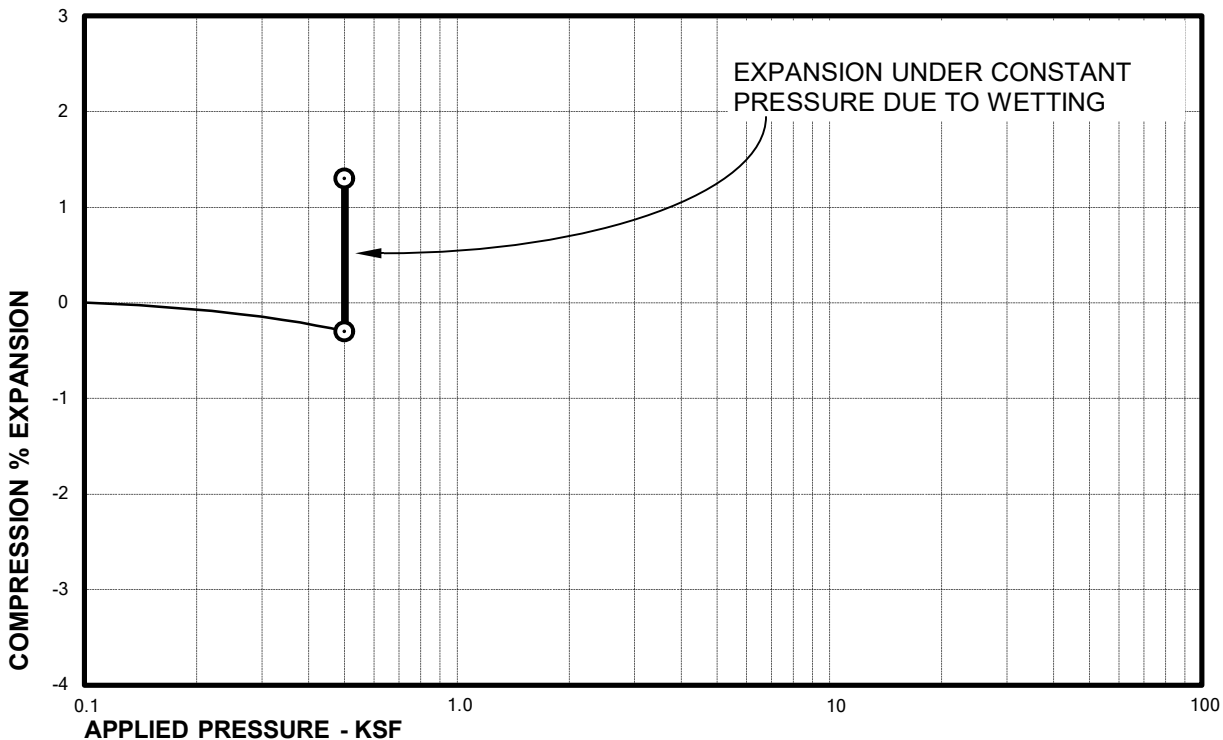
Sample of SANDSTONE, VERY CLAYEY  
From TH-4 AT 4 FEET

DRY UNIT WEIGHT= 125 PCF  
MOISTURE CONTENT= 8.2 %

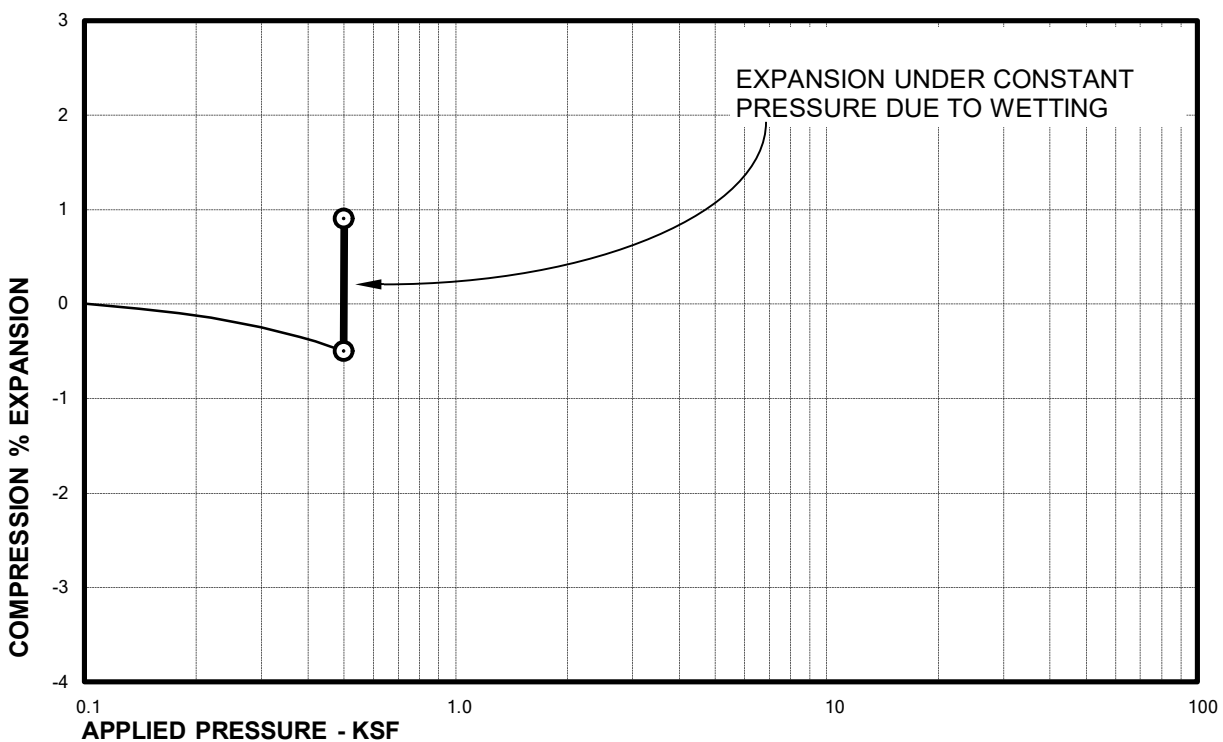
Sample of CLAYSTONE, SANDY  
From TH-7 AT 4 FEET

DRY UNIT WEIGHT= 119 PCF  
MOISTURE CONTENT= 12.4 %

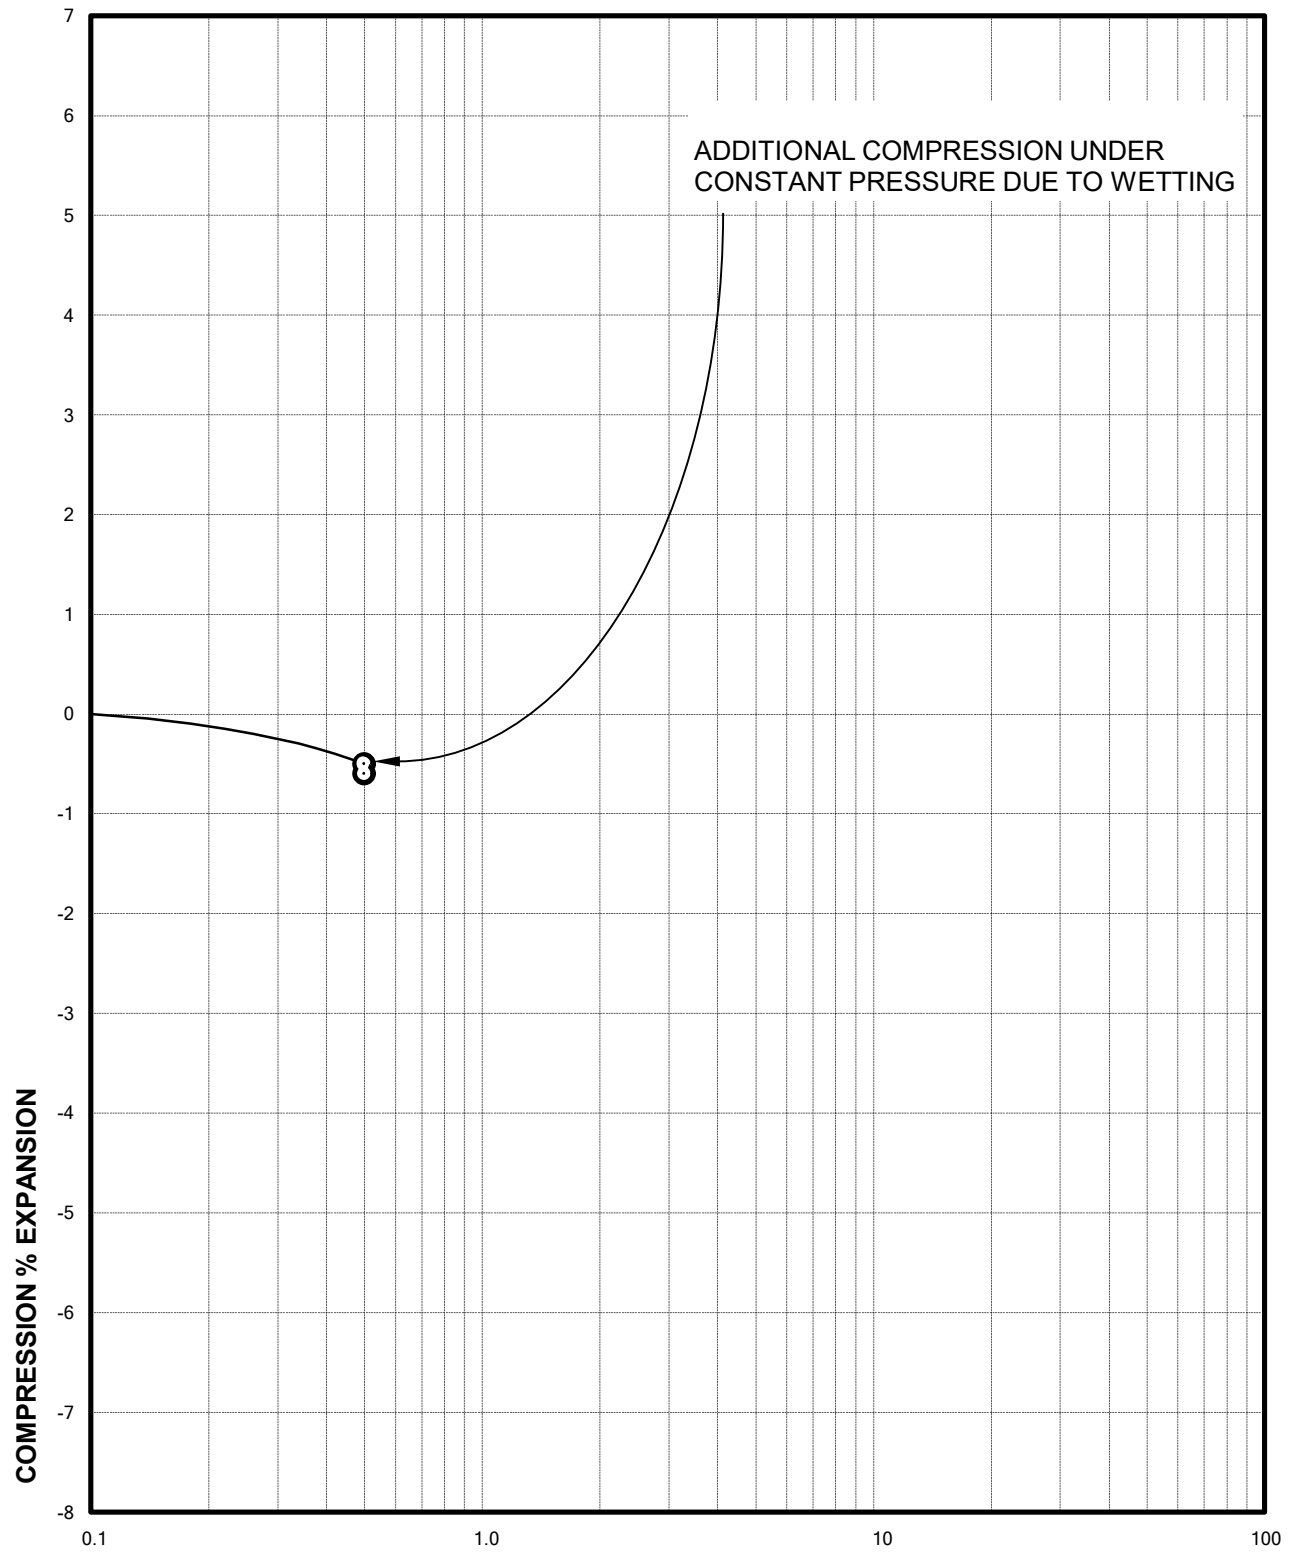
### Swell Consolidation Test Results

**APPLIED PRESSURE - KSF**  
Sample of SANDSTONE, VERY CLAYEY  
From TH-7 AT 9 FEET

DRY UNIT WEIGHT= 126 PCF  
MOISTURE CONTENT= 9.3 %

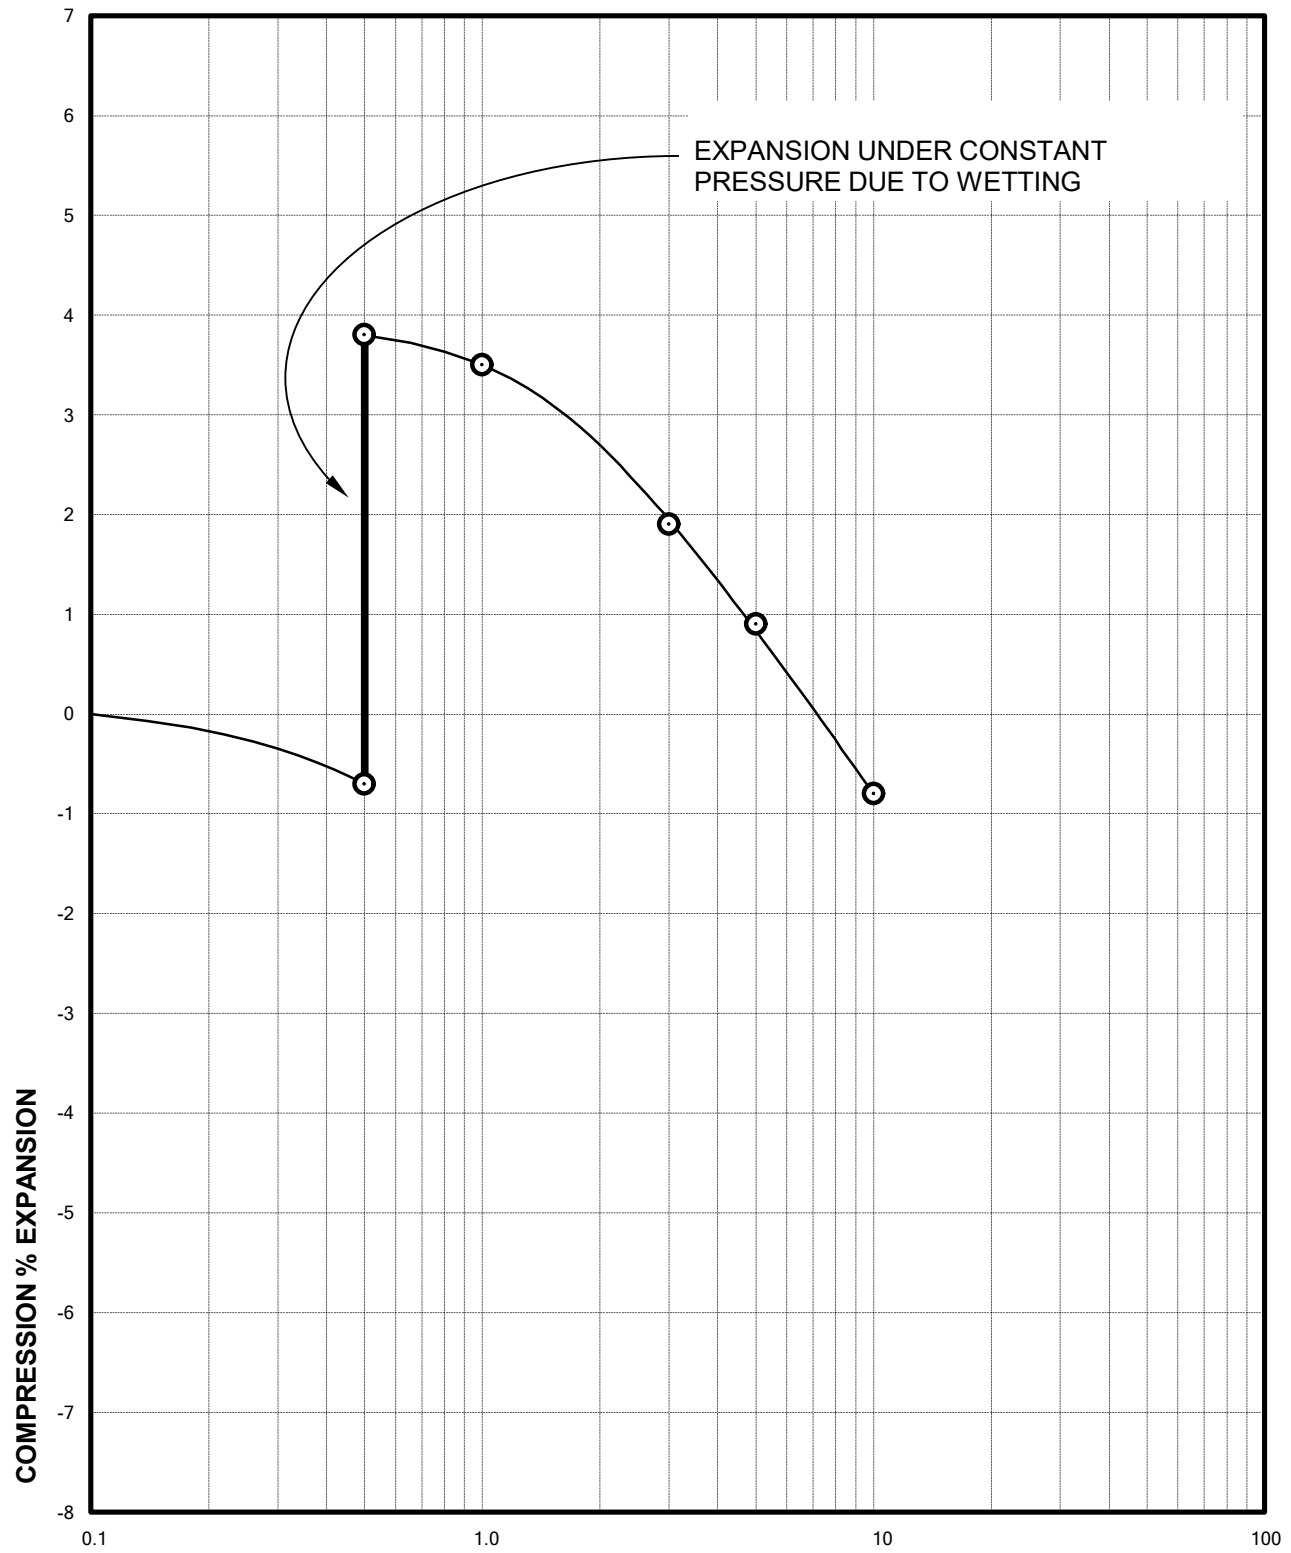
**APPLIED PRESSURE - KSF**  
Sample of CLAYSTONE, VERY SANDY  
From TH-8 AT 4 FEET

DRY UNIT WEIGHT= 124 PCF  
MOISTURE CONTENT= 8.5 %

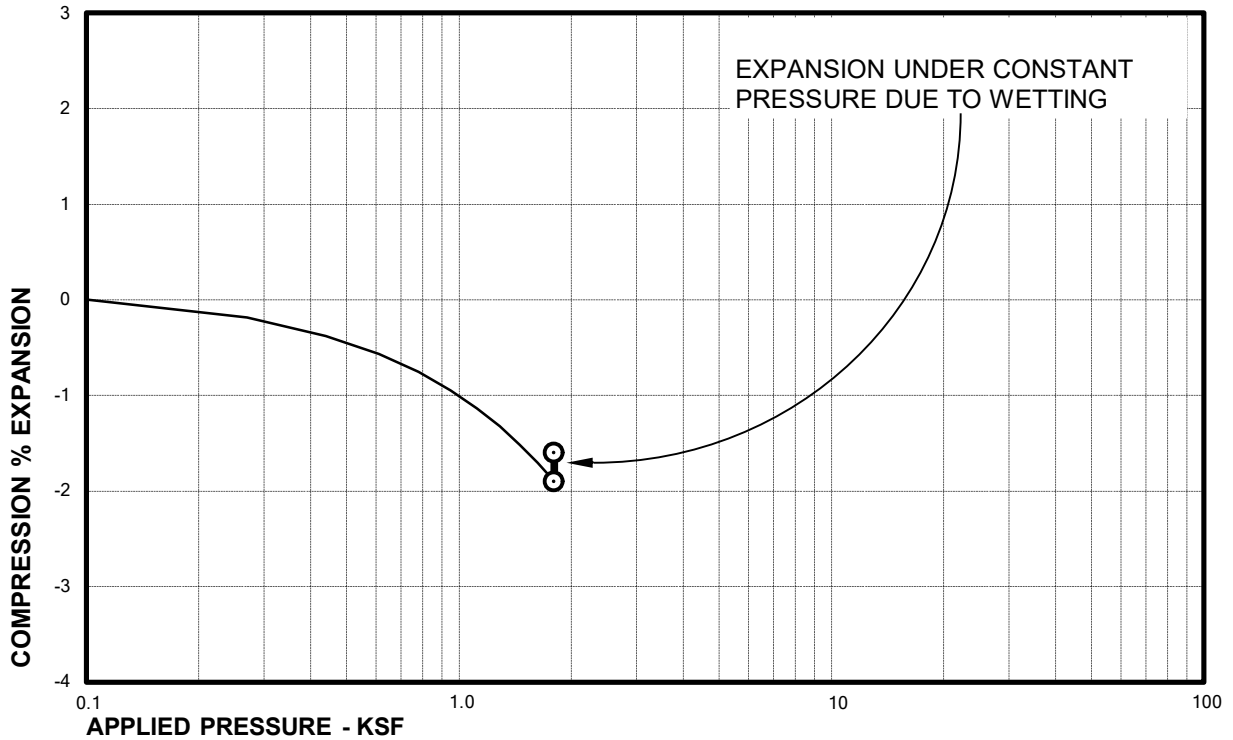
Sample of SANDSTONE, VERY CLAYEY  
From TH-9 AT 14 FEET

DRY UNIT WEIGHT= 111 PCF  
MOISTURE CONTENT= 19.0 %

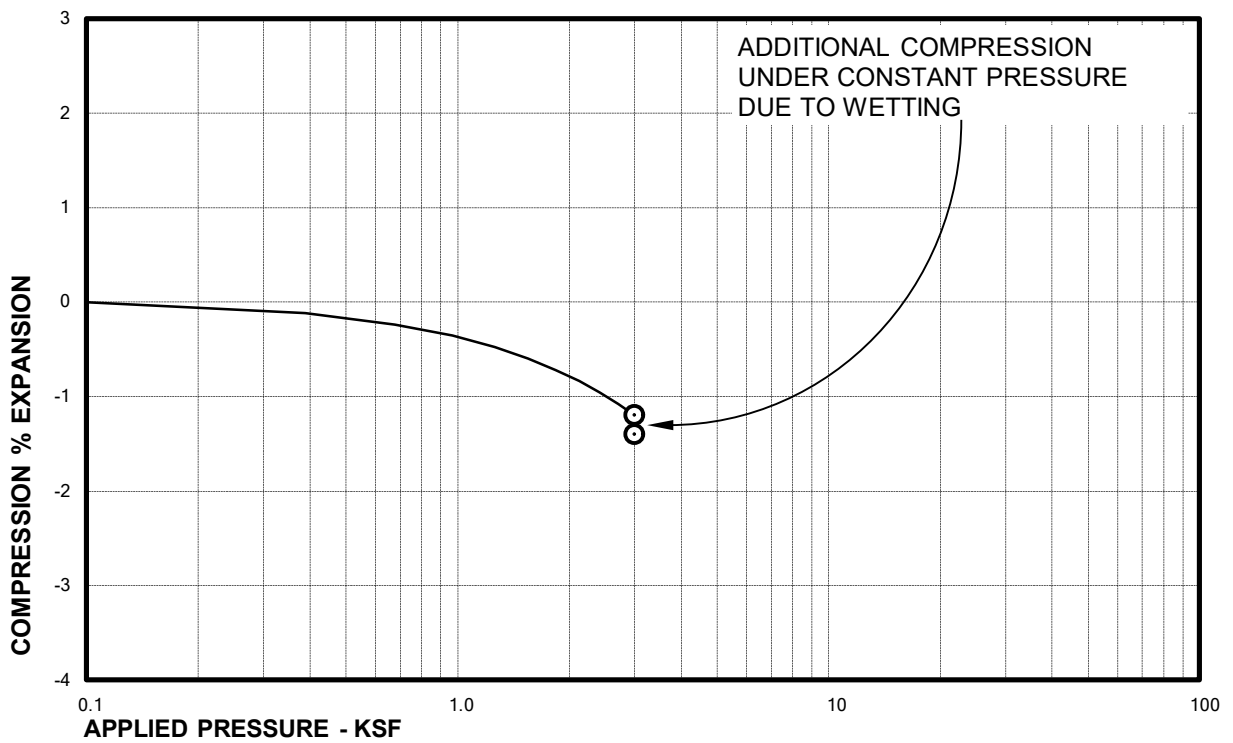
Sample of SANDSTONE, CLAYEY  
From TH-11 AT 24 FEET

DRY UNIT WEIGHT= 111 PCF  
MOISTURE CONTENT= 14.3 %

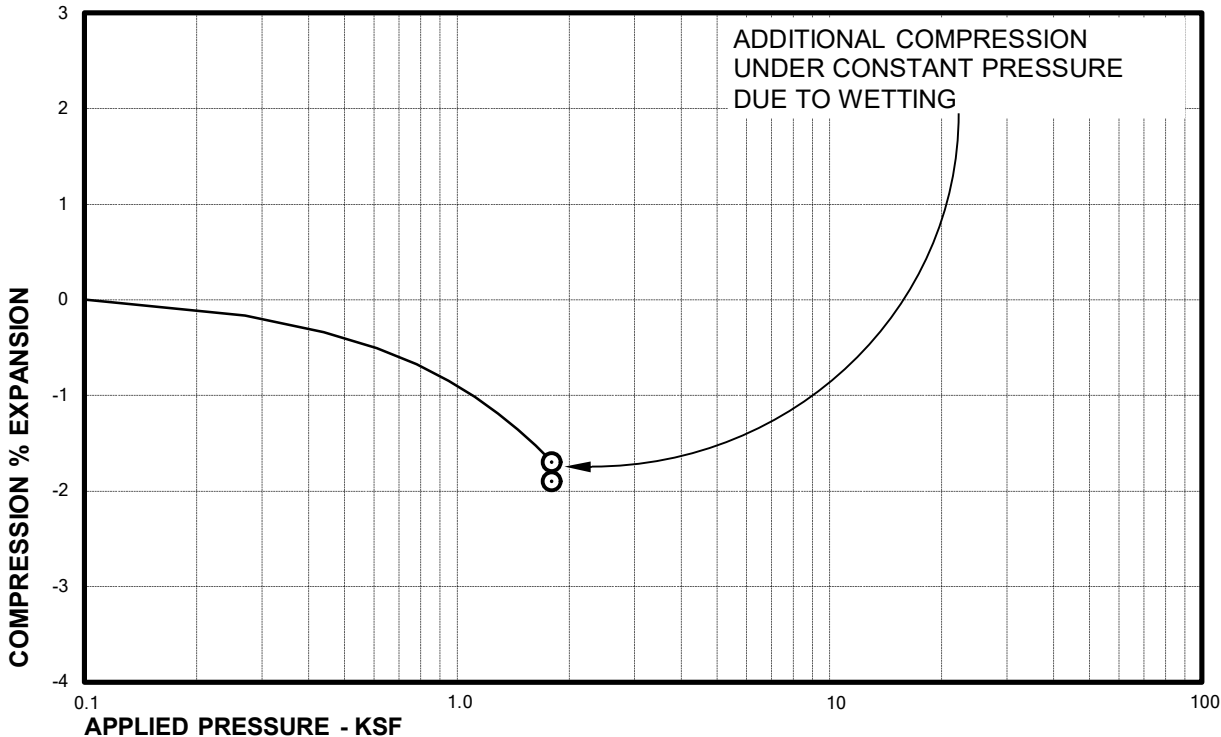
Sample of SANDSTONE, VERY SILTY  
From TH-13 AT 14 FEET

DRY UNIT WEIGHT= 122 PCF  
MOISTURE CONTENT= 11.2 %
