**PRELIMINARY GEOTECHNICAL INVESTIGATION  
AND GEOLOGIC HAZARDS EVALUATION  
LATIGO TRAILS FILINGS 9 AND 10, 78 LOTS  
SOUTHWEST OF EASTONVILLE ROAD  
AND LATIGO BOULEVARD  
EL PASO COUNTY, COLORADO**

Project No. CS19409-115

August 3, 2021  
Revised March 31, 2022

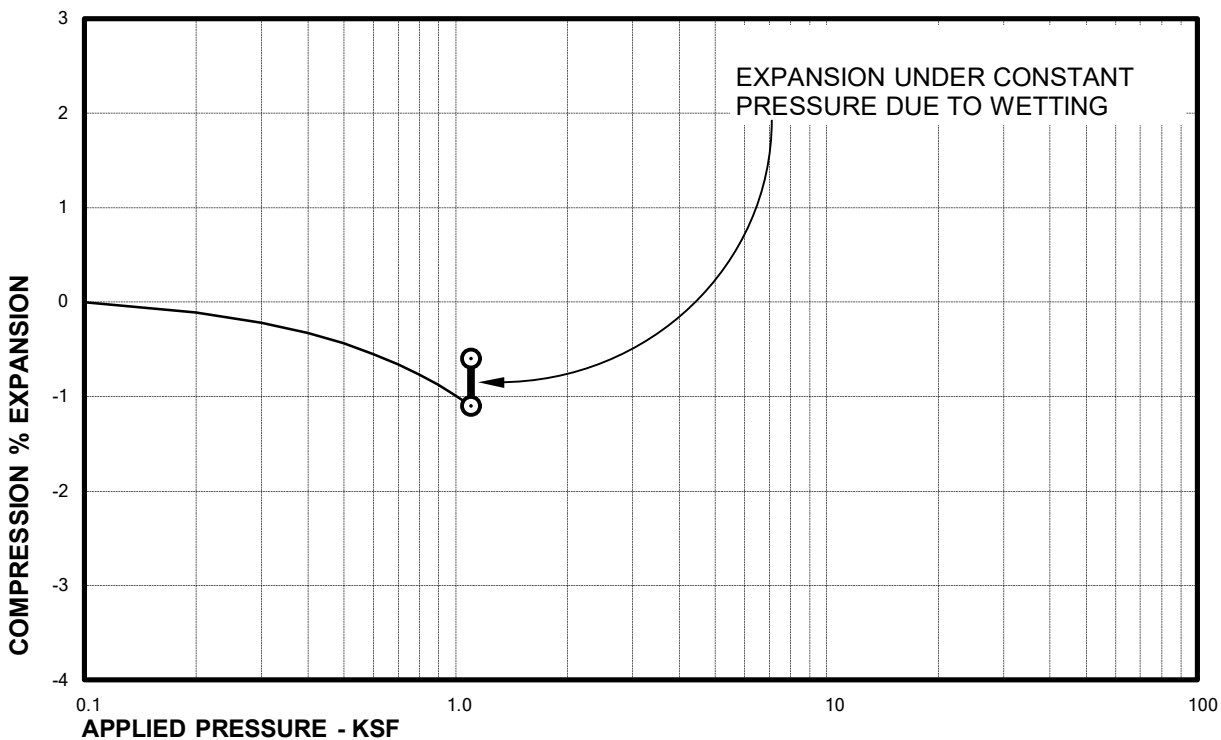
Sample of CLAYSTONE, VERY SANDY  
From TH-17 AT 9 FEET

DRY UNIT WEIGHT= 124 PCF  
MOISTURE CONTENT= 10.1 %

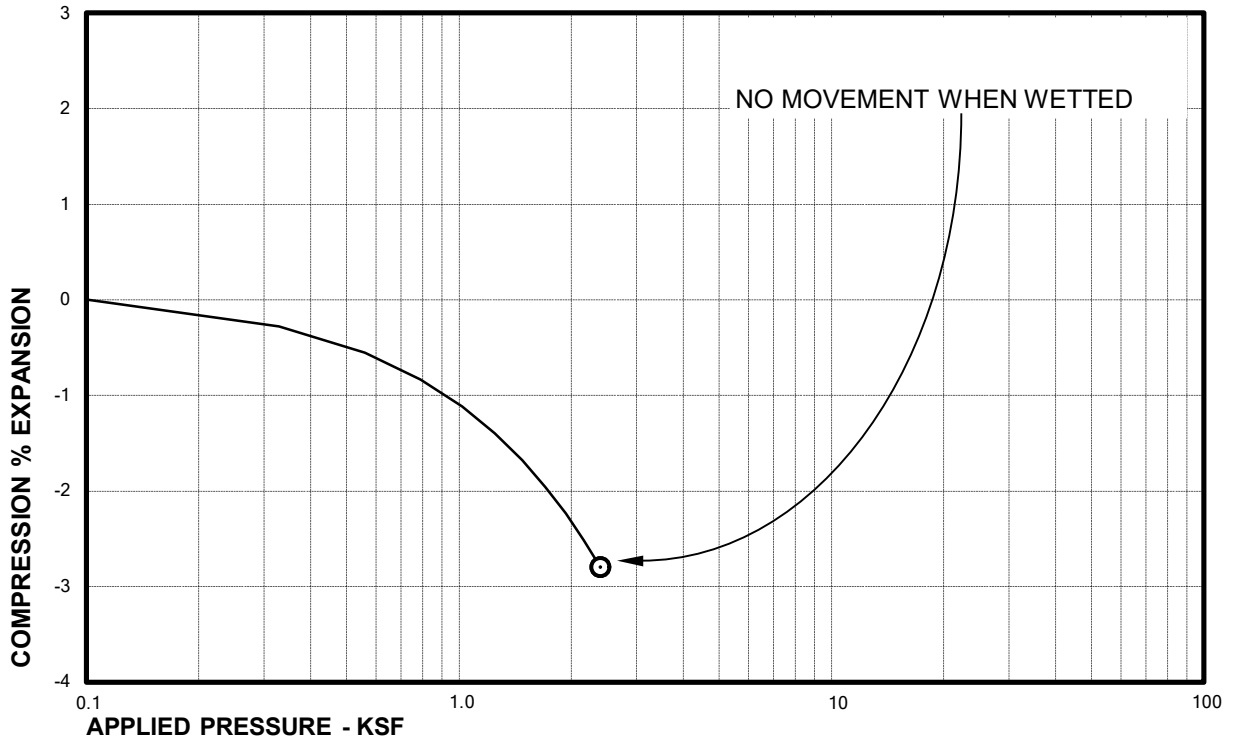
Sample of SANDSTONE  
From TH-17 AT 19 FEET

DRY UNIT WEIGHT= 121 PCF  
MOISTURE CONTENT= 12.5 %

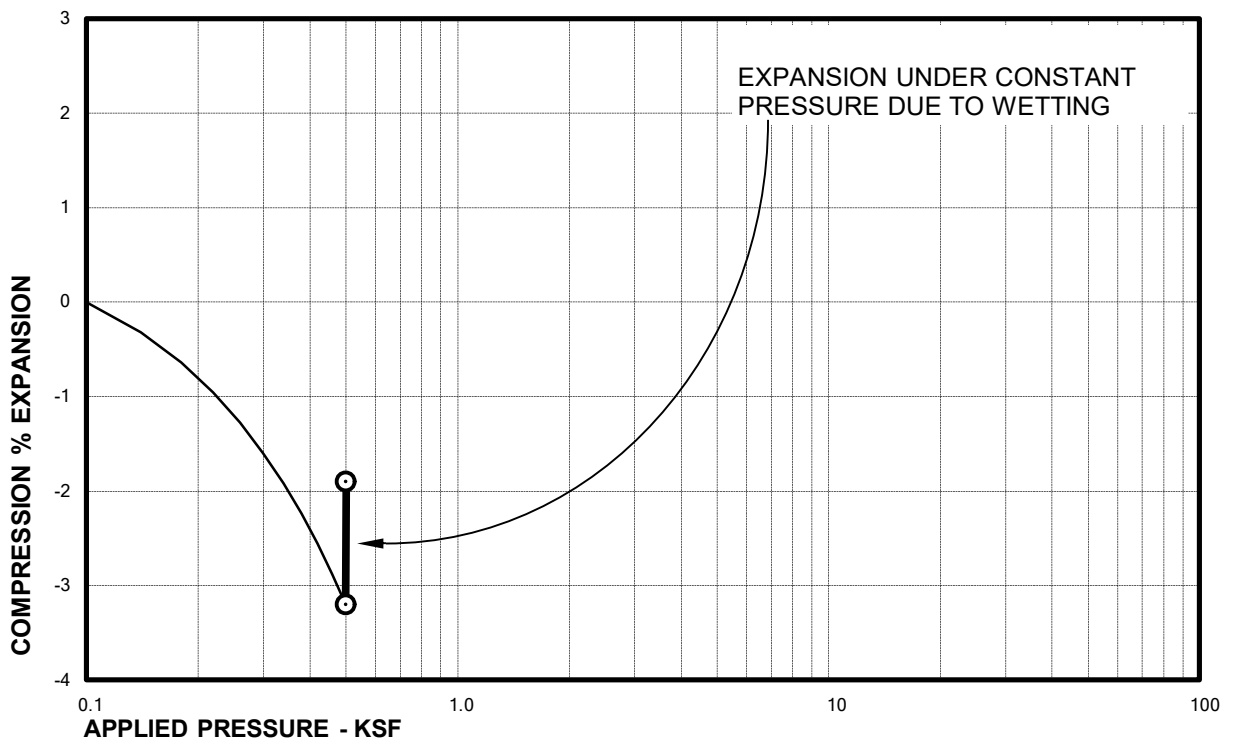
Sample of SANDSTONE, VERY CLAYEY  
From TH-18 AT 4 FEET

DRY UNIT WEIGHT= 124 PCF  
MOISTURE CONTENT= 9.7 %

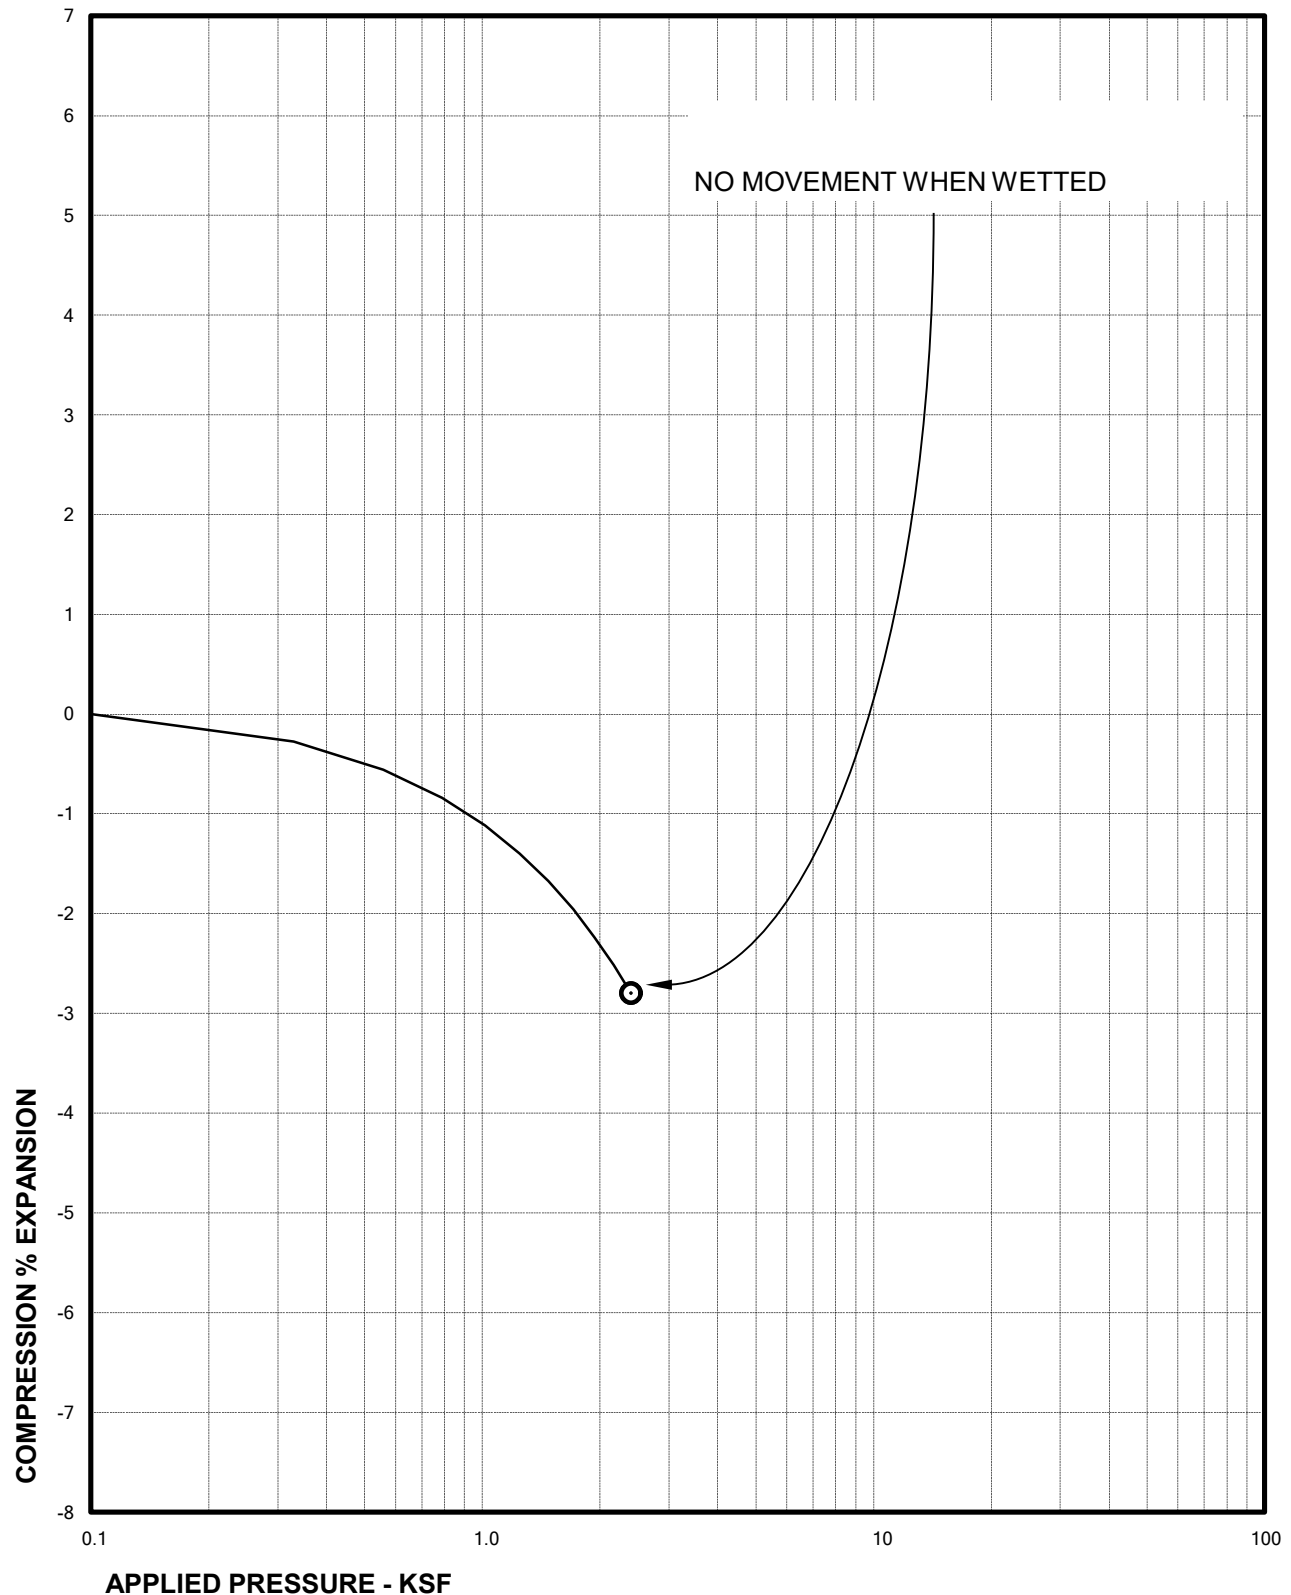
### Swell Consolidation Test Results

Sample of SANDSTONE  
From TH-17 AT 19 FEET

DRY UNIT WEIGHT= 121 PCF  
MOISTURE CONTENT= 12.5 %

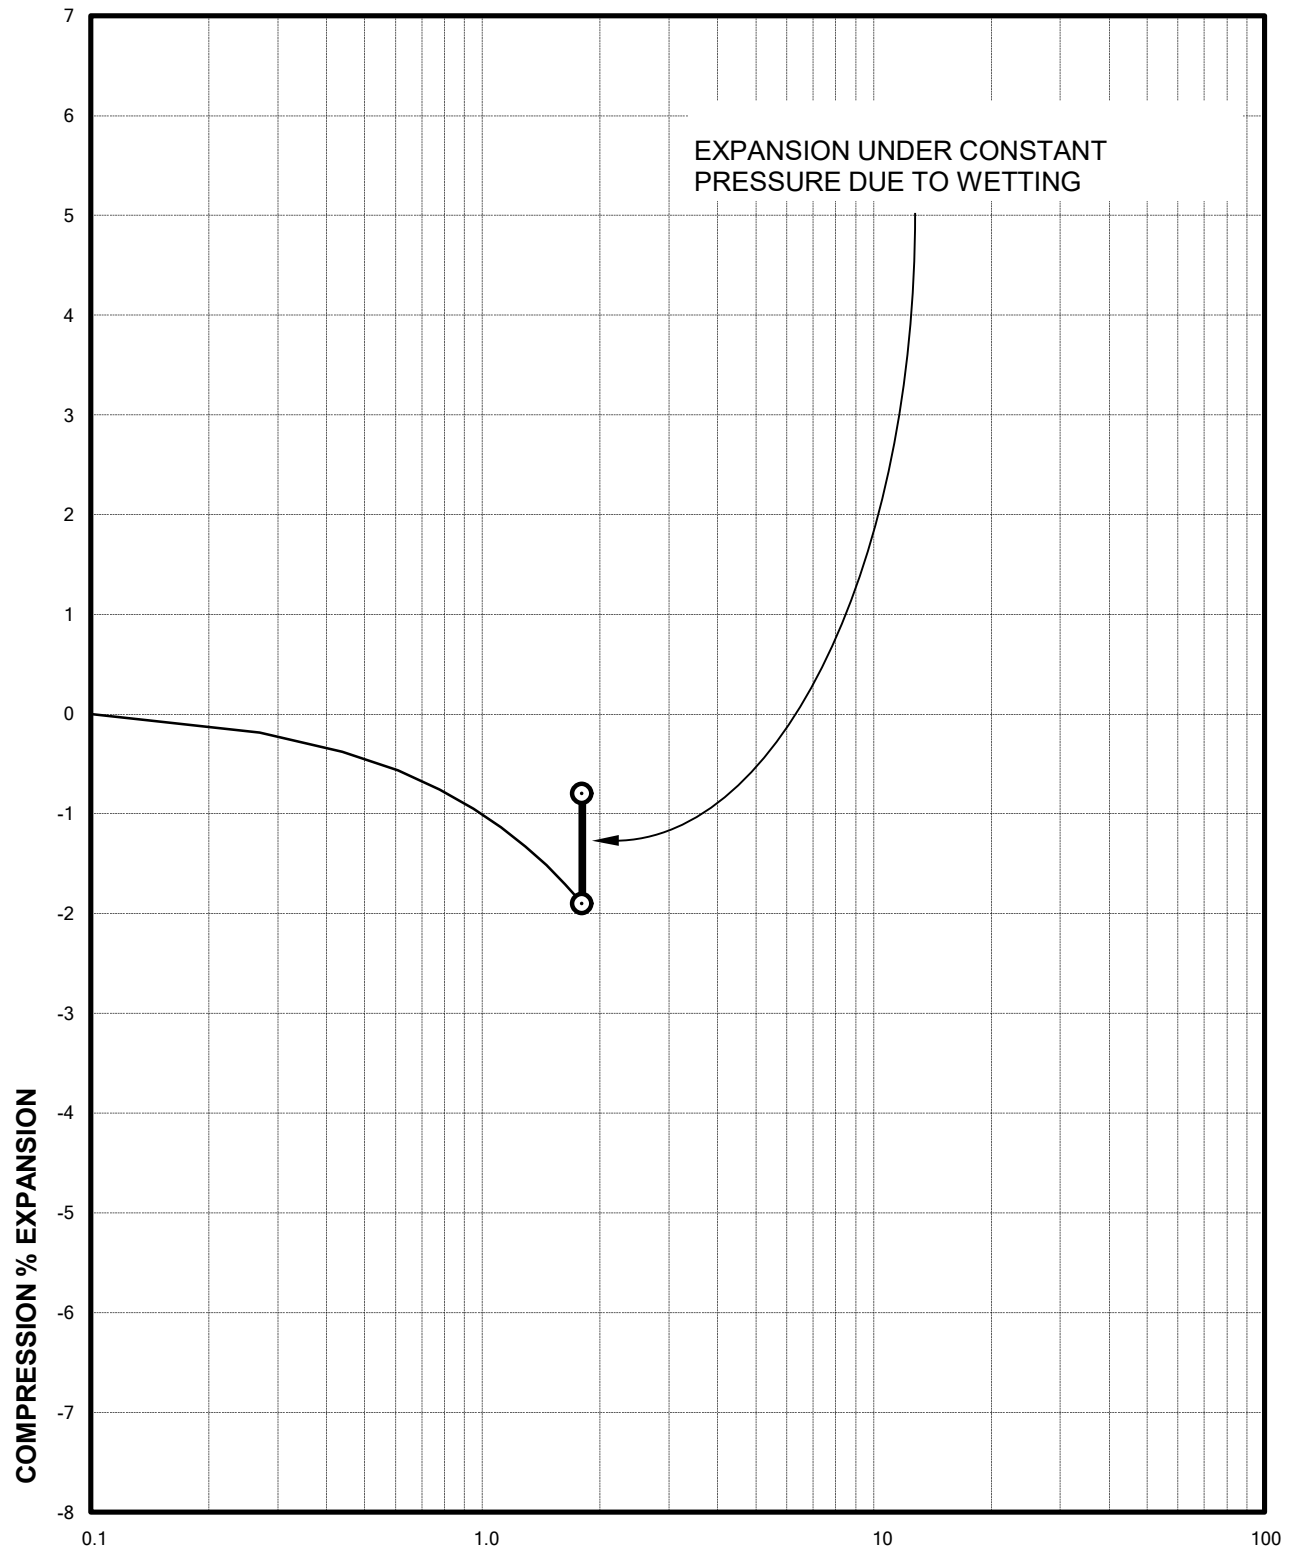
**APPLIED PRESSURE - KSF**  
Sample of SANDSTONE, CLAYEY  
From TH-20 AT 14 FEET

DRY UNIT WEIGHT= 121 PCF  
MOISTURE CONTENT= 12.0 %

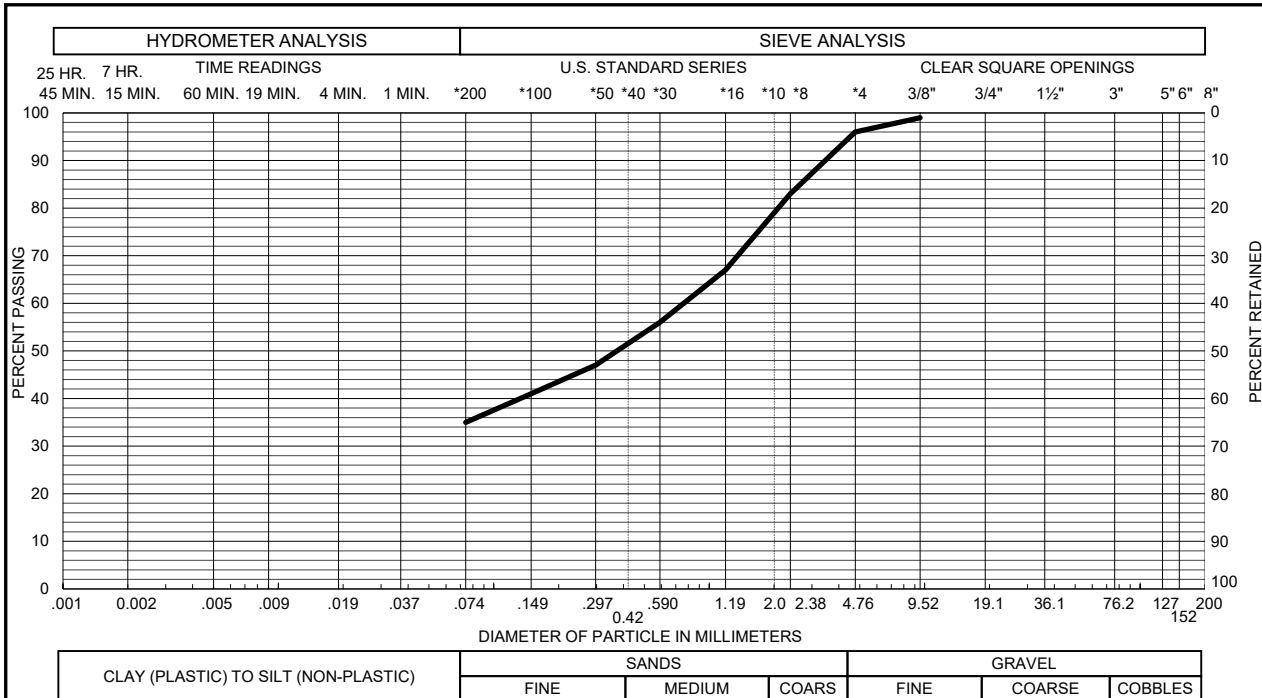
Sample of SANDSTONE, SILTY GRAVEL 4 % SAND 61 %  
 From TH - 2 AT 9 FEET SILT & CLAY 35 % LIQUID LIMIT     %   
 PLASTICITY INDEX     %

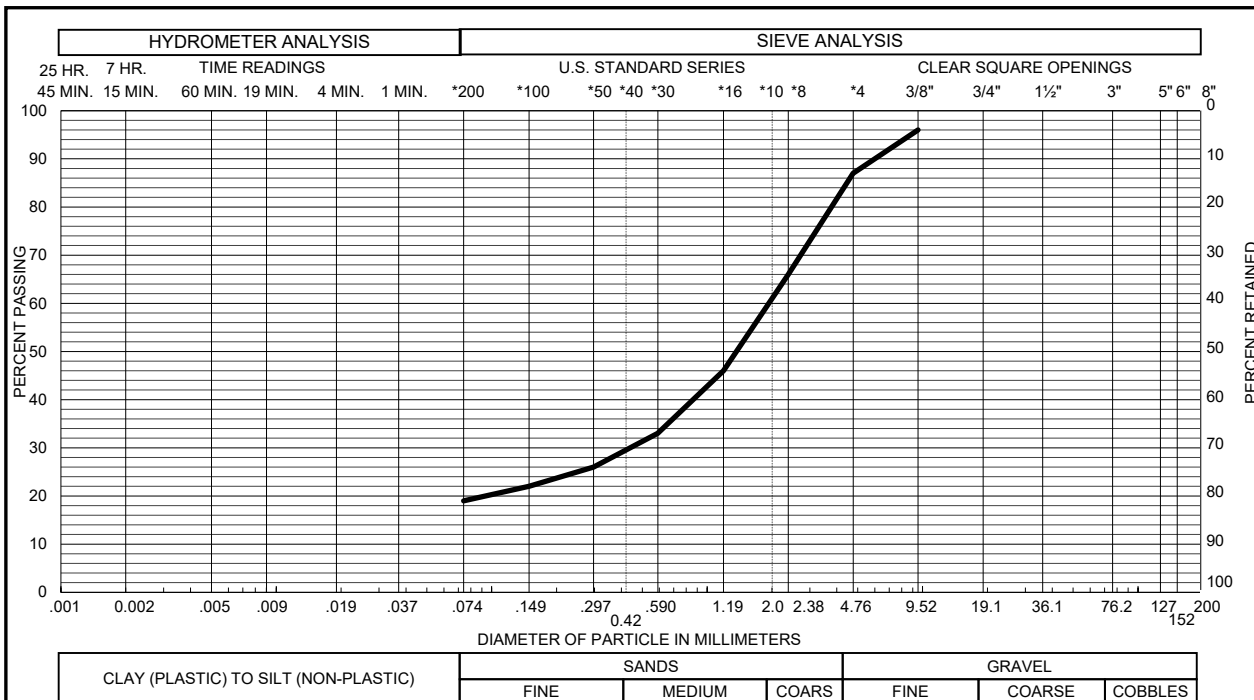
Sample of SANDSTONE, SILTY GRAVEL 13 % SAND 68 %  
 From TH - 3 AT 4 FEET SILT & CLAY 19 % LIQUID LIMIT     %   
 PLASTICITY INDEX     %

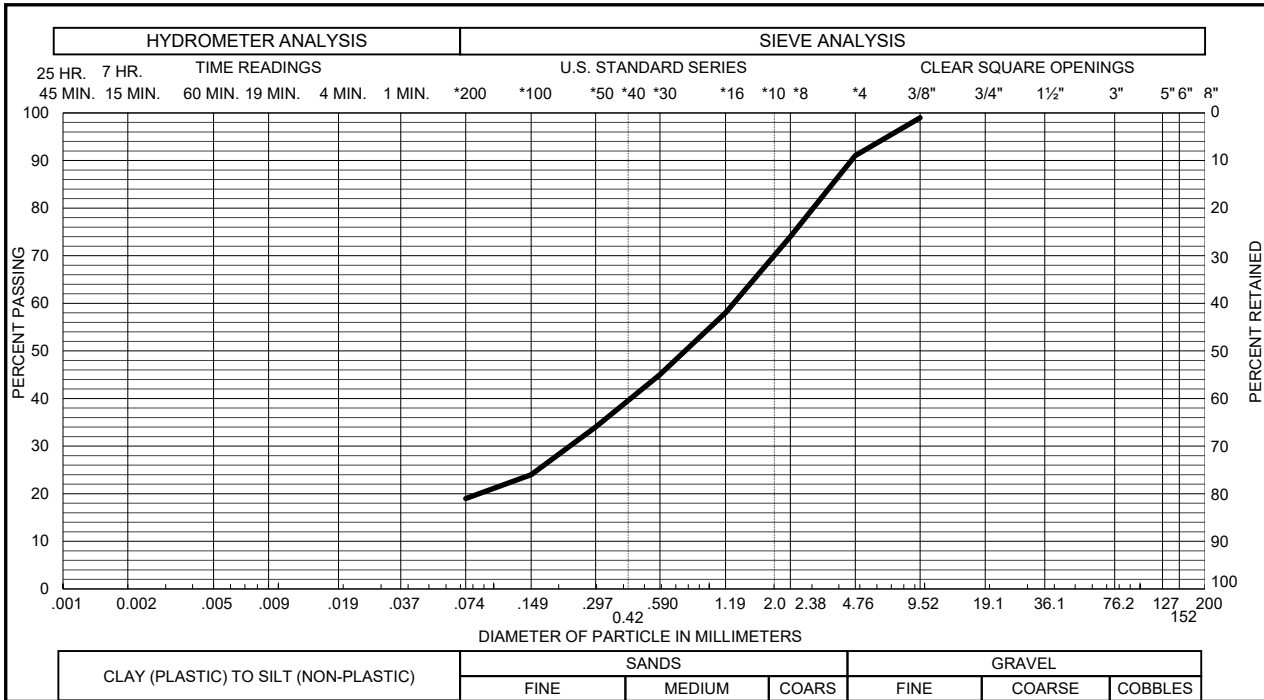
Sample of SANDSTONE, SILTY GRAVEL 9 % SAND 72 %  
 From TH - 4 AT 14 FEET SILT & CLAY 19 % LIQUID LIMIT     %   
 PLASTICITY INDEX     %

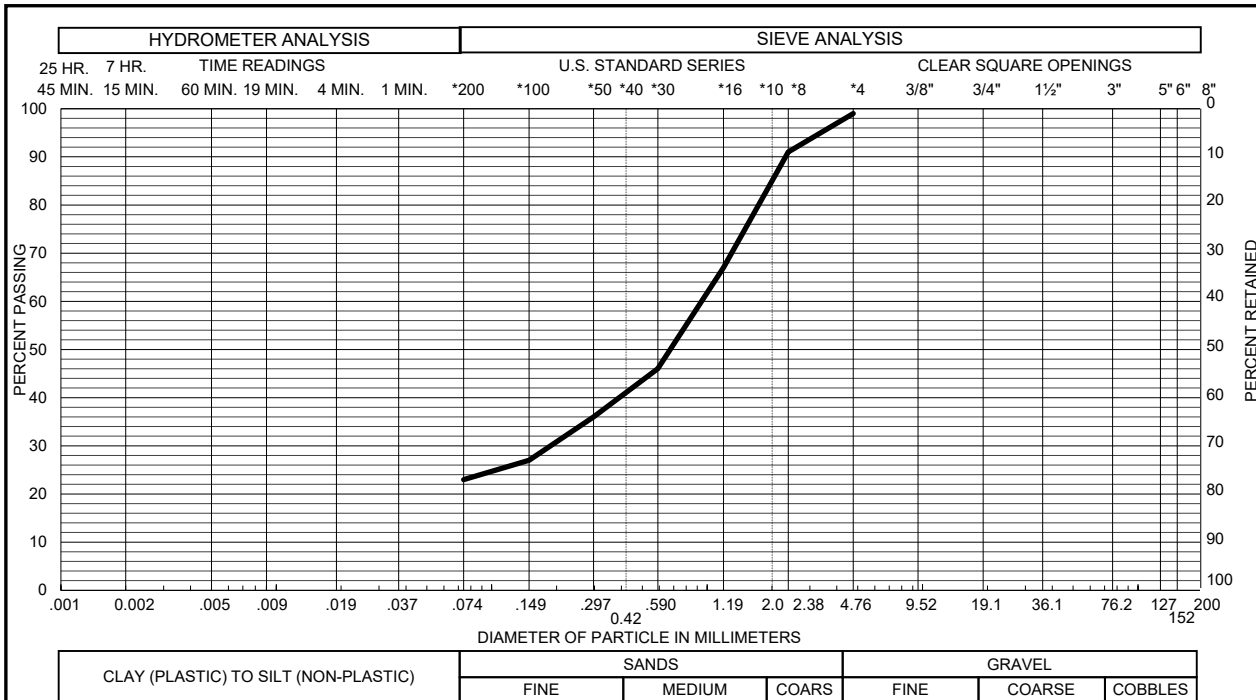
Sample of SANDSTONE, SILTY GRAVEL 1 % SAND 76 %  
 From TH - 5 AT 9 FEET SILT & CLAY 23 % LIQUID LIMIT     %   
 PLASTICITY INDEX     %

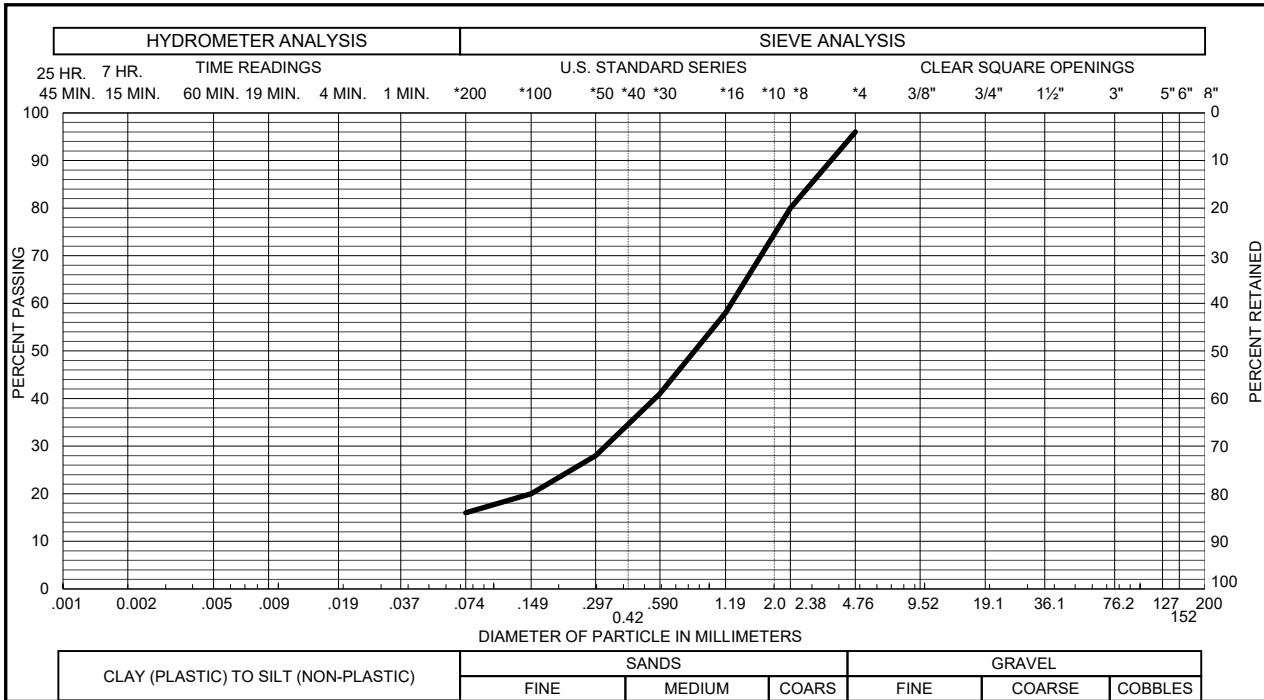
Sample of SANDSTONE, SILTY GRAVEL 4 % SAND 80 %  
 From TH - 6 AT 4 FEET SILT & CLAY 16 % LIQUID LIMIT     %   
 PLASTICITY INDEX     %

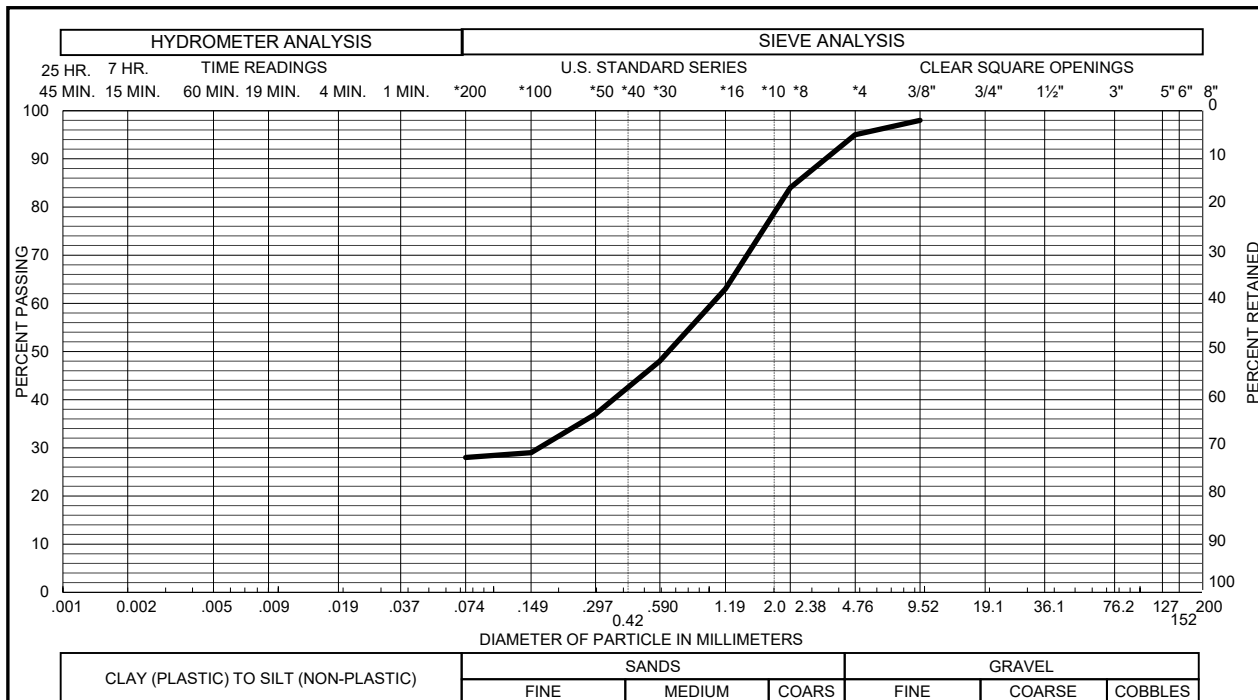
Sample of SANDSTONE, CLAYEY GRAVEL 5 % SAND 67 %  
 From TH - 10 AT 4 FEET SILT & CLAY 28 % LIQUID LIMIT     %   
 PLASTICITY INDEX     %

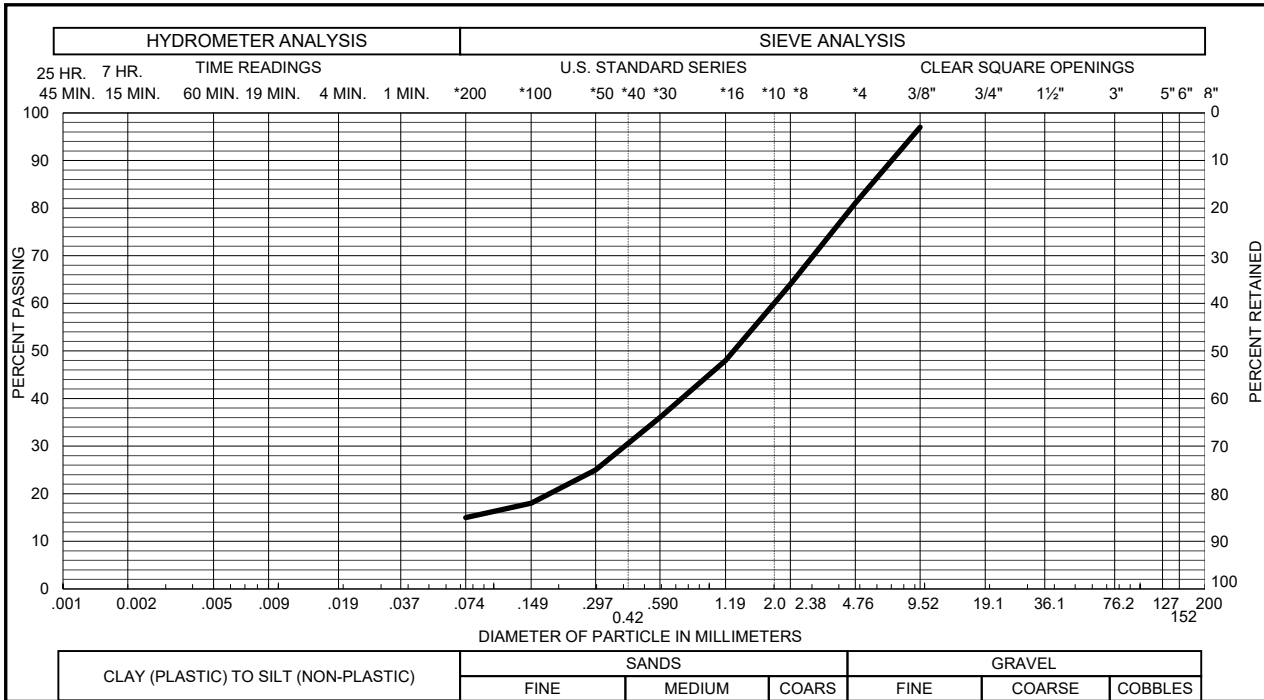
Sample of SANDSTONE, SILTY GRAVEL 19 % SAND 66 %  
 From TH - 12 AT 4 FEET SILT & CLAY 15 % LIQUID LIMIT     %   
 PLASTICITY INDEX     %

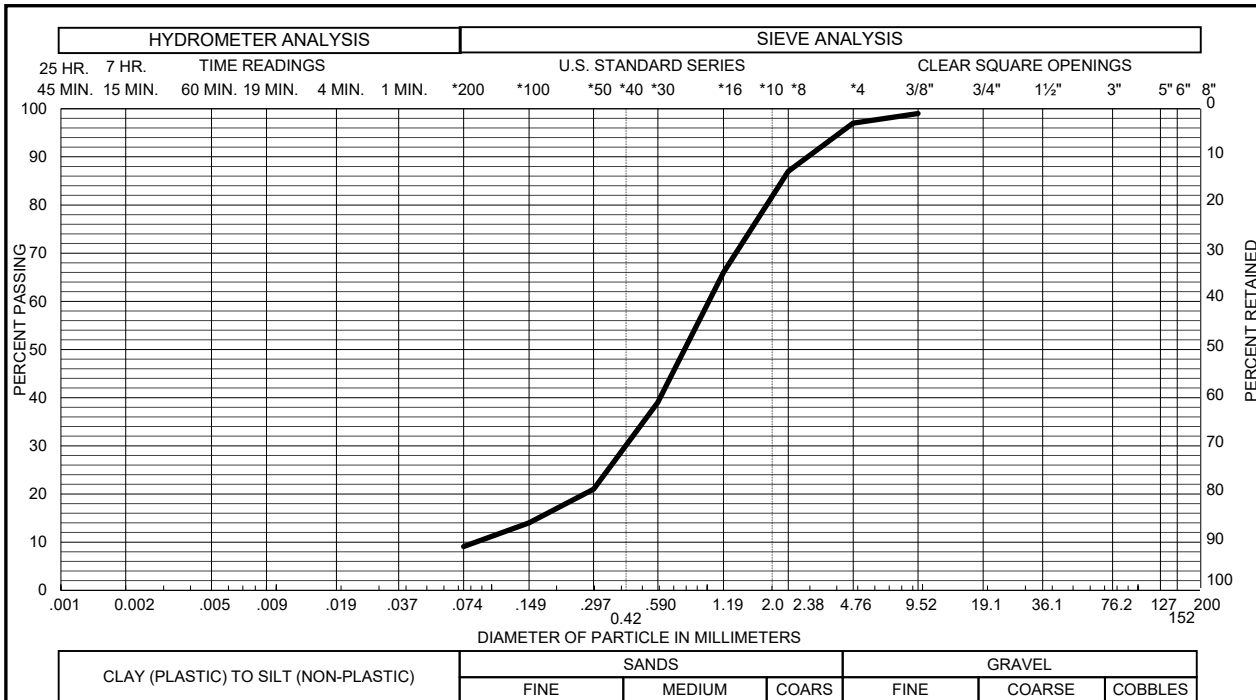
Sample of SANDSTONE, SLIGHTLY SILTY GRAVEL 3 % SAND 88 %  
 From TH - 14 AT 9 FEET SILT & CLAY 9 % LIQUID LIMIT     %   
 PLASTICITY INDEX     %

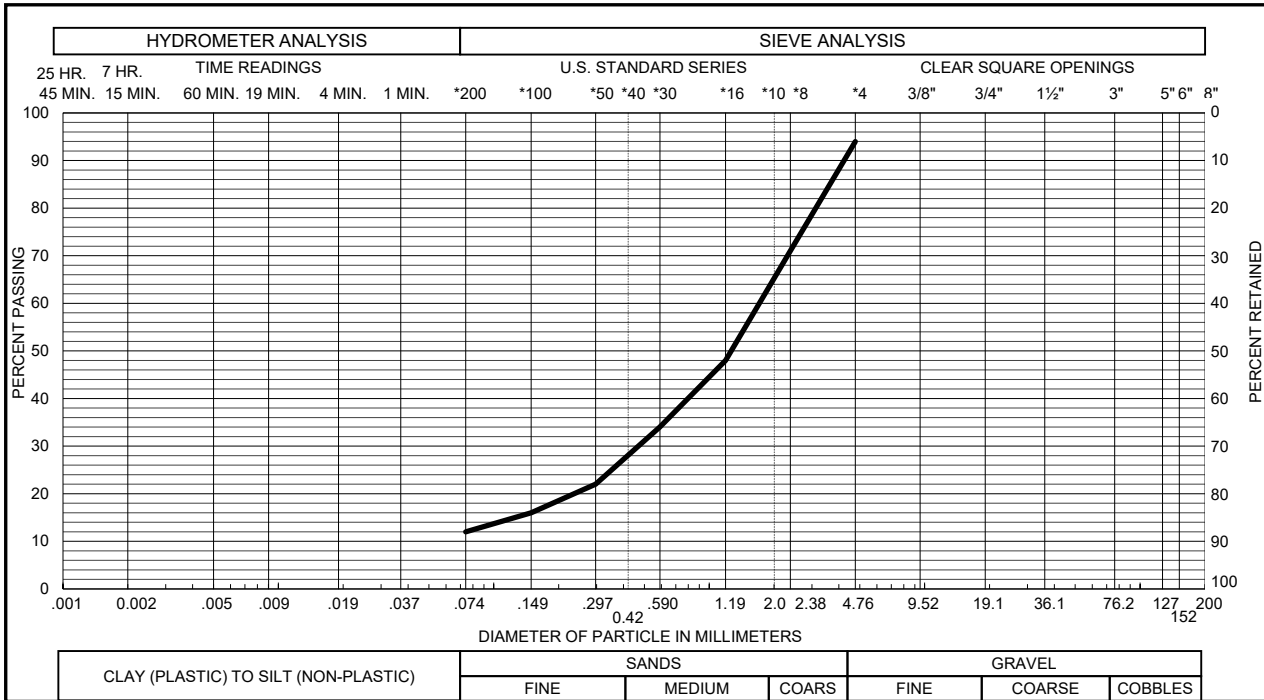
Sample of SANDSTONE, SLIGHTLY SILTY GRAVEL 6 % SAND 82 %  
 From TH - 20 AT 9 FEET SILT & CLAY 12 % LIQUID LIMIT \_\_\_\_\_ %  
 PLASTICITY INDEX \_\_\_\_\_ %
