**ENTECH**  
ENGINEERING, INC.

May 26, 2021  
Revised: February 14, 2022

Re: OWTS – Wastewater Study  
Koinonia Ranch  
Parcel No. 52190-00-059  
6170 Old Ranch Road  
El Paso County, Colorado

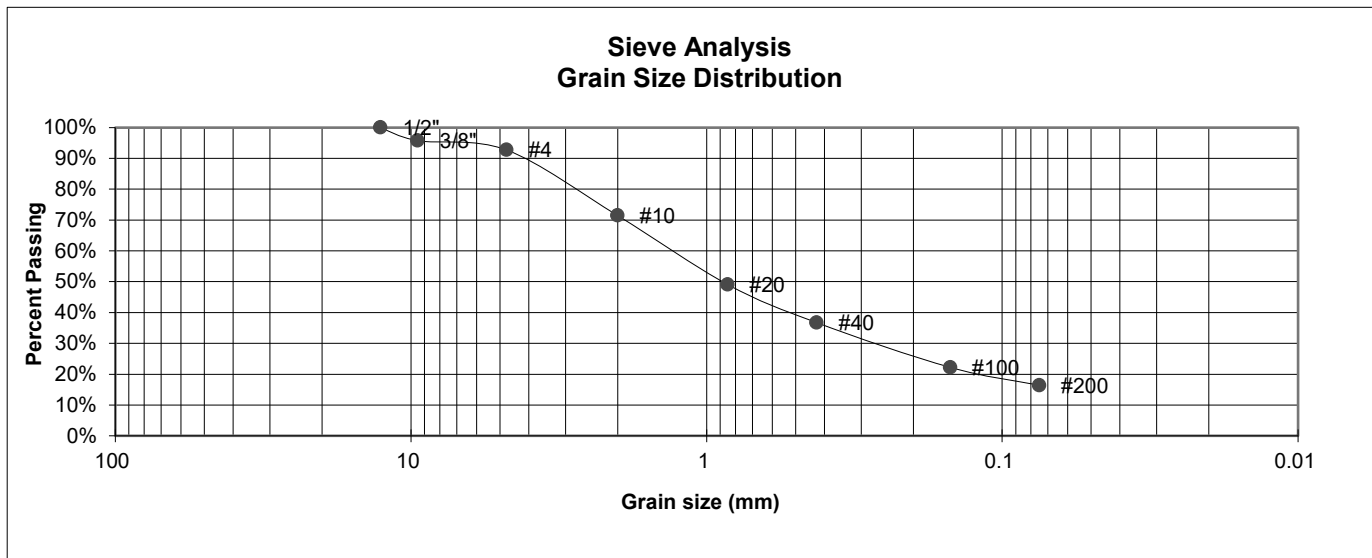
BORING NO.	1	UNIFIED CLASSIFICATION	SM	TEST BY	BL
DEPTH(ft)	2-3	AASHTO CLASSIFICATION		JOB NO.	202498
CLIENT	SALLY BARTELS				
PROJECT	6170 OLD RANCH ROAD

U.S. Sieve #	Percent Finer
3"	
1 1/2"	
3/4"	
1/2"	100.0%
3/8"	95.8%
4	92.7%
10	71.4%
20	49.1%
40	36.7%
100	22.2%
200	16.4%

encountered at very dense states and moderate moisture conditions. The samples of sand tested had 16 percent of the soil size particles passing the No. 200 sieve. The samples of sandstone tested had 12 to 31 percent of the soil size particles passing the No. 200 sieve. The silty sand and sandstone typically have low expansion potential. Highly expansive claystone and siltstone lenses are commonly interbedded in the sandstone in the area.

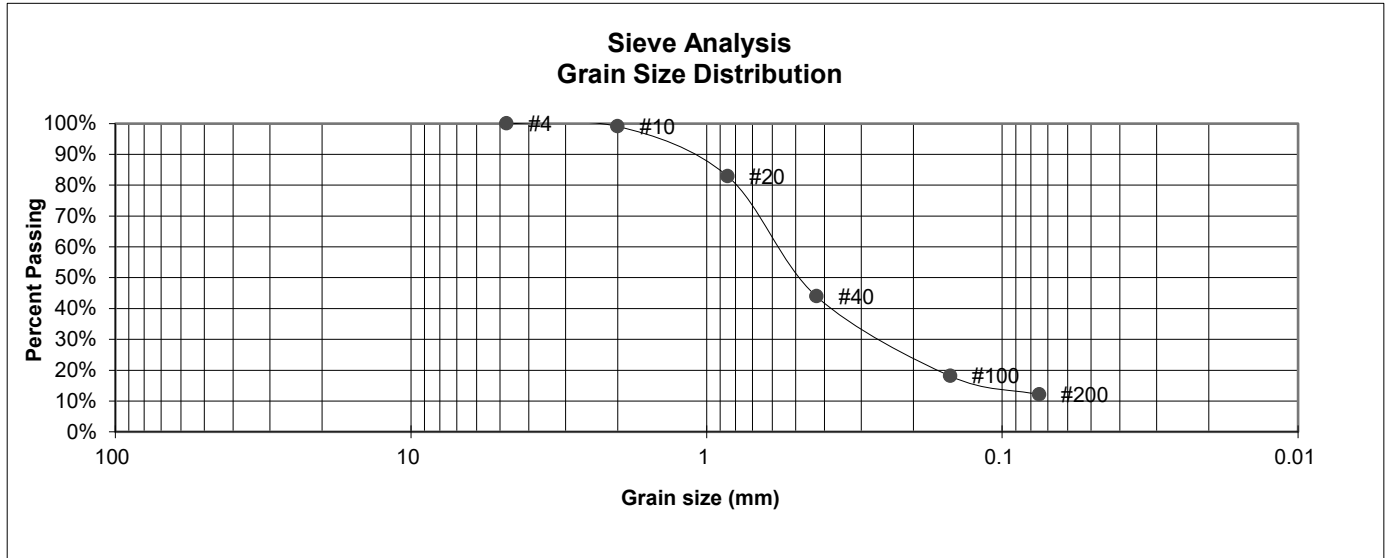
BORING NO.	1	UNIFIED CLASSIFICATION	SM	TEST BY	BL
DEPTH(ft)	15	AASHTO CLASSIFICATION		JOB NO.	202498
CLIENT	SALLY BARTELS				
PROJECT	6170 OLD RANCH ROAD

U.S. Sieve #	Percent Finer	Atterberg Limits
3"		Plastic Limit
1 1/2"		Liquid Limit
3/4"		Plastic Index
1/2"		
3/8"		
4	100.0%	<u>Swell</u>
10	99.0%	Moisture at start
20	82.9%	Moisture at finish
40	44.0%	Moisture increase
100	18.1%	Initial dry density (pcf)
200	12.1%	Swell (psf)

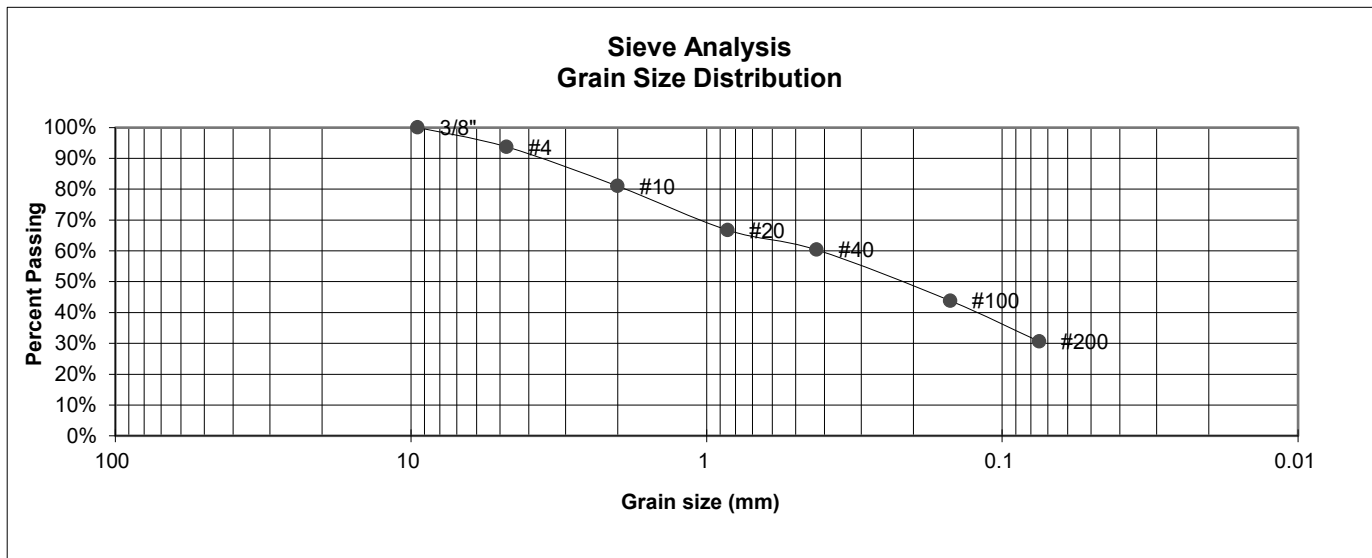
BORING NO.	2	UNIFIED CLASSIFICATION	SM	TEST BY	BL
DEPTH(ft)	5	AASHTO CLASSIFICATION		JOB NO.	202498
CLIENT	SALLY BARTELS				
PROJECT	6170 OLD RANCH ROAD

U.S. Sieve #	Percent Finer
3"	
1 1/2"	
3/4"	
1/2"	
3/8"	100.0%
4	93.7%
10	81.0%
20	66.7%
40	60.4%
100	43.8%
200	30.6%

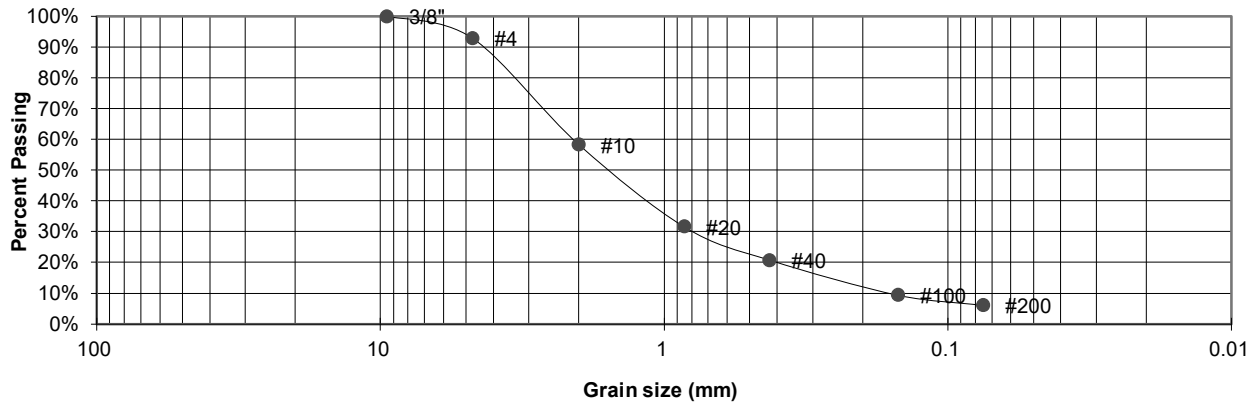
BORING NO.	TP-2	UNIFIED CLASSIFICATION	SM-SW	TEST BY	BL
DEPTH(ft)	5	AASHTO CLASSIFICATION		JOB NO.	202498
CLIENT	SALLY BARTELS				
PROJECT	6170 OLD RANCH ROAD

U.S. Sieve #	Percent Finer
3"	
1 1/2"	
3/4"	
1/2"	
3/8"	100.0%
4	93.0%
10	58.3%
20	31.7%
40	20.7%
100	9.4%
200	6.1%

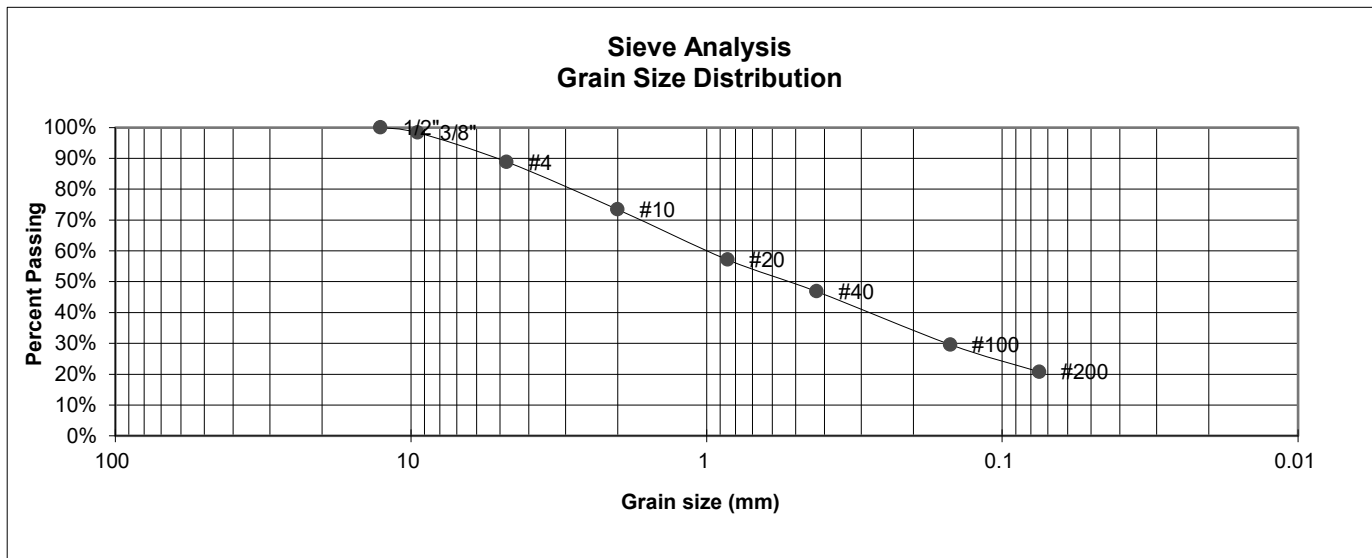
BORING NO.	TP-2	UNIFIED CLASSIFICATION	SC	TEST BY	BL
DEPTH(ft)	2	AASHTO CLASSIFICATION		JOB NO.	202498
CLIENT	SALLY BARTELS				
PROJECT	6170 OLD RANCH ROAD

U.S. Sieve #	Percent Finer
3"	
1 1/2"	
3/4"	
1/2"	100.0%
3/8"	98.3%
4	88.9%
10	73.4%
20	57.1%
40	46.8%
100	29.6%
200	20.7%

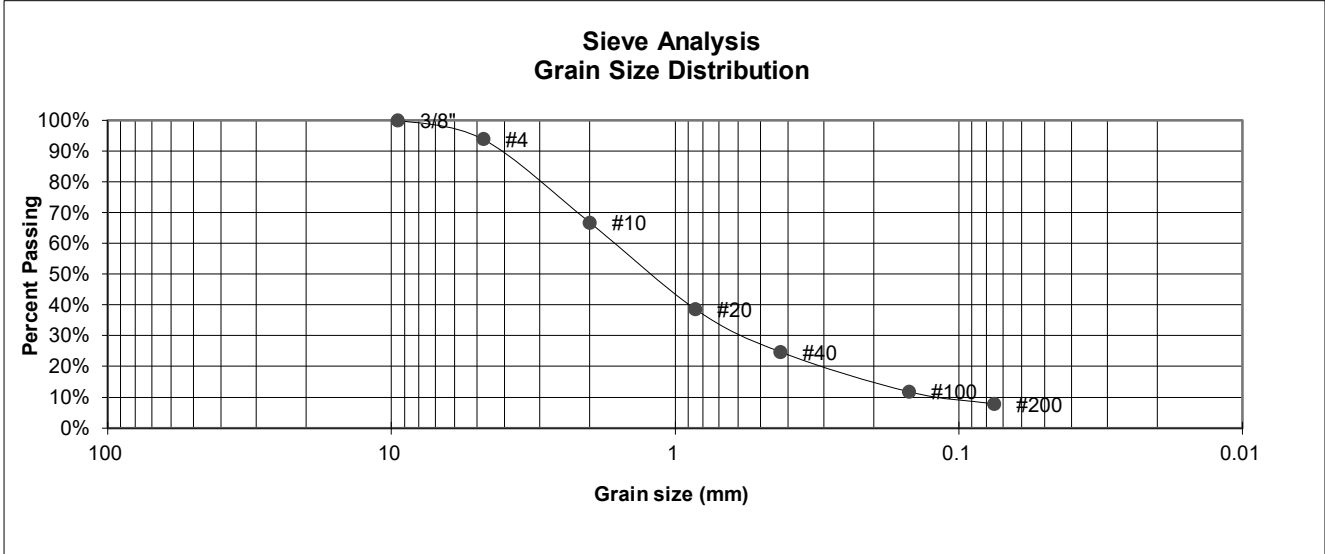
BORING NO.	TP-1	UNIFIED CLASSIFICATION	SM-SW	TEST BY	BL
DEPTH(ft)	5	AASHTO CLASSIFICATION		JOB NO.	202498
CLIENT	SALLY BARTELS				
PROJECT	6170 OLD RANCH ROAD

U.S. Sieve #	Percent Finer	Atterberg Limits
3"		Plastic Limit
1 1/2"		Liquid Limit
3/4"		Plastic Index
1/2"		
3/8"	100.0%	
4	94.0%	<u>Swell</u>
10	66.7%	Moisture at start
20	38.7%	Moisture at finish
40	24.7%	Moisture increase
100	11.8%	Initial dry density (pcf)
200	7.9%	Swell (psf)

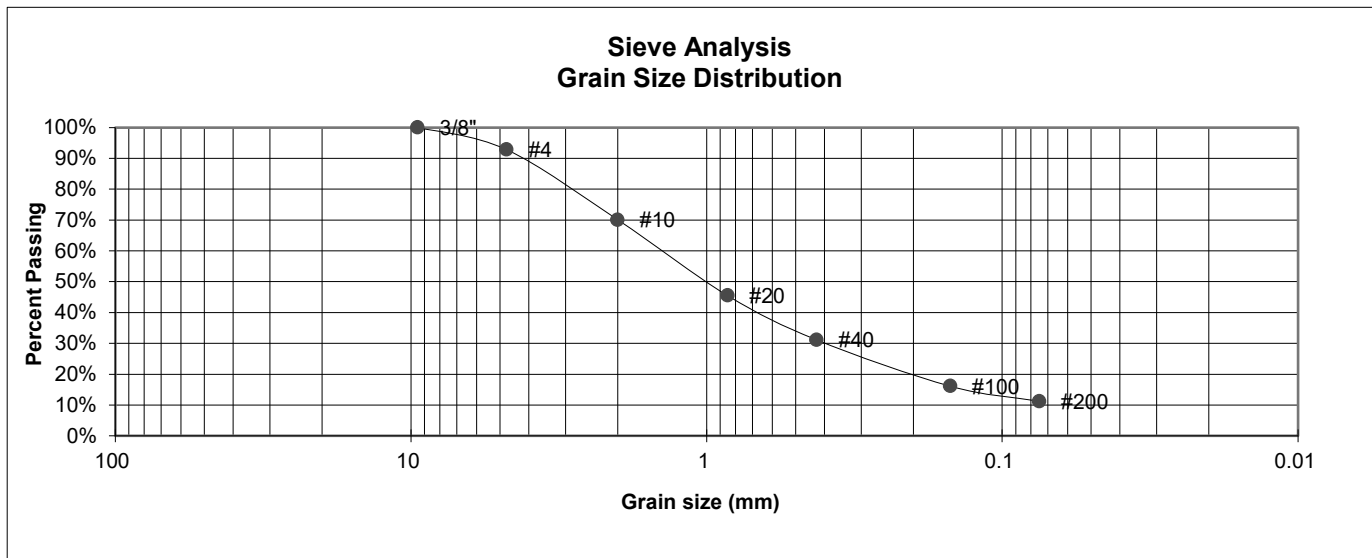
BORING NO.	TP-3	UNIFIED CLASSIFICATION	SC-SW	TEST BY	BL
DEPTH(ft)	2	AASHTO CLASSIFICATION		JOB NO.	202498
CLIENT	SALLY BARTELS				
PROJECT	6170 OLD RANCH ROAD

U.S. Sieve #	Percent Finer
3"	
1 1/2"	
3/4"	
1/2"	
3/8"	100.0%
4	92.8%
10	70.1%
20	45.5%
40	31.1%
100	16.1%
200	11.2%
