**GEOLOGIC HAZARDS EVALUATION AND
PRELIMINARY GEOTECHNICAL INVESTIGATION
105 ACRE CONEXUS SITE
OLD DENVER ROAD AND 2ND STREET
MONUMENT, COLORADO**

SCHUCK COMMUNITIES
2 North Cascade Avenue, Suite 1280
Colorado Springs, Colorado 80903

CTL|T Project No. CS19248-115

June 18, 2020
Re-issue Date: November 10, 2021

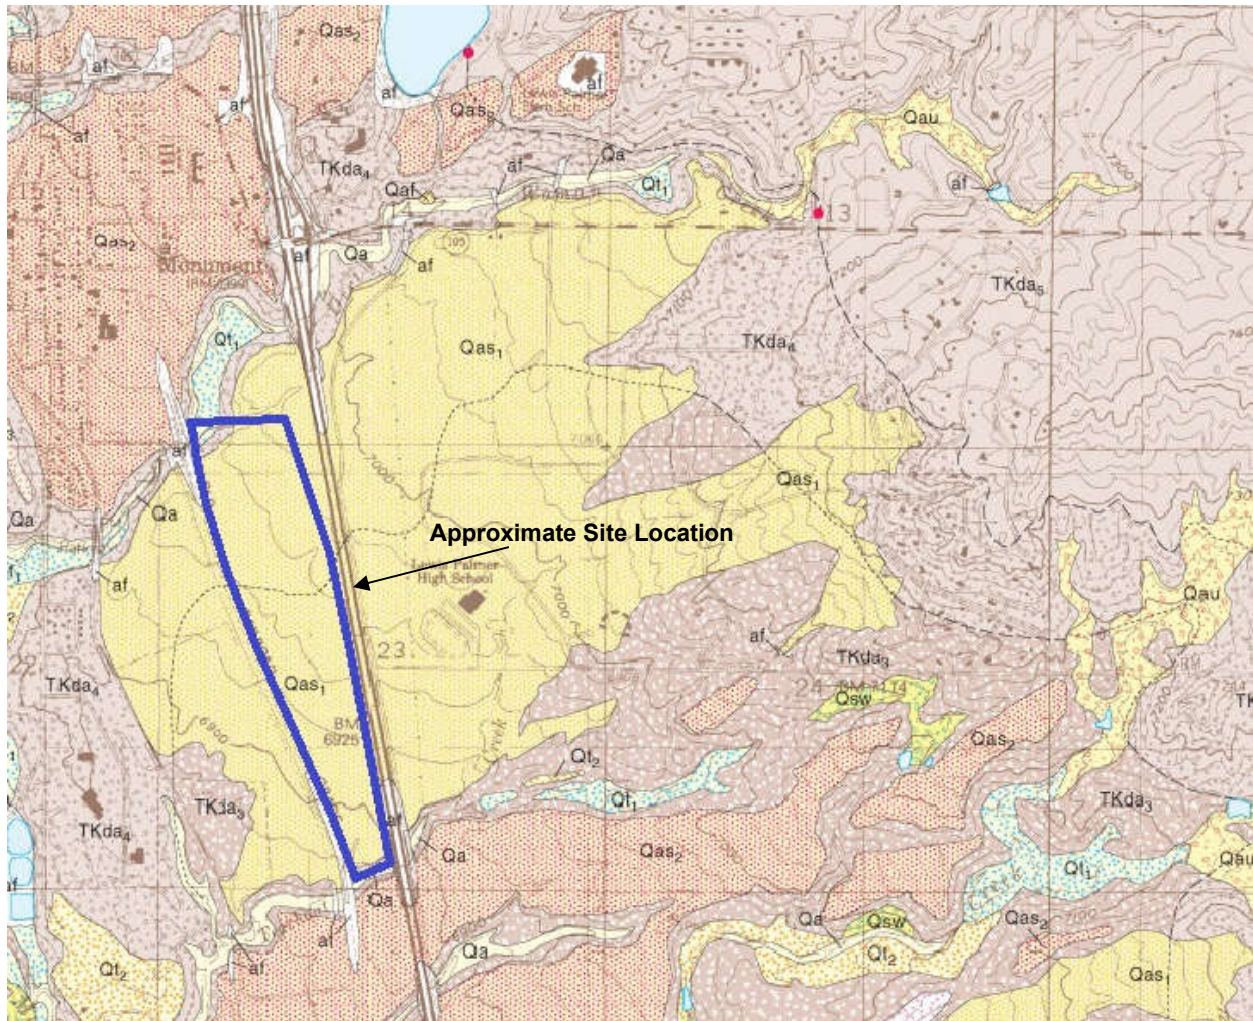
Excerpt from CGS 2003, Geologic Map of the Monument Quadrangle, El Paso County, Colorado

The geology of this 105 acre site was evaluated through the review of published geologic maps and through the drilling of the ten exploratory borings widely spaced across the site. Information from these sources was used to produce our interpretation of surficial geologic conditions, as shown in Fig. 2. An excerpt from the Colorado Geological Survey’s “Geologic Map of the Monument Quadrangle, El Paso County, Colorado” (dated 2003) is presented below. Our subsurface investigation and observations generally confirm the mapping. The following sections discuss the mapped units.

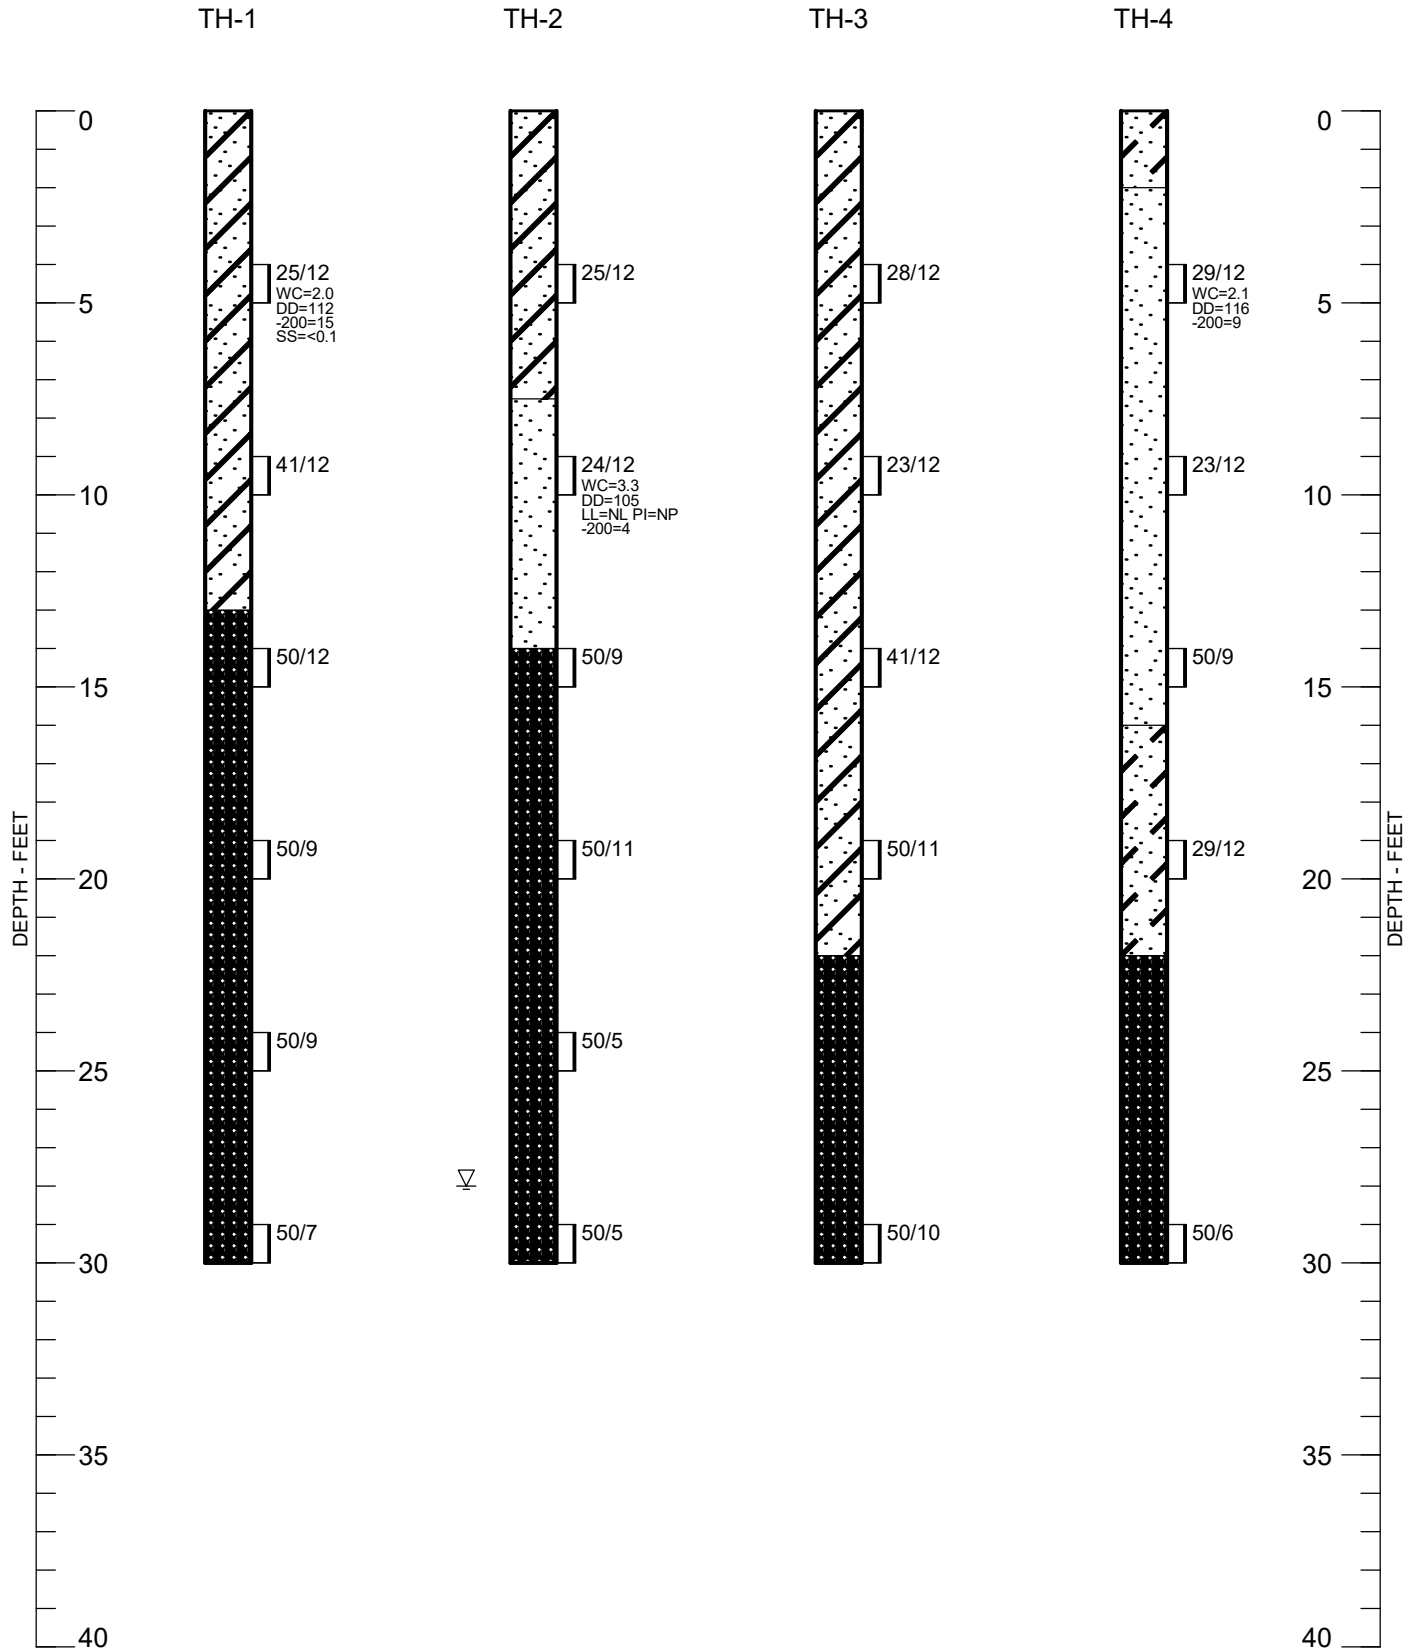
SUMMARY LOGS OF EXPLORATORY BORINGS

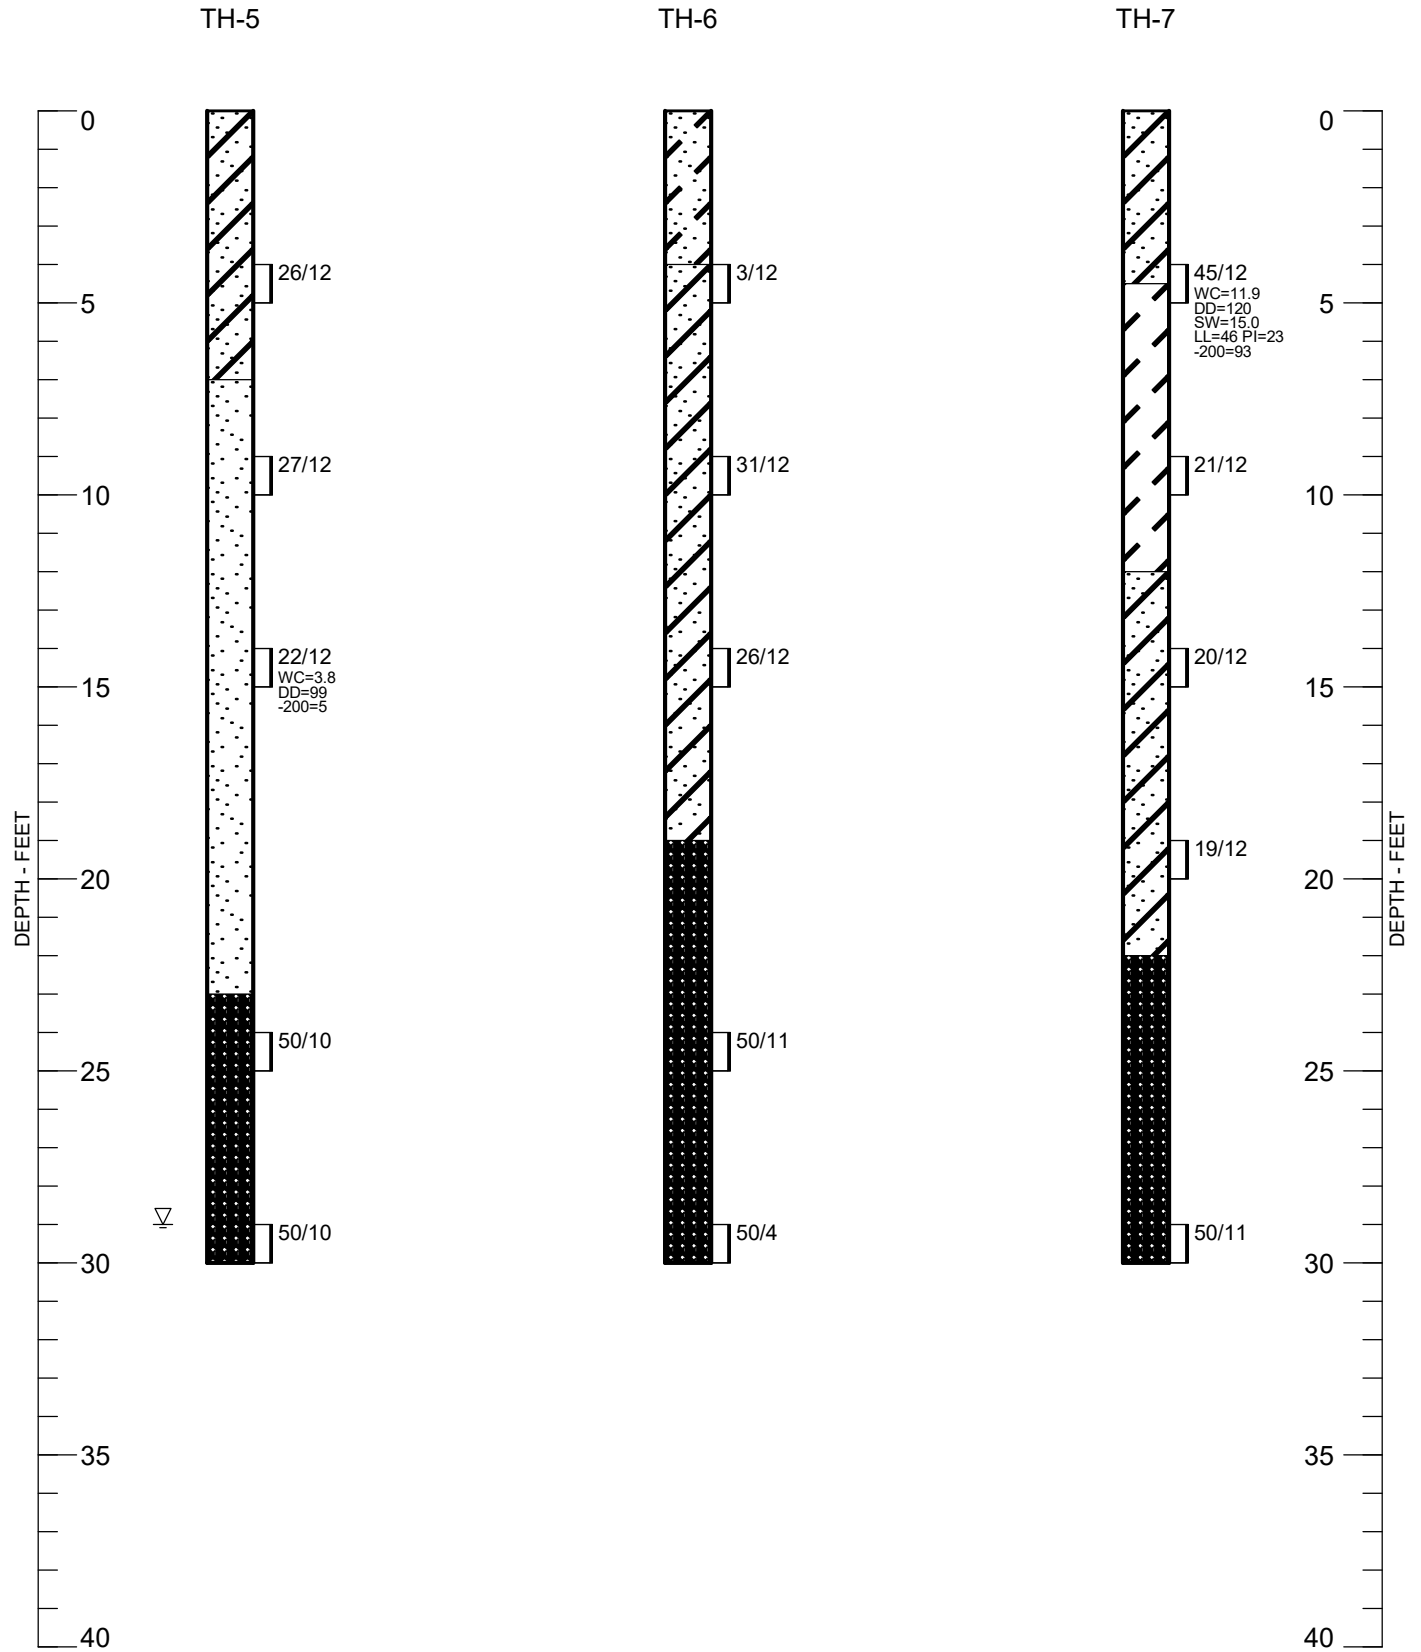
SUMMARY LOGS OF EXPLORATORY BORINGS

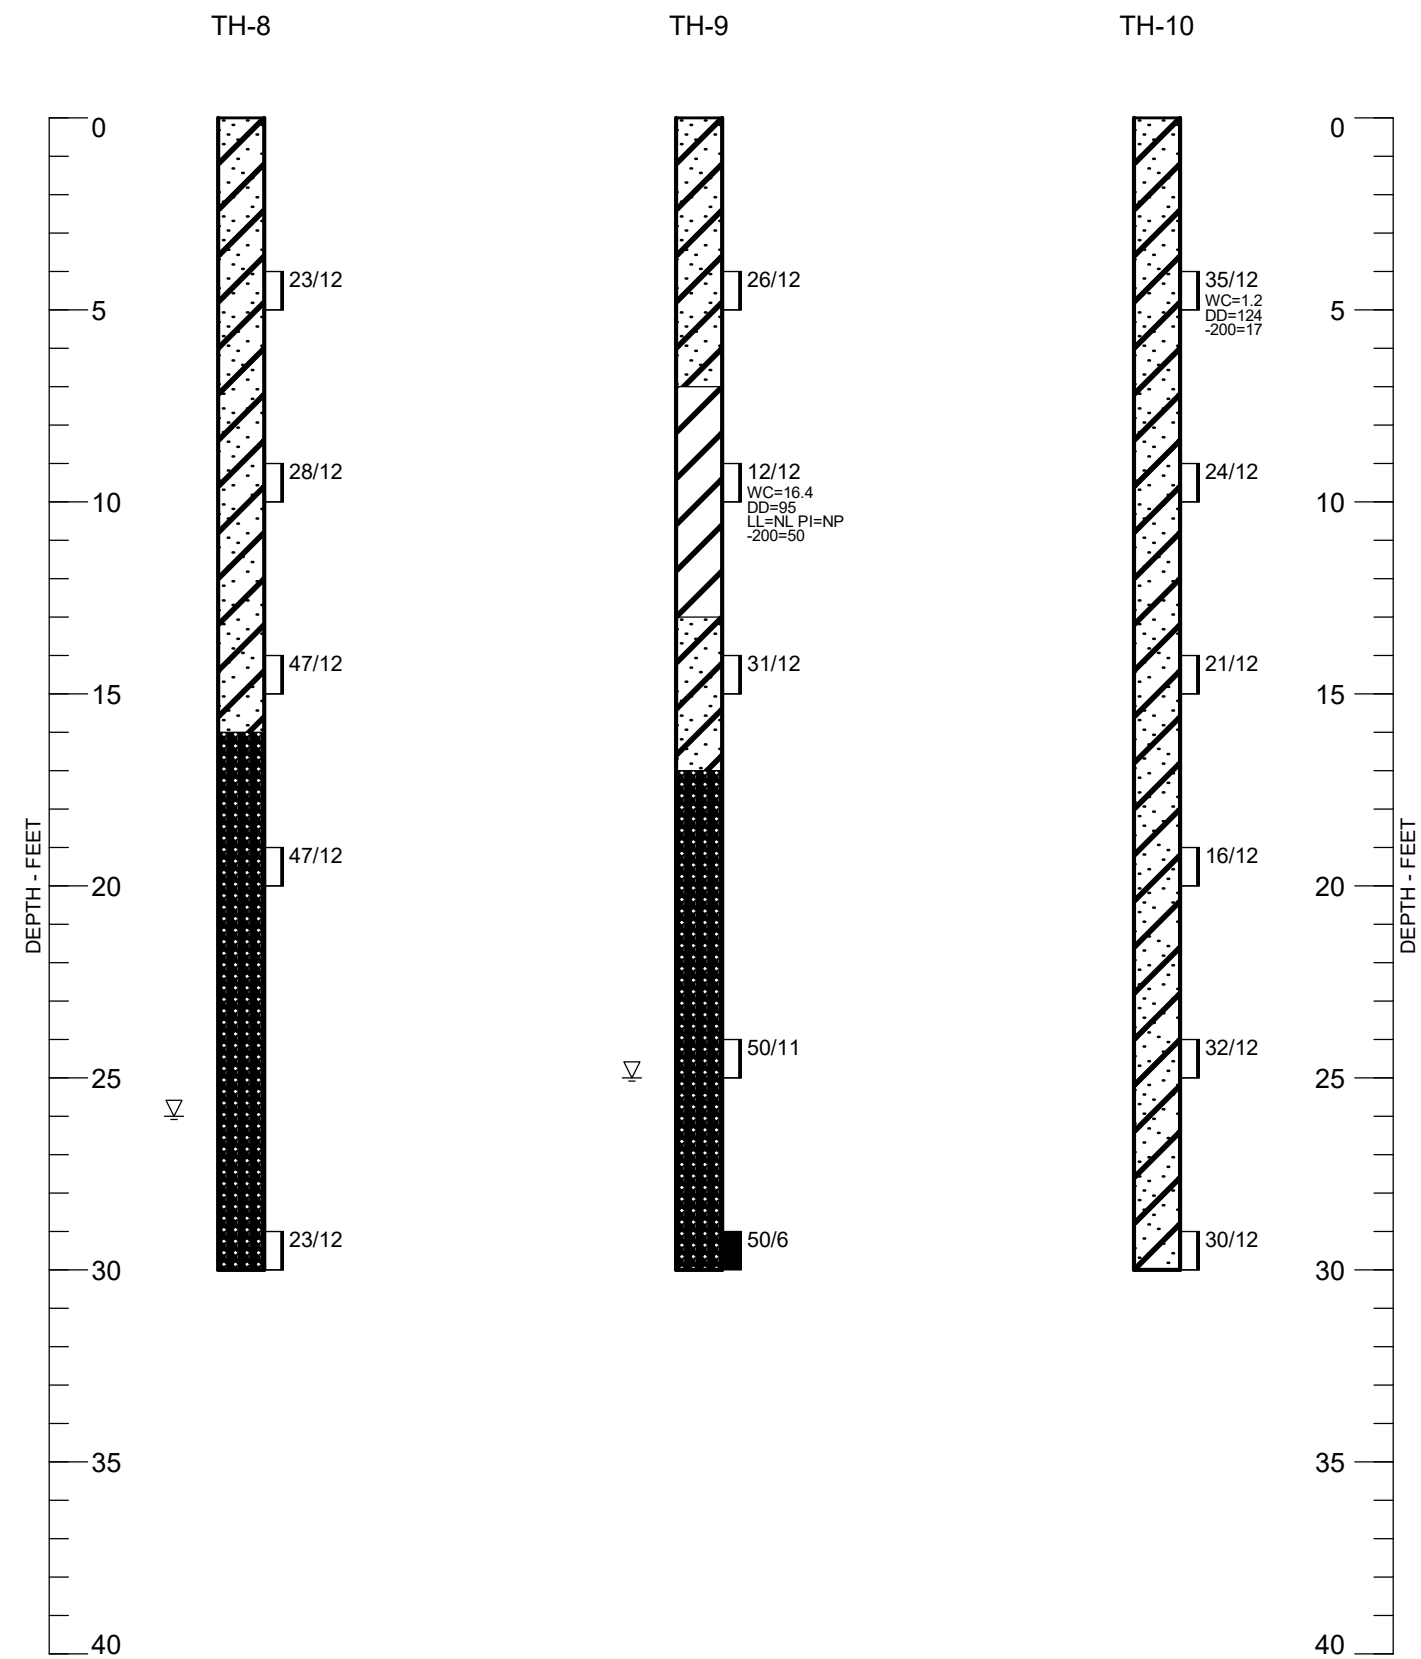
SUMMARY LOGS OF EXPLORATORY BORINGS

- CLAY, VERY STIFF, SLIGHTLY MOIST, LIGHT BROWN (CL).
- SAND, CLAYEY, MEDIUM DENSE, SLIGHTLY MOIST, LIGHT BROWN, RUST (SC).
- SAND, SILTY TO VERY SILTY, LOOSE TO VERY DENSE, SLIGHTLY MOIST, LIGHT BROWN (SM).
- SAND, CLEAN TO SLIGHTLY SILTY, MEDIUM DENSE TO VERY DENSE, SLIGHTLY MOIST, LIGHT BROWN (SP, SP-SM).
- SILT, VERY SANDY TO SAND, VERY SILTY, STIFF, MOIST, REDDISH BROWN (ML-SM).
- BEDROCK, SANDSTONE, SILTY TO CLAYEY, HARD TO VERY HARD, WEAKLY TO MODERATELY CEMENTED, SLIGHTLY MOIST TO MOIST, LIGHT BROWN.
- DRIVE SAMPLE. THE SYMBOL 25/12 INDICATES 25 BLOWS OF AN AUTOMATIC 140-POUND HAMMER FALLING 30 INCHES WERE REQUIRED TO DRIVE A 2.5-INCH O.D. SAMPLER 12 INCHES.
- WATER LEVEL MEASURED AT TIME OF DRILLING.

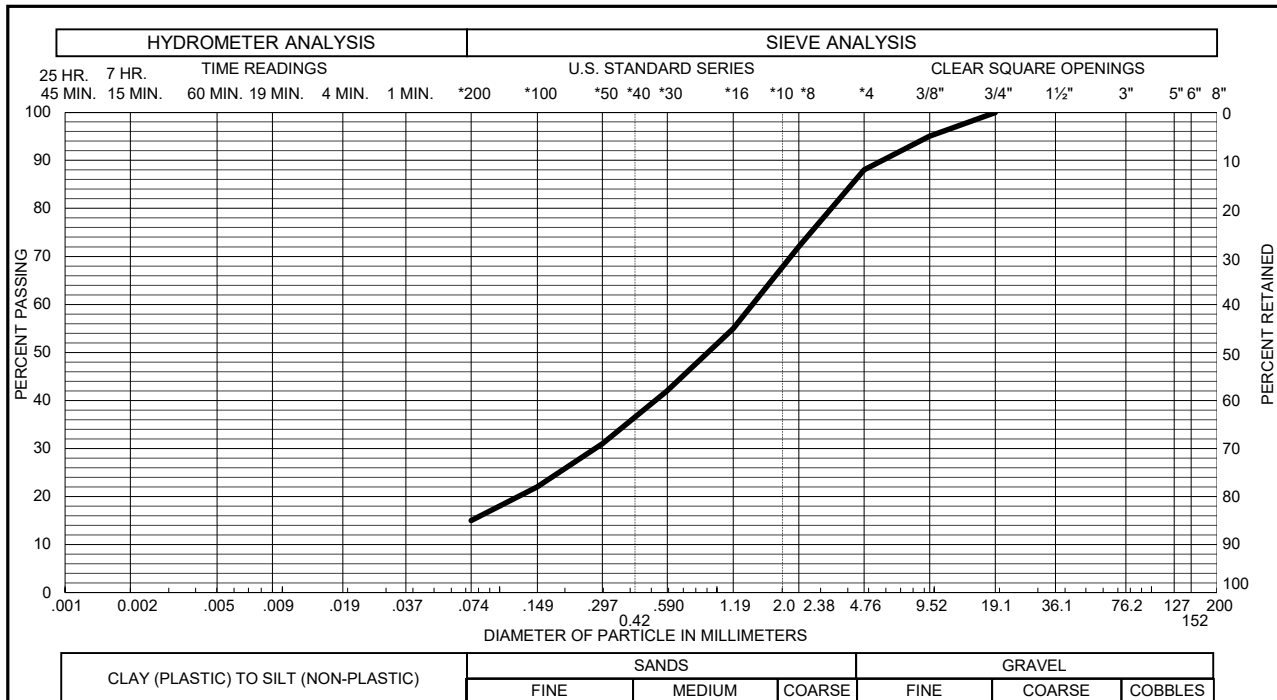
Sample of SAND, SILTY (SM) GRAVEL 12 % SAND 73 %
From TH - 1 AT 4 FEET SILT & CLAY 15 % LIQUID LIMIT
PLASTICITY INDEX

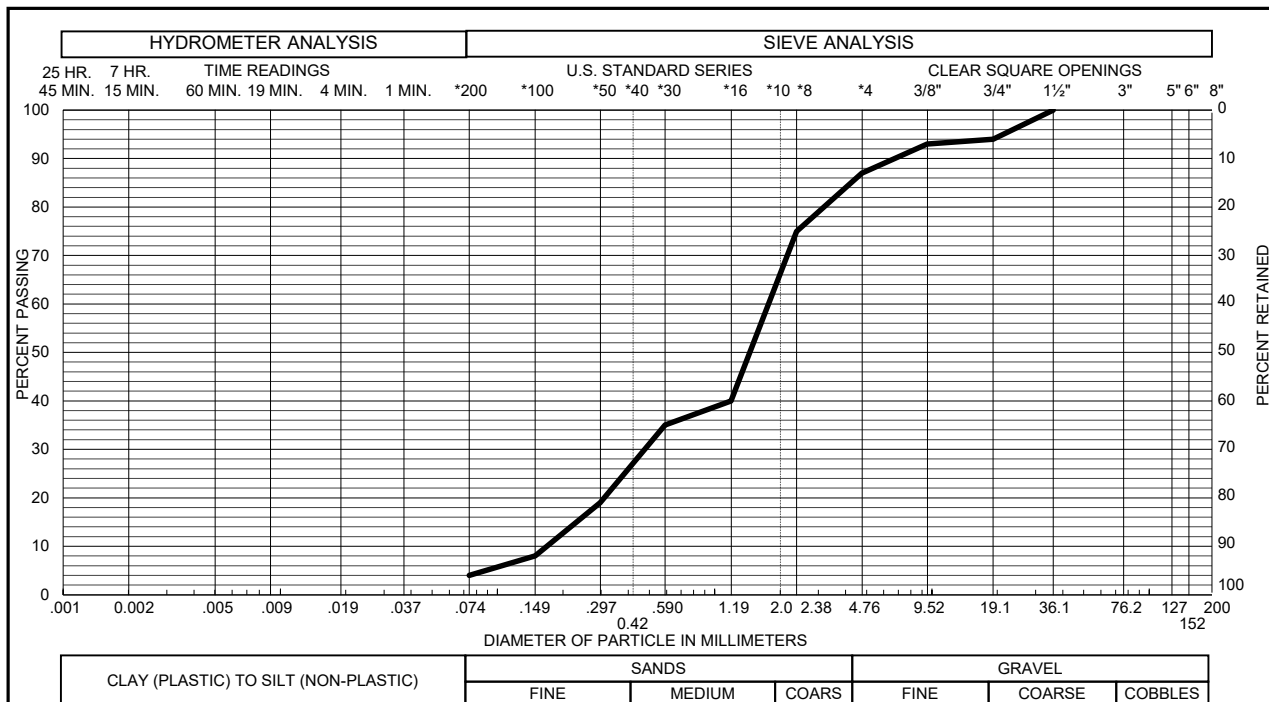
FIG. B-2

Sample of SAND (SP) GRAVEL 13 % SAND 83 %
From TH - 2 AT 9 FEET SILT & CLAY 4 % LIQUID LIMIT
PLASTICITY INDEX

Gradation Test Results

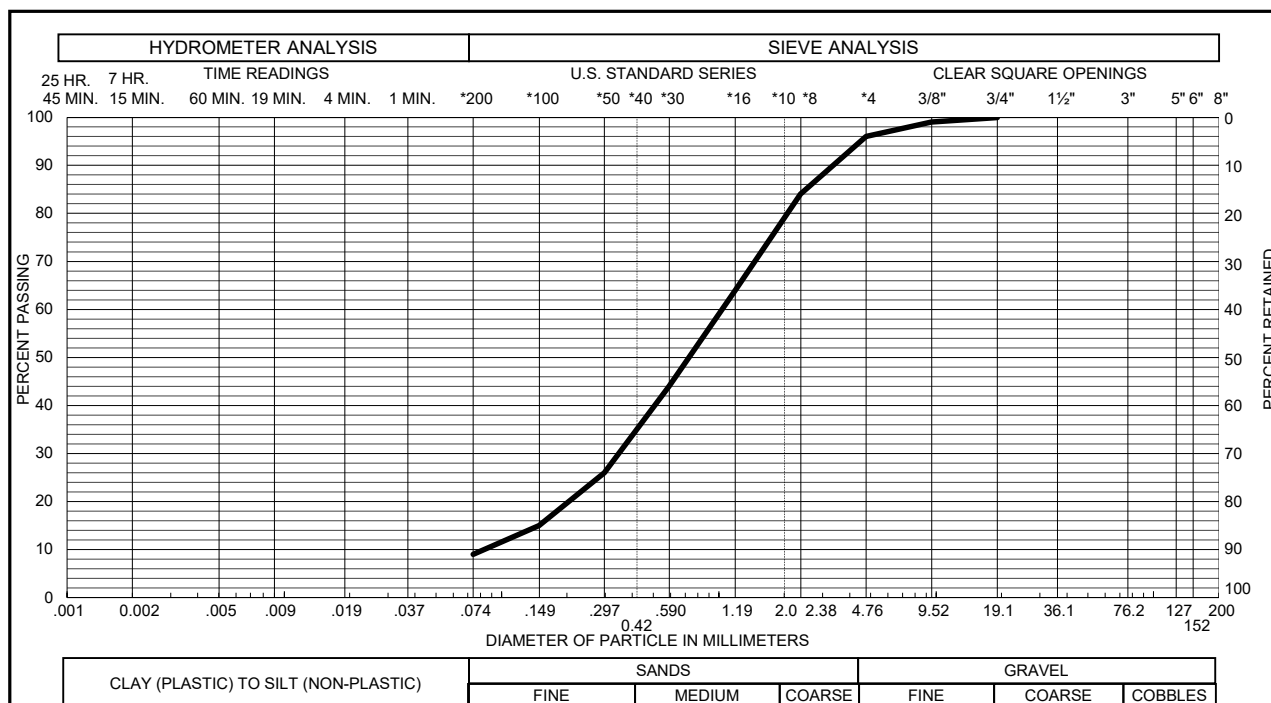
Sample of SAND, SLIGHTLY SILTY (SP-SM) GRAVEL 4 % SAND 87 %
From TH - 4 AT 4 FEET SILT & CLAY 9 % LIQUID LIMIT
PLASTICITY INDEX

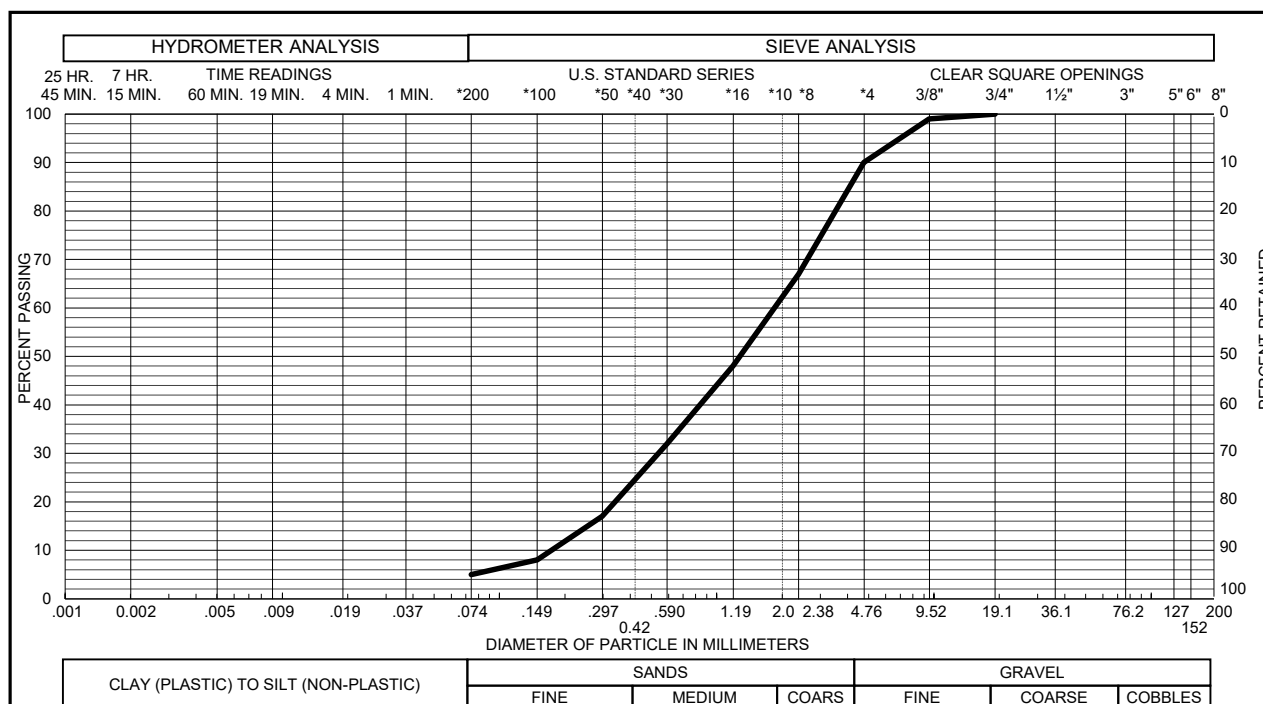
FIG. B-3

Sample of SAND, SLIGHTLY SILTY (SP-SM) GRAVEL 10 % SAND 85 %
From TH - 5 AT 14 FEET SILT & CLAY 5 % LIQUID LIMIT
PLASTICITY INDEX

Gradation Test Results

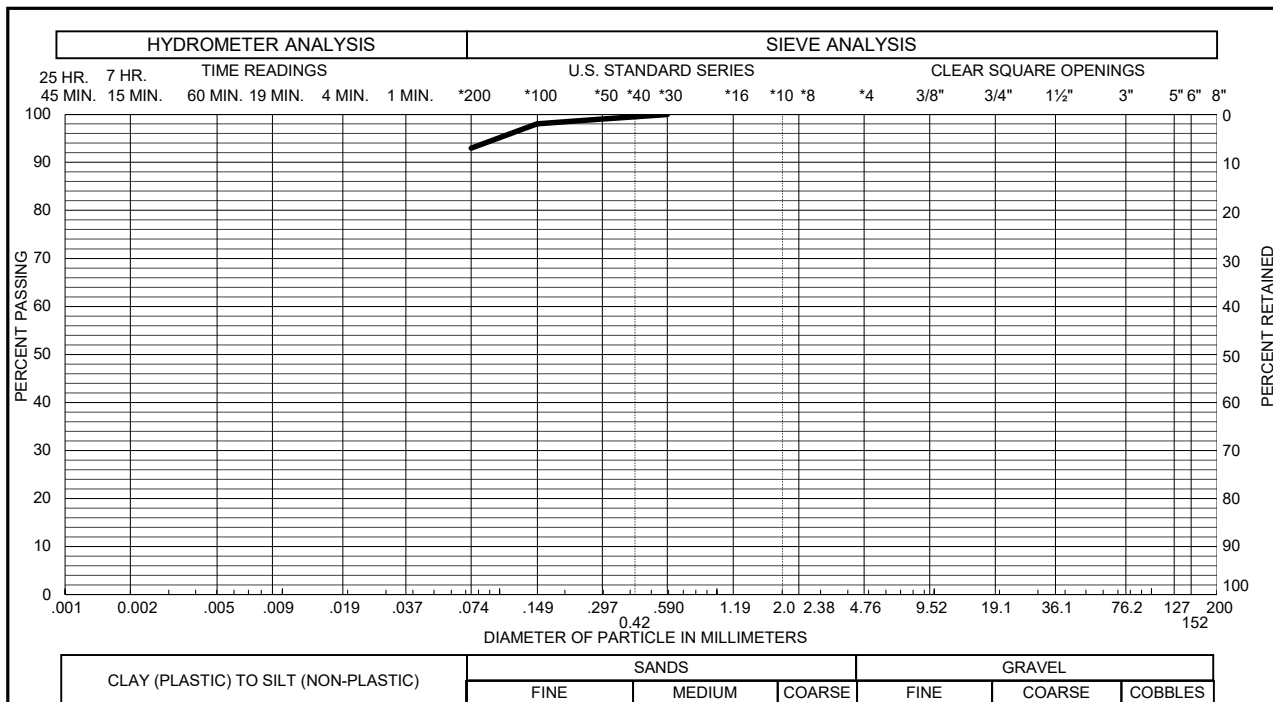
Sample of CLAY (CL) GRAVEL 0 % SAND 7 %
From TH - 7 AT 4 FEET SILT & CLAY 93 % LIQUID LIMIT 46
PLASTICITY INDEX 23

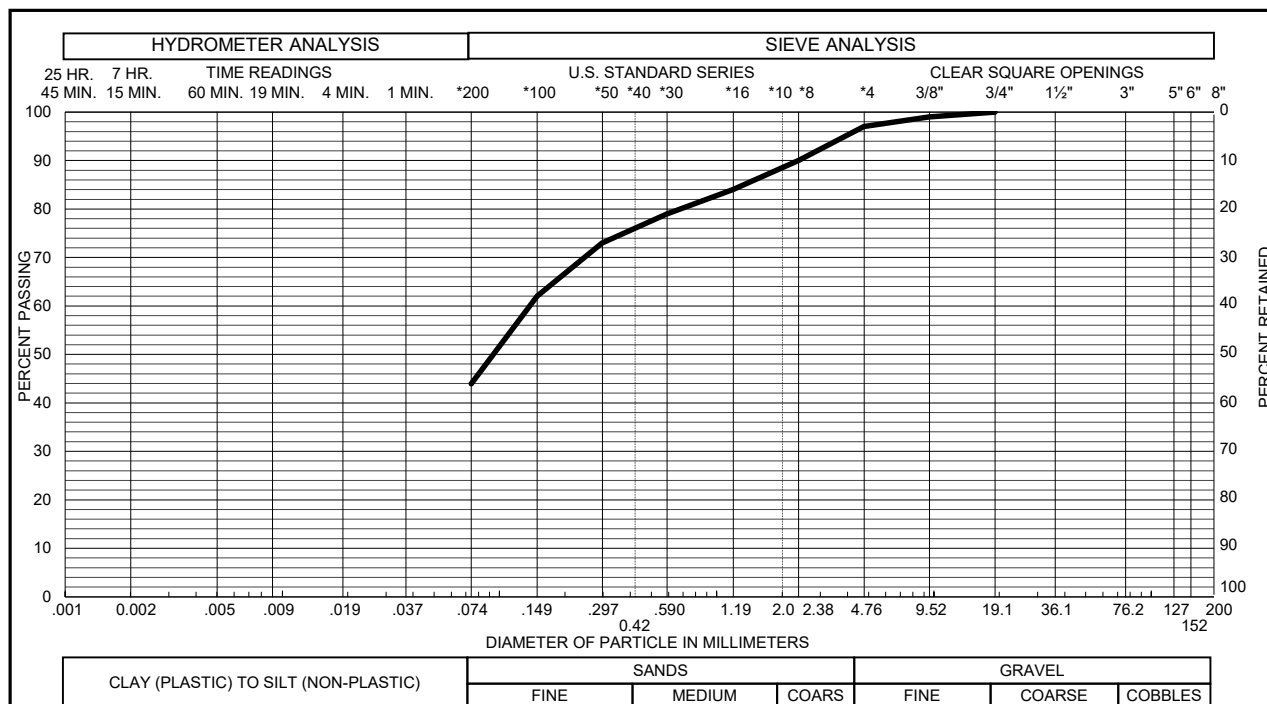
FIG. B-4

Sample of SAND, VERY SILTY (SM) GRAVEL 3 % SAND 53 %
From TH - 8 AT 4 FEET SILT & CLAY 44 % LIQUID LIMIT
PLASTICITY INDEX

Gradation Test Results

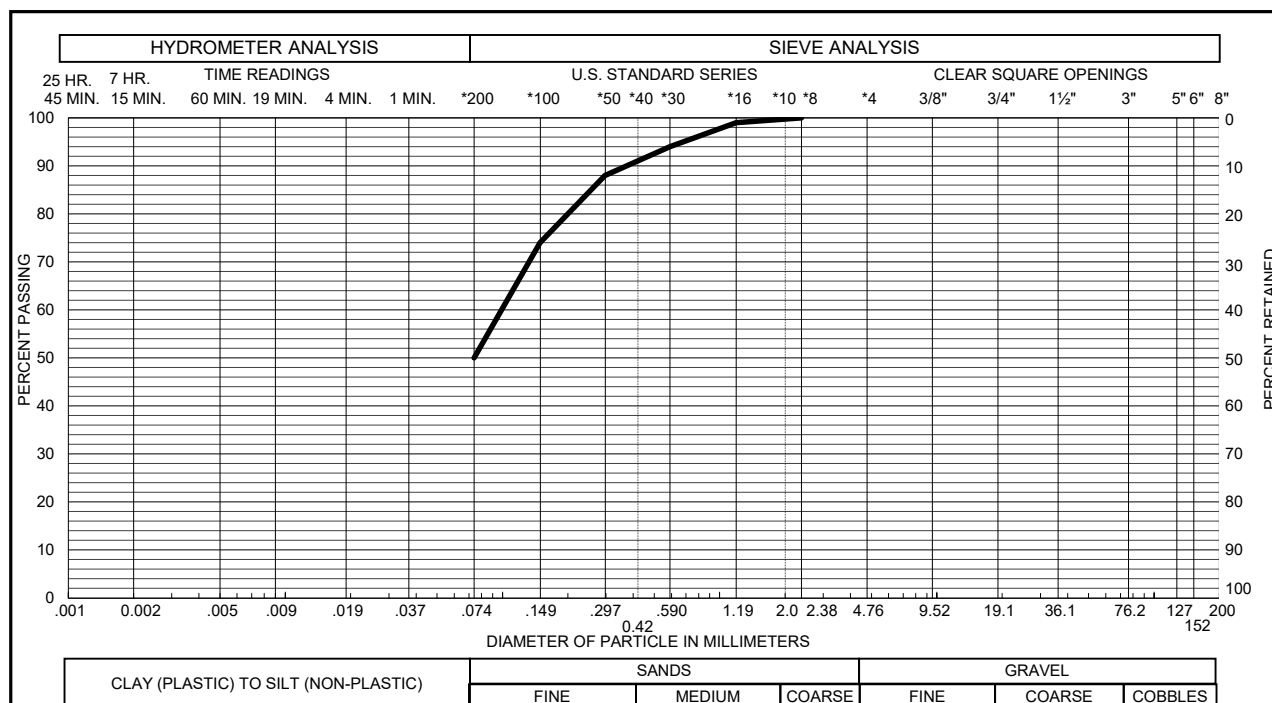
Sample of SILT, VERY SANDY TO SAND, VERY SILTY (ML-SM) GRAVEL 0 % SAND 50 %
From TH - 9 AT 9 FEET SILT & CLAY 50 % LIQUID LIMIT _____
PLASTICITY INDEX _____

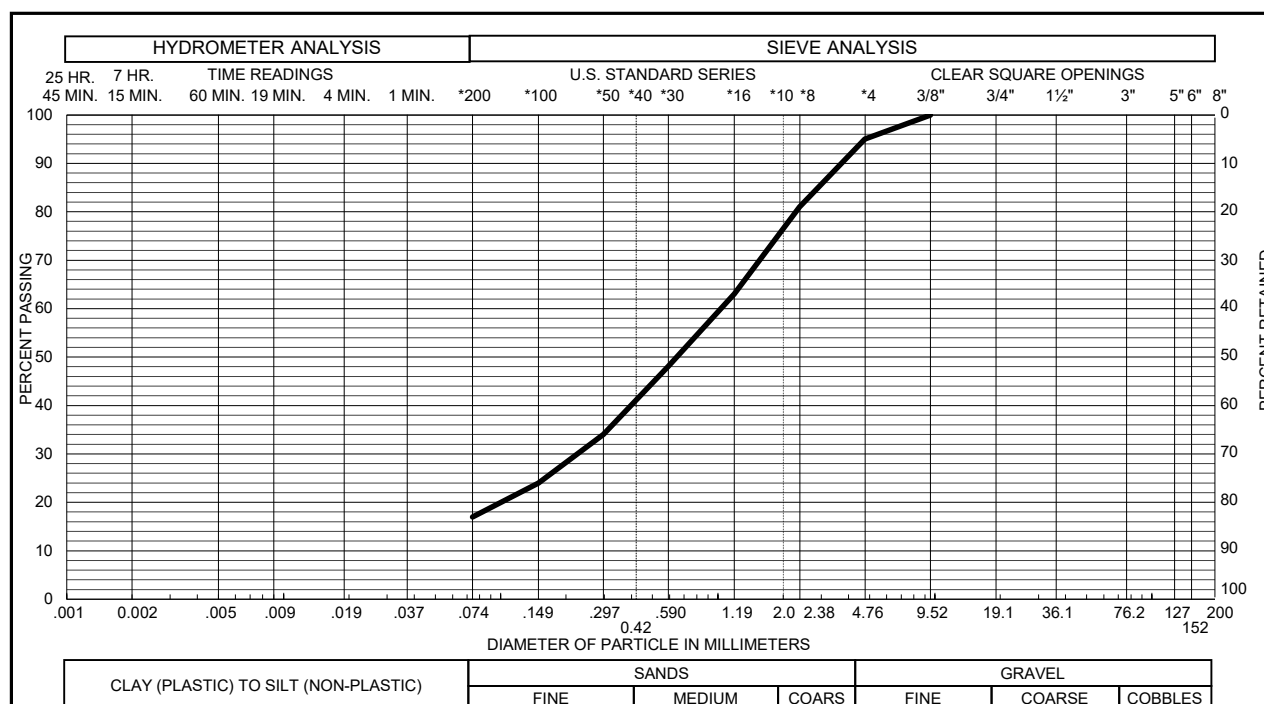
Sample of SAND, SILTY (SM) GRAVEL 5 % SAND 78 %
From TH - 10 AT 4 FEET SILT & CLAY 17 % LIQUID LIMIT _____
PLASTICITY INDEX _____

Gradation Test Results
