Channel Design Report For 60% Design: Rolling Meadows Channel and Floodplain Modification

Updated: January 31, 2023

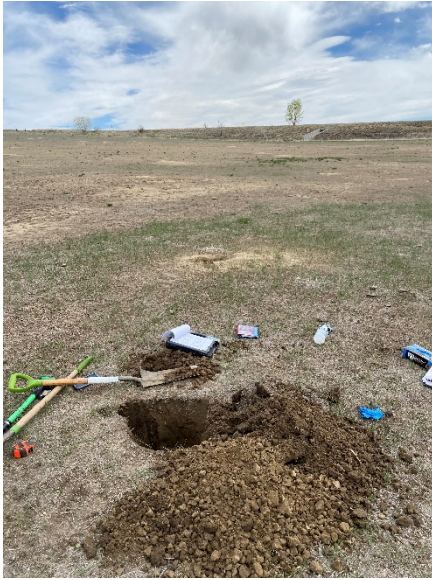
Photo 1 – Community 1 includes a relatively flat area identified as a seasonally flooded riverine system by the USFWS NWI. Test pit shown in center of foreground.

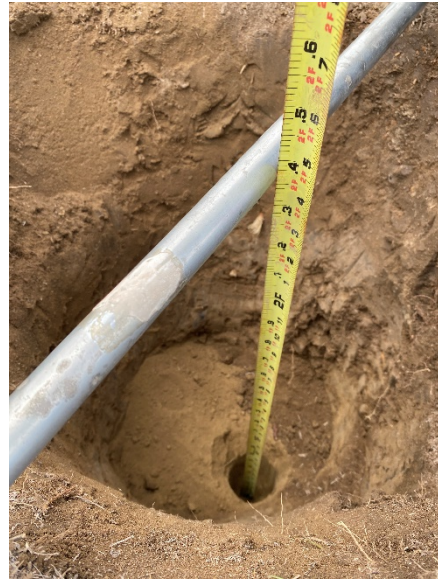
Photo 2 – Community 1’s sandy clay soils didn’t exhibit hydric soil indicators. Additionally, saturation and a water table were not encountered despite the soil pit extending to a depth of 28 inches.

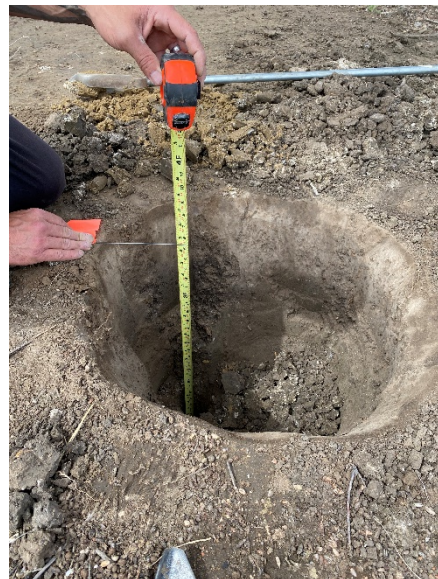
Photo 4 – Community 2’s sandy clay loam and clay soils didn’t exhibit hydric soil indicators. Additionally, saturation and a water table were not encountered despite the soil pit extending to a depth of 42 inches.

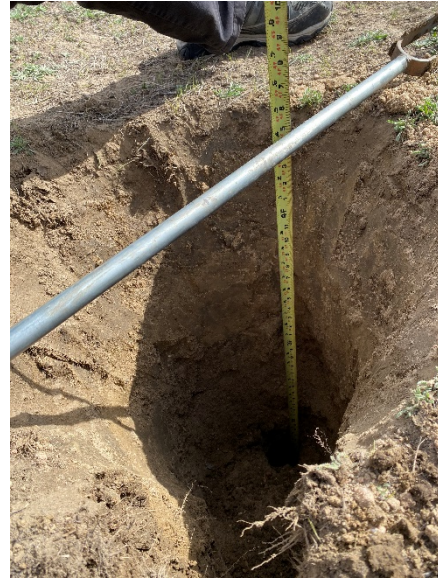
Photo 6 – Community 3's sandy loam, loamy sand and sand soils didn't exhibit hydric soil indicators, and saturation and a water table were not encountered despite the soil pit extending to a depth of 52 inches.

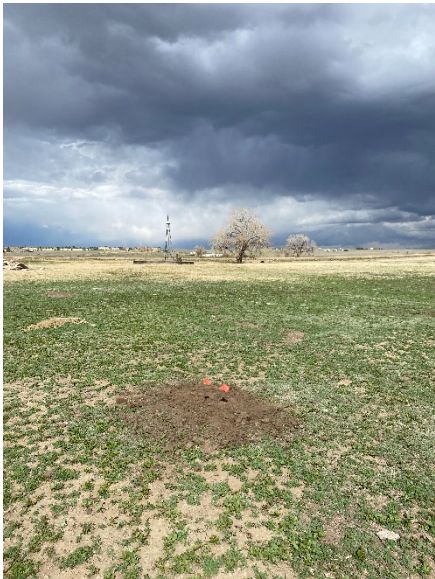
Photo 7 – Community 4 includes a relatively flat area identified as a seasonally flooded riverine system by the USFWS NWI. Test pit is in the center of the middle ground.

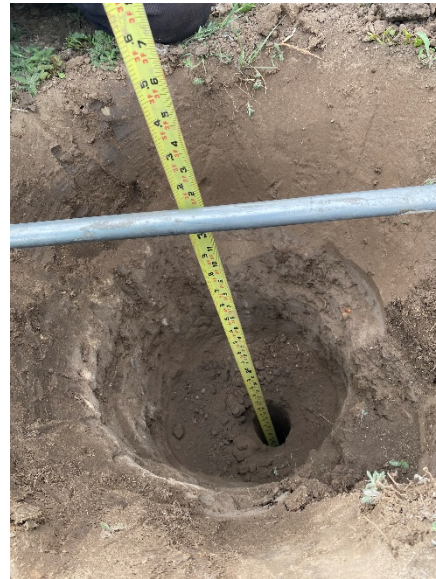
Photo 8 – Community 4's sandy loam and sandy clay loam soils didn't exhibit hydric soil indicators, and saturation and a water table were not encountered despite the soil pit extending to a depth of 38 inches.

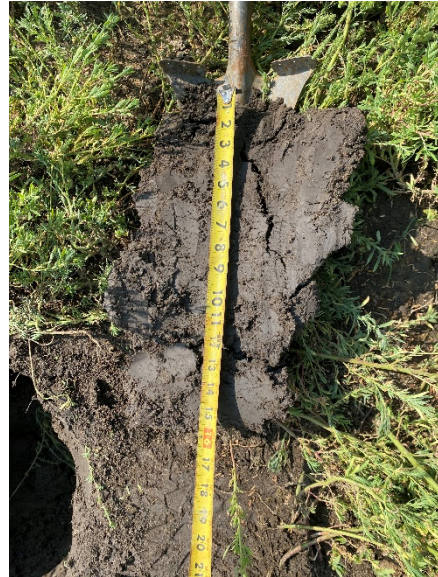
Photo 12 – Community 6’s sandy loam soils contained 5% prominent redox concentrations from 4-12 inches, which satisfied the criteria for redox dark surface.

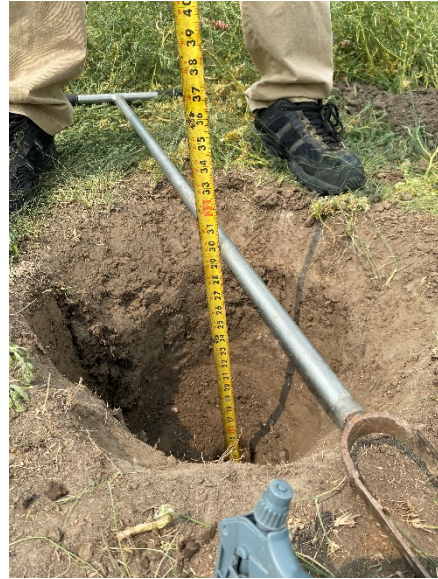
Photo 14 – Community 7's silty clay loam and sandy loam soils didn't exhibit hydric soil indicators, and saturation and a water table were not encountered despite the soil pit extending to a depth of 30 inches.

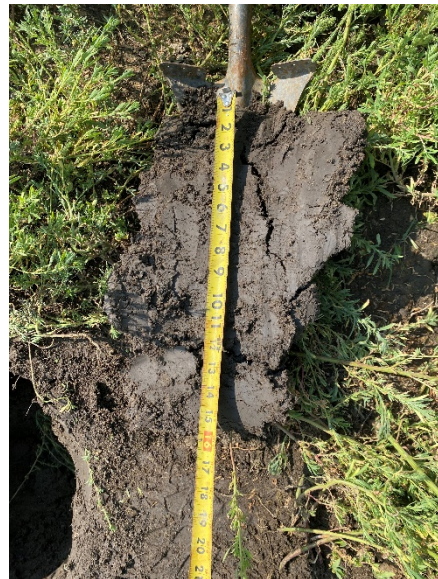
Photo 16 – Community 8's clay loam and silty loam soils didn't exhibit hydric soil indicators, and saturation and a water table were not encountered despite the soil pit extending to a depth of 48 inches.

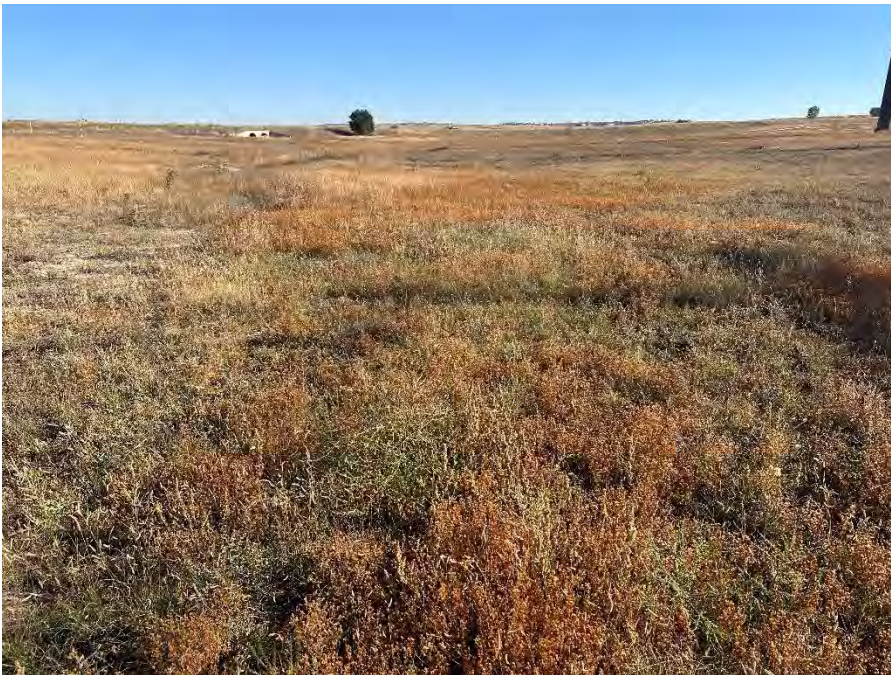
Photo 2: Standing away from the northern side of the Property, looking north, towards the culvert crossing.

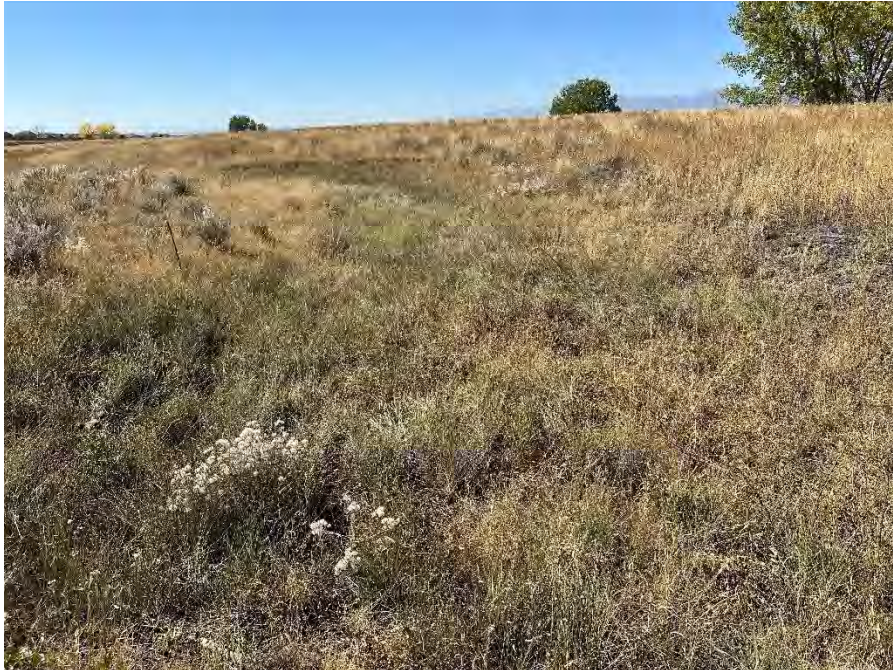
Photo 3: Representative photo of the channel within the northern section of the Property.

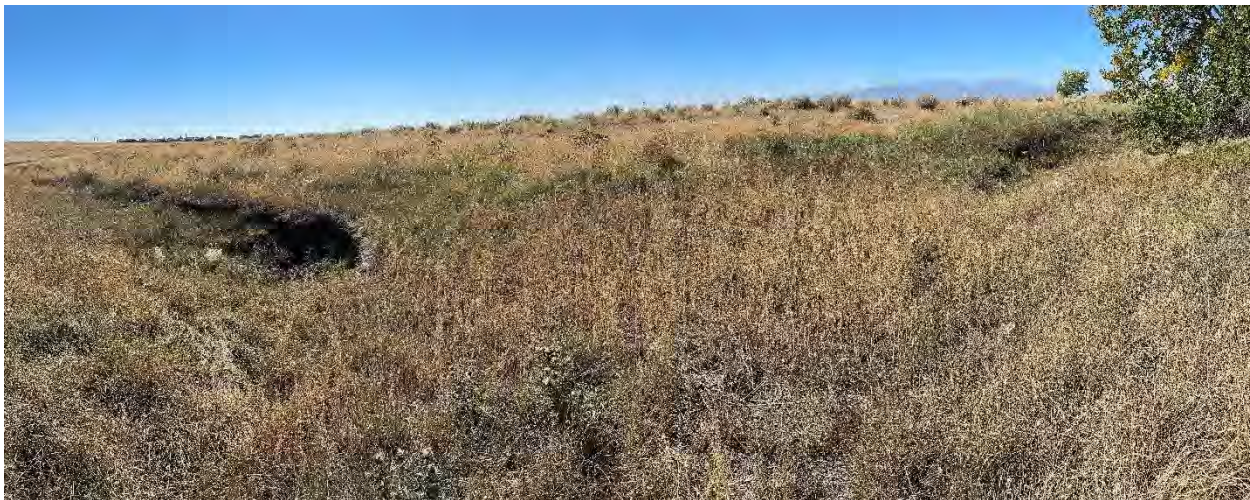
Photo 4: Representative photo of the lack of channel connectivity, throughout the drainage.

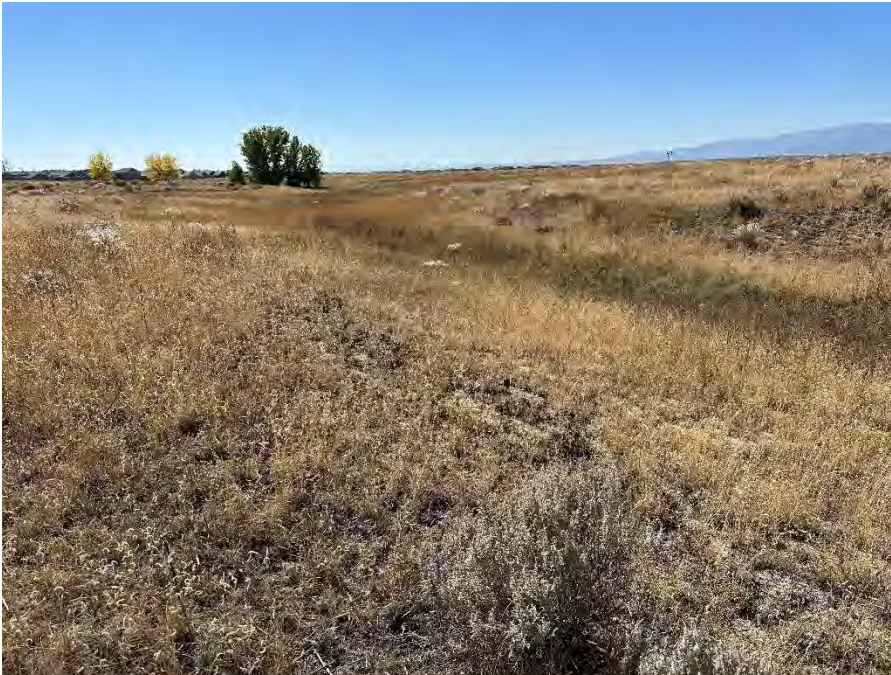
Photo 5: Representative of fully vegetated channel, near the center of the Property.

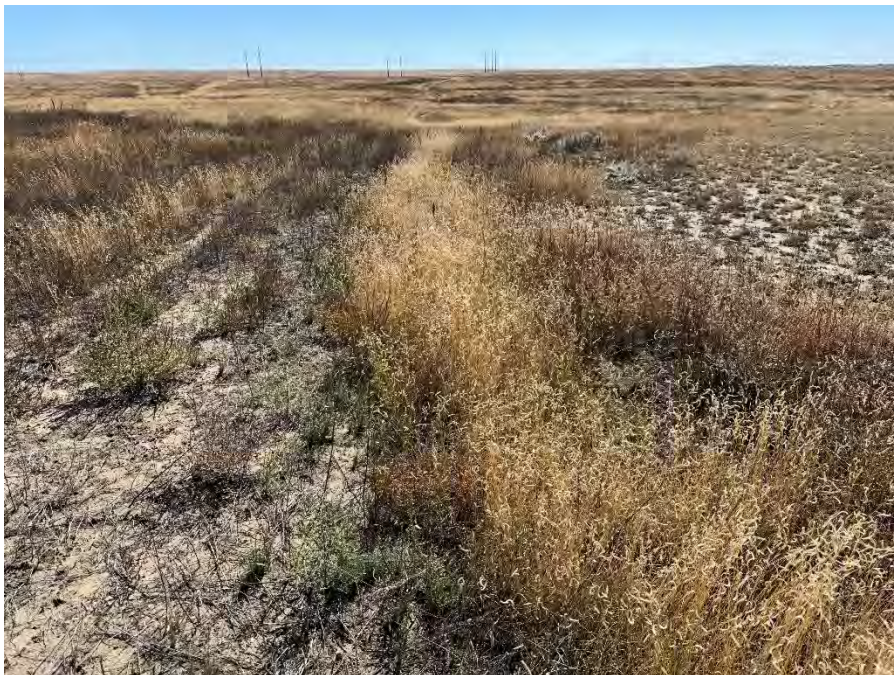
Photo 8: Representative photo of an earthen dam, dividing the channel.

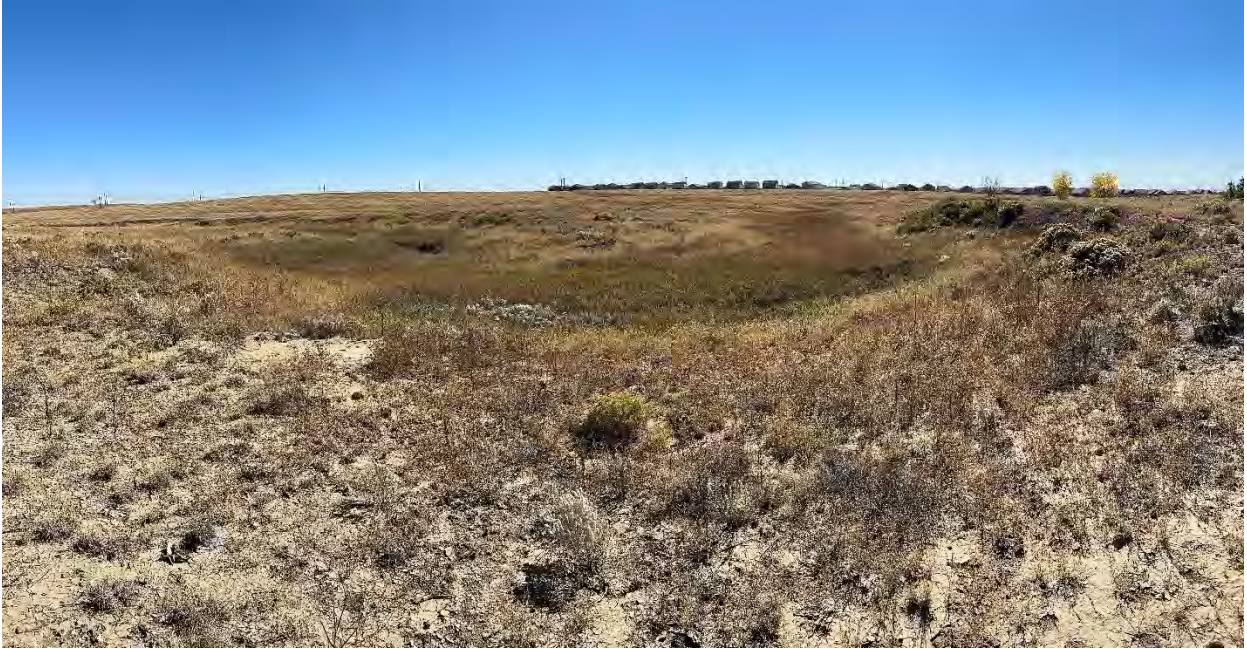
Photo 9: Depression within the channel.

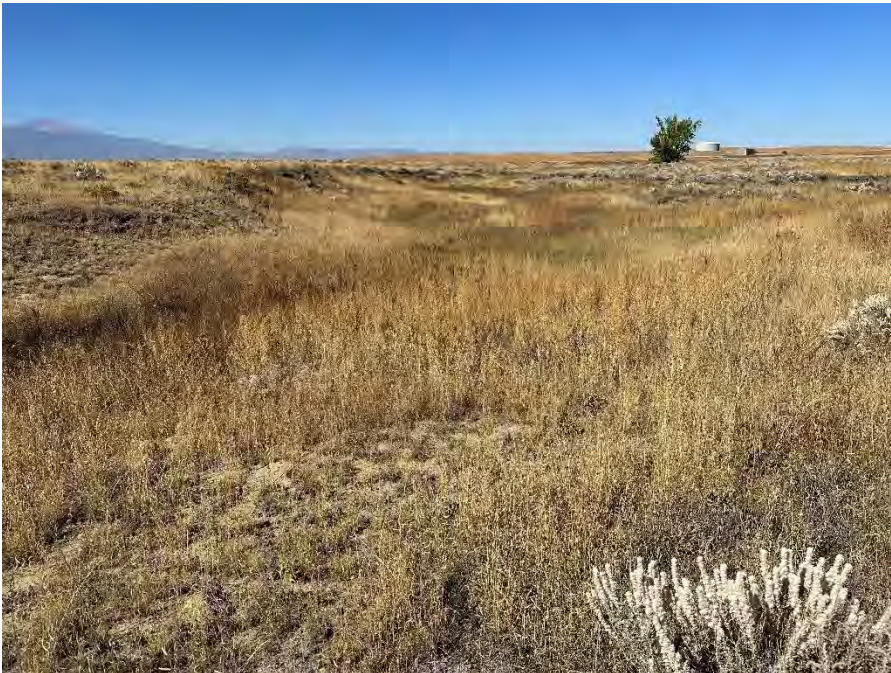
Photo 10: Standing in the channel, facing northwest, on the southern end of the Property.

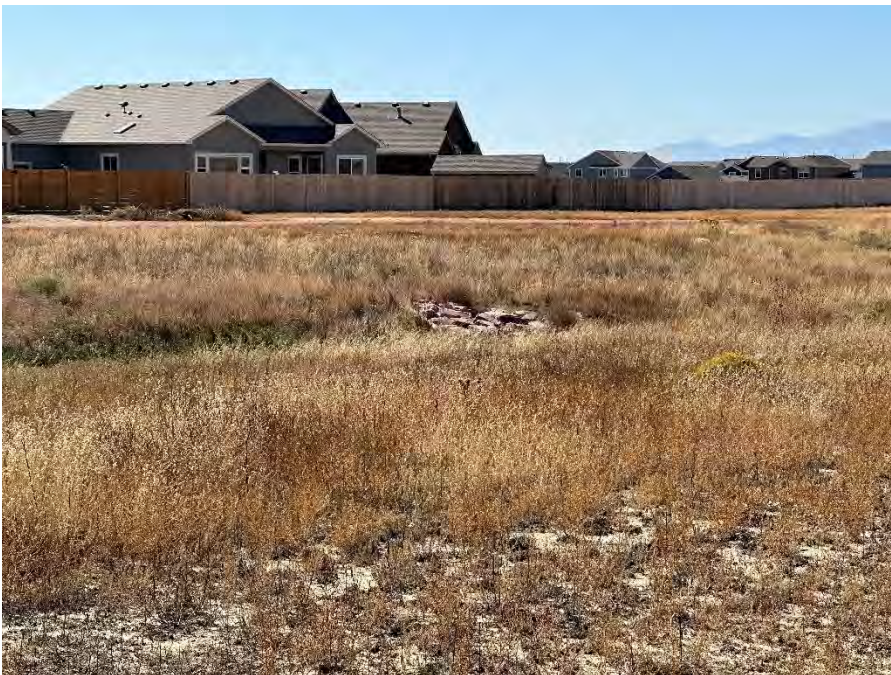
Photo 12: Representative photo of a rock structure within the channel, near the south end of the Property.

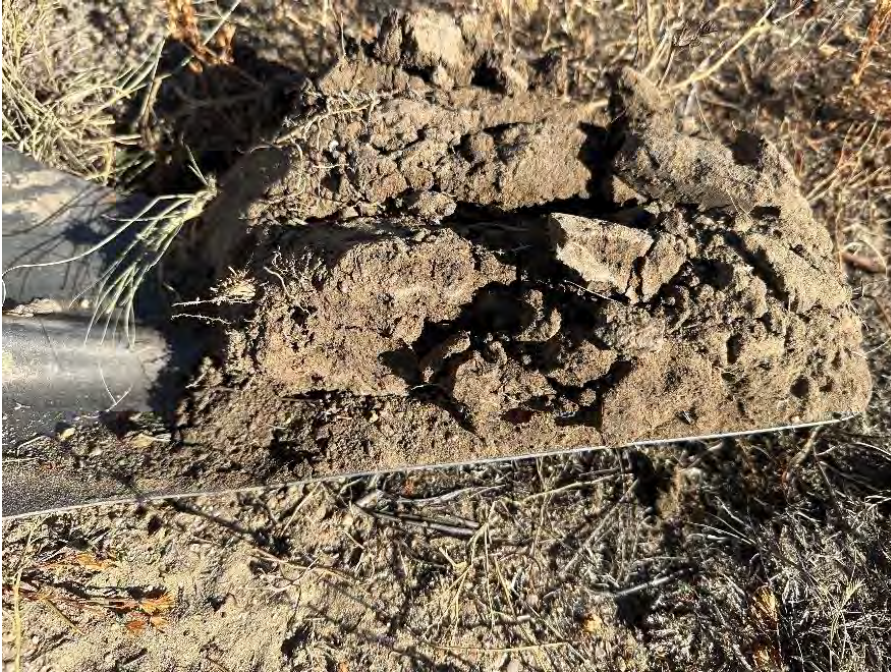
Photo 13: Representative photo of the upland soil profile, throughout the Property.

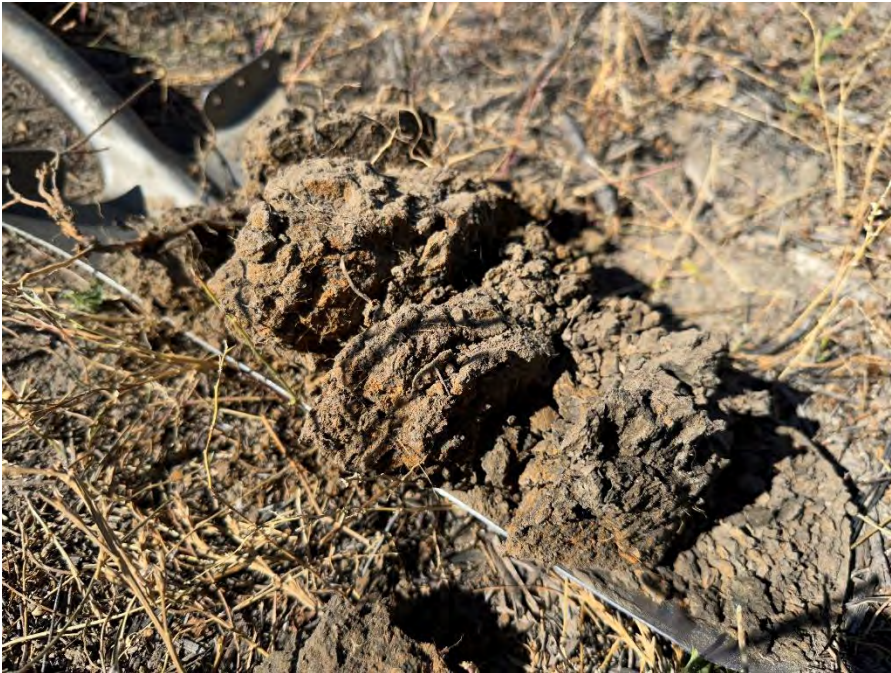
Photo 14: Representative photo of the isolated wetland depressional soil profile, throughout the Property.

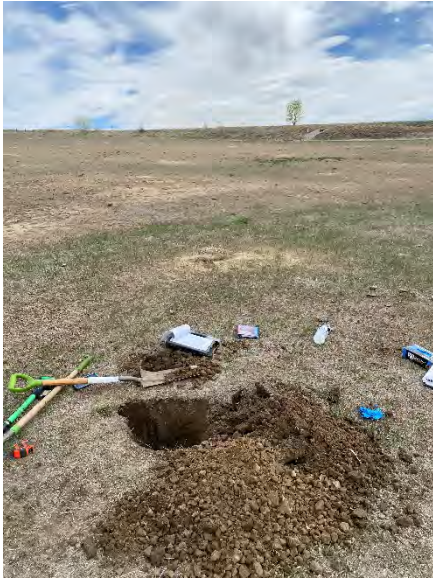
Photo 1 – Community 1 includes a relatively flat area identified as a seasonally flooded riverine system by the USFWS NWI. Test pit shown in center of foreground.

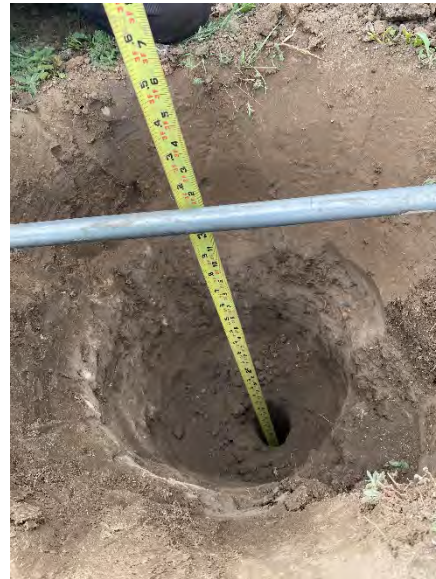
Photo 8 – Community 4's sandy loam and sandy clay loam soils didn't exhibit hydric soil indicators, and saturation and a water table were not encountered despite the soil pit extending to a depth of 38 inches.

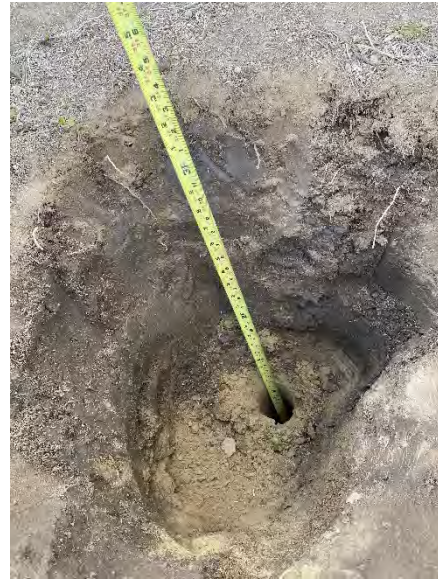
Photo 10 – Community 5's sandy clay and sandy loam soils didn't exhibit hydric soil indicators; however, oxidized rhizospheres along living roots were detectable within 12 inches of the soil surface.

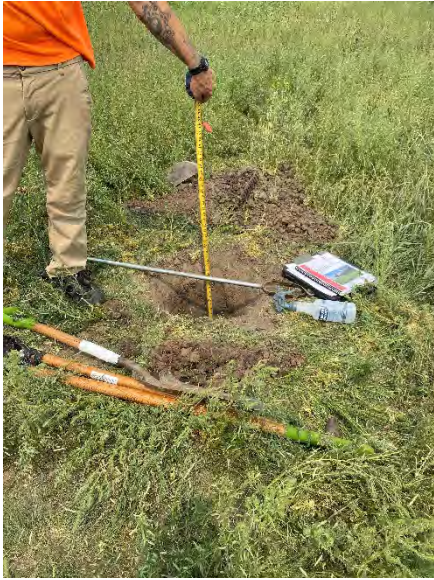
Photo 13 – Community 7 includes the southern edge of the drainage channel that forms Community 6. Test pit is in the center of the middle ground.

Photo 13 – Community 7 includes the southern edge of the drainage channel that forms Community 6. Test pit is in the center of the middle ground.

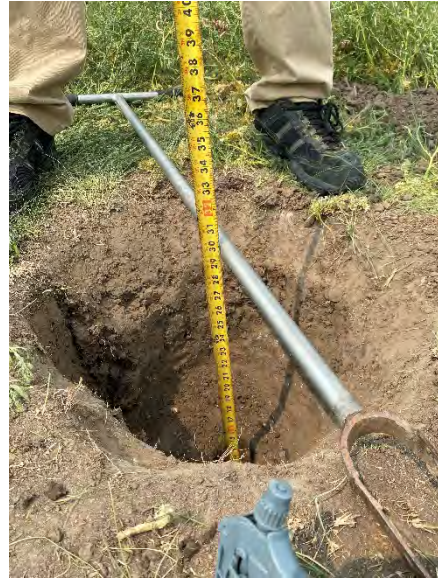
Photo 14 – Community 7's silty clay loam and sandy loam soils didn't exhibit hydric soil indicators, and saturation and a water table were not encountered despite the soil pit extending to a depth of 30 inches.

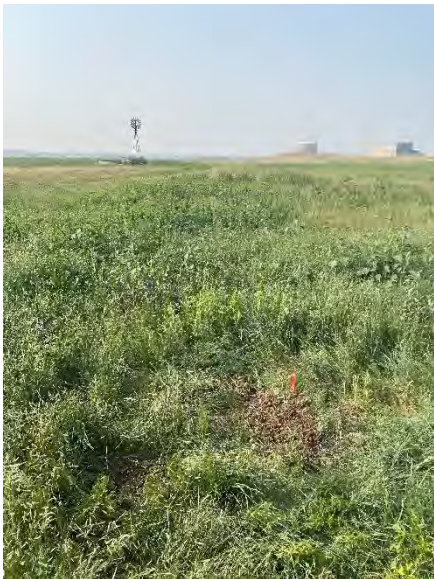
Photo 15 – Community 8 includes a relatively flat area identified as a seasonally flooded riverine system by the USFWS NWI. Test pit is in the center of the foreground.

Photo 15 – Community 8 includes a relatively flat area identified as a seasonally flooded riverine system by the USFWS NWI. Test pit is in the center of the foreground.

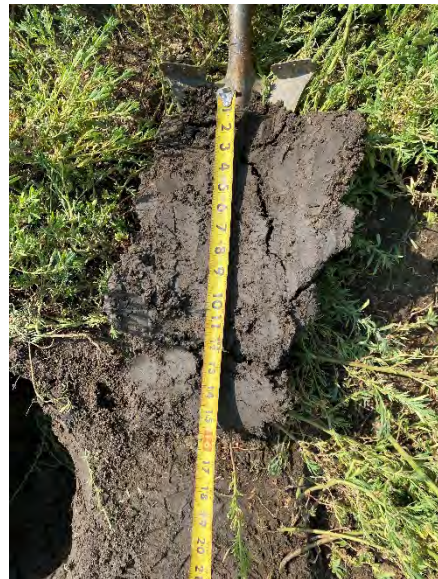
Photo 16 – Community 8's clay loam and silty loam soils didn't exhibit hydric soil indicators, and saturation and a water table were not encountered despite the soil pit extending to a depth of 48 inches.

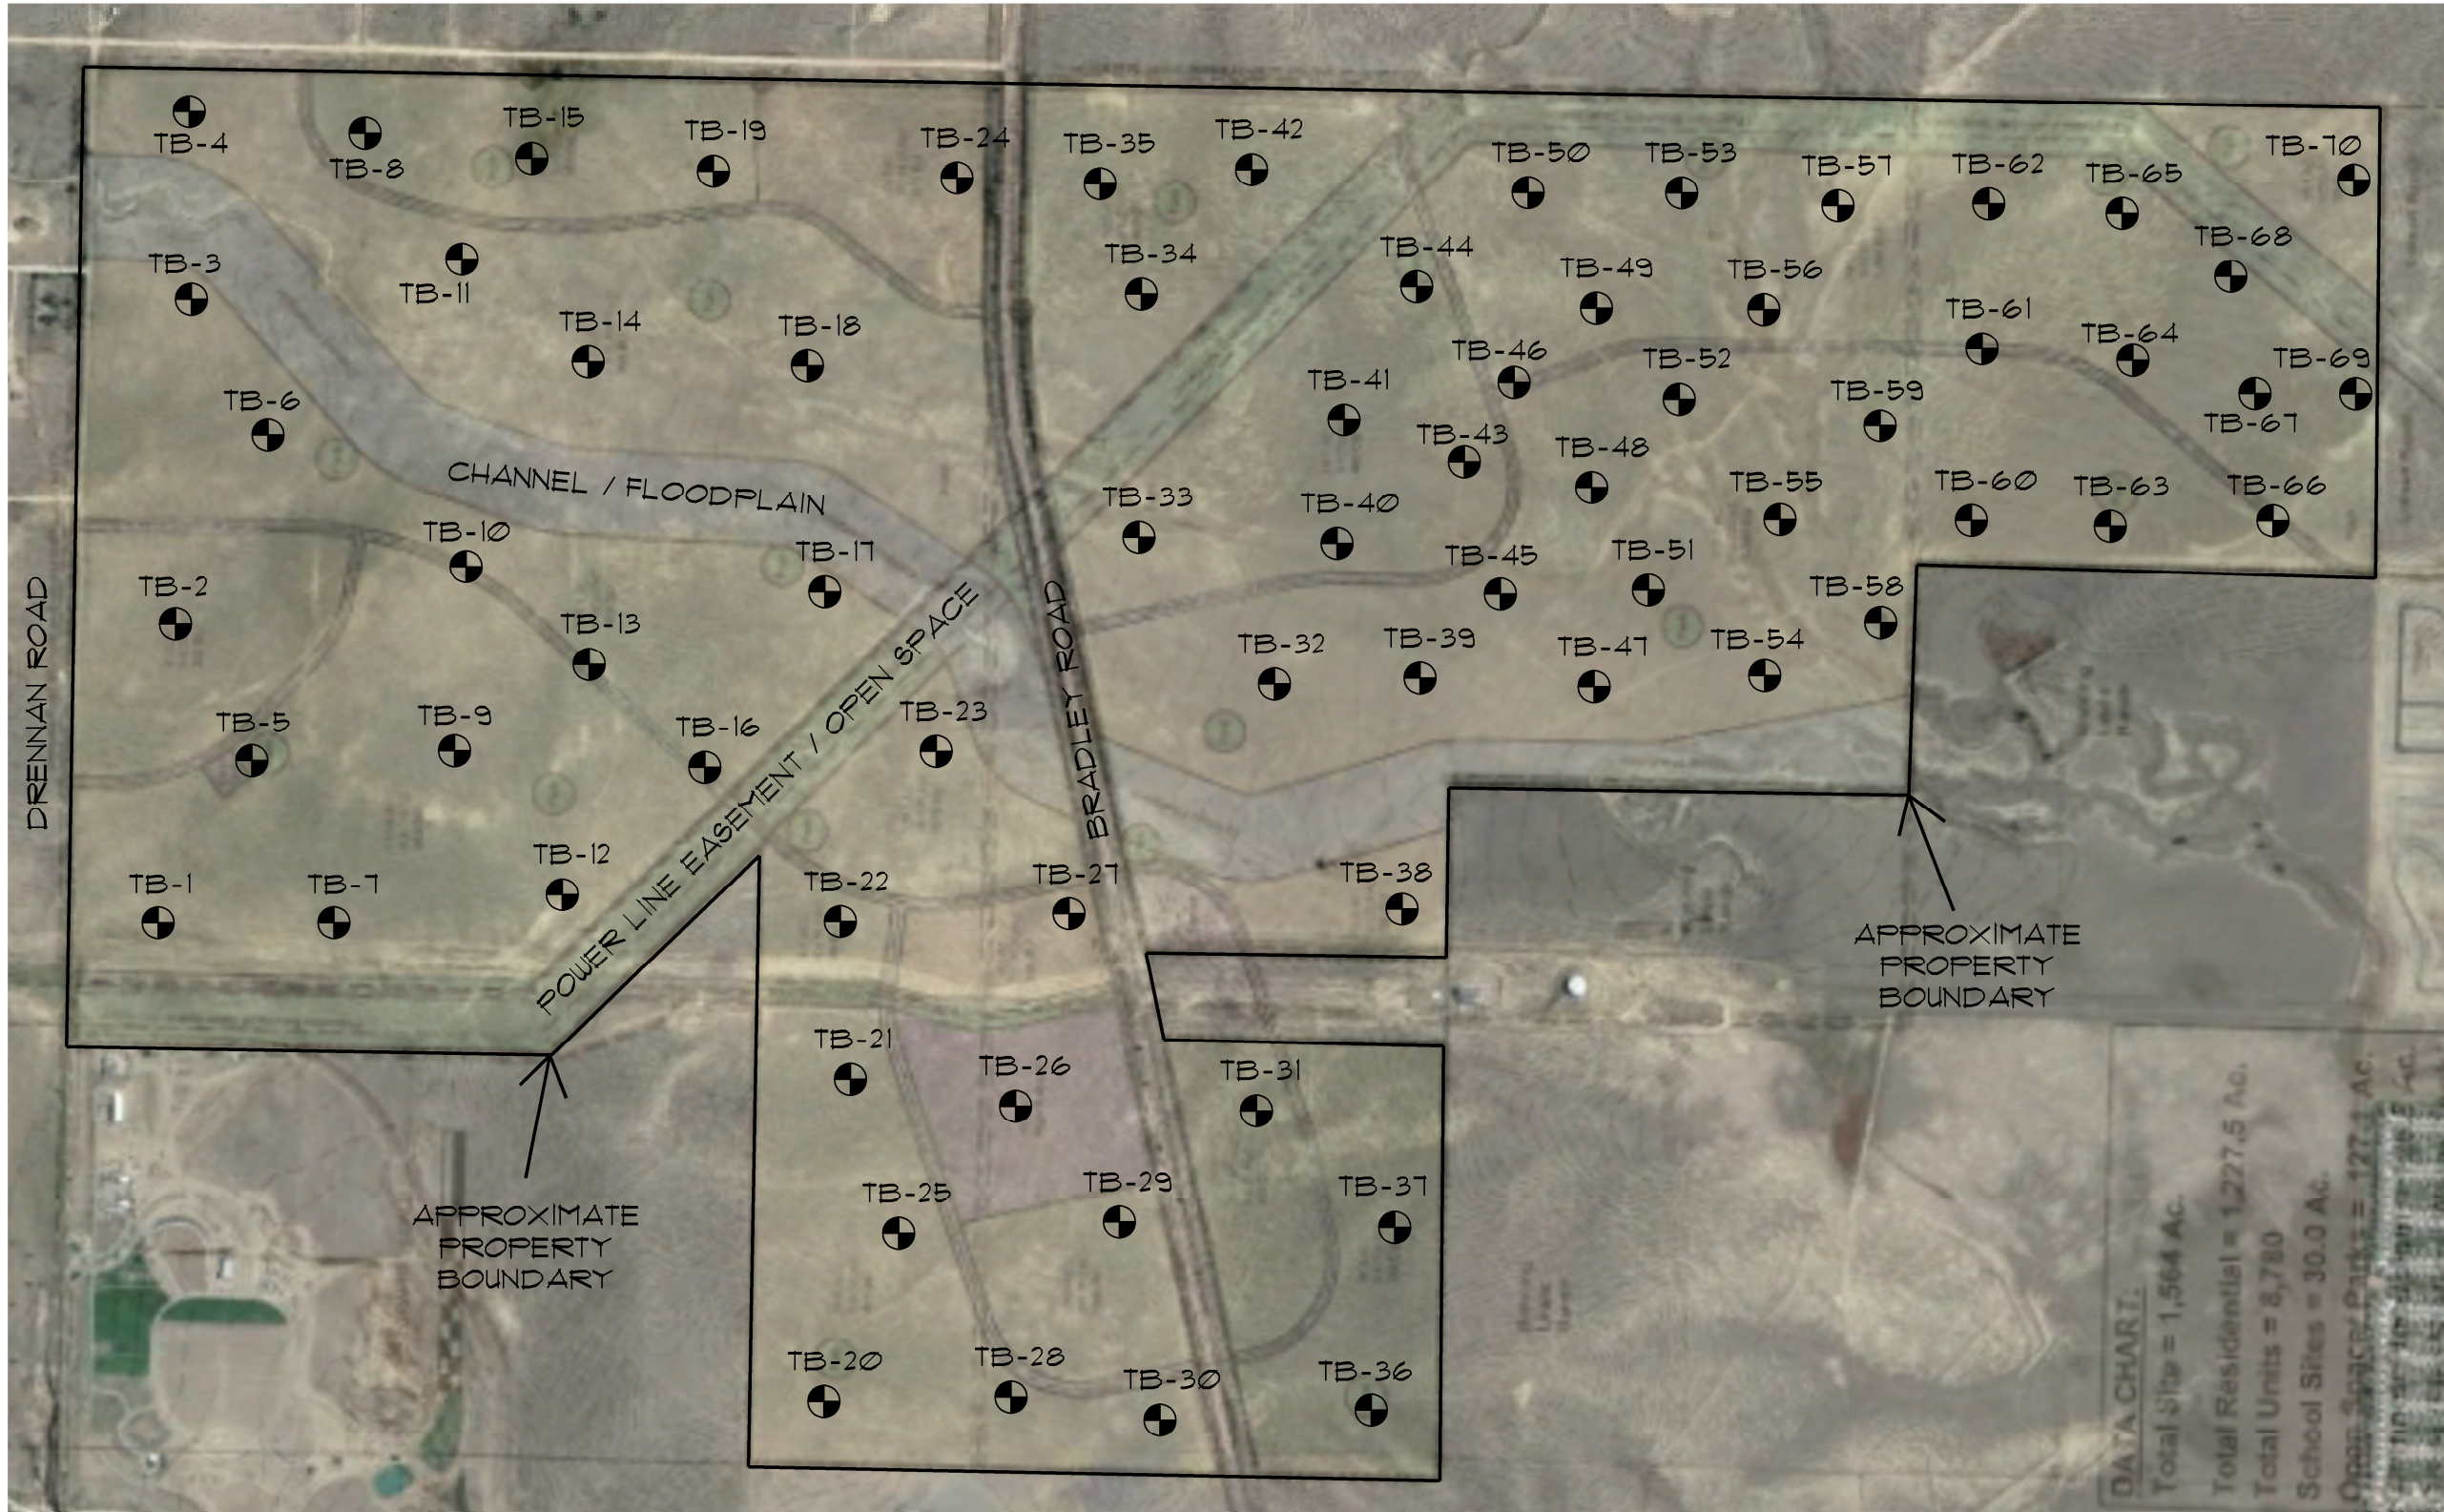
SHEET No. FIG-2

⊕ DENOTES APPROXIMATE LOCATION OF TEST BORINGS

The proposed site development is to consist of approximately 7,785 residential units, comprised of a mixture of single-family to multi-family structures. The lots reportedly are to range from 2,975 to 6,600 square feet. Entrance into the subdivision is to be provided from the east and west by the existing Bradley Road by extending the existing Meridian Road, and from the north by the existing Drennan Road. Additional proposed land usage includes four elementary schools, one middle school, fire station, substations, parks, detention ponds, power line and open space easements, floodplain/channel easements, and a water tank. It is our understanding the existing powerline easement is to remain an open space. The Test Boring Location Plan is presented in Figure 2.

The subsurface conditions within the property were explored by drilling a total of 70 exploratory test borings to depths of approximately 20 to 35 feet below the existing ground surface. The test boring locations are presented on the Test Boring Location Plan, Figure 2.

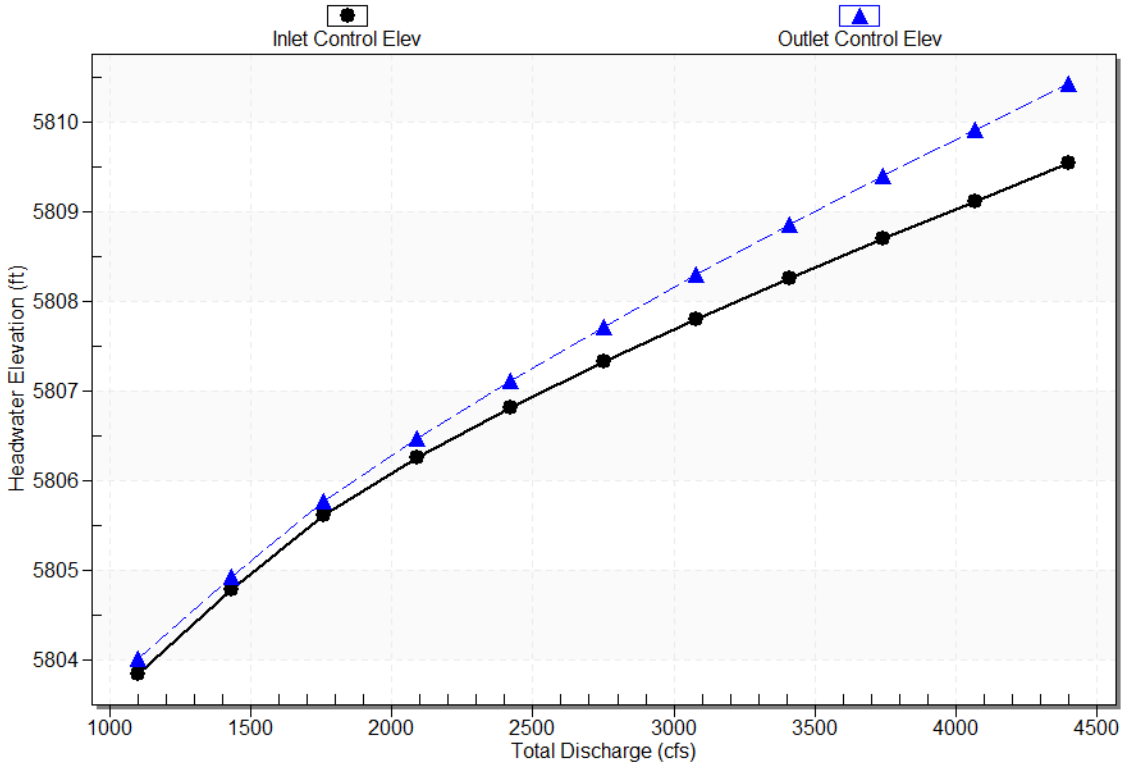
Performance Curve Culvert: CONSPAN O742

Culvert Performance Curve Plot: CONSPAN O742

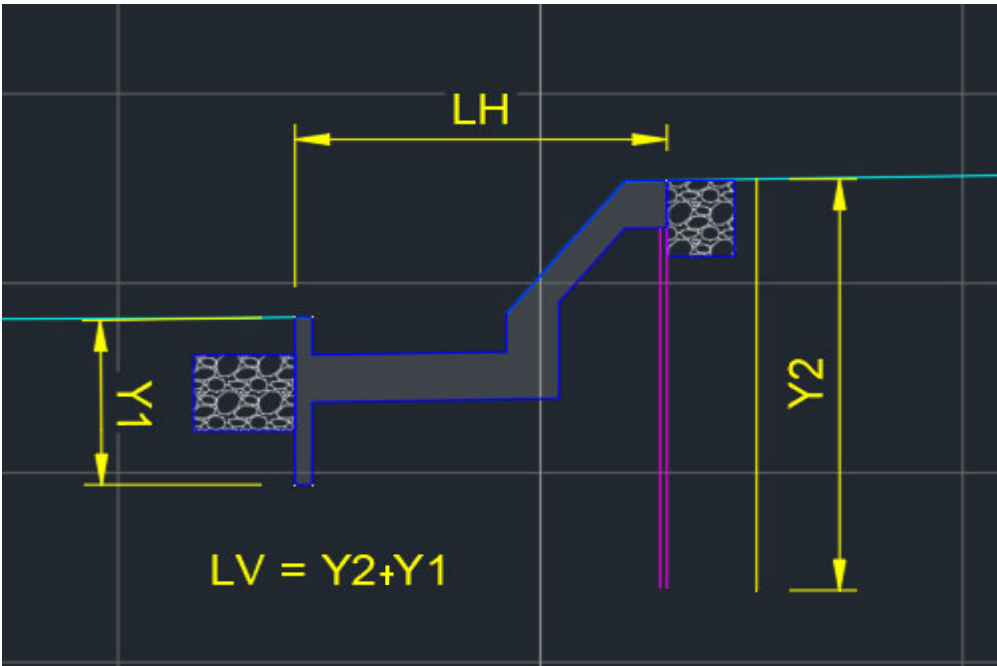
1. Based on the geotechnical report, the soil was found to be predominantly composed of alluvial sand, silt and clay deposits. A target creep ratio for fine sand ($C_w=7.0$) was assumed based on the percent of sand and fines found in the soil.
2. Weep drains are being installed, which reduces the calculated creep ratio by 10%.
3. The horizontal creep length (L_H) was taken from the profile in CAD. See figure below.

Creep Analysis							Upstream Design Sheet Pile Depth (Y2)**	Calculated Cw	Calculated Cw (non-conservative)
Drop	Design Cw	H	L _H	Y1***	Type				
4.5	7.0	4.3	39.0	4.0	Sheet Pile	9.6	5.6	10.4	
3.5	7.0	3.4	35.0	4.0	Sheet Pile	5.2	5.6	9.9	
2.5	7.0	2.4	30.0	4.0	Sheet Pile	9	8.7	16.7
