Channel Design Report For 60% Design: Rolling Meadows Channel and Floodplain Modification

Updated: January 31, 2023

Matrix Design Group

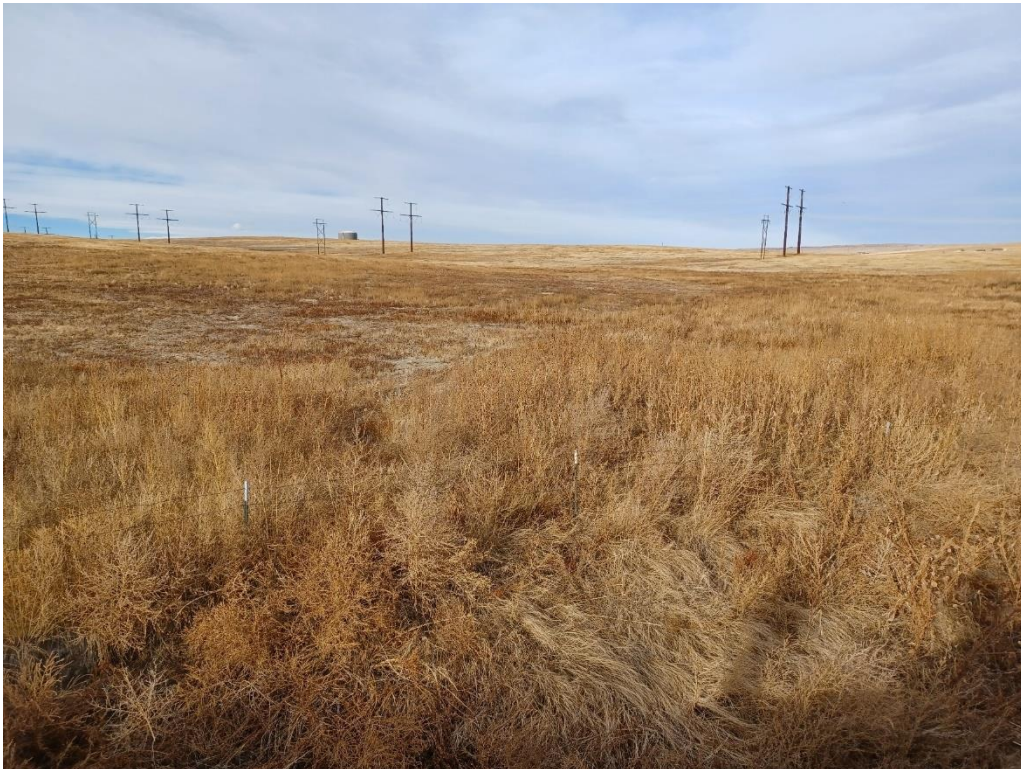
Figure 4. View from Bradley Rd looking South.

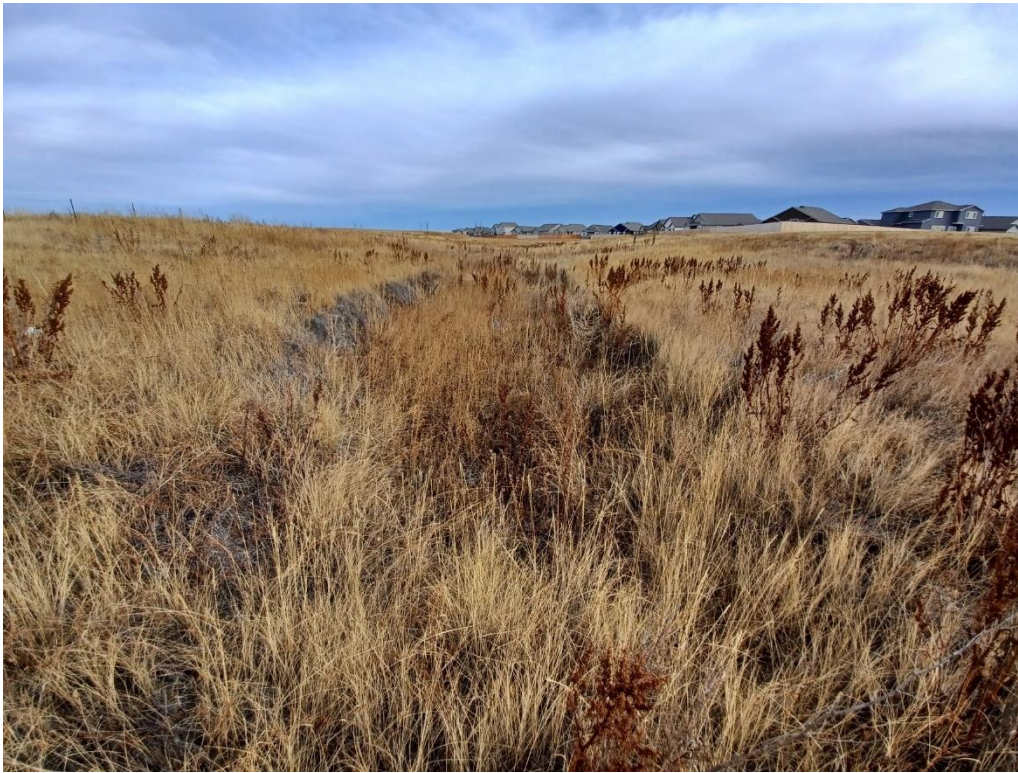
Figure 5. View from southern end of project extents.

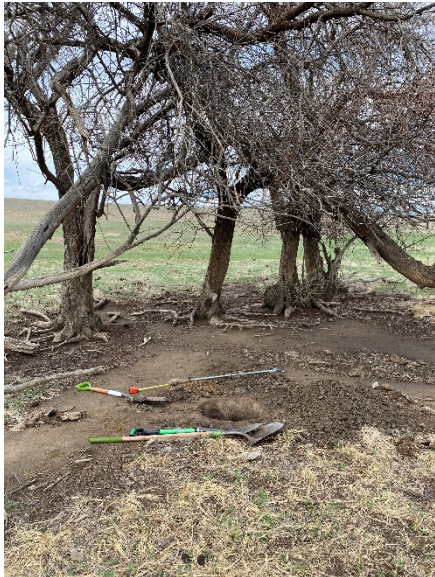
Photo 3 – Community 2 includes a small depression near the eastern boundary of the Site. Test pit is in the center of the middle ground.

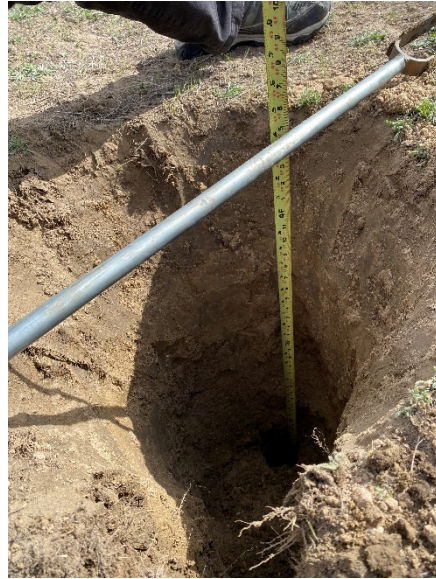
Photo 6 – Community 3's sandy loam, loamy sand and sand soils didn't exhibit hydric soil indicators, and saturation and a water table were not encountered despite the soil pit extending to a depth of 52 inches.

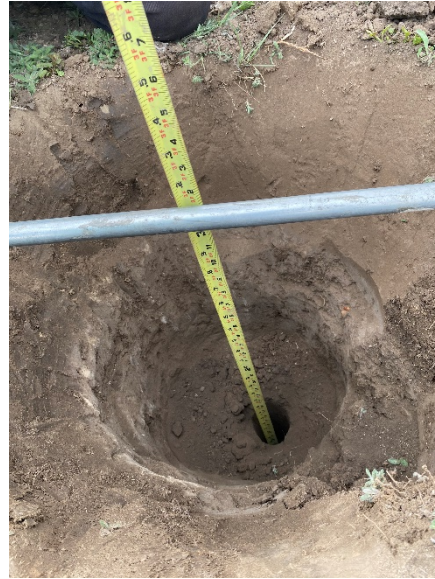
Photo 8 – Community 4's sandy loam and sandy clay loam soils didn't exhibit hydric soil indicators, and saturation and a water table were not encountered despite the soil pit extending to a depth of 38 inches.

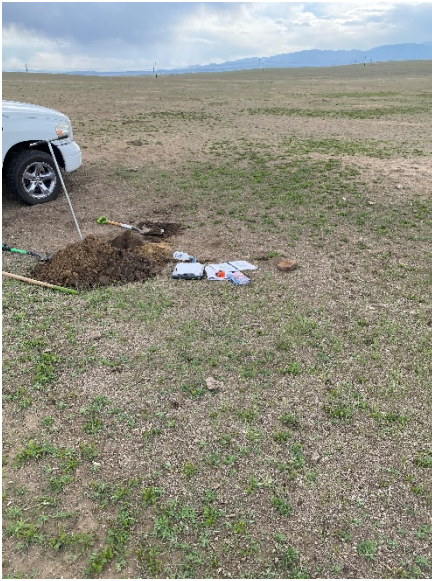
Photo 9 – Community 5 includes a depression near the eastern boundary of the Site within the area identified as a seasonally flooded riverine system by the USFWS NWI. Test pit is on the left in the middle ground.

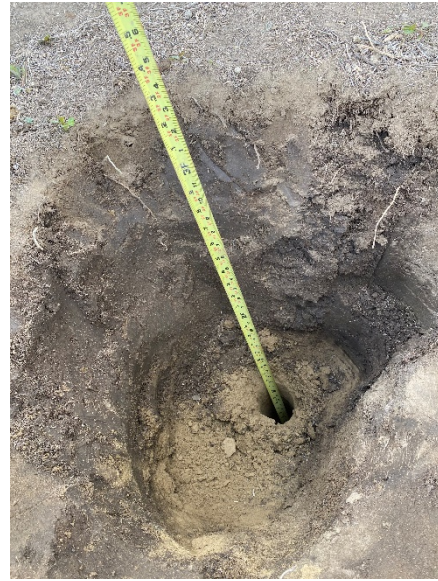
Photo 10 – Community 5’s sandy clay and sandy loam soils didn’t exhibit hydric soil indicators; however, oxidized rhizospheres along living roots were detectable within 12 inches of the soil surface.

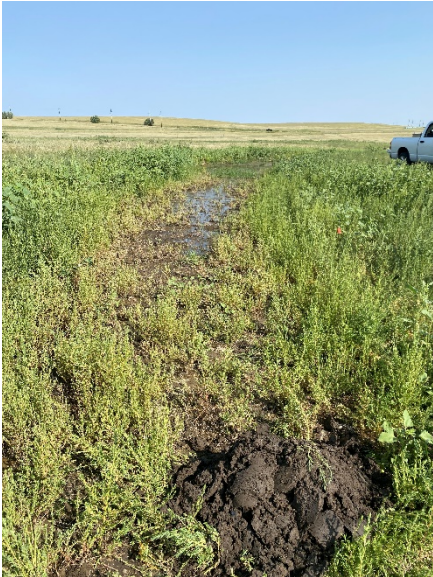
Photo 11 – Community 6 is approximately 0.18 acres and includes a drainage channel associated with a windmill-powered well south of Bradley Road. Test pit is partially shown in the center of the foreground.

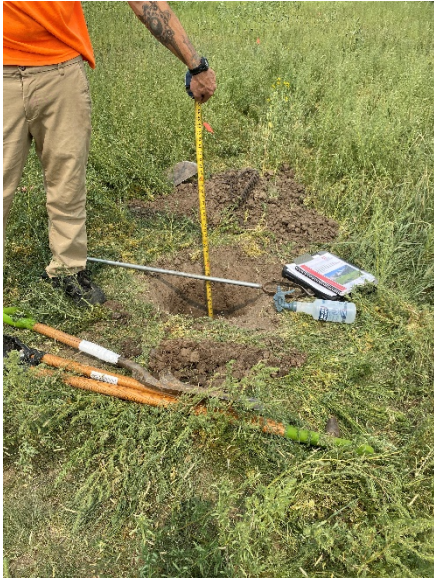
Photo 13 – Community 7 includes the southern edge of the drainage channel that forms Community 6. Test pit is in the center of the middle ground.

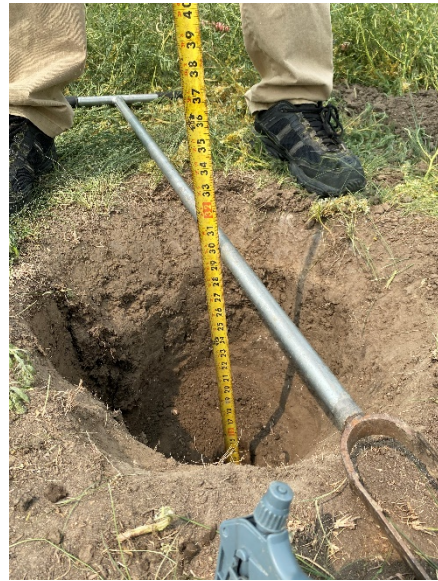
Photo 14 – Community 7's silty clay loam and sandy loam soils didn't exhibit hydric soil indicators, and saturation and a water table were not encountered despite the soil pit extending to a depth of 30 inches.

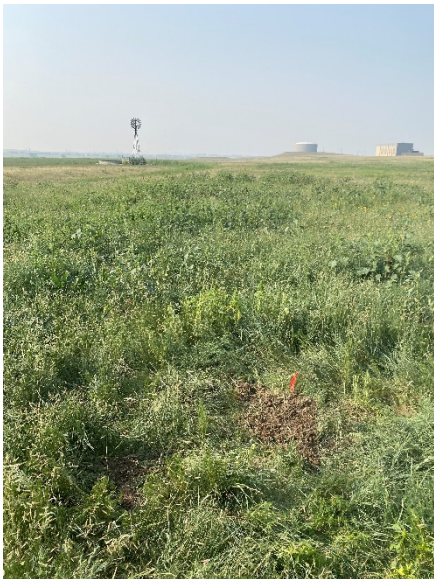
Photo 15 – Community 8 includes a relatively flat area identified as a seasonally flooded riverine system by the USFWS NWI. Test pit is in the center of the foreground.

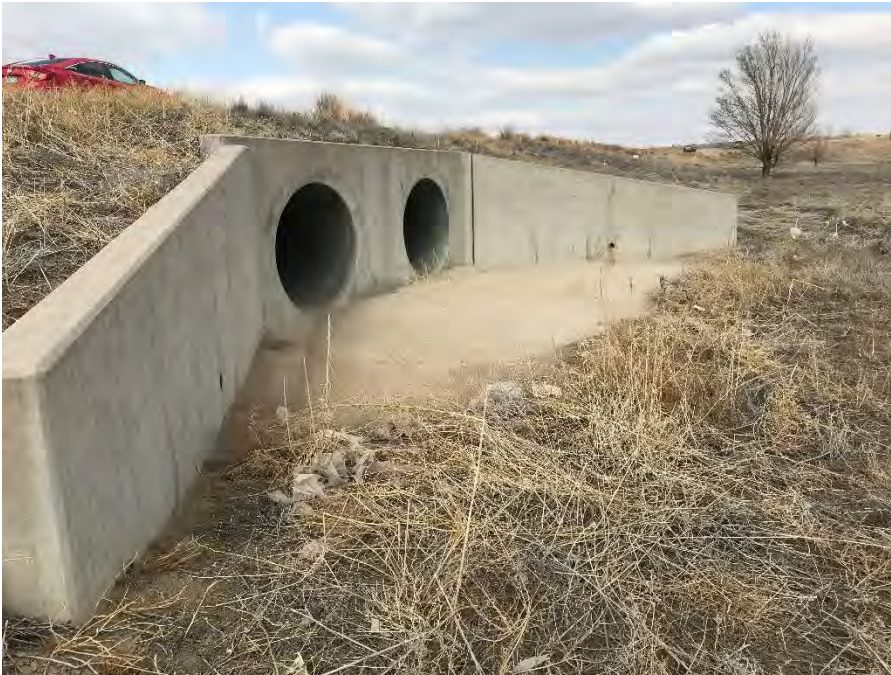
Photo 1: Standing at the northern side of the Property, looking north, towards the culvert crossing.

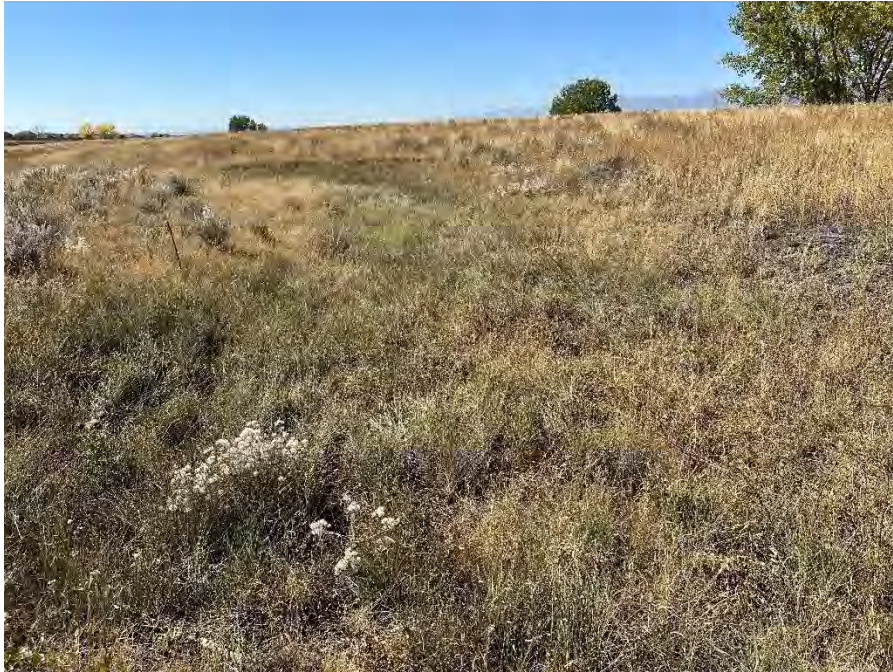
Photo 3: Representative photo of the channel within the northern section of the Property.

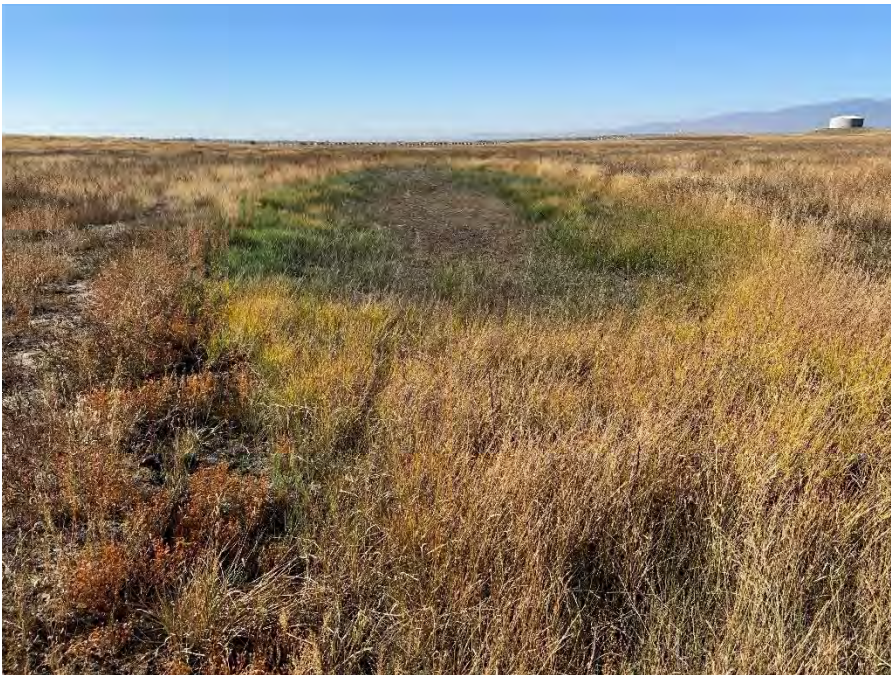
Photo 6: Representative photo of an isolated depression within the channel.

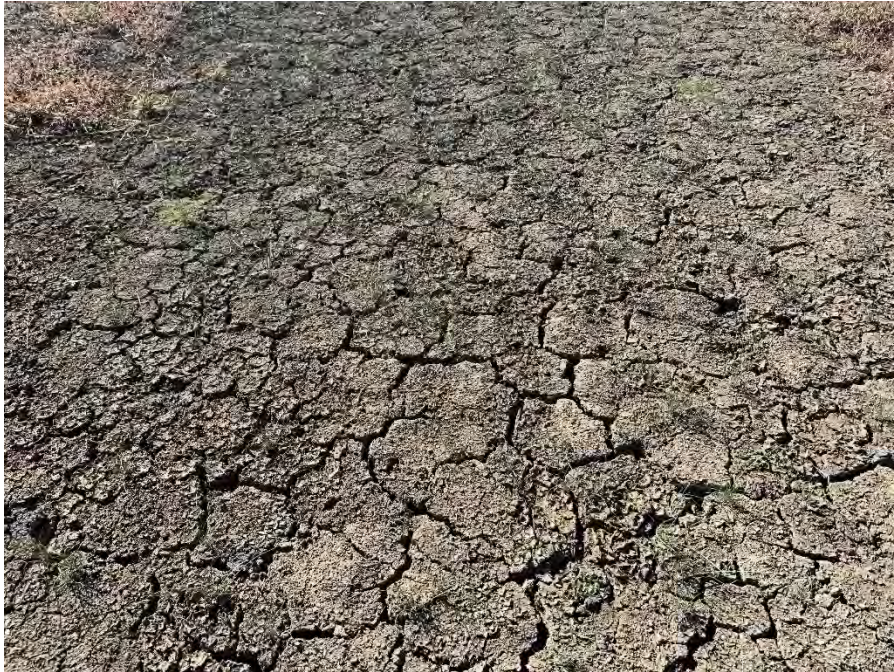
Photo 7: Representative photo of the top soil within the isolated depressions.

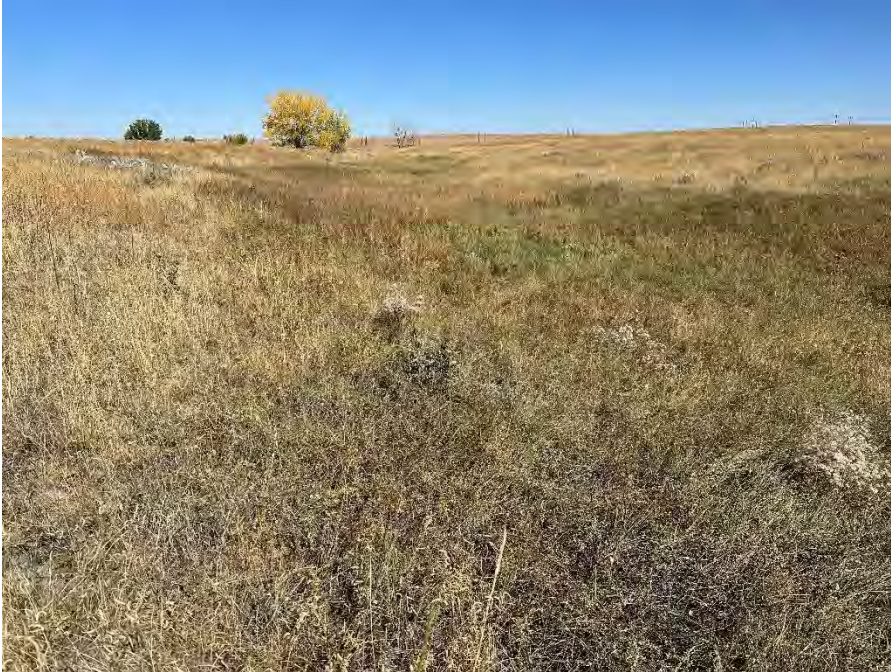
Photo 11: Representative photo of the channel on the south end of the Property.

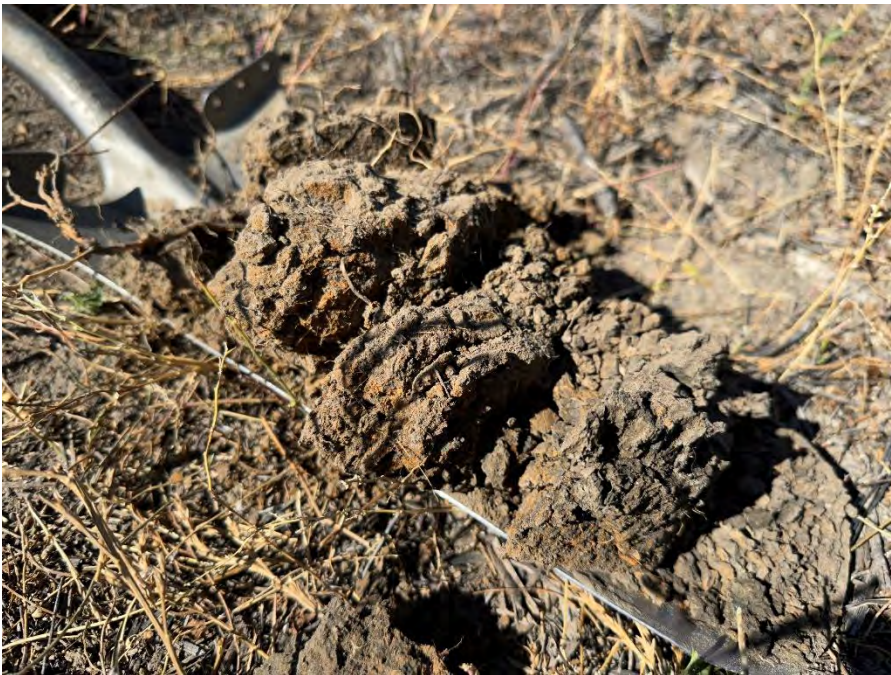
Photo 14: Representative photo of the isolated wetland depressional soil profile, throughout the Property.

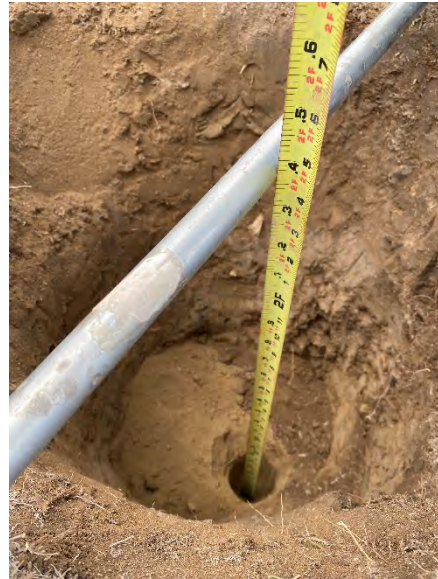
Photo 2 – Community 1's sandy clay soils didn't exhibit hydric soil indicators. Additionally, saturation and a water table were not encountered despite the soil pit extending to a depth of 28 inches.

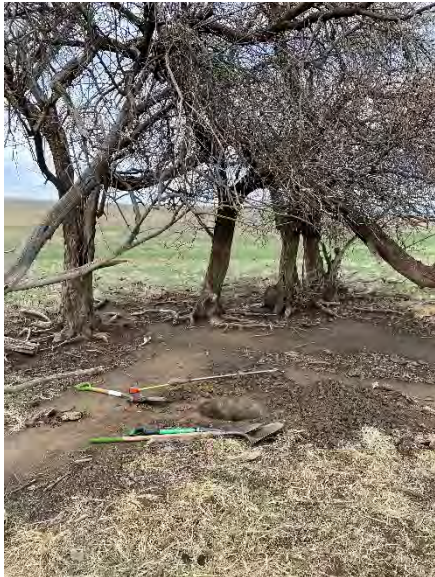
Photo 3 – Community 2 includes a small depression near the eastern boundary of the Site. Test pit is in the center of the middle ground.

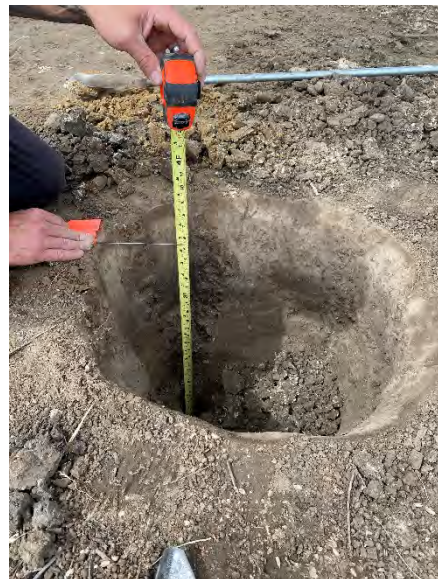
Photo 4 – Community 2's sandy clay loam and clay soils didn't exhibit hydric soil indicators. Additionally, saturation and a water table were not encountered despite the soil pit extending to a depth of 42 inches.

Photo 4 – Community 2's sandy clay loam and clay soils didn't exhibit hydric soil indicators. Additionally, saturation and a water table were not encountered despite the soil pit extending to a depth of 42 inches.

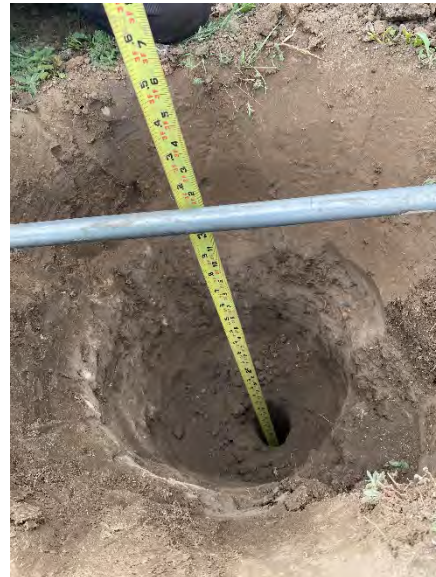
Photo 8 – Community 4's sandy loam and sandy clay loam soils didn't exhibit hydric soil indicators, and saturation and a water table were not encountered despite the soil pit extending to a depth of 38 inches.

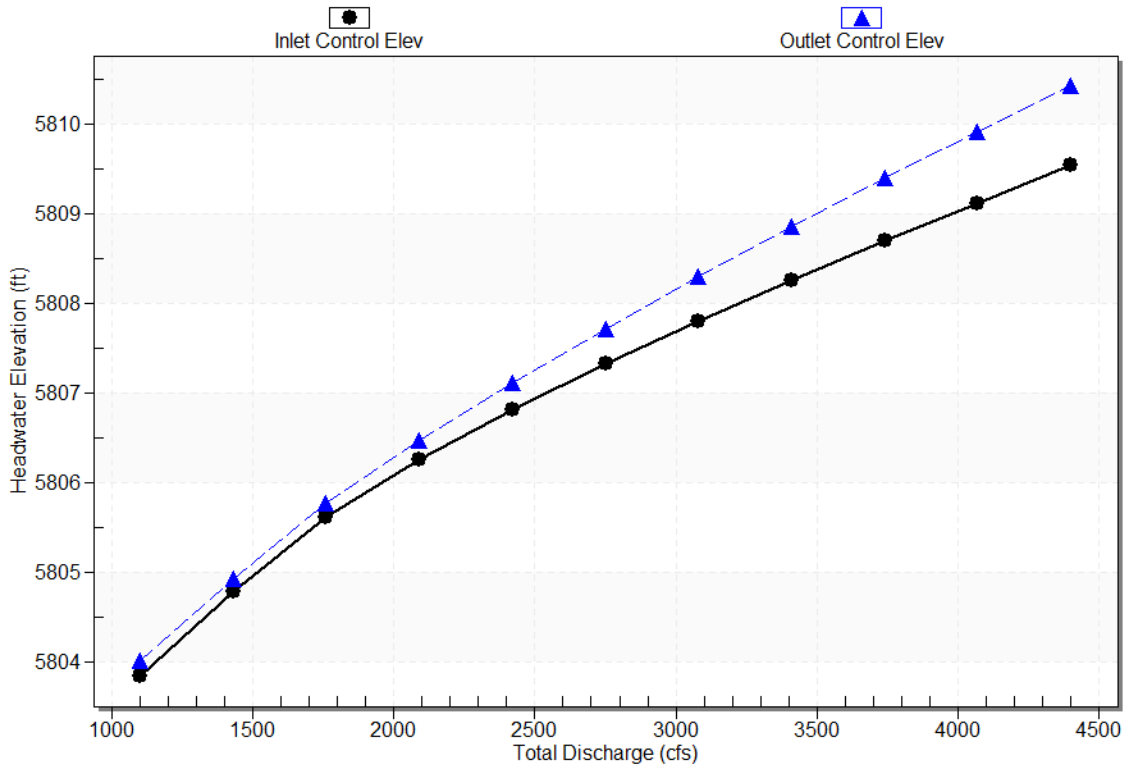
Culvert Performance Curve Plot: CONSPAN O742

Performance Curve Culvert: CONSPAN O742
