Channel Design Report For 60% Design: Rolling Meadows Channel and Floodplain Modification

Updated: January 31, 2023

Matrix Design Group

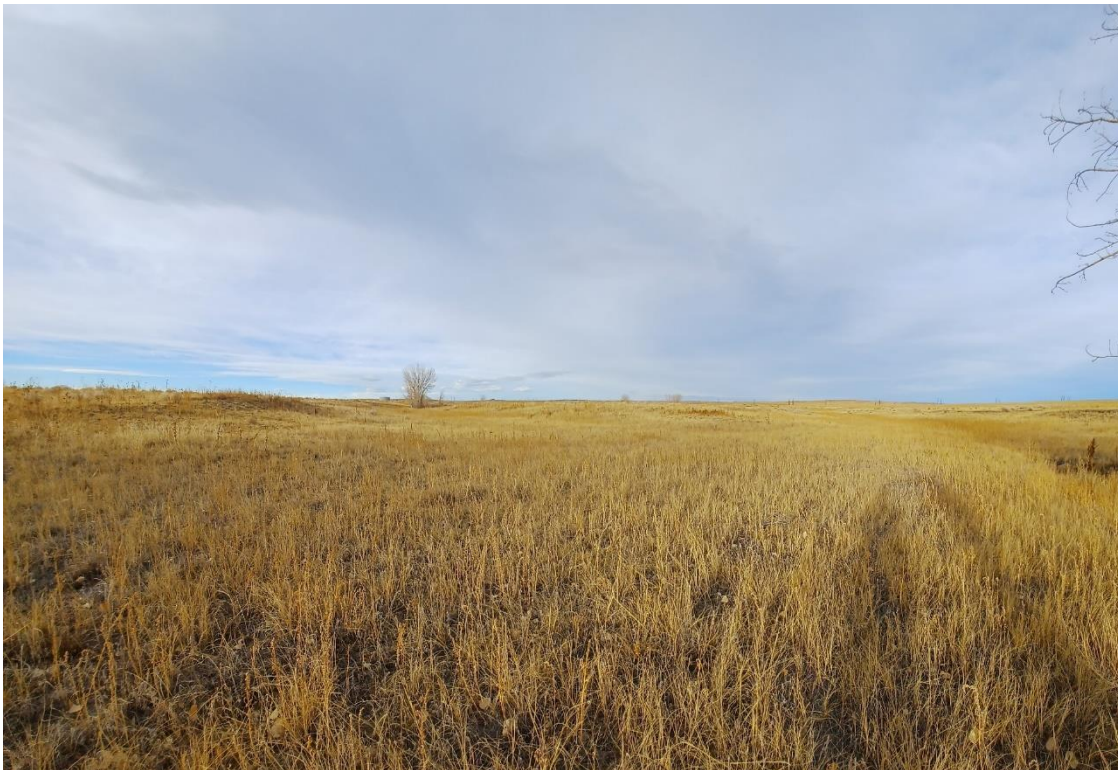
Figure 2. Typical floodplain on East Fork Jimmy Camp Creek.

The existing channel area has no defined bank or bed features and conveys no baseflow. During flooding, the water spreads extensively across the undeveloped plains, as modeled in the FEMA floodplain mapping. Example photos of the floodplain are in Figure 2 through Figure 5 below. The Project reach is bounded to the north by Drennan Rd, Bradley Rd bisects the project, and the Lorson Ranch development borders the project to the south.

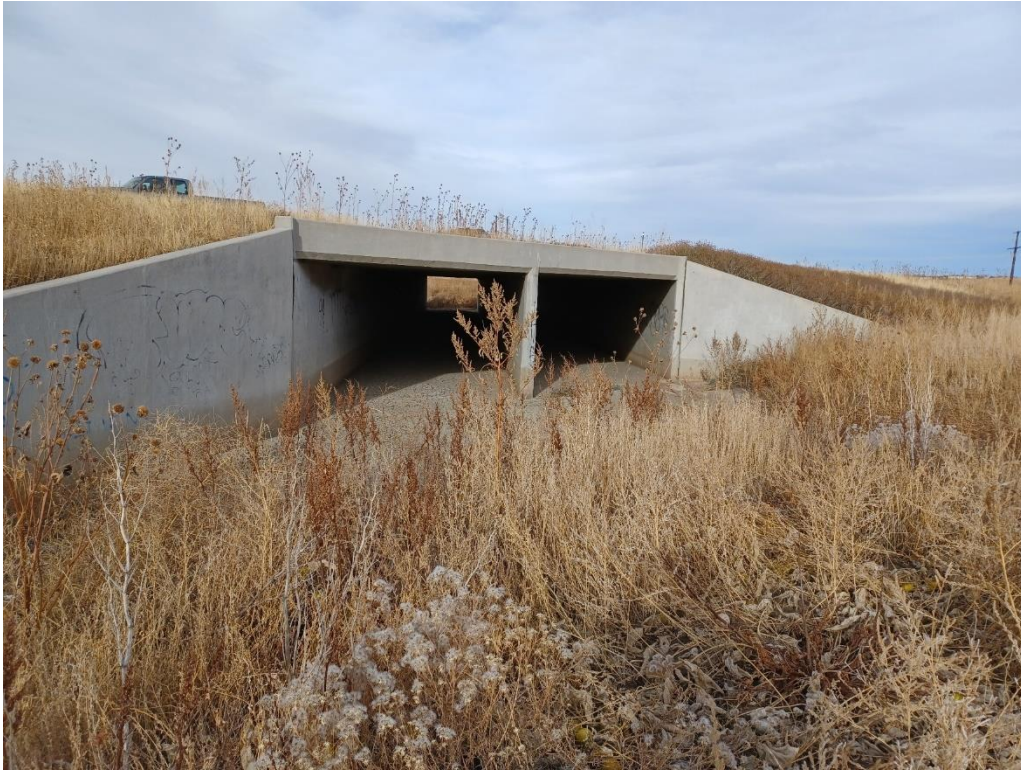
Figure 3. Bradley Rd Culvert

The project reach is bounded to the north by Drennan Rd where a 58' bridge provides adequate flow capacity for the existing 100-year flood flows, 1,720 CFS (DBPS, 2015). Bradley Rd bisects the project reach and flows pass through two 8'x12' concrete box culverts (DBPS, 2015). The DBPS notes that the Bradley Rd culverts do not contain adequate capacity to pass the existing 100-year flows, 2,860 CFS, and recommends the installation of an additional culvert to pass the existing 100-year flows.

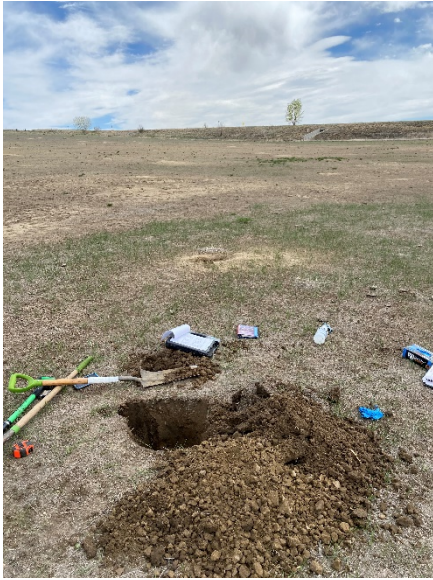
Photo 1 – Community 1 includes a relatively flat area identified as a seasonally flooded riverine system by the USFWS NWI. Test pit shown in center of foreground.

Photo 1 – Community 1 includes a relatively flat area identified as a seasonally flooded riverine system by the USFWS NWI. Test pit shown in center of foreground.

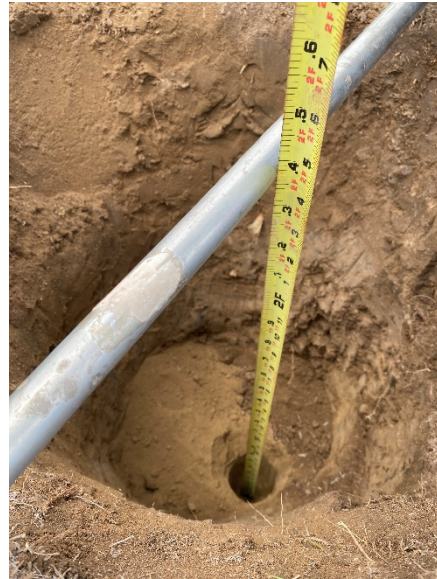
Photo 2 – Community 1's sandy clay soils didn't exhibit hydric soil indicators. Additionally, saturation and a water table were not encountered despite the soil pit extending to a depth of 28 inches.

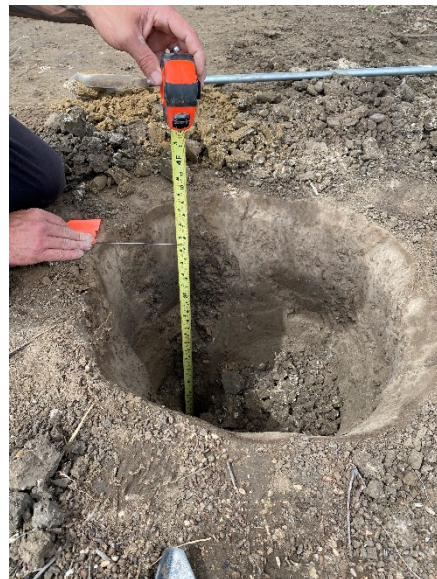
Photo 4 – Community 2's sandy clay loam and clay soils didn't exhibit hydric soil indicators. Additionally, saturation and a water table were not encountered despite the soil pit extending to a depth of 42 inches.

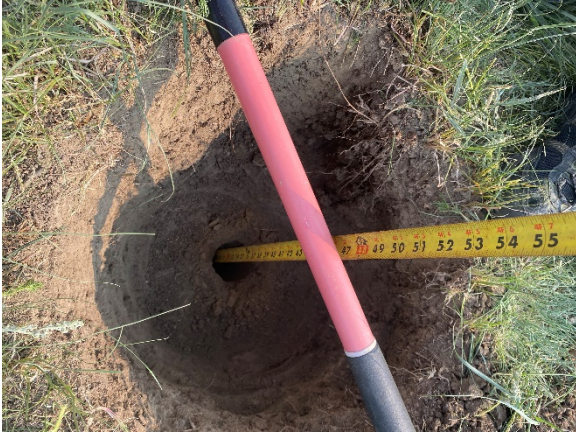
Photo 5 – Community 3 includes the drainage swale identified as Jimmy Camp Creek East Tributary. Test pit is in the center of the foreground.

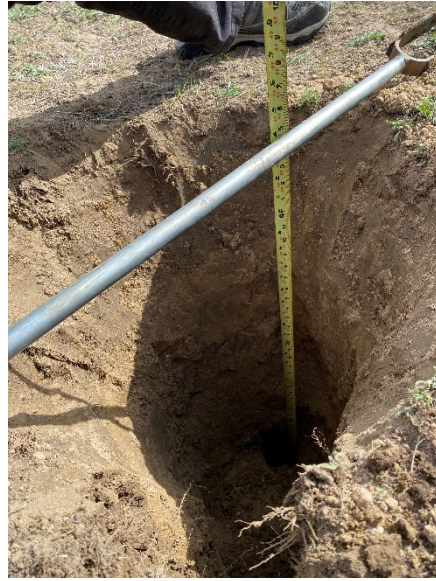
Photo 6 – Community 3's sandy loam, loamy sand and sand soils didn't exhibit hydric soil indicators, and saturation and a water table were not encountered despite the soil pit extending to a depth of 52 inches.

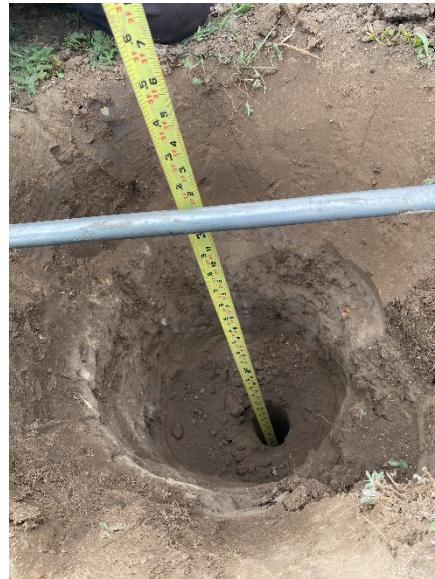
Photo 8 – Community 4's sandy loam and sandy clay loam soils didn't exhibit hydric soil indicators, and saturation and a water table were not encountered despite the soil pit extending to a depth of 38 inches.

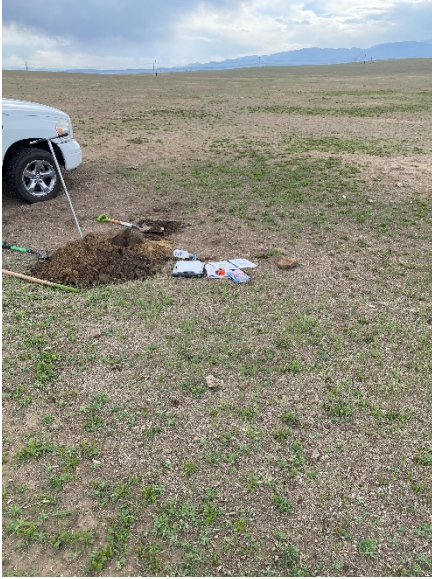
Photo 9 – Community 5 includes a depression near the eastern boundary of the Site within the area identified as a seasonally flooded riverine system by the USFWS NWI. Test pit is on the left in the middle ground.

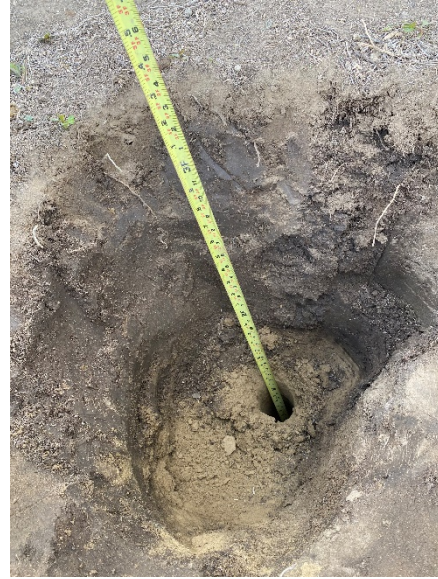
Photo 10 – Community 5's sandy clay and sandy loam soils didn't exhibit hydric soil indicators; however, oxidized rhizospheres along living roots were detectable within 12 inches of the soil surface.

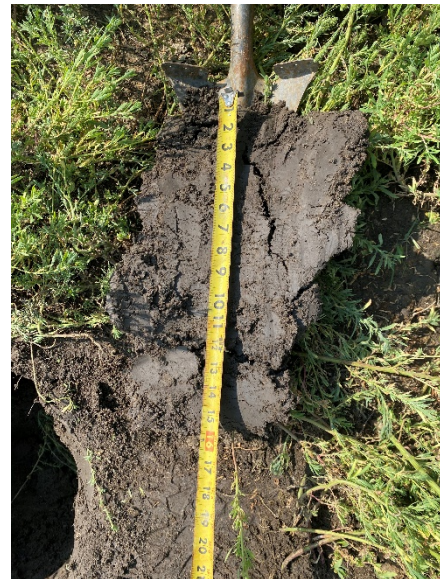
Photo 16 – Community 8's clay loam and silty loam soils didn't exhibit hydric soil indicators, and saturation and a water table were not encountered despite the soil pit extending to a depth of 48 inches.

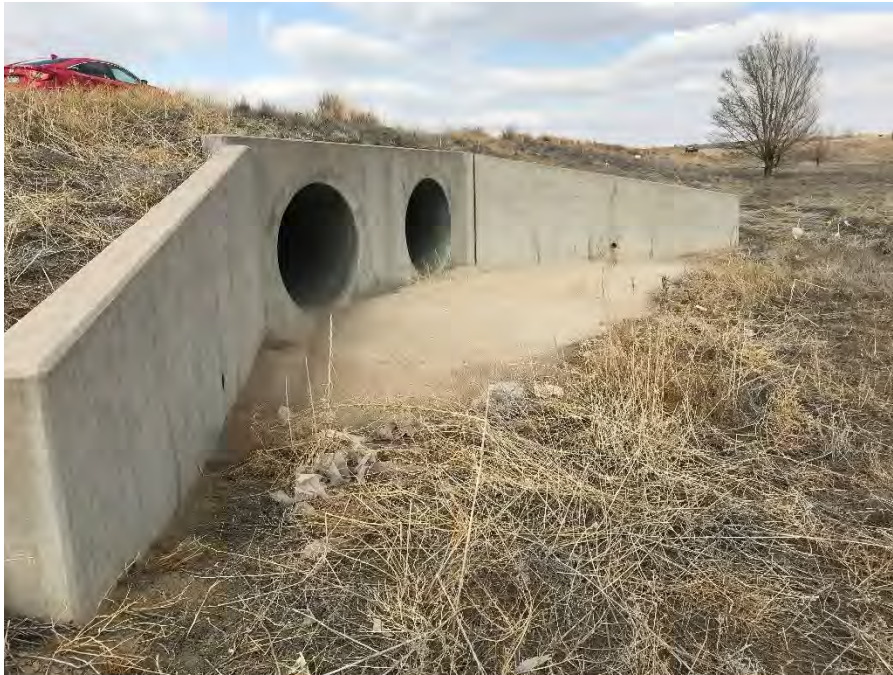
Photo 1: Standing at the northern side of the Property, looking north, towards the culvert crossing.

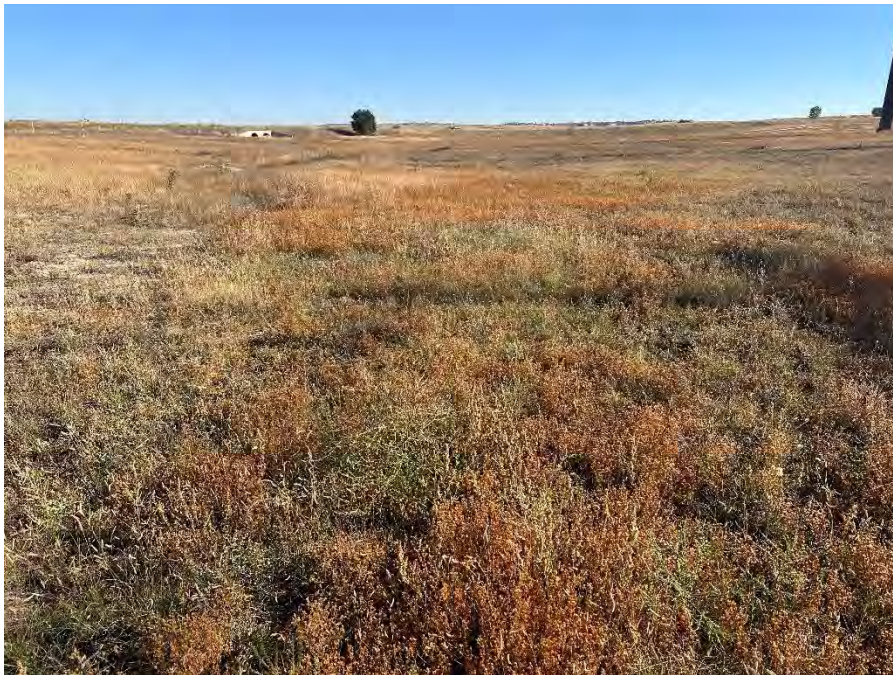
Photo 2: Standing away from the northern side of the Property, looking north, towards the culvert crossing.

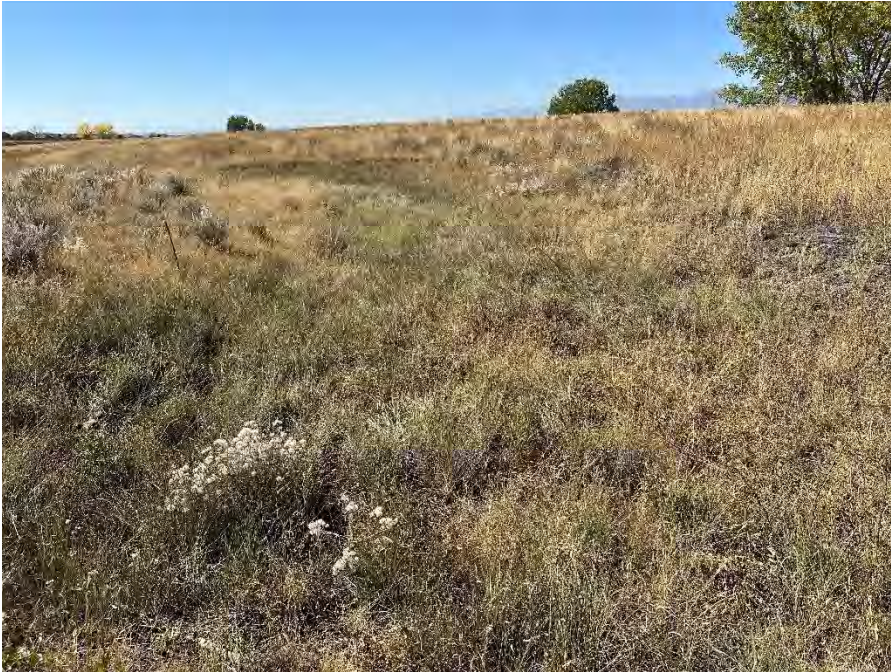
Photo 3: Representative photo of the channel within the northern section of the Property.

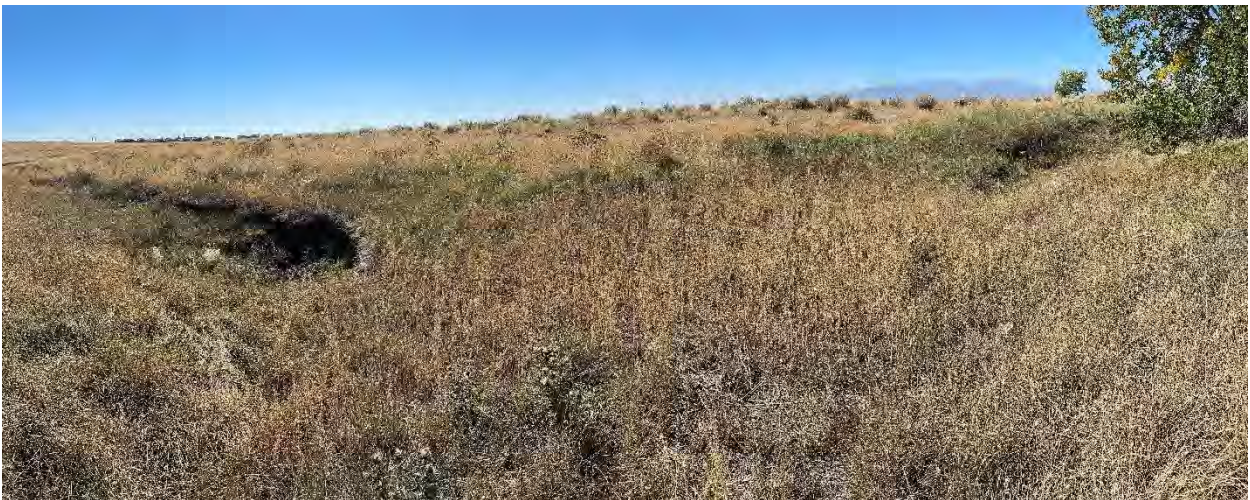
Photo 4: Representative photo of the lack of channel connectivity, throughout the drainage.

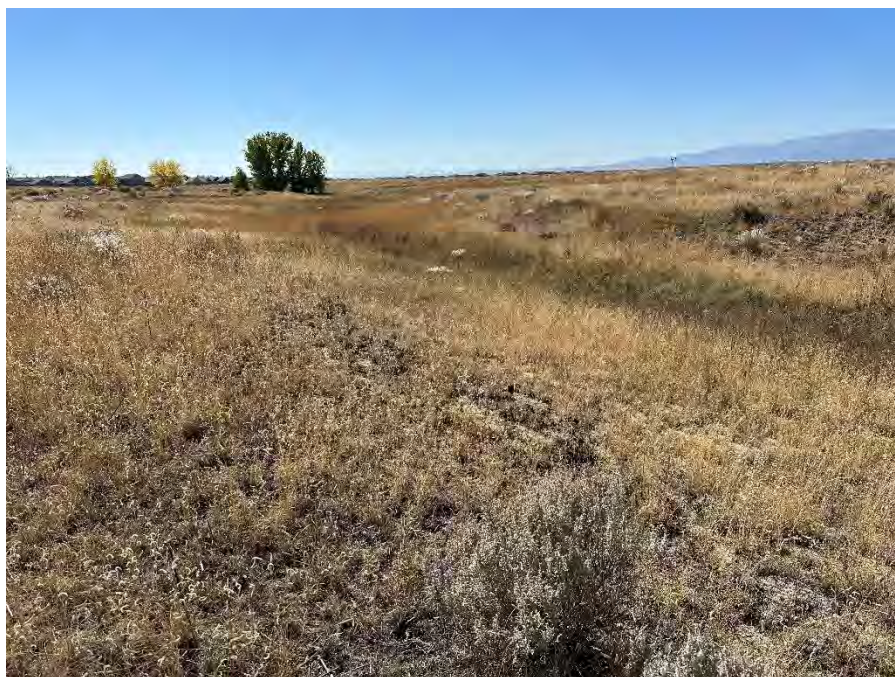
Photo 5: Representative of fully vegetated channel, near the center of the Property.

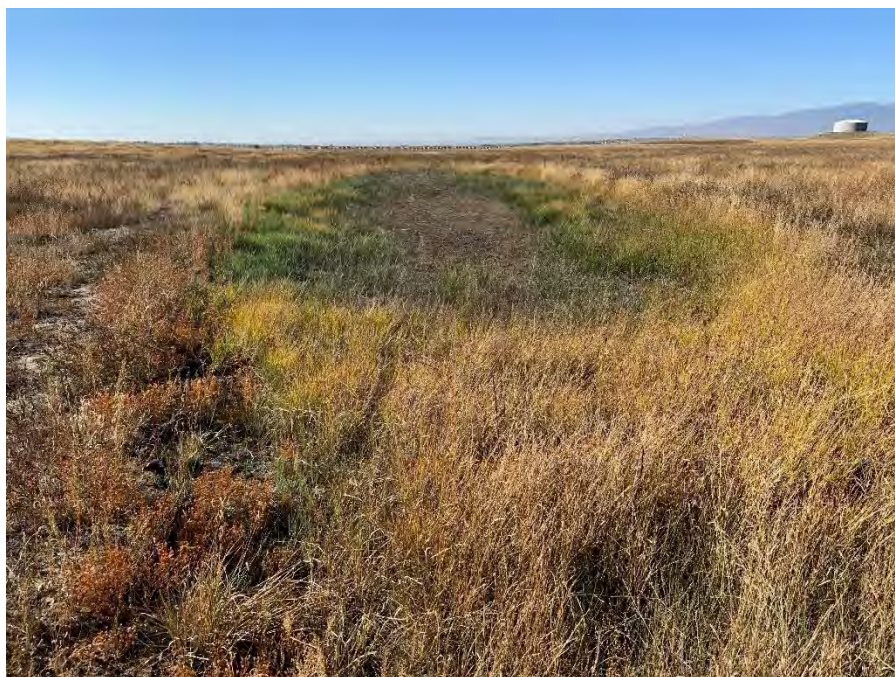
Photo 6: Representative photo of an isolated depression within the channel.

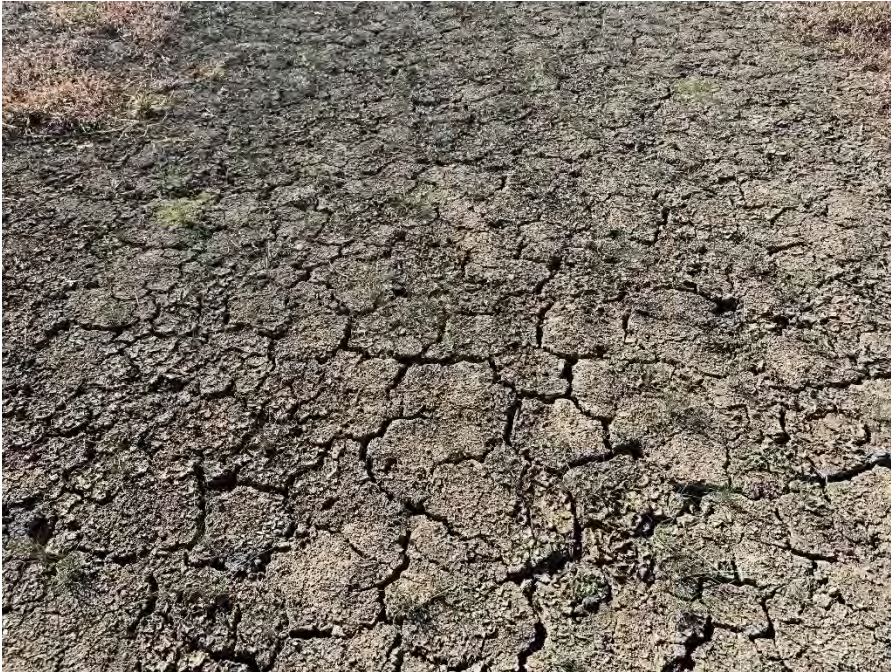
Photo 7: Representative photo of the top soil within the isolated depressions.

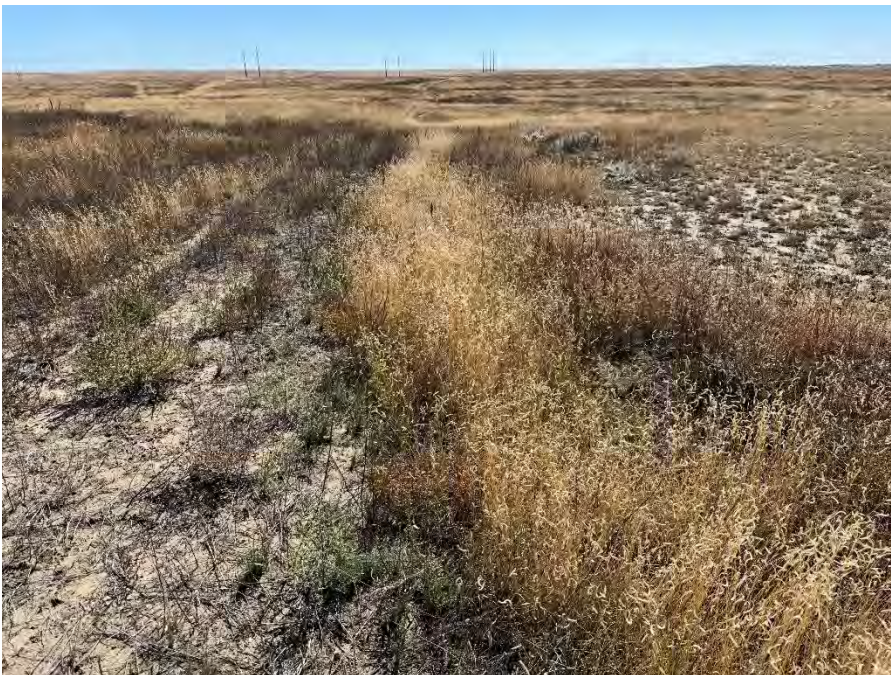
Photo 8: Representative photo of an earthen dam, dividing the channel.

Review of aerial imagery and field observations confirmed the location and extents of all six unnamed drainages, which traverse through the center of the Property and one detention basin, which included a ponding area behind an earthen dam. No culvert connection or overflow structure was observed along the earthen dam during the site visit; however, a vegetated drainage channel was observed downstream of the dam which confluent with Unnamed Drainage 1. No standing water was observed in the detention basin during the site visit. Based on NHD mapping, all drainage headwaters originate east of the Property (Figure 4), and flow, if present, would be conveyed from the northeast to the southwest across the Property, and adjacent lands, before converging with an intermittent stream, Jimmy Camp Creek, east of Marksheffel Road. Fountain Creek is the closest naturally occurring, year-round flowing feature with a continuous ordinary high-water mark (OHWM). It is approximately 13 river miles and approximately 6.5 aerial miles from the downstream end of the Property. The drainages are generally situated within a relatively flat grassland with gentle slopes from east to the southwest and within the mapped 100-year floodplain. The

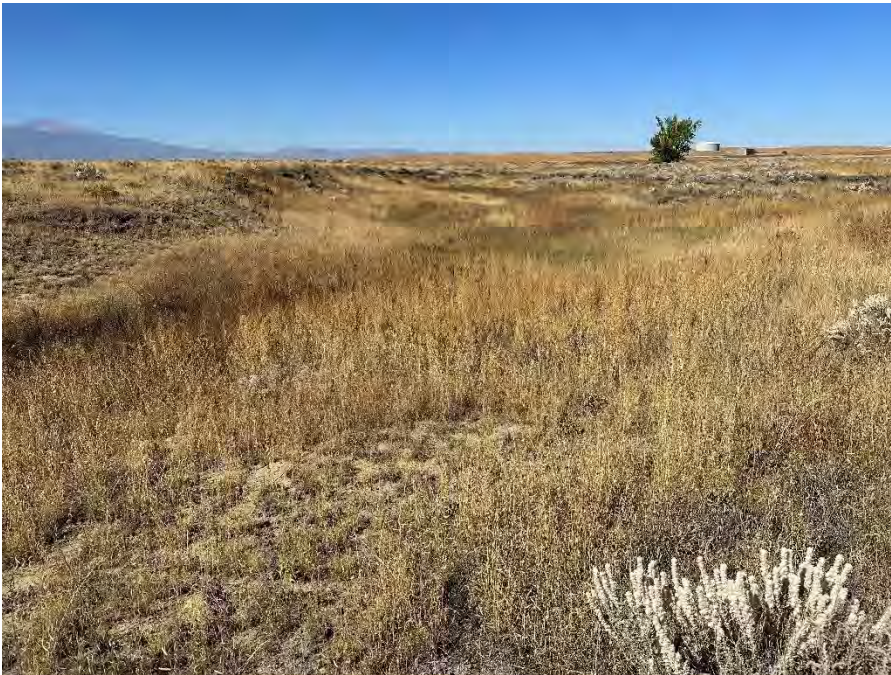
Photo 10: Standing in the channel, facing northwest, on the southern end of the Property.

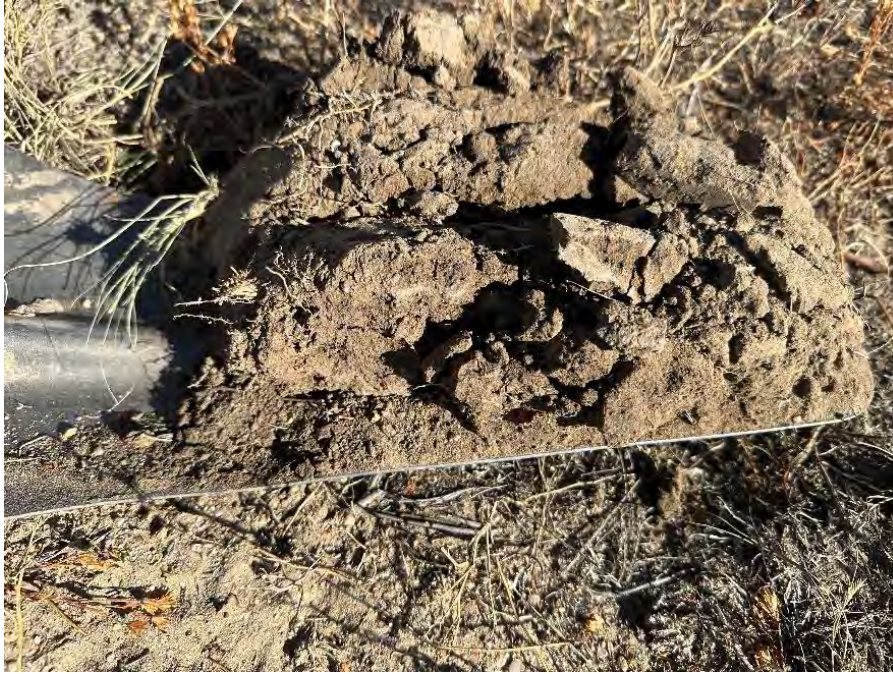
Photo 13: Representative photo of the upland soil profile, throughout the Property.

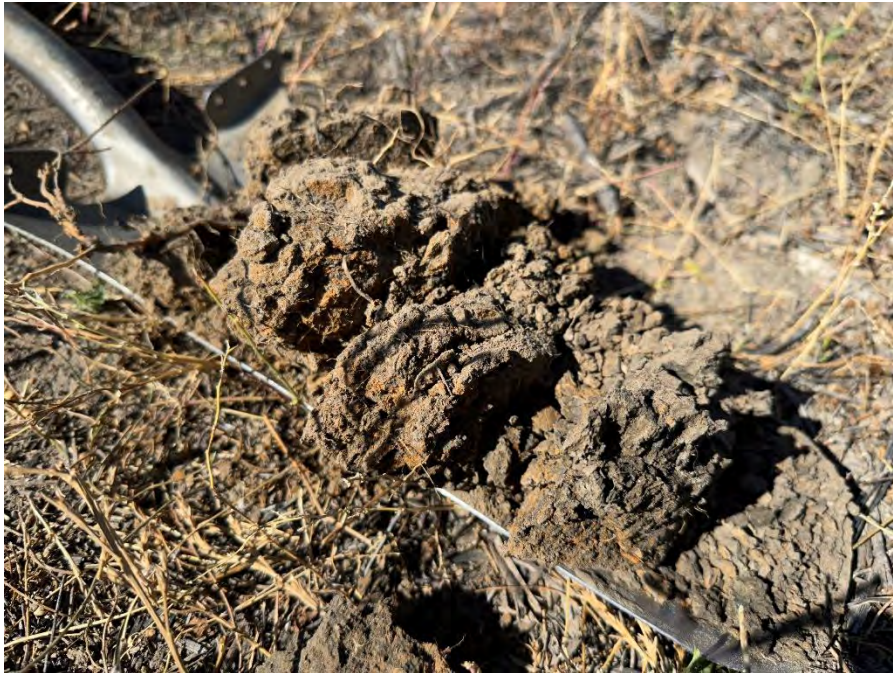
Photo 14: Representative photo of the isolated wetland depressional soil profile, throughout the Property.

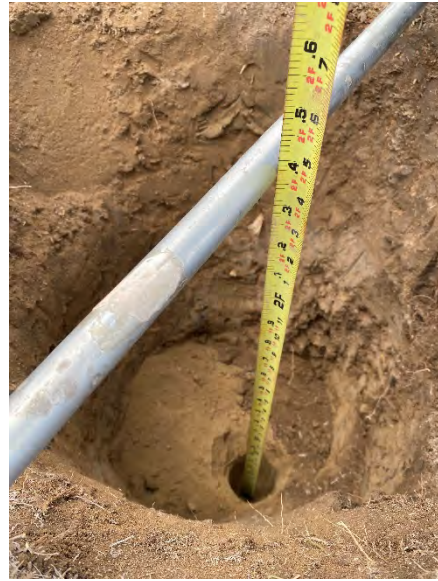
Photo 2 – Community 1's sandy clay soils didn't exhibit hydric soil indicators. Additionally, saturation and a water table were not encountered despite the soil pit extending to a depth of 28 inches.

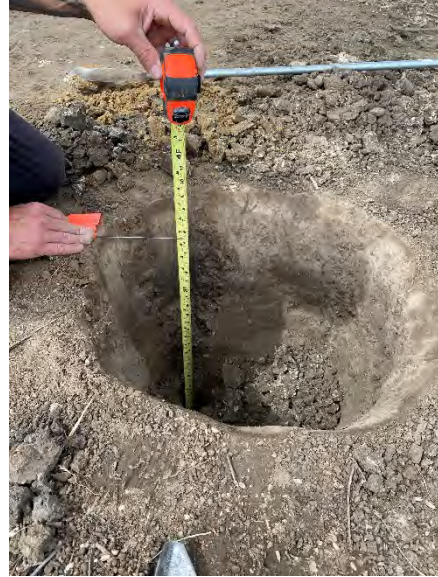
Photo 4 – Community 2's sandy clay loam and clay soils didn't exhibit hydric soil indicators. Additionally, saturation and a water table were not encountered despite the soil pit extending to a depth of 42 inches.

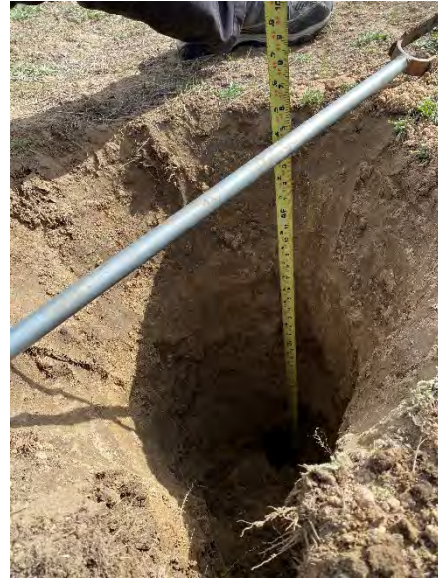
Photo 6 – Community 3's sandy loam, loamy sand and sand soils didn't exhibit hydric soil indicators, and saturation and a water table were not encountered despite the soil pit extending to a depth of 52 inches.

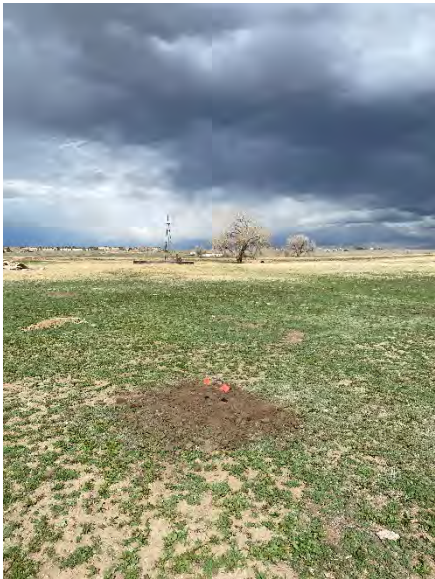
Photo 7 – Community 4 includes a relatively flat area identified as a seasonally flooded riverine system by the USFWS NWI. Test pit is in the center of the middle ground.

Photo 7 – Community 4 includes a relatively flat area identified as a seasonally flooded riverine system by the USFWS NWI. Test pit is in the center of the middle ground.

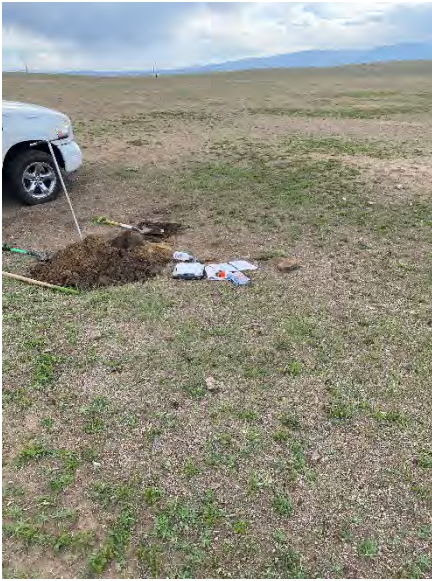
Photo 9 – Community 5 includes a depression near the eastern boundary of the Site within the area identified as a seasonally flooded riverine system by the USFWS NWI. Test pit is on the left in the middle ground.

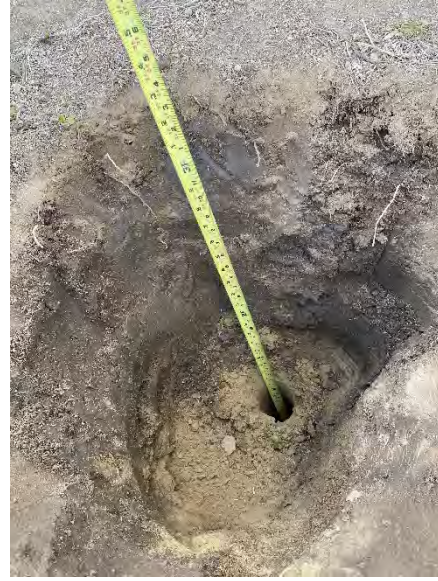
Photo 10 – Community 5's sandy clay and sandy loam soils didn't exhibit hydric soil indicators; however, oxidized rhizospheres along living roots were detectable within 12 inches of the soil surface.

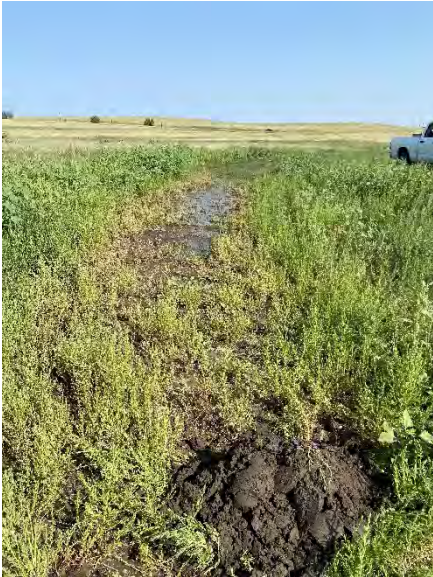
Photo 11 – Community 6 is approximately 0.18 acres and includes a drainage channel associated with a windmill-powered well south of Bradley Road. Test pit is partially shown in the center of the foreground.

Photo 11 – Community 6 is approximately 0.18 acres and includes a drainage channel associated with a windmill-powered well south of Bradley Road. Test pit is partially shown in the center of the foreground.

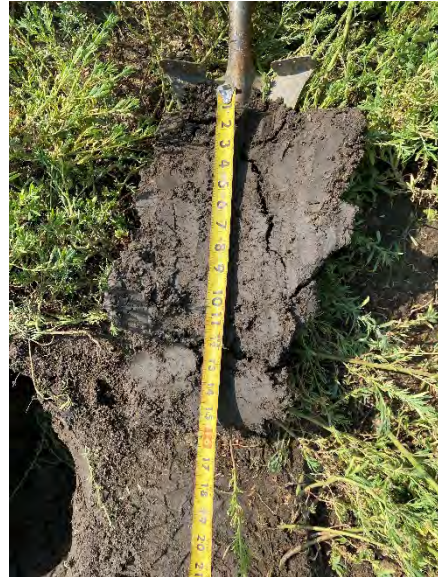
Photo 12 – Community 6's sandy loam soils contained 5% prominent redox concentrations from 4-12 inches, which satisfied the criteria for redox dark surface.

Photo 12 – Community 6's sandy loam soils contained 5% prominent redox concentrations from 4-12 inches, which satisfied the criteria for redox dark surface.

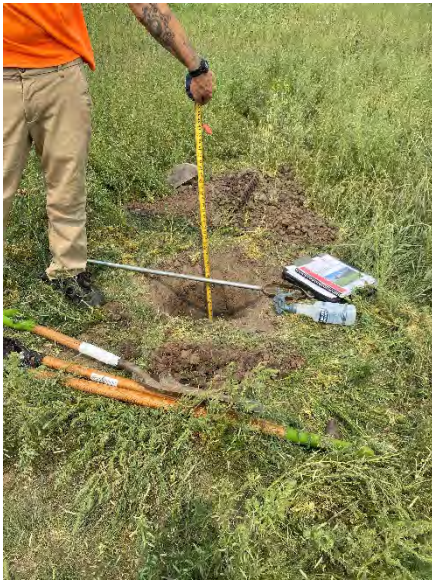
Photo 13 – Community 7 includes the southern edge of the drainage channel that forms Community 6. Test pit is in the center of the middle ground.

Photo 13 – Community 7 includes the southern edge of the drainage channel that forms Community 6. Test pit is in the center of the middle ground.

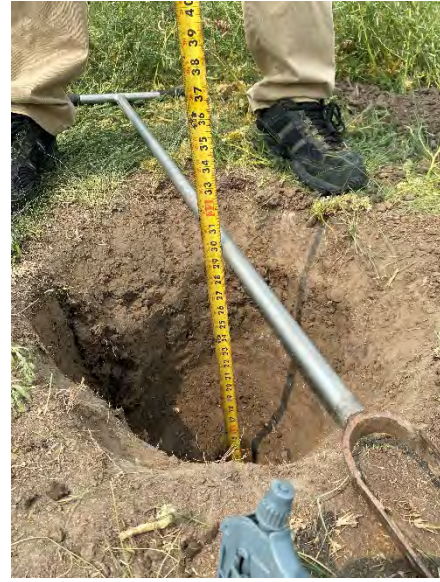
Photo 14 – Community 7's silty clay loam and sandy loam soils didn't exhibit hydric soil indicators, and saturation and a water table were not encountered despite the soil pit extending to a depth of 30 inches.

Photo 14 – Community 7's silty clay loam and sandy loam soils didn't exhibit hydric soil indicators, and saturation and a water table were not encountered despite the soil pit extending to a depth of 30 inches.

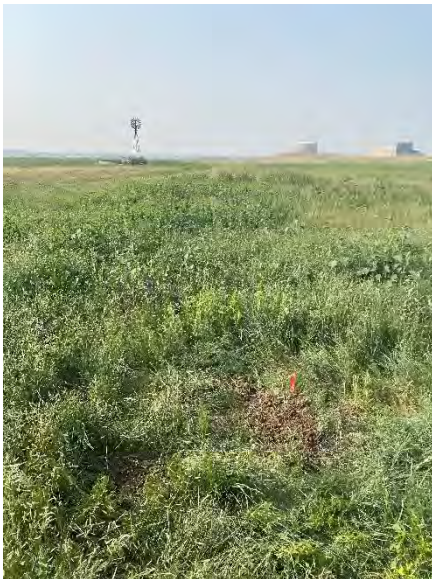
Photo 15 – Community 8 includes a relatively flat area identified as a seasonally flooded riverine system by the USFWS NWI. Test pit is in the center of the foreground.

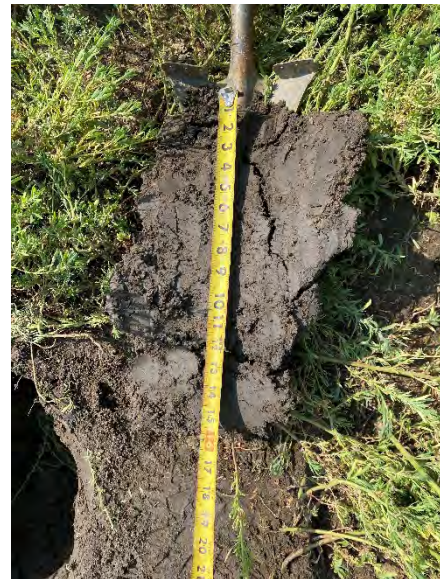
Photo 16 – Community 8's clay loam and silty loam soils didn't exhibit hydric soil indicators, and saturation and a water table were not encountered despite the soil pit extending to a depth of 48 inches.

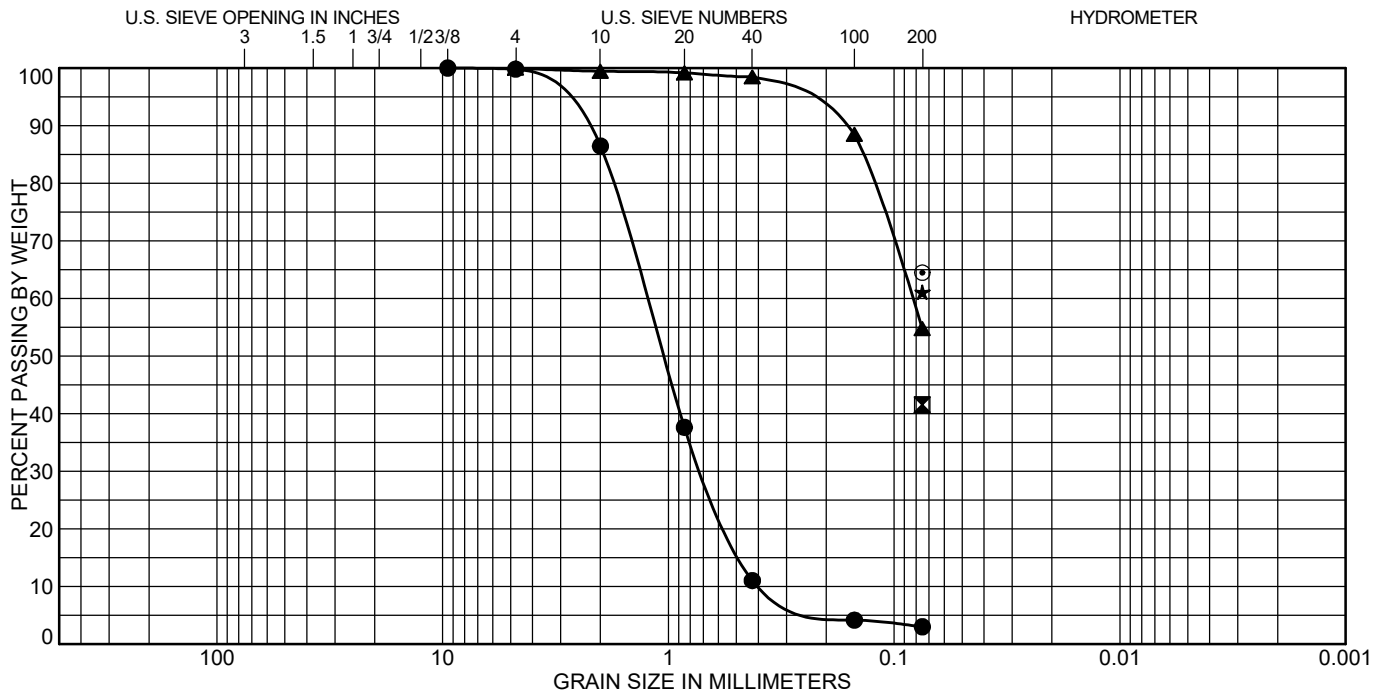
FIGURE No. 44

Test Boring	Depth (ft)	Classification				LL	PL	PI
● 14	9.0	POORLY GRADED SAND(SP)						
⊠ 15	4.0	CLAYEY SAND(SC)				32	11	21
▲ 16	4.0	SANDY LEAN CLAY(CL)				27	19	8
★ 19	19.0							
⊙ 19	29.0	SANDY LEAN CLAY(CL)				32	15	17
Test Boring	Depth (ft)	%Gravel	%Sand	%Silt	%Clay			
● 14	9.0	0.2	96.8	3.0				
⊠ 15	4.0			41.6				
▲ 16	4.0	0.0	45.2	54.8				
★ 19	19.0			61.1				
⊙ 19	29.0			64.5

Soil laboratory testing was performed as part of this investigation. The laboratory tests included moisture content, dry density, grain-size analyses, Atterberg Limits and Swell/Consolidation tests. A Summary of Laboratory Test Results is presented in Figure 40. Soils Classification Data is presented in Figures 41 through 55. Swell/Consolidation Test Results are presented in Figures 56 through 78.

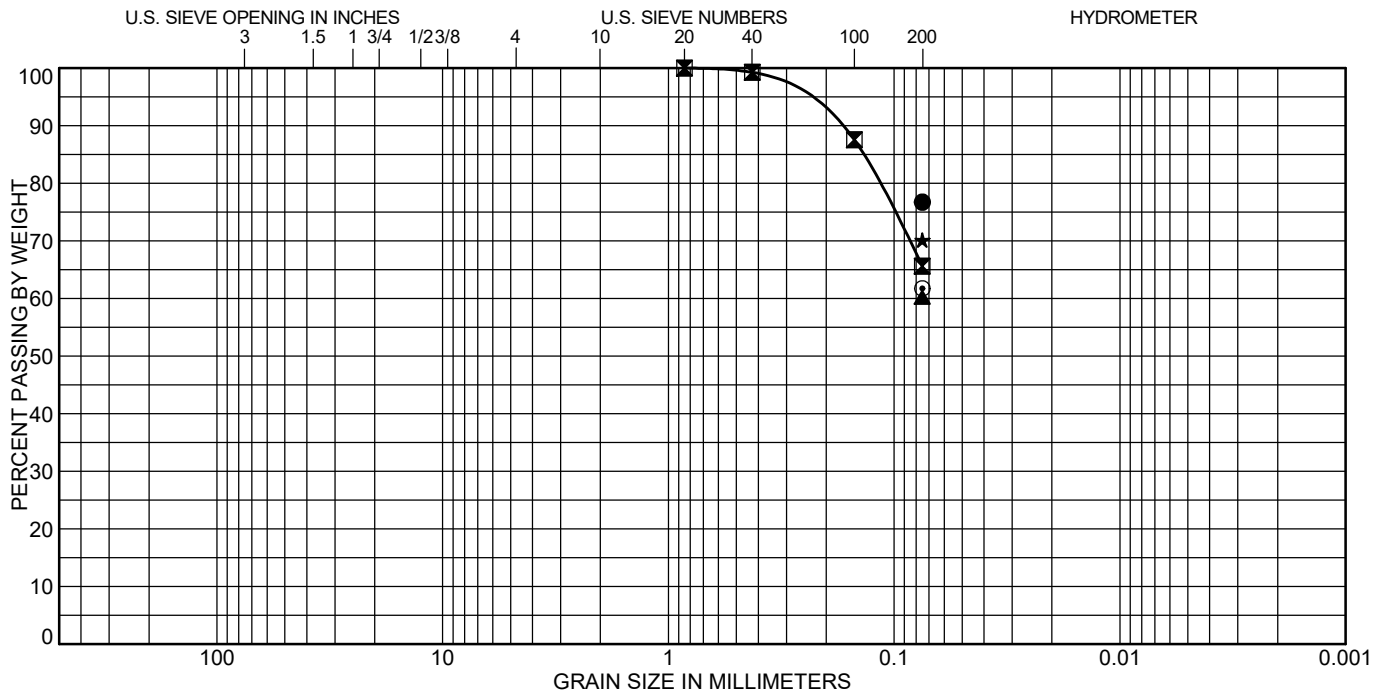
FIGURE No. 45

Test Boring	Depth (ft)	Classification	LL	PL	PI
● 20	4.0	LEAN CLAY with SAND(CL)	35	10	25
⊠ 21	9.0	SANDY LEAN CLAY(CL)	33	14	19
▲ 22	4.0				
★ 23	9.0	LEAN CLAY with SAND(CL)	36	11	25
⊙ 25	24.0	SANDY LEAN CLAY(CL)	32	15	17

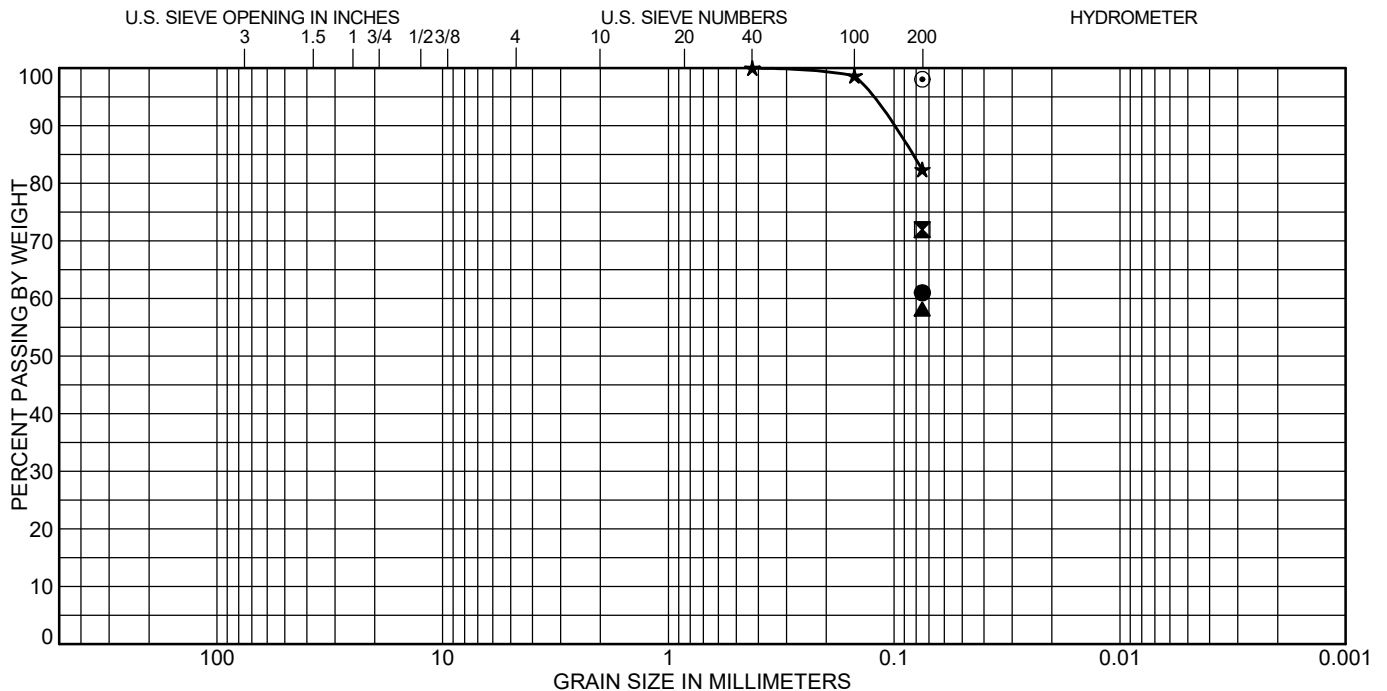
FIGURE No. 46

Test Boring	Depth (ft)	Classification	LL	PL	PI
● 25	29.0	SANDY LEAN CLAY(CL)	35	13	22
⊠ 26	9.0	LEAN CLAY with SAND(CL)	33	11	22
▲ 27	4.0				
★ 28	9.0				
⊙ 29	4.0

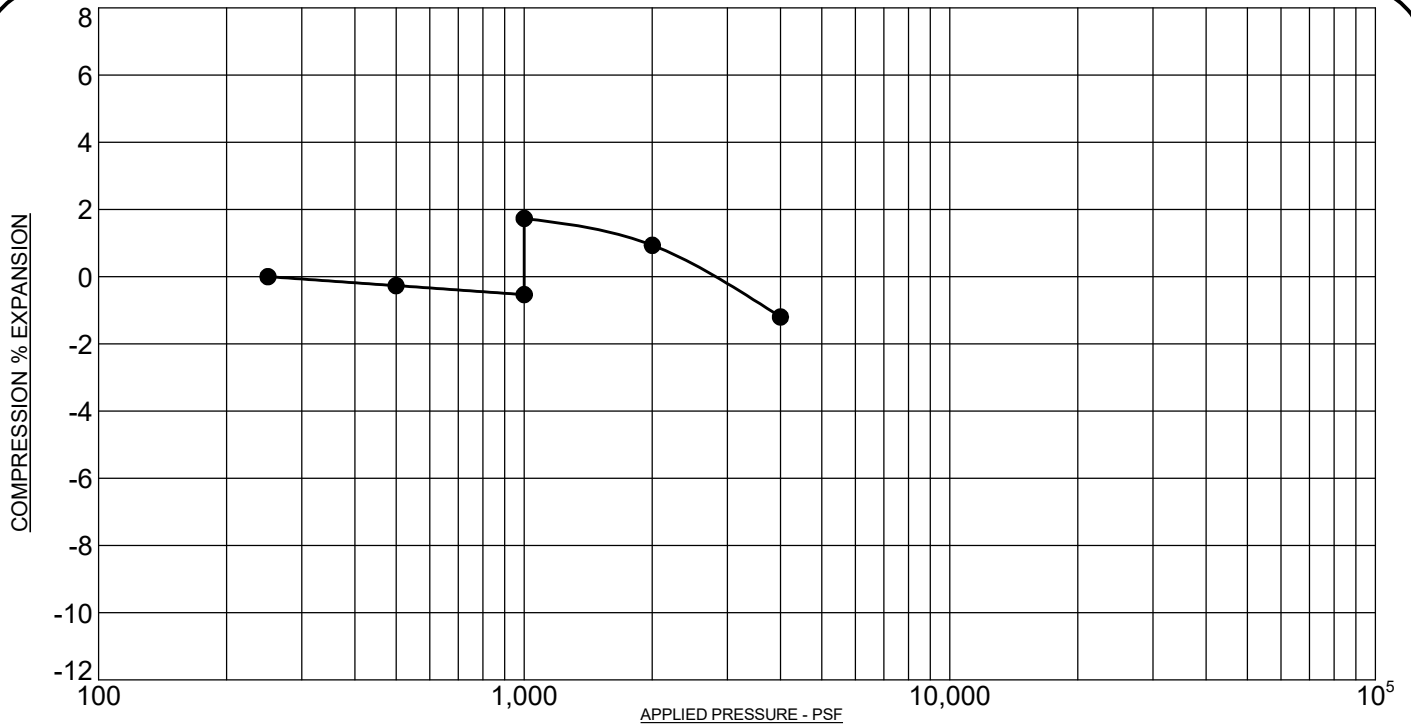
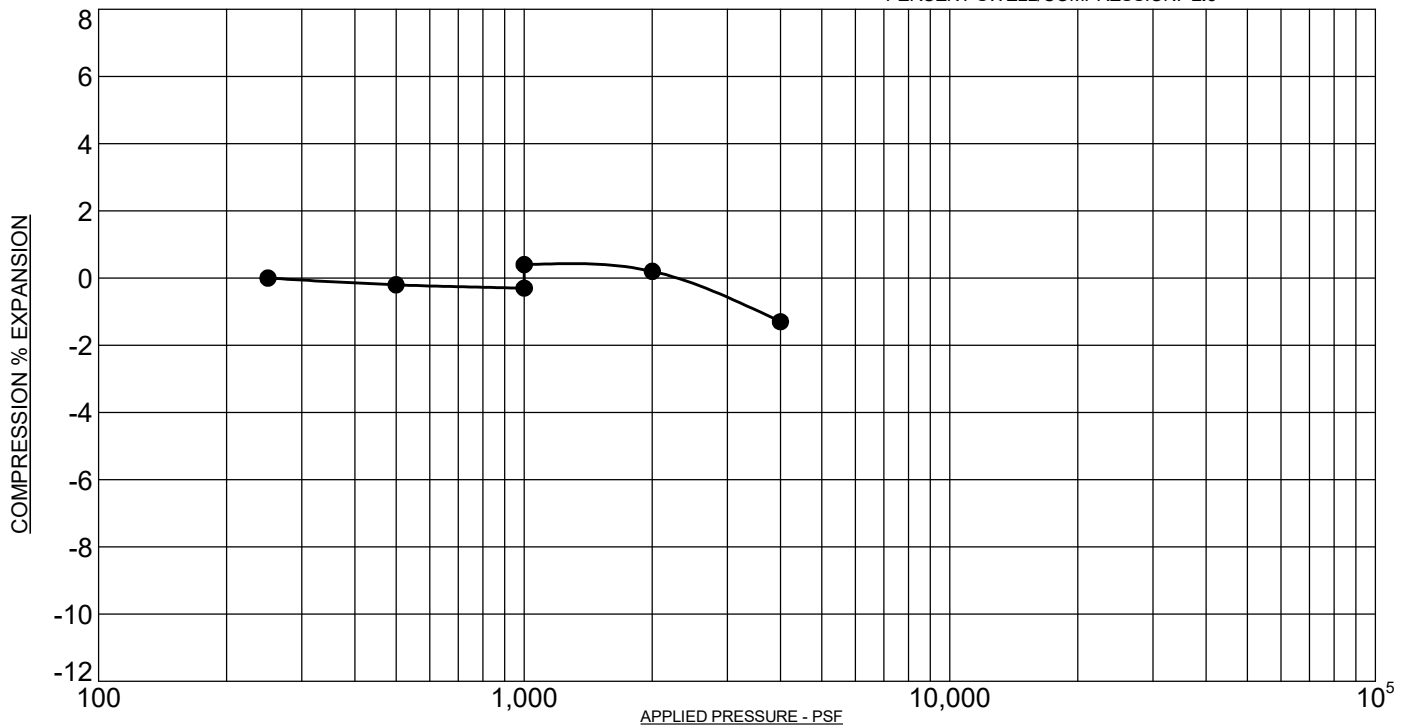
FIGURE No. 63

PROJECT: **Rolling Hills El Paso County, Colorado**
 SAMPLE DESCRIPTION: **CLAY, SANDY**
 NOTE: **SAMPLE WAS INUNDATED WITH WATER AT 1,000 PSF**

SAMPLE LOCATION: **24 @ 14 FT**
 NATURAL DRY UNIT WEIGHT: **113.3 PCF**
 NATURAL MOISTURE CONTENT: **8.6%**
 PERCENT SWELL/COMPRESSION: **2.3**

SAMPLE LOCATION: **25 @ 14 FT**
 NATURAL DRY UNIT WEIGHT: **106.0 PCF**
 NATURAL MOISTURE CONTENT: **7.7%**
 PERCENT SWELL/COMPRESSION: **0.7**
