Channel Design Report For 60% Design: Rolling Meadows Channel and Floodplain Modification

Updated: January 31, 2023

Matrix Design Group

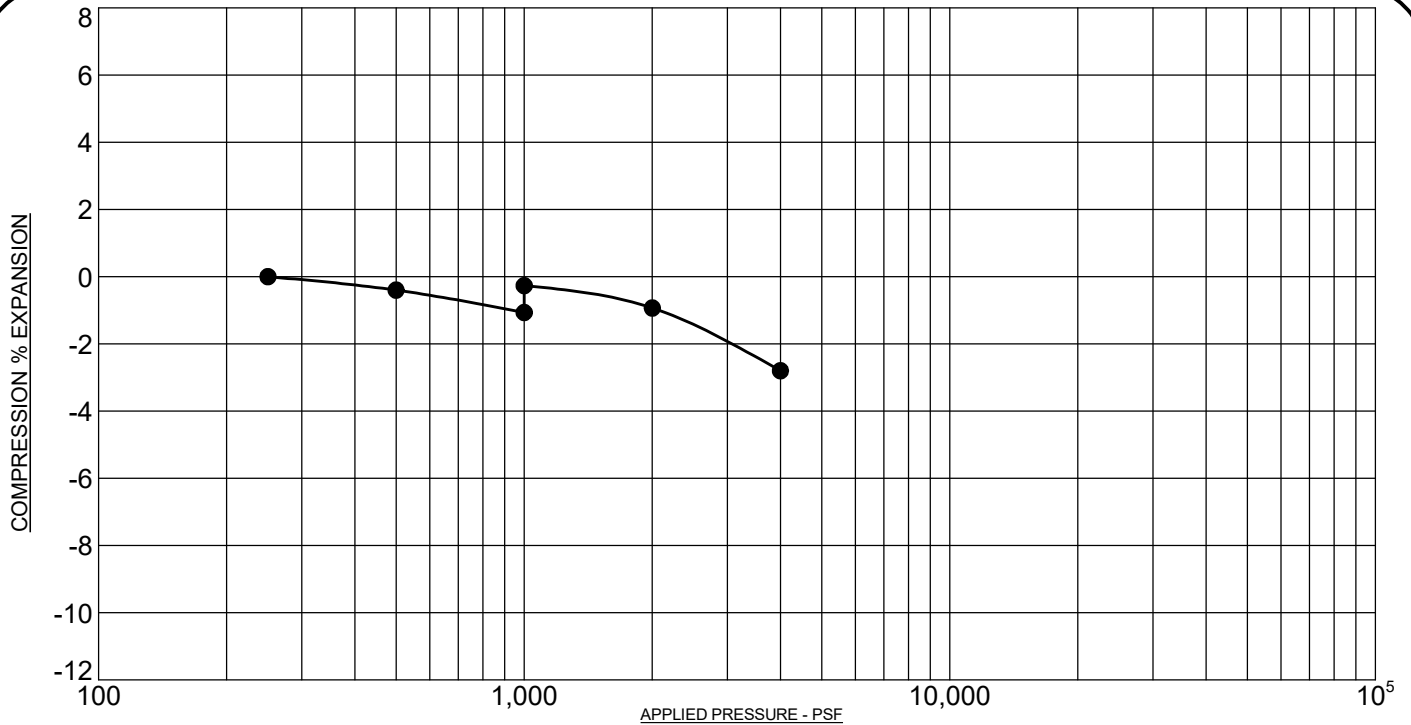
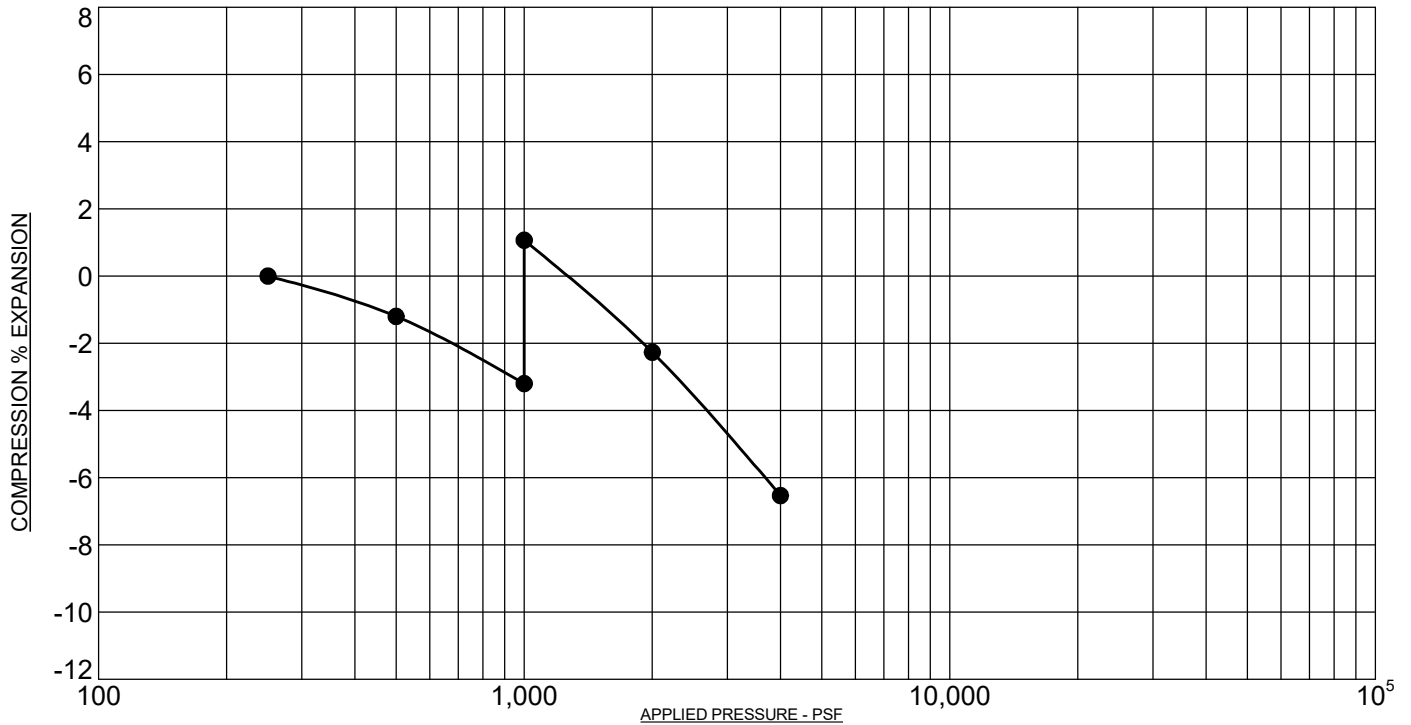
FIGURE No. 64

PROJECT: **Rolling Hills El Paso County, Colorado**
 SAMPLE DESCRIPTION: **CLAY, SANDY**
 NOTE: **SAMPLE WAS INUNDATED WITH WATER AT 1,000 PSF**

SAMPLE LOCATION: **26 @ 9 FT**
 NATURAL DRY UNIT WEIGHT: **114.8 PCF**
 NATURAL MOISTURE CONTENT: **9.3%**
 PERCENT SWELL/COMPRESSION: **0.8**

SAMPLE LOCATION: **27 @ 4 FT**
 NATURAL DRY UNIT WEIGHT: **85.0 PCF**
 NATURAL MOISTURE CONTENT: **7.3%**
 PERCENT SWELL/COMPRESSION: **4.3**

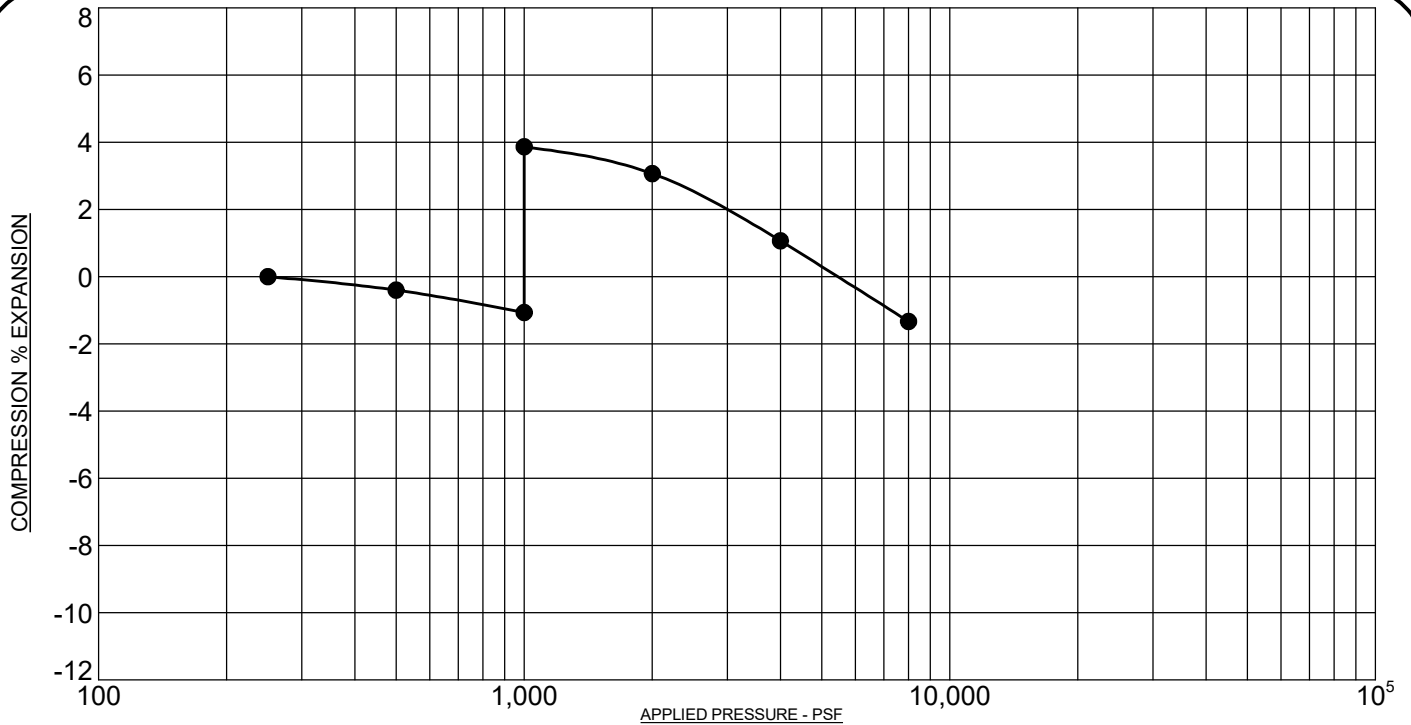
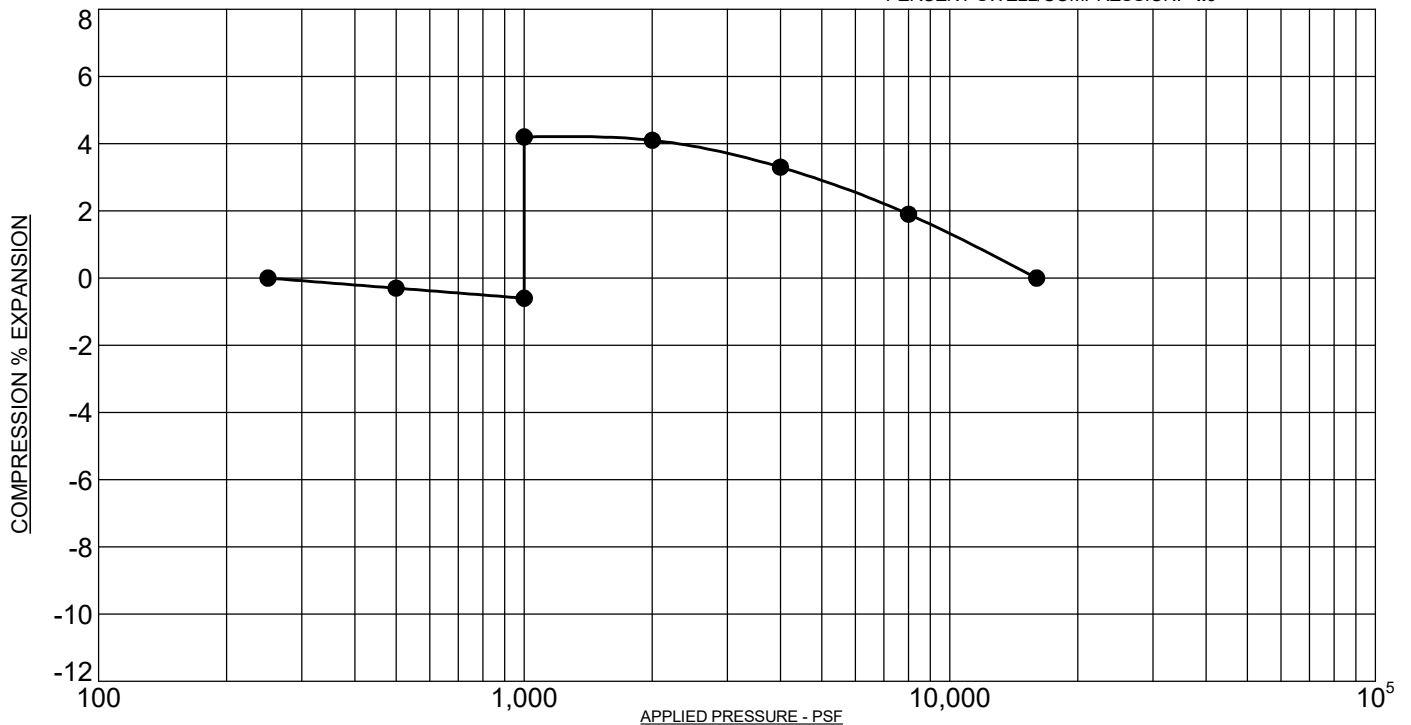
FIGURE No. 65

PROJECT: **Rolling Hills El Paso County, Colorado**
 SAMPLE DESCRIPTION: **CLAYSTONE, SANDY**
 NOTE: **SAMPLE WAS INUNDATED WITH WATER AT 1,000 PSF**

SAMPLE LOCATION: **29 @ 4 FT**
 NATURAL DRY UNIT WEIGHT: **117.0 PCF**
 NATURAL MOISTURE CONTENT: **14.3%**
 PERCENT SWELL/COMPRESSION: **4.9**

SAMPLE LOCATION: **31 @ 9 FT**
 NATURAL DRY UNIT WEIGHT: **127.4 PCF**
 NATURAL MOISTURE CONTENT: **5.5%**
 PERCENT SWELL/COMPRESSION: **4.8**

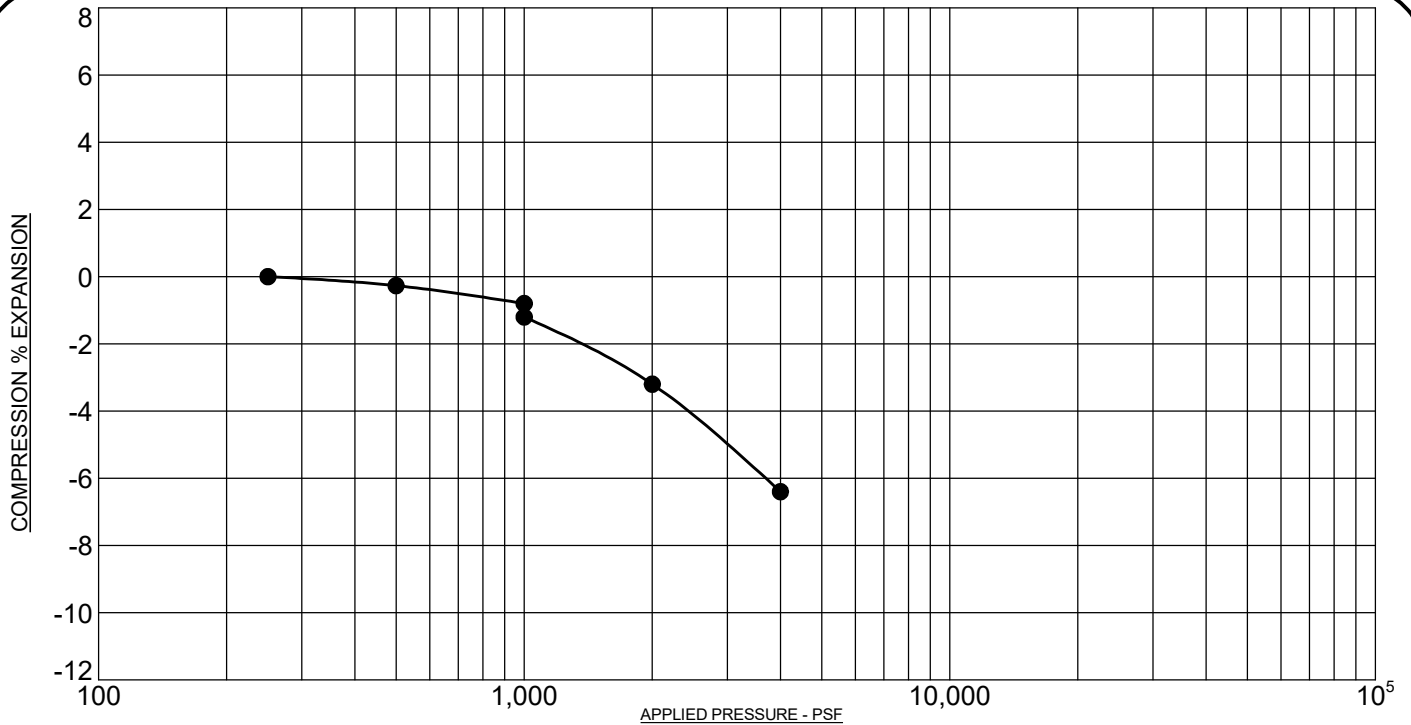
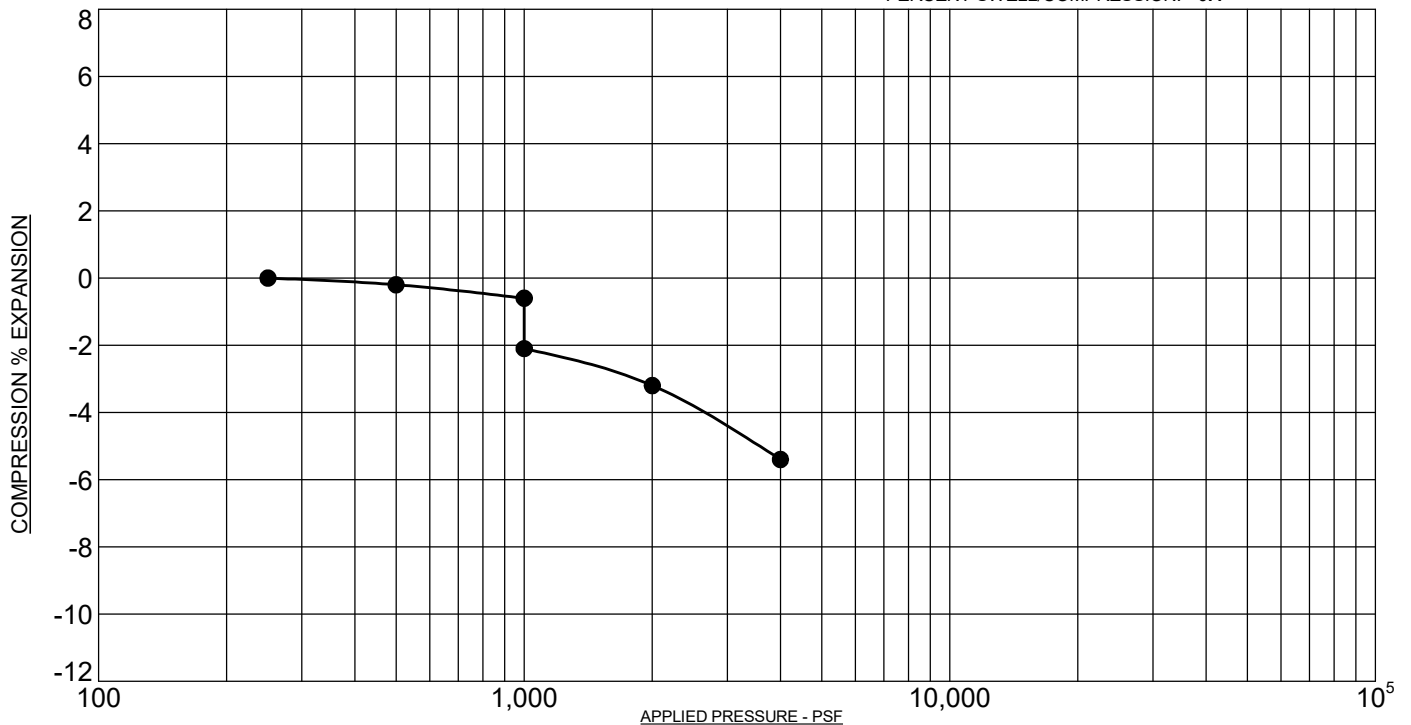
FIGURE No. 66

PROJECT: **Rolling Hills El Paso County, Colorado**
 SAMPLE DESCRIPTION: **CLAY, SANDY**
 NOTE: **SAMPLE WAS INUNDATED WITH WATER AT 1,000 PSF**

SAMPLE LOCATION: **32 @ 4 FT**
 NATURAL DRY UNIT WEIGHT: **96.4 PCF**
 NATURAL MOISTURE CONTENT: **13.4%**
 PERCENT SWELL/COMPRESSION: **- 0.4**

SAMPLE LOCATION: **36 @ 4 FT**
 NATURAL DRY UNIT WEIGHT: **101.6 PCF**
 NATURAL MOISTURE CONTENT: **6.0%**
 PERCENT SWELL/COMPRESSION: **- 1.5**

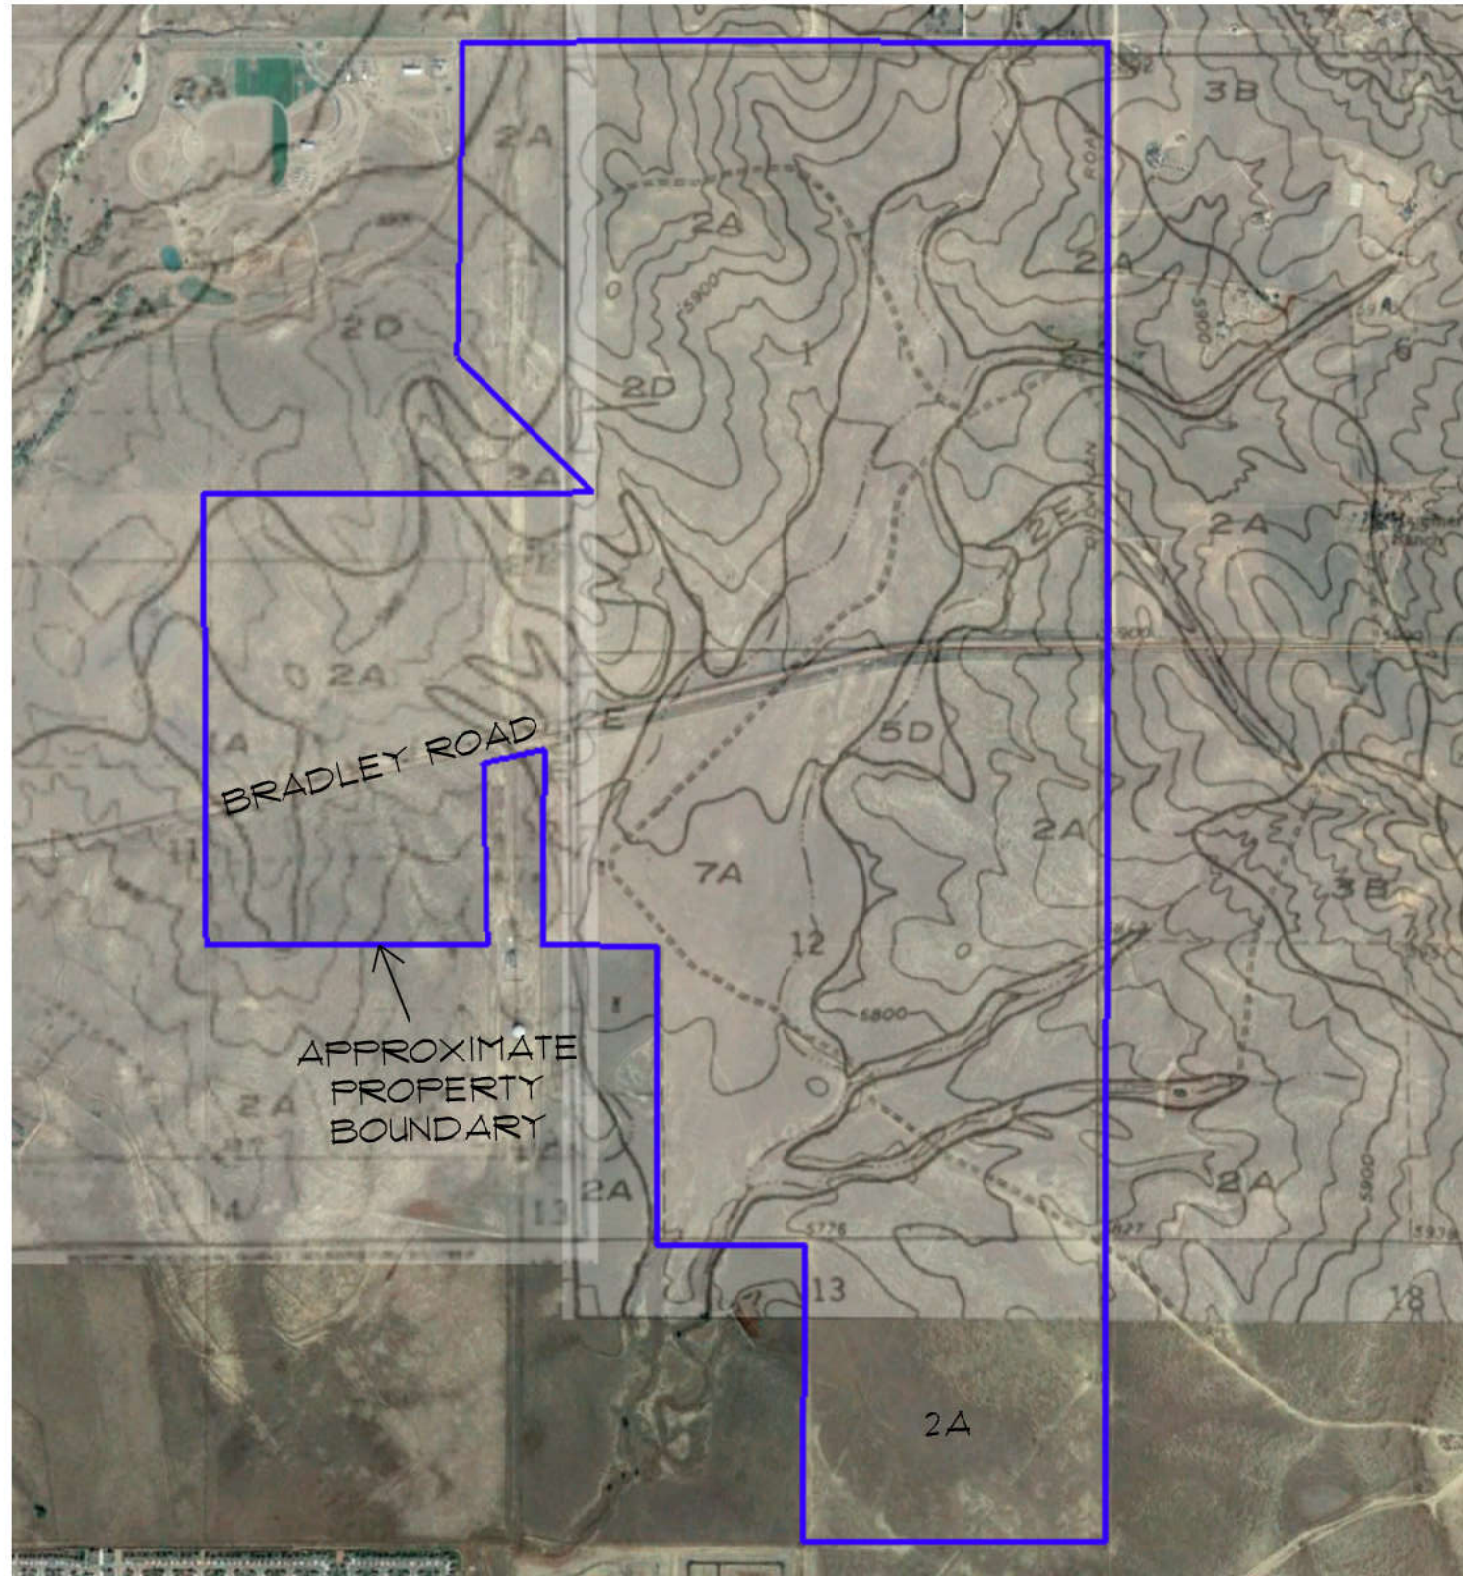
FIG-80

ENGINEERING CONDITIONS

1A - Stable alluvium, colluvium and bedrock on flat to gentle slopes (0-5%)

The potential geologic hazards and surficial deposits as mapped by Robinson and Associates is presented in the Engineering Map of Potential Geologic Hazards and Surficial Deposits, Figure 79. The environmental and engineering conditions as mapped by Robinson and Associates is presented in the Environmental and Engineering Geologic Map for Land Use, Figure 80.
