ENTECH
ENGINEERING, INC.

Re: Wastewater Study
305 Pine Oaks Road
Parcel No. 75250-00-014
El Paso County, Colorado
Entech Job No. 231440

The project consists of subdividing 17-acres into two rural residential lots. The existing home and out buildings on Lot 1 will remain, and a new residence is proposed for Lot 2. The site is located west of the intersection of Pine Oaks Road and Highway 115, in El Paso County, Colorado.

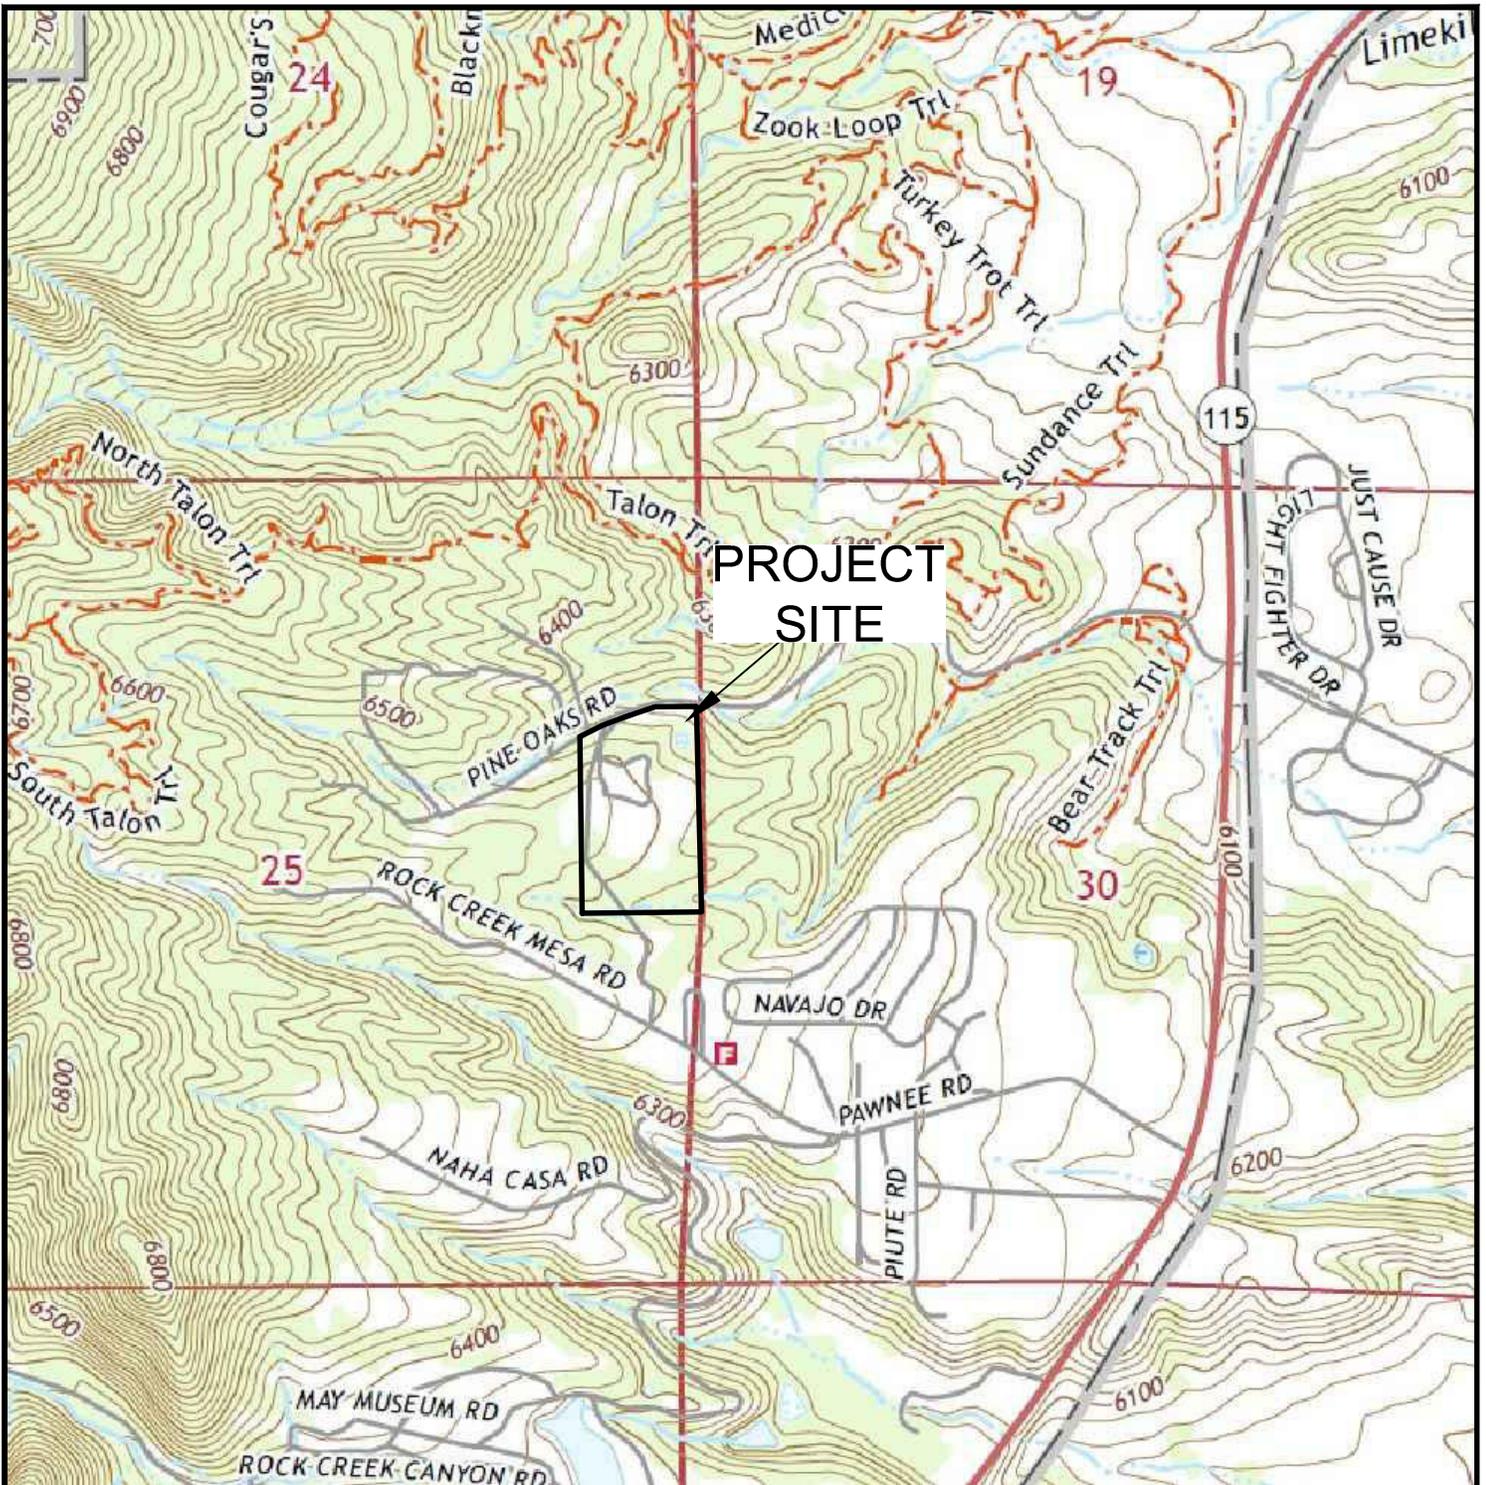
FIG. 2

USGS TOPOGRAPHY MAP

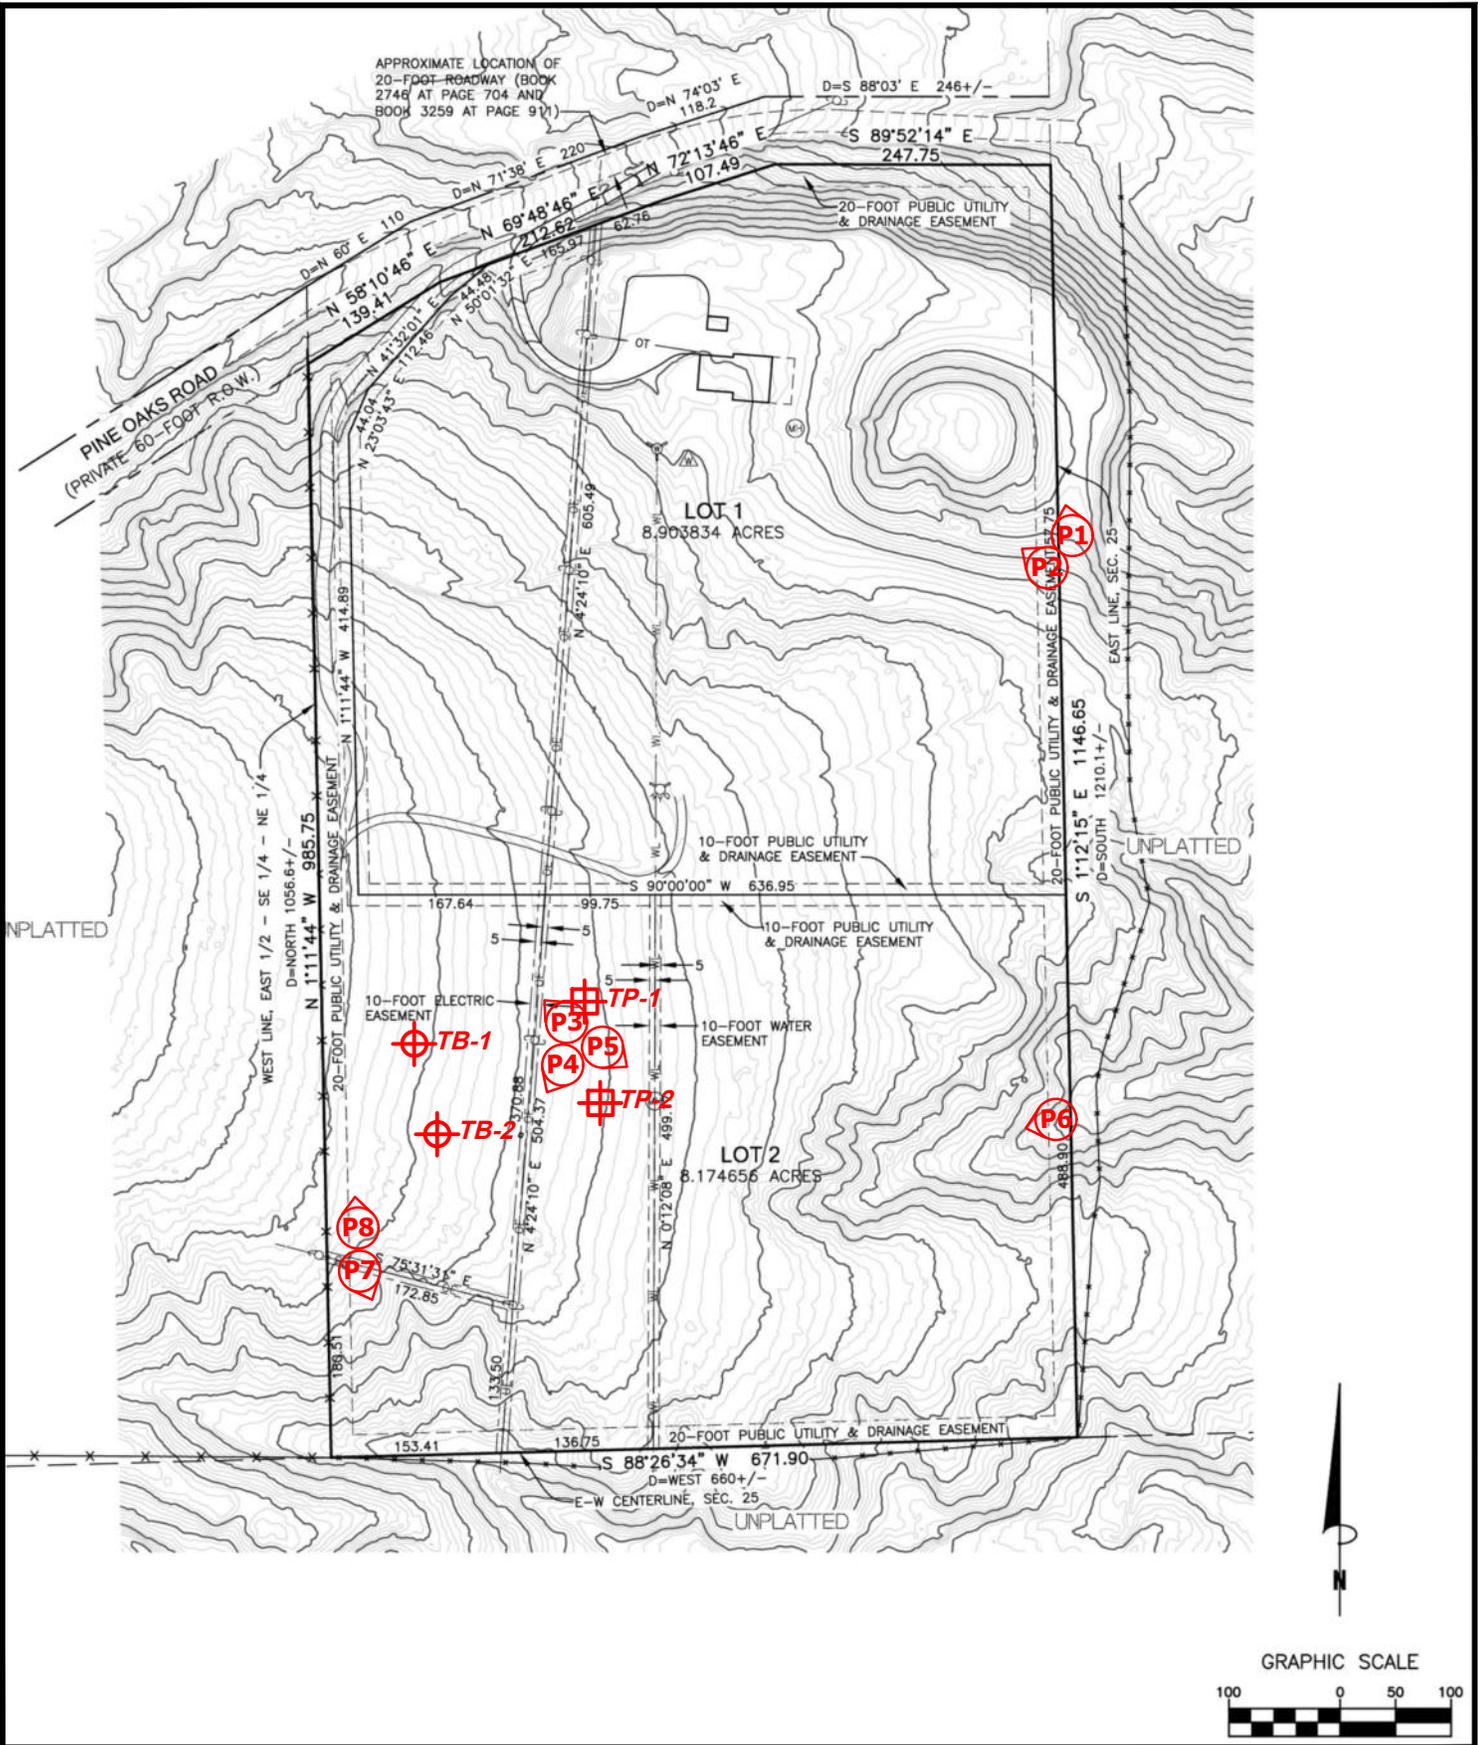
FIG. 3

EXPLORATION AND SITE PLAN

Total acreage involved in the proposed subdivision is 17-acres. Two rural residential lots are proposed. The proposed lot sizes range from 8.17 to 8.9-acres. The existing residence, outbuilding, on-site wastewater treatment system, and water well located on proposed Lot 1, will remain. The new lot will be serviced by a water cistern and on-site wastewater treatment system. The Site Plan with the proposed replat is presented in Figure 3.

Two test borings and two test pits were excavated on the site to determine general suitability for the use of on-site wastewater treatment systems and general soil characteristics. The location of the test pit is indicated on the Site Plan/Test Pit Location Map, Figure 3. The Test Pit Log is presented in Appendix B. Results of this testing will be discussed later in this report.

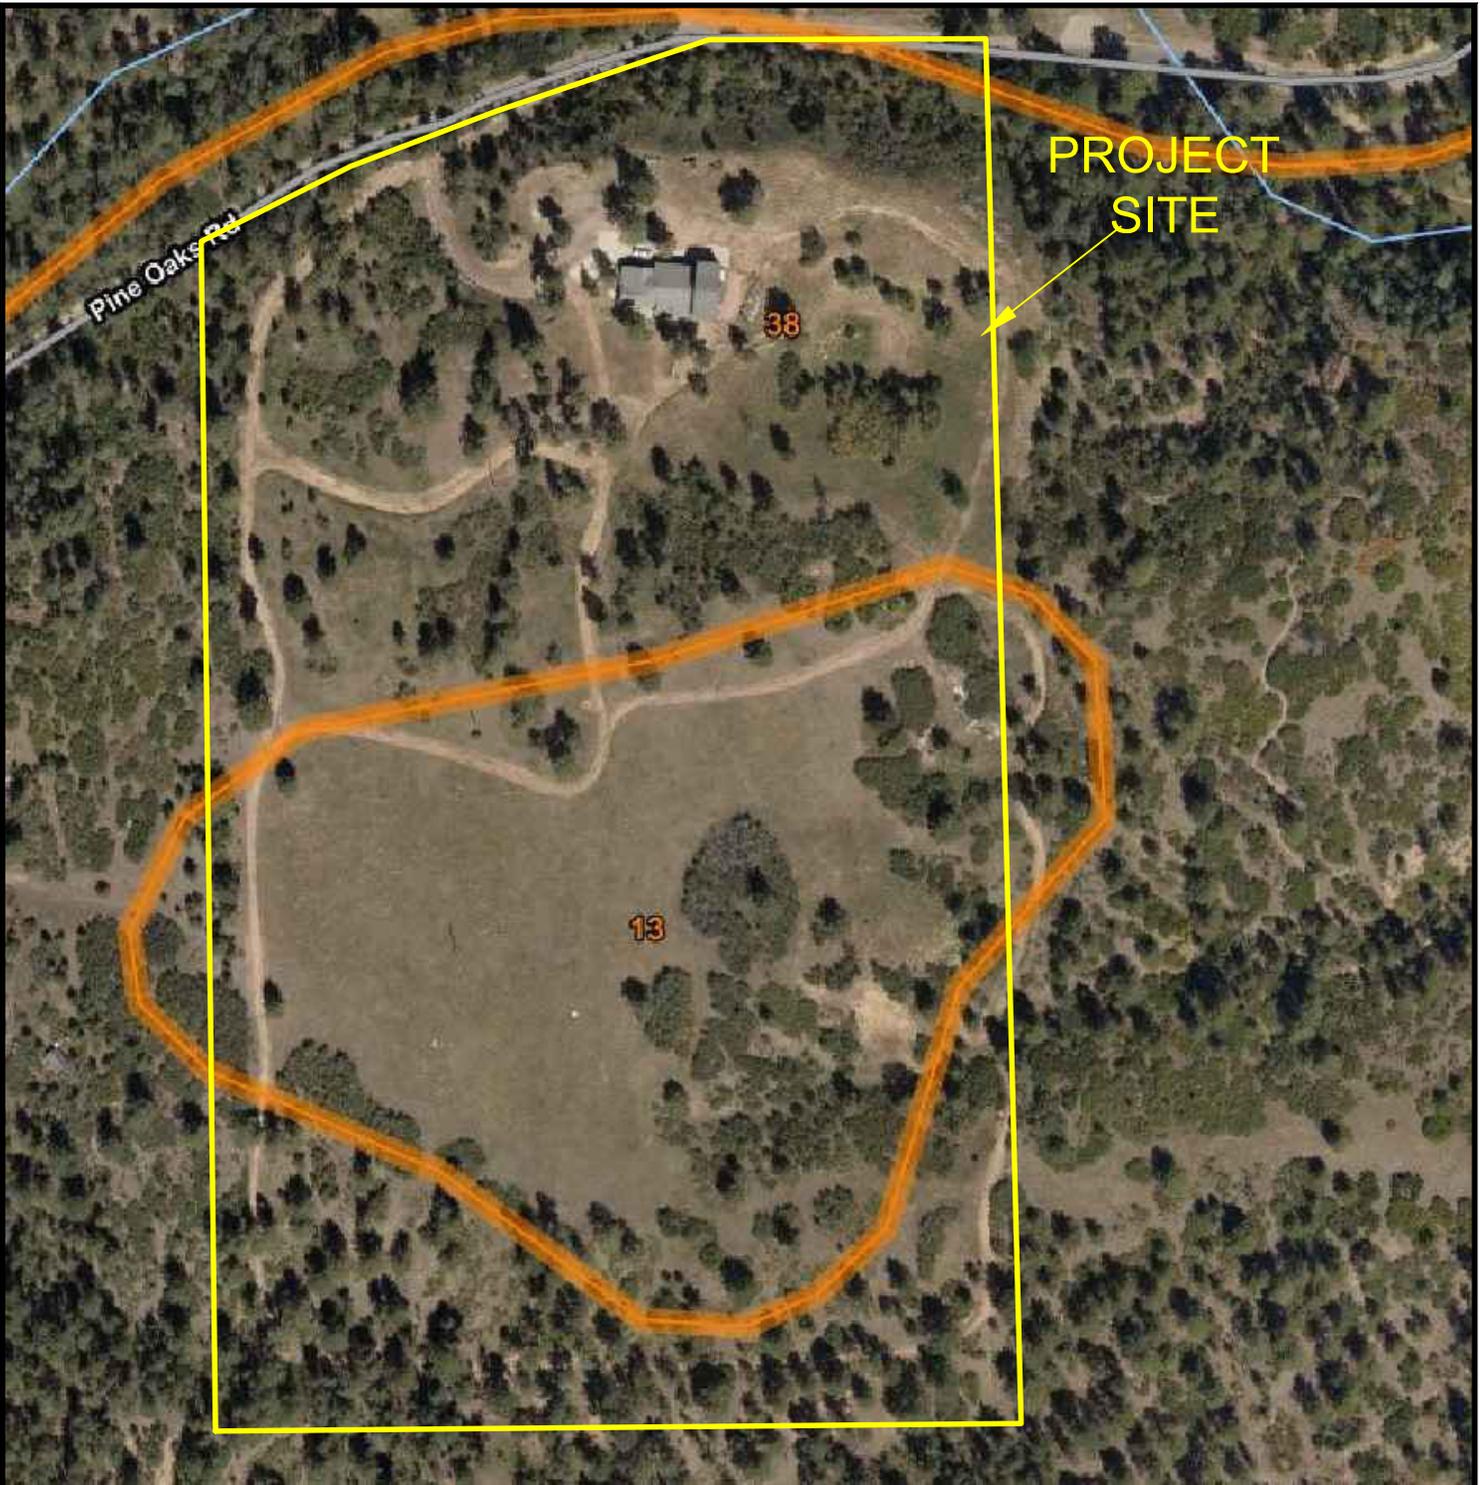
FIG. 4

SOIL SURVEY MAP

The Natural Resource Conservation Service (NRCS) (Reference 1, Figure 4), previously the Soil Conservation Service (Reference 2) has mapped three soil types on the site. Complete descriptions of the soil types are presented in Appendix D. In general, the soils consist of sandy loam to gravelly loamy sand. The soils are described as follows:

The Natural Resource Conservation Service (Reference 1), previously the Soil Conservation Service (Reference 2) has been mapped with three soil descriptions. The Soil Survey Map (Reference 1) is presented in Figure 4, and the Soil Survey Descriptions (Reference 2) are presented in Appendix D. The soils are described as having moderate to rapid percolation rates. Records for the existing septic system were not available for the site.

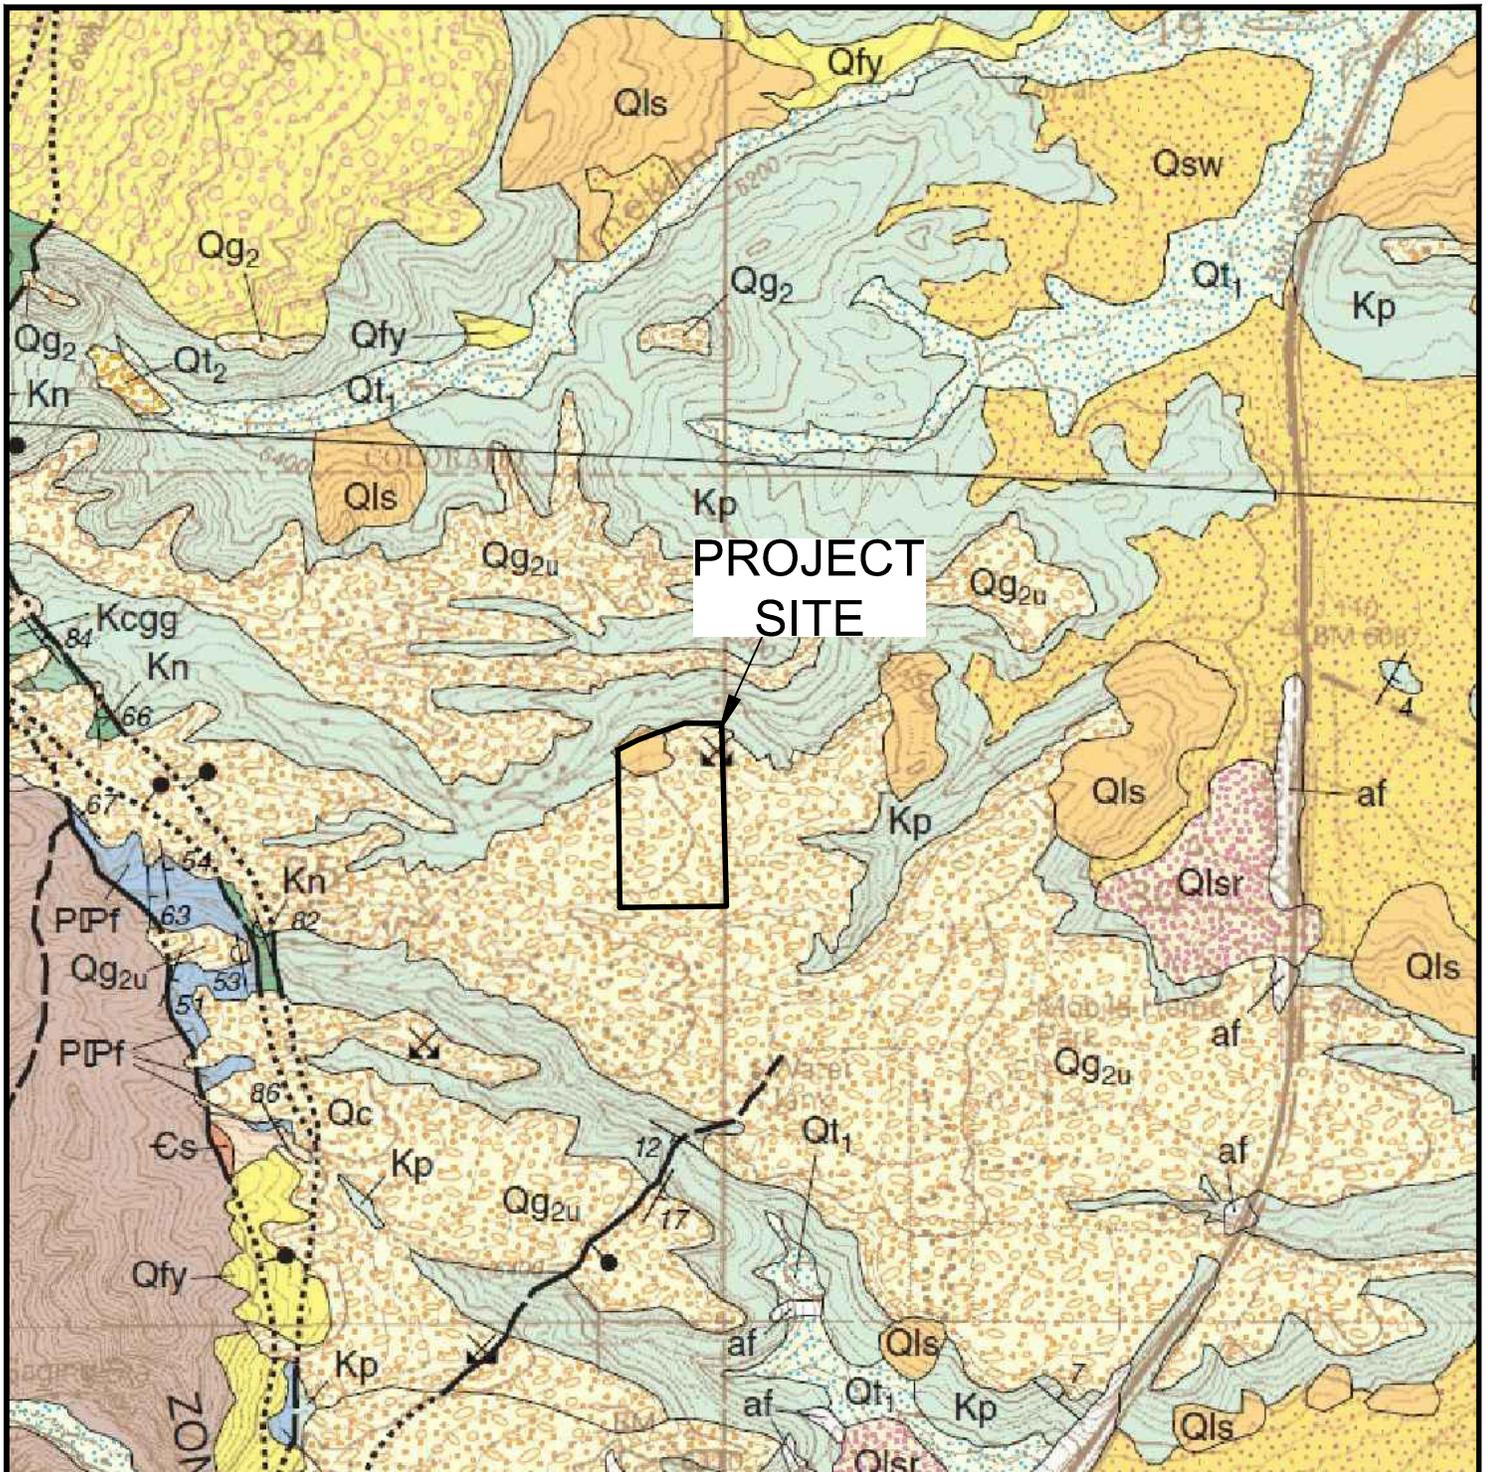
**CHEYENNE MOUNTAIN QUADRANGLE
GEOLOGIC MAP**
305 PINE OAKS ROAD
EL PASO COUNTY, COLORADO
T-BONE CONSTRUCTION

The geology of the site was evaluated using the *Geologic Map of the Cheyenne Mountain Quadrangle*, by Rowley et. al. in 2003, (Reference 4, Figure 5). The Geology Map for the site is presented in Figure 6. Two mappable units were identified on this site which is described as follows:

The soils listed above were mapped from site-specific mapping, the *Geologic Map of the Cheyenne Mountain Quadrangle* distributed by the Colorado Geologic Survey in 2003 (Reference 4, Figure 5), The *Geologic Map of the Colorado Springs-Castle Rock Area*, distributed by the US Geological Survey in 1979 (Reference 5), and the *Geologic Map of the Pueblo 1° x 2° Quadrangle*, distributed by the US Geological Survey in 1978 (Reference 6). The test borings and test pits were used in evaluating the site and is included in Appendix B. The Geology Map prepared for the site is presented in Figure 6.

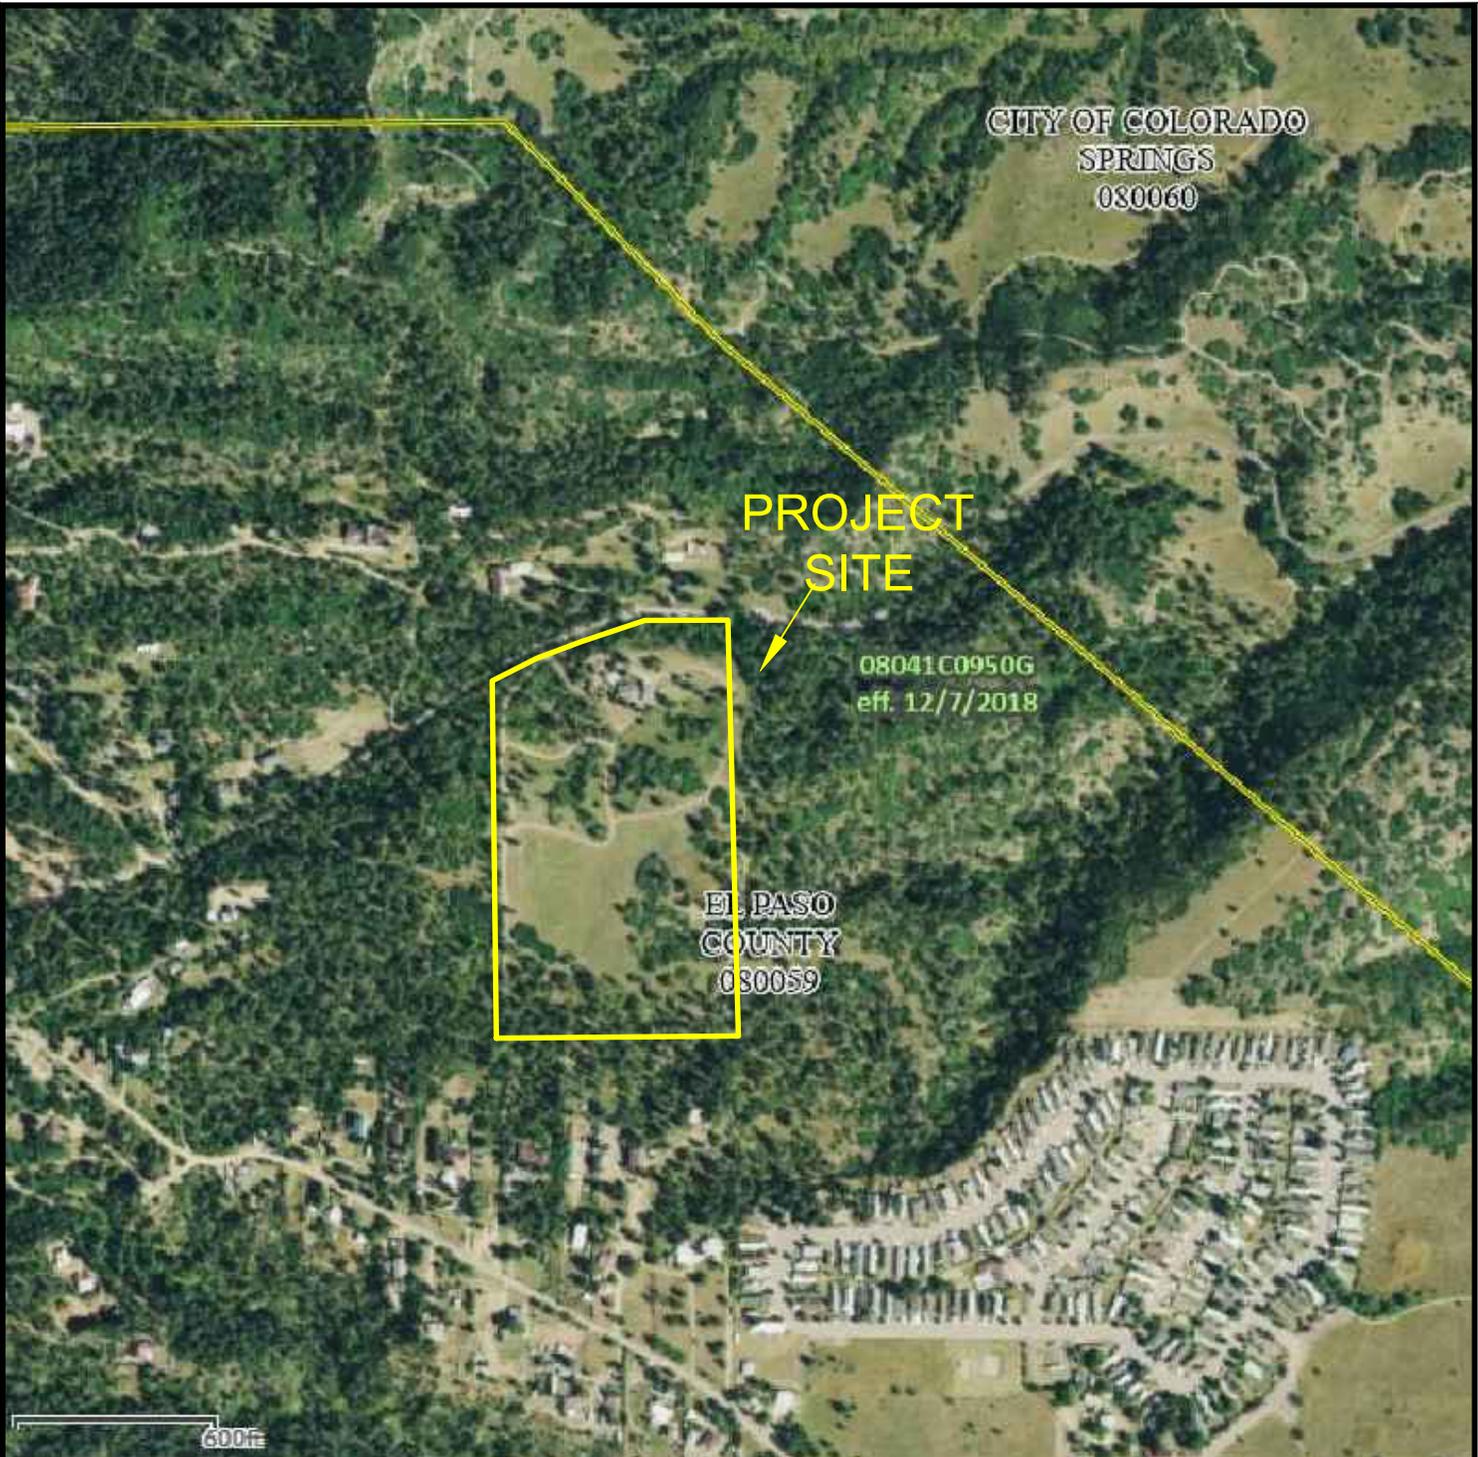
FIG. 7

FEMA FLOODPLAIN MAP

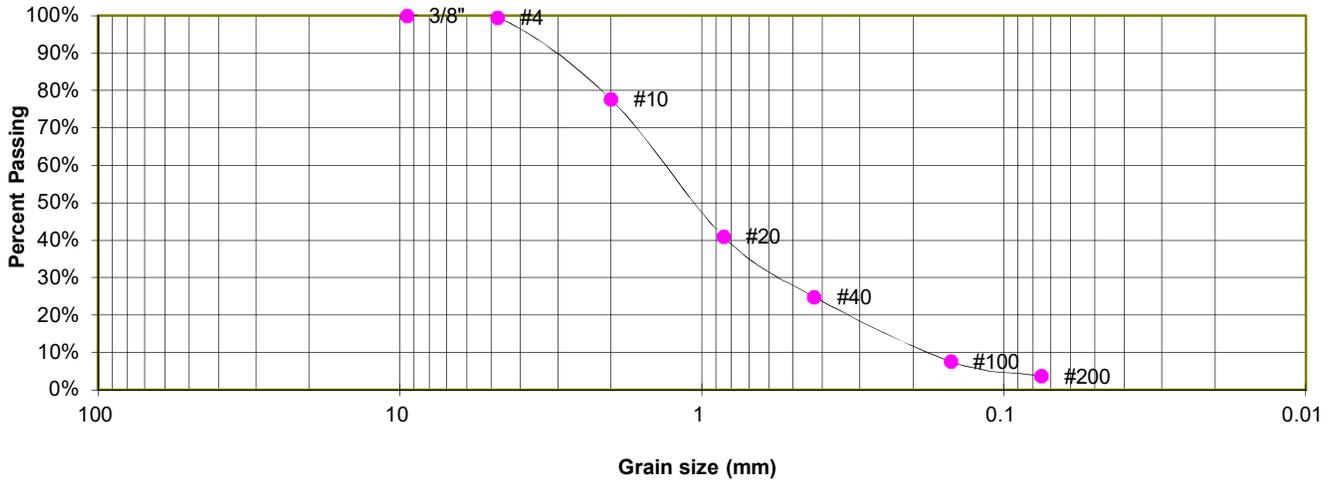
SOIL DESCRIPTION SAND, SLIGHTLY SILTY

**Sieve Analysis
 Grain Size Distribution**

GRAIN SIZE ANALYSIS

U.S. Sieve #	Percent Finer
3"	
1 1/2"	
3/4"	
1/2"	
3/8"	100.0%
4	99.5%
10	77.6%
20	41.0%
40	24.9%
100	7.6%
200	3.7%

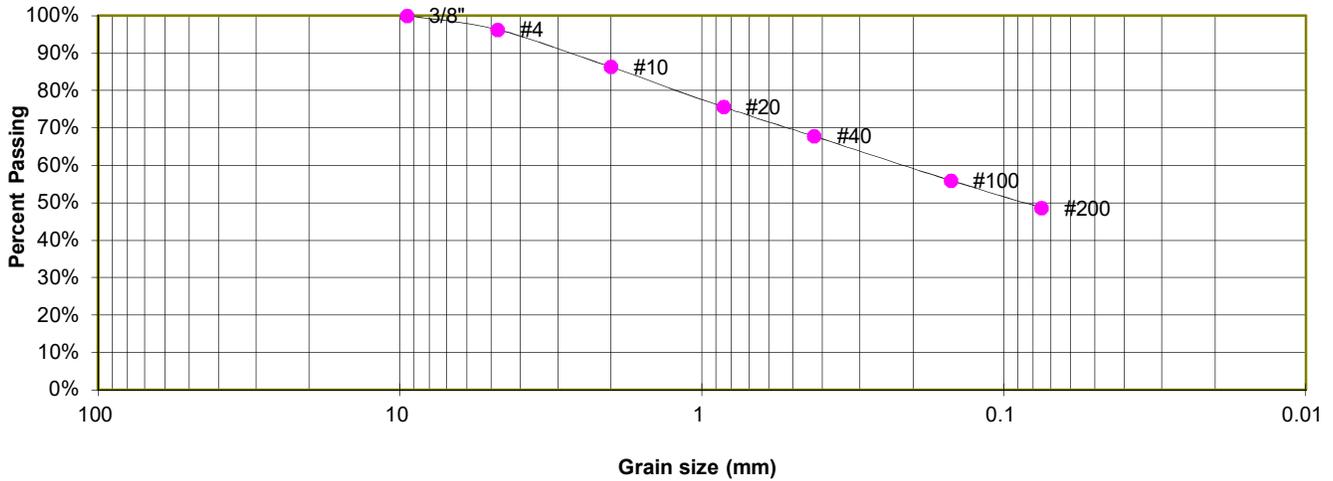
SOIL DESCRIPTION SAND, CLAYEY

Sieve Analysis Grain Size Distribution

GRAIN SIZE ANALYSIS

U.S. Sieve #	Percent Finer
3"	
1 1/2"	
3/4"	
1/2"	
3/8"	100.0%
4	96.3%
10	86.3%
20	75.6%
40	67.8%
100	56.0%
200	48.7%

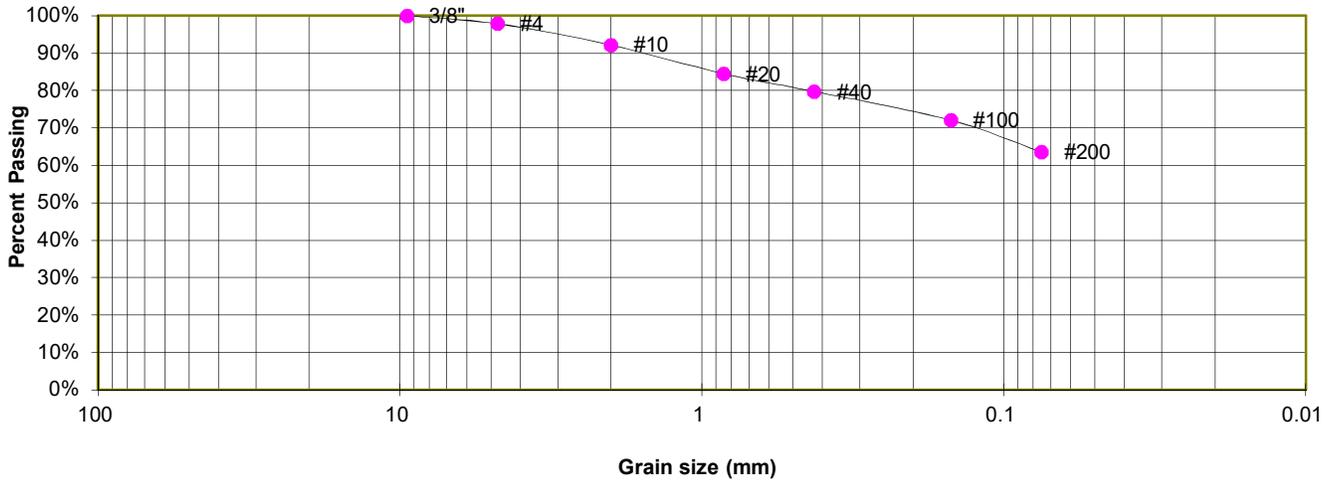
SOIL DESCRIPTION CLAY, SANDY

Sieve Analysis Grain Size Distribution

GRAIN SIZE ANALYSIS

U.S. Sieve #	Percent Finer
3"	
1 1/2"	
3/4"	
1/2"	
3/8"	100.0%
4	97.9%
10	92.2%
20	84.5%
40	79.8%
100	72.1%
200	63.6%

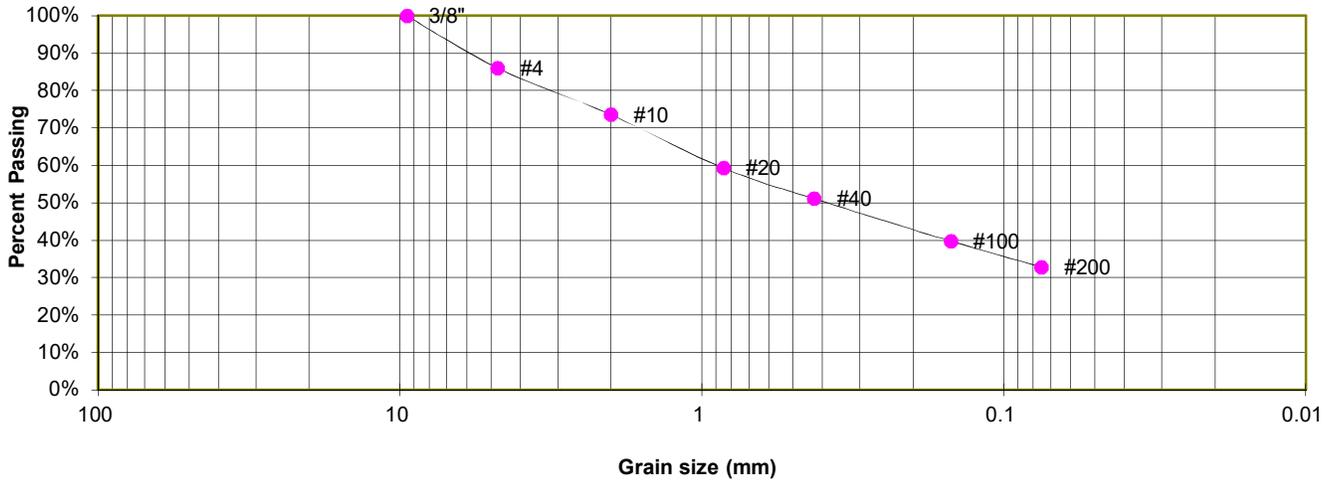
SOIL DESCRIPTION SAND, CLAYEY

Sieve Analysis Grain Size Distribution

GRAIN SIZE ANALYSIS

U.S. Sieve #	Percent Finer
3"	
1 1/2"	
3/4"	
1/2"	
3/8"	100.0%
4	86.0%
10	73.5%
20	59.3%
40	51.1%
100	39.8%
200	32.8%
