SOILS AND GEOLOGY STUDY

**Dwire Storage Yard, Filing No. 1
El Paso County, Colorado**

JOB NO. 168498

**March 4, 2020
Revised June 10, 2020**

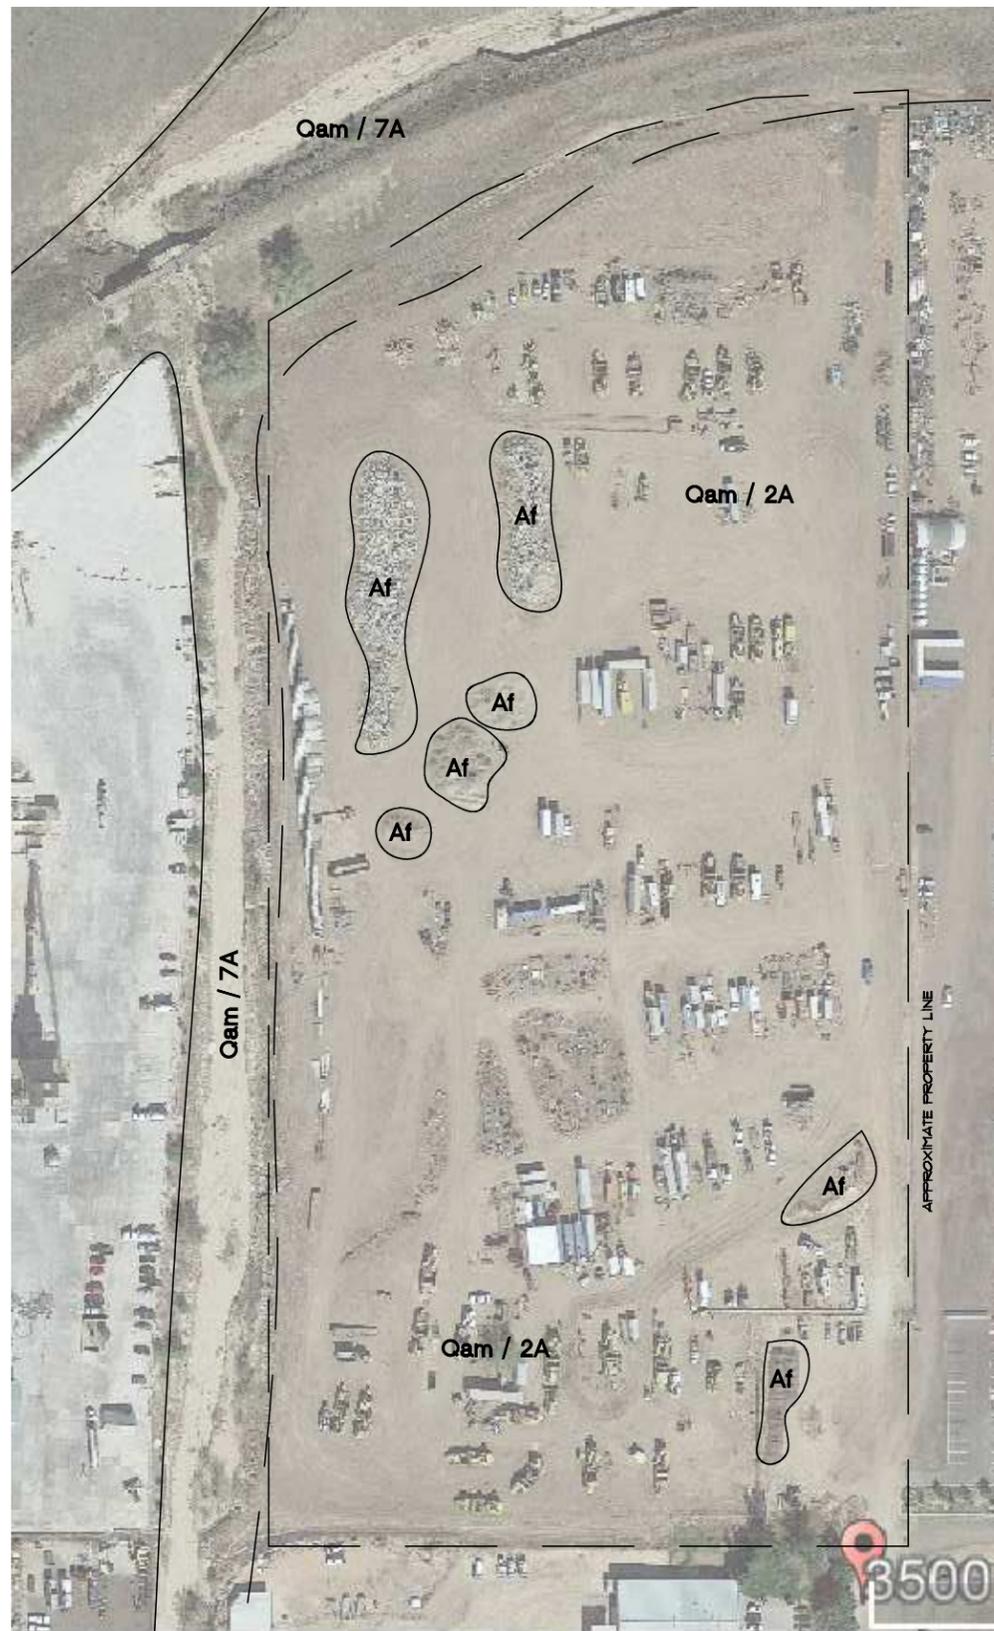
FIG-4

Af - Artificial fill (late Holocene) - stockpiles of debris to include concrete and soils

Based on our field observations and the Geologic Map of the Falcon NW Quadrangle, an interpreted geologic map of significant surficial deposits and features was mapped for the site. The identified geologic conditions affecting the development are presented in the Engineering and Geology Map, Figure 4.

The Engineering Geology is presented in the Engineering and Geology Map, Figure 4.

If development is to occur on the lot in the future, it is recommended that all construction is to remain outside this area, as shown on the Engineering and Geology Map, Figure 4. Additional mitigation for the lot is not required at this time. As noted herein, the foundation drainage measures for the office building are determined in the Geotechnical Investigation presented in Appendix B. Additional drainage measures for the warehouse and any future structures are to be determined by the site-specific subsurface soil investigations performed at the time of construction.

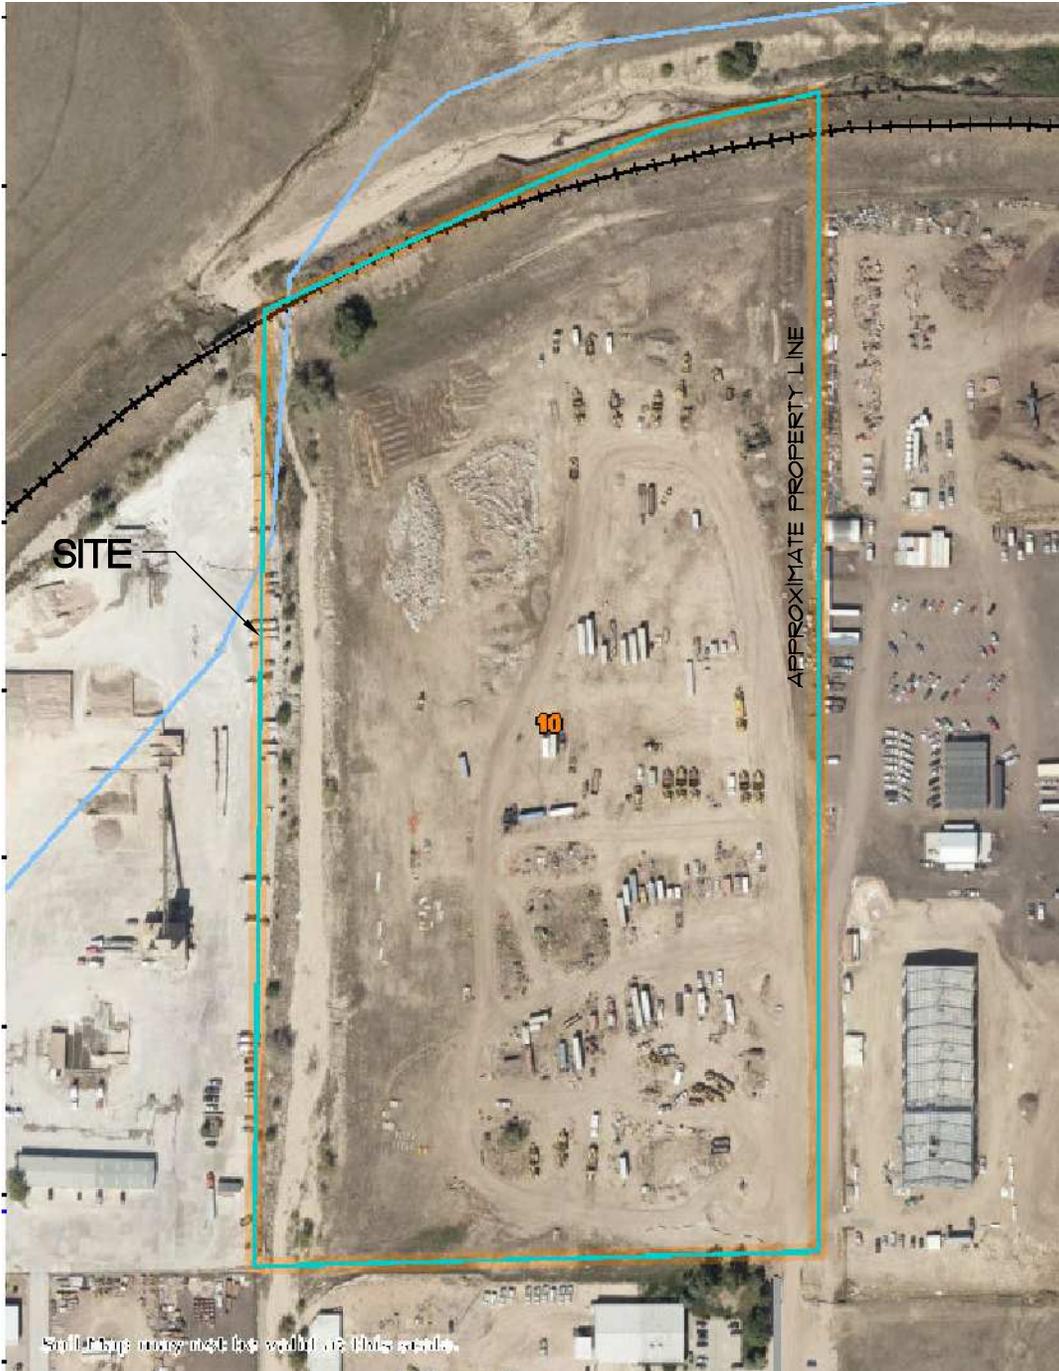
FIG No. 5

10 - BLENDON sandy loam, 0 to 3% slopes

The USDA Soil Survey Map is presented in Figure 5.

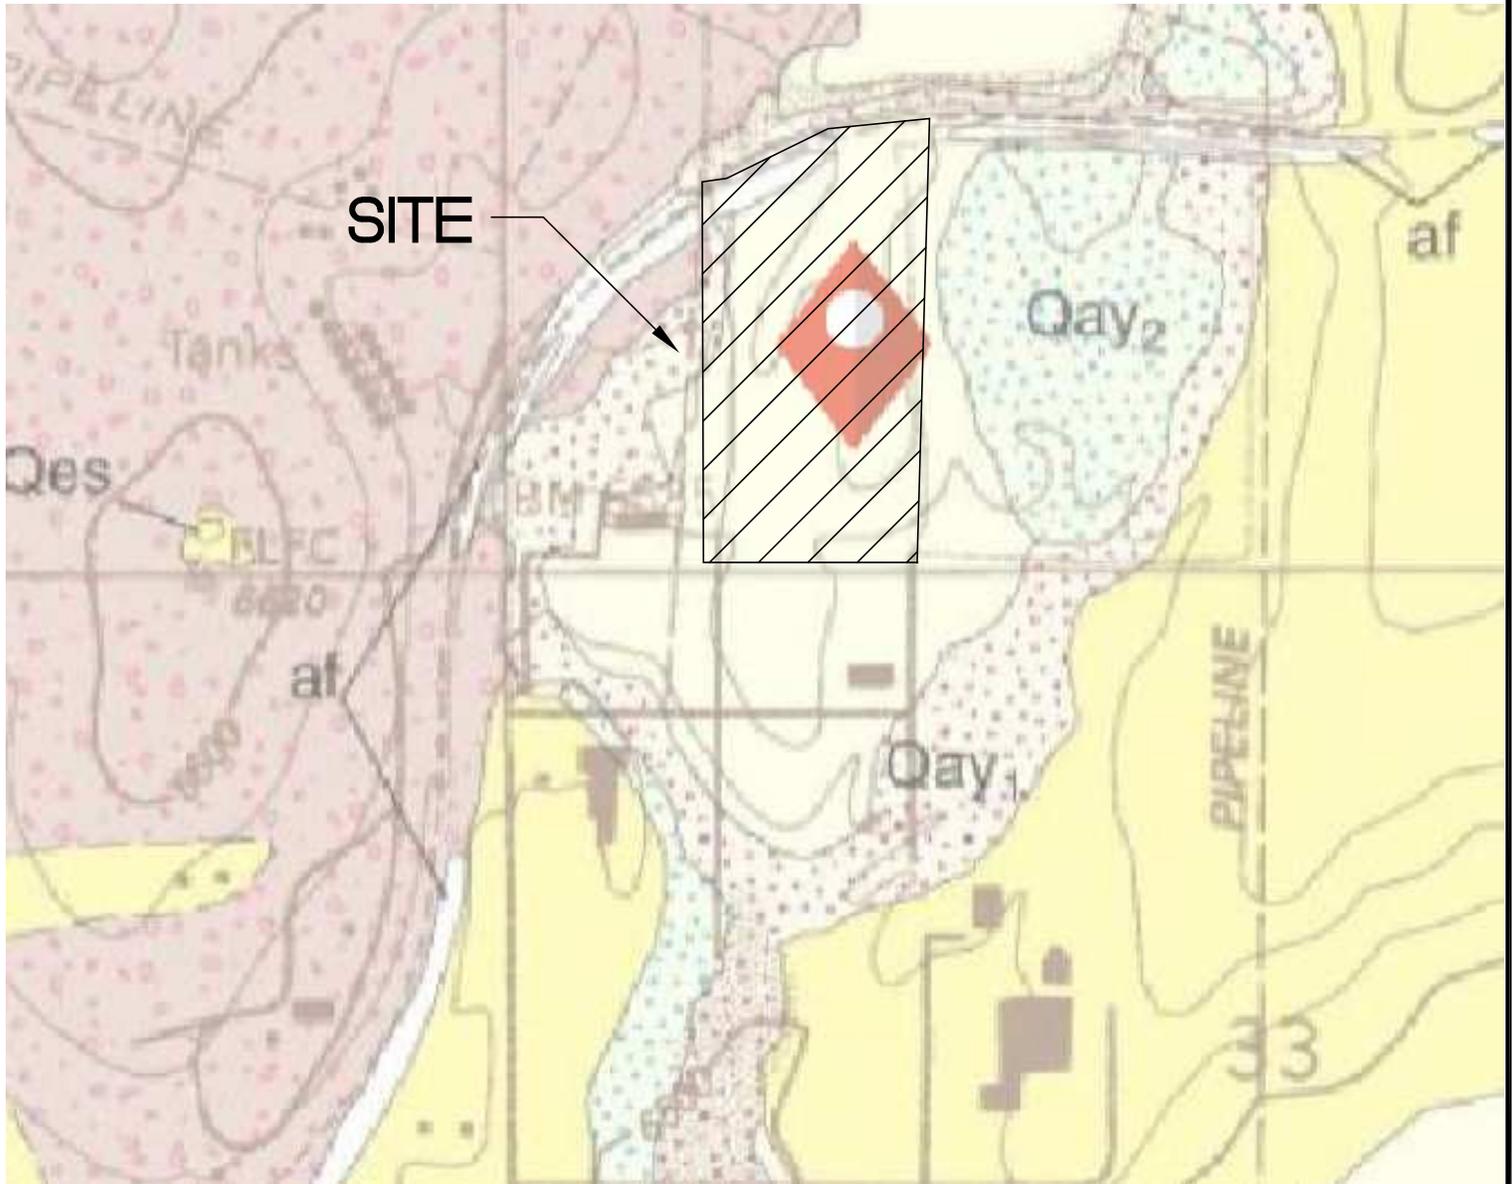
FIG No. 6

Qam - Middle alluvium (early Holocene to late Pleistocene)

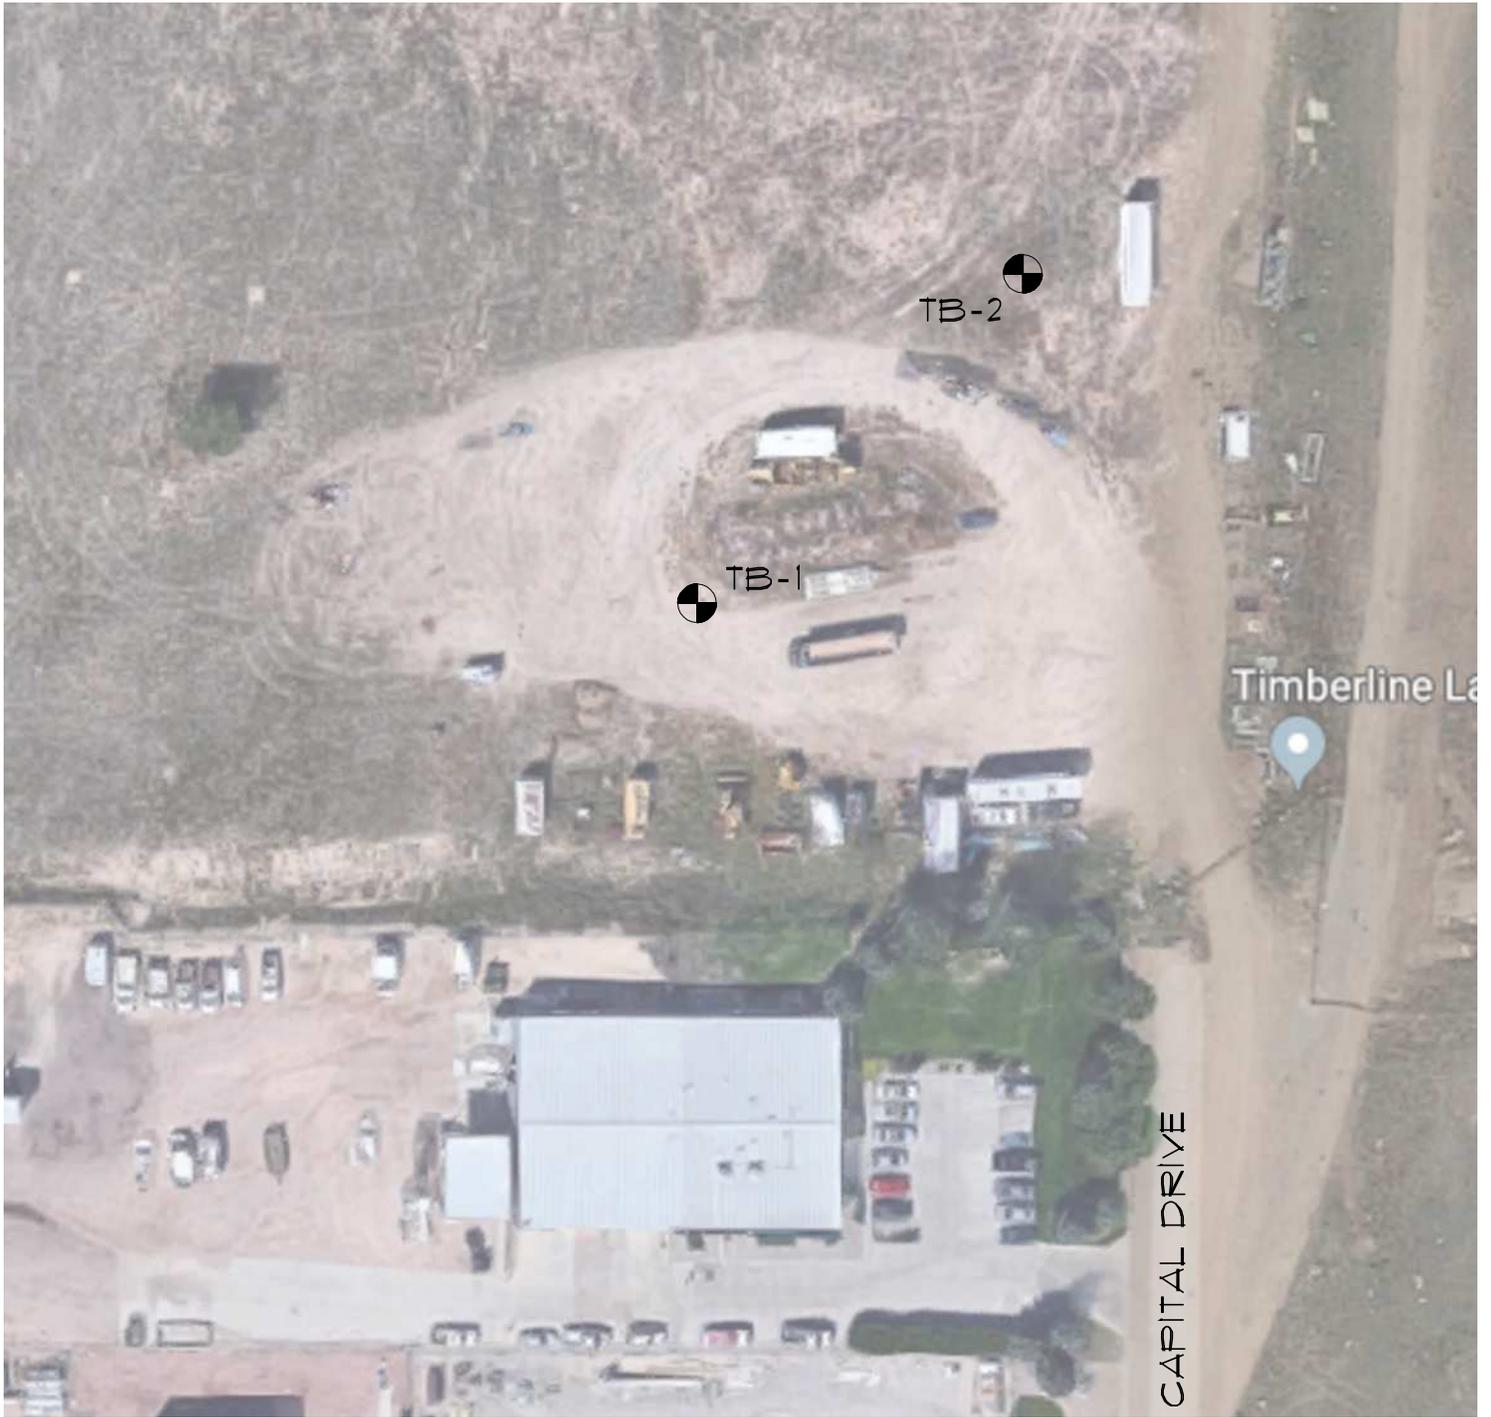
⊕ DENOTES APPROXIMATE LOCATION OF TEST BORINGS

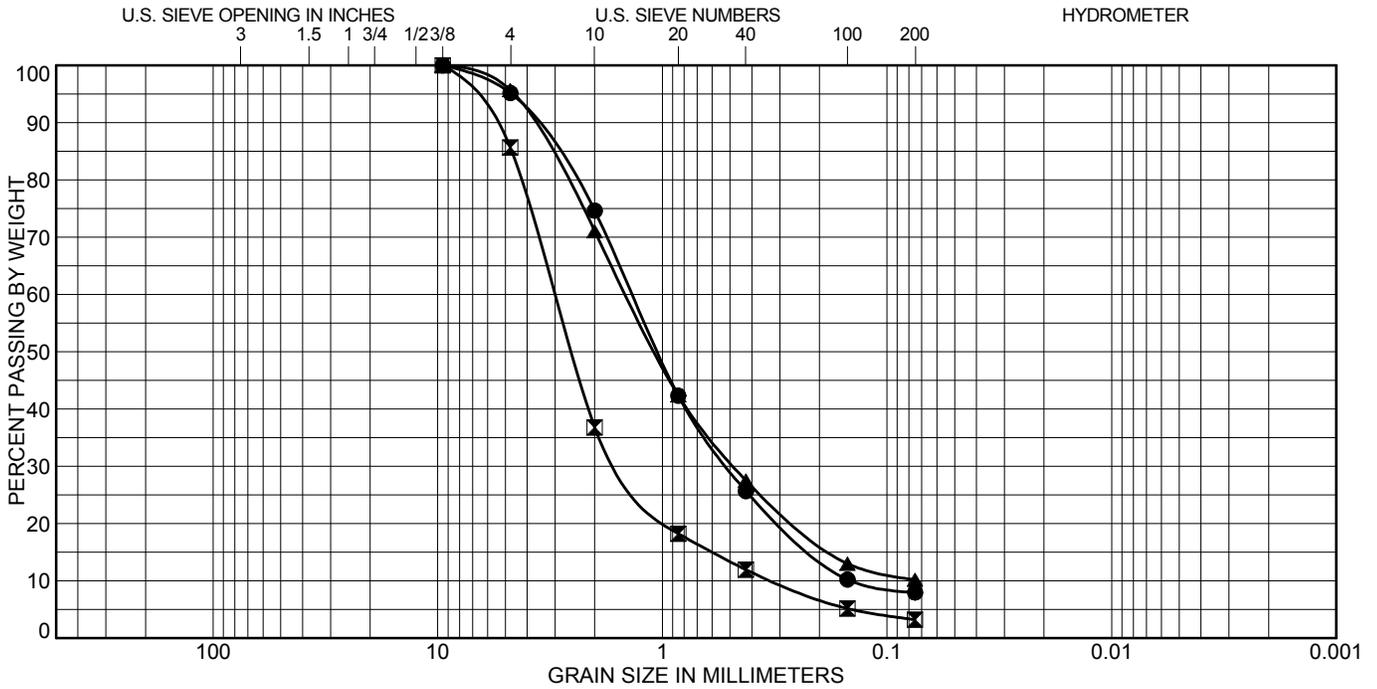
FIGURE No. 6

COBBLES	GRAVEL		SAND			SILT OR CLAY
	coarse	fine	coarse	medium	fine

Test Boring	Depth (ft)	Classification	LL	PL	PI
● 1	9.0	WELL-GRADED SAND with SILT(SW-SM)	NP	NP	NP
☒ 2	4.0	WELL-GRADED SAND(SW)	NP	NP	NP
▲ 2	14.0	WELL-GRADED SAND with SILT(SW-SM)	NP	NP	NP

The moisture content for the recovered samples was obtained in the laboratory. Grain-size analysis, Atterberg Limits, and Denver Swell/Consolidation tests were performed on selected samples for purposes of classification and to develop pertinent engineering properties. A Summary of Laboratory Test Results is presented in Figure 5. Soil Classification Data are presented in Figure 6. The soil was deemed to be non-plastic and therefore swell/Consolidation Tests were not performed.
