GEOLOGIC HAZARD EVALUATION AND PRELIMINARY GEOTECHNICAL INVESTIGATION GRANDVIEW RESERVE, PHASE 3 EASTONVILLE ROAD AND U.S. HIGHWAY 24 FALCON, COLORADO

Project No. CS19345.300-115

March 12, 2024

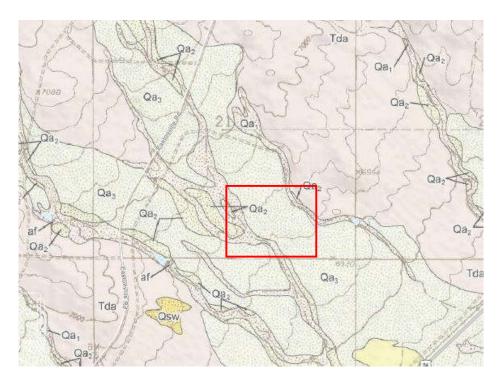
Excerpt from Falcon Quadrangle Geologic Map, El Paso County, Colorado, 2012. General Site Area is Depicted in Red

The predominant geologic unit at the site is Quaternary-age Alluvium (Qa₁, Qa₂, and Qa₃). The alluvium consists of poorly to well sorted, poorly to moderately consolidated, silt, sand, gravel, and minor clay along active stream channels and terraces. The Dawson Formation bedrock (Tda) is mapped underlying the site at depth. The Dawson Formation consists of white to tan, thick to massive, cross-bedded arkoses, pebbly arkoses, and arkosic pebble conglomerates. The Dawson Formation in the site area is predominantly sandstone with sparse interbeds of thin-bedded gray claystone and sandy claystone. The bedrock underlies the surficial alluvium throughout the site. Conditions at the site were found to be similar to the mapped conditions.

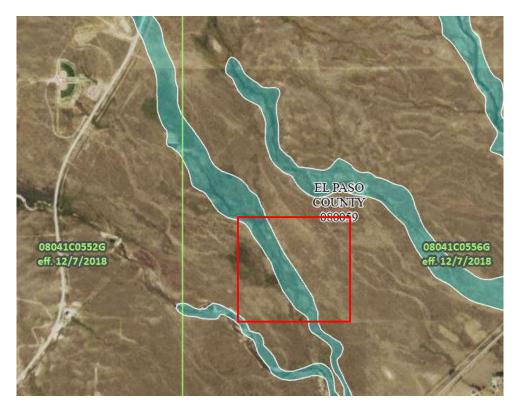
Excerpt from FEMA National Flood Hazard Layer Viewer, General Site Area is Depicted in Red

The majority of the site lies within Zone D (undetermined flood hazard), as shown on FIRM Community Map Number 08041C0556G, revised December 7, 2018. Zone D indicates floods are possible, but not likely. Some portions of the site within drainage areas lie within Zone A, as shown below.

Based on the topography at the site, the potential for a flood to impact the majority of the site area is low. During peak precipitation events, some accumulation of surface sheet flow in drainages is expected with possible inundation within the Zone A areas that are identified in the bluish-green color shown above. Development will increase the relative area of impervious surfaces, which can lead to drainage problems and erosion if surface water flow is not adequately designed. Surface drainage design and evaluation of flood potential should be performed by a civil engineer as part of the project design.

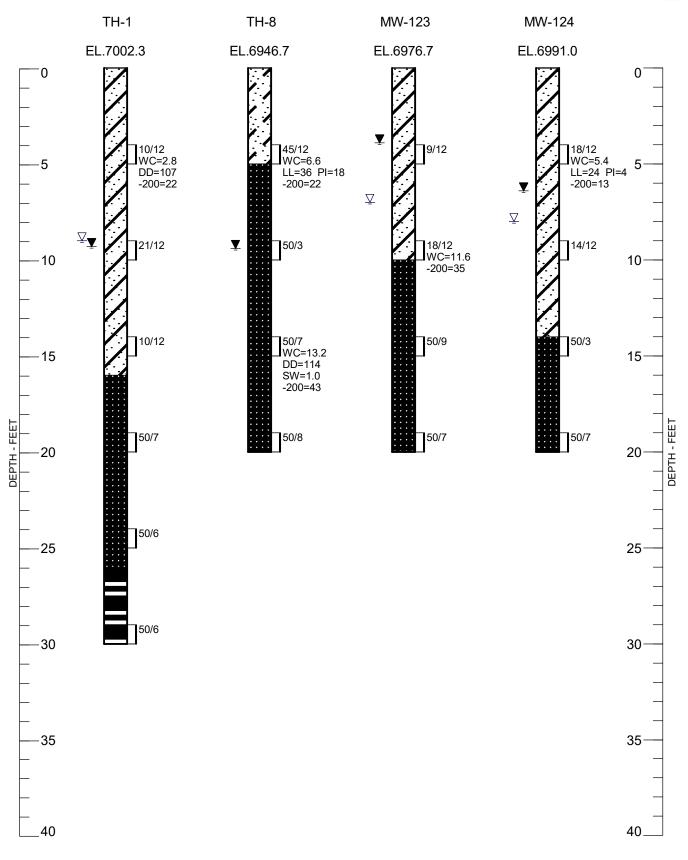
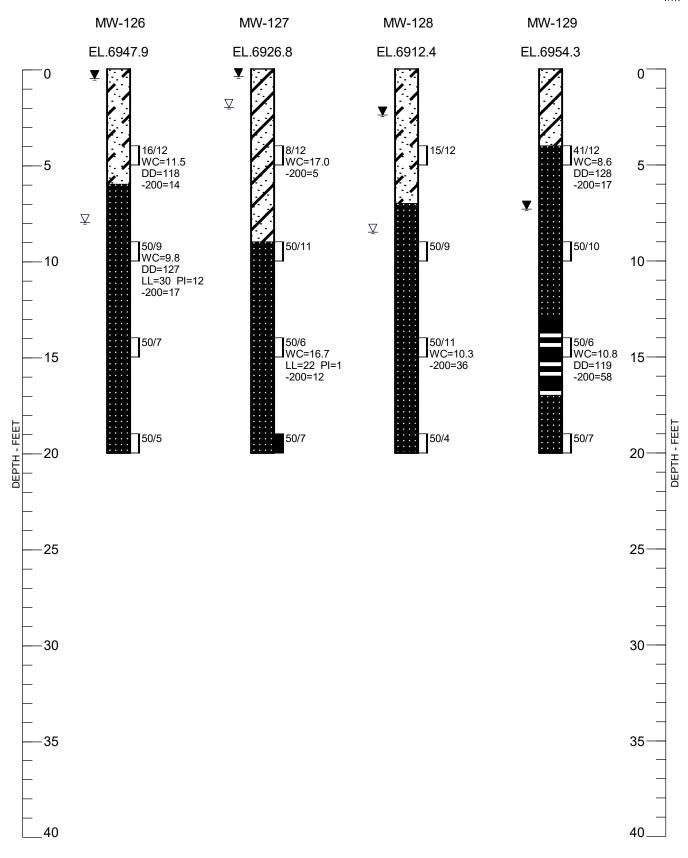
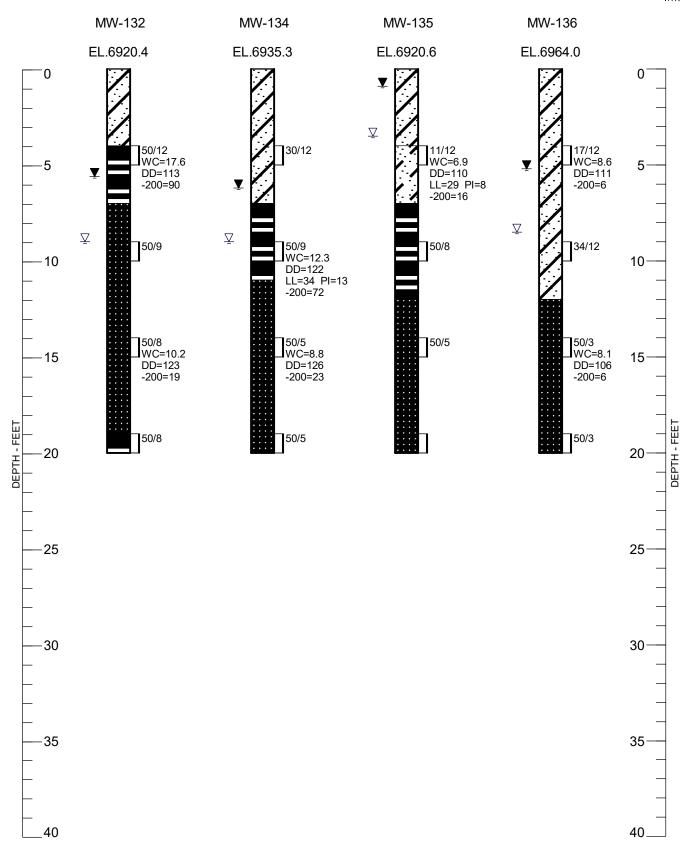
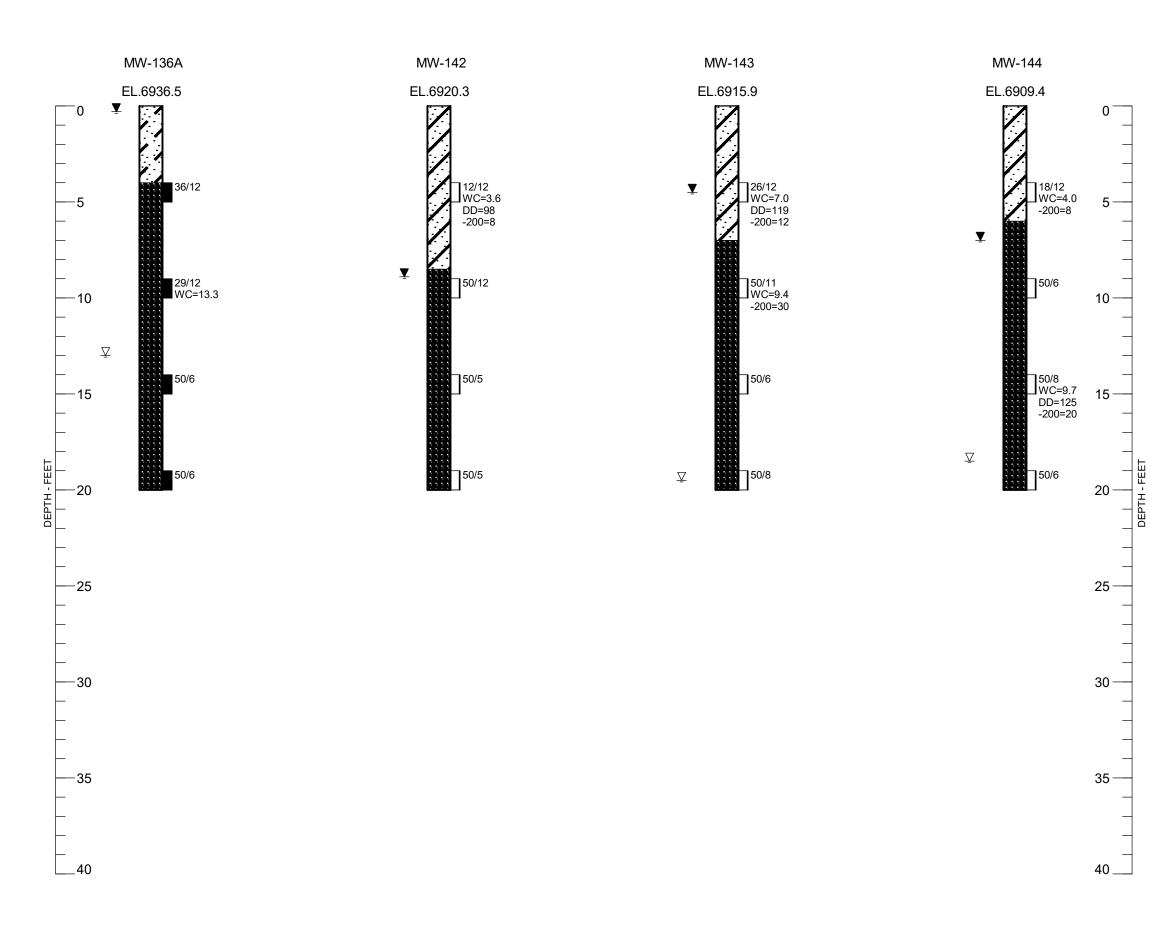
D.R. HORTON GRANDVIEW RESERVE, PHASE 3 CTL|T PROJECT NO. CS19345.300-115 Summary Logs of Exploratory Borings

SUMMARY LOGS OF EXPLORATORY BORINGS AND MONITORING WELLS

SAND, CLAYEY, DENSE, SLIGHTLY MOIST, BROWN, LIGHT BROWN (SC).

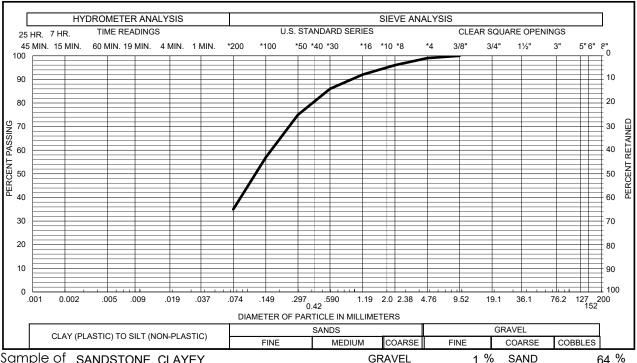
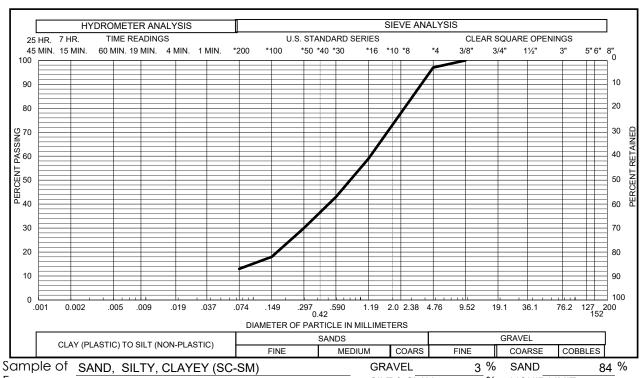
GRAVEL 1 % SAND 35 % LIQUID LIMIT SILT & CLAY PLASTICITY INDEX

From MW - 124 AT 4 FEET SILT & CLAY 13 % LIQUID LIMIT 24 PLASTICITY INDEX

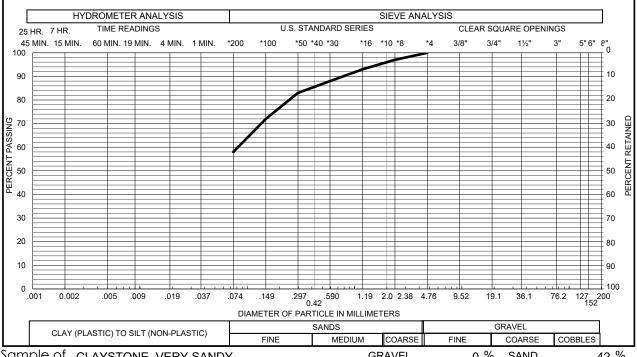
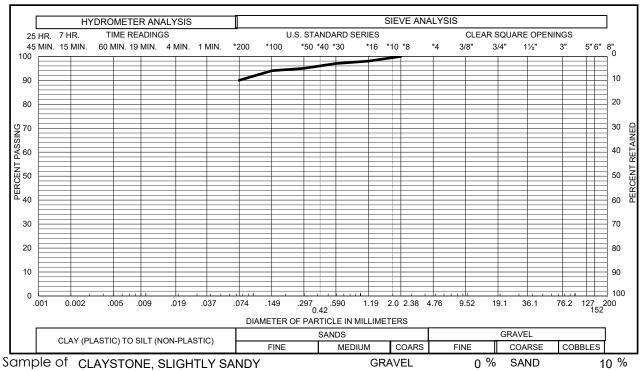
GRAVEL 0 % SAND 42 % SILT & CLAY 58 % LIQUID LIMIT PLASTICITY INDEX

From CLAYSTONE, SLIGHTLY SANDY
MW - 132 AT 4 FEET

GRAVEL 0 % SAND 10 % SILT & CLAY 90 % LIQUID LIMIT PLASTICITY INDEX

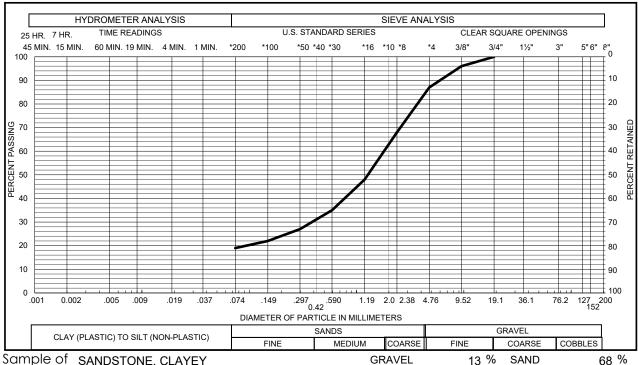
GRAVEL 13 % SAND 68 % SILT & CLAY 19 % LIQUID LIMIT PLASTICITY INDEX
