SOILS AND GEOLOGY REPORT

Telle Subdivision

El Paso County, Colorado

February 06, 2021

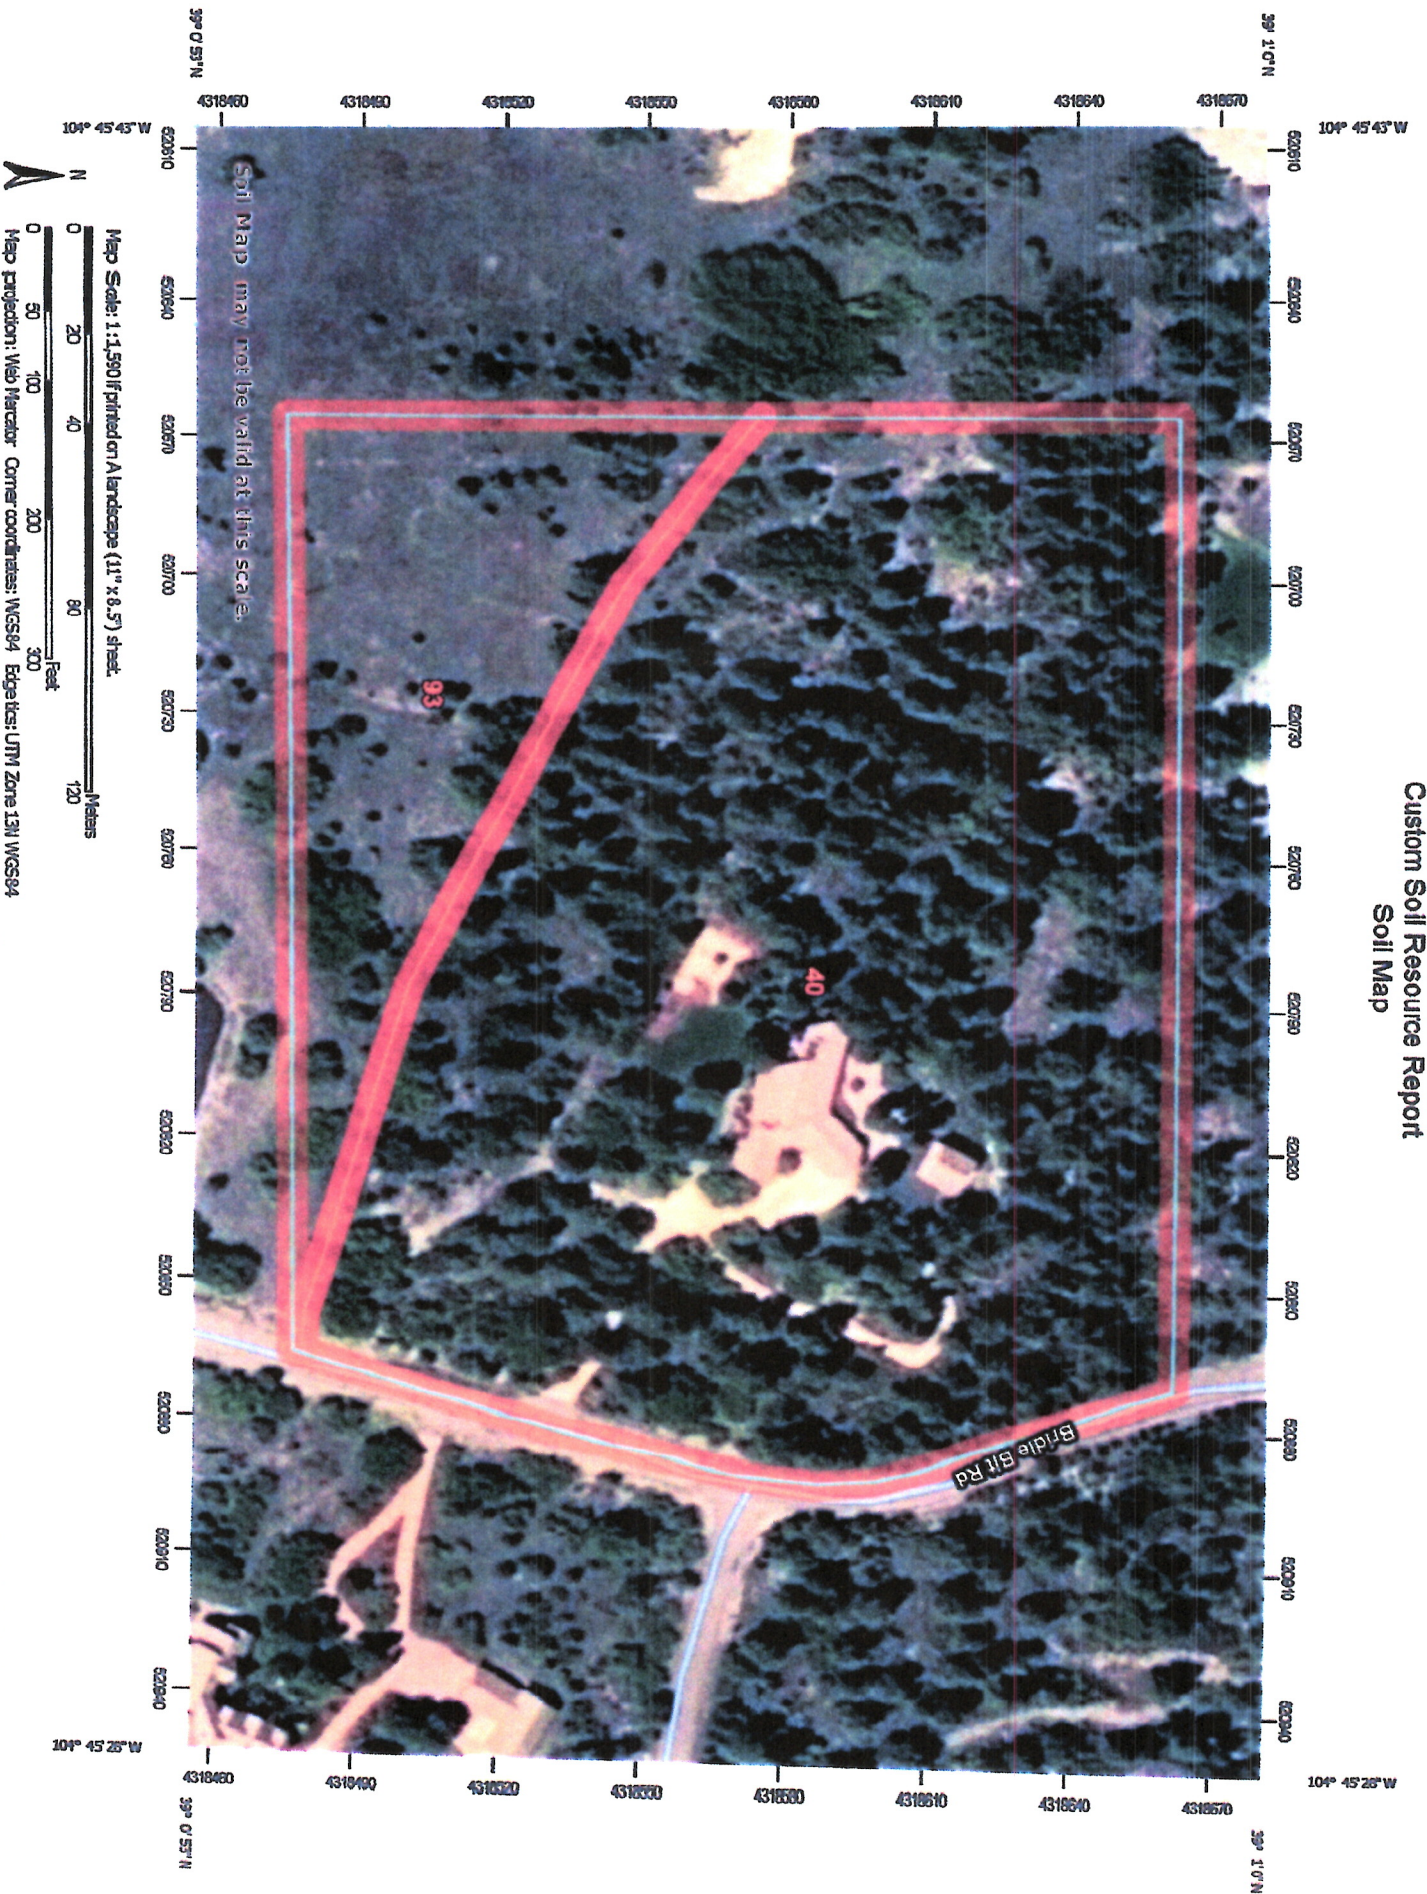
FIGURE 5

Custom Soil Resource Report Soil Map

The natural drainage class for the Kettle gravely loamy sand (Type 40) is “well drained” to “somewhat extensively drained” therefore the runoff potential is low (NRCS, 2018)(Figure 5). Tomah-Crowfoot complex is well drained having a medium potential for runoff. The soils in this region are all classified as Hydrologic Soils Group B. “Group B soils are described as having a moderate infiltration rate when thoroughly wet. These soils consist primarily of moderately deep or deep, moderately well drained to well drained soils. The texture is fine to course and can transmit water at a moderate rate. As the surface runoff is slow, there is a low-to-moderate hazard for erosion” (USDA, 1981).

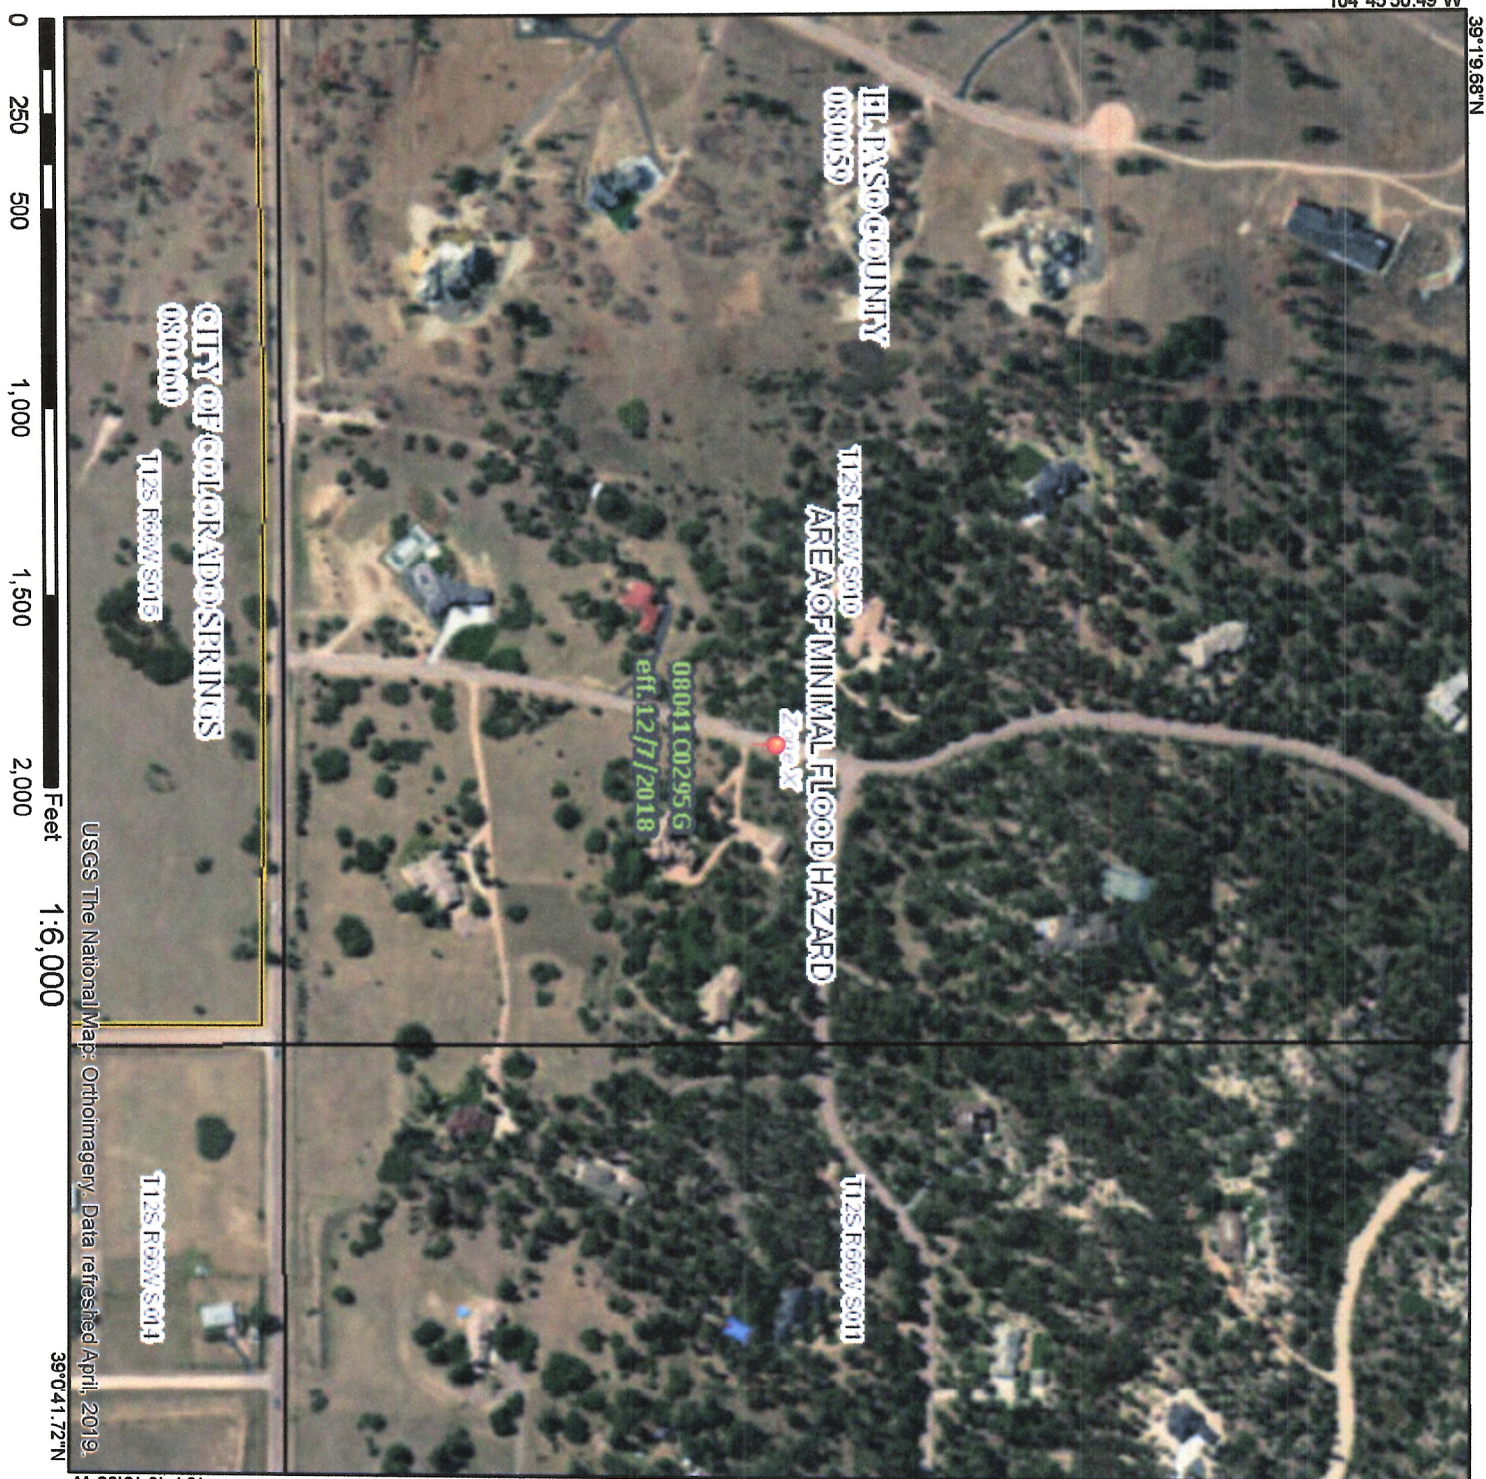
National Flood Hazard Layer FIRMeTte

The flood hazard information is derived directly from the authoritative NFHL web services provided by FEMA. This map was exported on 8/17/2019 at 6:11:40 PM and does not reflect changes or amendments subsequent to this date and time. The NFHL and effective information may change or become superseded by new data over time.

The Subdivision Site was evaluated for geologic hazards that may impact development. Hazards presented in the El Paso County Land Development Code including: mining, high water table or polluted water, landfills, fill areas, flooding, contamination; airports and major utility facilities, surface water, and landslides were evaluated and were not identified within the Subdivision Site. The Subdivision Site does not lie within the 100 or 500-year floodplain. The FEMA Map is presented in Figure 7.
