## **SOIL AND GEOLOGY STUDY**

**Crossroads Apartments  
Crossroads Mixed Use, Filing No. 2  
Parcel No. 5408305005  
El Paso County, Colorado**

**JOB NO. 177025-2**

**March 22, 2023**  
PCD File No. SF2238

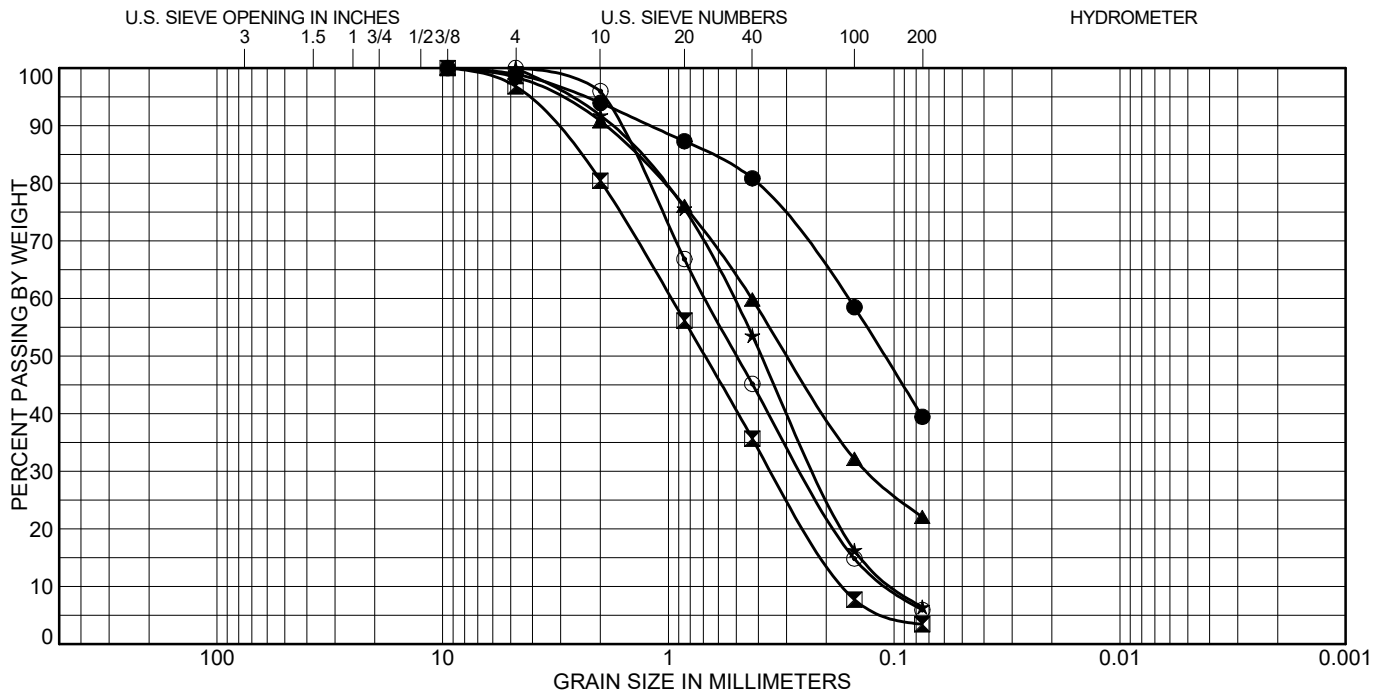
JOB No. 177025  
FIGURE No. 10  
PAGE 2 OF 2  
DATE Aug/18/2020

## SUMMARY OF LABORATORY TEST RESULTS

Test Boring	Depth (ft)	Classification	LL	PL	PI
● 1	4.0	CLAYEY SAND(SC)	25	13	12
⊠ 2	9.0	POORLY GRADED SAND(SP)	NP	NP	NP
▲ 3	4.0	SILTY SAND(SM)	NP	NP	NP
★ 4	14.0	POORLY GRADED SAND with SILT(SP-SM)	NP	NP	NP
⊙ 5	9.0	POORLY GRADED SAND with SILT(SP-SM)	NP	NP	NP

Test Boring	Depth (ft)	%Gravel	%Sand	%Silt	%Clay
● 1	4.0	1.1	59.5	39.5	
⊠ 2	9.0	3.2	93.4	3.4	
▲ 3	4.0	1.6	76.3	22.1	
★ 4	14.0	0.0	93.6	6.4	
⊙ 5	9.0	0.0	94.1	5.9

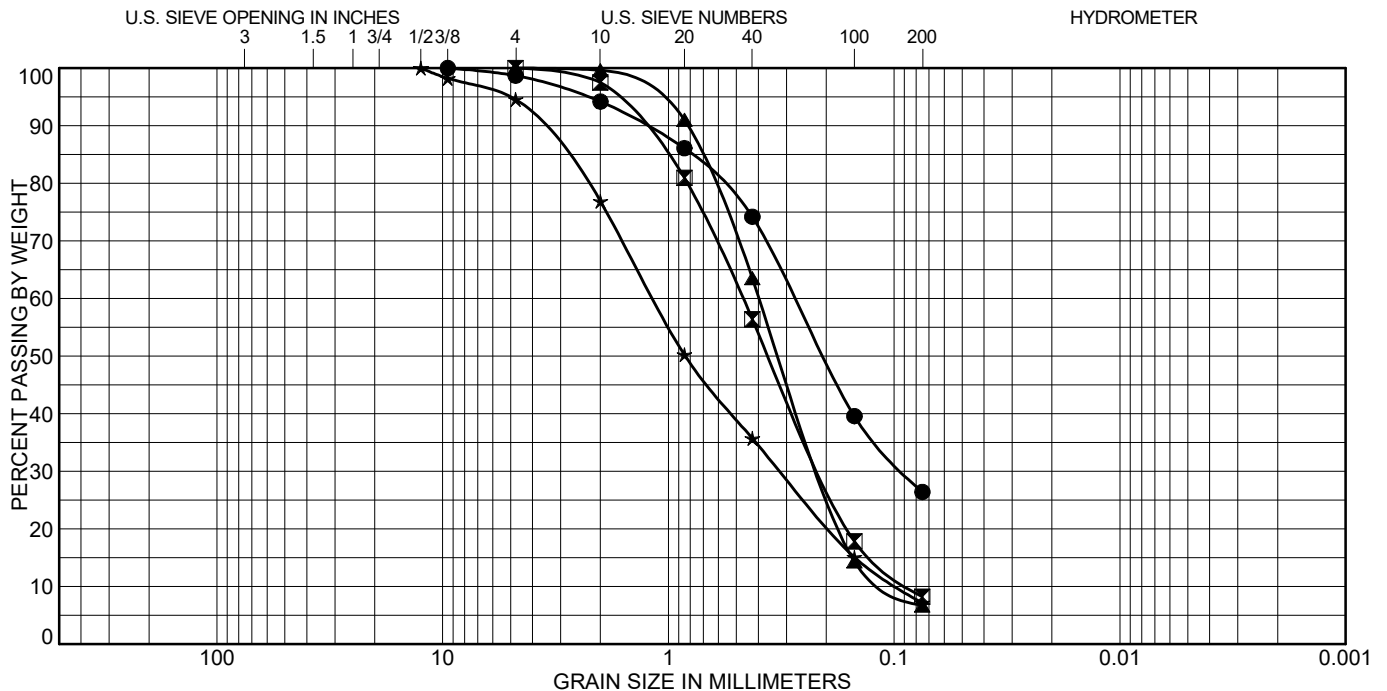
FIGURE No. 11

COBBLES	GRAVEL		SAND			SILT OR CLAY
	coarse	fine	coarse	medium	fine

Test Boring	Depth (ft)	Classification	LL	PL	PI
● 7	4.0	CLAYEY SAND(SC)	24	14	10
⊠ 8	9.0	POORLY GRADED SAND with SILT(SP-SM)	NP	NP	NP
▲ 9	4.0	POORLY GRADED SAND with SILT(SP-SM)	NP	NP	NP
★ 10	4.0	POORLY GRADED SAND with SILT(SP-SM)	NP	NP	NP

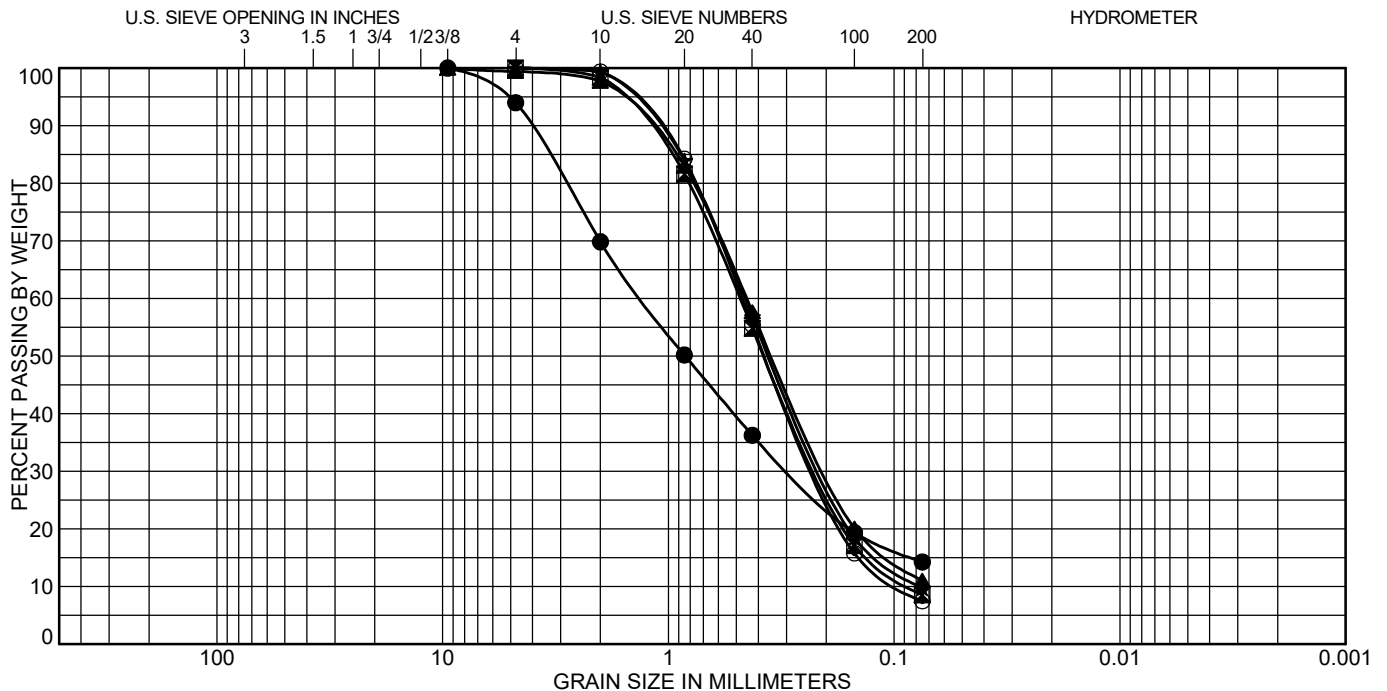
COBBLES	GRAVEL		SAND			SILT OR CLAY
	coarse	fine	coarse	medium	fine

Test Boring	Depth (ft)	Classification	LL	PL	PI
● 1	2.0	SILTY SAND(SM)	NP	NP	NP
⊠ 2	2.0	POORLY GRADED SAND with SILT(SP-SM)	NP	NP	NP
▲ 3	2.0	WELL-GRADED SAND with SILT(SW-SM)	NP	NP	NP
★ 4	2.0	WELL-GRADED SAND with SILT(SW-SM)	NP	NP	NP
⊙ 5	2.0	POORLY GRADED SAND with SILT(SP-SM)	NP	NP	NP
