## SOILS AND GEOLOGY STUDY

**Dwire Storage Yard, Filing No. 1  
El Paso County, Colorado**

**Dwire Earthmoving & Excavating  
6799 Bismark Road, Suite A  
Colorado Springs, CO 80922**

**JOB NO. 168498**

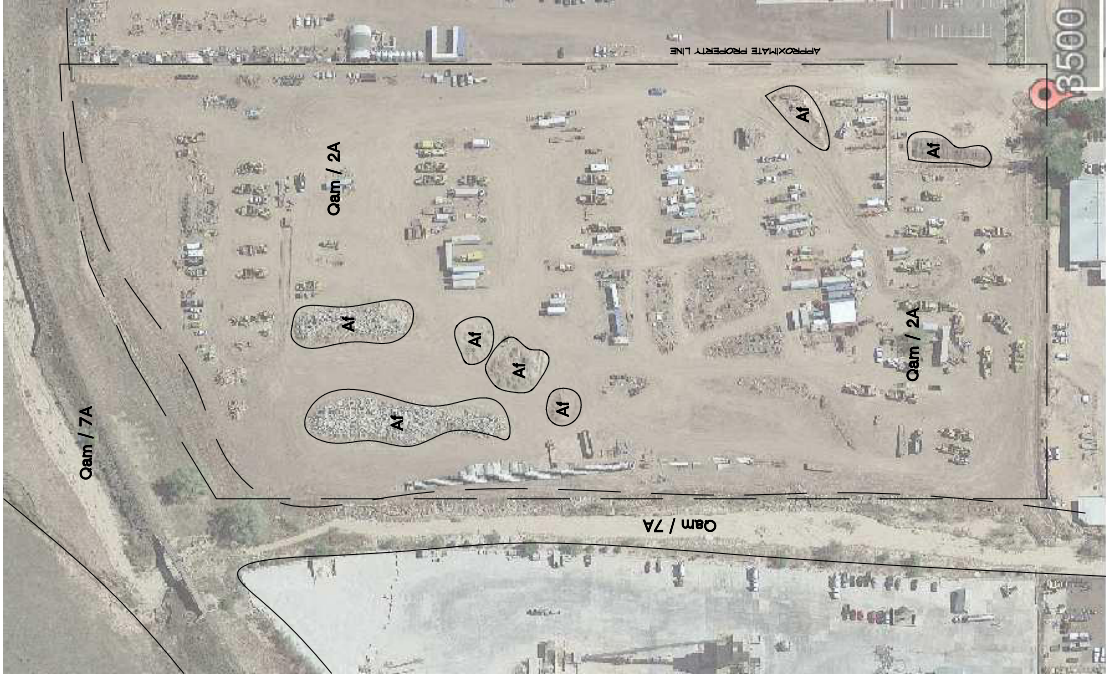
FIG-4

Af - Artificial fill (late Holocene) - stockpiles of debris to include concrete and soils

Based on our field observations and the Geologic Map of the Falcon NW Quadrangle, an interpreted geologic map of significant surficial deposits and features was mapped for the site. The identified geologic conditions affecting the development are presented in the Engineering and Geology Map, Figure 4.

The Engineering Geology is presented in the Engineering and Geology Map, Figure 4.

If development is to occur on Lot 4 in the future, it is recommended that all construction is to remain outside this area, as shown on the Engineering and Geology Map, Figure 4. Additional mitigation for Lots 1-3 is not required at this time. As noted herein, the foundation drainage measures for the office building are determined in the Geotechnical Investigation presented in Appendix B. Additional drainage measures for the warehouse on Lot 1 and any future structures on Lots 2-4 are to be determined by the site-specific subsurface soil investigations performed at the time of construction.

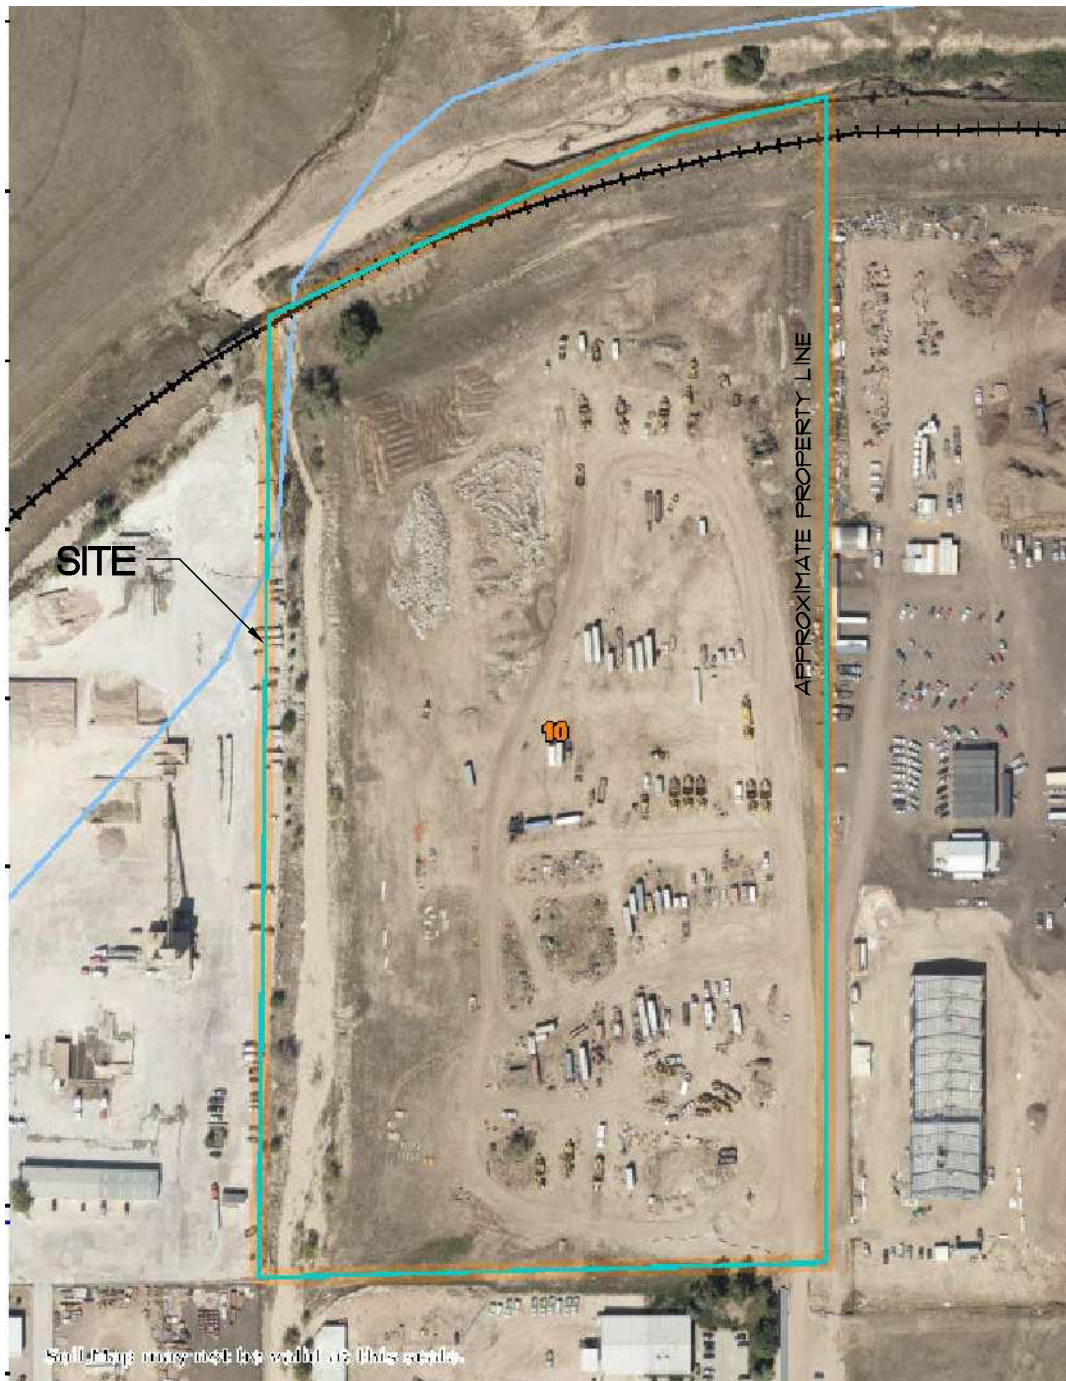
FIG No. 5

NOT TO SCALE  
BASE MAP PROVIDED BY: USDA

10 - BLENDON sandy loam, 0 to 3% slopes

The USDA Soil Survey Map is presented in Figure 5.

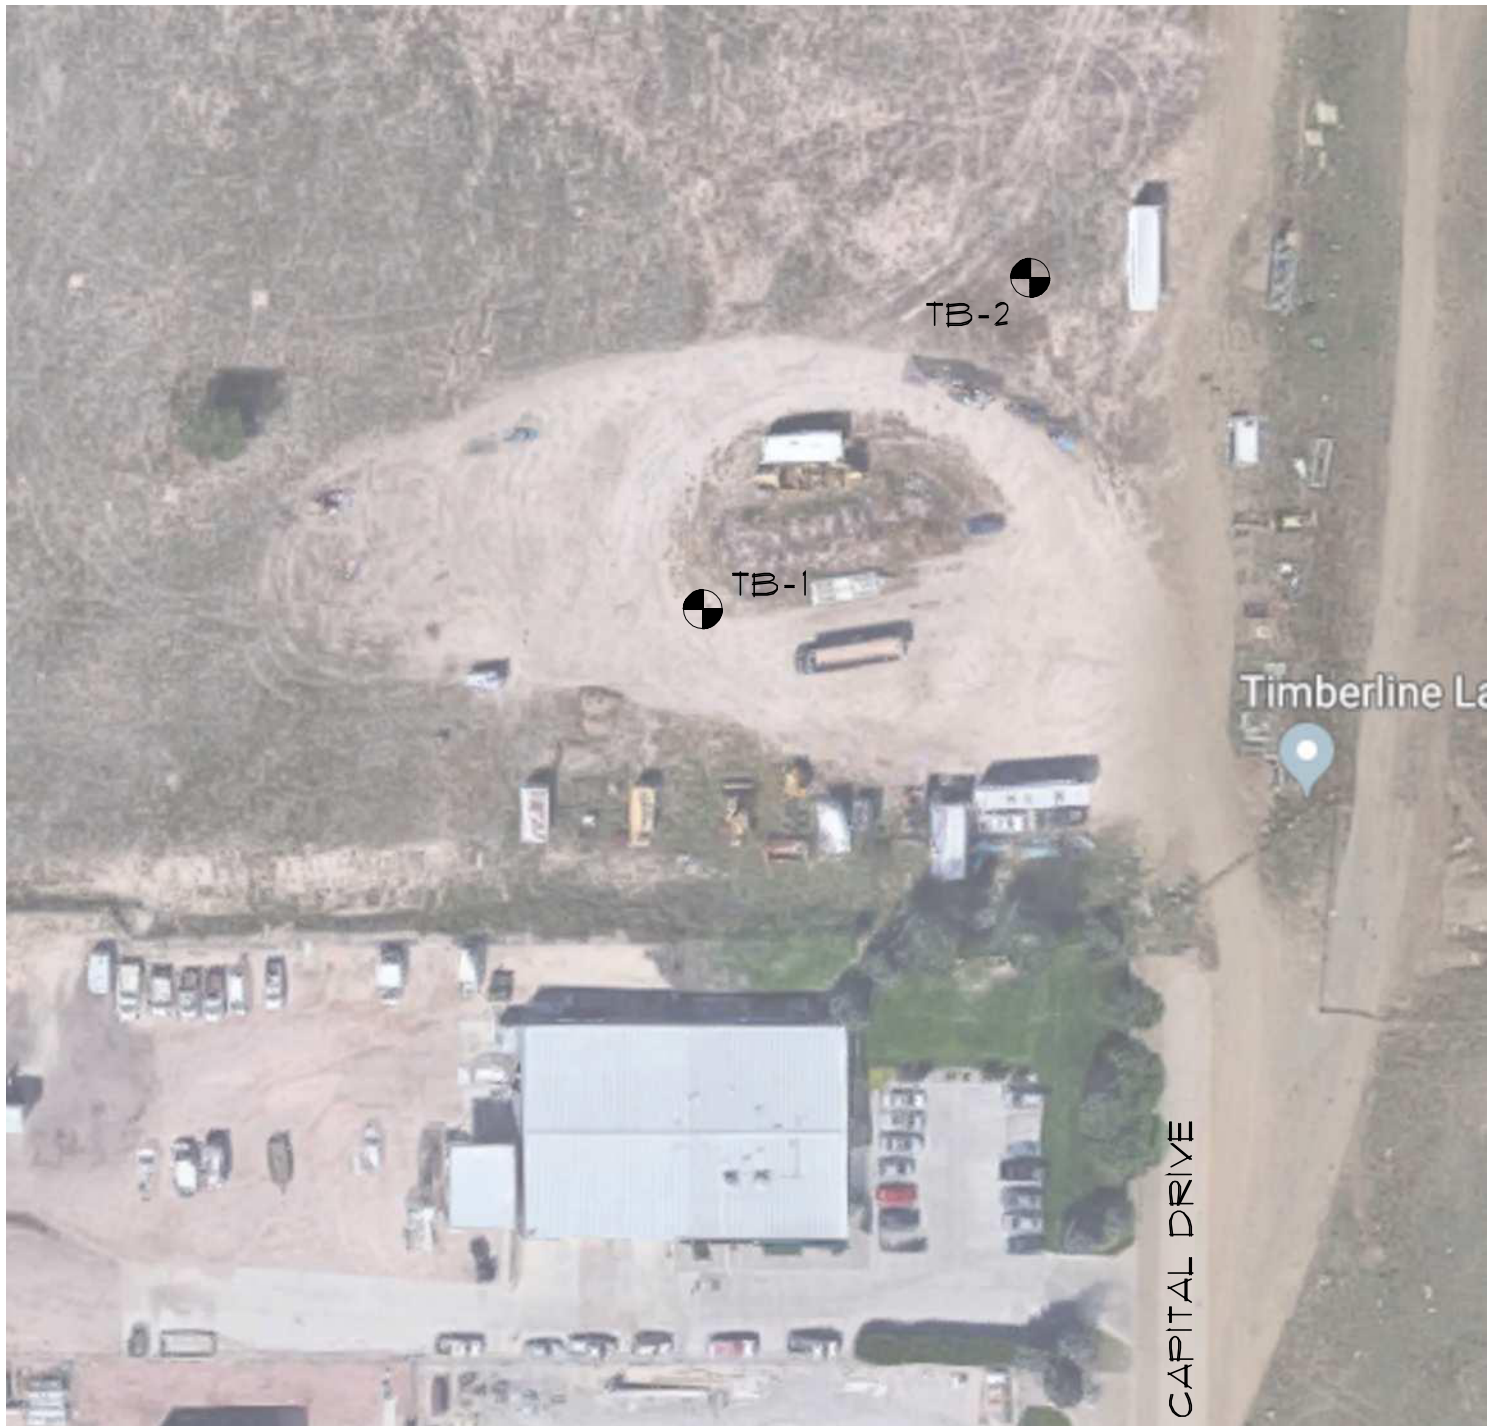
⊕ DENOTES APPROXIMATE  
LOCATION OF TEST BORINGS

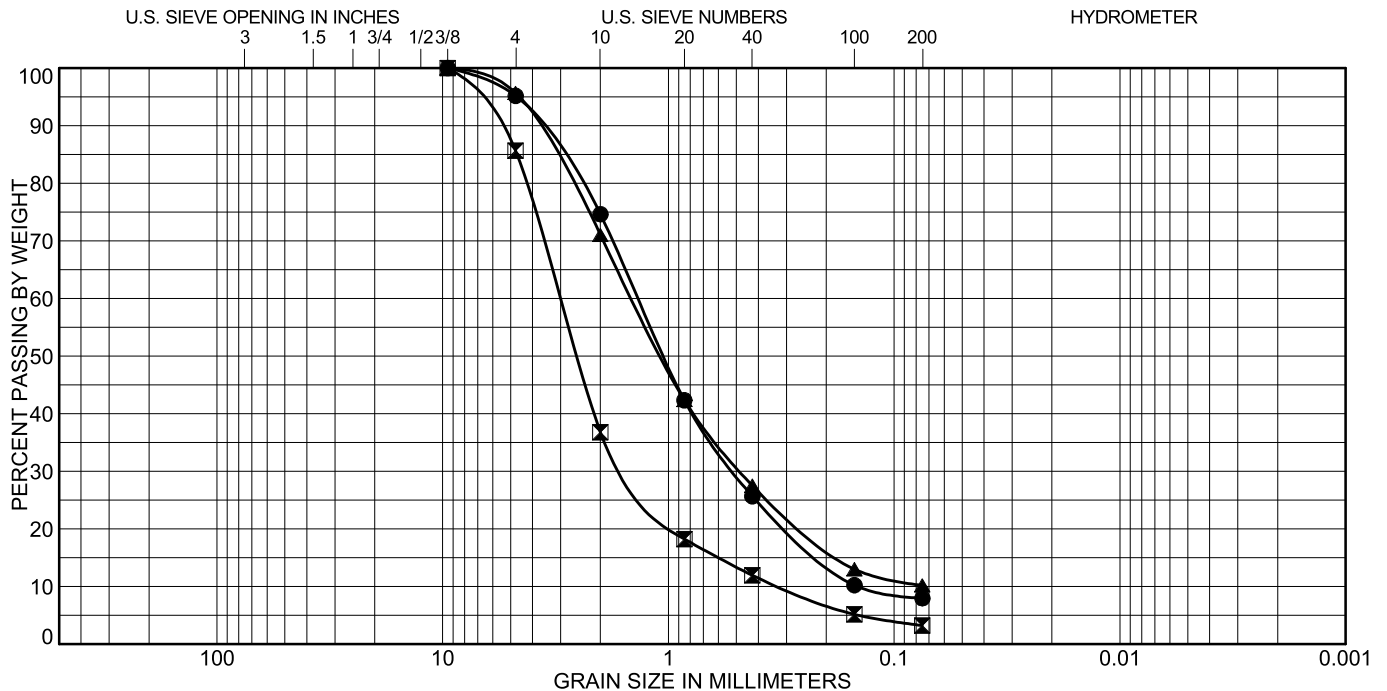
FIGURE No. 6

COBBLES	GRAVEL		SAND			SILT OR CLAY
	coarse	fine	coarse	medium	fine

Test Boring	Depth (ft)	Classification	LL	PL	PI
● 1	9.0	WELL-GRADED SAND with SILT(SW-SM)	NP	NP	NP
☒ 2	4.0	WELL-GRADED SAND(SW)	NP	NP	NP
▲ 2	14.0	WELL-GRADED SAND with SILT(SW-SM)	NP	NP	NP

The moisture content for the recovered samples was obtained in the laboratory. Grain-size analysis, Atterberg Limits, and Denver Swell/Consolidation tests were performed on selected samples for purposes of classification and to develop pertinent engineering properties. A Summary of Laboratory Test Results is presented in Figure 5. Soil Classification Data are presented in Figure 6. The soil was deemed to be non-plastic and therefore swell/Consolidation Tests were not performed.
