Subject: Response to Review Comments  
Solace Apartment Complex  
Powers Boulevard and Galley Road  
Colorado Springs, Colorado  
CTLT Project Nos CS19163.000-105

CTLThompson, Inc. prepared a Geologic Hazards Evaluation and Preliminary Geotechnical Investigation (Project No. CS19163.000-105; report dated December 10, 2019) and a Geotechnical Investigation (Project No. CS19163.001-125 dated January 15, 2020) for the proposed apartment complex located at Powers Boulevard and Galley Road in Colorado Springs, Colorado. The development plan changed after preparation of our report. We were provided the most recent development and grading plans in order to address review comments.

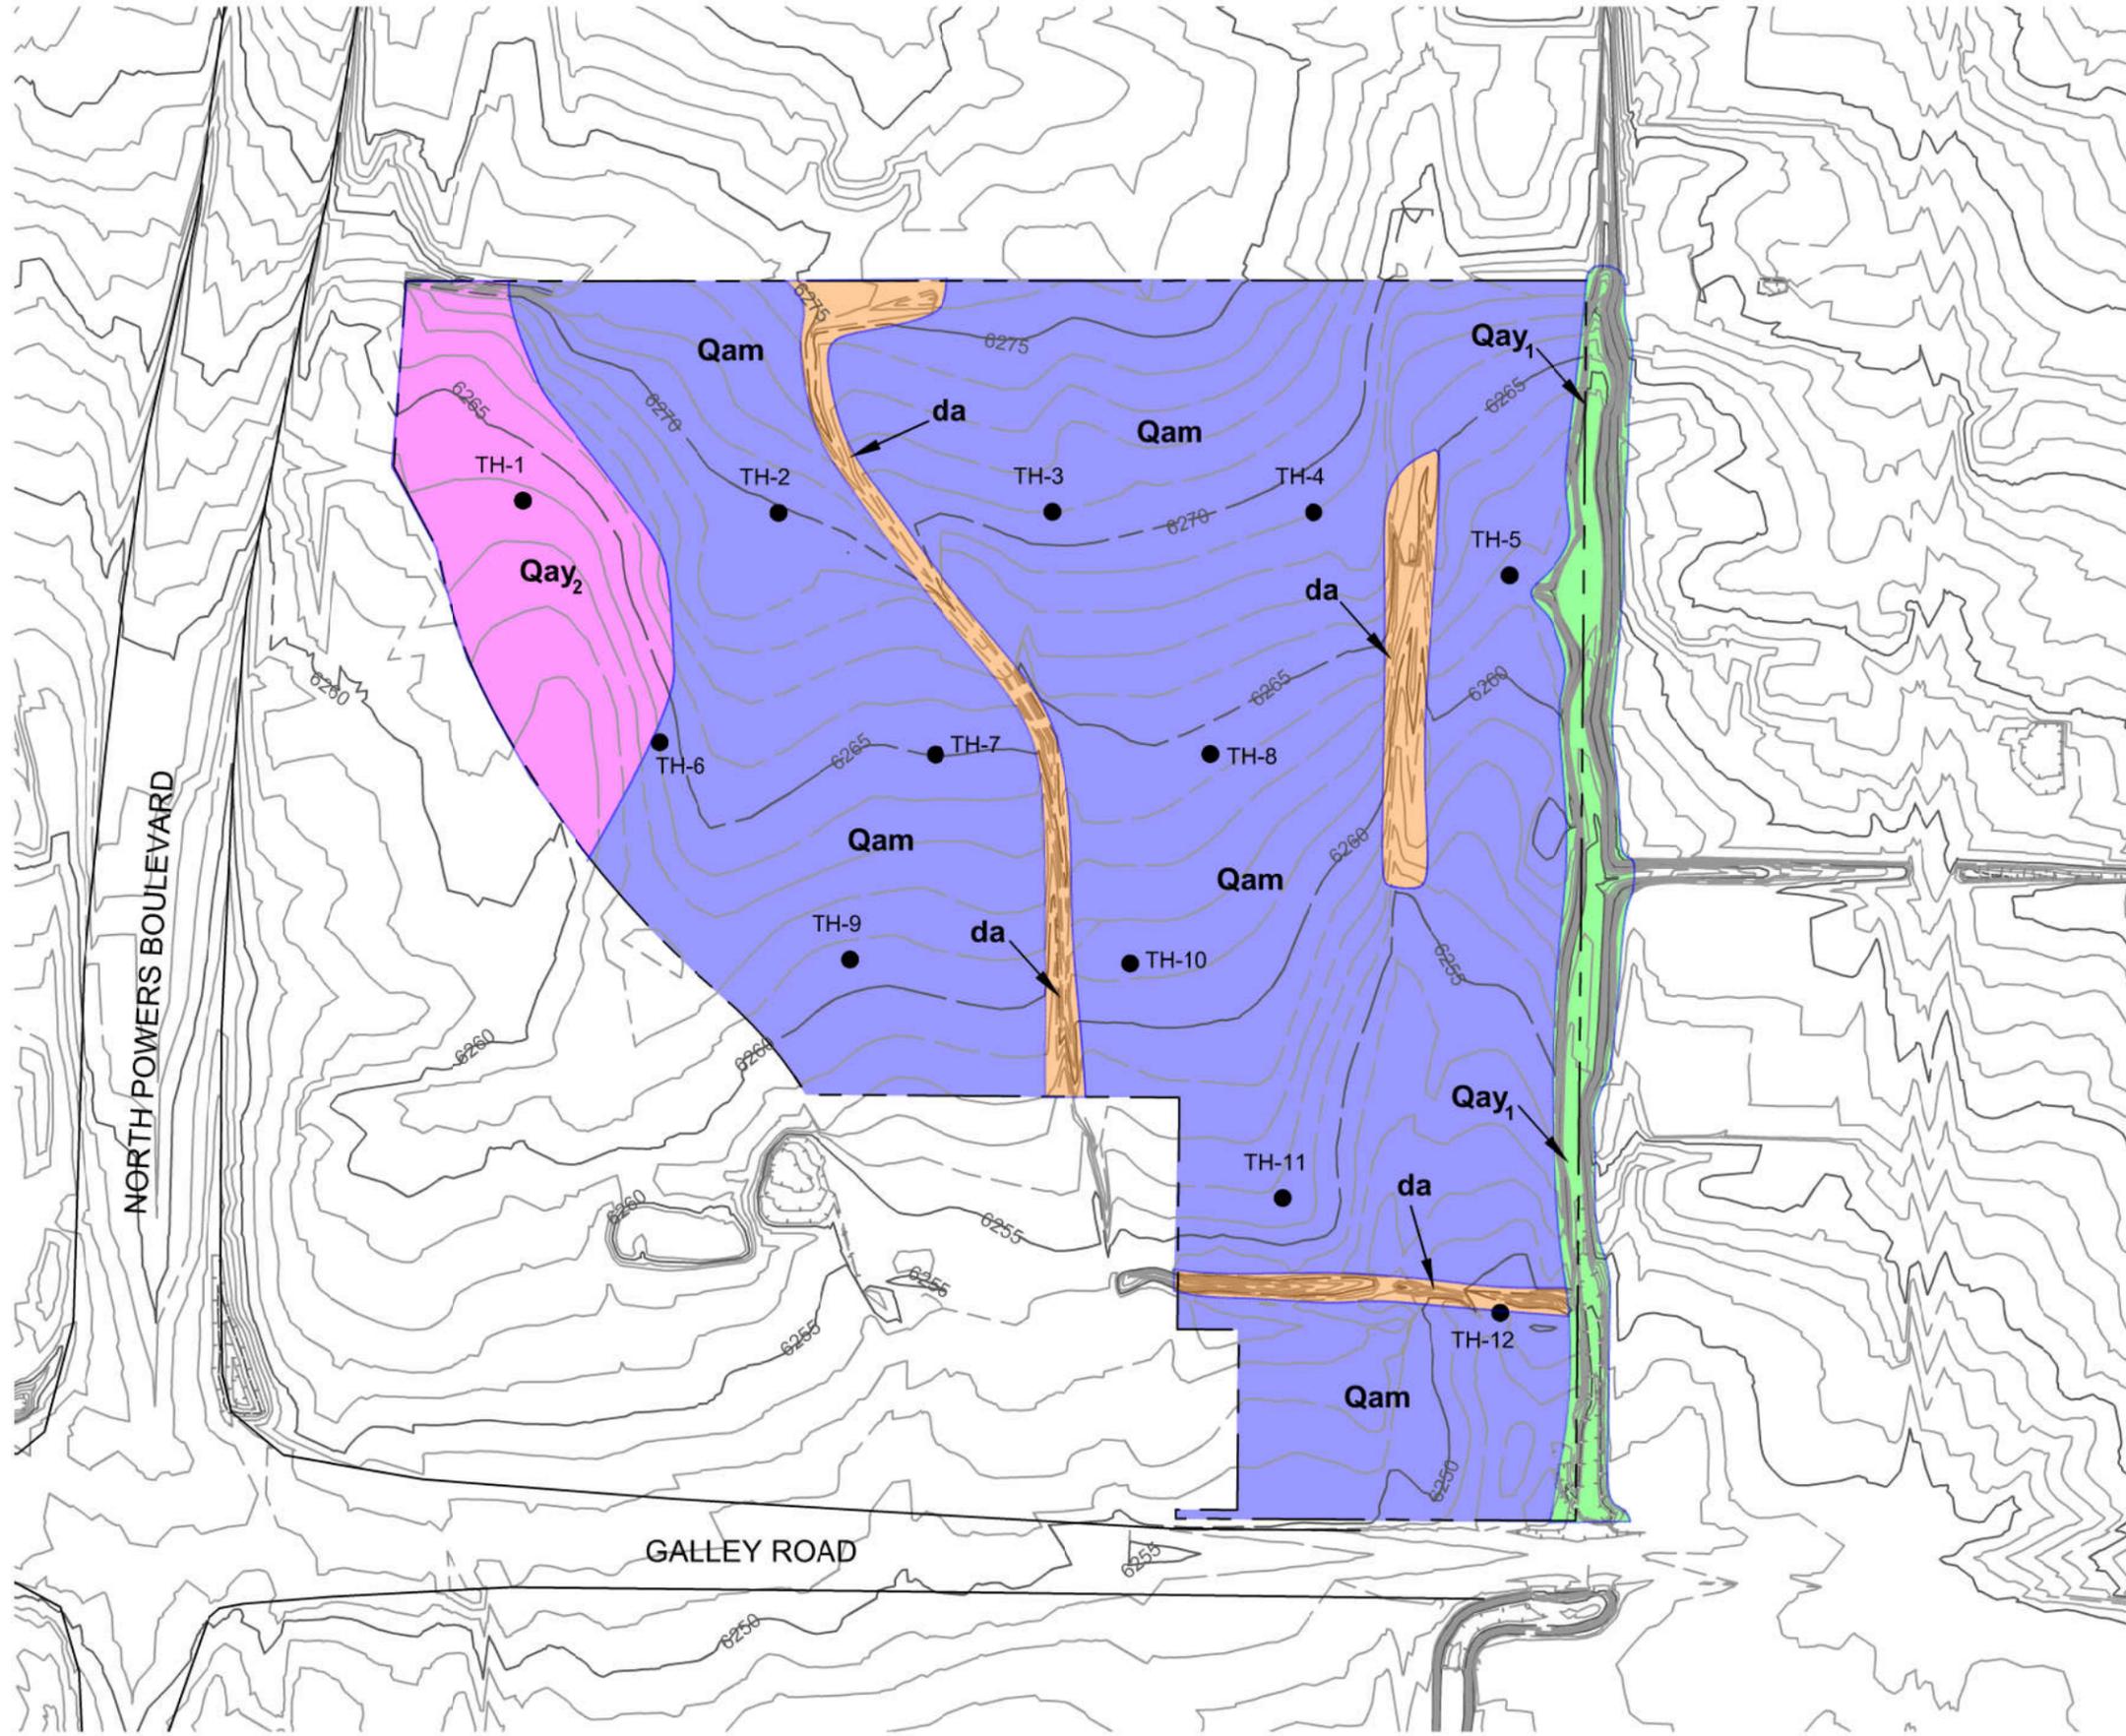
**GEOLOGIC MAP LEGEND**

**Qay<sub>1</sub>** YOUNG ALLUVIUM ONE, LATE HOLOCENE, POORLY-SORTED, SILTY SANDS TYPICALLY FOUND IN NARROW FLOOD PLAINS AND THE FLOORS OF STREAM CHANNELS.

**Qay<sub>2</sub>** YOUNG ALLUVIUM TWO, LATE AND MIDDLE HOLOCENE, POORLY-SORTED, SILTY SANDS TYPICALLY FOUND IN BROAD VALLEY FLOORS.

NOTES:  
 1. BASE DRAWING WAS PROVIDED BY NES IN AN EMAIL DATED NOVEMBER 21, 2019.  
 2. ALL BOUNDARIES SHOWN SHOULD BE CONSIDERED APPROXIMATE. THEY ARE BASED UPON A SUBJECTIVE INTERPRETATION OF PUBLISHED MAPS, AERIAL PHOTOGRAPHS AND AN INITIAL FIELD RECONNAISSANCE. CHANGES IN THE MAPPED BOUNDARIES SHOWN ARE POSSIBLE AND SHOULD BE EXPECTED WITH MORE DETAILED WORK AND FURTHER INFORMATION. ALL INTERPRETATIONS AND CONDITIONS SHOWN ARE PRELIMINARY AND FOR LAND-USE PLANNING ONLY.

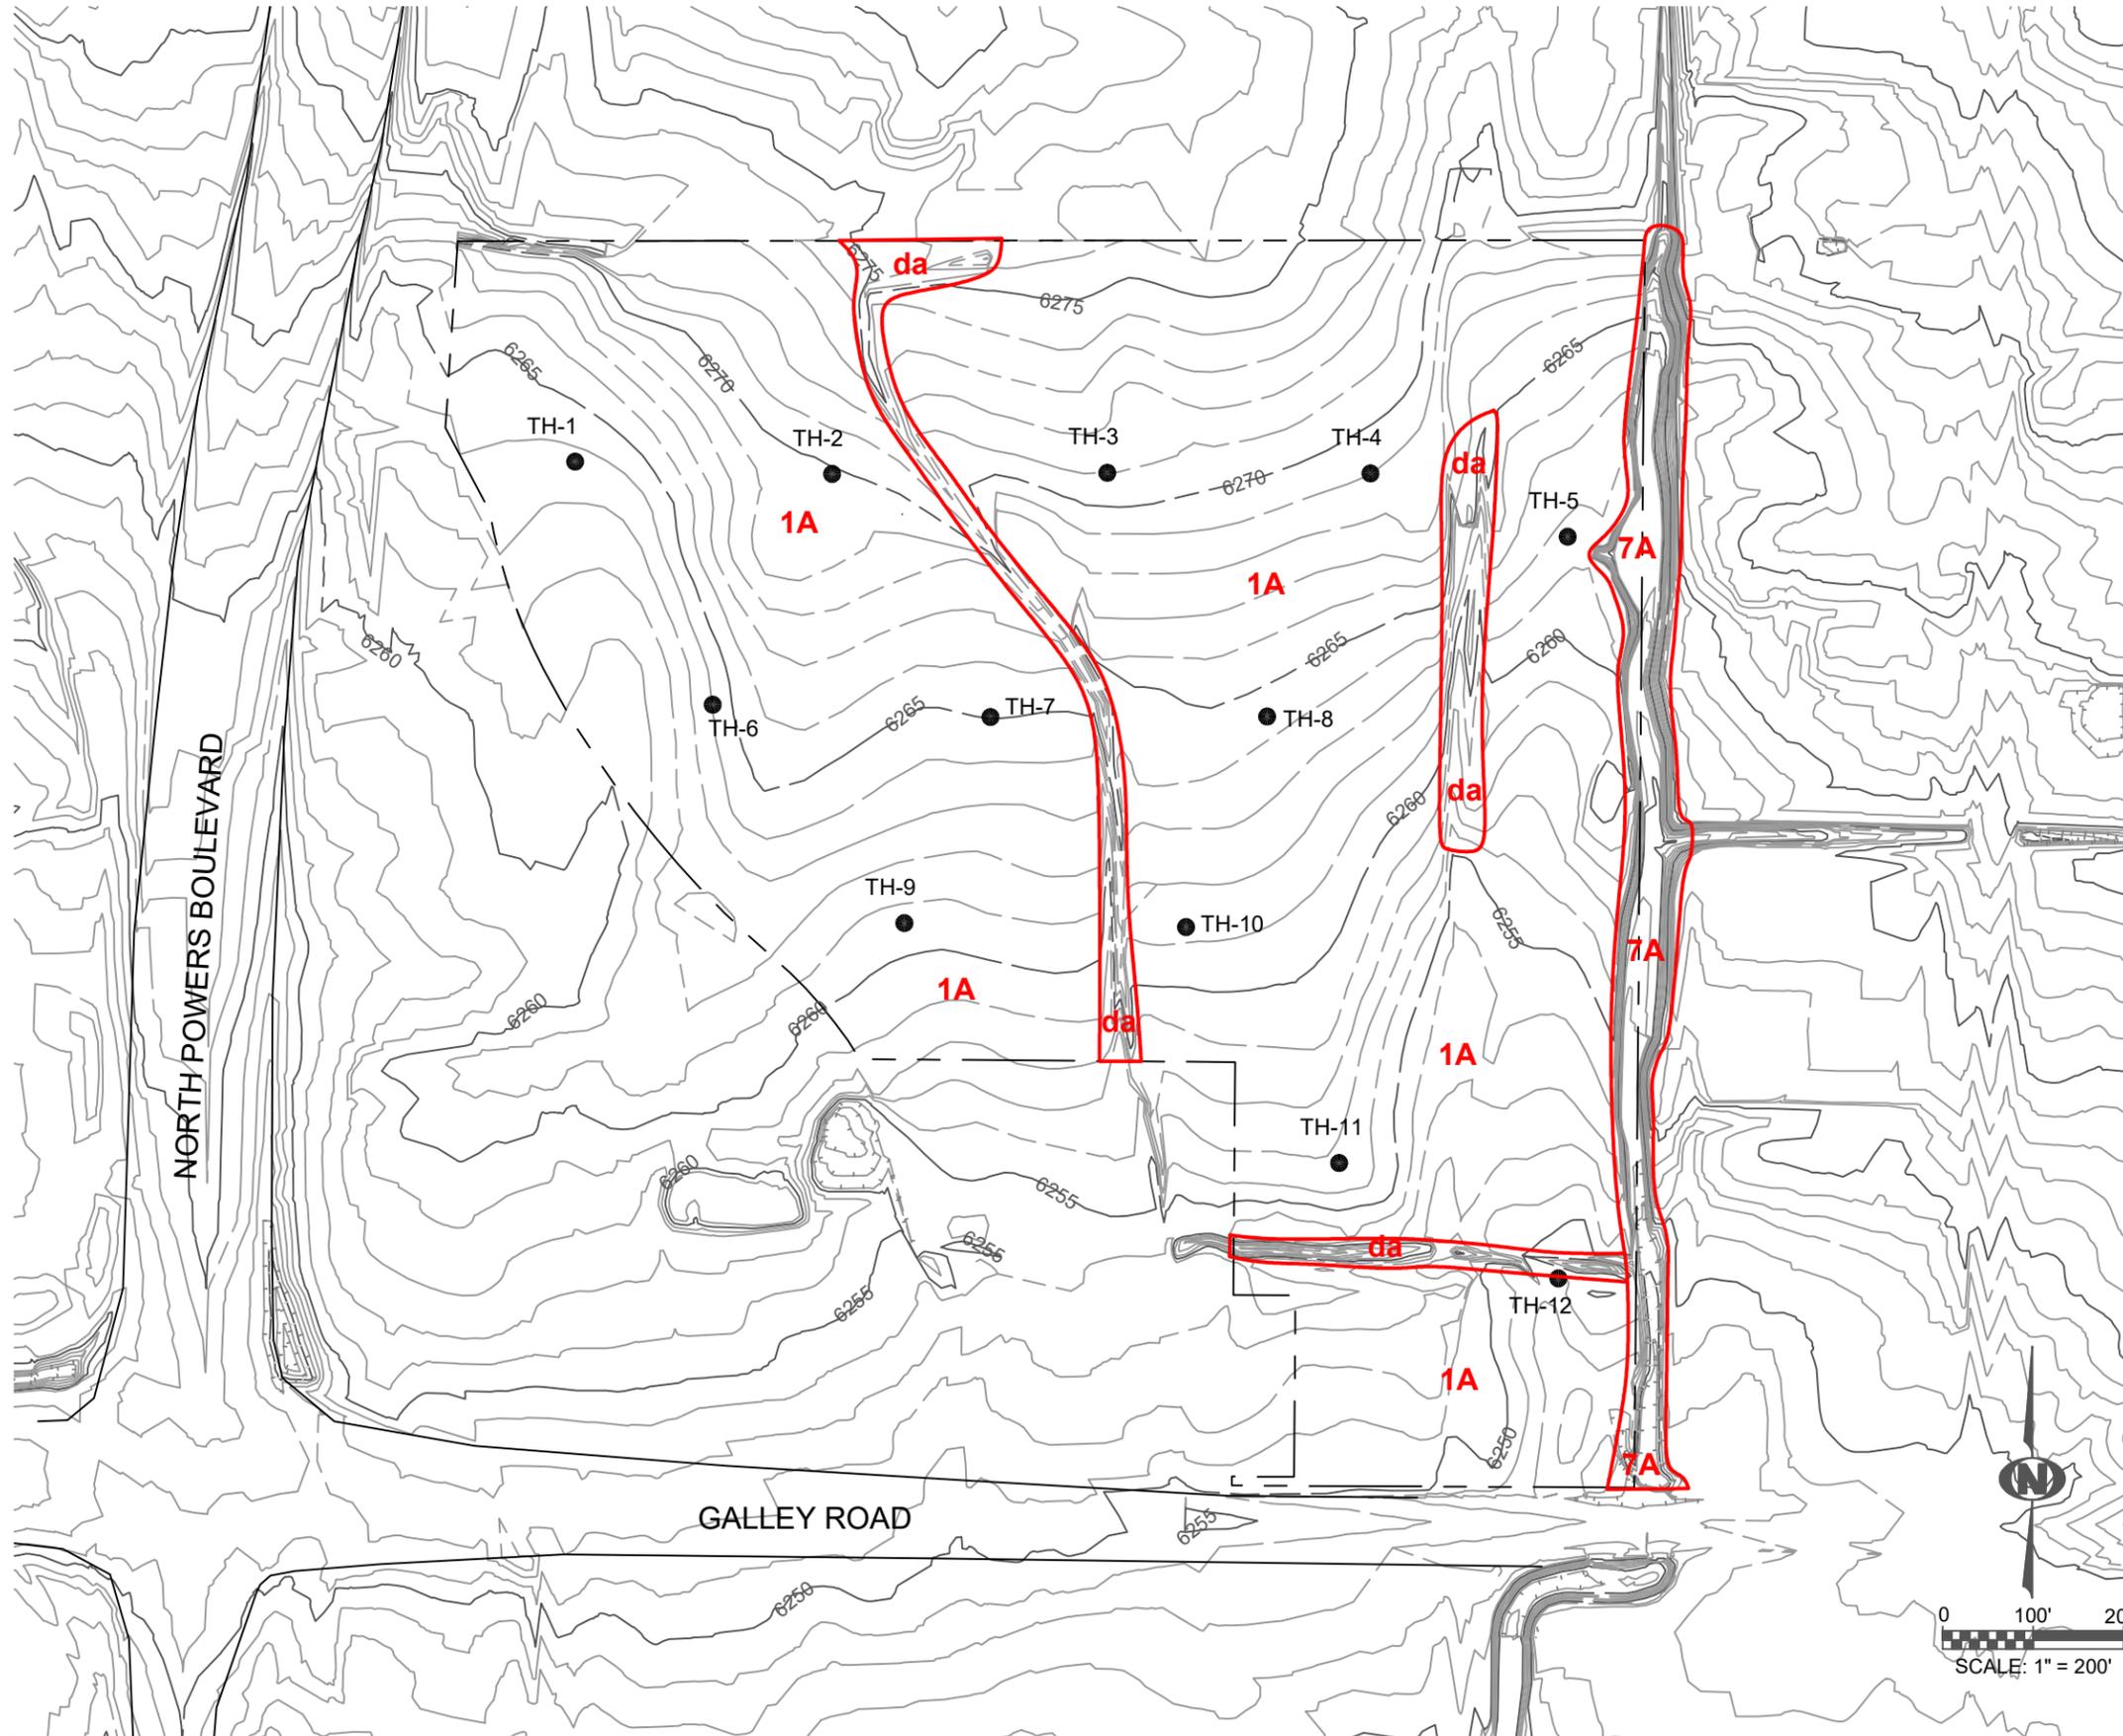
ENGINEERING CONTACTS
- 1A**    STABLE ALLUVIUM WITH GENTLE SLOPES LESS THAN ABOUT 5 PERCENT. THESE AREAS HAVE THICK SAND SOILS THAT CAN BE EROSION PRONE.
- 7A**    PHYSIOGRAPHIC FLOOD PLAIN AND ADJACENT AREAS WHERE EROSION IS ON-GOING. SOME OVER-STEEPENED STREAM BANKS ARE PRESENT AND ARE CONSIDERED UNSTABLE. FLOODING AND SLOPE STABILITY ARE CONCERNS.
- da**    DISTURBED AREA

1. BASE DRAWING WAS PROVIDED BY NES IN AN EMAIL DATED NOVEMBER 21, 2019.
2. ALL BOUNDARIES SHOWN SHOULD BE CONSIDERED APPROXIMATE. THEY ARE BASED UPON A SUBJECTIVE INTERPRETATION OF PUBLISHED MAPS, AERIAL PHOTOGRAPHS AND AN INITIAL FIELD RECONNAISSANCE. CHANGES IN THE MAPPED BOUNDARIES SHOWN ARE POSSIBLE AND SHOULD BE EXPECTED WITH MORE DETAILED WORK AND FURTHER INFORMATION. ALL INTERPRETATIONS AND CONDITIONS SHOWN ARE PRELIMINARY AND FOR INITIAL LAND-USE PLANNING ONLY.
3. MAP LEGEND IS MODIFIED FROM CHARLES S. ROBINSON & ASSOCIATES, INC., GOLDEN, COLORADO, DATED 1977.

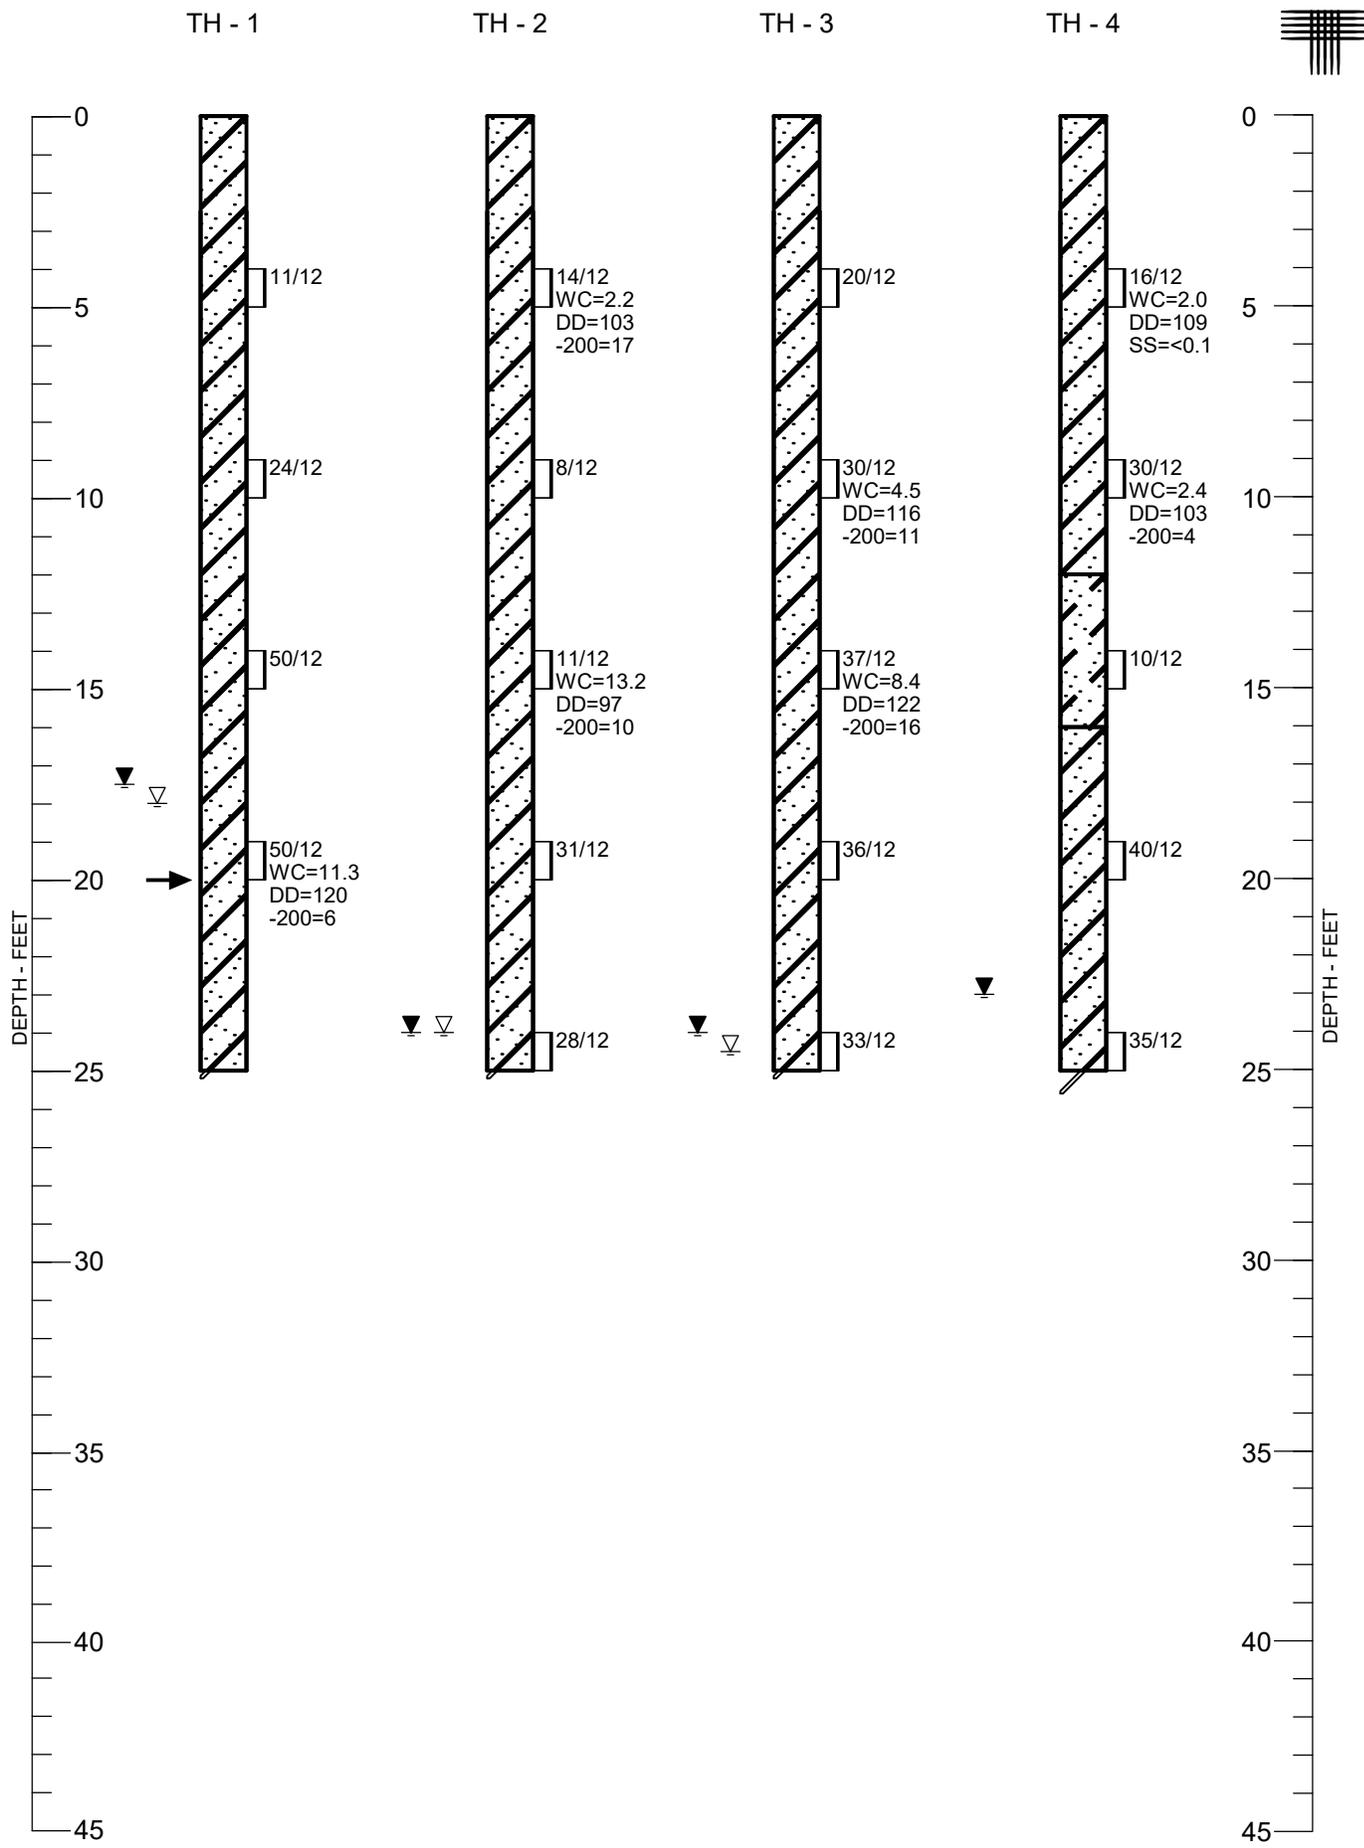
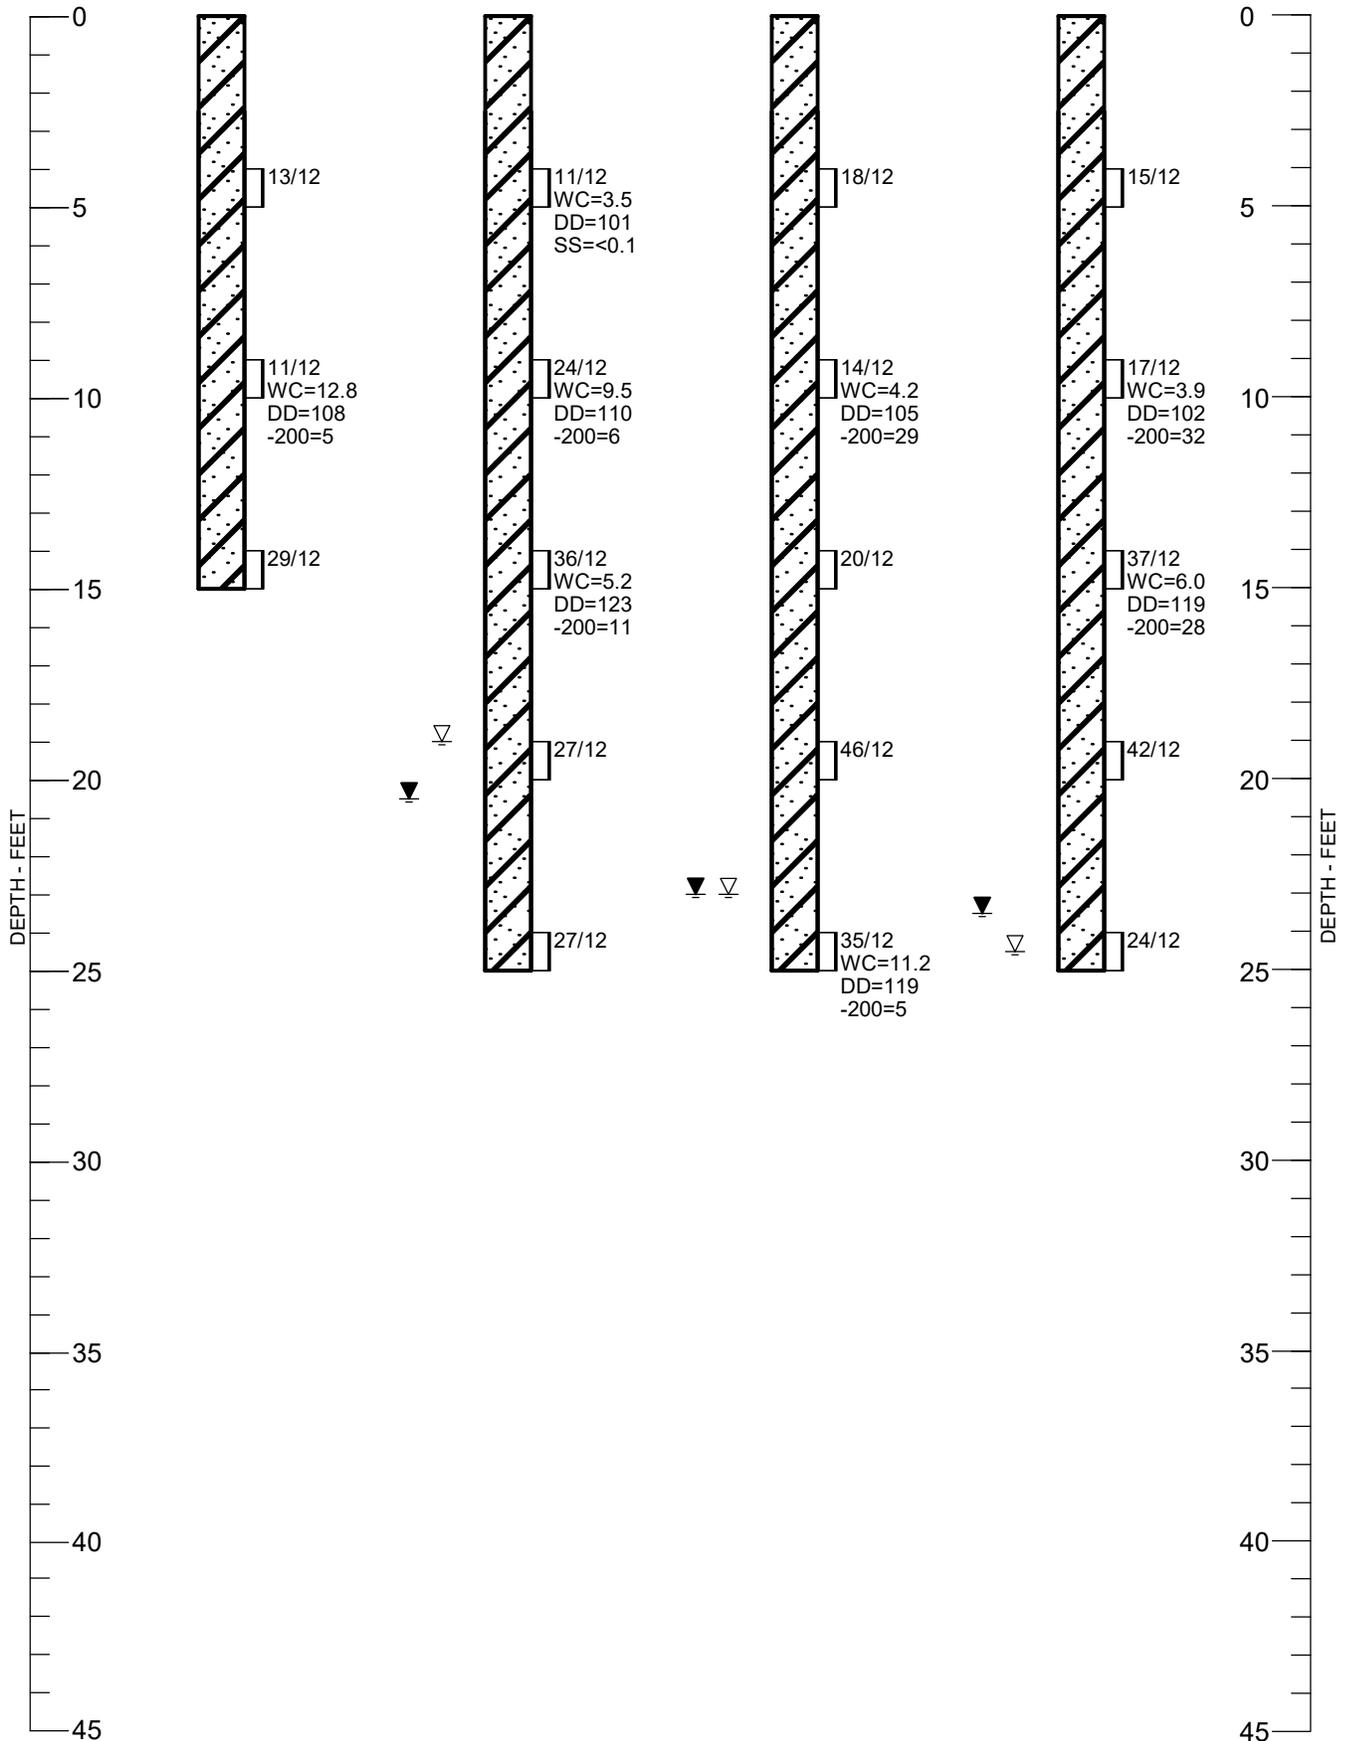
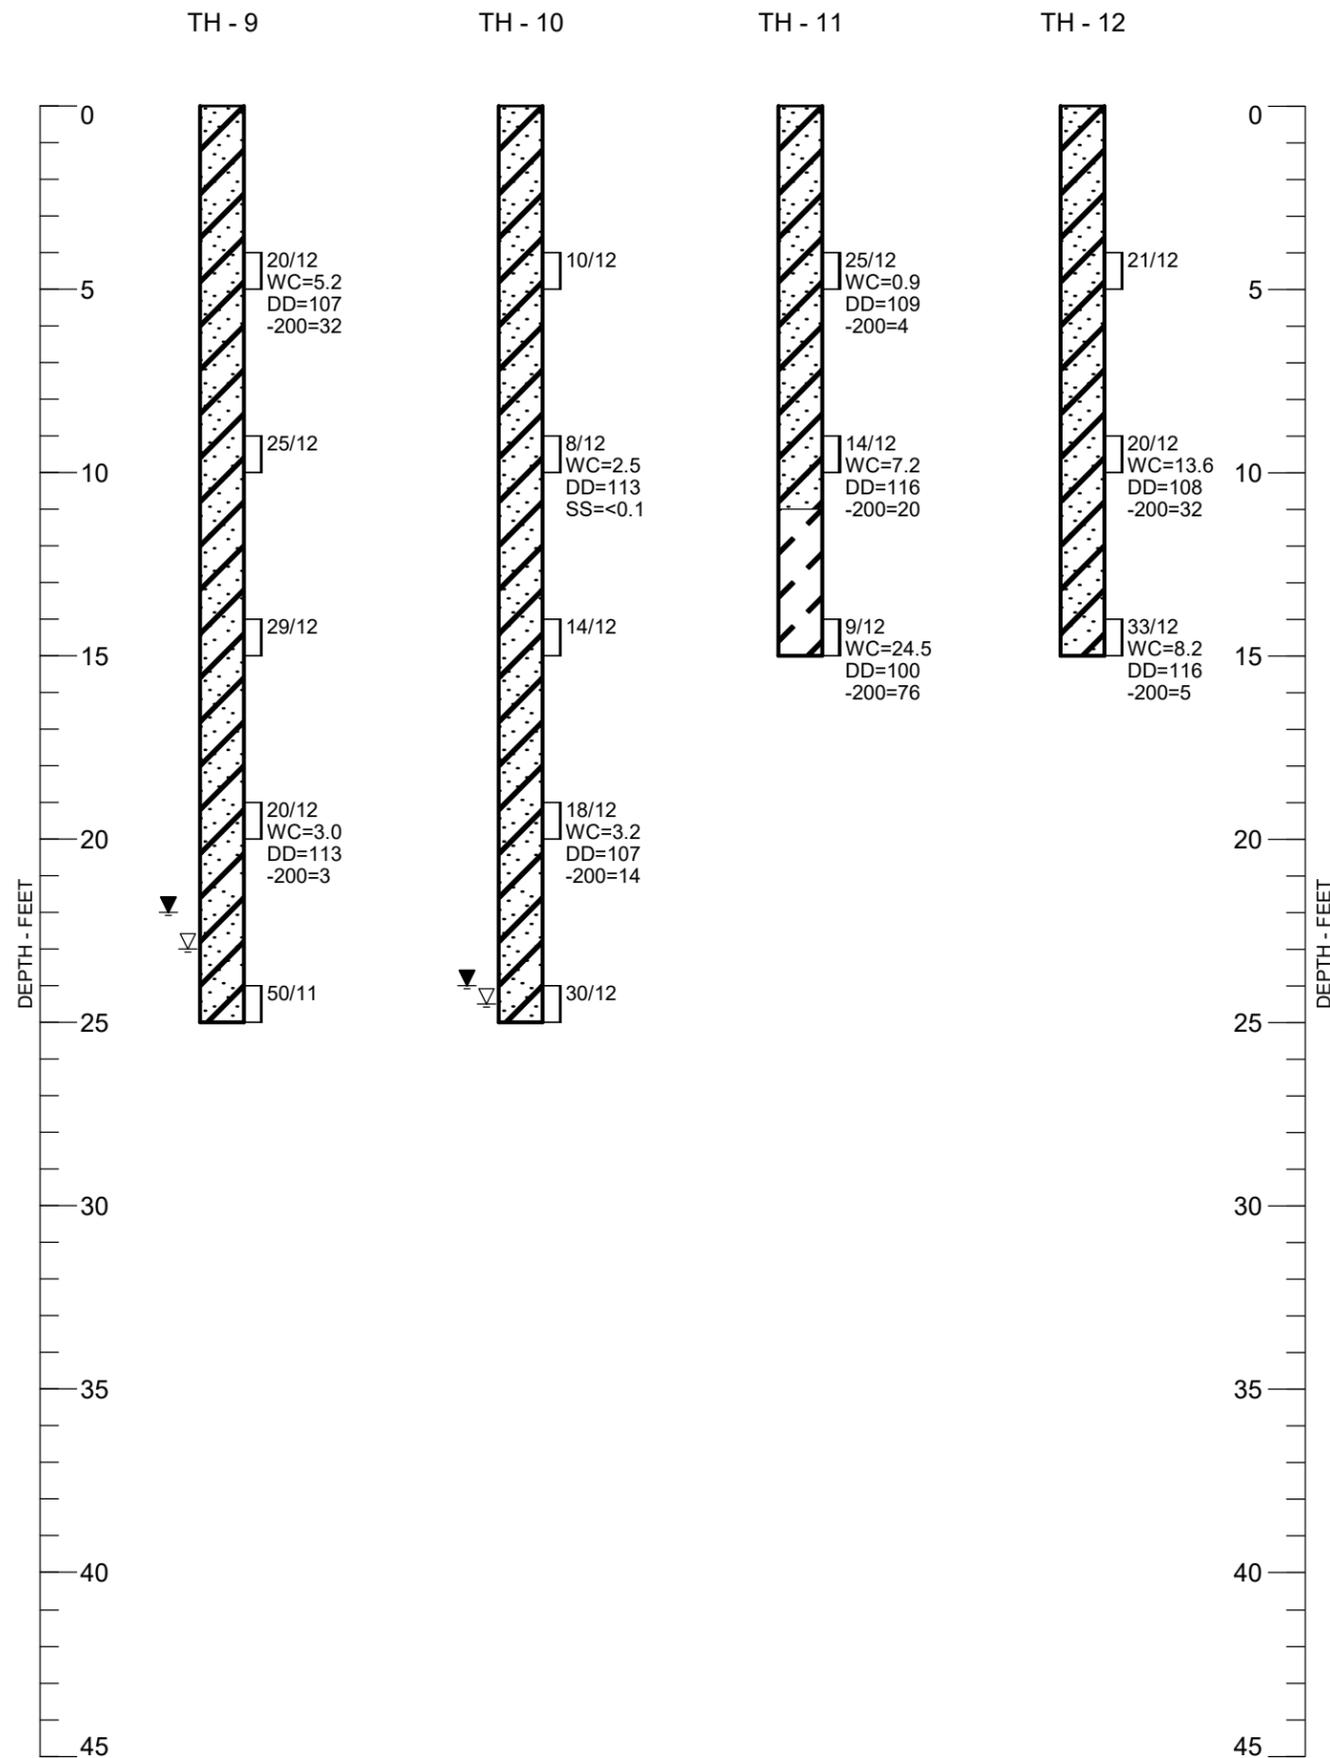
**Summary Logs of  
 Exploratory  
 Borings**

1. THE BORINGS WERE DRILLED OCTOBER 10 AND 17, 2019 USING A 4-INCH DIAMETER, CONTINUOUS-FLIGHT AUGER AND A CME-55, TRUCK-MOUNTED DRILL RIG.
2. THESE LOGS ARE SUBJECT TO THE EXPLANATIONS, LIMITATIONS, AND CONCLUSIONS AS CONTAINED IN THIS REPORT.
3. WC - INDICATES MOISTURE CONTENT. (%)  
 DD - INDICATES DRY DENSITY. (PCF)  
 -200 - INDICATES PASSING NO. 200 SIEVE. (%)  
 SS - INDICATES WATER-SOLUBLE SULFATE CONTENT. (%)

- SAND, CLEAN TO SILTY, LOOSE TO DENSE, SLIGHTLY MOIST TO WET, LIGHT TO MEDIUM BROWN, LIGHT GRAY. (SP, SP-SM, SW-SM, SM)
- SAND, CLAYEY, MEDIUM DENSE, MOIST, DARK BROWN. (SC)
- CLAY, SANDY, STIFF, VERY MOIST, GRAY BROWN. (CL)
- DRIVE SAMPLE. THE SYMBOL 14/12 INDICATES 14 BLOWS OF A 140-POUND HAMMER FALLING 30 INCHES WERE REQUIRED TO DRIVE A 2.5-INCH O.D. SAMPLER 12 INCHES.
- GROUNDWATER LEVEL MEASURED AT TIME OF DRILLING.
- GROUNDWATER LEVEL MEASURED SIX DAYS AFTER DRILLING.
- INDICATES DEPTH WHERE THE TEST HOLE CAVED DURING DRILLING.

Subsurface conditions encountered in exploratory borings drilled within the proposed sites of the detention ponds (borings TH-5 and TH-12) consisted of 15 feet of medium dense to dense, slightly silty to silty sand. In our opinion, the anticipated subgrade materials are suitable to underlie the planned embankment fills with minimal subgrade compression.

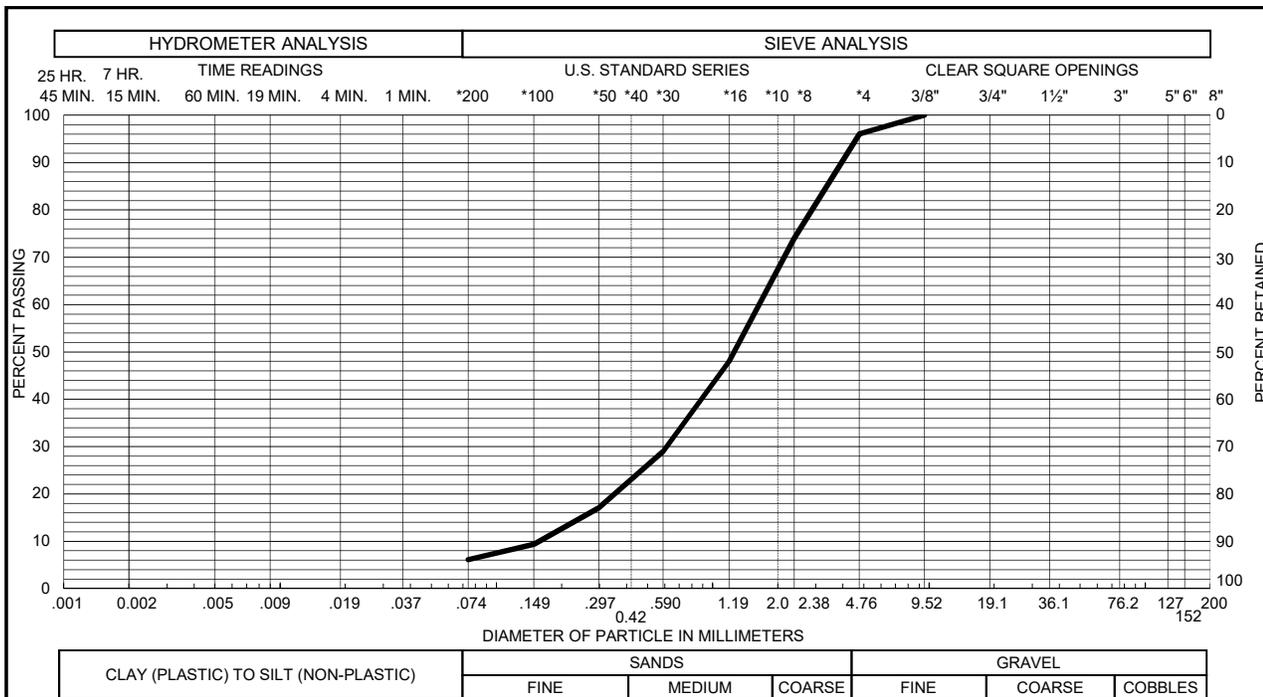
Sample of **SAND, SLIGHTLY SILTY (SW-SM)** GRAVEL 4 % SAND 90 %  
 From **TH - 1 AT 19 FEET** SILT & CLAY 6 % LIQUID LIMIT \_\_\_\_\_ %  
 PLASTICITY INDEX \_\_\_\_\_ %

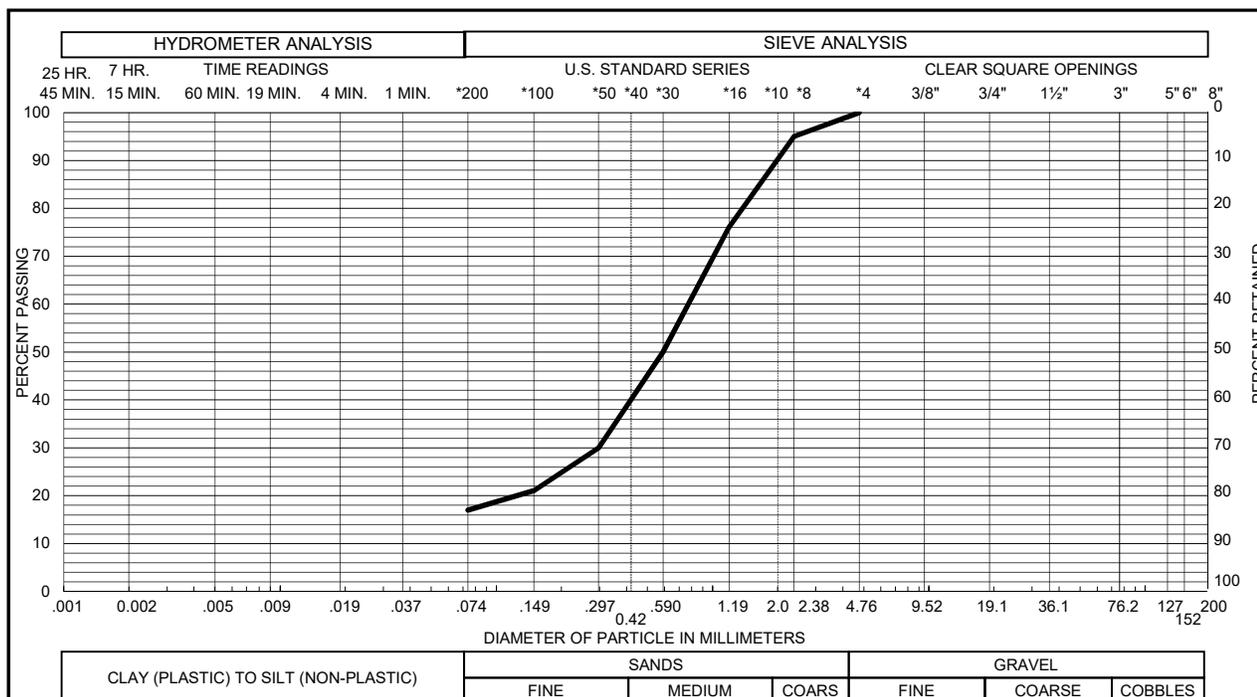
Sample of **SAND, SILTY (SM)** GRAVEL 0 % SAND 83 %  
 From **TH - 2 AT 4 FEET** SILT & CLAY 17 % LIQUID LIMIT \_\_\_\_\_ %  
 PLASTICITY INDEX \_\_\_\_\_ %

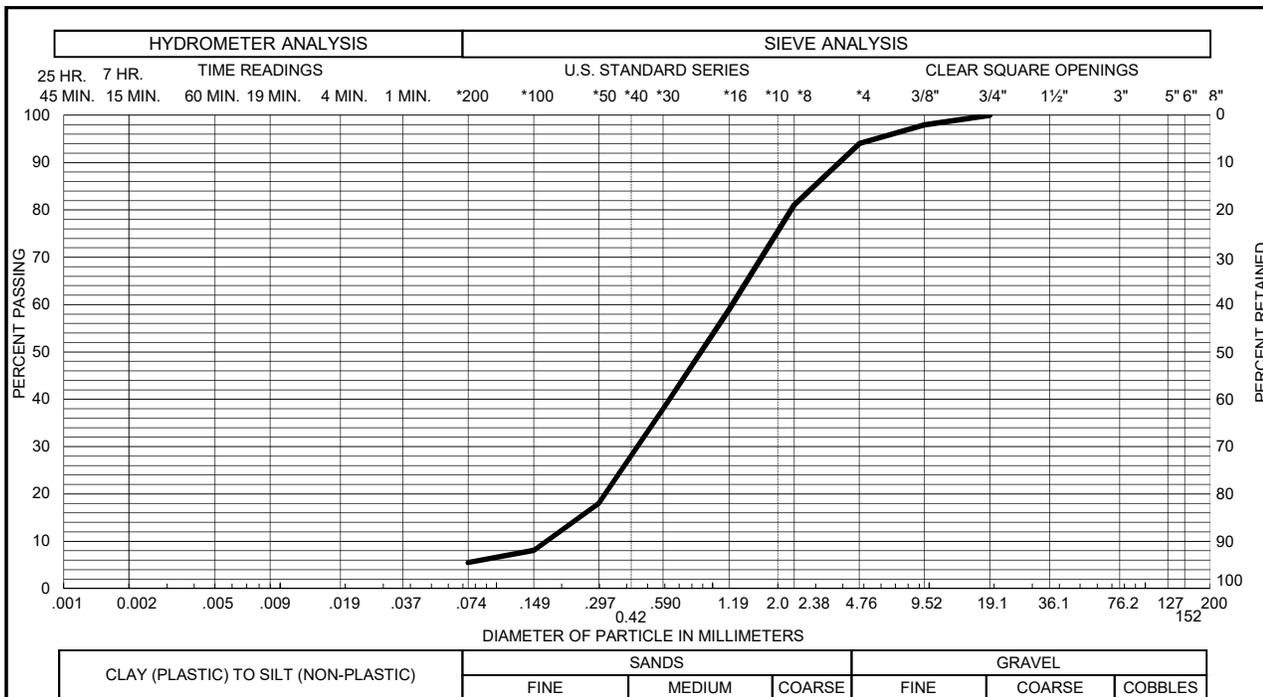
Sample of **SAND, SLIGHTLY SILTY (SP-SM)** GRAVEL 6 % SAND 88 %  
 From **TH - 6 AT 9 FEET** SILT & CLAY 6 % LIQUID LIMIT \_\_\_\_\_ %  
 PLASTICITY INDEX \_\_\_\_\_ %

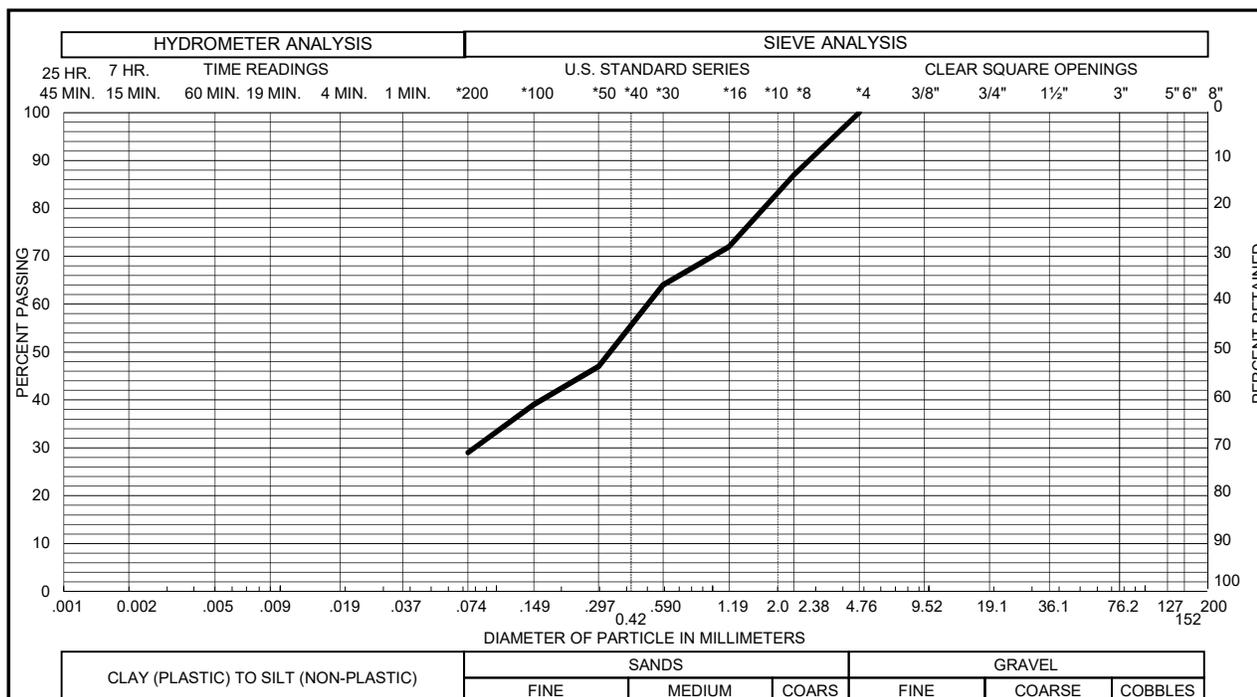
Sample of **SAND, SILTY (SM)** GRAVEL 0 % SAND 71 %  
 From **TH - 7 AT 9 FEET** SILT & CLAY 29 % LIQUID LIMIT \_\_\_\_\_ %  
 PLASTICITY INDEX \_\_\_\_\_ %

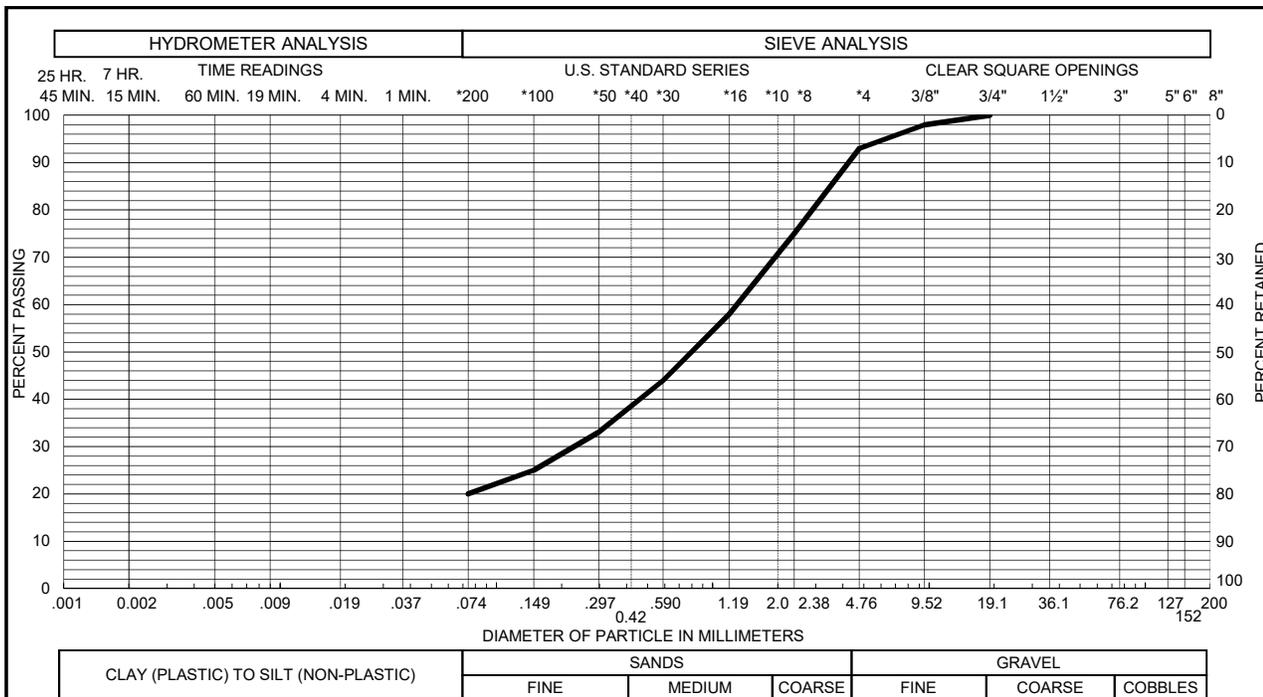
Sample of **SAND, SILTY (SM)** GRAVEL 7 % SAND 73 %  
 From TH - 11 AT 9 FEET SILT & CLAY 20 % LIQUID LIMIT \_\_\_\_\_ %  
 PLASTICITY INDEX \_\_\_\_\_ %
