Subject: Response to Review Comments  
Geologic Hazards Evaluation and Preliminary Geotechnical Investigation  
Mayberry, 540 Acre Site, PUD2  
Highway 94 and Log Road  
El Paso County, Colorado  
CTL|T Project No. CS18969.004-105-L1 Rev

CTL|Thompson, Inc. (CTL|T) prepared a Geologic Hazard Evaluation and Preliminary Geotechnical Investigation (CTL|T Project No. CS18969.004-105, dated March 13, 2023), for the Mayberry, 540 Acre Site. Our firm has performed two design level geotechnical investigations that cover the area within PUD 2, (CTL|T Project No. CS19587.000-120, dated February 20, 2025 AND CTL|T Project No. CS19587.001-125, dated February 18, 2025).

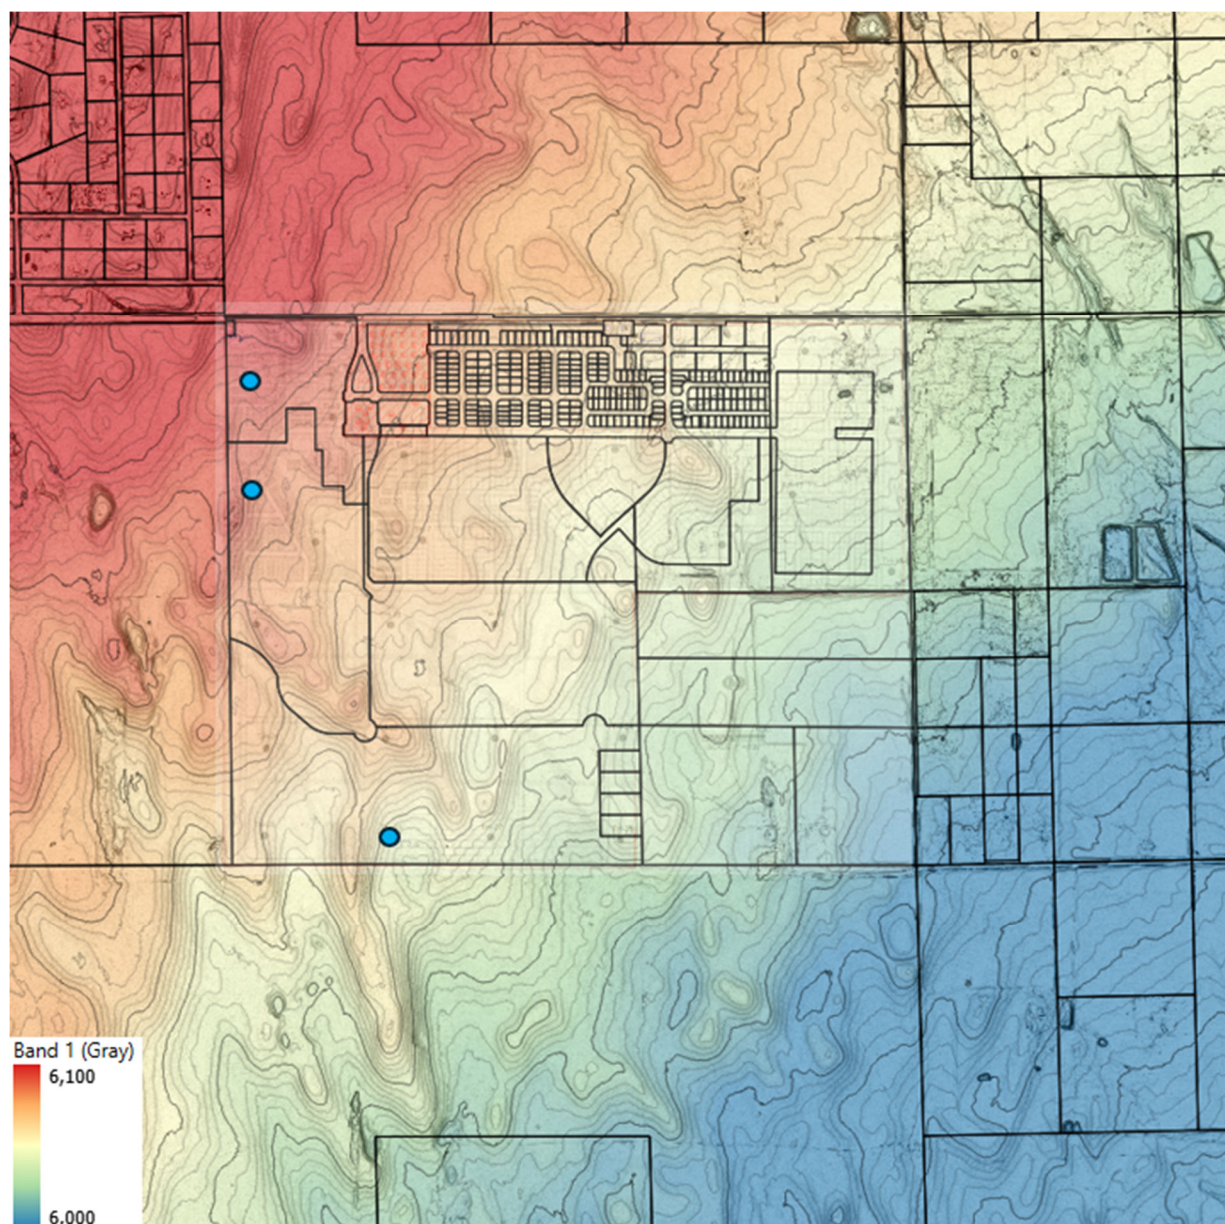
Topography of Mayberry Site and Surrounding Area

The CGS recommendation for a groundwater monitoring/observation program is excessive and unwarranted. Our firm has advanced over 100 borings at the Mayberry site during the past 6 years. Shallow groundwater has not been identified as a geologic hazard or engineering constraint. We have reviewed historic aerial imagery of the site and conducted numerous site visits. No surface evidence of springs or seeps were found. No channelized drainages were observed within the site. Localized groundwater greater than 10 feet below the surface and outside of the PUD2 project limits does not justify a costly groundwater monitoring program that would delay development for over a year. An elevation shaded DEM overlaying a slope shaded DEM of the Mayberry Site with 2-foot contours generated from the 2018 3DEP East CO El Paso 1-meter resolution Lidar is provided below. The three borings where groundwater was encountered are indicated with blue dots.

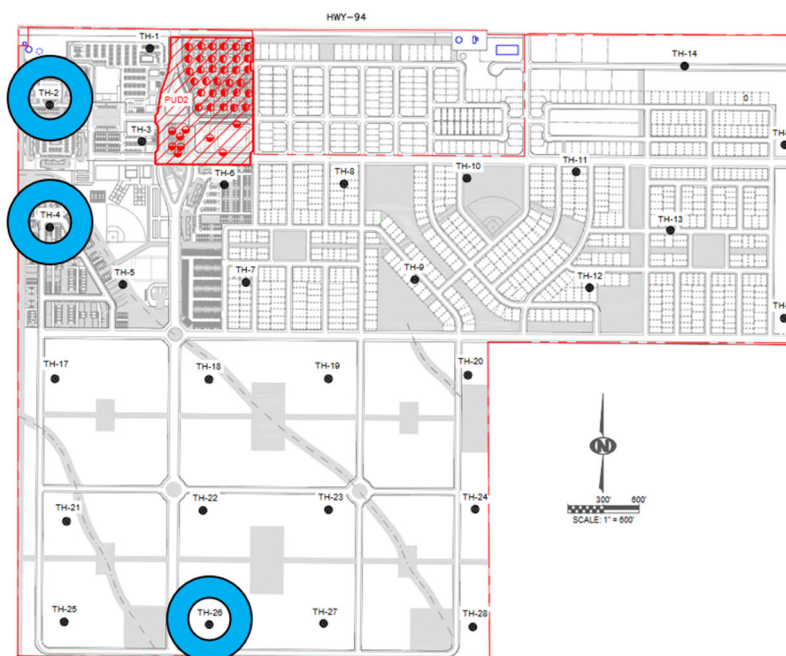
This investigation (CTL|T Project No. CS18969.00-105) that covers the 540-acre site, including PUD2, had three borings in which we observed groundwater. The boring numbers are TH-2, TH-4, and TH-26. These three borings lie along the western edge (TH-2 and TH-4) and southern edge (TH-26) of the overall development, and are well outside of the boundary of PUD2. A screenshot of the revised Fig. 1 (attached) with the locations of borings TH-2, TH-4, and TH-26 (circled in light blue) relative to the location of PUD2 (outlined in red) within the overall development is included below:

Shallow groundwater was not identified within PUD2, therefore, it does not require mitigation measures.

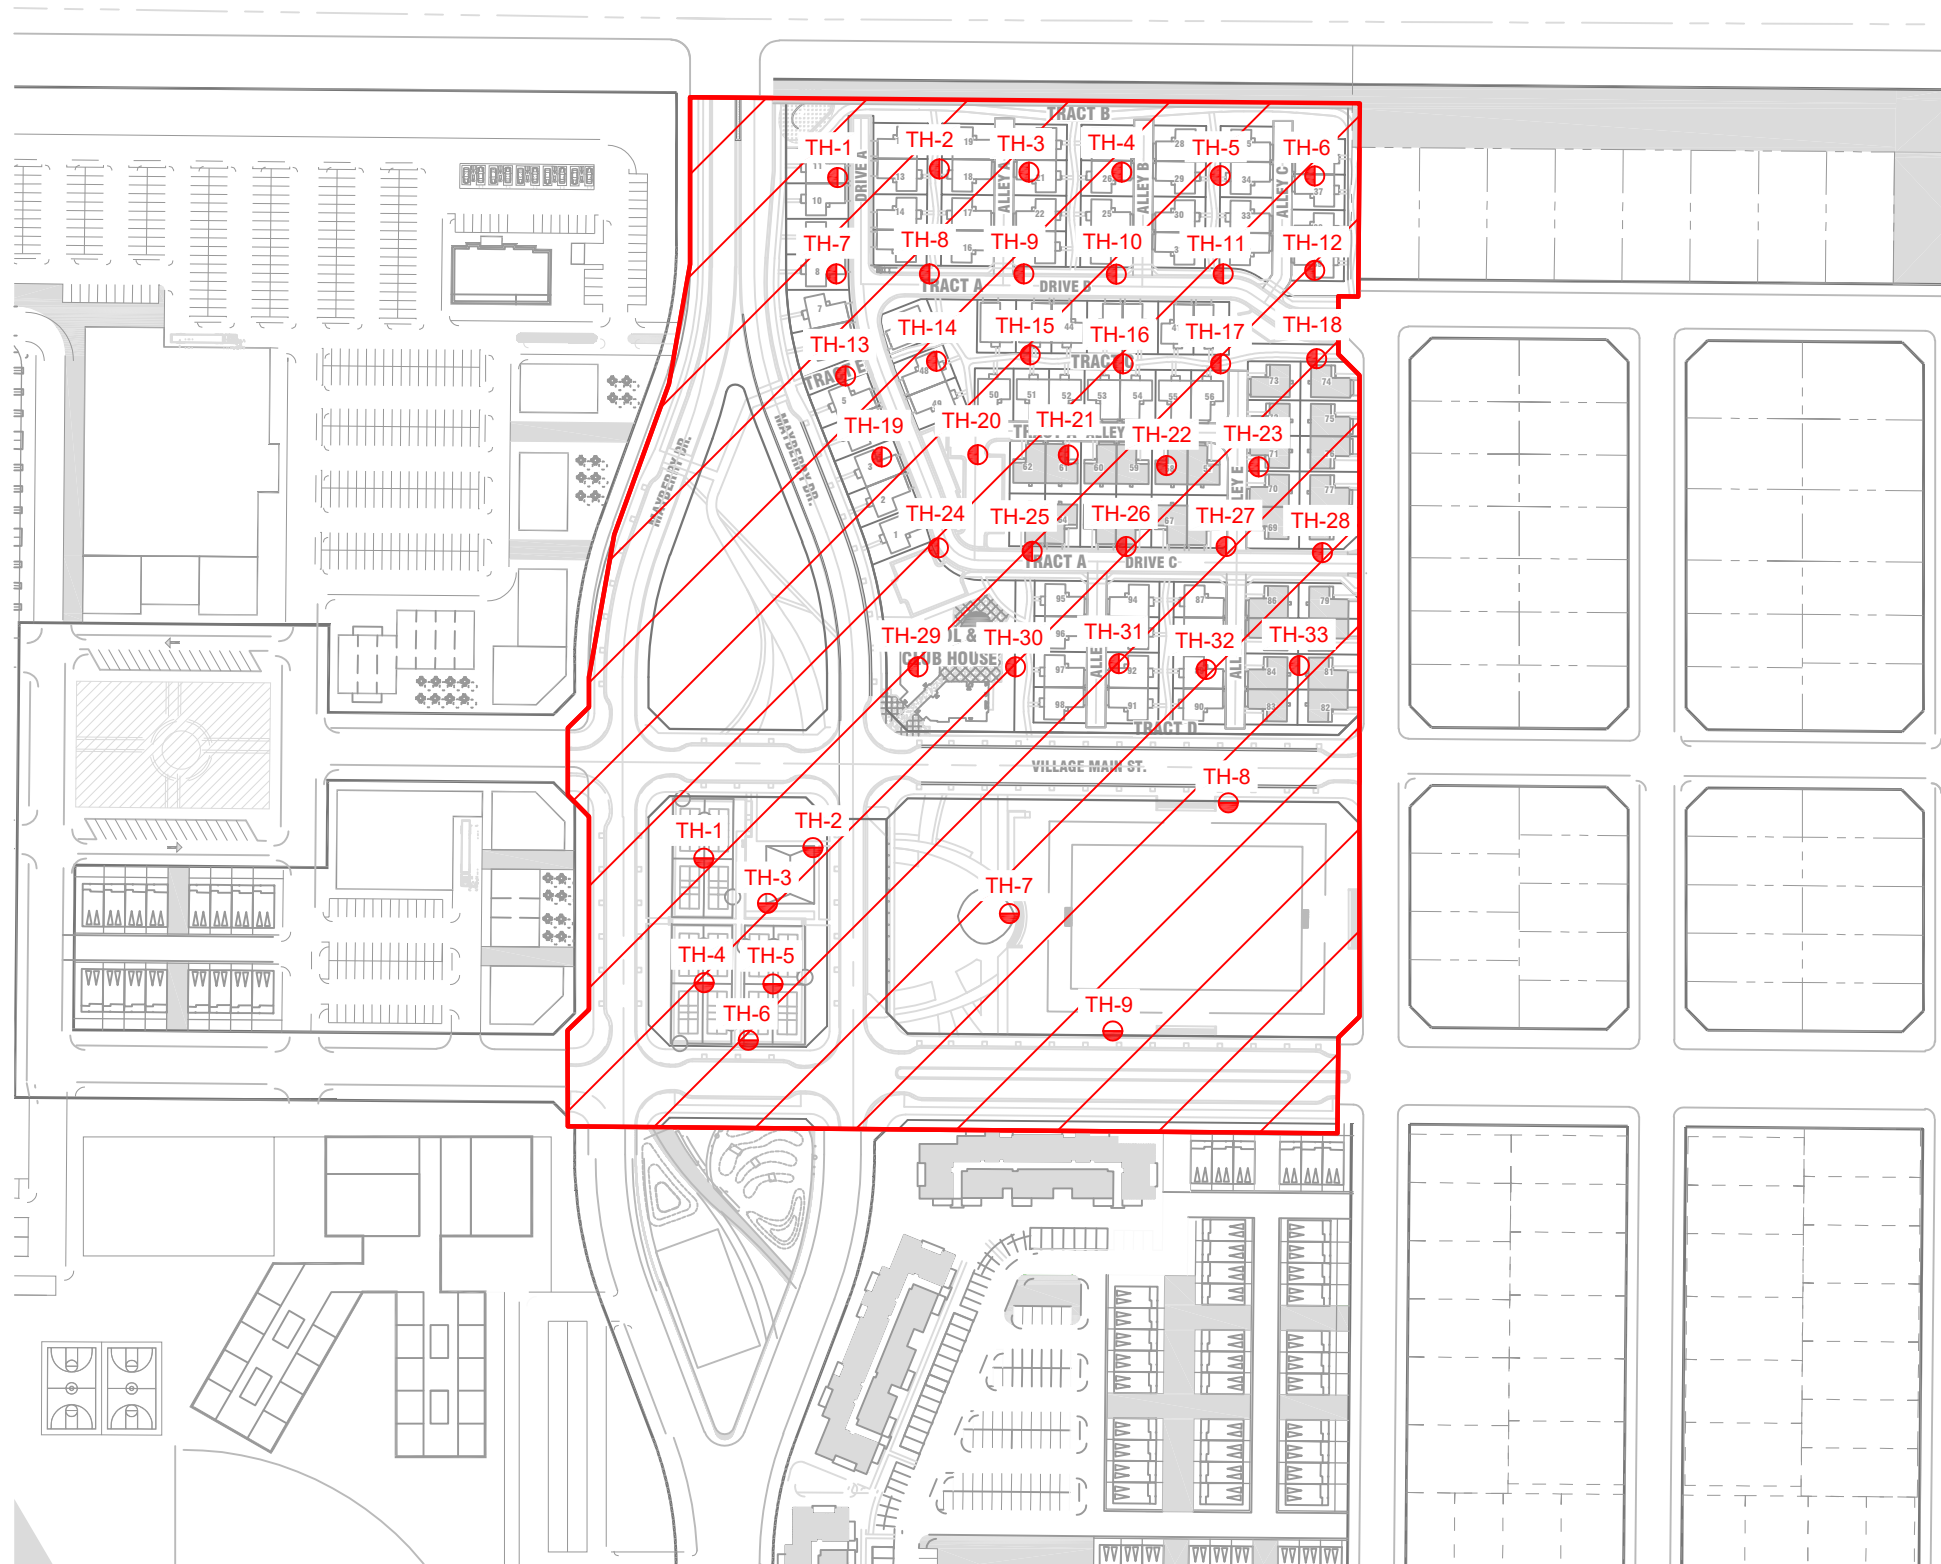
Location of Exploratory Borings - PUD2

APPROXIMATE LOCATION OF EXPLORATORY BORING (CTL/T PROJECT NO. CS19587.000-120).
-

APPROXIMATE LOCATION OF EXPLORATORY BORING (CTL/T PROJECT NO. CS19587.001-125).
-

APPROXIMATE BOUNDARY PUD2

1. BASE DRAWING OF PUD2 WAS PROVIDED BY LJA (DATED JUNE 3, 2026).

PUD2 is a part of the 540-Acre Site, which is covered by this report. We have revised Figure 1 to include a boundary for PUD2 and we have added a Figure 2, which is a detail of the PUD2 area from Figure 1, since the PUD2 area is relatively small compared to the overall 540 Acre site.

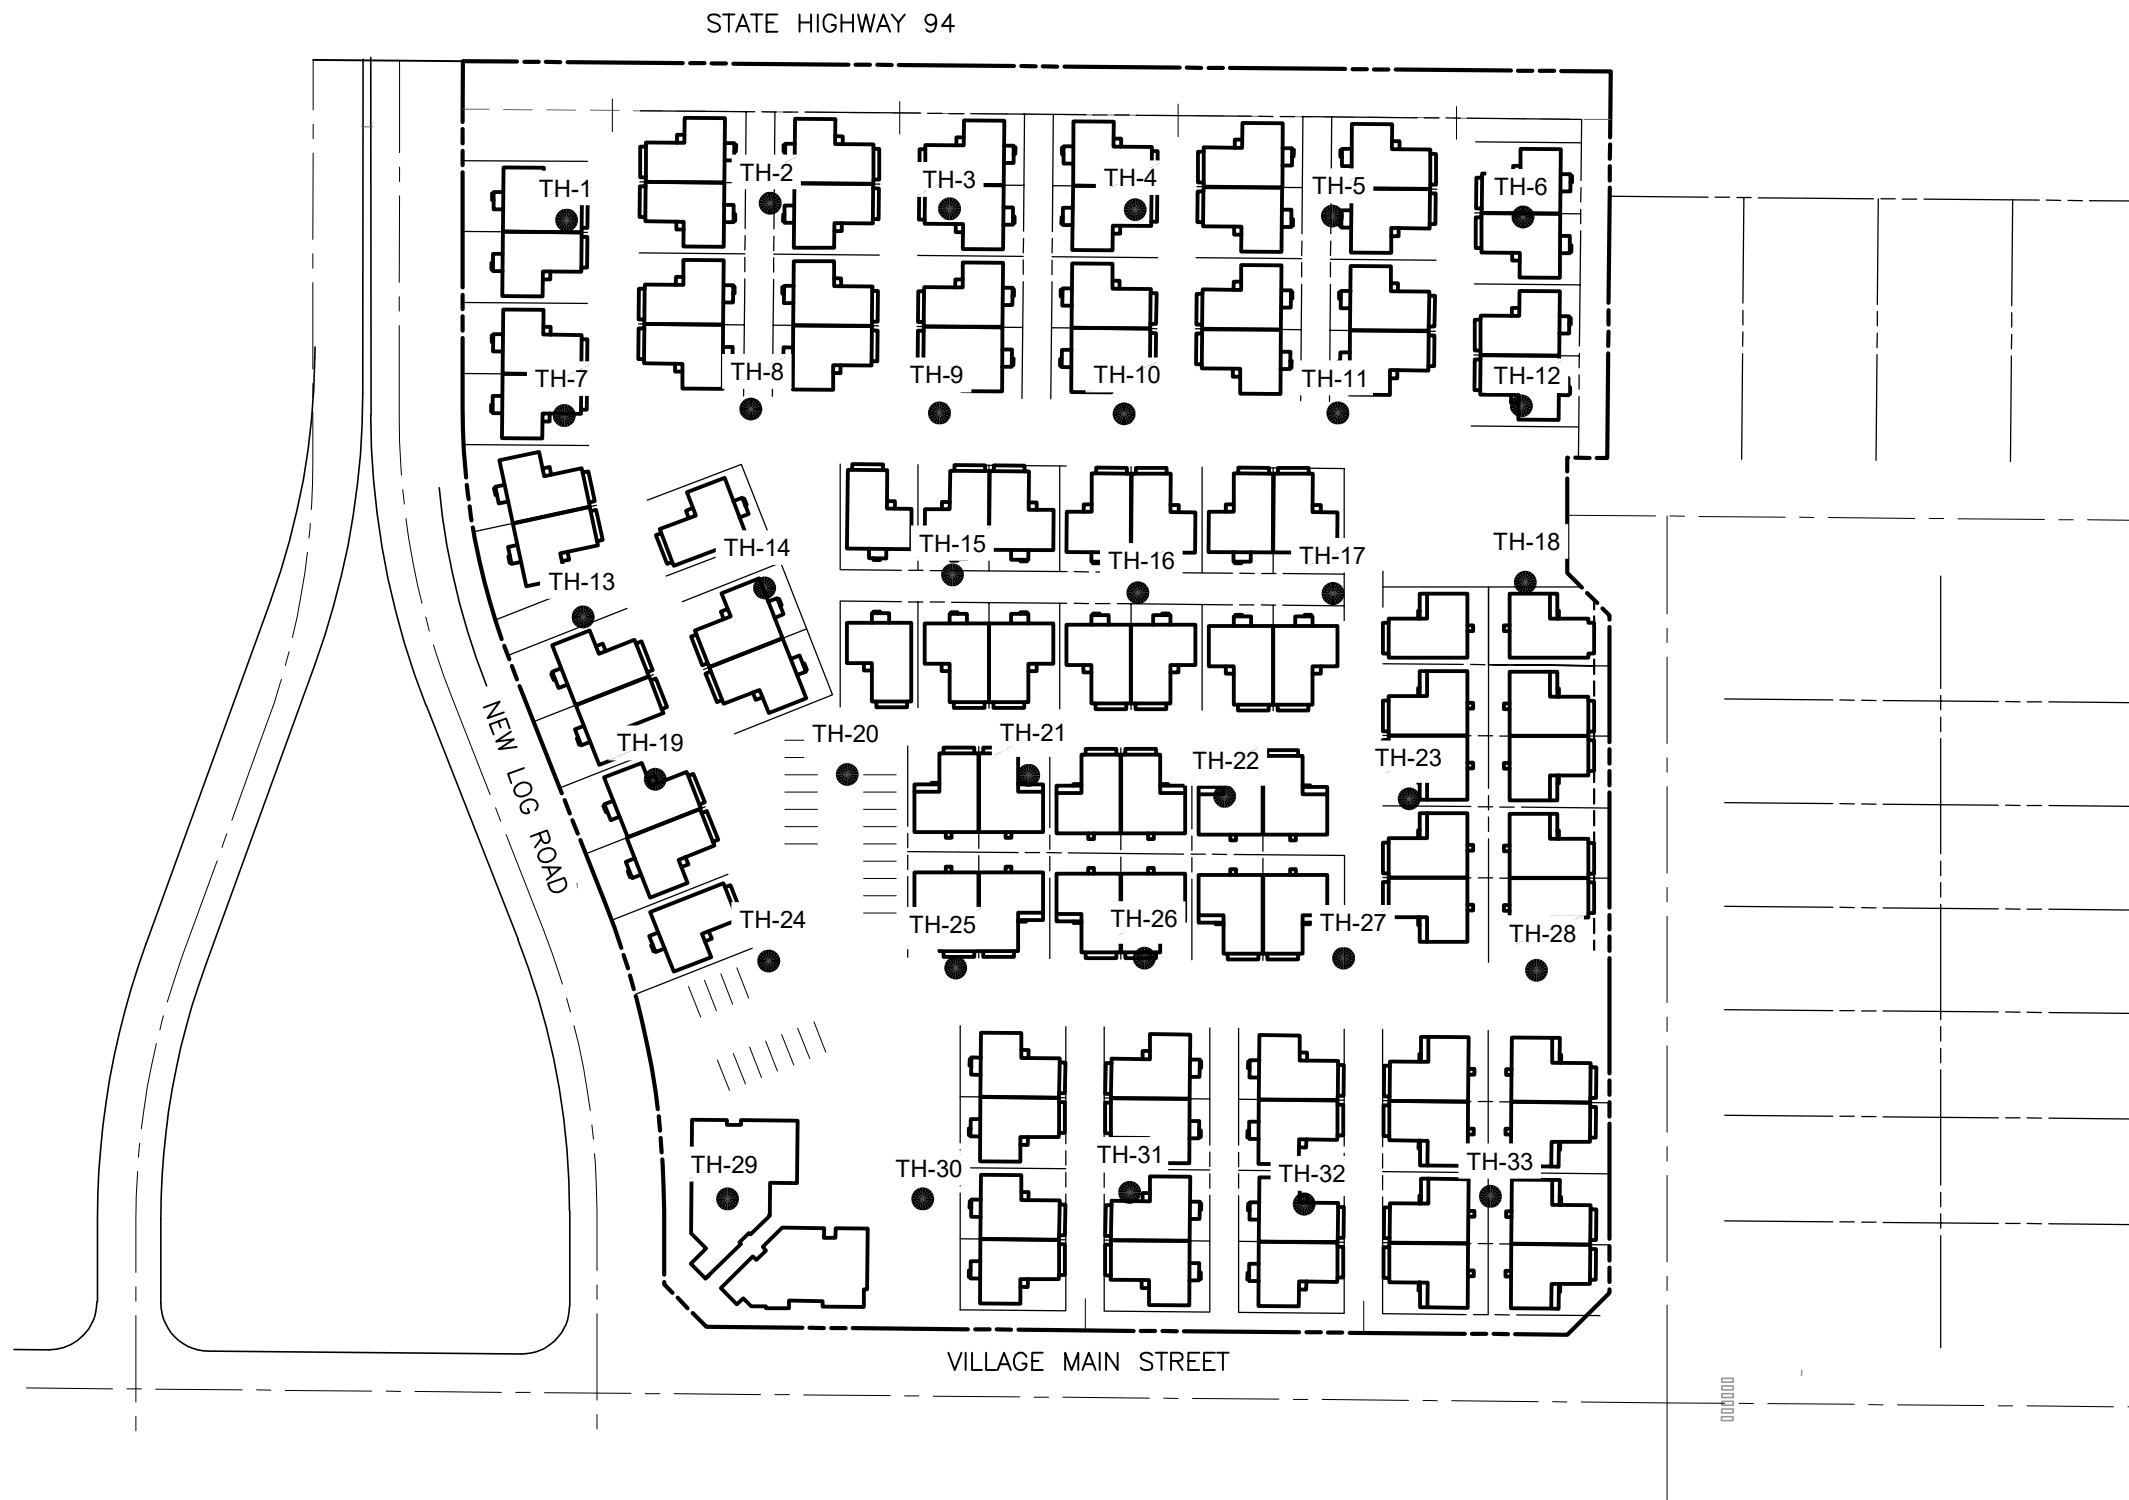
FIG. 1

TH-1      APPROXIMATE LOCATION OF EXPLORATORY BORING.

Location of  
Exploratory  
Borings
