***WASTEWATER DISPOSAL REPORT***

***Atwell, LLC  
Mariah Trail Filing No. 1  
Subdivision***

***EPC Parcel #: 5100000511***

**April 2023**

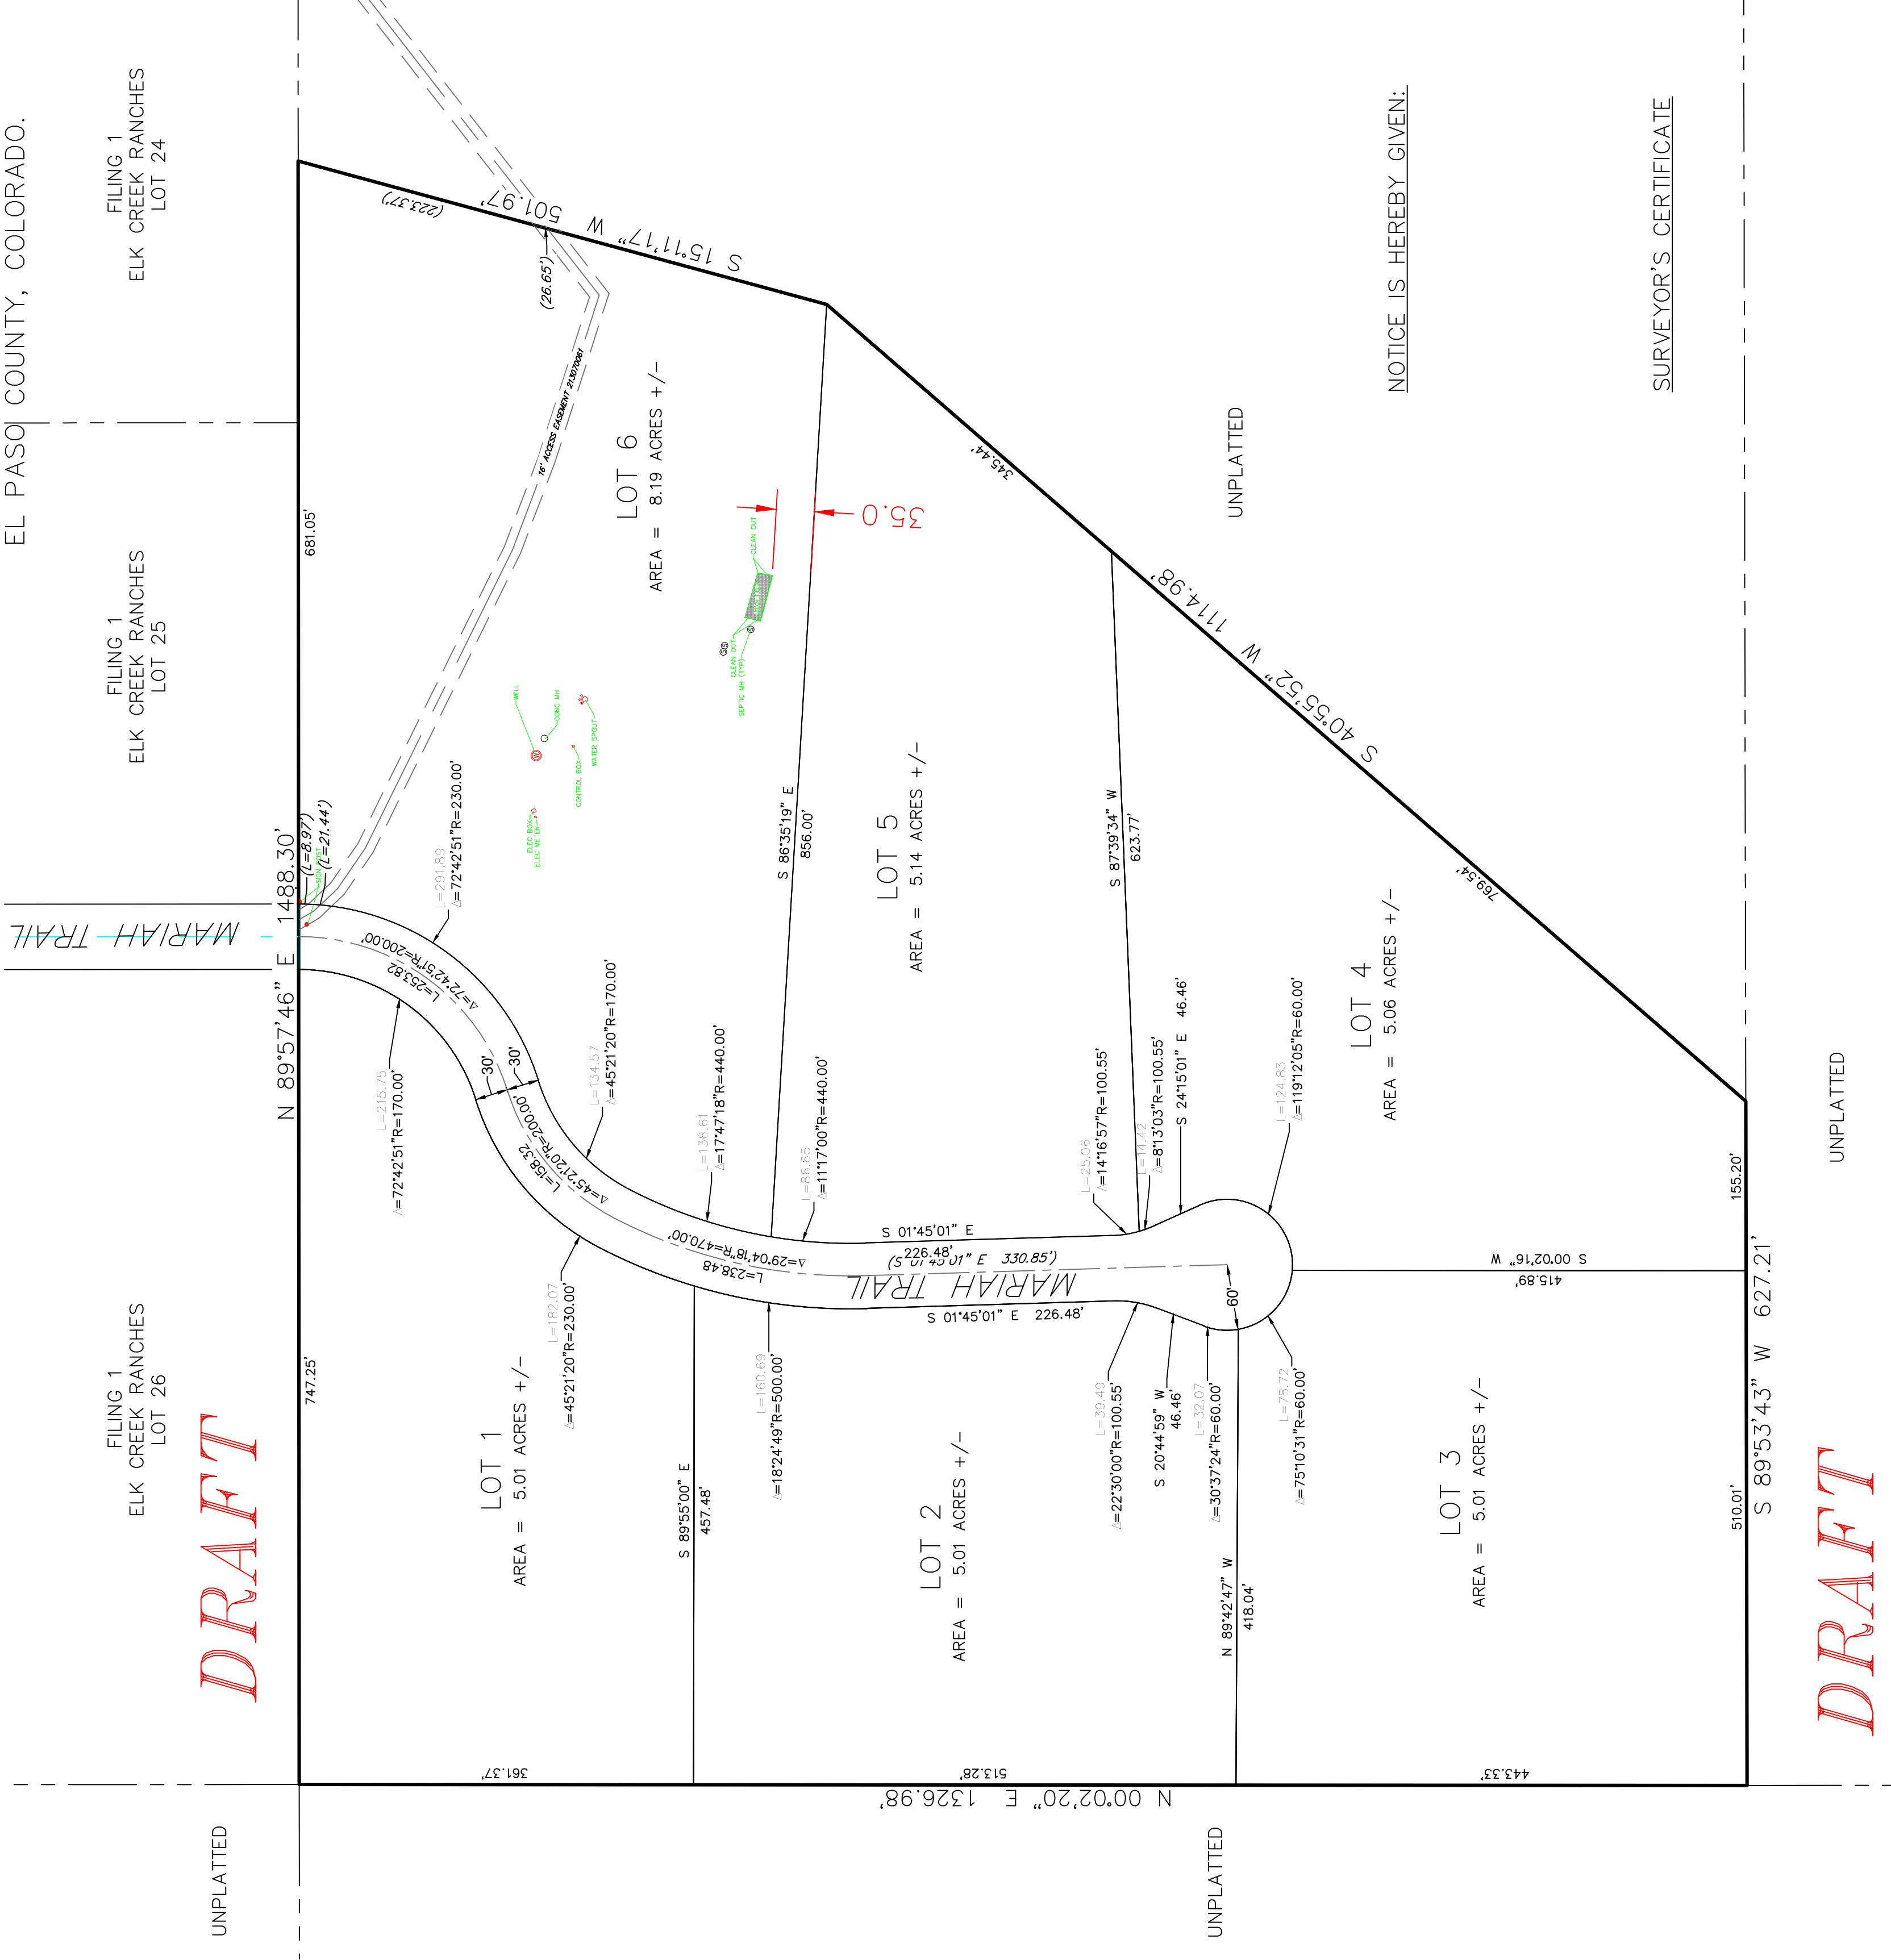
# MARIAH TRAIL FILING NO. 1

A PORTION OF THE NORTHWEST QUARTER OF SECTION 7,  
TOWNSHIP 11 SOUTH, RANGE 65 WEST, OF THE 6TH PRINCIPAL MERIDIAN,  
EL PASO COUNTY, COLORADO.

This report pertains to the existing 35-acre parcel that is proposed to be divided into six (6) lots, with three lots described as 5.01 acres, one lot at 5.06 acres, one lot at 5.14 acres, and one lot at 8.19 acres. Please refer to the Land Use Exhibit in **Appendix A**.

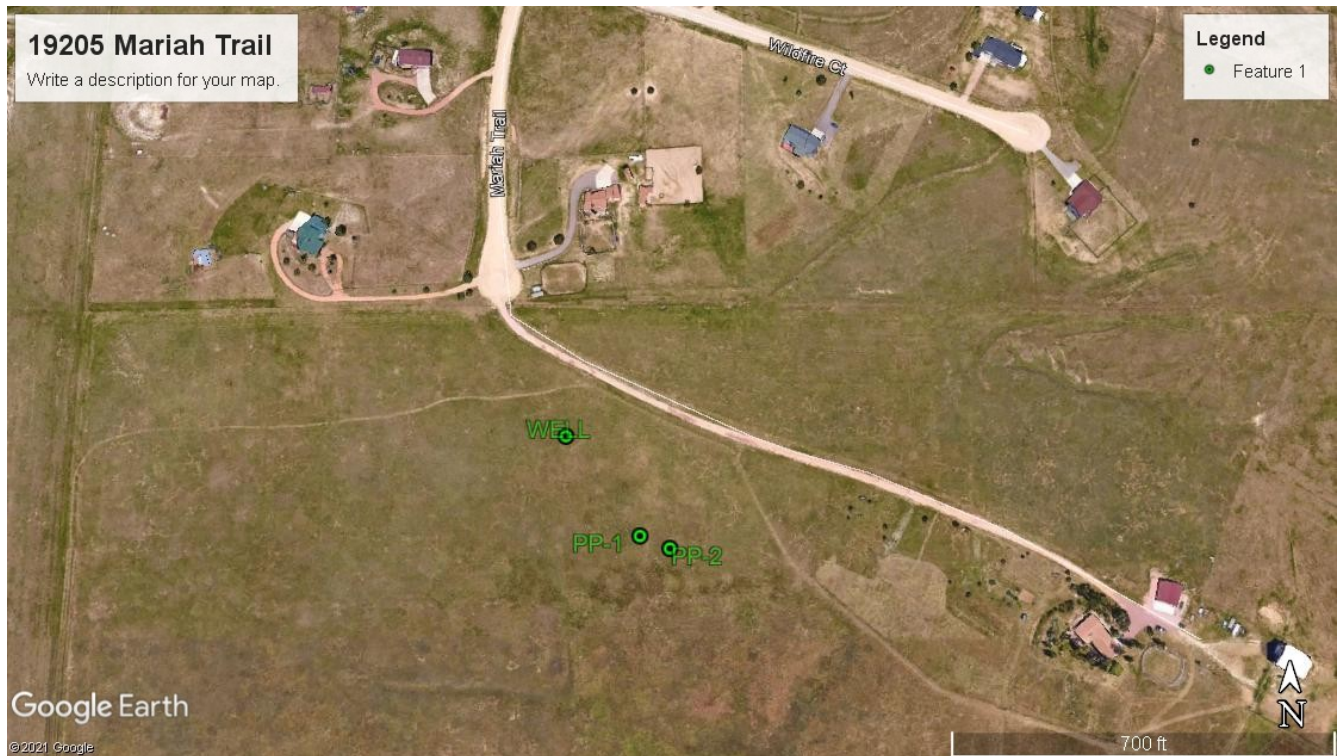
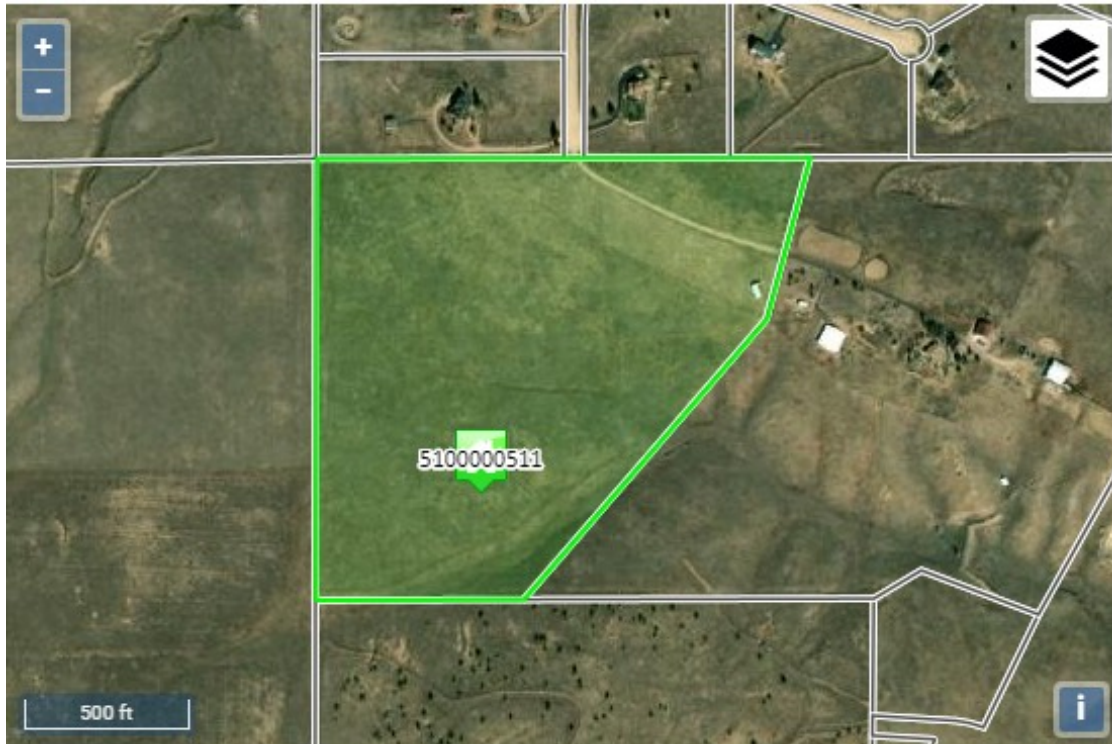
Profile Pit #1	Profile Pit #2
Groundwater	Not Encountered	Not Encountered
Bedrock	Not Encountered	Not Encountered
Redoximorphic Features	Not Encountered	Not Encountered
Well	> 100'	> 100'
Gulches	> 25'	> 25'
Water Body	> 150'	> 150'
Grade	5%	5%
GPS	39° 6'48.85"N, 104°42'56.95"W	39° 6'48.63"N, 104°42'56.25"W

This Profile Pit Examination was performed to evaluate soil conditions for a new Soil Treatment Area (STA) on the property. Two Profile Pits were dug to a depth of 8 feet with a Kubota excavator. A visual / tactile examination was performed.

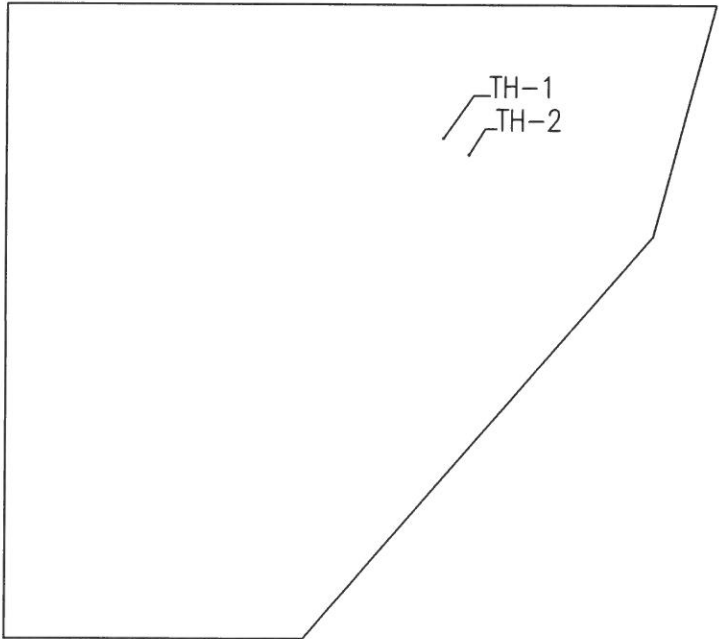
Lot #1  
19205 Mariah Trail  
El Paso County  
Colorado  
Job #21-0989  
By: jwg

0 100 200 300 400  
GRAPHIC SCALE IN FEET  
SCALE: 1" = 400'

Two exploratory holes were drilled on August 17, 2021, at the locations shown on the enclosed site map. The location of these test holes was determined by Thomas Kirk. The test holes were drilled with a 4-inch diameter auger. At intervals anticipated to be the foundation depths, and as determined by the soils conditions, the drill tools were removed, and samples were taken by the use of a 2-inch split barrel sampler connected to a 140-pound drop-hammer. This hammer is dropped 30 inches to drive the penetration sampler into the soil **(ASTM D-1586)**. The depths and descriptions of the materials encountered in each test boring at which the samples were taken are shown on the enclosed log sheets. All samples were classified both in the field and in the laboratory to evaluate the physical and mechanical properties of the materials encountered.

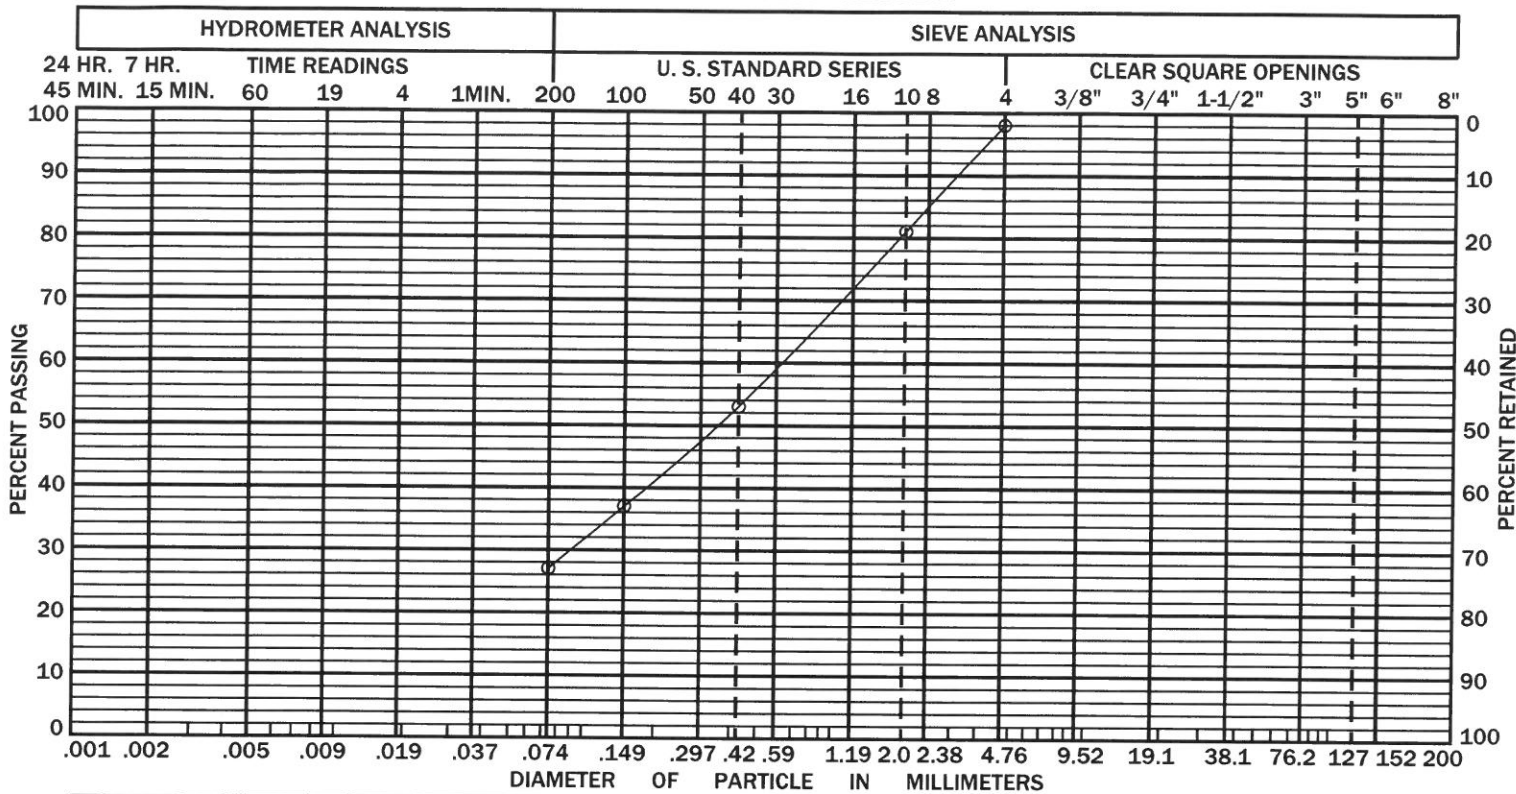
**GEOQUEST LLC**  
**GRADATION TEST RESULTS**

CLAY TO SILT	SAND			GRAVEL		COBBLES
	FINE	MEDIUM	COARSE	FINE	COARSE	
CLASSIFICATION <u>SM</u>	NOTES: <u>2.91 %</u> Moisture content					
GRAVEL <u>1.81 %</u>	Cu = <u>38.29</u>					
SAND <u>70.74 %</u>	Cc = <u>0.52</u>					
FINES <u>27.45 %</u>						
SAMPLE# <u>1</u> HOLE# <u>TH-1</u> DEPTH <u>4'</u> FEET

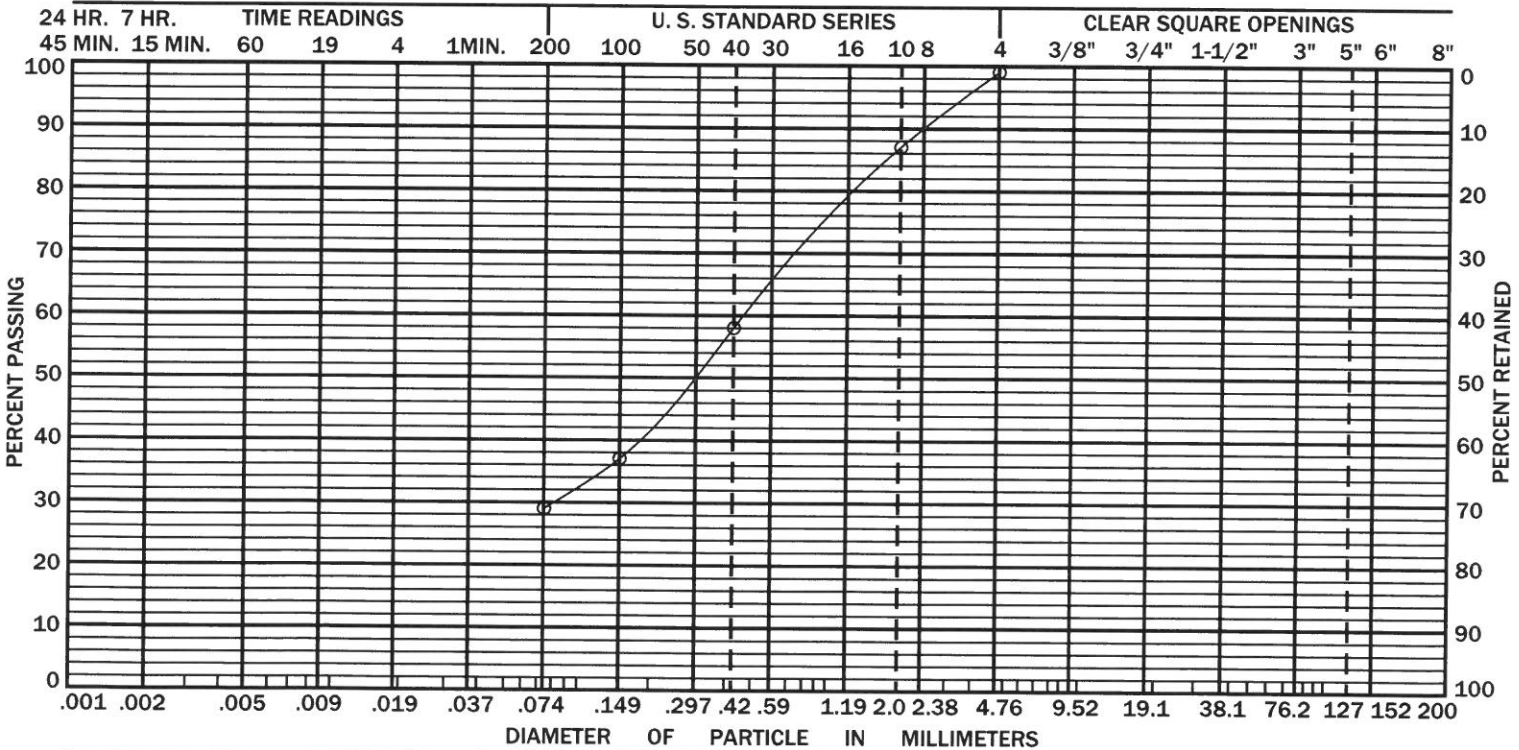
CLAY TO SILT	SAND			GRAVEL		COBBLES
	FINE	MEDIUM	COARSE	FINE	COARSE	
CLASSIFICATION <u>SM</u>	NOTES: <u>7.67 %</u> Moisture content					
GRAVEL <u>0.81 %</u>	Cu = <u>36.52</u>					
SAND <u>70.36 %</u>	Cc = <u>0.85</u>					
FINES <u>28.83 %</u>						
SAMPLE# <u>2</u> HOLE# <u>TH-1</u> DEPTH <u>9</u> FEET	Job: #21-0989 By: CHS 09/01/2021

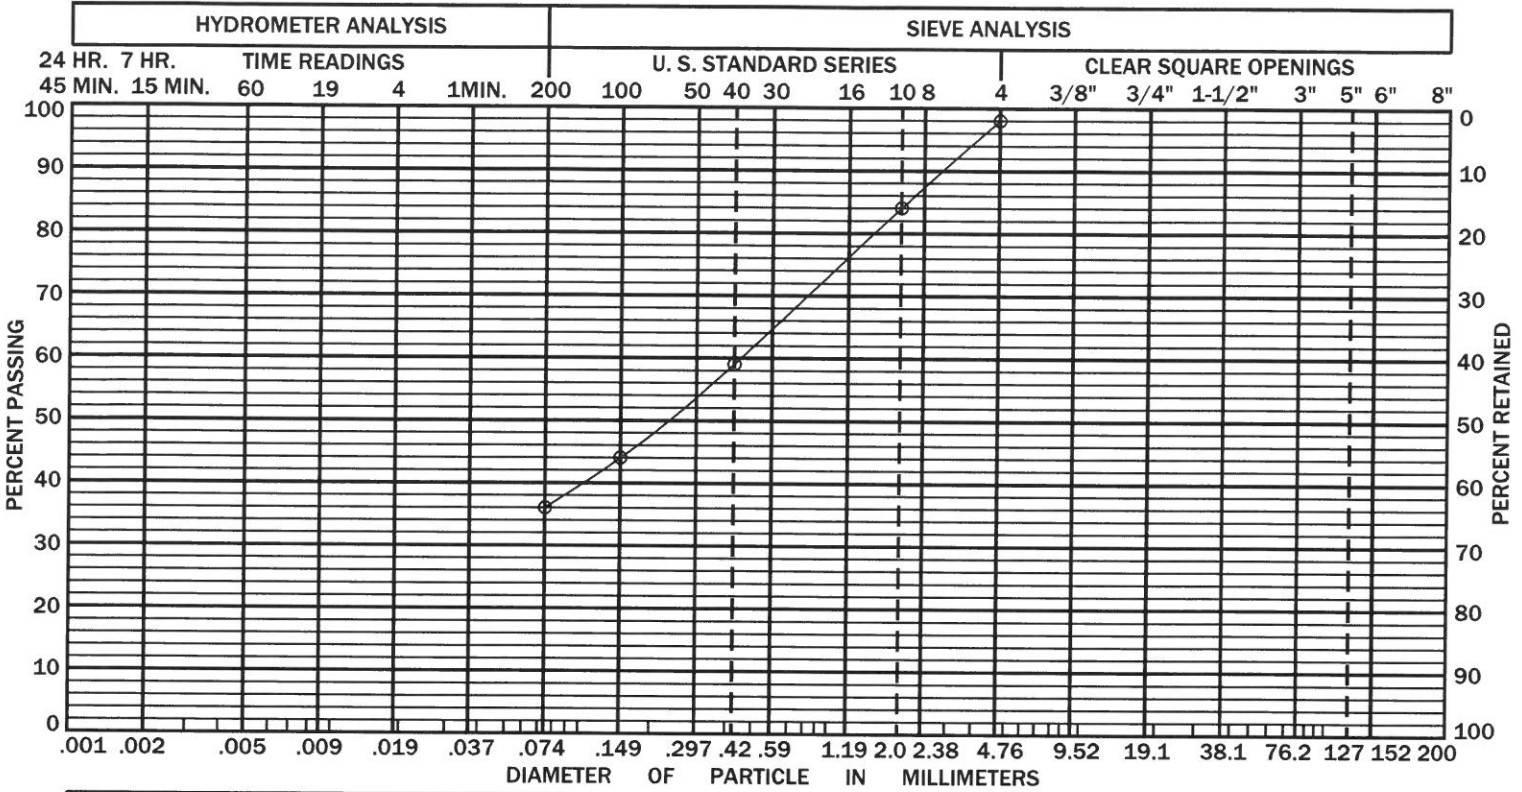
**GEOQUEST LLC**  
**GRADATION TEST RESULTS**

CLAY TO SILT	SAND			GRAVEL		COBBLES
	FINE	MEDIUM	COARSE	FINE	COARSE	
CLASSIFICATION <u>SC</u>	NOTES: <u>6.53 % Moisture content</u>					
GRAVEL <u>1.69 %</u>						
SAND <u>61.88 %</u>						
FINES <u>36.44 %</u>						
SAMPLE# <u>3</u> HOLE# <u>TH-2</u> DEPTH <u>4</u> FEET

6. The clayey sand (SC) has been analyzed for its expansion and/or consolidation potential. Basement slabs, garage slabs, and all concrete floor slabs, however, exert a very low dead-load pressure on the soil. Since this soil contains at least a small amount of swell potential, slabs will crack and heave or settle if excess water is allowed to penetrate the sub-grade. For example, column openings to pads below the placed slab, if exposed to precipitation during construction, will conduct water to the sub-grade, possibly causing it to expand. Also, if the slab is placed with concrete too wet, expansion may occur. We recommend 3,000 psi concrete placed at a maximum slump of 4 inches.

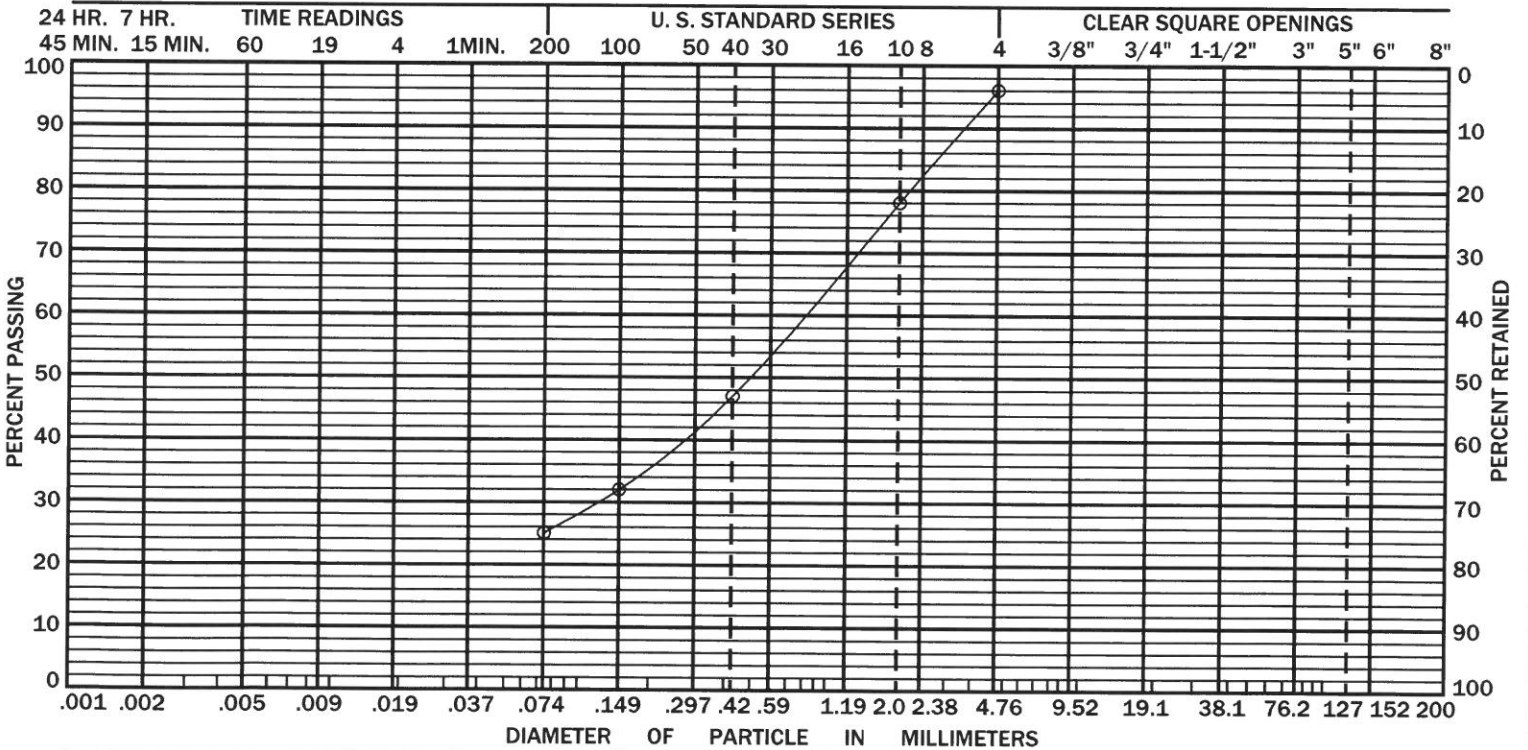
CLAY TO SILT	SAND			GRAVEL		COBBLES
	FINE	MEDIUM	COARSE	FINE	COARSE	
CLASSIFICATION <u>SM</u>	NOTES: <u>6.72 % Moisture content</u>					
GRAVEL <u>3.95 %</u>	<u>Cu = 74.96</u>					
SAND <u>70.86 %</u>	<u>Cc = 1.02</u>					
FINES <u>25.18 %</u>						
SAMPLE# <u>4</u> HOLE# <u>TH-2</u> DEPTH <u>9</u> FEET	Job: #21-0989 By: CHS 09/01/2021

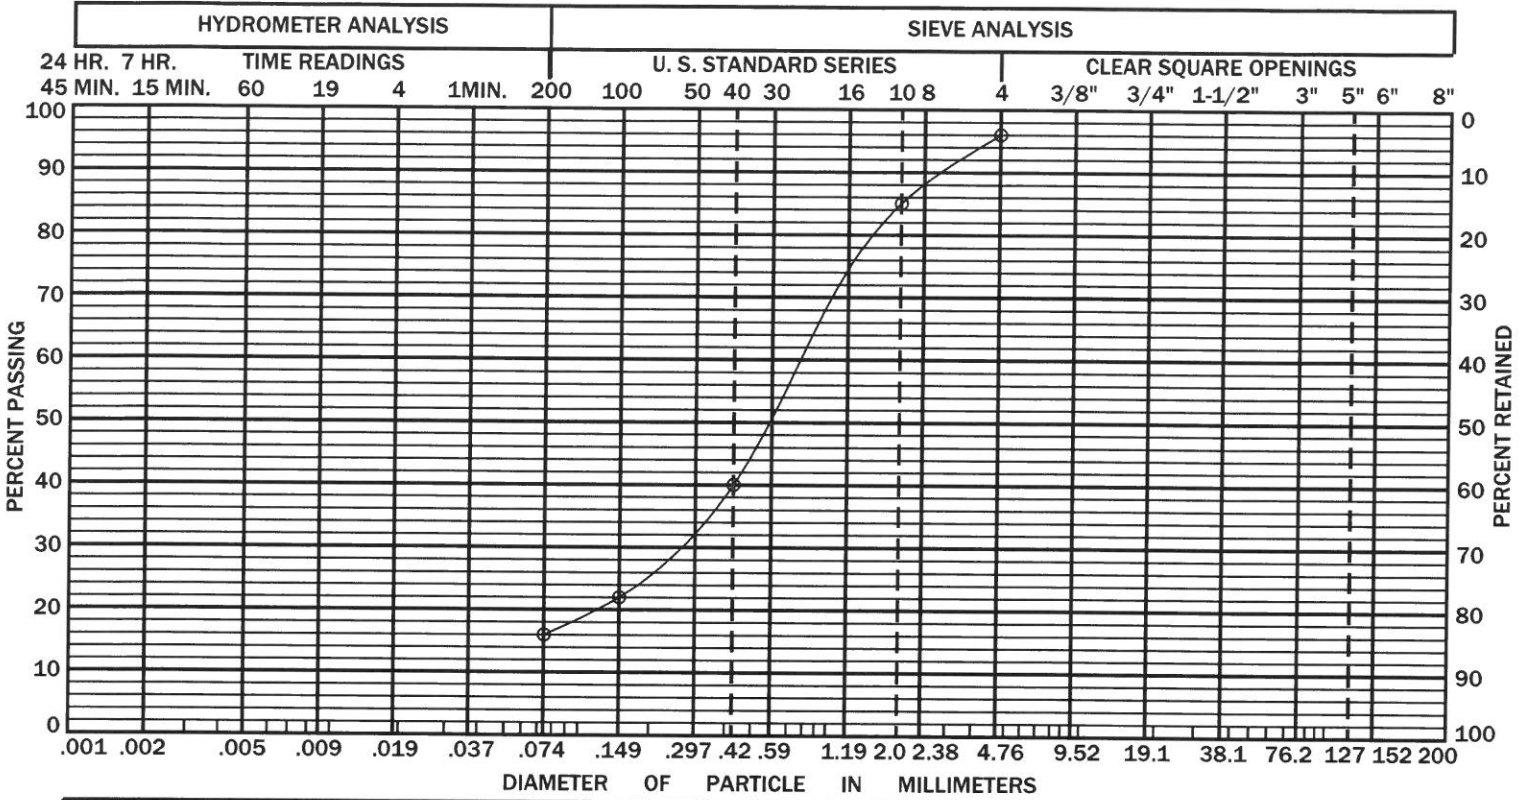
## GRADATION TEST RESULTS

CLASSIFICATION SM  
 GRAVEL 3.99 %  
 SAND 79.59 %  
 FINES 16.42 %  
 SAMPLE# 5 HOLE# TH-2 DEPTH 14 FEET

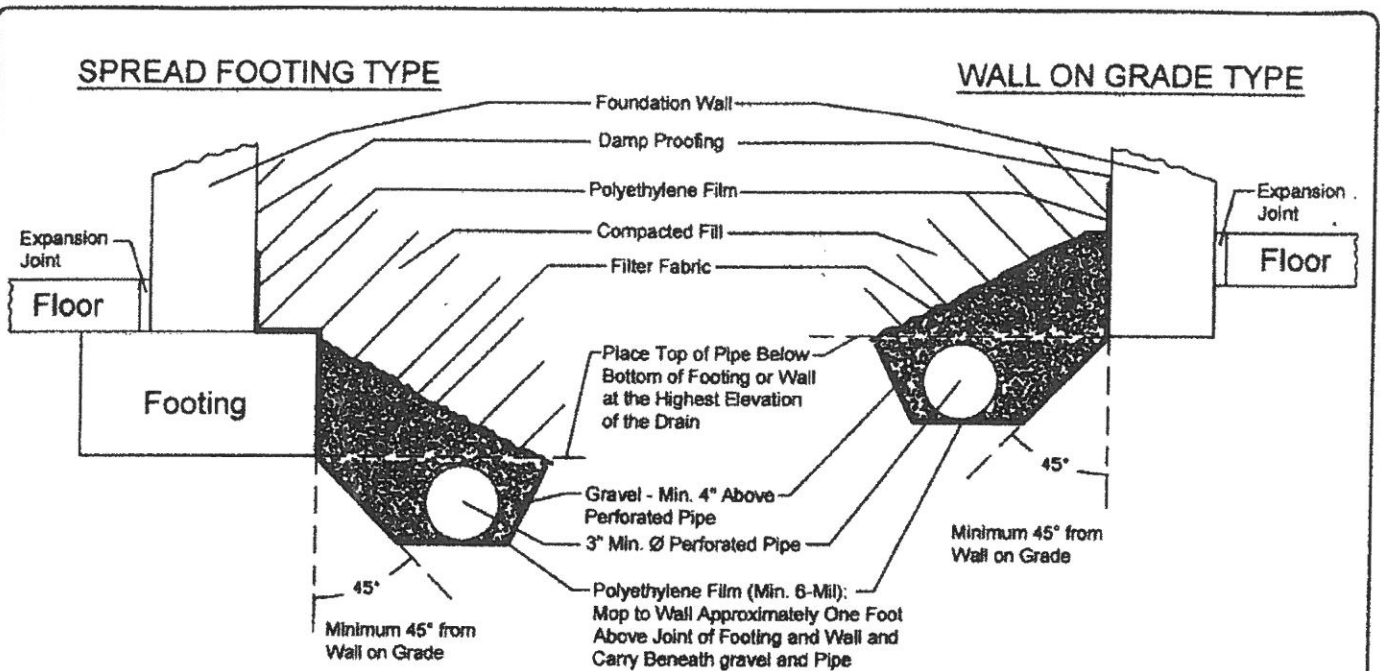
## EXTERIOR DRAIN DETAIL

1. Gravel to be Not More Than 1-1/2" and Not Less Than 1/2" Diameter.
2. Perforated Pipe Diameter Varies With Expected Seepage. 3"Ø and 4"Ø are Most Common. ABS and PVC are Most Common Materials for Pipe. We approve the use of an "EZ Flow Drainage System" by Infiltrator. All specifications in this drain detail are still applicable.

3. Pipe to be Laid out in a Minimum Slope of 1" in 10'.
4. Gravity Outfall is Desired if Possible. Portion of Pipe in Area Not Drained Shall be Non-Perforated. Daylight Must be Maintained Clear of Debris in Order to Function Properly.

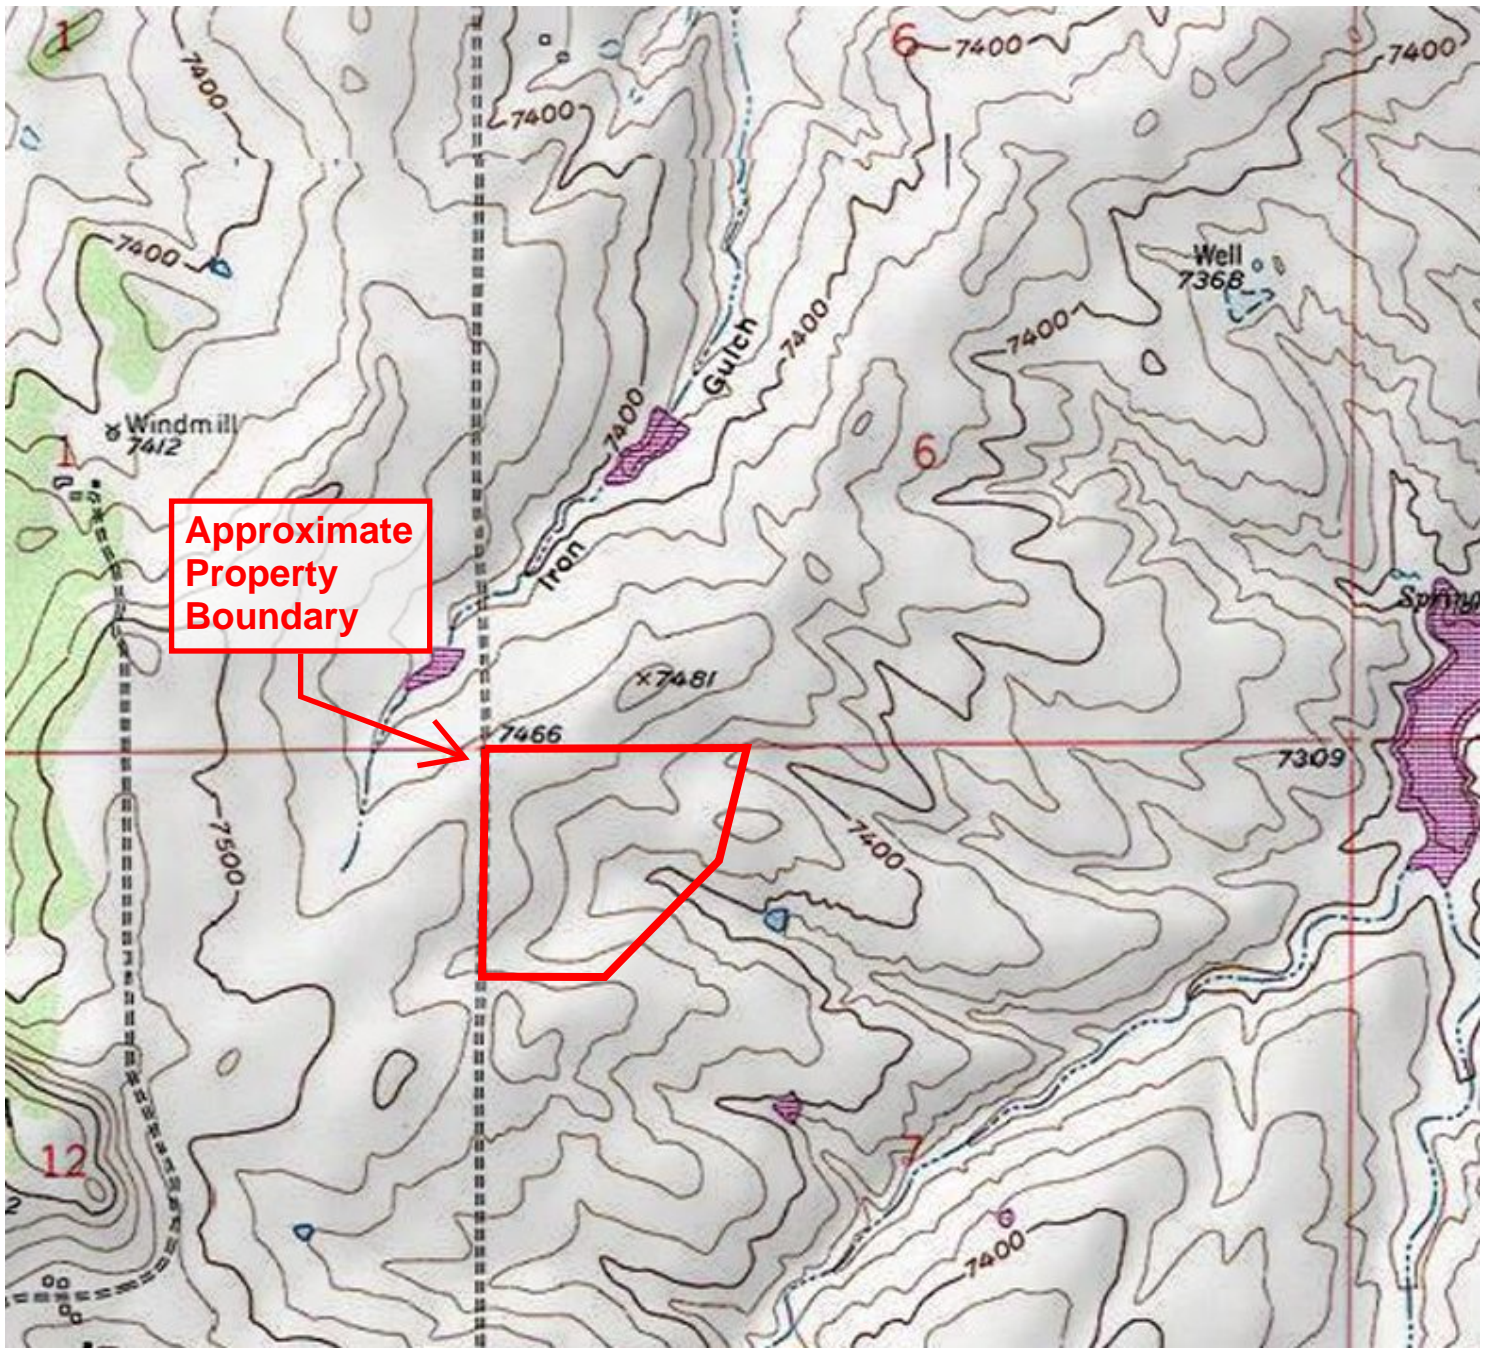
Project No: D23-2-587	<b>TOPOGRAPHIC MAP</b>	Figure  <b>5</b>
	Date: 1/31/23		
	Drawn by: JA	Mariah Trail Subdivision, Filing No. 1 El Paso County, Colorado	
	Reviewed by: WJB

Not to Scale. Base image obtained from USGS 7.5 Minute Quadrangle, 1961

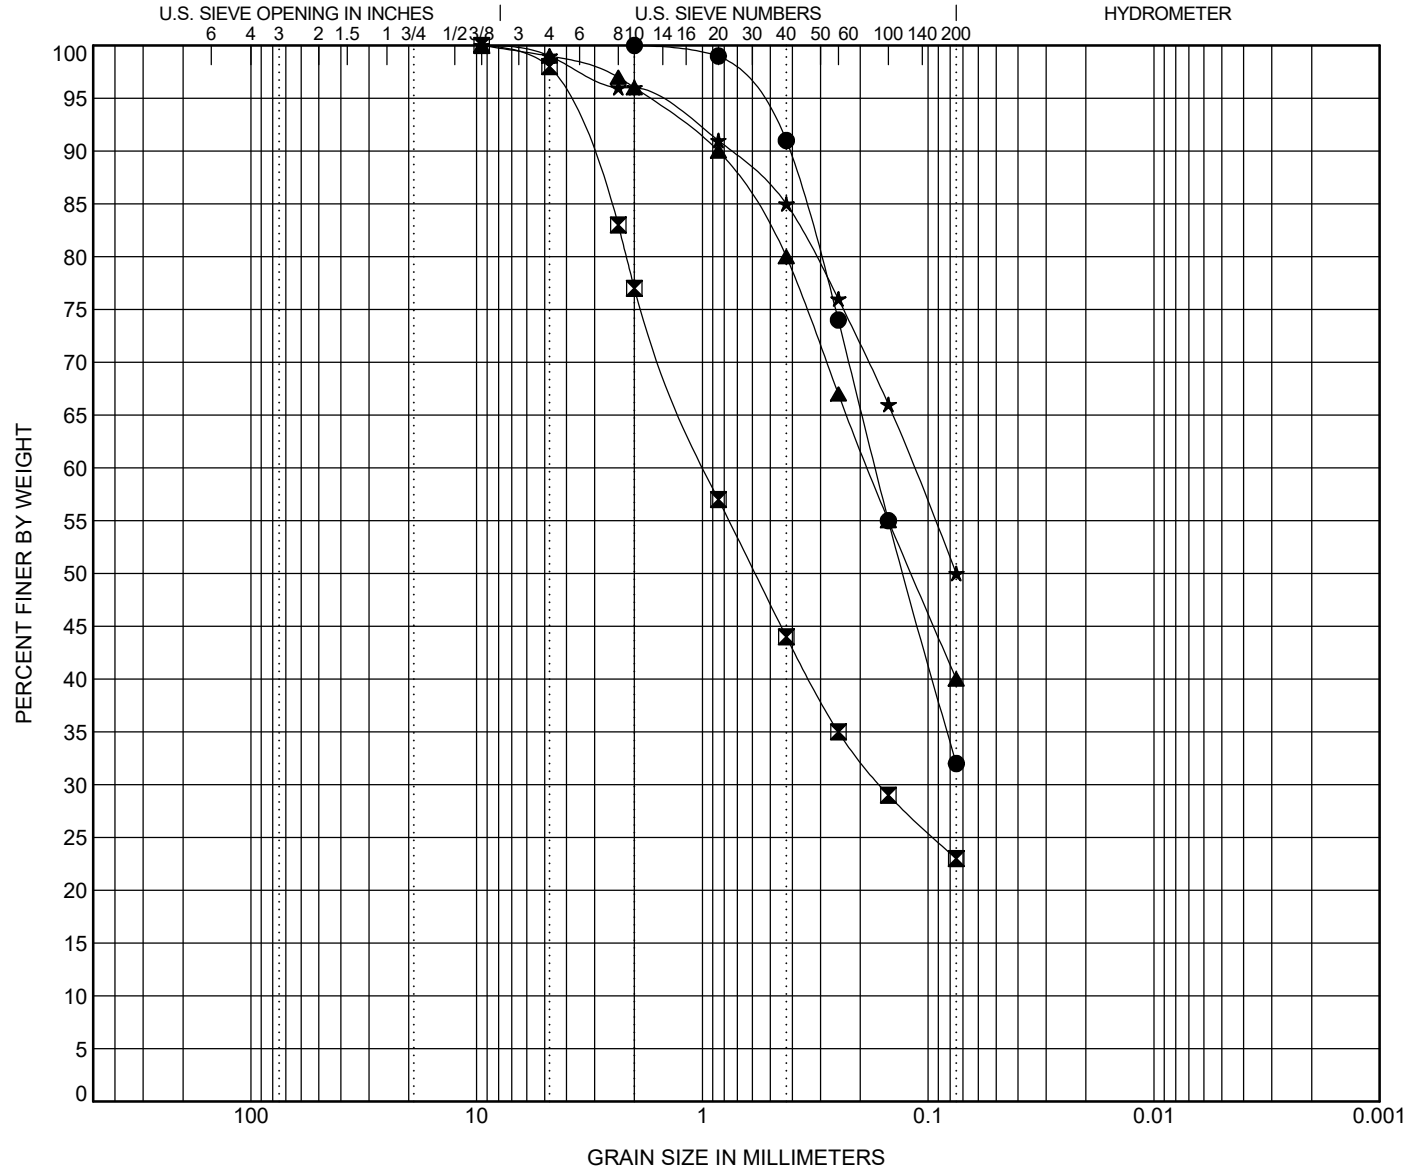
COBBLES	GRAVEL		SAND			SILT OR CLAY
	coarse	fine	coarse	medium	fine

BOREHOLE	DEPTH	Classification	LL	PL	PI	Cc	Cu
● B-2	4.0	SILTY SAND(SM)	NP	NP	NP		
☒ B-3	2.0	SILTY, CLAYEY SAND(SC-SM)	23	16	7		
▲ B-4	2.0	SILTY SAND(SM)	20	17	3		
★ B-4	4.0	SANDY SILTY CLAY(CL-ML)	24	19	5

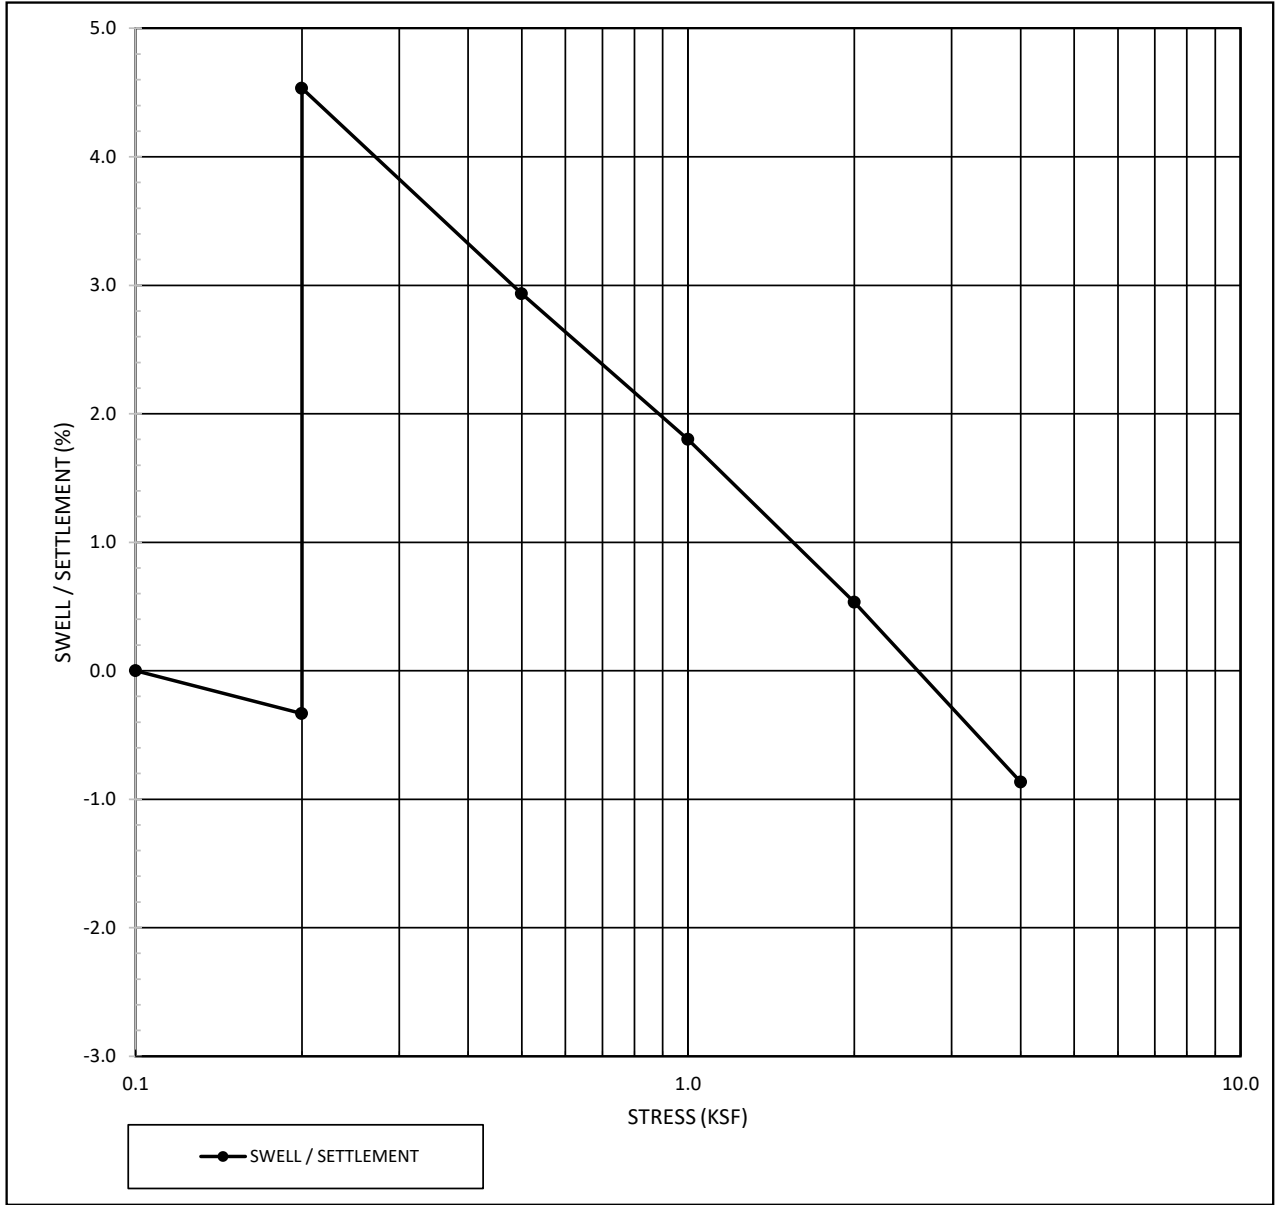
Project Name:	Mariah Trail Subdivision, Filing No. 1	Date	3/3/2023
Project No.:	D23-2-587		
Boring ID.:	B-1	Sample Depth (ft)	2
Sample Description:	Clayey SAND, brown, slightly moist		
		Swell @ Wetting Weight:	4.9 %

<b>Initial Condition</b>	
Moisture Content %	8.7
Dry Density (pcf)	118.9
<b>Post-Swell Condition</b>	
Moisture Content %	17.7

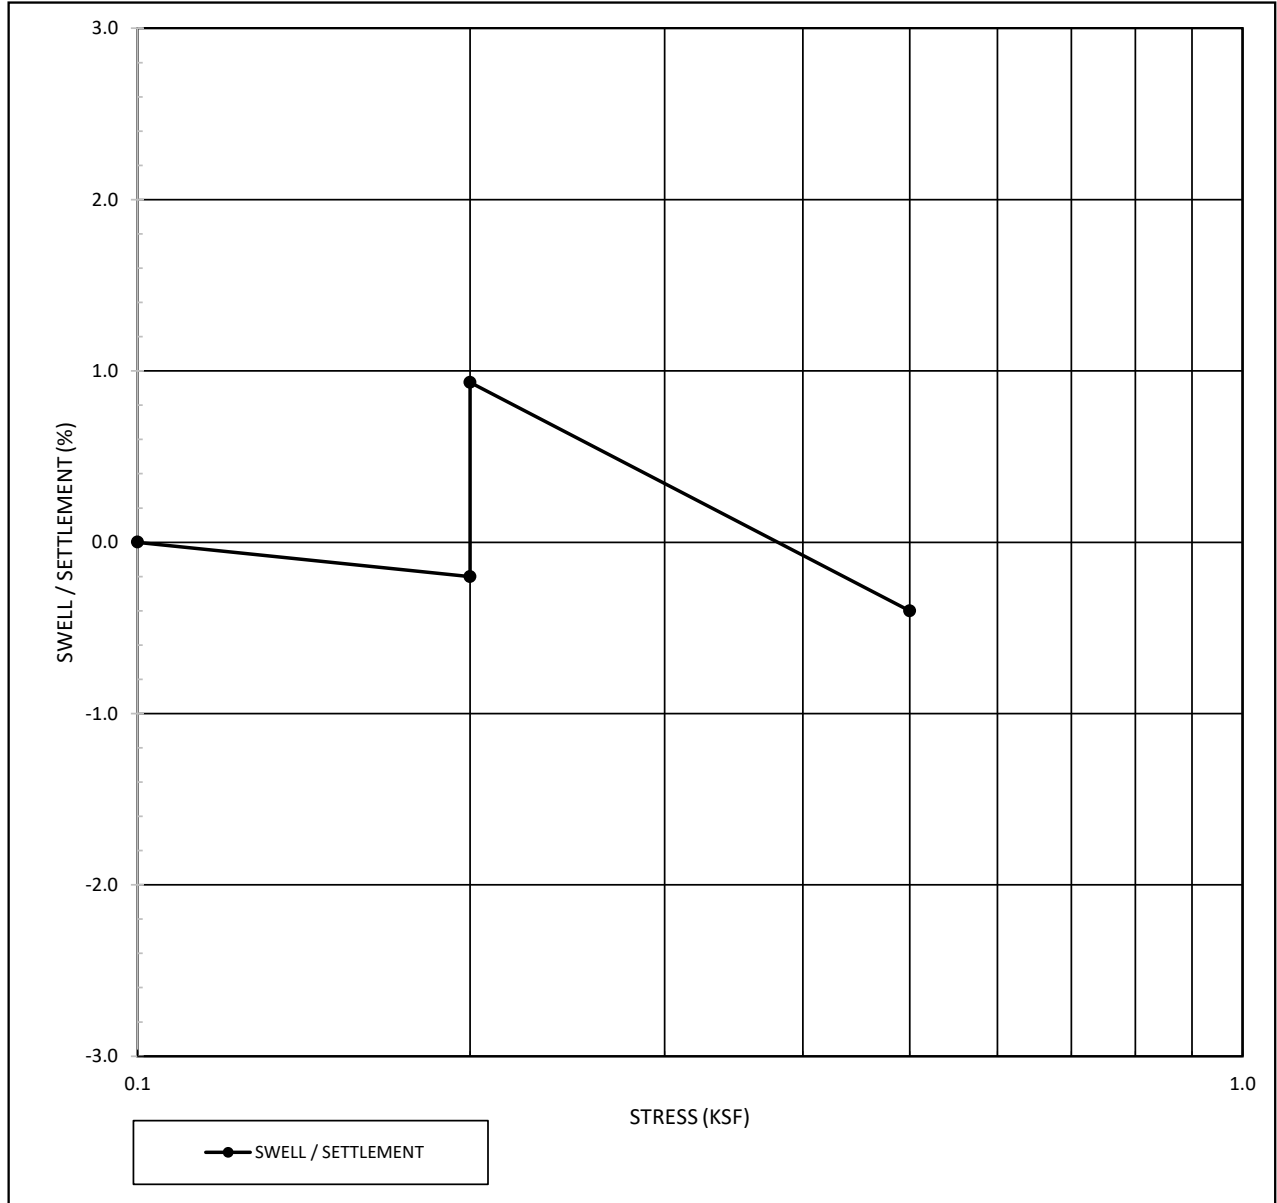
Project Name:	Mariah Trail Subdivision, Filing No. 1	Date	3/3/2023
Project No.:	D23-2-587		
Boring ID.:	B-2	Sample Depth (ft)	2
Sample Description:	Clayey SAND, light brown, slightly moist		
		Swell @ Wetting Weight:	1.1 %

<b>Initial Condition</b>	
Moisture Content %	4.6
Dry Density (pcf)	108.7
<b>Post-Swell Condition</b>	
Moisture Content %	18.1

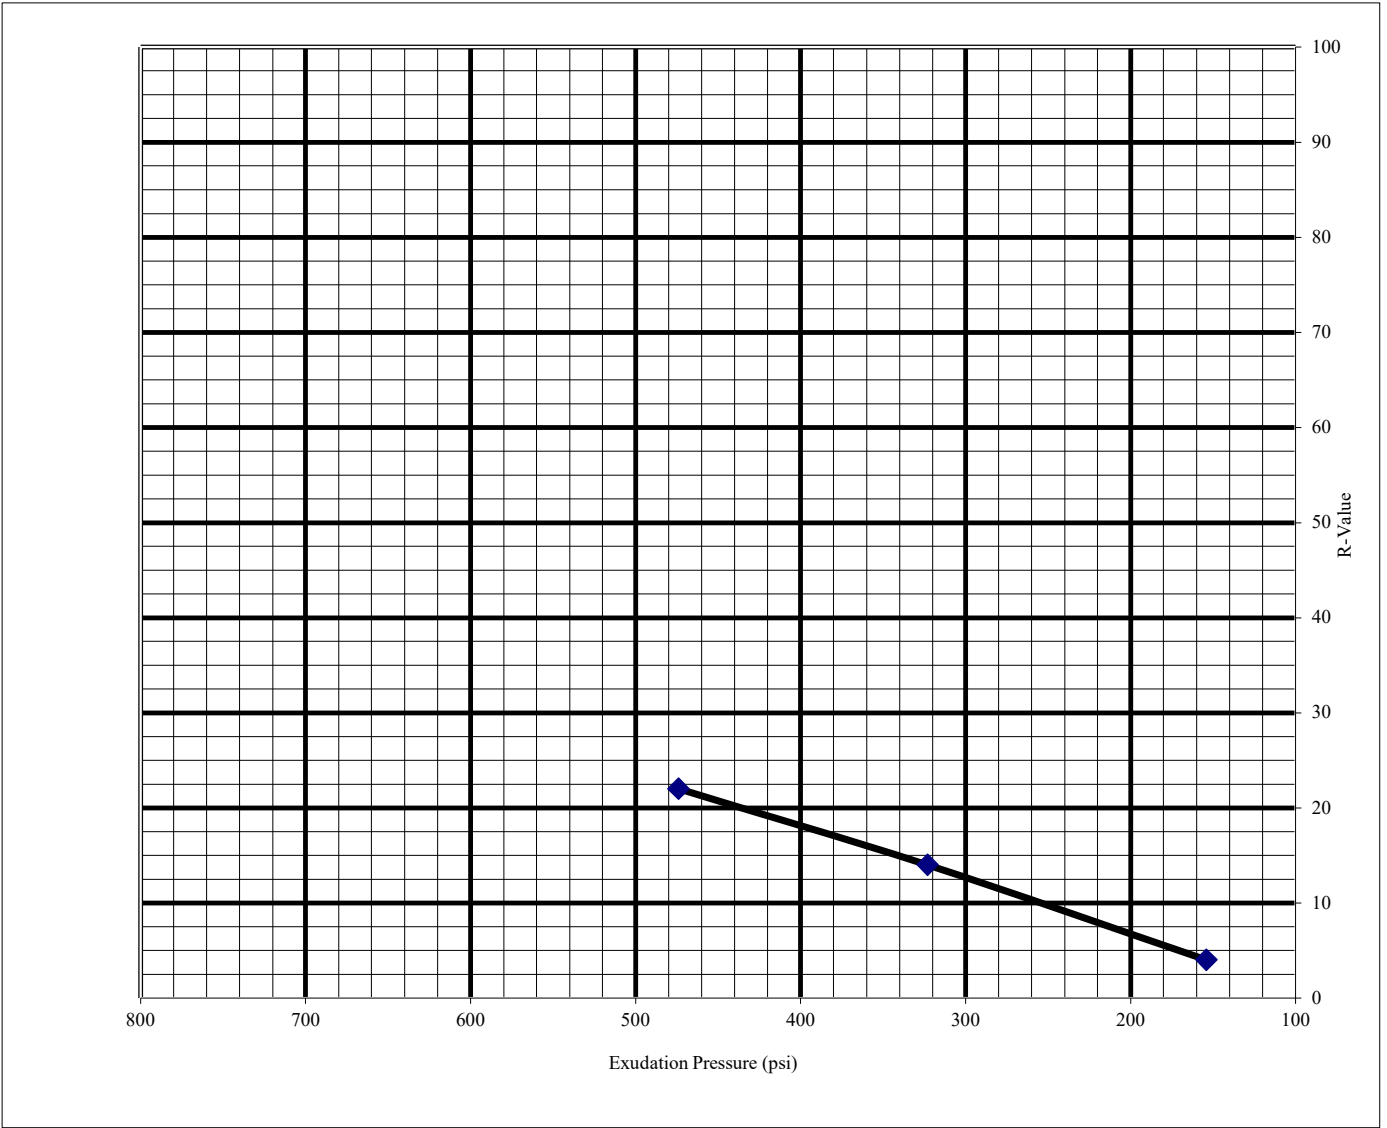
Project Name: Mariah Trail Subdivision, Filing No. 1  
Depth (ft): 0-4'  
Classification: N/A  
Date Tested: 3/9/2023

R-Value at 300 psi exudation pressure = 12

Test No.	Compact. Press. (psi)	Density (pcf)	Moist. (%)	Horizont. Pressure (psi)' @ 160 psi	Sample Height (in).	Exud. Pressure (psi)	R Value	R Value Correct.
1	180	123.0	8.9	110	2.49	474	22	22
2	160	117.0	10.5	129	2.63	323	12	14
3	120	111.8	12.9	148	2.62	154	4	4
