Geology and Soils Evaluation Report

Proposed Mariah Trail Subdivision, Filing No. 1

El Paso County, Colorado

VIVID Project No.: D23-2-587

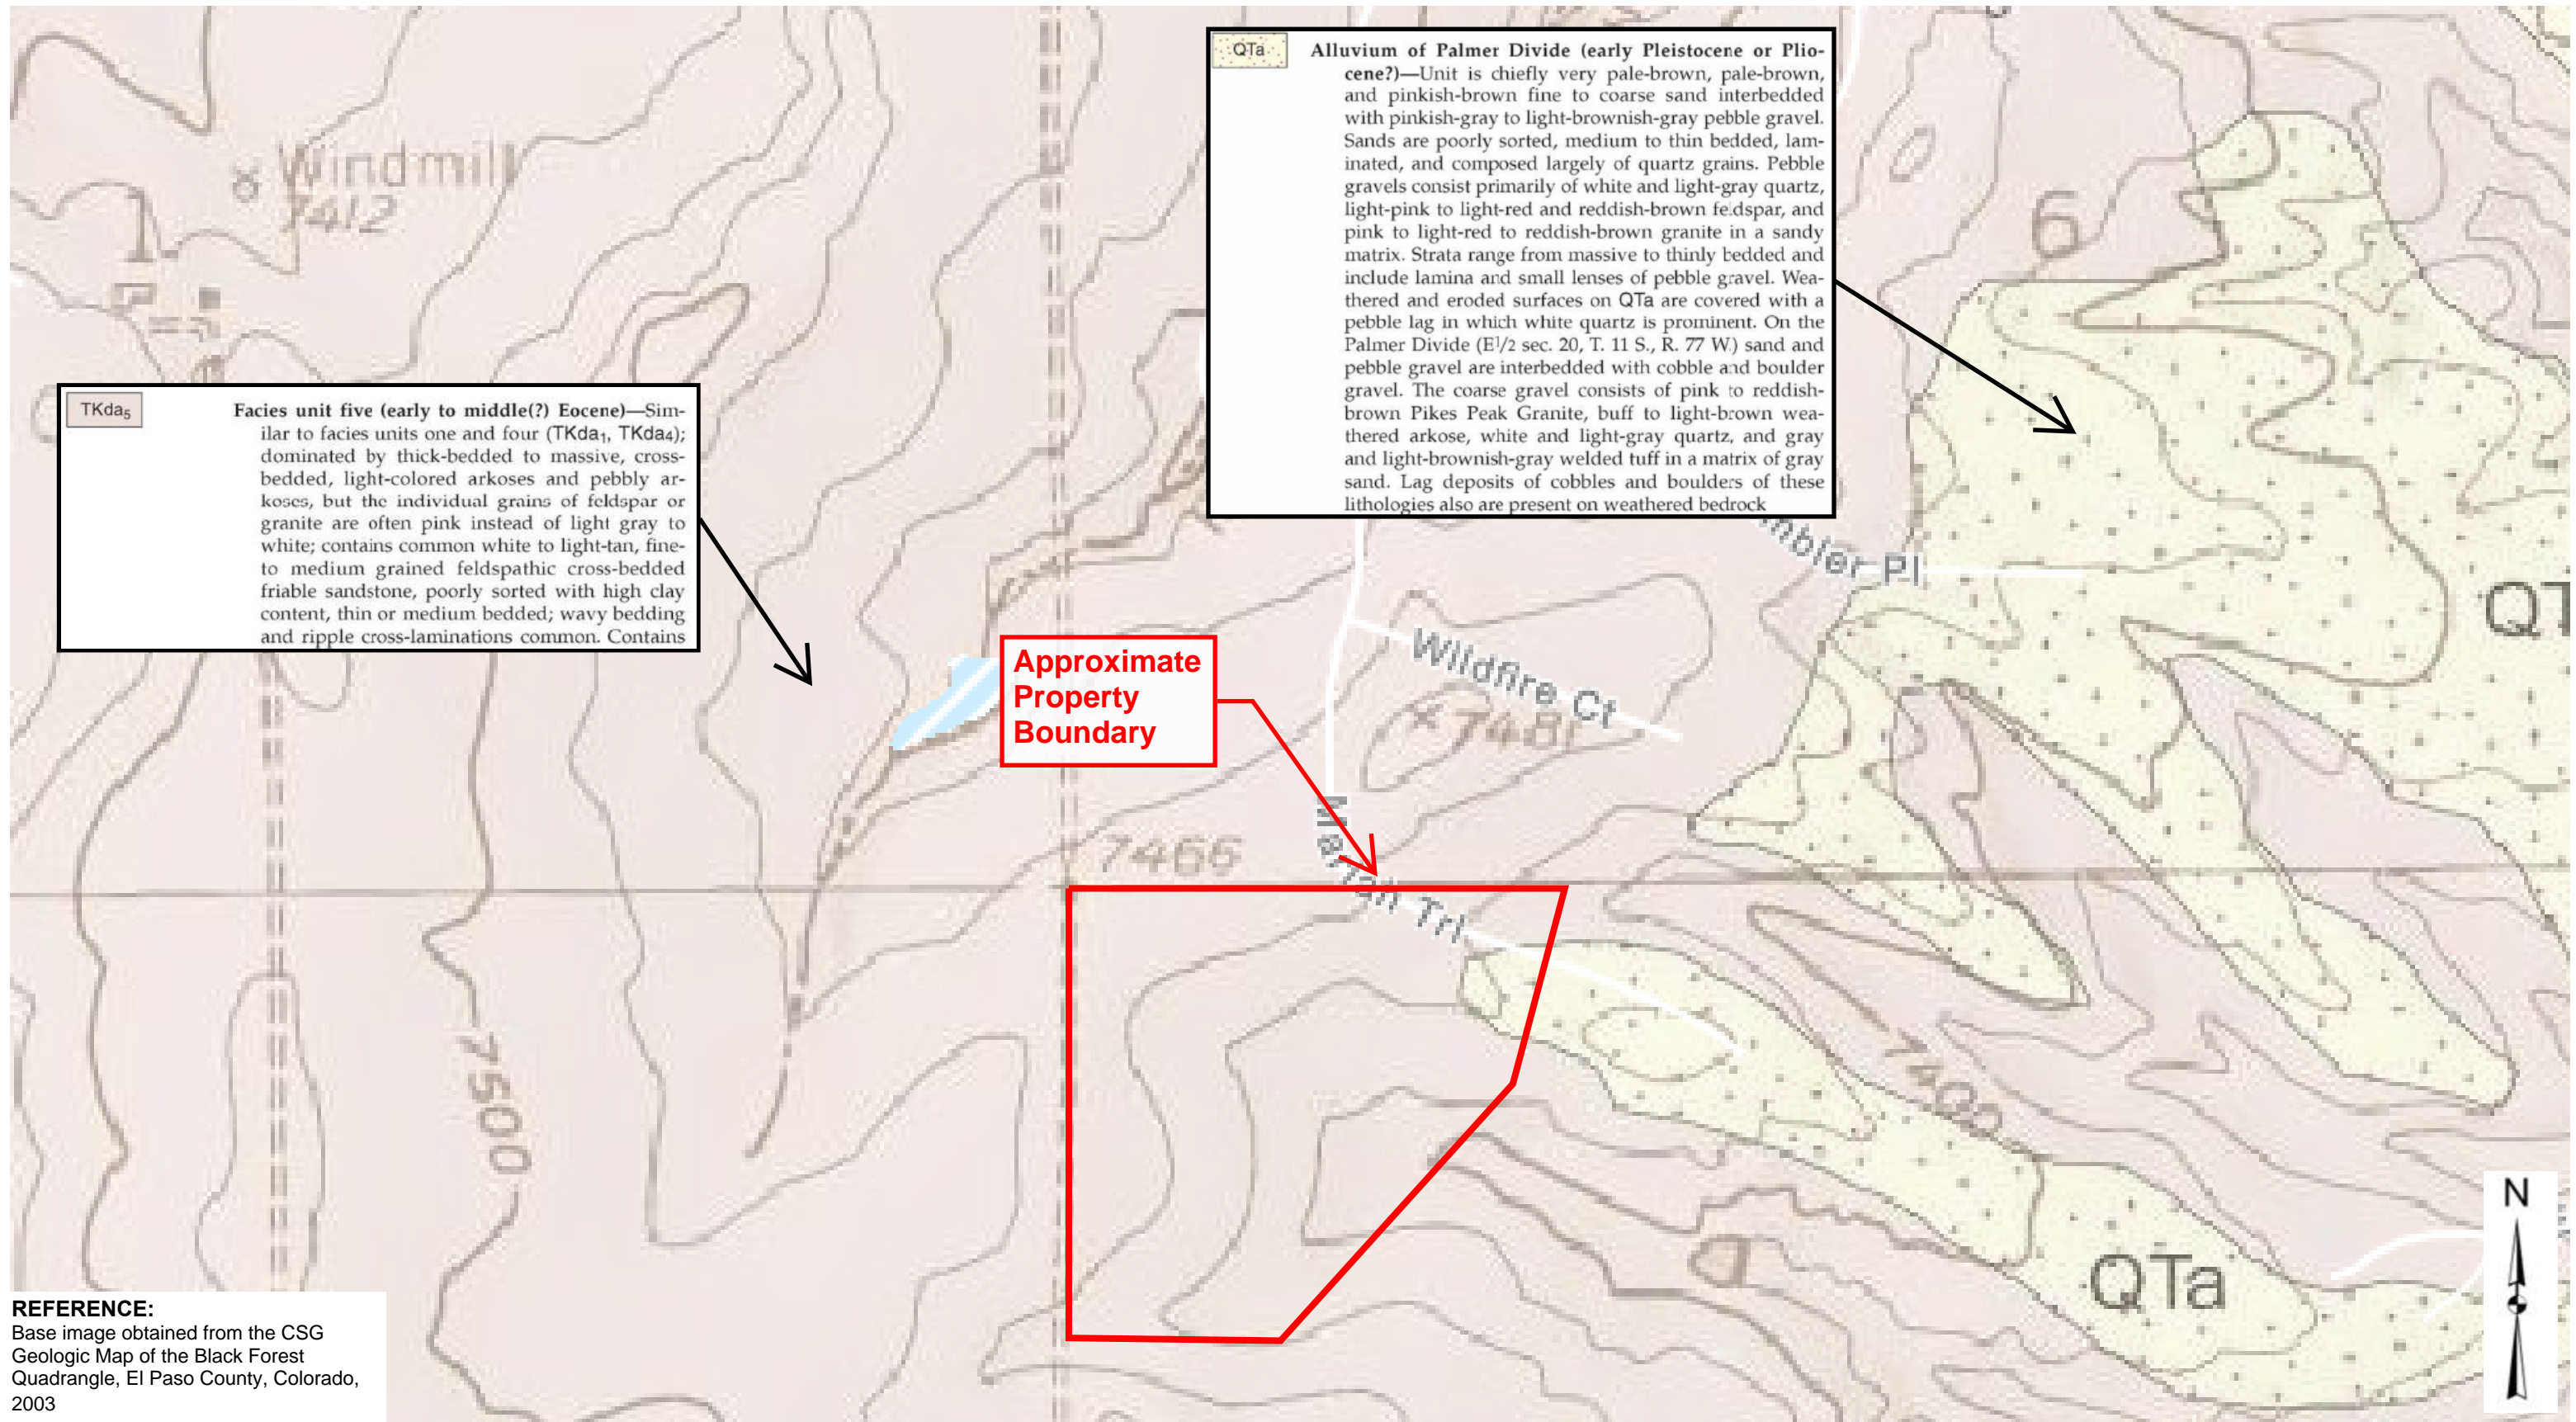
Not to Scale. Base image dated 10/6/2019 and obtained from Google Earth, 2023.

The proposed project includes the re-platting and development of a 35-acre parcel into a residential subdivision. Six lots are planned that will vary from approximately 5 to 7 acres in size. The property has no current improvements and is in a generally native condition. The development will include the extension of Mariah Trail (approximately 1000 feet) into the subdivision. A preliminary site layout is shown on Figure 2, attached to this report.

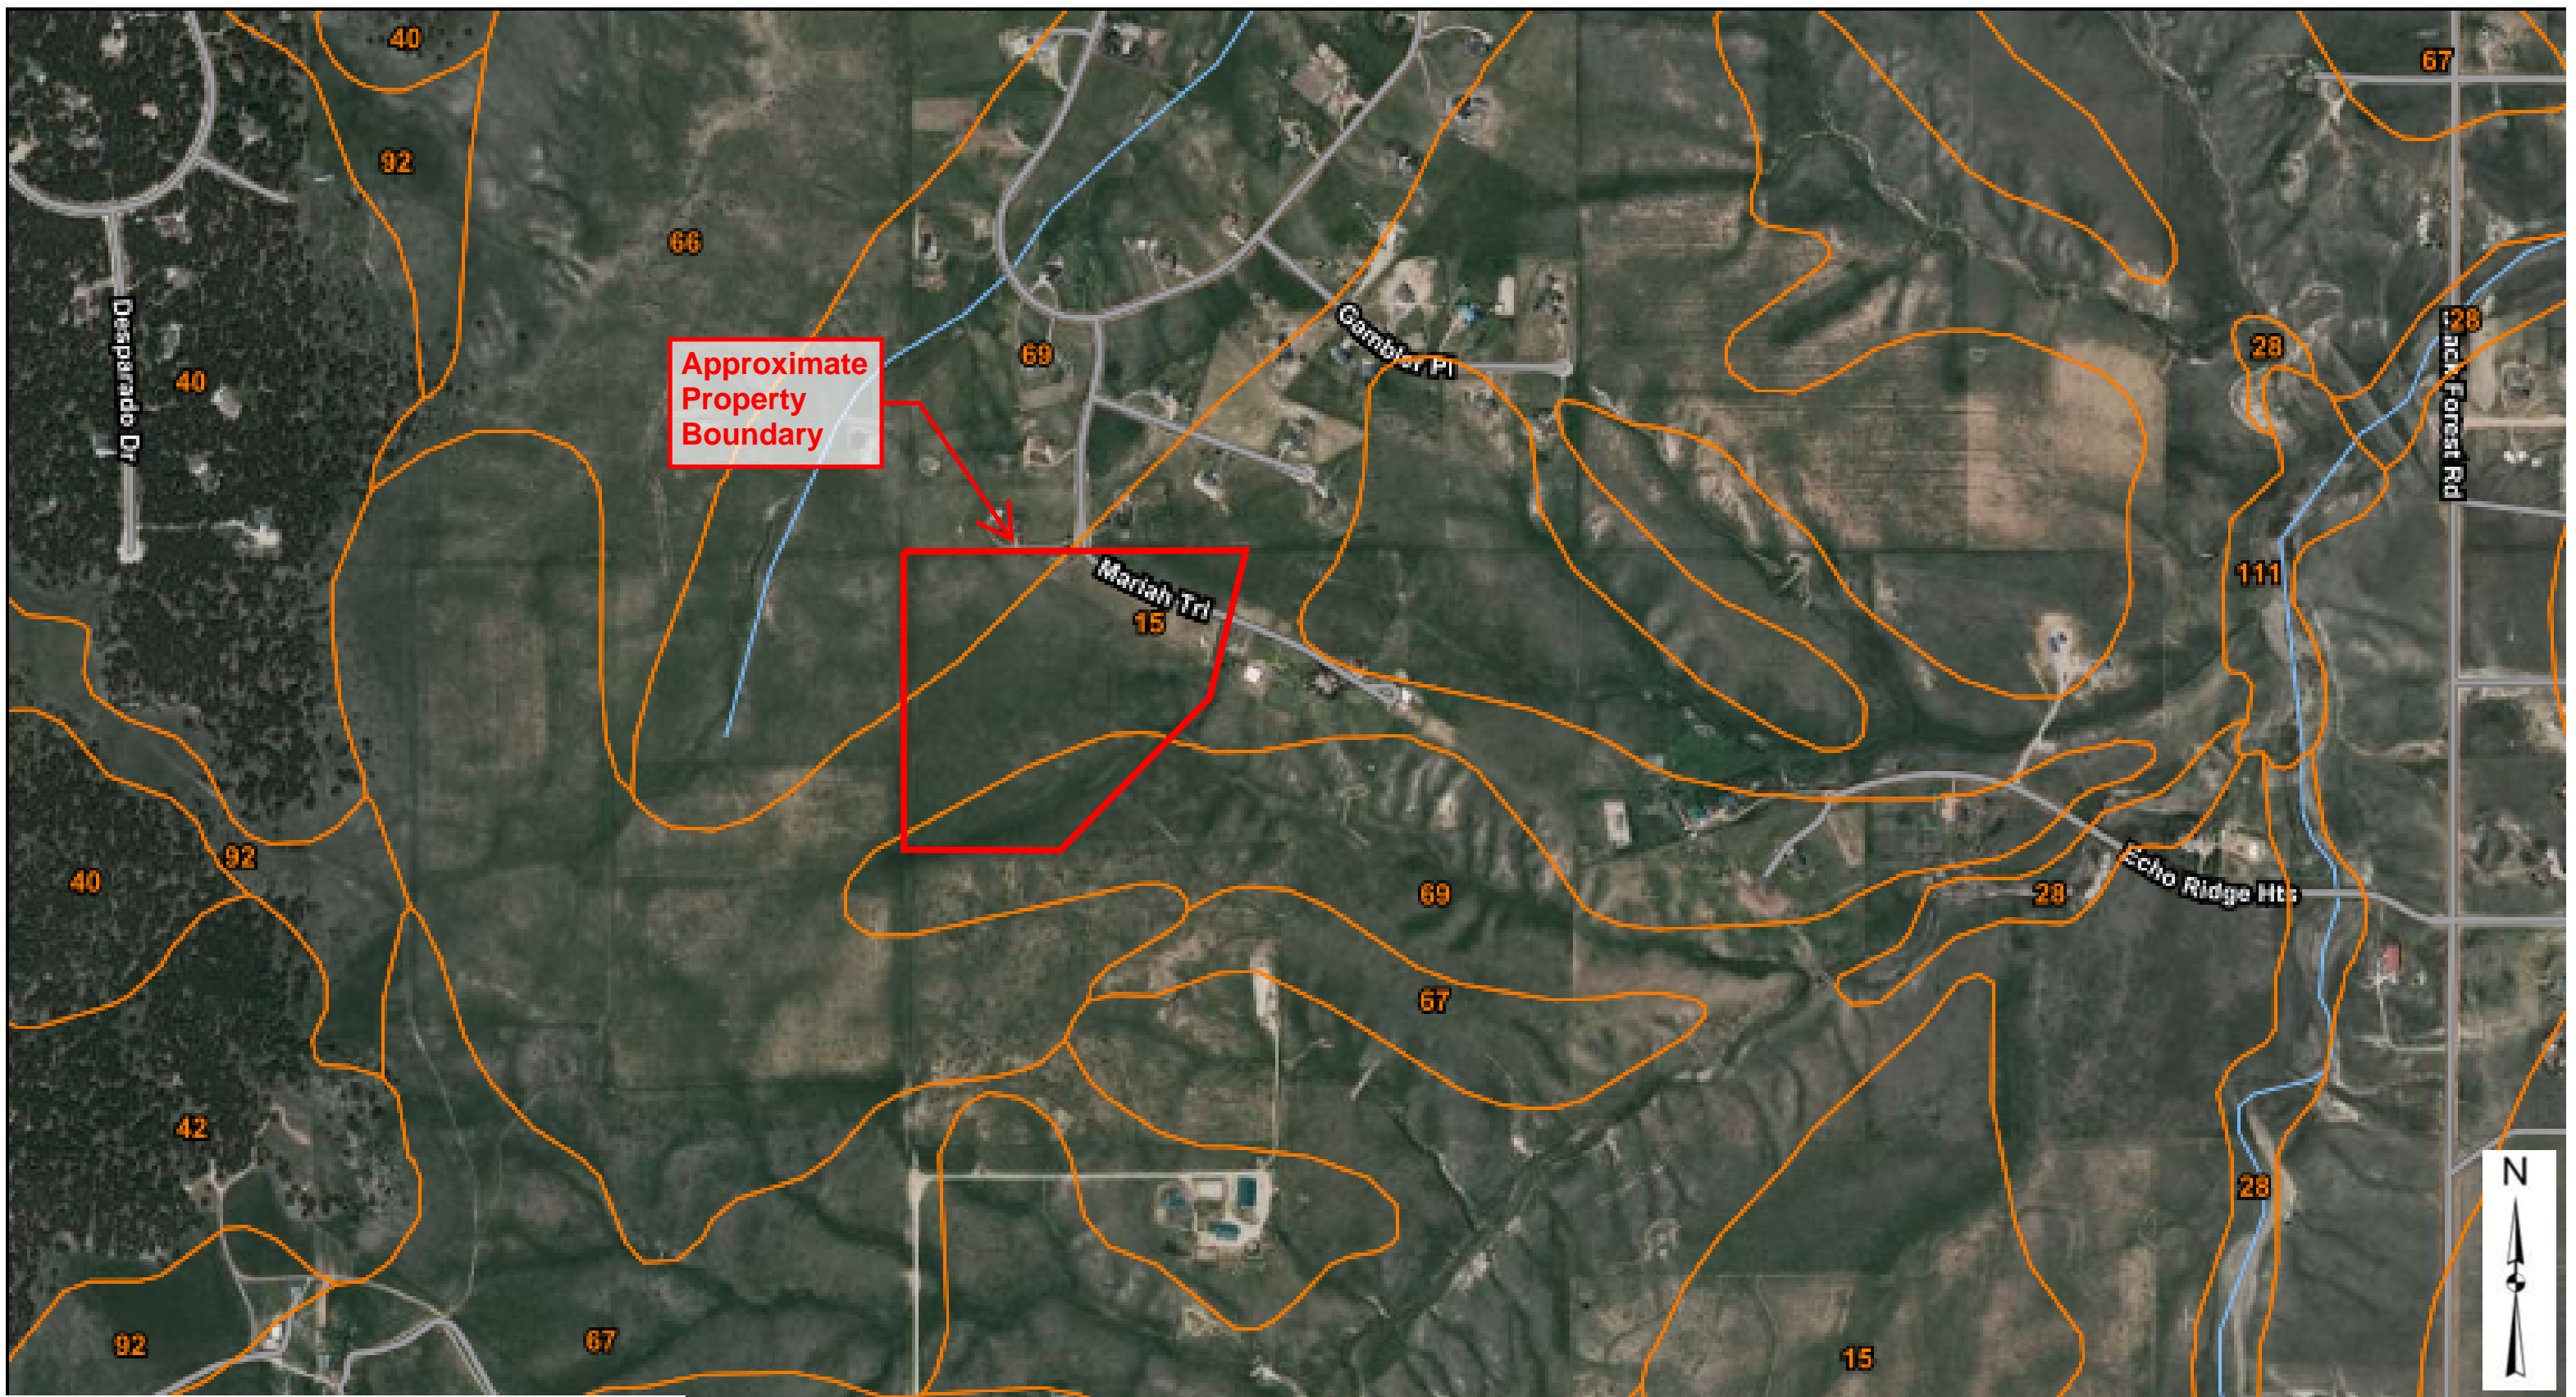
Not to Scale. Base image from <https://websoilsurvey.sc.egov.usda.gov/App/WebSoilSurvey.aspx>

Portions of geologic mapping are presented as Figure 3a-Regional Geology Map and Figure 3b-Site Specific Geology Map, attached to this report. An NRCS Soil Survey Map and associated Soil Descriptions are presented as Figures 4a, 4b, 4c, and 4d. A USGS Topographic Map is attached as Figure 5.

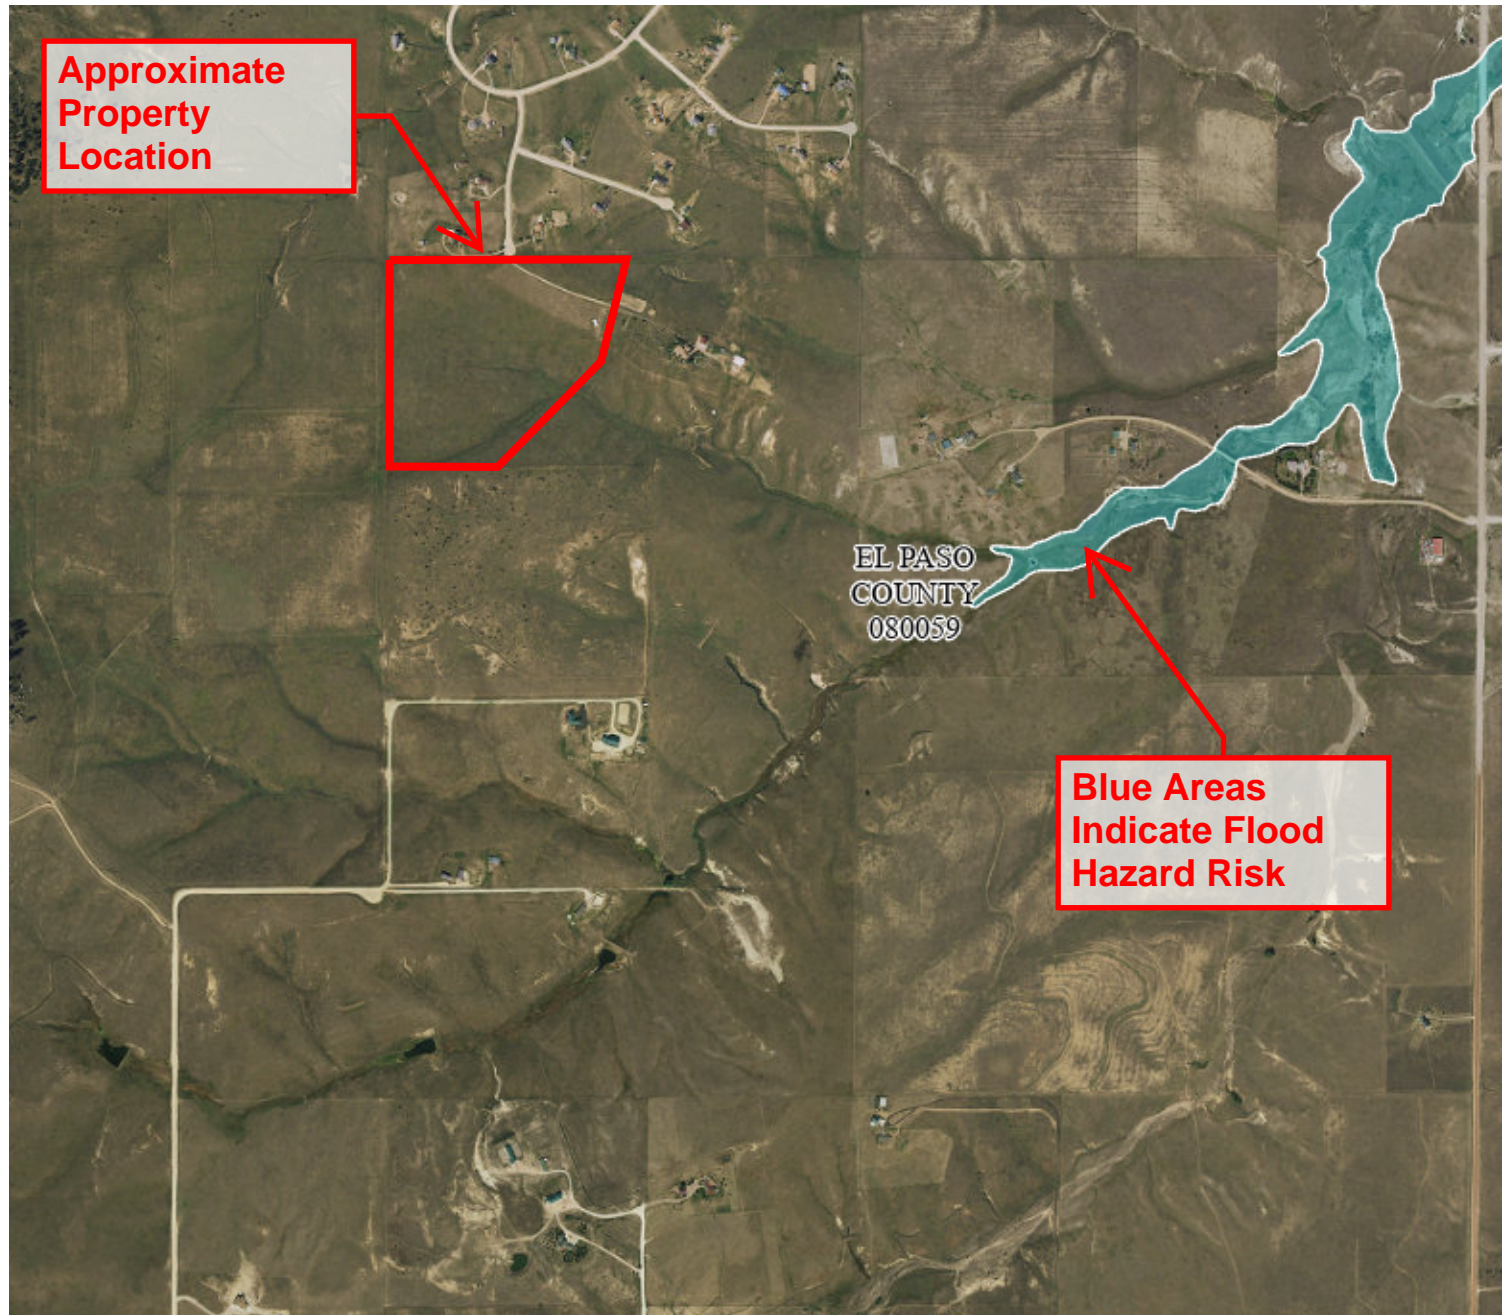
**Approximate
Property
Location**

**Blue Areas
Indicate Flood
Hazard Risk**

As shown on Figure 6, the project site is outside of mapped flood plain areas. Based on the mapping and our site observations flooding is not considered to be a hazard for this development.
