# Geology and Soils Evaluation Report

**Proposed Mariah Trail Subdivision, Filing No. 1**

**El Paso County, Colorado**

**VIVID Project No.: D23-2-587**

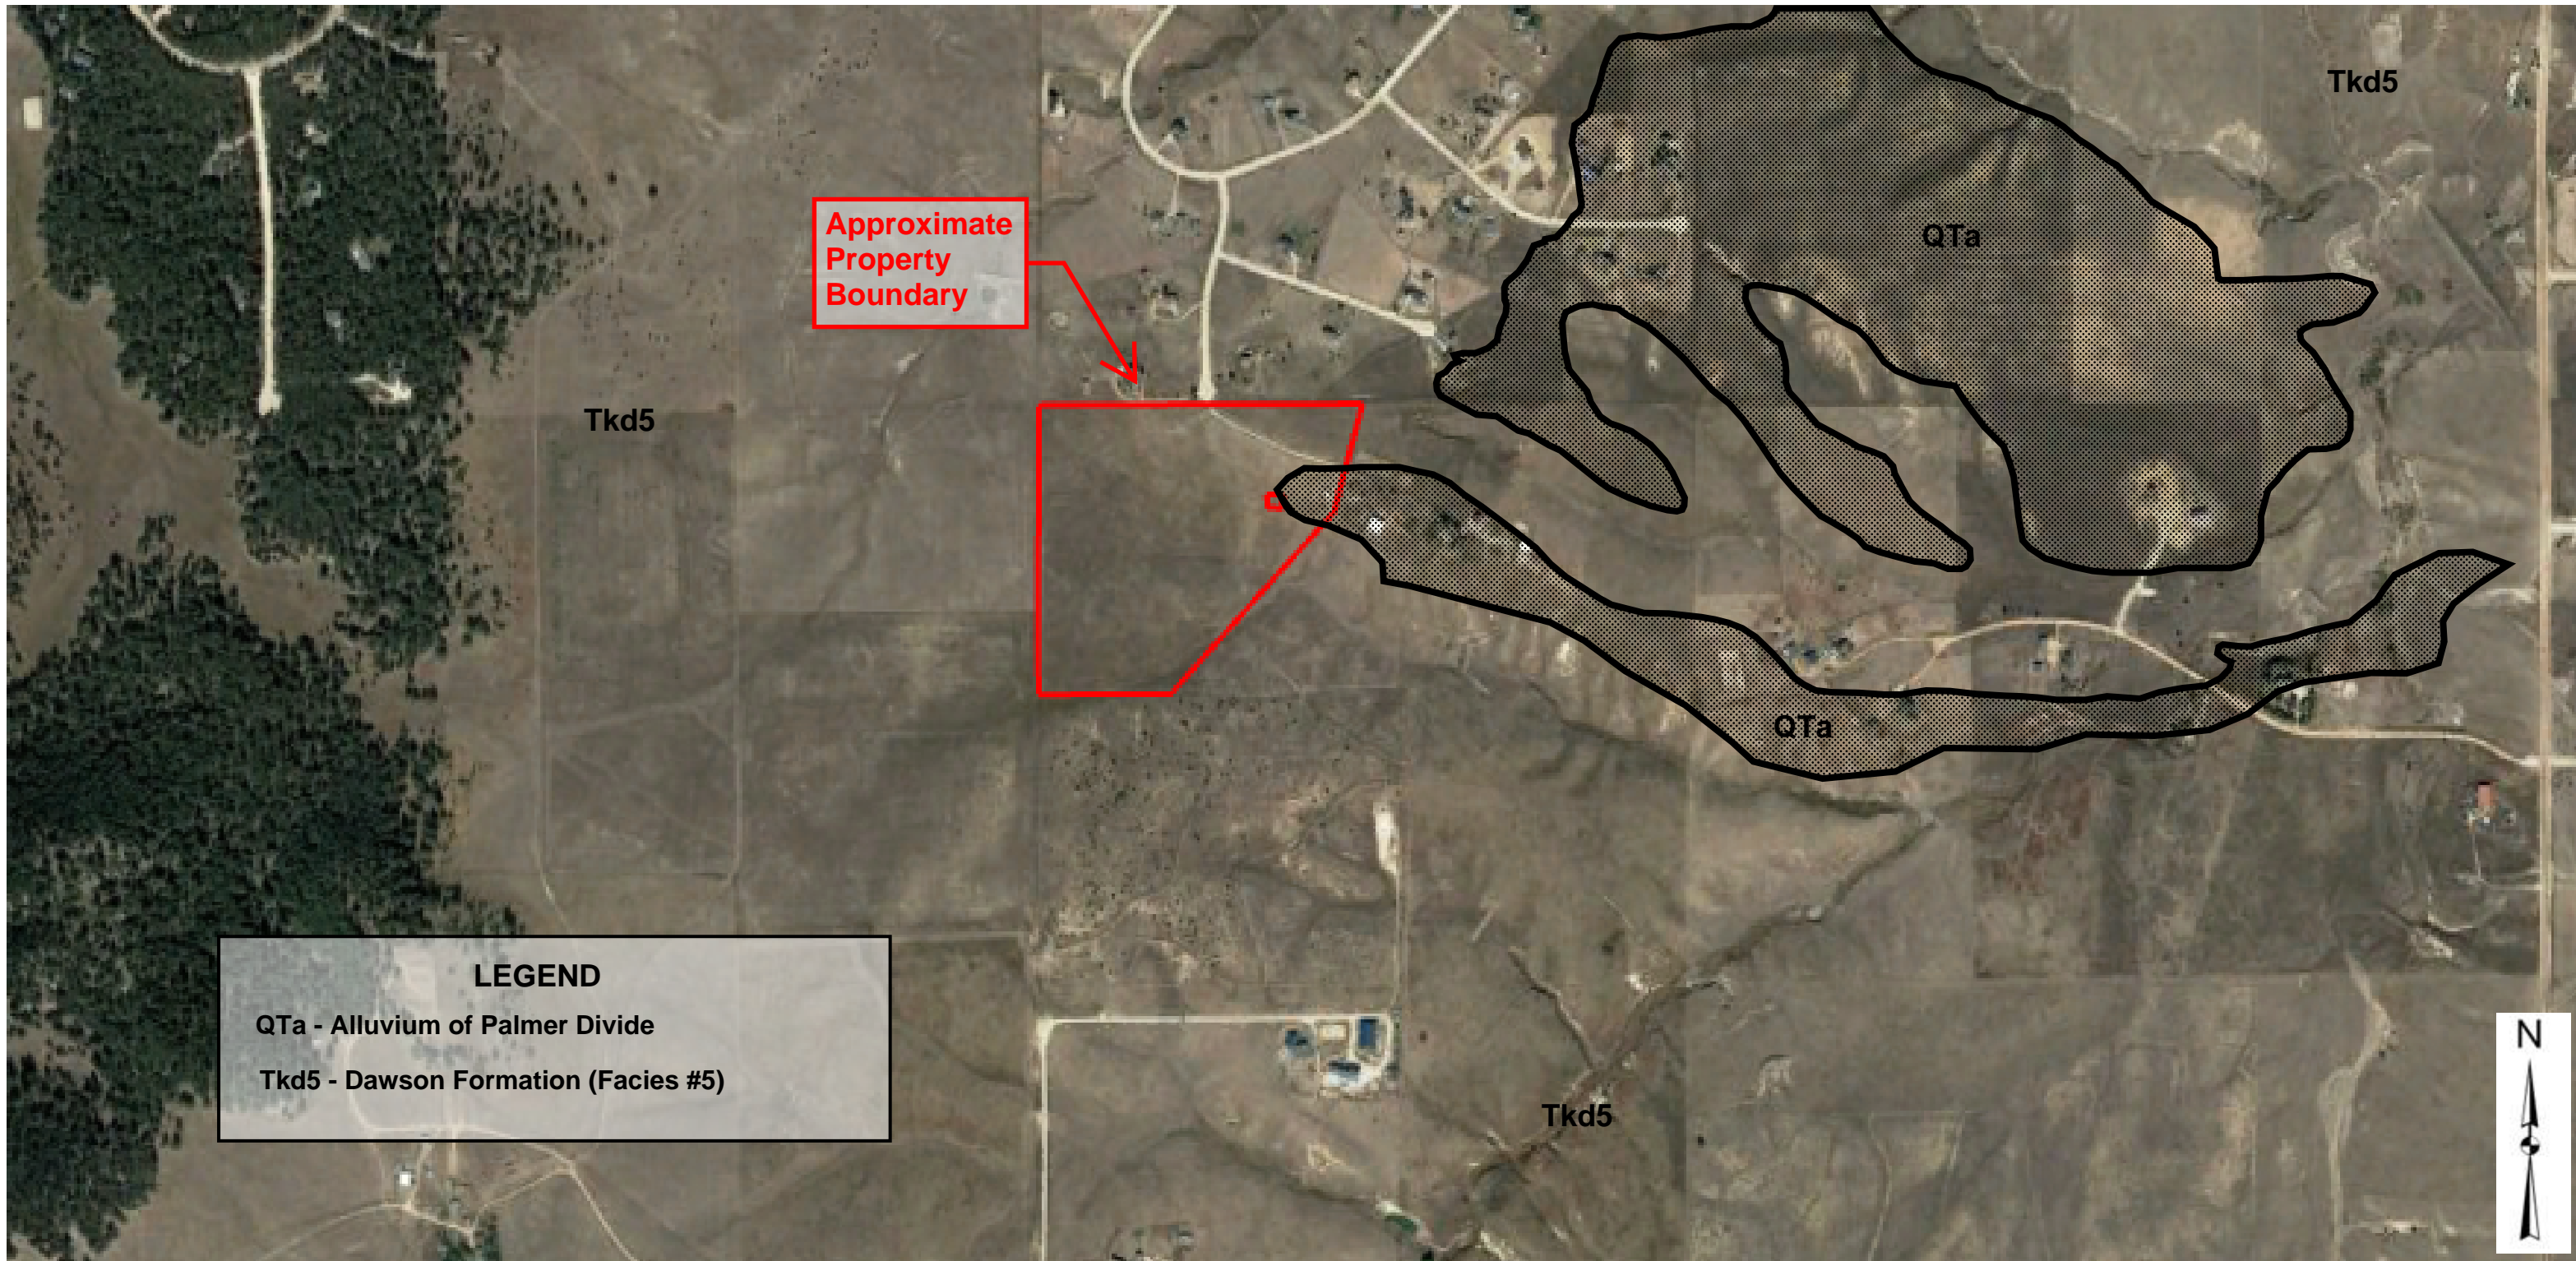
Figure  
**3b**

Not to Scale. Base image dated 10/6/2019 and obtained from Google Earth, 2023.
