SOILS REPORT

PALACE HOMES

JOB #17-0765

Site #237,
Crystal Park Subdivision,
5320 Lost Cabin Road,
El Paso County,
Colorado

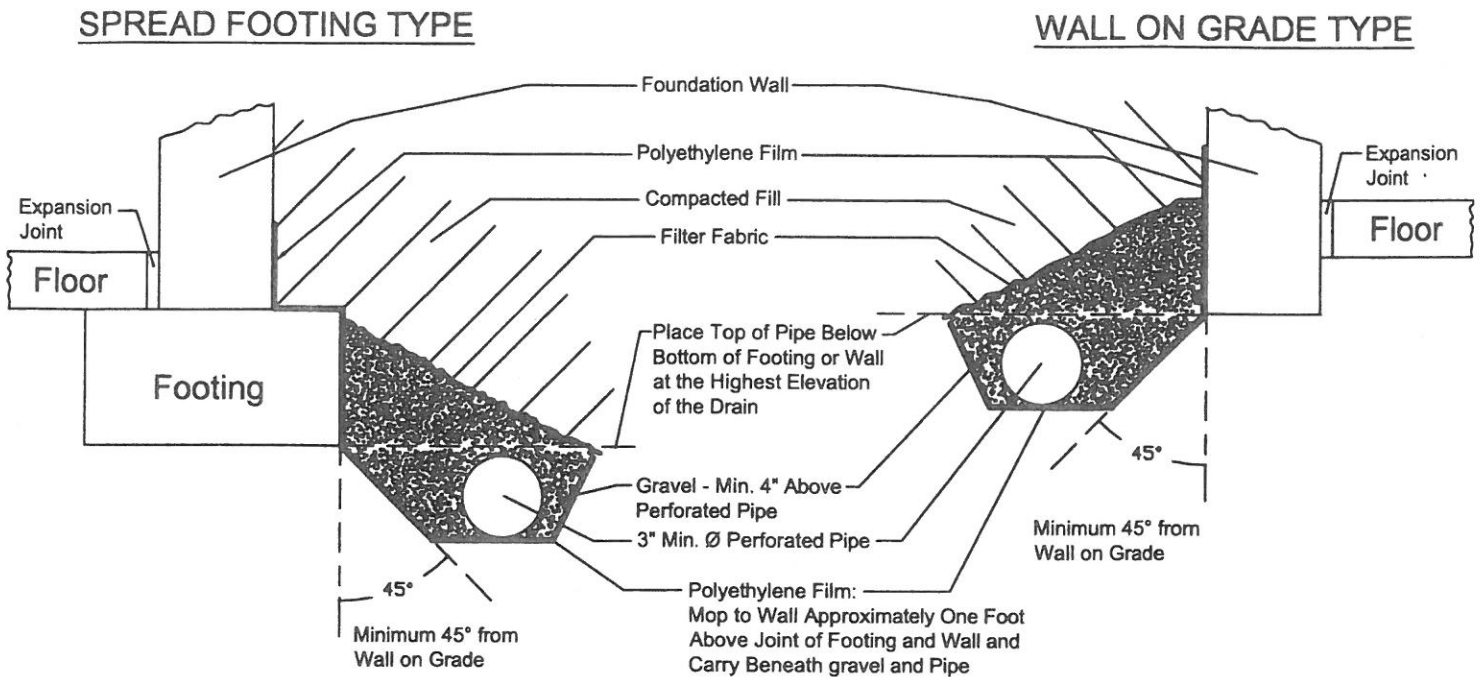
EXTERIOR DRAIN DETAIL

1. Gravel to be Not More Than 1-1/2" and Not Less Than 1/2" Diameter.
2. Perforated Pipe Diameter Varies With Expected Seepage. 3" \varnothing and 4" \varnothing are Most Common. ABS and PVC are Most Common Materials for Pipe.

3. Pipe to be Laid out in a Minimum Slope of 1" in 10'.
4. Gravity Outfall is Desired if Possible. Portion of Pipe in Area Not Drained Shall be Non-Perforated. Daylight Must be Maintained Clear of Debris in Order to Function Properly.
