**ENTECH**  
ENGINEERING, INC.

SOIL, GEOLOGY, GEOLOGIC HAZARD,  
AND WASTEWATER STUDY  
PRAIRIE RIDGE  
EL PASO COUNTY, COLORADO

May 31, 2007

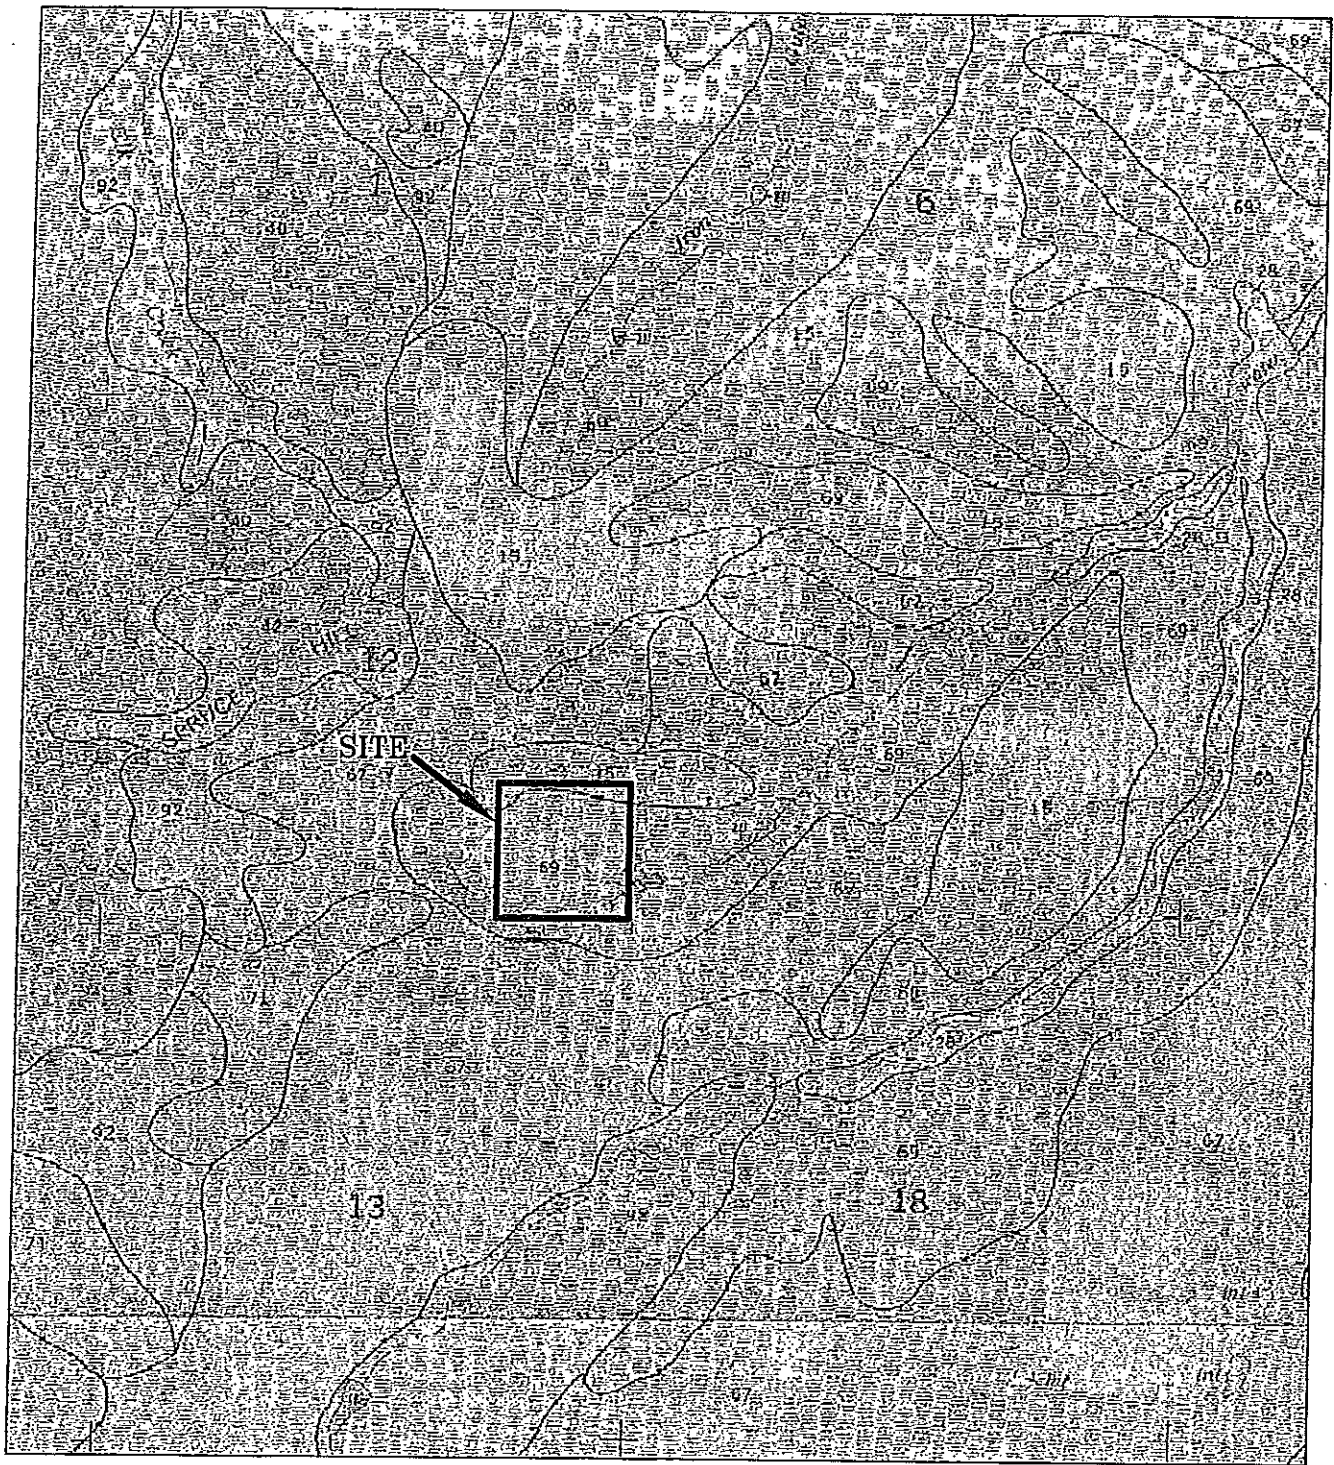
SCS Map  
Prairie Ridge  
El Paso County, CO.  
For: Prairie Ridge Properties

Permeability of this Brussett soil is moderate. Effective rooting depth is 60 inches or more. Available water capacity is high. Surface runoff is medium to rapid. The hazard of erosion is moderate, especially when snow melts in spring while the ground is frozen. Some gullies are present.

The main limitations for urban development are moderate shrink-swell potential and frost action potential. Dwellings and roads can be designed to overcome these limitations. Capability subclass IVe.

69—Peyton-Pring complex, 8 to 15 percent slopes. These gently to moderately sloping soils are on valley side slopes and on uplands. Elevation ranges from 6,800 to 7,600 feet. The average annual precipitation is about 17 inches, the average annual air temperature is about 48 degrees F, and the average frost-free period is about 120 days.

Permeability of the Peyton soil is moderate. Effective rooting depth is 60 inches or more. Available water capacity is high. Surface runoff is medium to rapid, and the hazard of erosion is moderate to high. Some gullies have developed along drainageways and livestock trails.

Permeability of the Pring soil is rapid. Effective rooting depth is 60 inches or more. Available water capacity is moderate. Surface runoff is medium to rapid, and the hazard of erosion is moderate to high. Some gullies have developed along drainageways and livestock trails.

These soils have good potential for use as homesites. The main limitations are steepness of slope, limited ability to support a load, and frost-action potential. Buildings and roads can be designed to overcome these limitations. These soils also require special site or building designs because of the slope. Access roads should have adequate cut-slope grade, and drains should be provided to control surface runoff and keep soil losses to a minimum. Capability subclass VIe.
