**SOIL, GEOLOGY, GEOLOGIC HAZARD,
AND WASTEWATER STUDY
PRAIRIE RIDGE
EL PASO COUNTY, COLORADO**

Prairie Ridge Properties, LLC
c/o K & C Rushing, NV LLLP
P. O. Box 88270
Colorado Springs, Colorado 80908

May 31, 2007

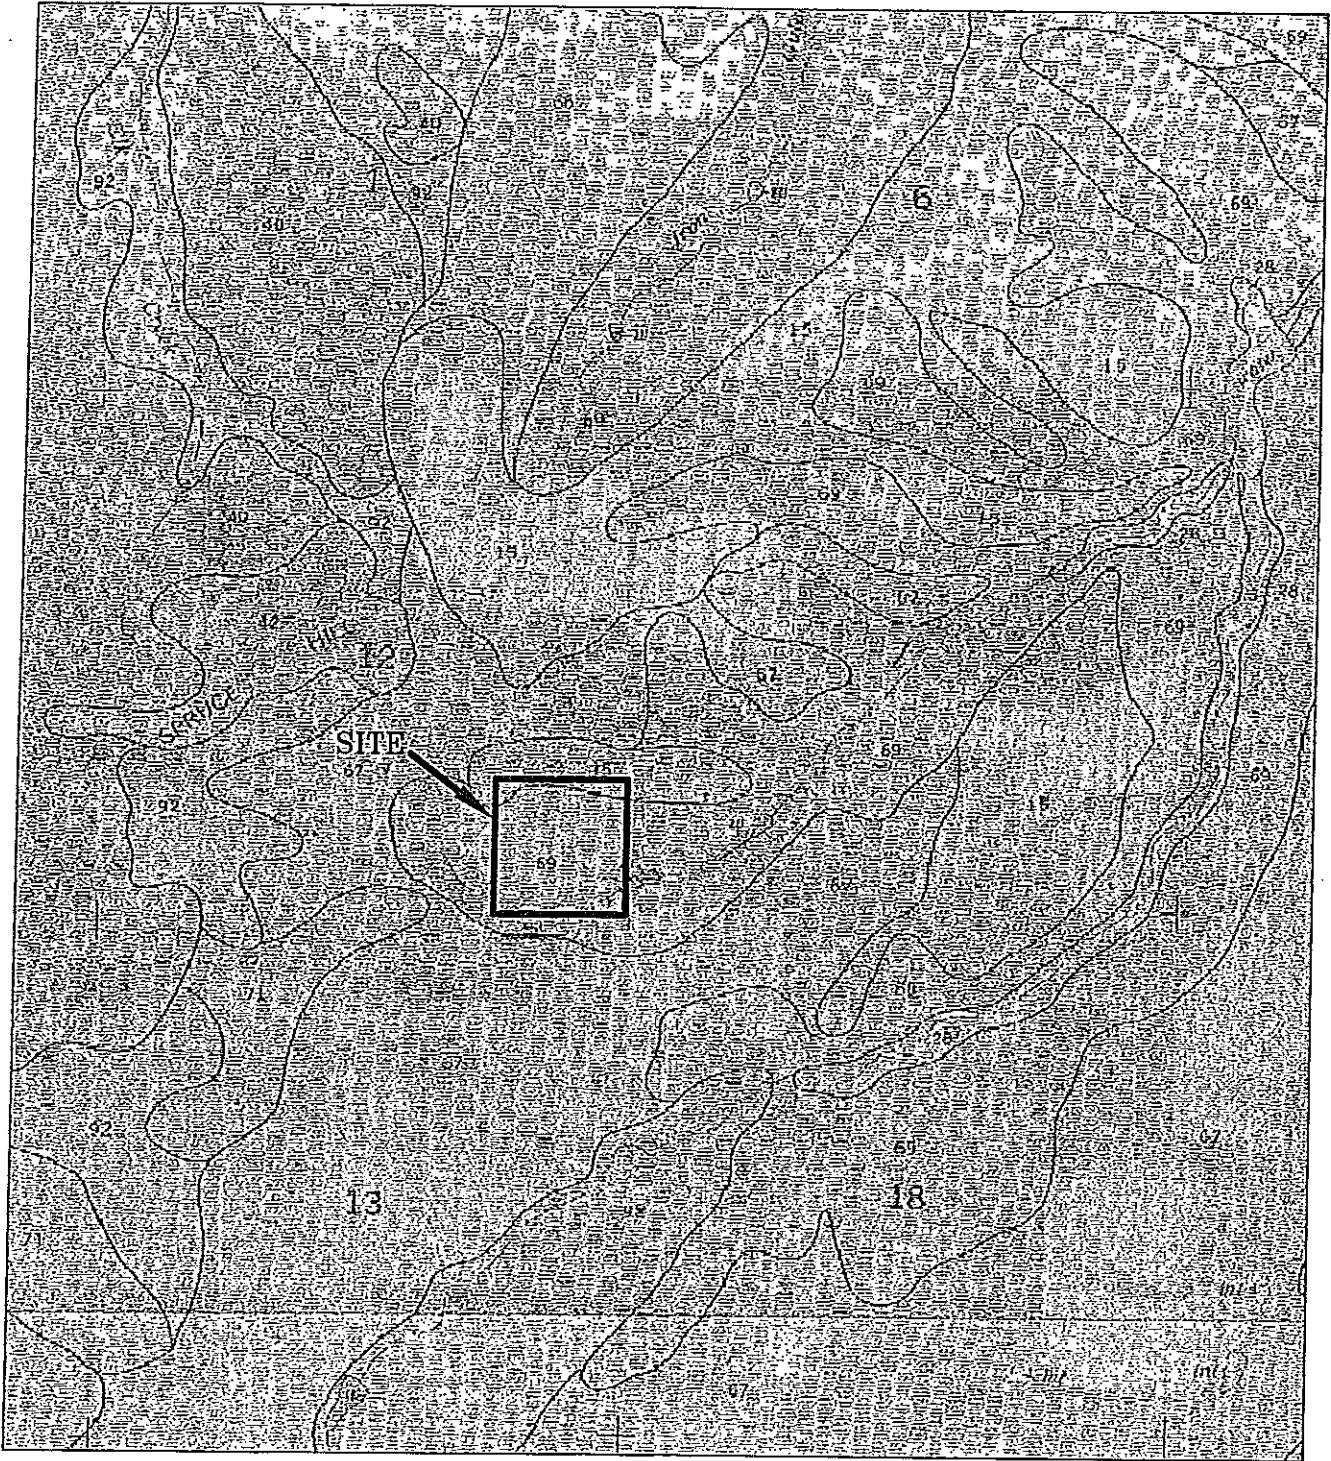
SCS Map
 Prairie Ridge
 El Paso County, CO.
 For: Prairie Ridge Properties

Permeability of this Brussett soil is moderate. Effective rooting depth is 60 inches or more. Available water capacity is high. Surface runoff is medium to rapid. The hazard of erosion is moderate, especially when snow melts in spring while the ground is frozen. Some gullies are present.

Permeability of the Peyton soil is moderate. Effective rooting depth is 60 inches or more. Available water capacity is high. Surface runoff is medium to rapid, and the hazard of erosion is moderate to high. Some gullies have developed along drainageways and livestock trails.

Permeability of the Pring soil is rapid. Effective rooting depth is 60 inches or more. Available water capacity is moderate. Surface runoff is medium to rapid, and the hazard of erosion is moderate to high. Some gullies have developed along drainageways and livestock trails.
