ENTECH
ENGINEERING, INC.

Re: OWTS – Wastewater Study
Prairie Ridge Subdivision
Brown Road
Parcel No. 61000-00-483
El Paso County, Colorado

Sonship Properties, LLC
OWTS – Wastewater Study
Prairie View Subdivision
Brown Road
Parcel No. 6100-00-483
El Paso County, Colorado

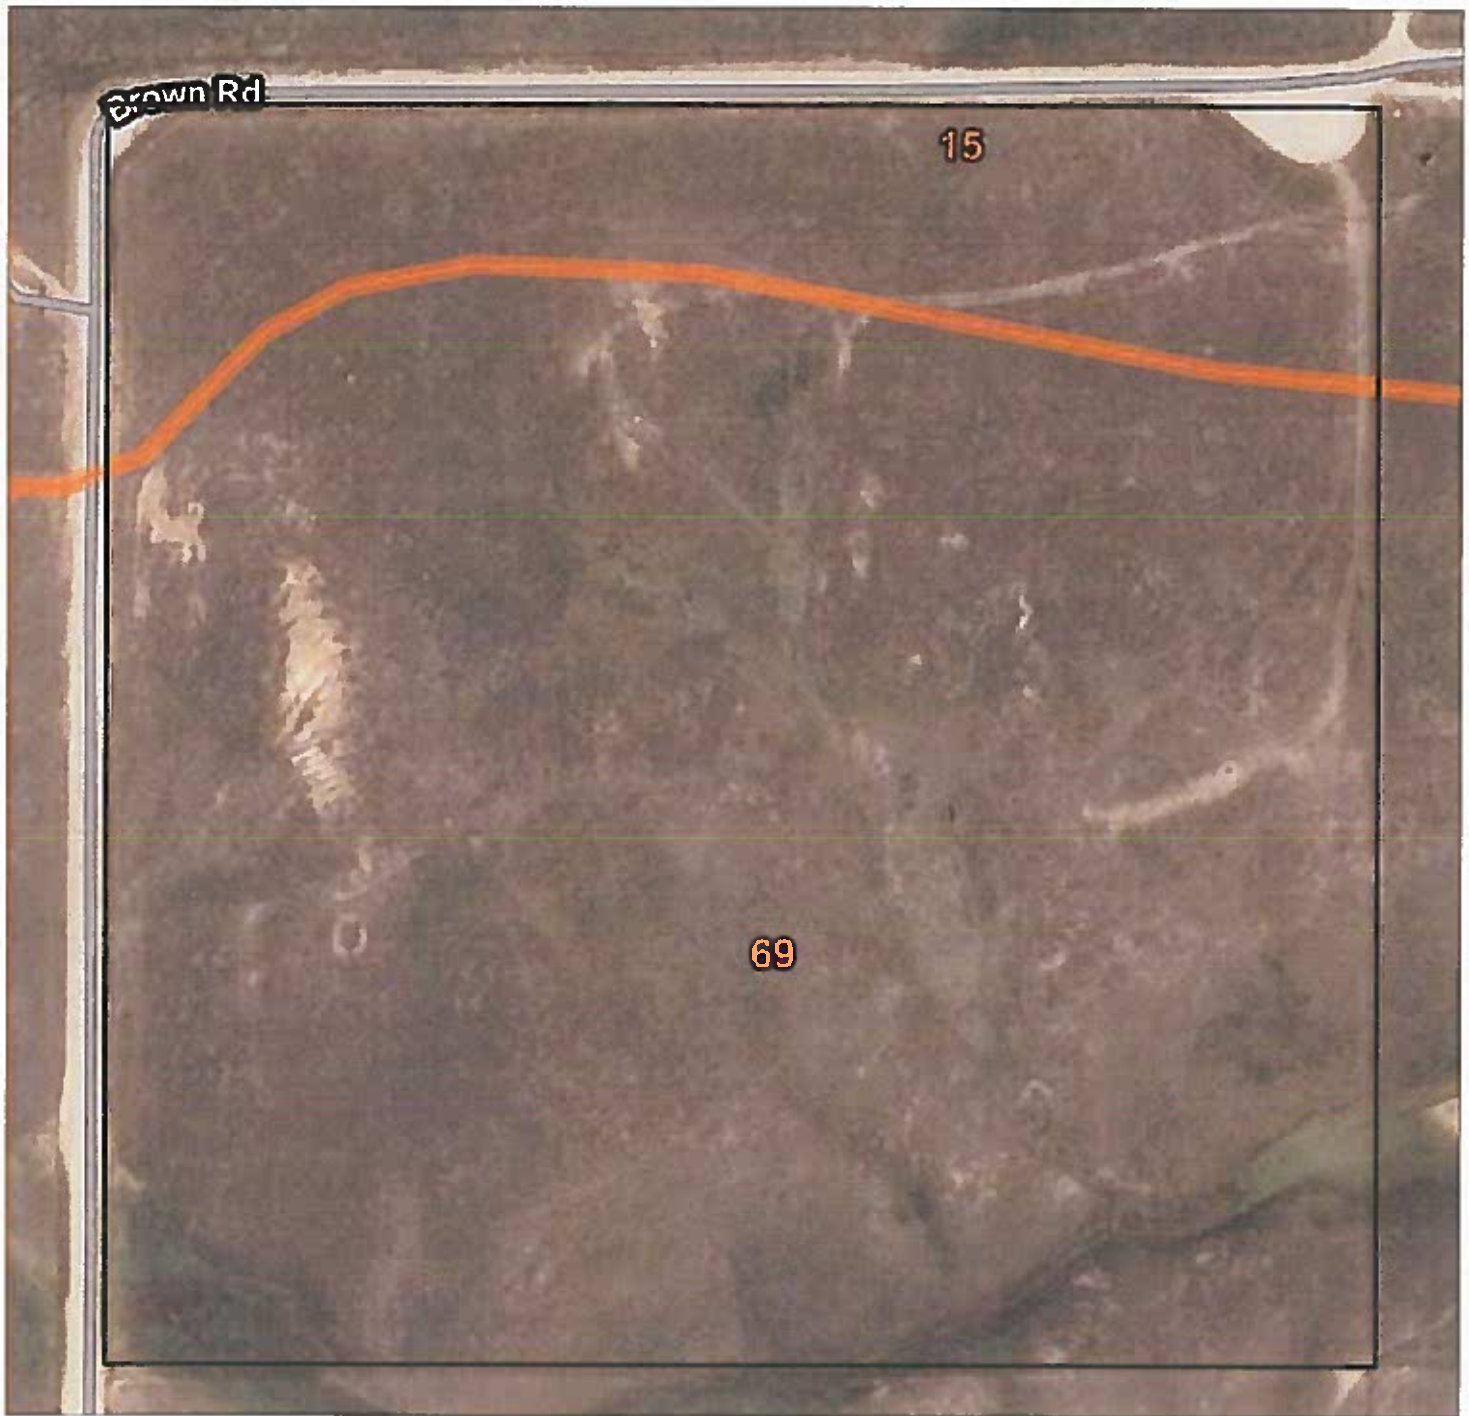
**FIG NO.:
 4**

**SOIL SURVEY MAP
 PRAIRIE RIDGE SUBDIVISION
 BROWN ROAD
 EL PASO COUNTY, CO.
 FOR: SONSHIP PROPERTIES, LLC**

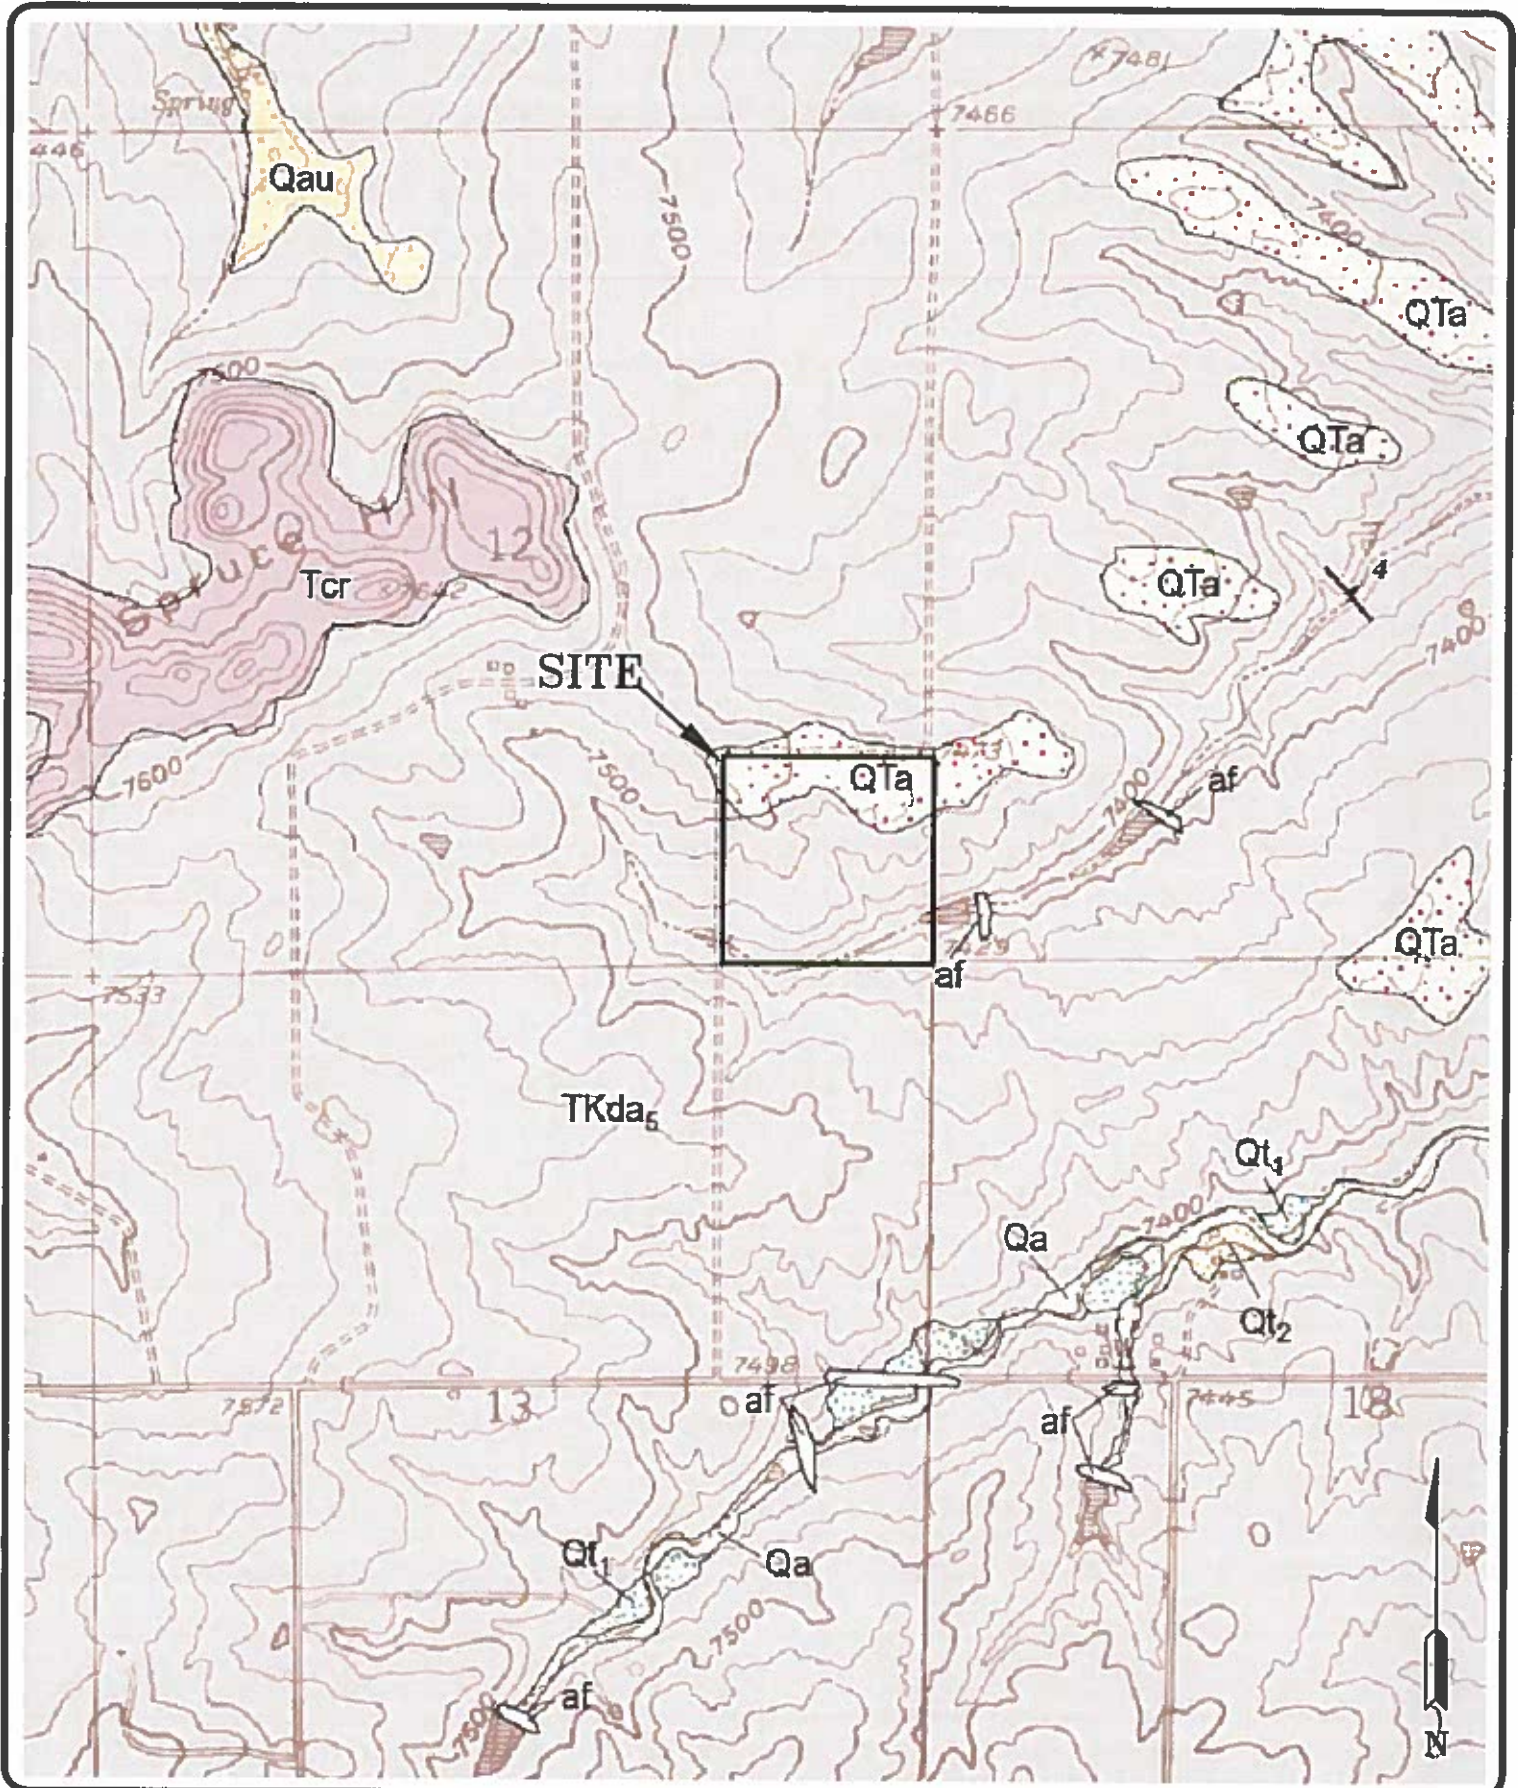
FIG NO.:
5

BLACK FOREST QUADRANGLE GEOLOGIC MAP
PRAIRIE RIDGE SUBDIVISION
BROWN ROAD
EL PASO COUNTY, CO.
FOR: SONSHIP PROPERTIES, LLC

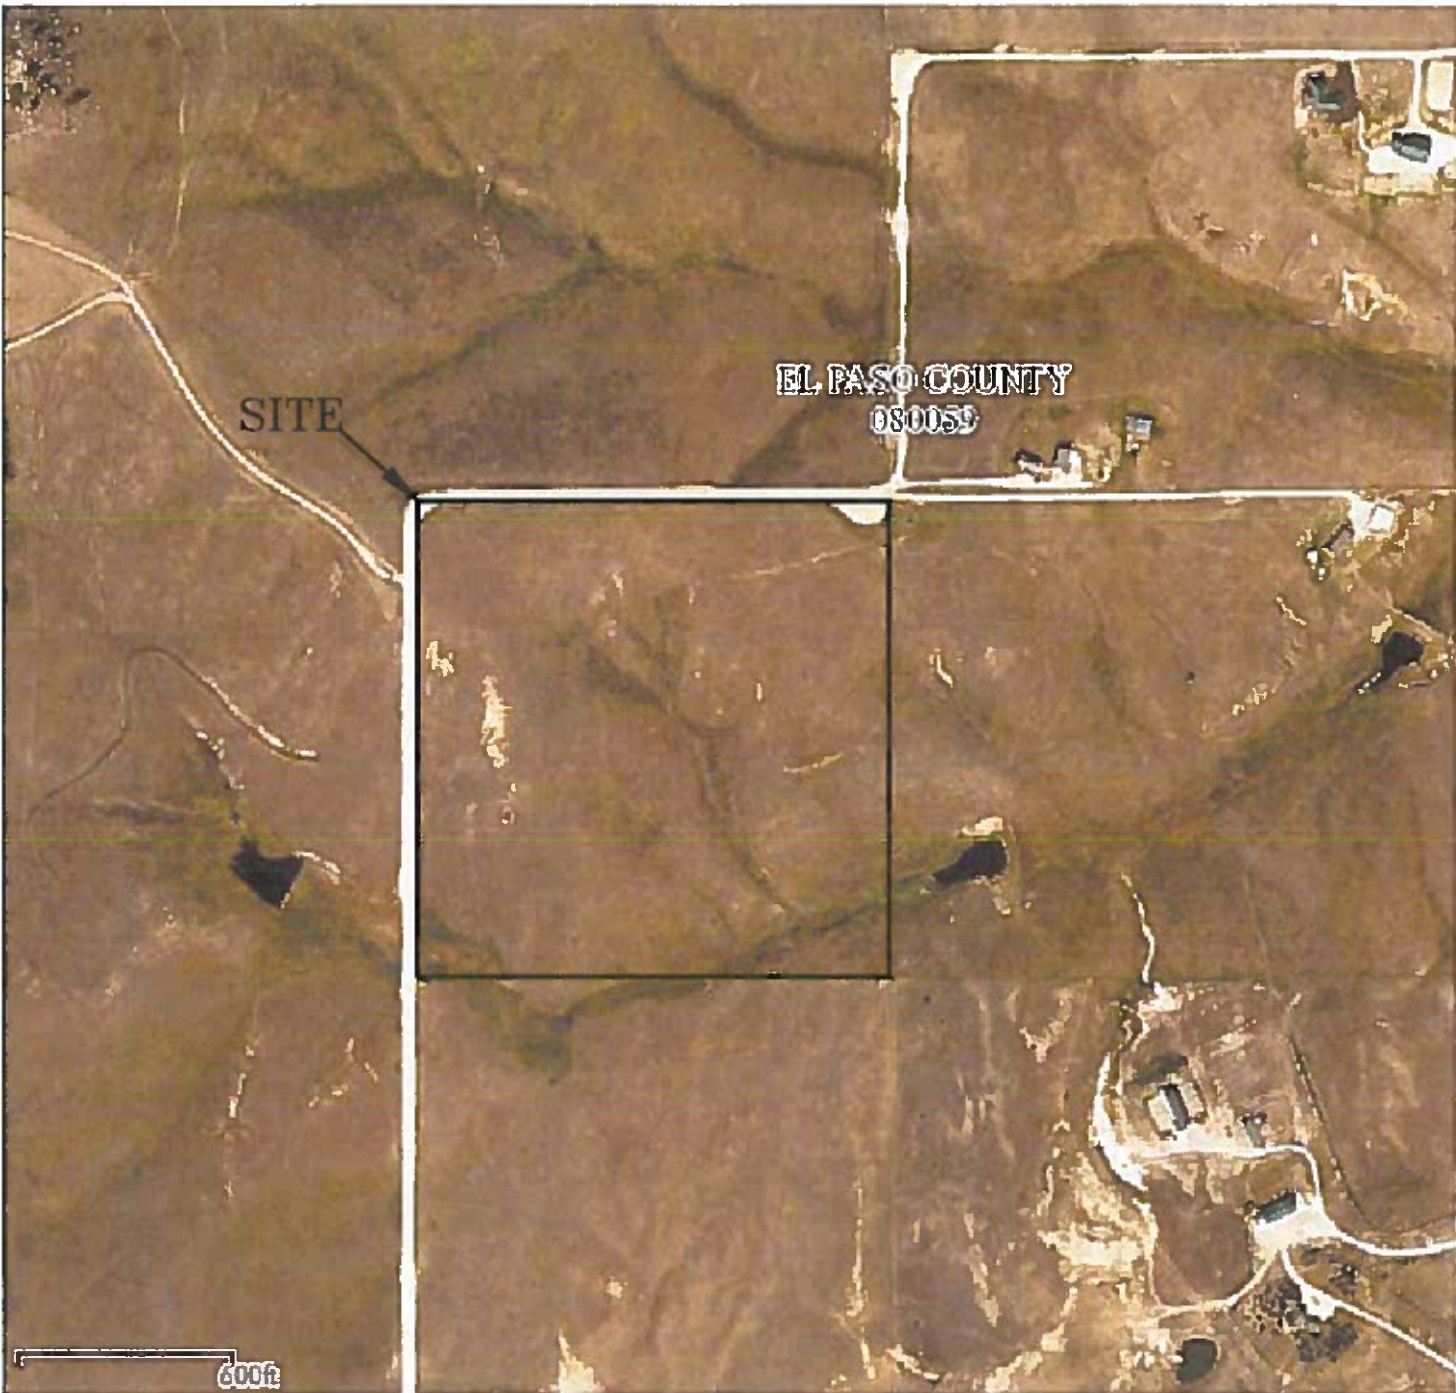
FEMA FLOODPLAIN MAP
 PRAIRIE RIDGE SUBDIVISION
 BROWN ROAD
 EL PASO COUNTY, CO.
 FOR: SONSHIP PROPERTIES, LLC

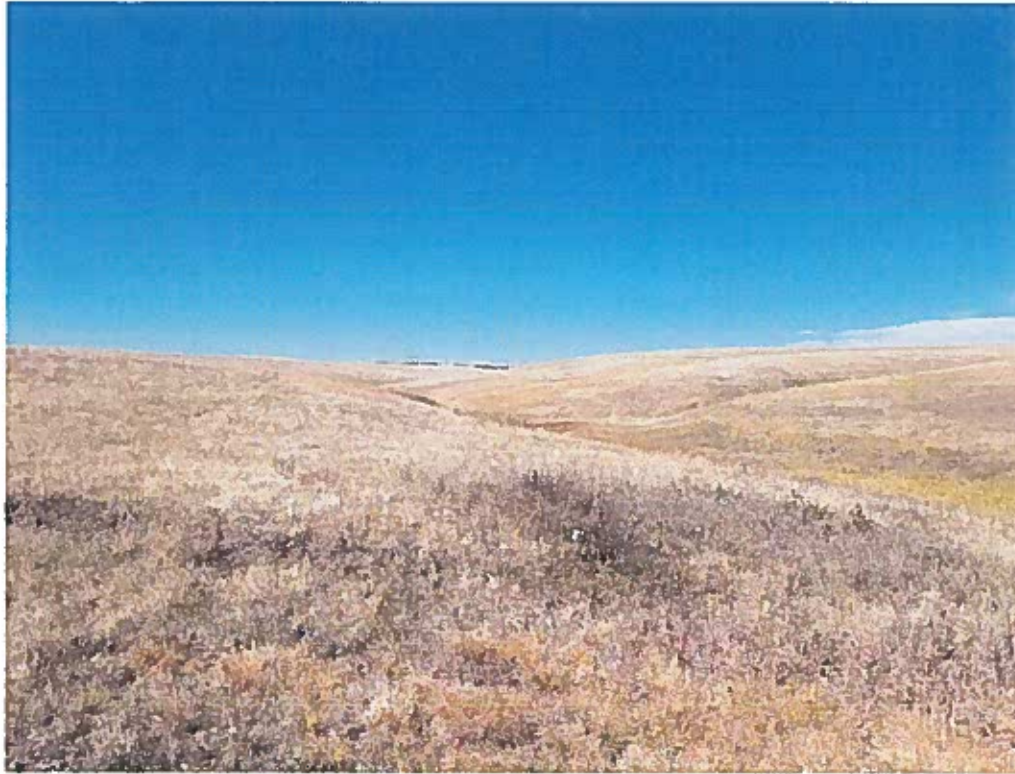
September 24, 2020

**Looking west along
the drainage in the
southern portion of the
site.**

A drainage exists in the southern portion of the site and a minor drainage in the central portion of the site that flow in easterly direction. No water was observed flowing in the drainages at the time of the investigation. These drainages have been mapped as potentially seasonal shallow and seasonal shallow groundwater areas (Figures 6 & 8).

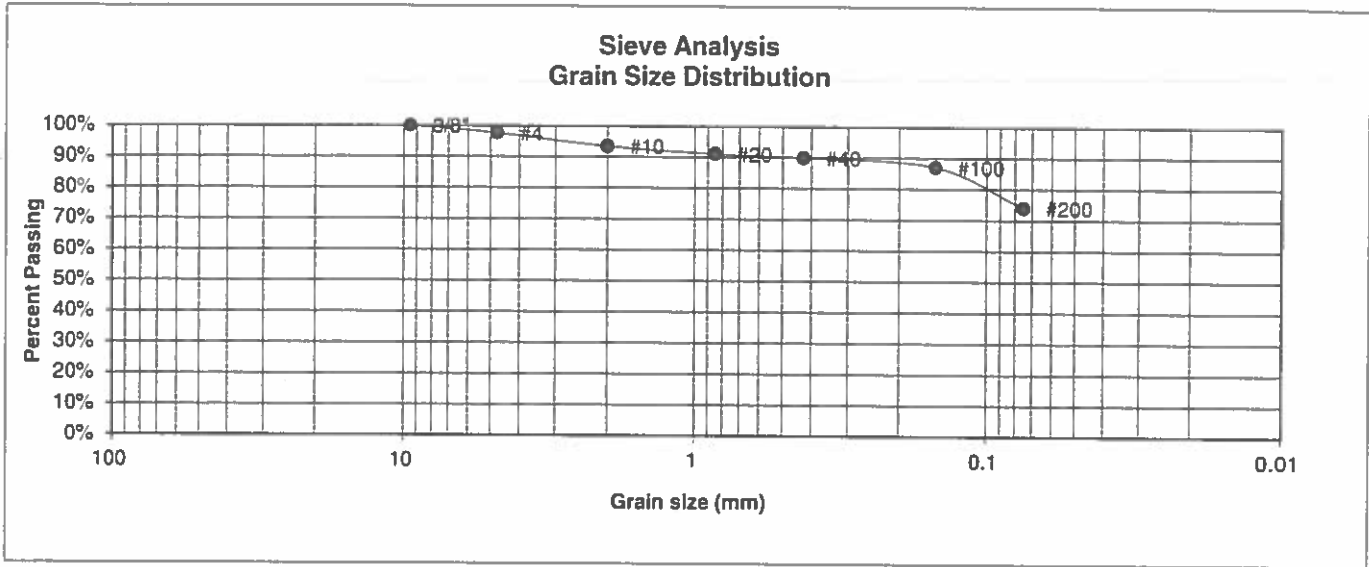
BORING NO.	TP-1	<u>UNIFIED CLASSIFICATION</u>	CL	<u>TEST BY</u>	BL
DEPTH(ft)	6	<u>AASHTO CLASSIFICATION</u>		<u>JOB NO.</u>	201794
CLIENT	SONSHIP PROPERTIES				
PROJECT	BROWN ROAD

U.S. Sieve #	Percent Finer
3"	
1 1/2"	
3/4"	
1/2"	
3/8"	100.0%
4	97.6%
10	93.4%
20	91.0%
40	89.9%
100	87.1%
200	74.0%

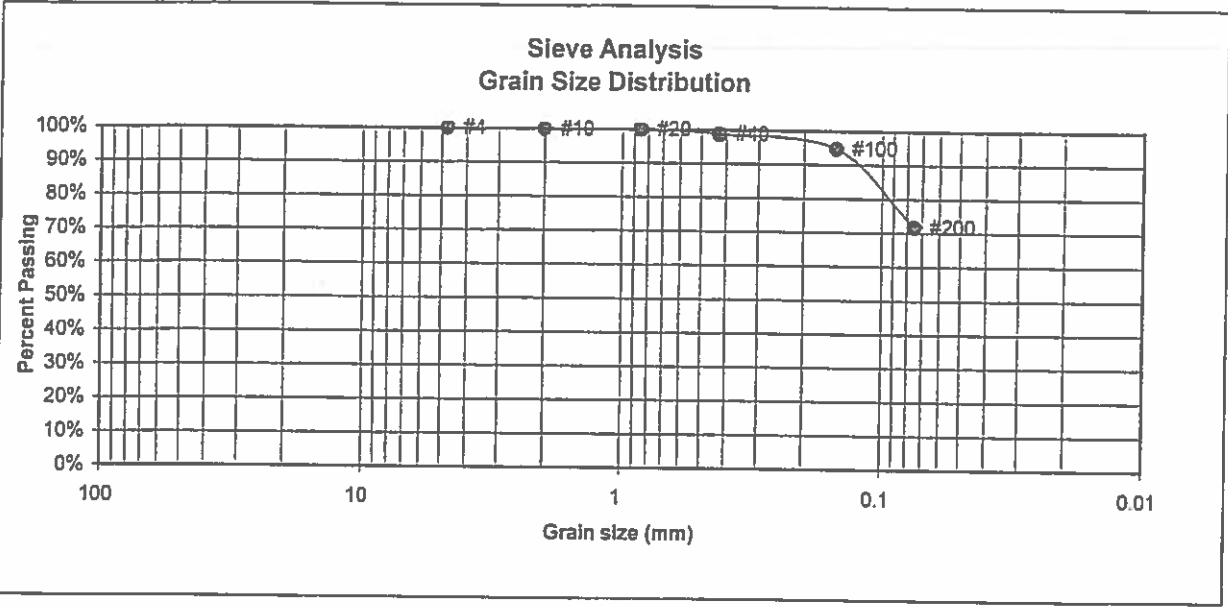
UNIFIED CLASSIFICATION CL-ML		CLIENT	PRAIRIE RIDGE PROP.
SOIL TYPE #	1	PROJECT	PRAIRIE RIDGE
TEST BORING #	1	JOB NO.	94477
DEPTH (FT)	5-10	TEST BY	DG

U.S. Sieve #	Percent Finer	Atterberg Limits	
3"		Plastic Limit	
1 1/2"		Liquid Limit	
3/4"		Plastic Index	
1/2"			
3/8"			
4	100.0%	<u>Swell</u>	
10	99.8%	Moisture at start	10.0%
20	99.9%	Moisture at finish	22.1%
40	98.7%	Moisture increase	12.1%
100	94.7%	Initial dry density (pcf)	100
200	71.6%	Swell (psf)	1177

Soil Type 1 is a sandy clay (CL), and sandy clay – silt (CL- ML) encountered in all of the profile holes. These soils were encountered at stiff to very stiff consistencies and at moist conditions. Samples tested had approximately 69% to 79% of the soil sized particles passing the No. 200 Sieve. A swell of 1177 psf was measured in the FHA Swell Test. This swell pressure is in the moderate expansion range. The clays are also potentially collapsible. Consolidations of 0.4% and 0.6% were measured in the Swell/Consolidation Test. These values are in the low consolidation range.

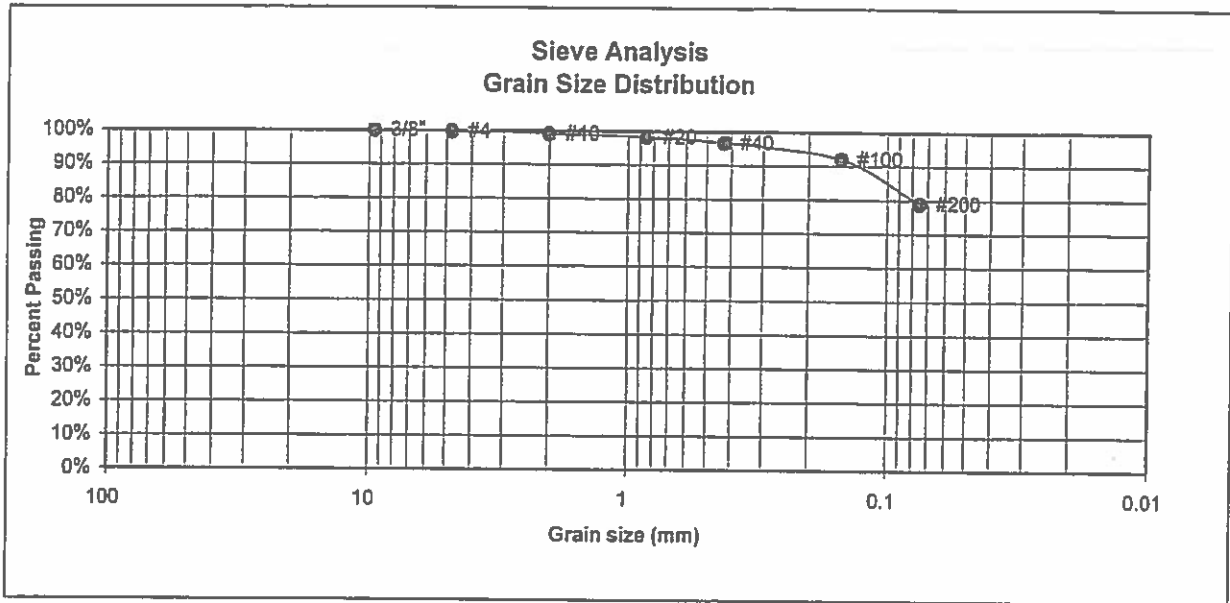
UNIFIED CLASSIFICATION	CL	CLIENT	PRAIRIE RIDGE PROP.
SOIL TYPE #	1	PROJECT	PRAIRIE RIDGE
TEST BORING #	2	JOB NO.	94477
DEPTH (FT)	10	TEST BY	DG

U.S. Sieve #	Percent Finer
3"	
1 1/2"	
3/4"	
1/2"	
3/8"	100.0%
4	99.7%
10	99.0%
20	98.1%
40	96.6%
100	91.9%
200	78.9%

Atterberg Limits	
Plastic Limit	17
Liquid Limit	28
Plastic Index	11

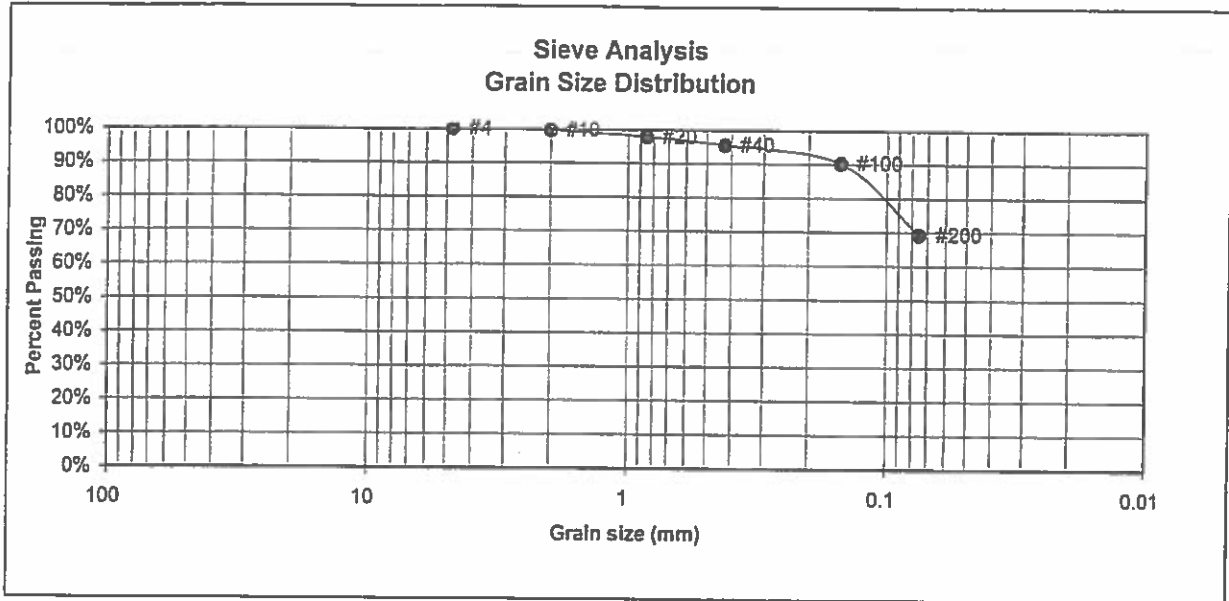
UNIFIED CLASSIFICATION	CL-ML	CLIENT	PRAIRIE RIDGE PROP.
SOIL TYPE #	1	PROJECT	PRAIRIE RIDGE
TEST BORING #	3	JOB NO.	94477
DEPTH (FT)	5	TEST BY	DG

U.S. Sieve #	Percent Finer
3"	
1 1/2"	
3/4"	
1/2"	
3/8"	
4	100.0%
10	99.6%
20	97.8%
40	95.4%
100	90.2%
200	69.2%

Atterberg Limits	
Plastic Limit	18
Liquid Limit	24
Plastic Index	6

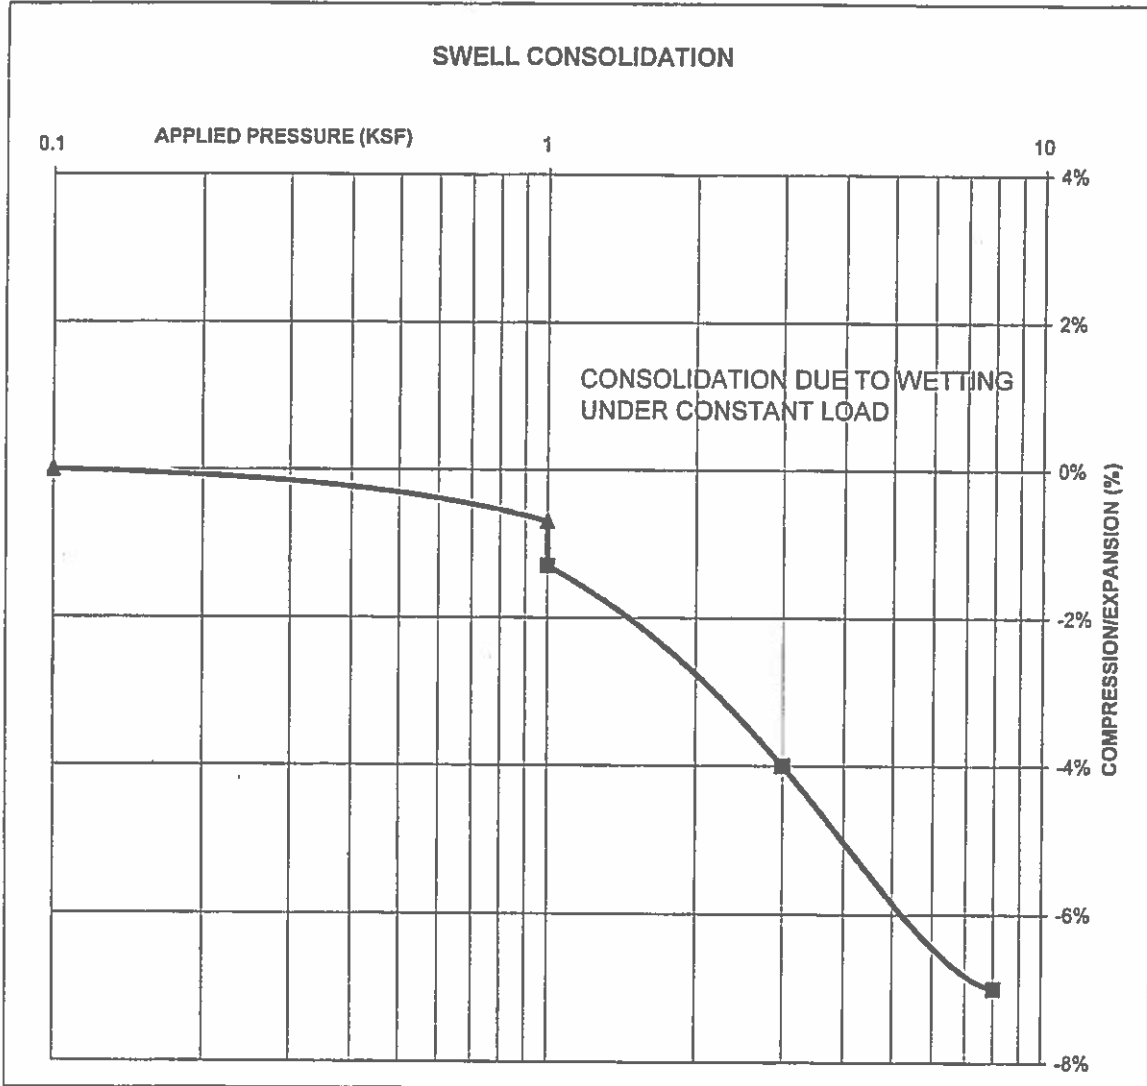
TEST BORING #	2	DEPTH(ft)	10
DESCRIPTION	CL	SOIL TYPE	1
NATURAL UNIT DRY WEIGHT (PCF)	93		
NATURAL MOISTURE CONTENT	9.0%		
SWELL/CONSOLIDATION (%)	-0.6%

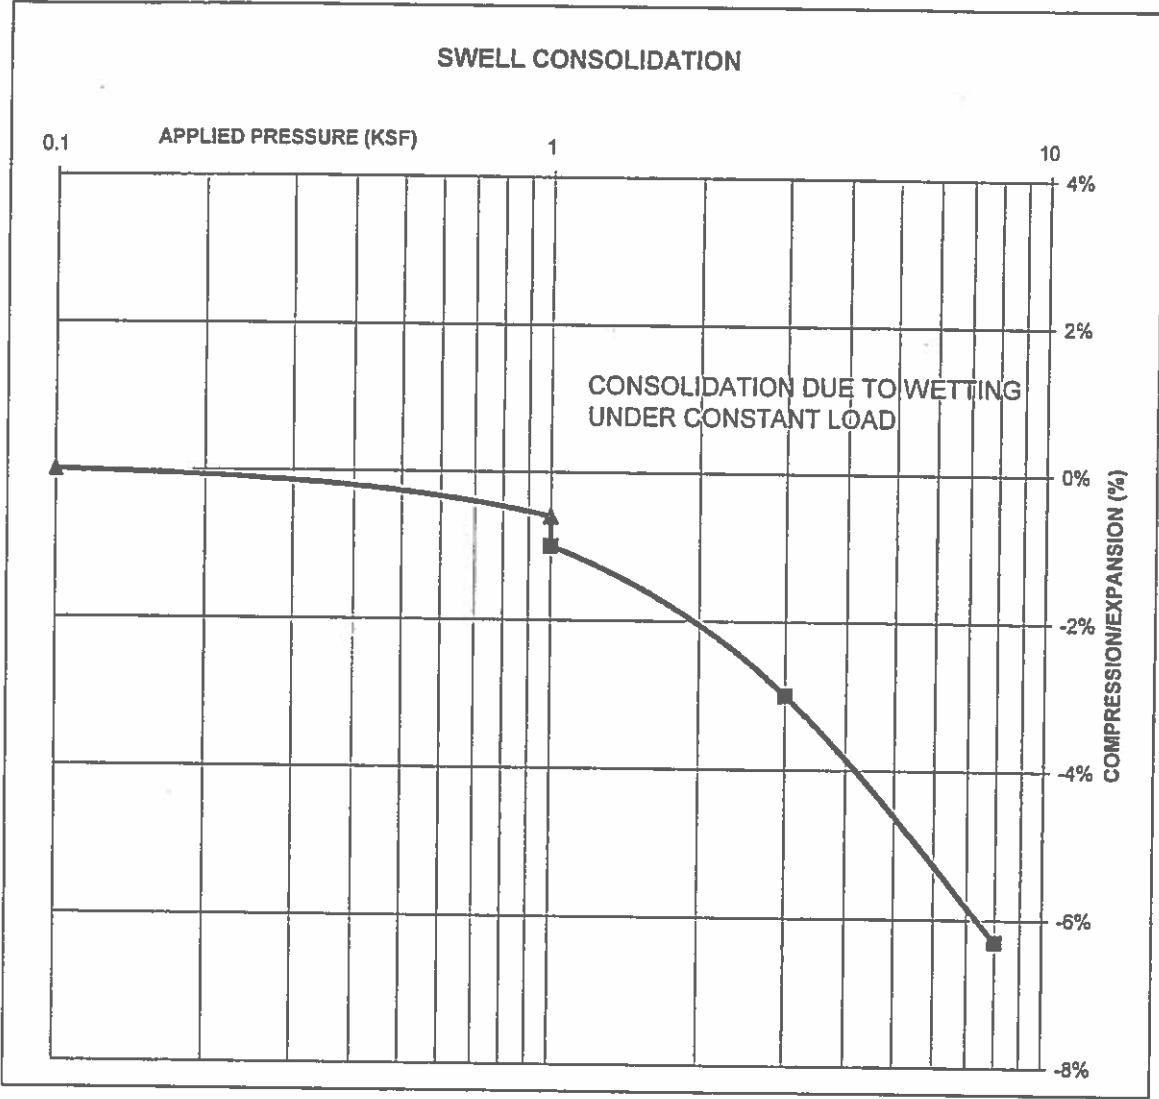
TEST BORING #	3	DEPTH(ft)	5
DESCRIPTION	CL-M	SOIL TYPE	1
NATURAL UNIT DRY WEIGHT (PCF)	94		
NATURAL MOISTURE CONTENT	6.6%		
SWELL/CONSOLIDATION (%)	-0.4%

SWELL CONSOLIDATION TEST RESULTS
