PAVEMENT DESIGN REPORT

**Village Center
Village at Lorson Ranch, Filing No. 1
El Paso County, Colorado**

**Eagle Development
212 N. Wahsatch Ave
Colorado Springs, CO 80903**

**April 28, 2025
Revised: July 9, 2025**

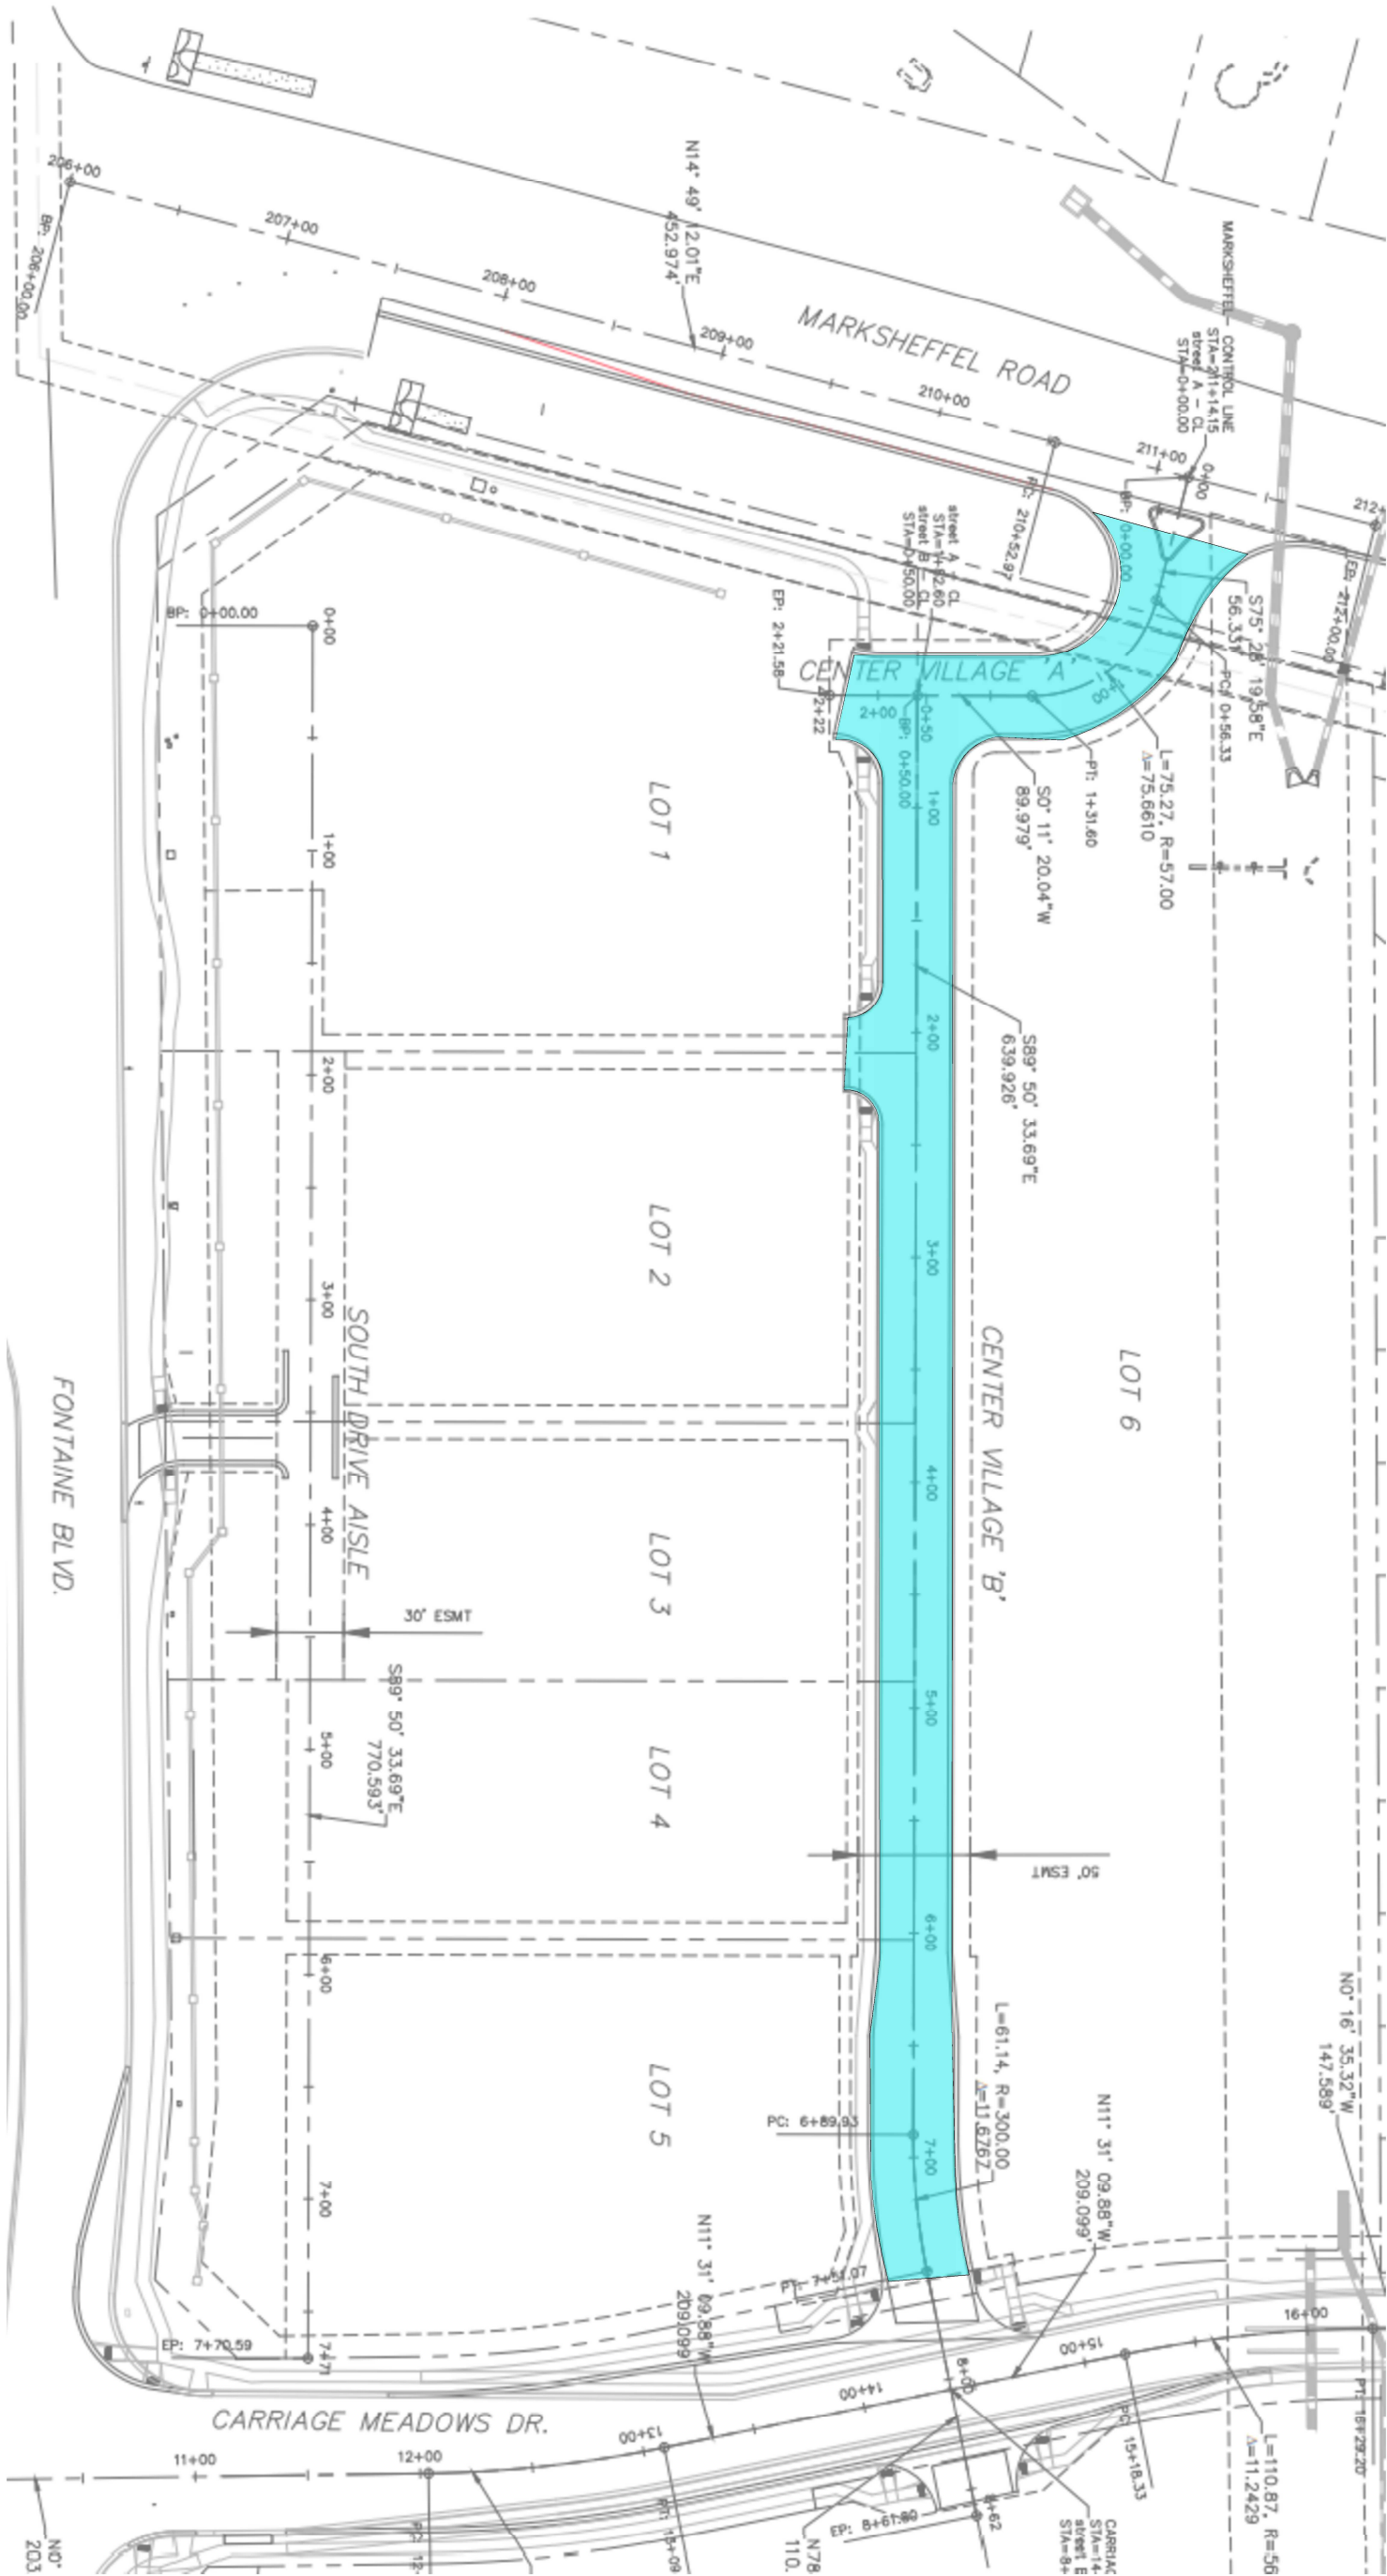
RECOMMENDED
PAVEMENT
SECTIONS

4.75" HMA OVER 11.5" CTS

Based on the design calculations, the recommended pavement sections are presented below and on Figure 2.
