## **SOIL AND GEOLOGY STUDY**

**2825/2819 Slocum Road  
Lots 1 and 2, Amo Acres, Filing No. 1  
El Paso County, Colorado**

**JOB NO. 198011**

**January 14, 2025**

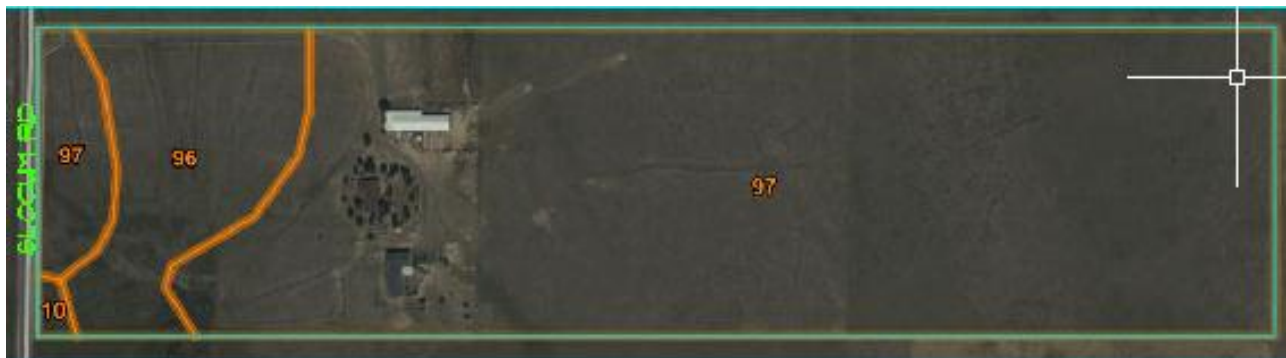
- 97 – Truckton loamy sand, 3 to 9 percent slopes. The Truckton loamy sand was mapped within the southeastern corner of the property. The properties of the Truckton loamy sand include well drained soils, depth of the water table is anticipated to be greater than 6.5 feet, runoff is anticipated to low, frequency of flooding and ponding is none, and landforms include interfluves and fan remnants.

The USDA Soil Survey Map is presented below.

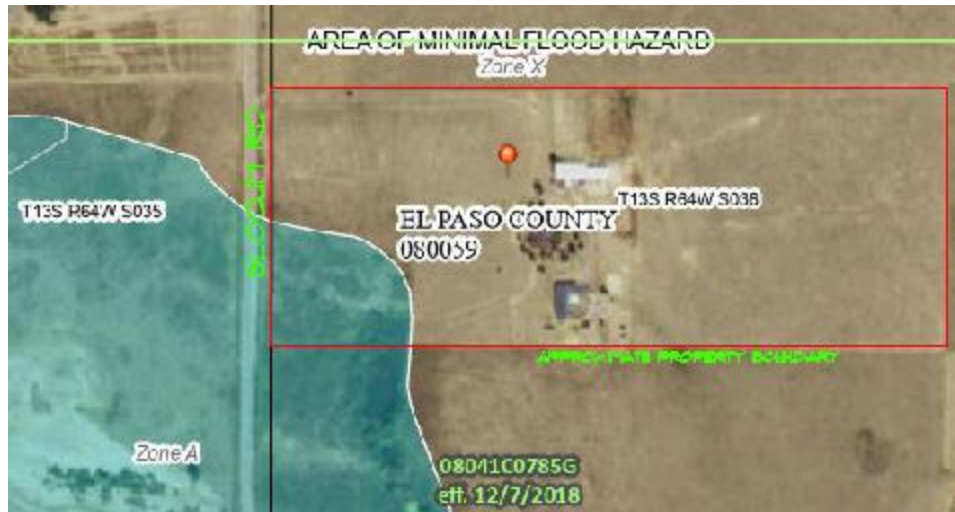
Based on our review of the Federal Emergency Management Agency (FEMA) Community Panel No. 08041C0785G the online ArcGIS Pikes Peak Regional Floodplain Map, an area designated Special Flood Hazard Area encroaches within the southwest corner of the site. Base Flood Elevations (BFE) have not been determined. The remainder of the site lies outside the 100-year or 500-year floodplains. The FEMA Map is presented below.

Portion of the site is within the 100 year Floodplain Zone A, the BFE's are required to be shown on the Final Plat (see related comment on the plat).

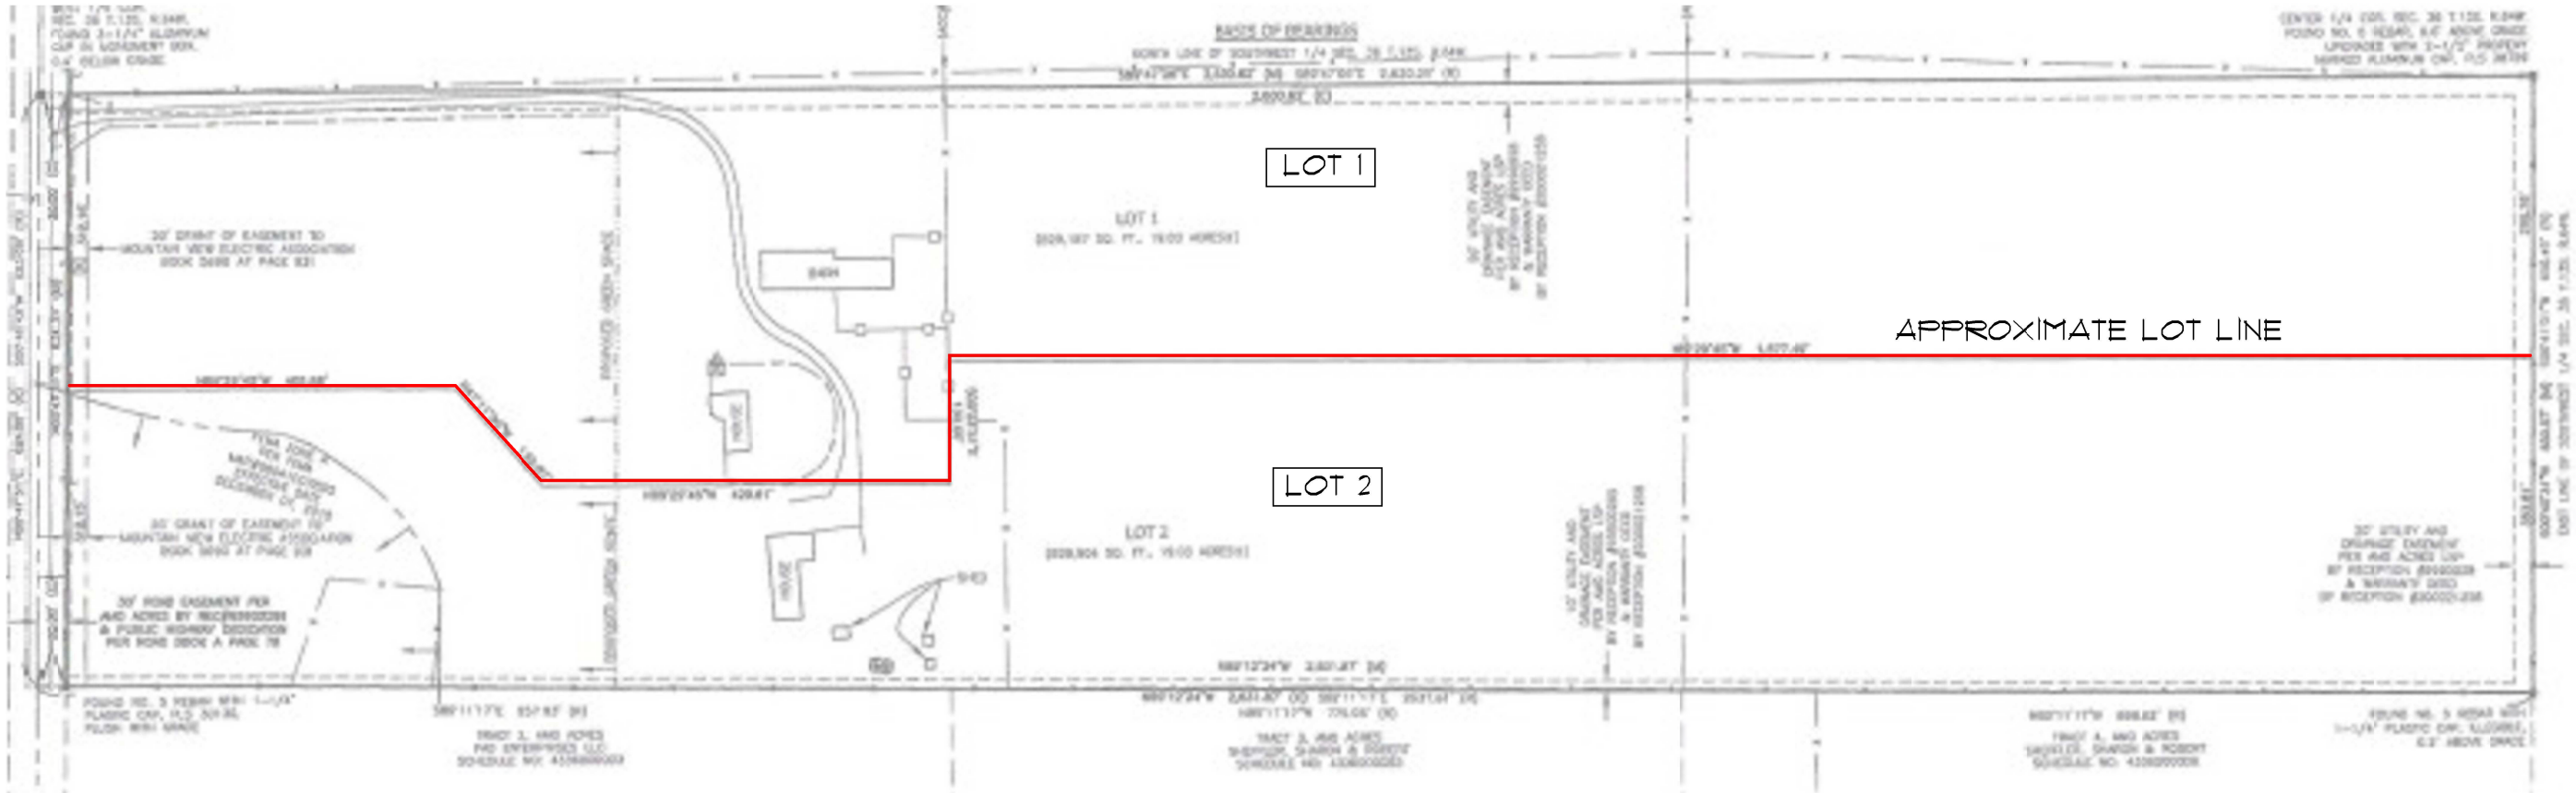
SHEET No.  
FIG-2

PROPOSED LOT  
LAYOUT

Both lots are to maintain the existing access from Slocum Road. The Proposed Lot Layout, Figure 2, outlines the proposed subdivision and the general boundaries of our investigation.

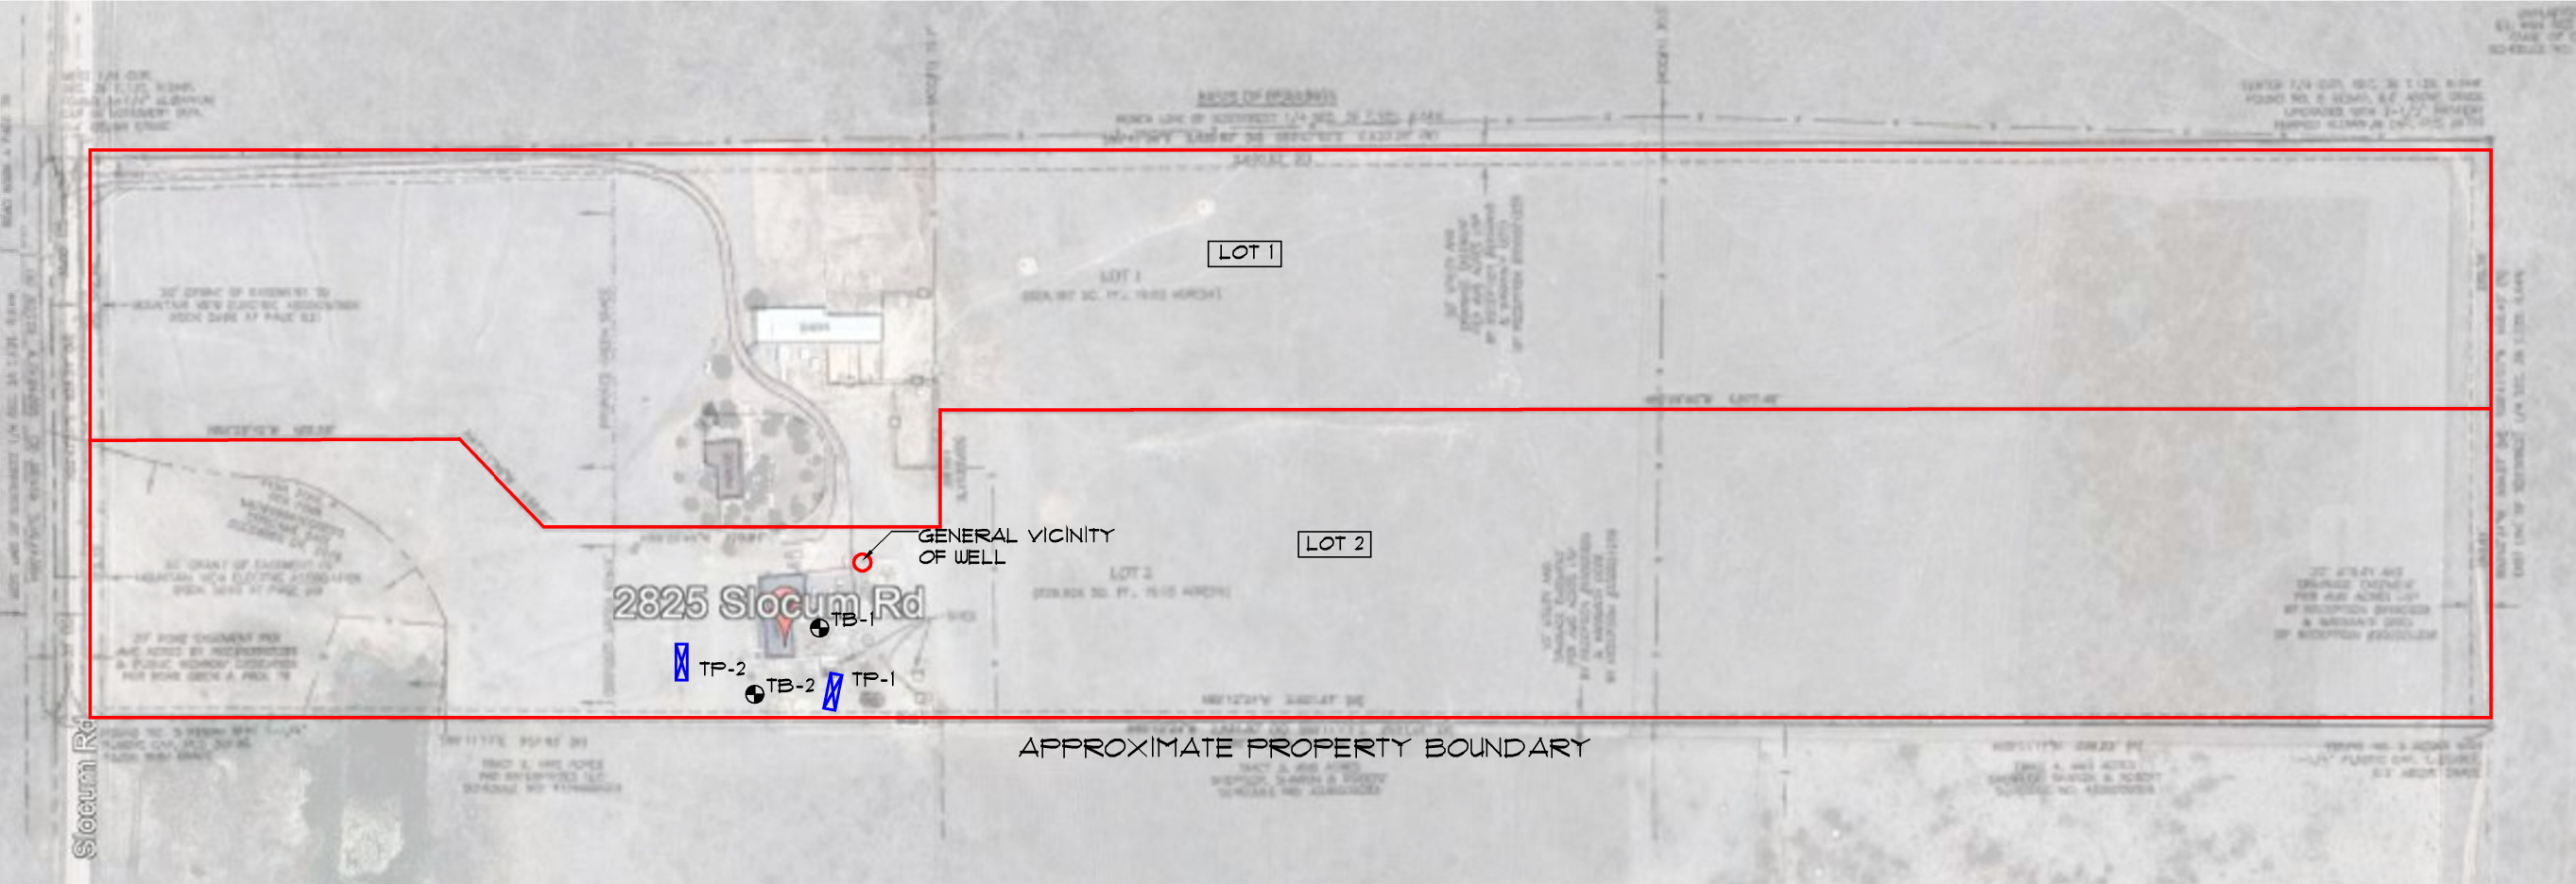
FIG-3

● DENOTES APPROXIMATE LOCATION OF TEST BORINGS

⌘ DENOTES APPROXIMATE LOCATION OF TEST PITS

For the purposes of this investigation, we are presenting our results and recommendations as though this report had been completed prior to the construction of the residence and septic system on Lot 2. Accordingly, the subsurface conditions within the area of proposed Lot 2 were explored by RMG, by drilling two (2) exploratory borings extending to 20 and 35 feet below the existing ground surface on December 6, 2024. Additionally, two (2) test pits were observed on Lot 2 on December 19, 2024. Neither test borings nor test pits were performed within the boundaries of Lot 1 for this investigation. The approximate locations of the test borings and test pits are presented on the Test Boring and Test Pit Layout, Figure 3.

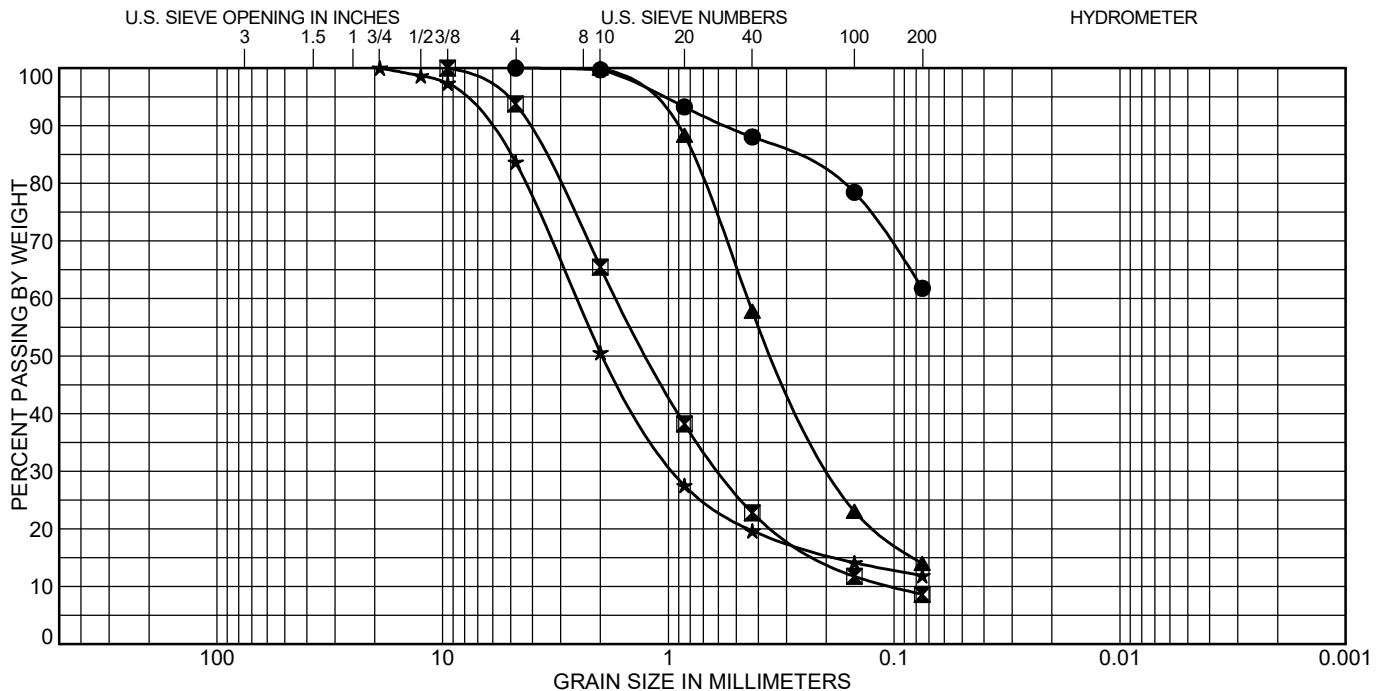
JOB No. 198011  
FIGURE No. 6  
PAGE 1 OF 1  
DATE Jan/14/2025

## SUMMARY OF LABORATORY TEST RESULTS

The moisture content for the recovered samples was obtained in the laboratory. Grain-size analysis, Atterberg Limits, and Denver Swell/Consolidation tests were performed on selected samples for purposes of classification and to develop pertinent engineering properties. A Summary of Laboratory Test Results is presented in Figure 6. Soil Classification Data are presented in Figure 7. Due to the loose nature of the sand soils, a Denver Swell/Consolidation test was not performed. Based on the percent fines ranging between 8.6% and 14.0% and the non-plasticity of the soil below 4 feet, it is our opinion the sand soil has low swell potential.

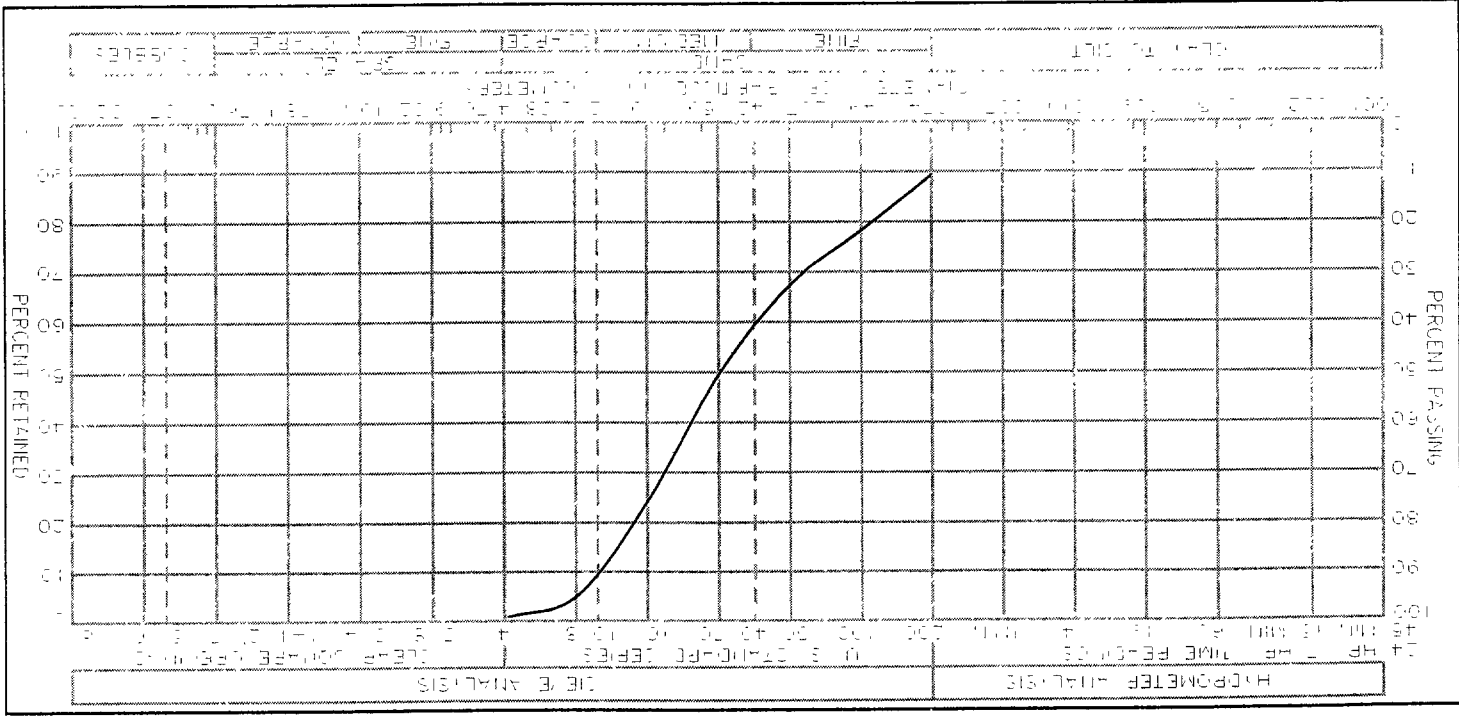
NOTES: 4.8 % Moisture Content

CLASSIFICATION SP-SM

GRAVEL 0.0 %

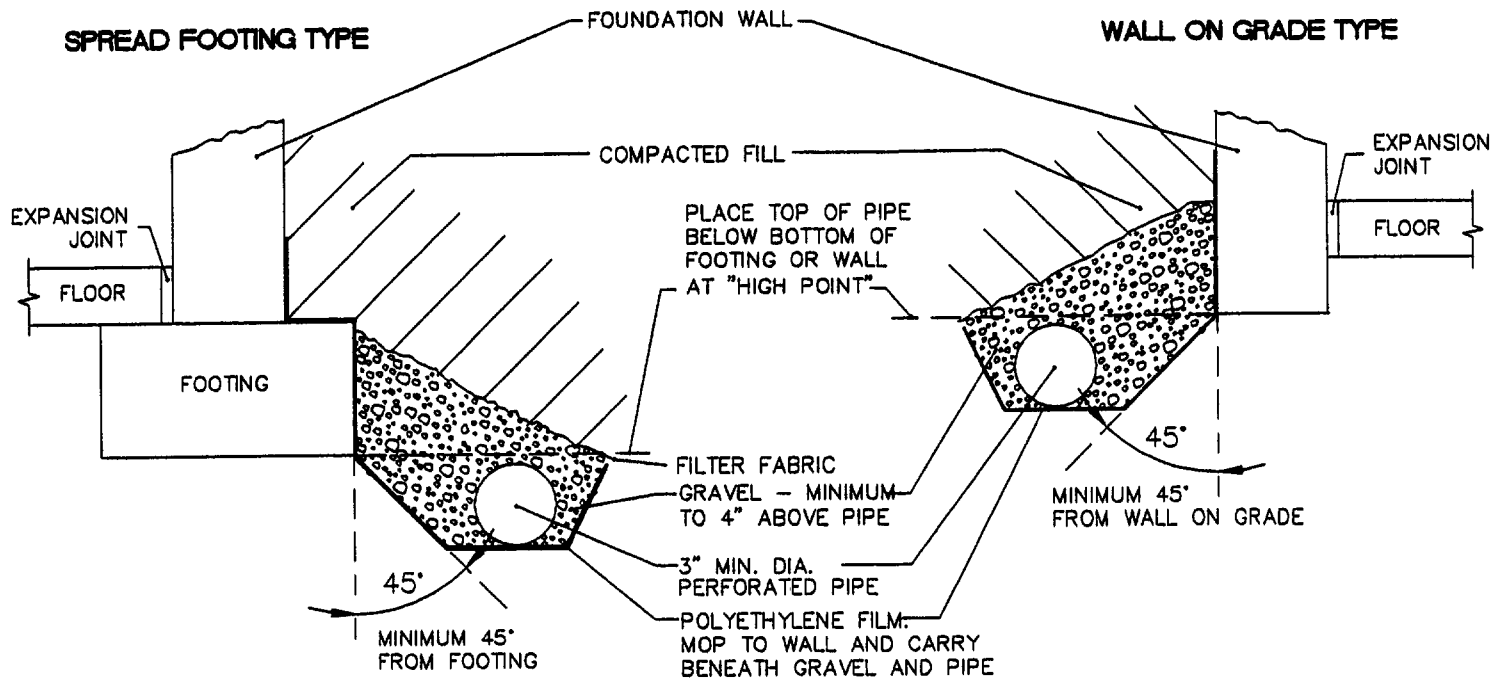
1. Gravel size shall not be less than 1/2" in diameter and not greater than 1 1/2" in diameter.
2. Diameter of perforated pipe varies with amount of seepage expected, three inch diameter is most common.

3. Pipe shall be laid at a minimum grade of 1" in 10'.
4. Outfall to be unobstructed, gravity outfall if possible. Use sump and pump only if gravity outfall does not exist. Discharge portion of pipe shall be non perforated past area to be drained. Owner is responsible to maintain daylighting of drain.

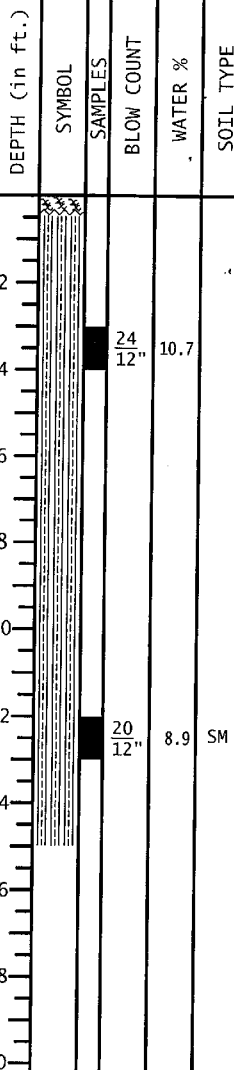
NO.: TH-1

0"-4" TOPSOIL

4"-15' SAND

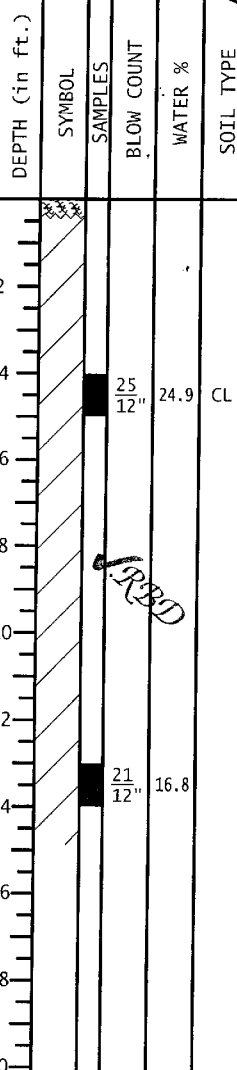
NO.: TH-2

0"-4" TOPSOIL

4"-15' CLAY

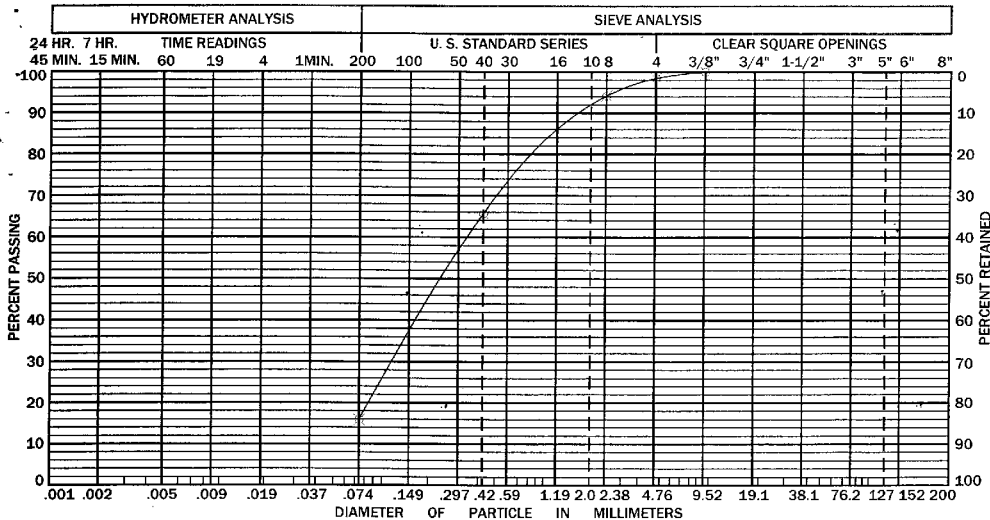
## GRADATION TEST RESULTS

| CLAY TO SILT | SAND | | | GRAVEL | | COBBLES |
|---|---|---|---|---|---|---|
| FINES <u>15.9 %</u> | | | | | | |
| SAMPLE# <u>1</u> HOLE# <u>TH-1</u> DEPTH <u>12</u> FEET | | | | | | |

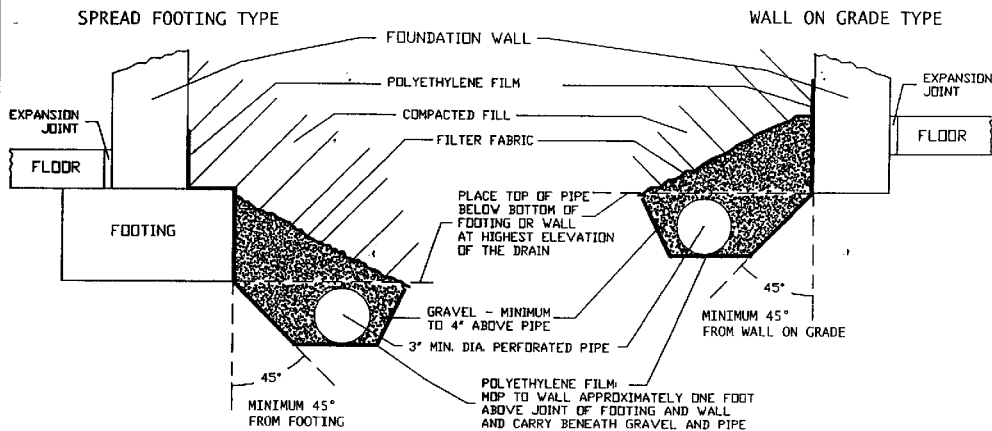
## EXTERIOR DRAIN DETAIL

1. Gravel size shall not be less than 1/2" in diameter and not greater than 1-1/2" in diameter.
2. Diameter of perforated pipe varies with amount of seepage expected, three inch diameter is most common.

3. Pipe shall be laid at a minimum grade of 1" in 10'.
4. Outfall to be unobstructed, gravity outfall if possible. Discharge portion of pipe shall be non perforated past area to be drained. Owner is responsible to maintain daylighting of drain.

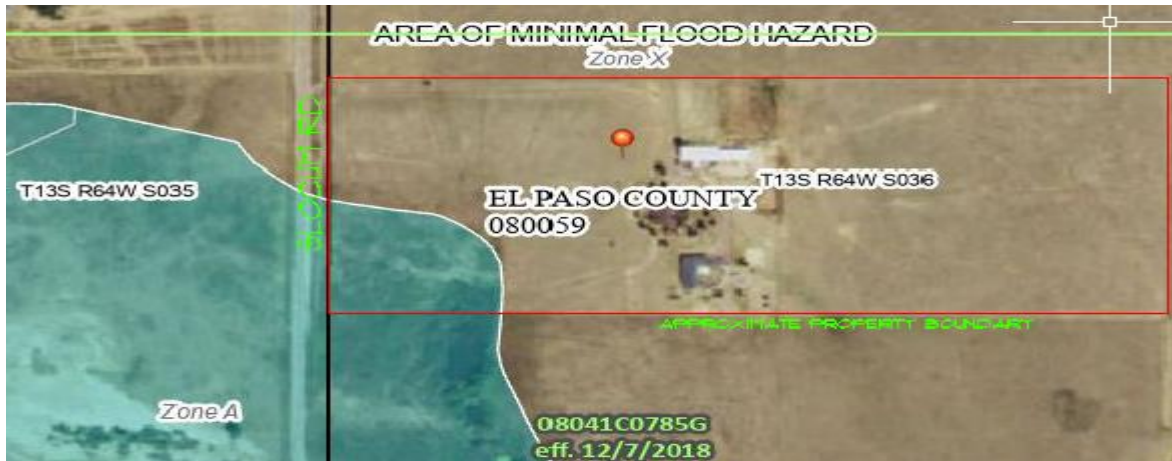
RMG has reviewed the above referenced site plan. We have identified the soil conditions that would have likely been encountered during construction of the OWTS on Lot 2. Our review included a review of documented Natural Resource Conservation Service (NRCS) data provided by [websoilsurvey.nrcs.usda.gov](http://websoilsurvey.nrcs.usda.gov). The Soil Survey Descriptions are presented below. A review of FEMA Map No. 08041C0785G, effective December 7, 2018 indicates that the existing treatment areas are not located within an identified floodplain. The FEMA Map is presented below.

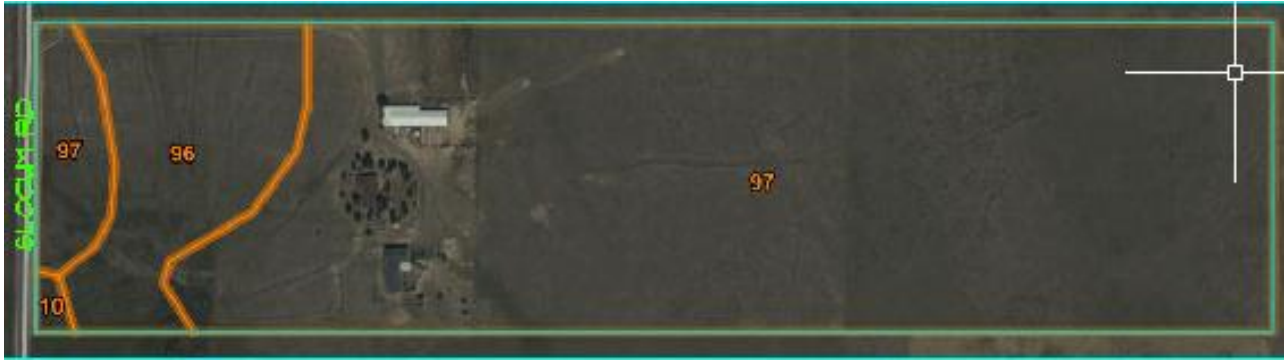
- 97 – Truckton loamy sand, 3 to 9 percent slopes. The Truckton loamy sand was mapped within the southeastern corner of the property. The properties of the Truckton loamy sand include well drained soils, depth of the water table is anticipated to be greater than 6.5 feet, runoff is anticipated to low, frequency of flooding and ponding is none, and landforms include interfluvies and fan remnants.

The USDA Soil Survey Map is presented below.

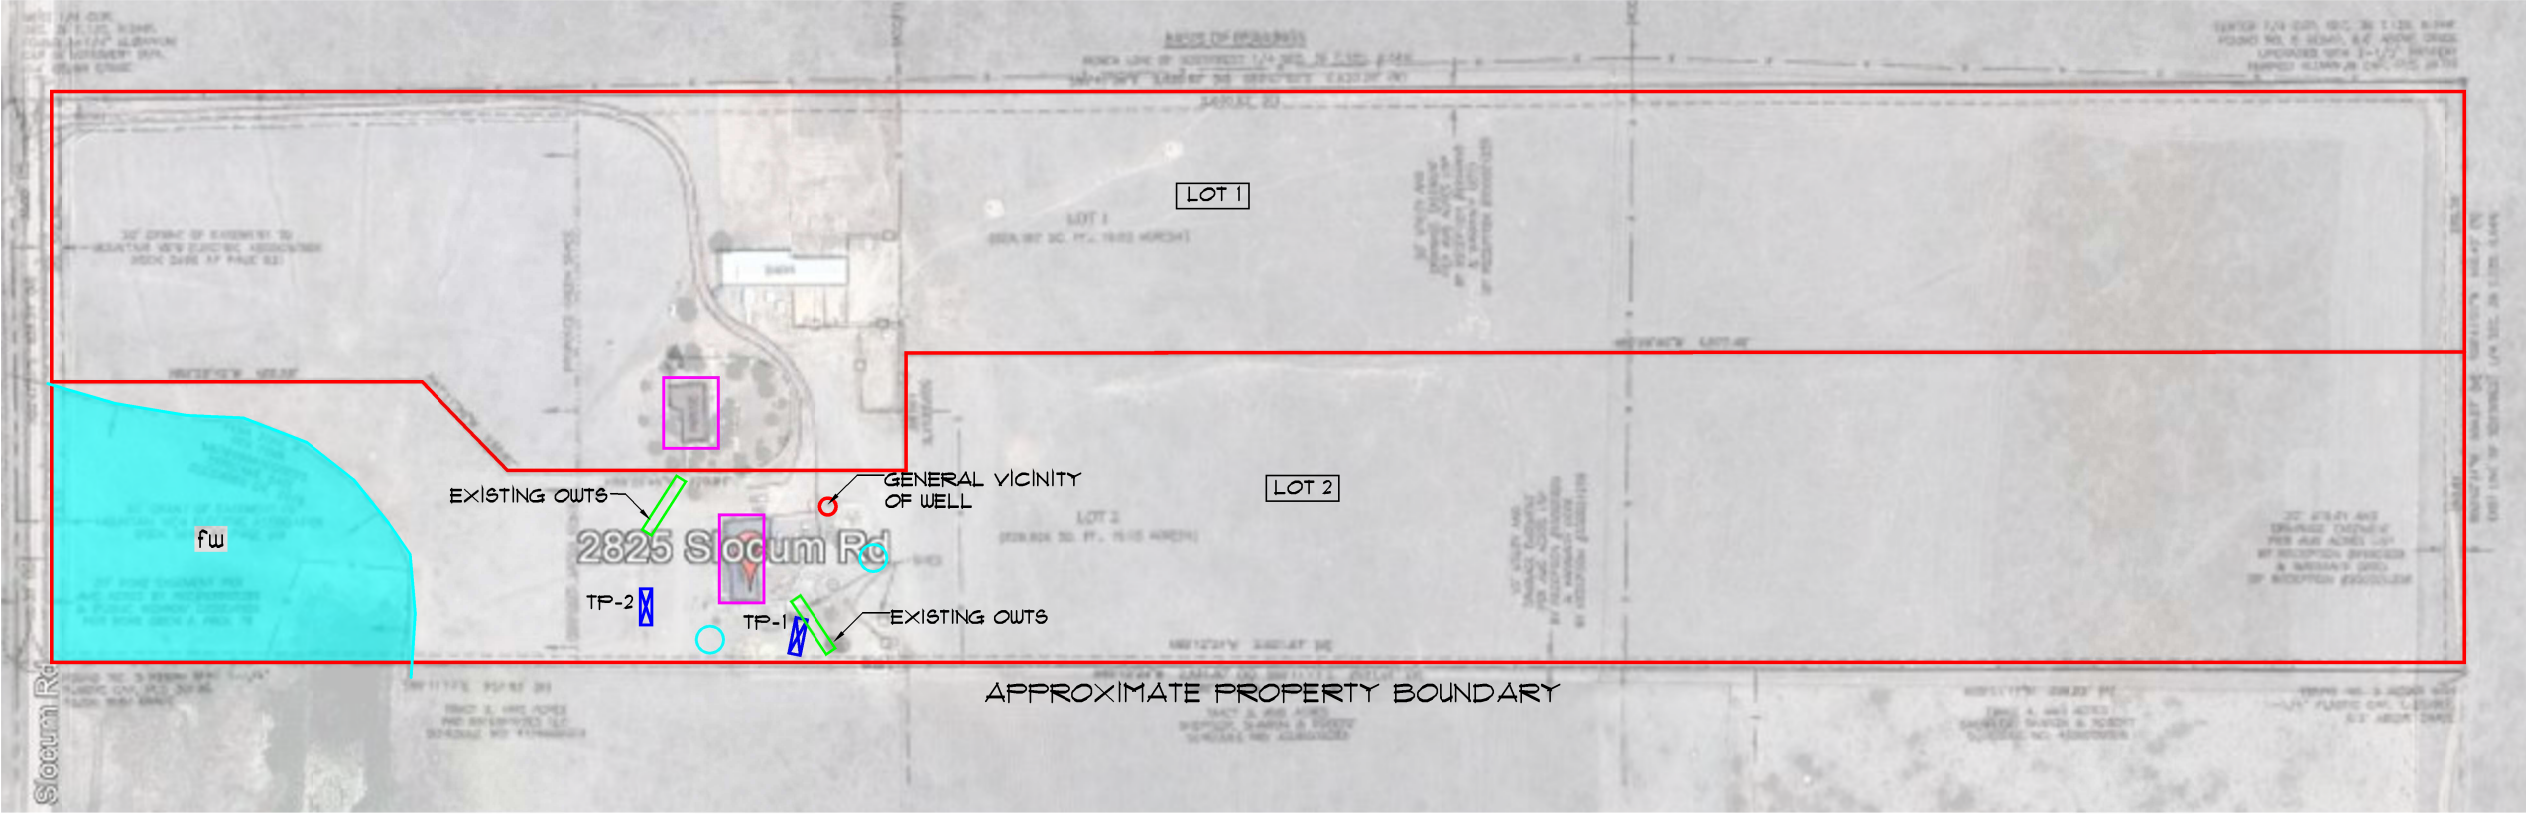
FIG No. 3

OWTS CONDITIONS

An OWTS was previously installed on each lot. The OWTS for Lot 1 (2825) was reportedly installed in 1996. The OWTS for Lot 2 (2819) was reportedly installed in 2008, prior to the subdivision. At this time, no additional OWTS are proposed for either lot. If an OWTS is proposed for either lot in the future, an additional OWTS site evaluation will need to be performed in accordance with the applicable health department codes prior to construction. This report may require additional profile pits in the vicinity of the proposed treatment field. A minimum separation of 4 feet shall be maintained from groundwater and bedrock to the infiltrative surface. The Septic Suitability Map, presented in Figure 4, indicates the existing location of each OWTS, along with an alternate location.
