## SOIL AND GEOLOGY STUDY

**2825/2819 Slocum Road  
Lots 1 and 2, Amo Acres, Filing No. 1  
El Paso County, Colorado**

**JOB NO. 198011**

**January 14, 2025**

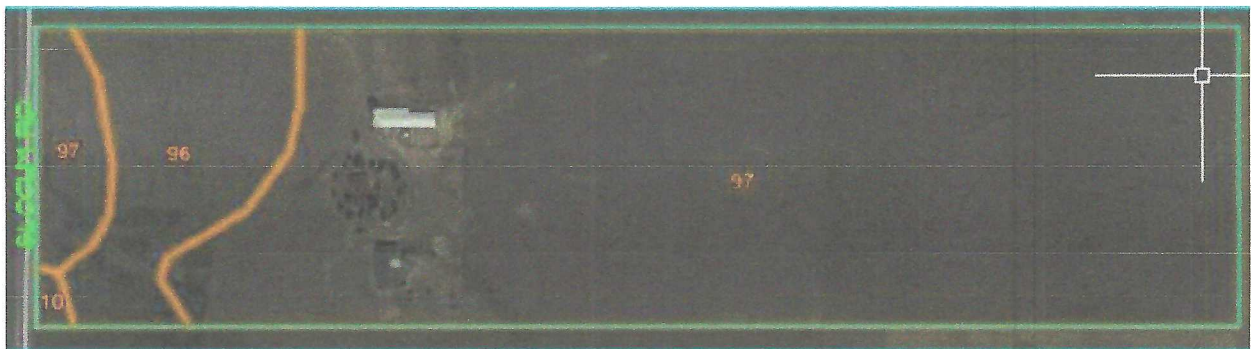
- 97 – Truckton loamy sand, 3 to 9 percent slopes. The Truckton loamy sand was mapped within the southeastern corner of the property. The properties of the Truckton loamy sand include well drained soils, depth of the water table is anticipated to be greater than 6.5 feet, runoff is anticipated to low, frequency of flooding and ponding is none, and landforms include interfluves and fan remnants.

The USDA Soil Survey Map is presented below.

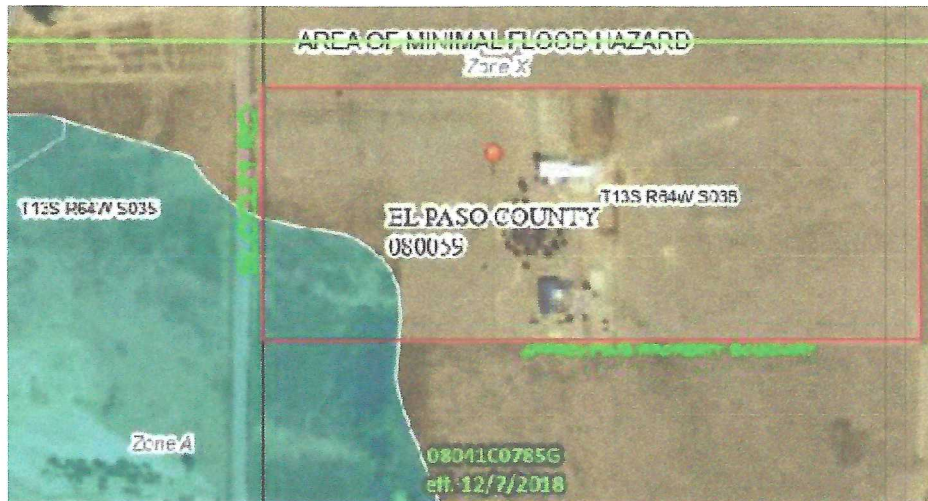
Based on our review of the Federal Emergency Management Agency (FEMA) Community Panel No. 08041C0785G the online ArcGIS Pikes Peak Regional Floodplain Map, an area designated Special Flood Hazard Area encroaches within the southwest corner of the site. Base Flood Elevations (BFE) have not been determined. The remainder of the site lies outside the 100-year or 500-year floodplains. The FEMA Map is presented below.

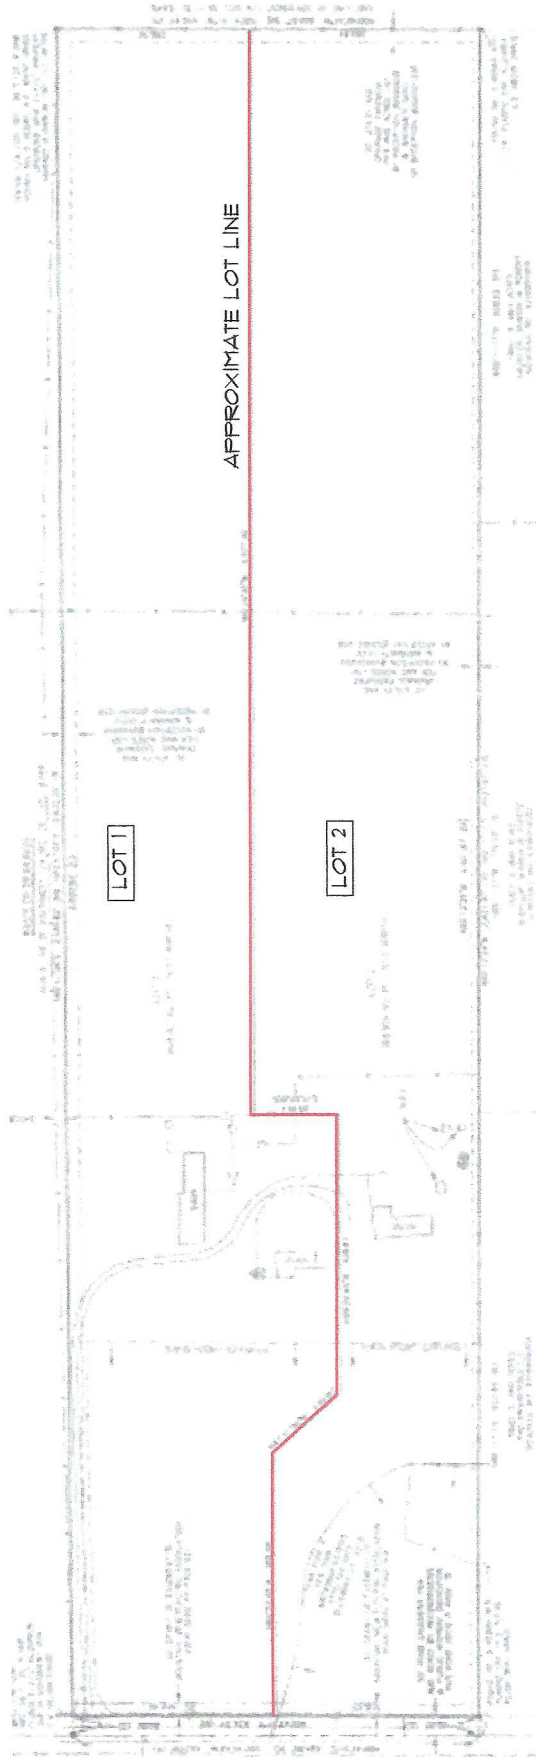
SHEET NO.  
**FIG-2**

PROPOSED LOT  
LAYOUT

Both lots are to maintain the existing access from Slocum Road. The Proposed Lot Layout, Figure 2, outlines the proposed subdivision and the general boundaries of our investigation.

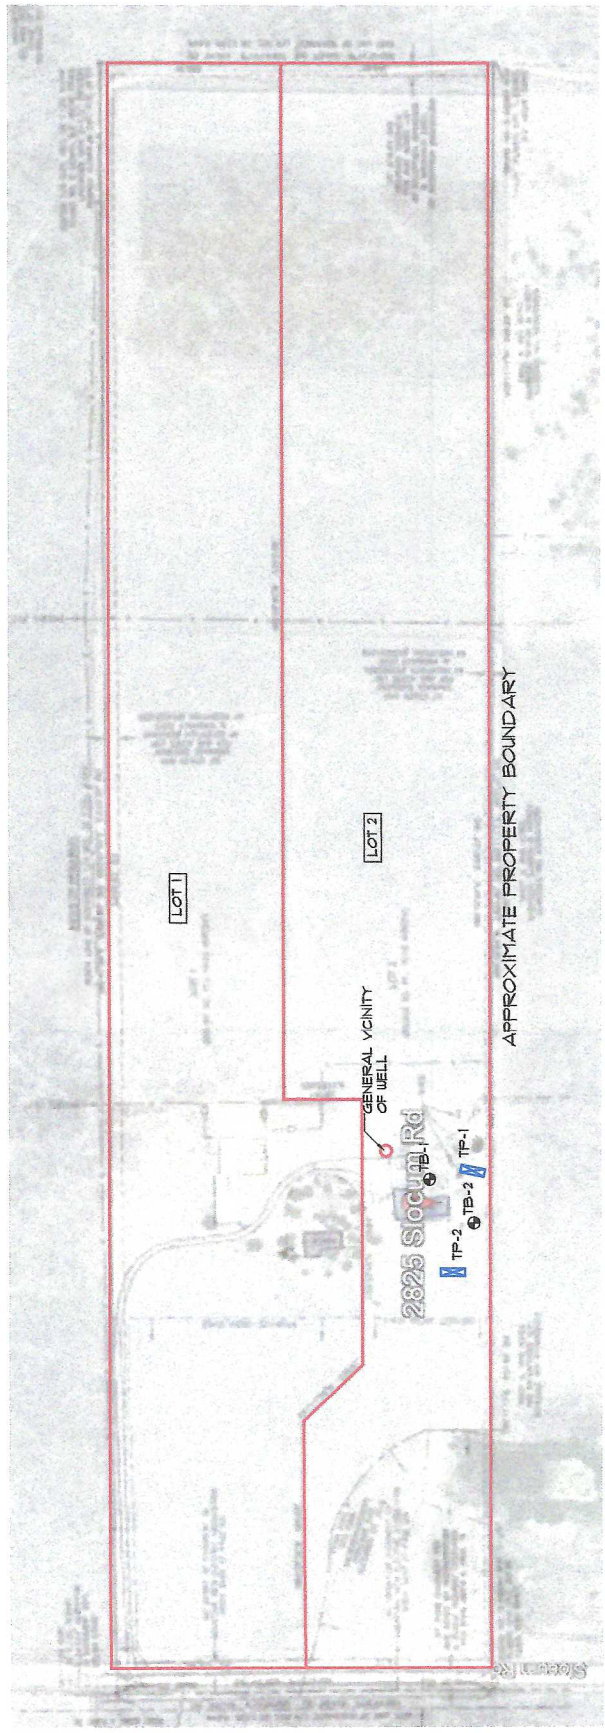
FIG-3

TEST PIT/BORING  
LOCATION PLAN  
SHEET No.

⊗ DENOTES APPROXIMATE  
LOCATION OF TEST PIT

⊙ DENOTES APPROXIMATE  
LOCATION OF TEST BORING

For the purposes of this investigation, we are presenting our results and recommendations as though this report had been completed prior to the construction of the residence and septic system on Lot 2. Accordingly, the subsurface conditions within the area of proposed Lot 2 were explored by RMG, by drilling two (2) exploratory borings extending to 20 and 35 feet below the existing ground surface on December 6, 2024. Additionally, two (2) test pits were observed on Lot 2 on December 19, 2024. Neither test borings nor test pits were performed within the boundaries of Lot 1 for this investigation. The approximate locations of the test borings and test pits are presented on the Test Boring and Test Pit Layout, Figure 3.

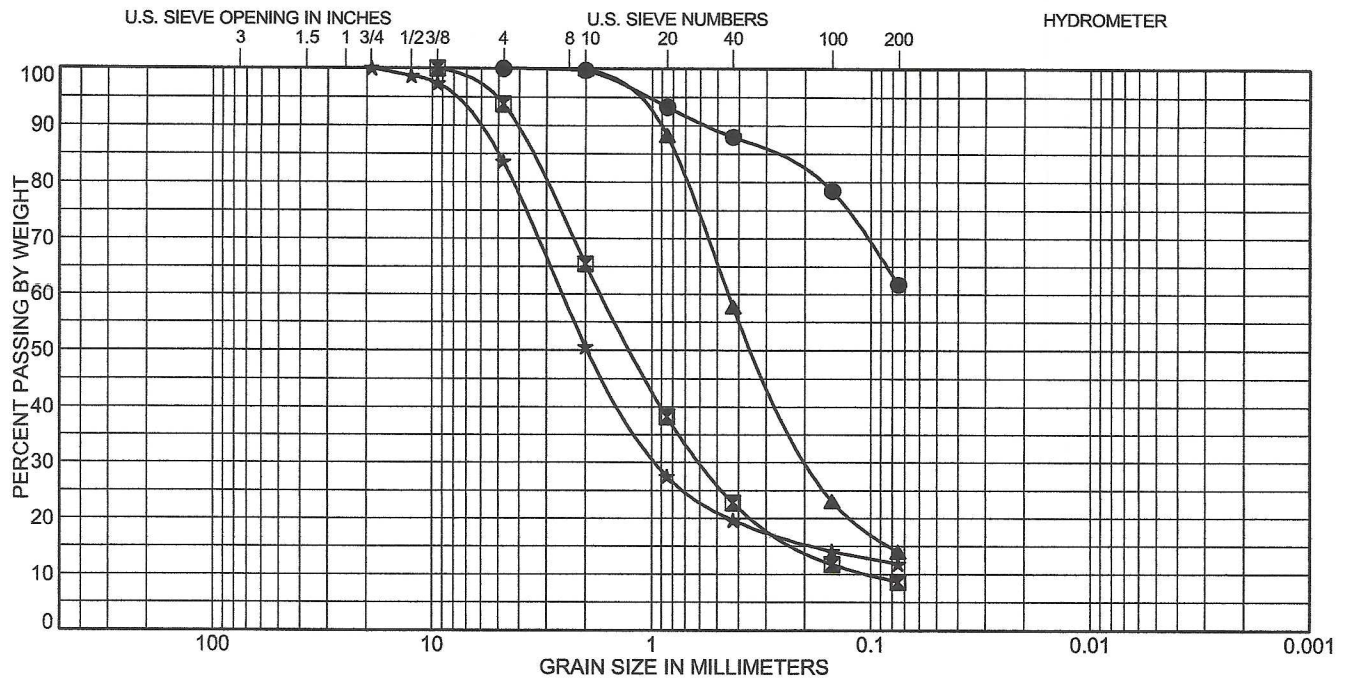
JOB No. 198011  
FIGURE No. 6  
PAGE 1 OF 1  
DATE Jan/14/2025

## SUMMARY OF LABORATORY TEST RESULTS

The moisture content for the recovered samples was obtained in the laboratory. Grain-size analysis, Atterberg Limits, and Denver Swell/Consolidation tests were performed on selected samples for purposes of classification and to develop pertinent engineering properties. A Summary of Laboratory Test Results is presented in Figure 6. Soil Classification Data are presented in Figure 7. Due to the loose nature of the sand soils, a Denver Swell/Consolidation test was not performed. Based on the percent fines ranging between 8.6% and 14.0% and the non-plasticity of the soil below 4 feet, it is our opinion the sand soil has low swell potential.
