ENTECH
ENGINEERING, INC.

**WASTEWATER STUDY
FLYING HORSE NORTH FILING NO. 3
EL PASO COUNTY, COLORADO**

August 23, 2023
Revised February 29, 2024

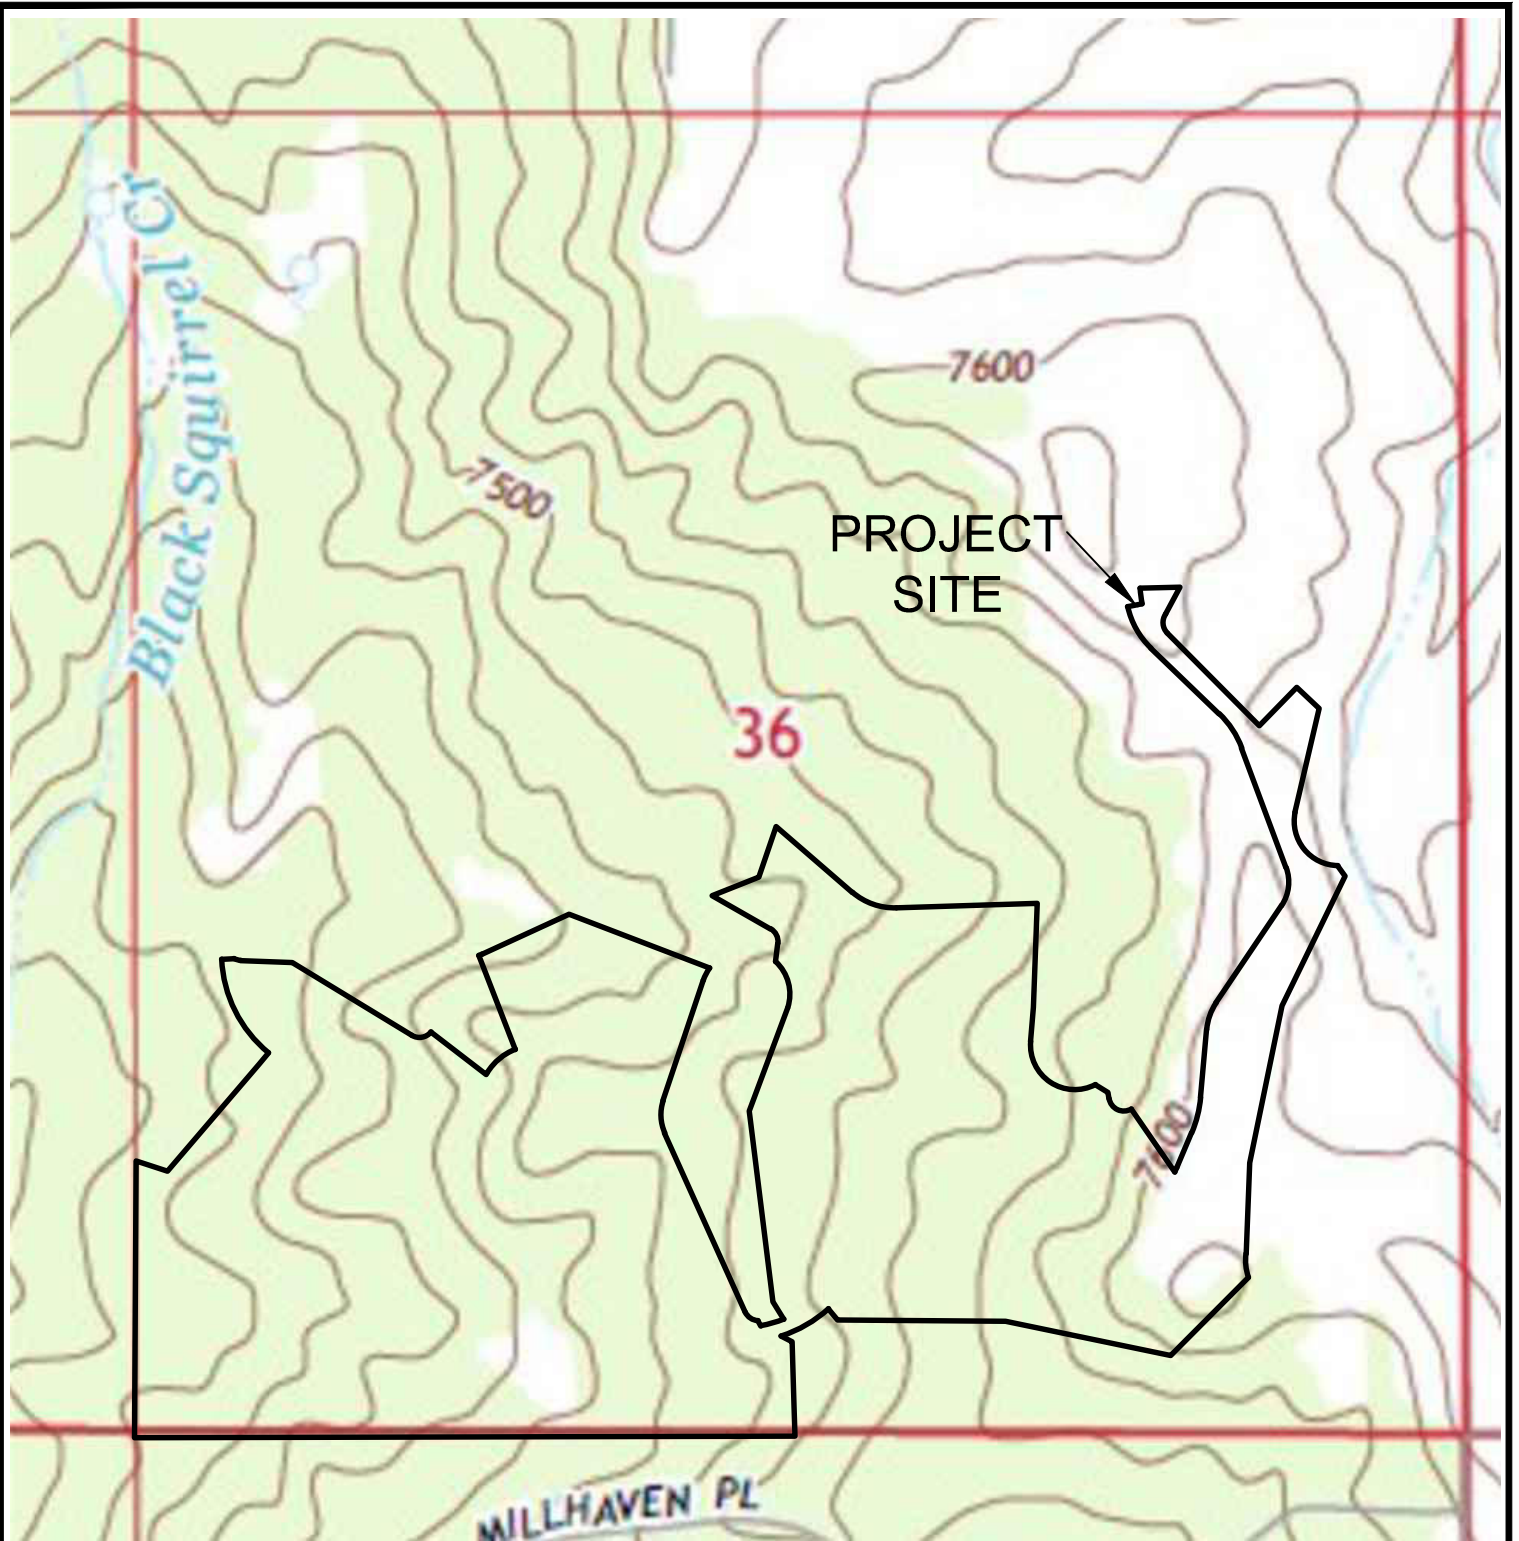
FIG. 2

USGS TOPOGRAPHY MAP
FLYING HORSE NORTH FILING NO. 3
EL PASO COUNTY, COLORADO
FLYING HORSE NORTH, LLC

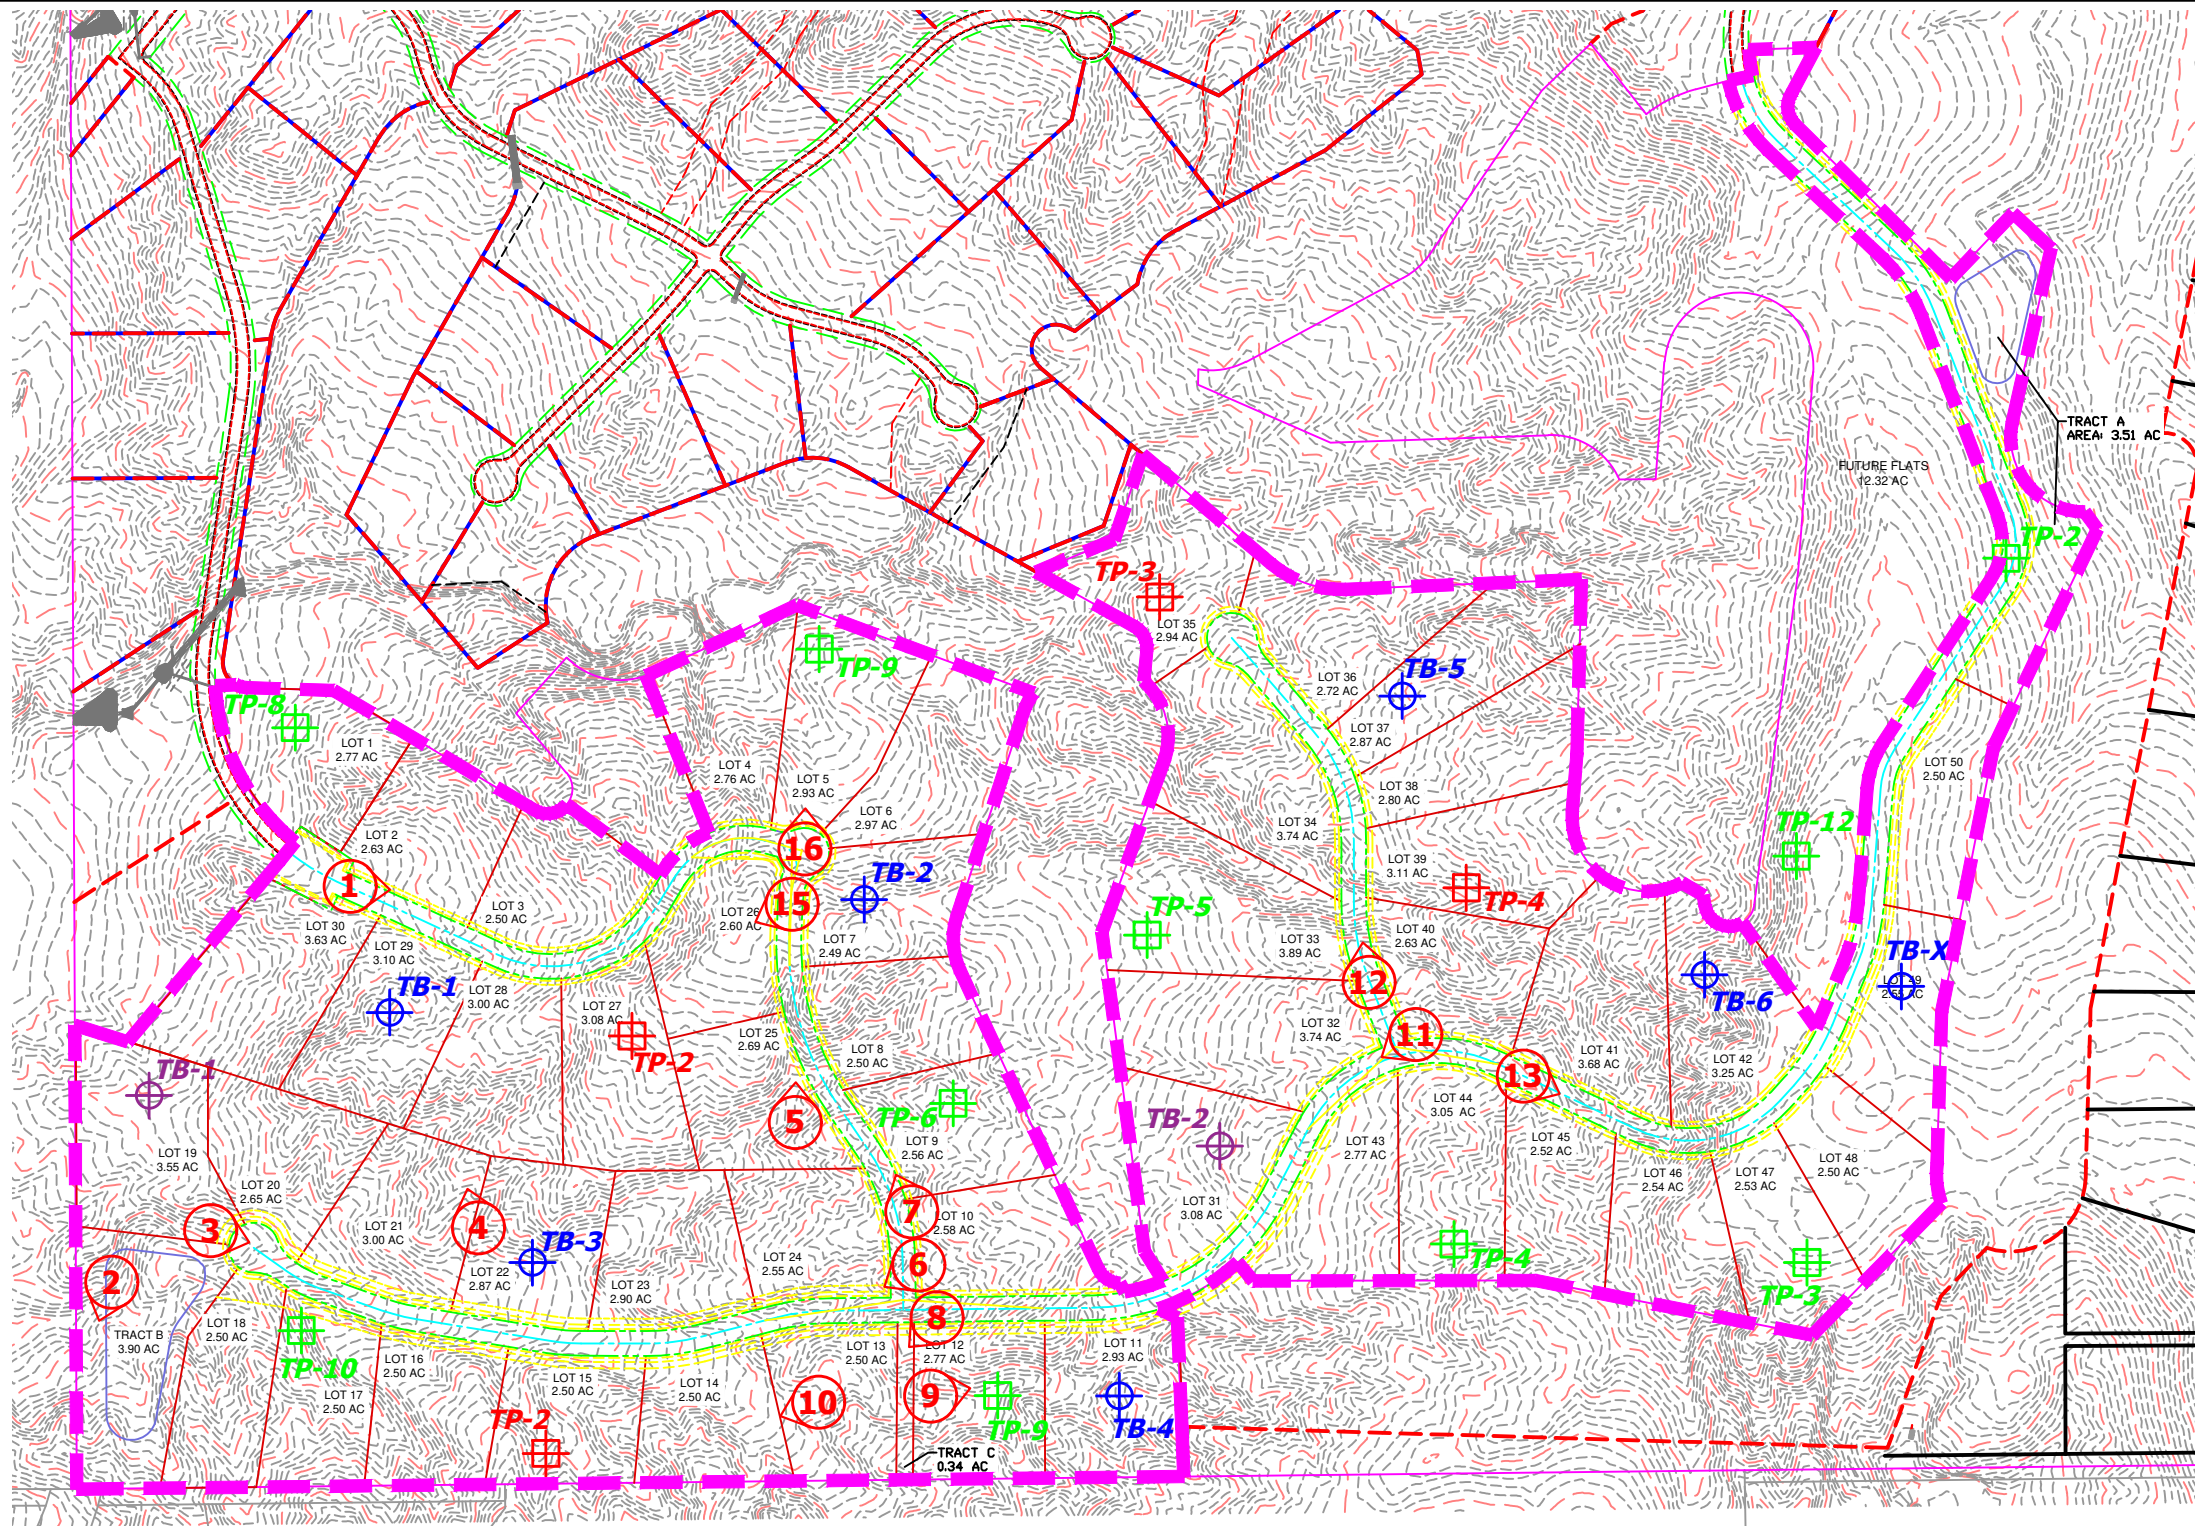
FIG. 3

- APPROXIMATE TEST PIT LOCATION AND NUMBER (OLD, NEW)
- APPROXIMATE TEST BORING LOCATION AND NUMBER (OLD, NEW)
- APPROXIMATE PHOTOGRAPH LOCATION AND NUMBER

SITE PLANT/TESTING LOCATION MAP
 FLYING HORSE NORTH FILING NO. 3
 EL PASO COUNTY, COLORADO
 FLYING HORSE NORTH, LLC

The topography of the site varies from gently to moderately sloping generally to the west and southwest with some steeper slopes along the drainages in portions of the site. The Palmer Divide is located along the northeastern portion of Filing No. 3. The drainages on site flow in westerly direction through the property. Water was observed flowing in the drainage in the southwestern portion of the site, and the remaining drainages were at the time of this investigation. Areas of ponded water were observed behind erosion berms in low-lying areas along the future roadway. The site boundaries are indicated on the USGS Map, Figure 2. Previous land uses have included grazing and pasture land. Flying Horse North Filing Nos. 1 and 2 have been mostly developed and the golf course has been completed. The site contains primarily field grasses and weeds in with areas of ponderosa pine tree coverage across Filing No. 3. Site photographs are included in Appendix A. The locations and directions of the photographs are indicated in Figure 3.

Flying Horse North Filing No. 3 Subdivision is 164.4 acres. Fifty (50) lots are proposed for the filing. The proposed development is to consist of 2.5 to 3.9-acre single-family residential estate lots, two drainage tracts, and other associated site improvements. Grading is expected to be primarily associated with the construction of roads. The Development Plan/Test Boring Location Map is presented in Figure 3.

The previous field investigation consisted of six (6) test borings and eighteen (18) test pits to determine general suitability of the site for construction (Reference 3). The location of the previous Test Borings and Test Pits indicated on the Site Map/Testing Location Map, Figure 3. Additionally, fourteen (14) profile holes were performed on the entire Flying Horse North property in previous studies.

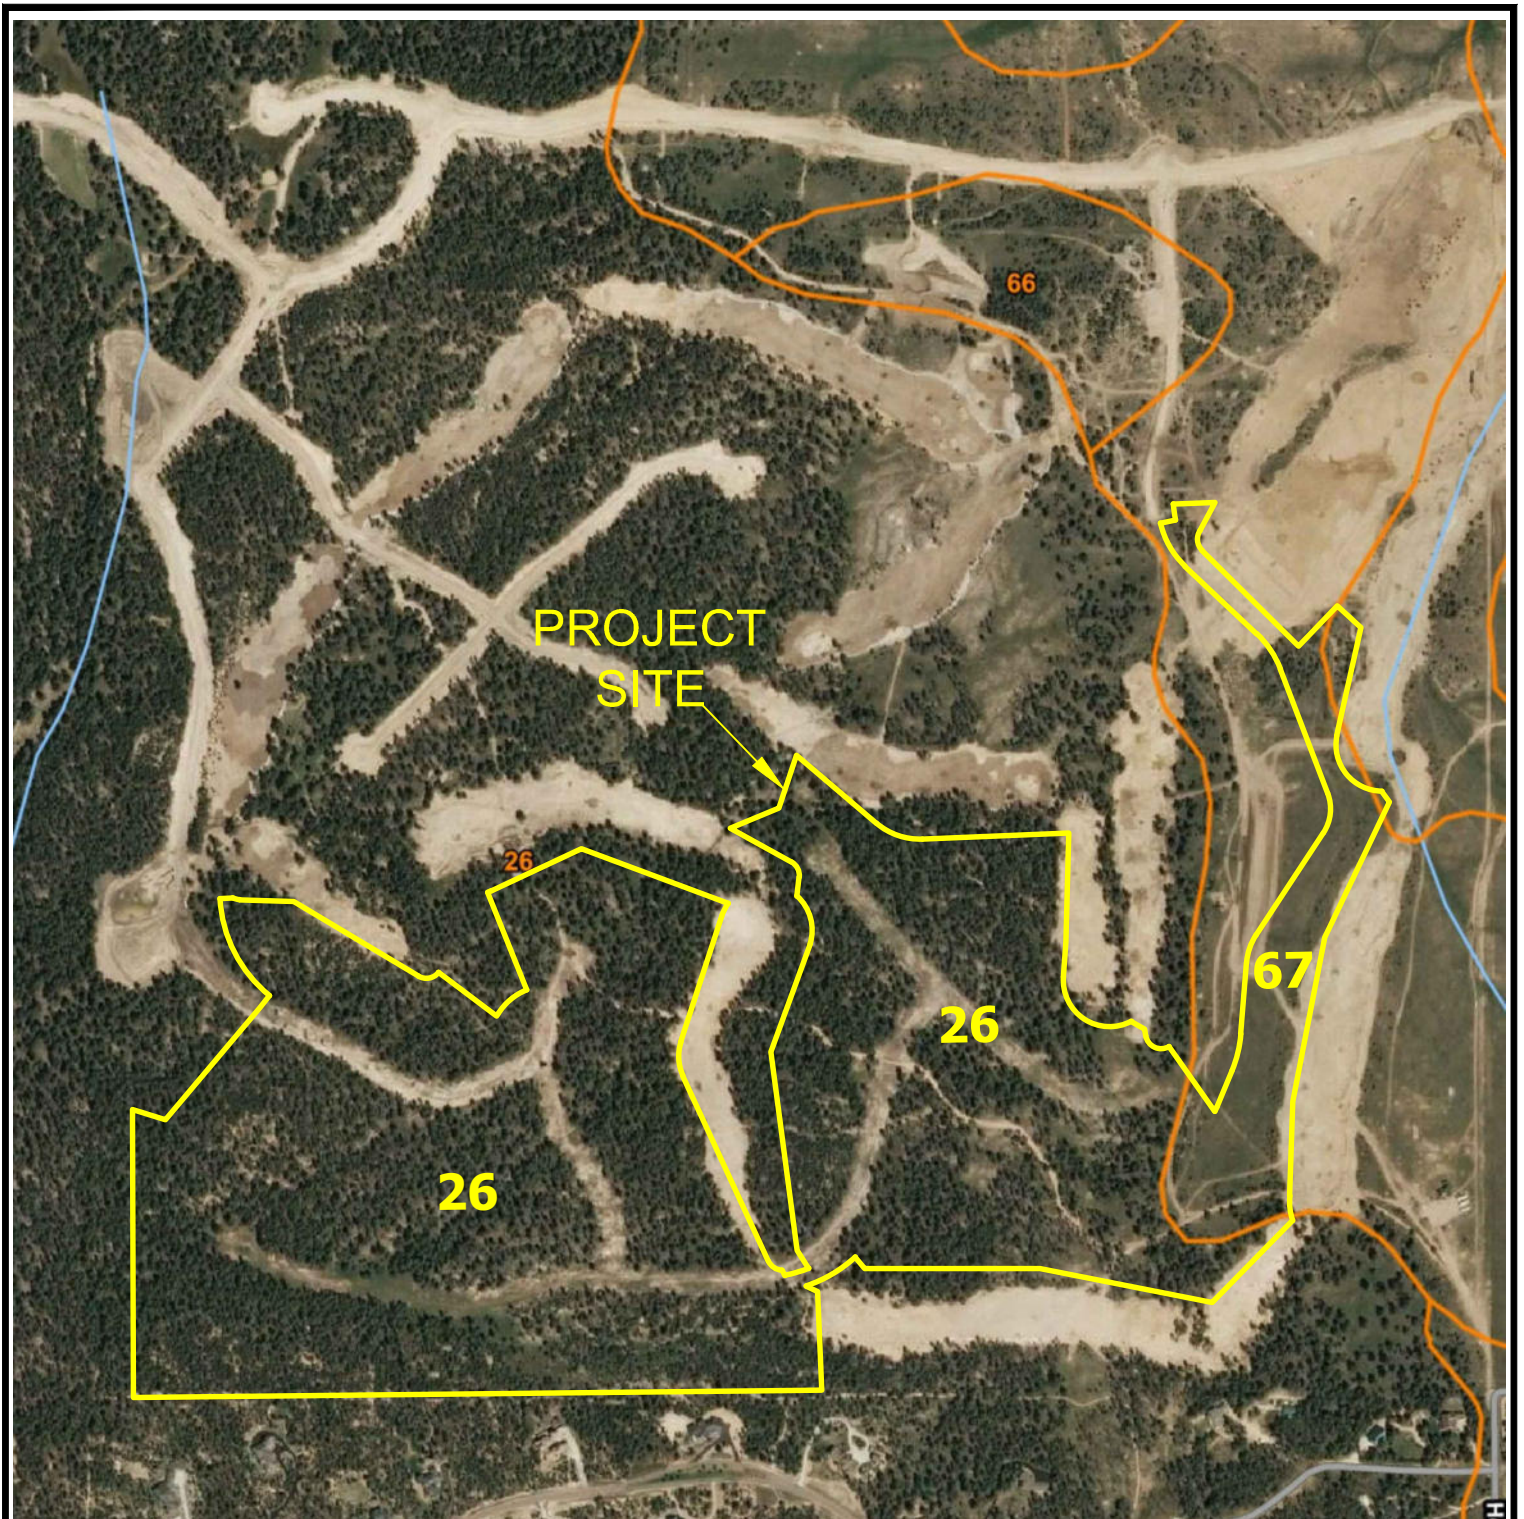
FIG. 4

SOIL SURVEY MAP
FLYING HORSE NORTH FILING NO. 3
EL PASO COUNTY, COLORADO
FLYING HORSE NORTH, LLC

The Natural Resource Conservation Service (Reference 5), previously the Soil Conservation Service (Reference 6) has mapped two soil types on the site (Figure 4). In general, the soils classify as coarse sandy loam, and sandy loam. The soils are described as follows:

The Natural Resource Conservation Service (Reference 5), previously the Soil Conservation Service (Reference 6) has been mapped with two soil descriptions. The Soil Survey Map (Reference 5) is presented in Figure 4, and the Soil Survey Descriptions are presented in Appendix D. The soils are described as having slow to rapid percolation rates. The majority of the soils have been described with moderate permeabilities.

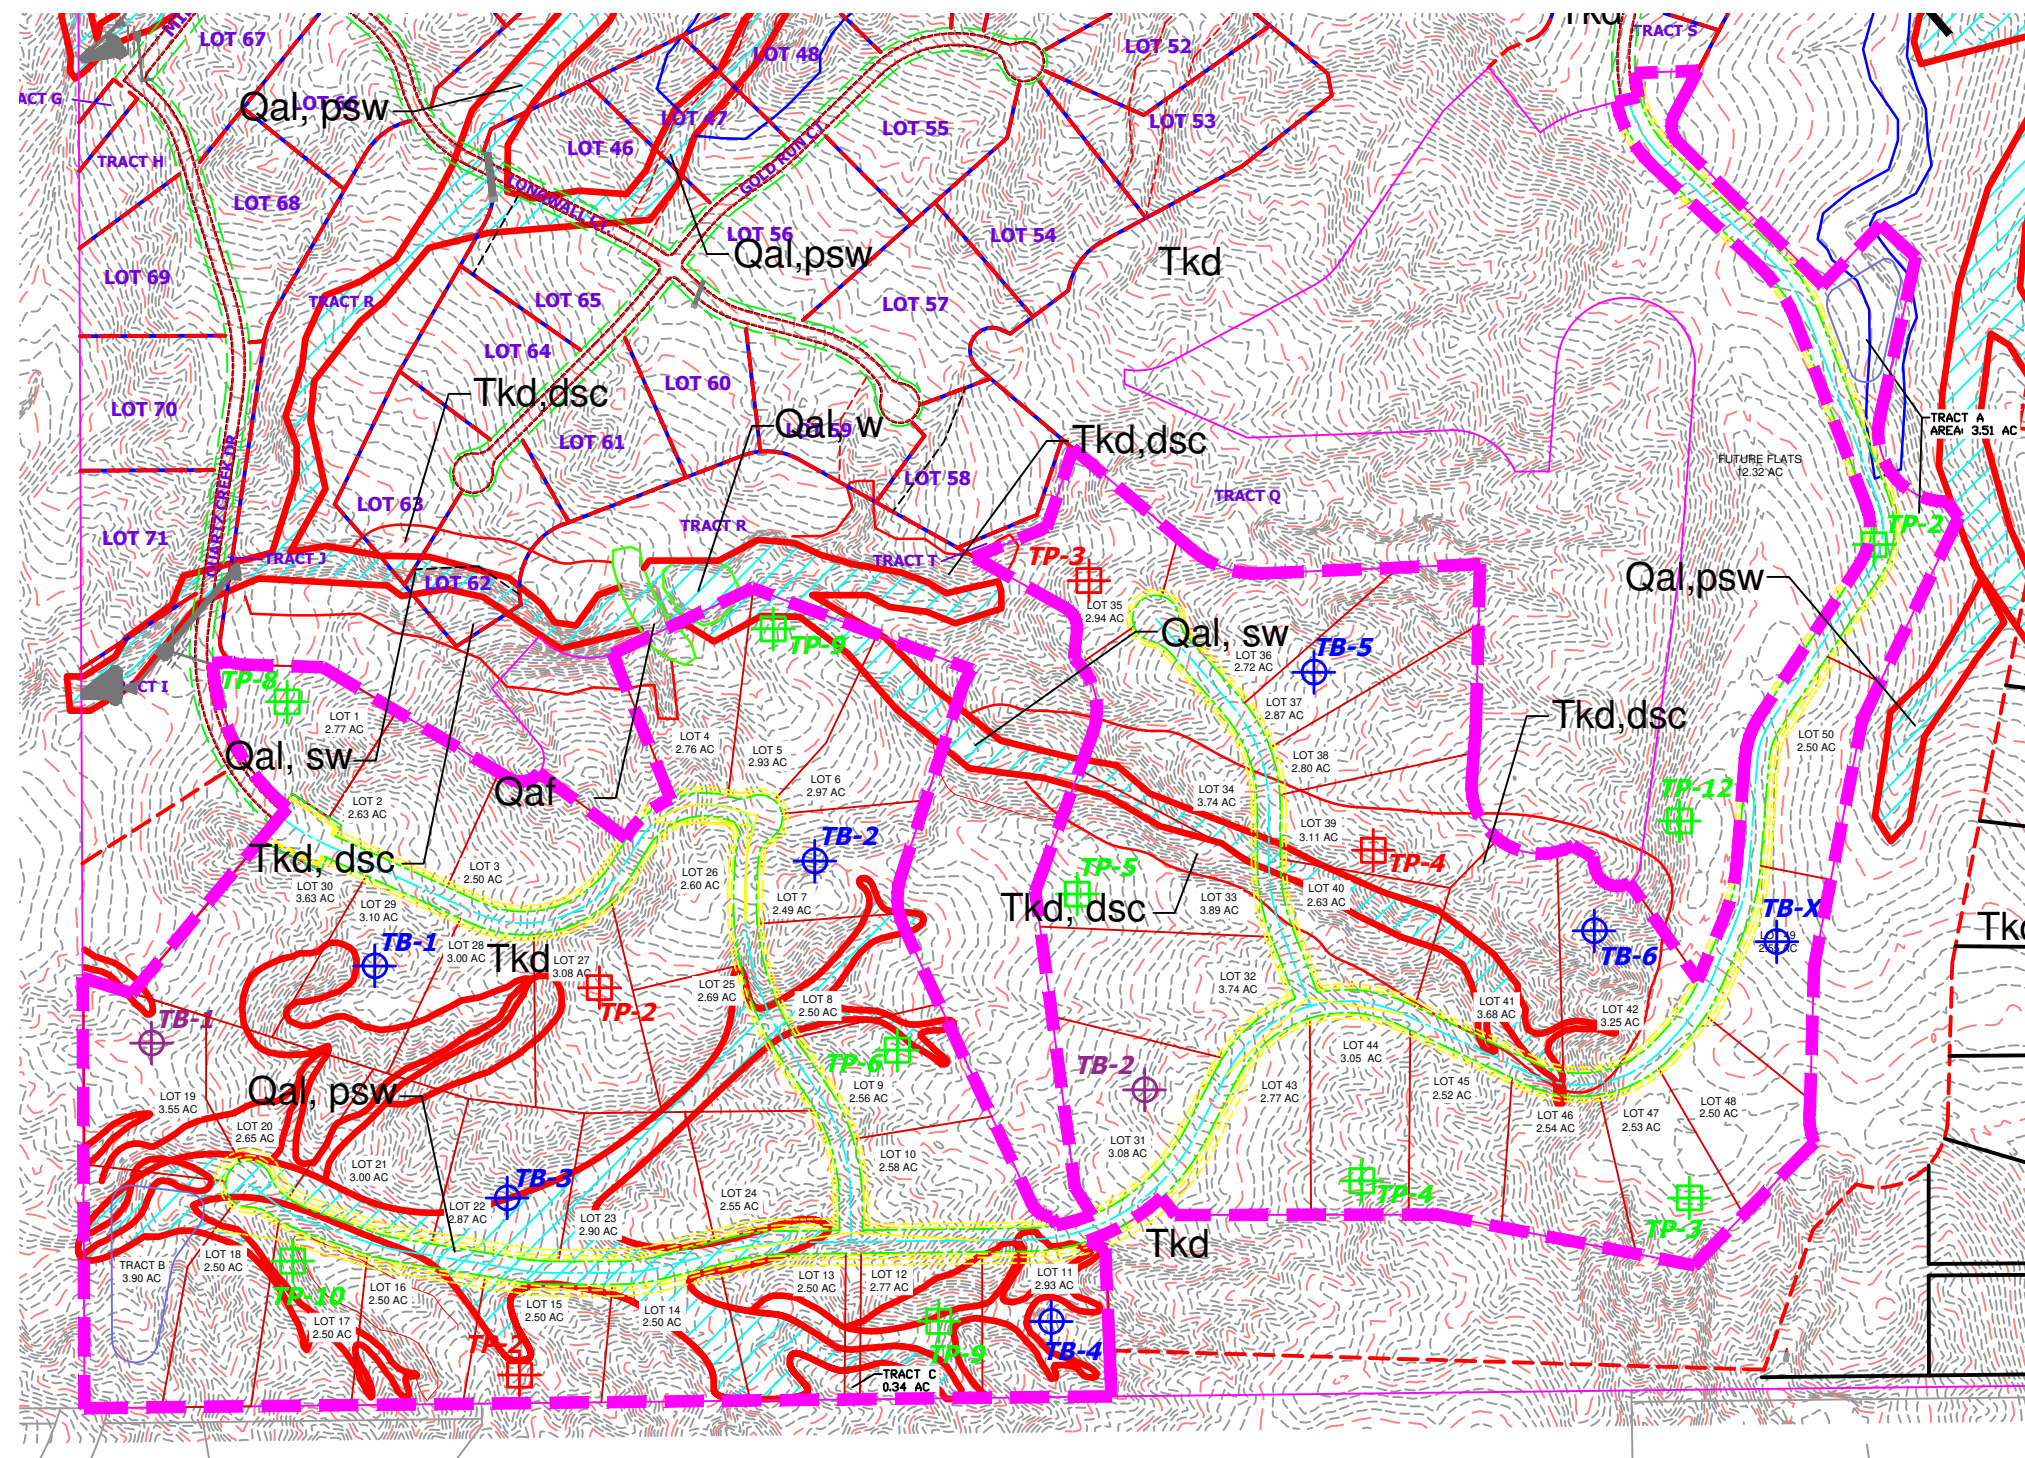
FIG. 6

- Legend:**
- Qaf - **Artificial Fill of Quaternary Age:**
man-made fill deposits associated with erosion berms, and earthen dams
 - Qal - **Alluvium of Quaternary Age:**
recent stream deposited materials
 - TKd - **Dawson Formation of Tertiary to Cretaceous Age:**
colluvial and residual soils overlying arkosic sandstone with interbedded fine-grained sandstone, siltstone, and claystone
 - dsc - downslope creep
 - er - erosion
 - fp - floodplain
 - psw - potentially seasonal shallow groundwater area
 - sw - seasonally wet areas
 - w - ponded water

GEOLOGY/ENGINEERING MAP
 FLYING HORSE NORTH FILING NO. 3
 EL PASO COUNTY, COLORADO
 FLYING HORSE NORTH, LLC

The soils listed above were mapped from site-specific mapping, the *Geologic Map of the Black Forest Quadrangle* distributed by the Colorado Geological Survey in 2003 (References 7), the *Geologic Map of the Colorado Springs-Castle Rock Area*, distributed by the US Geological Survey in 1979 (Reference 8), and the *Geologic Map of the Denver 1^o x 2^o Quadrangle*, distributed by the US Geological Survey in 1981 (Reference 9). The Test Pit Logs used in evaluating the site and are included in Appendix B. The Geology Map prepared for the site is presented in Figure 7.

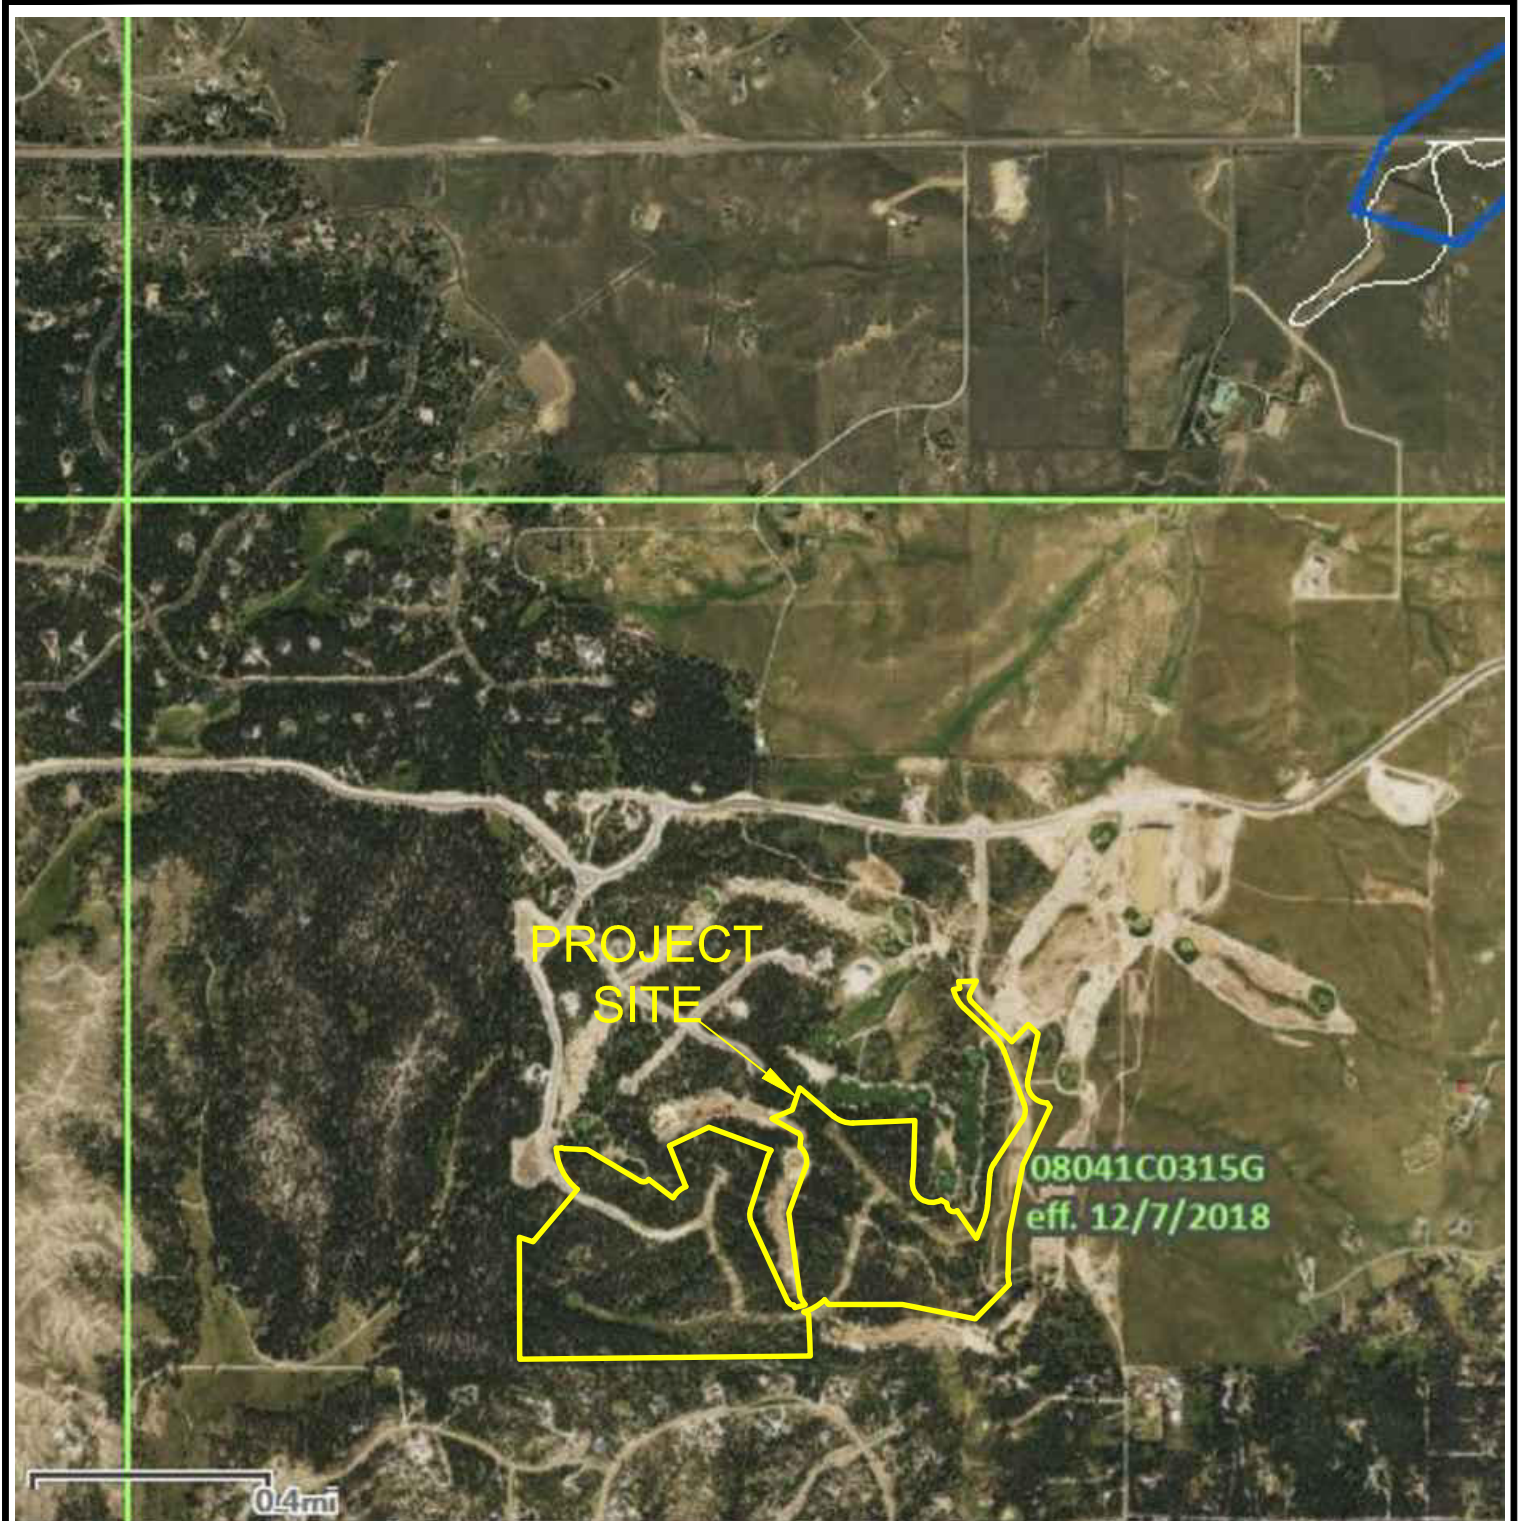
FIG. 7

FEMA FLOODPLAIN MAP
FLYING HORSE NORTH FILING NO. 3
EL PASO COUNTY, COLORADO
FLYING HORSE NORTH, LLC

Drainages are located in the northern and southern portions site, and several minor drainages are located across the site that generally flow in westerly directions. None of the drainages on the site have been mapped within floodplain zones according to the FEMA Map No. 08041CO315G, (Figure 7, Reference 11). Areas where potentially seasonal shallow, seasonal shallow, and ponded water have been indicated on the site geology/engineering geology map, Figure 6. OWTS soil treatment areas should not be located within areas mapped as seasonally shallow and potential seasonally shallow groundwater areas.

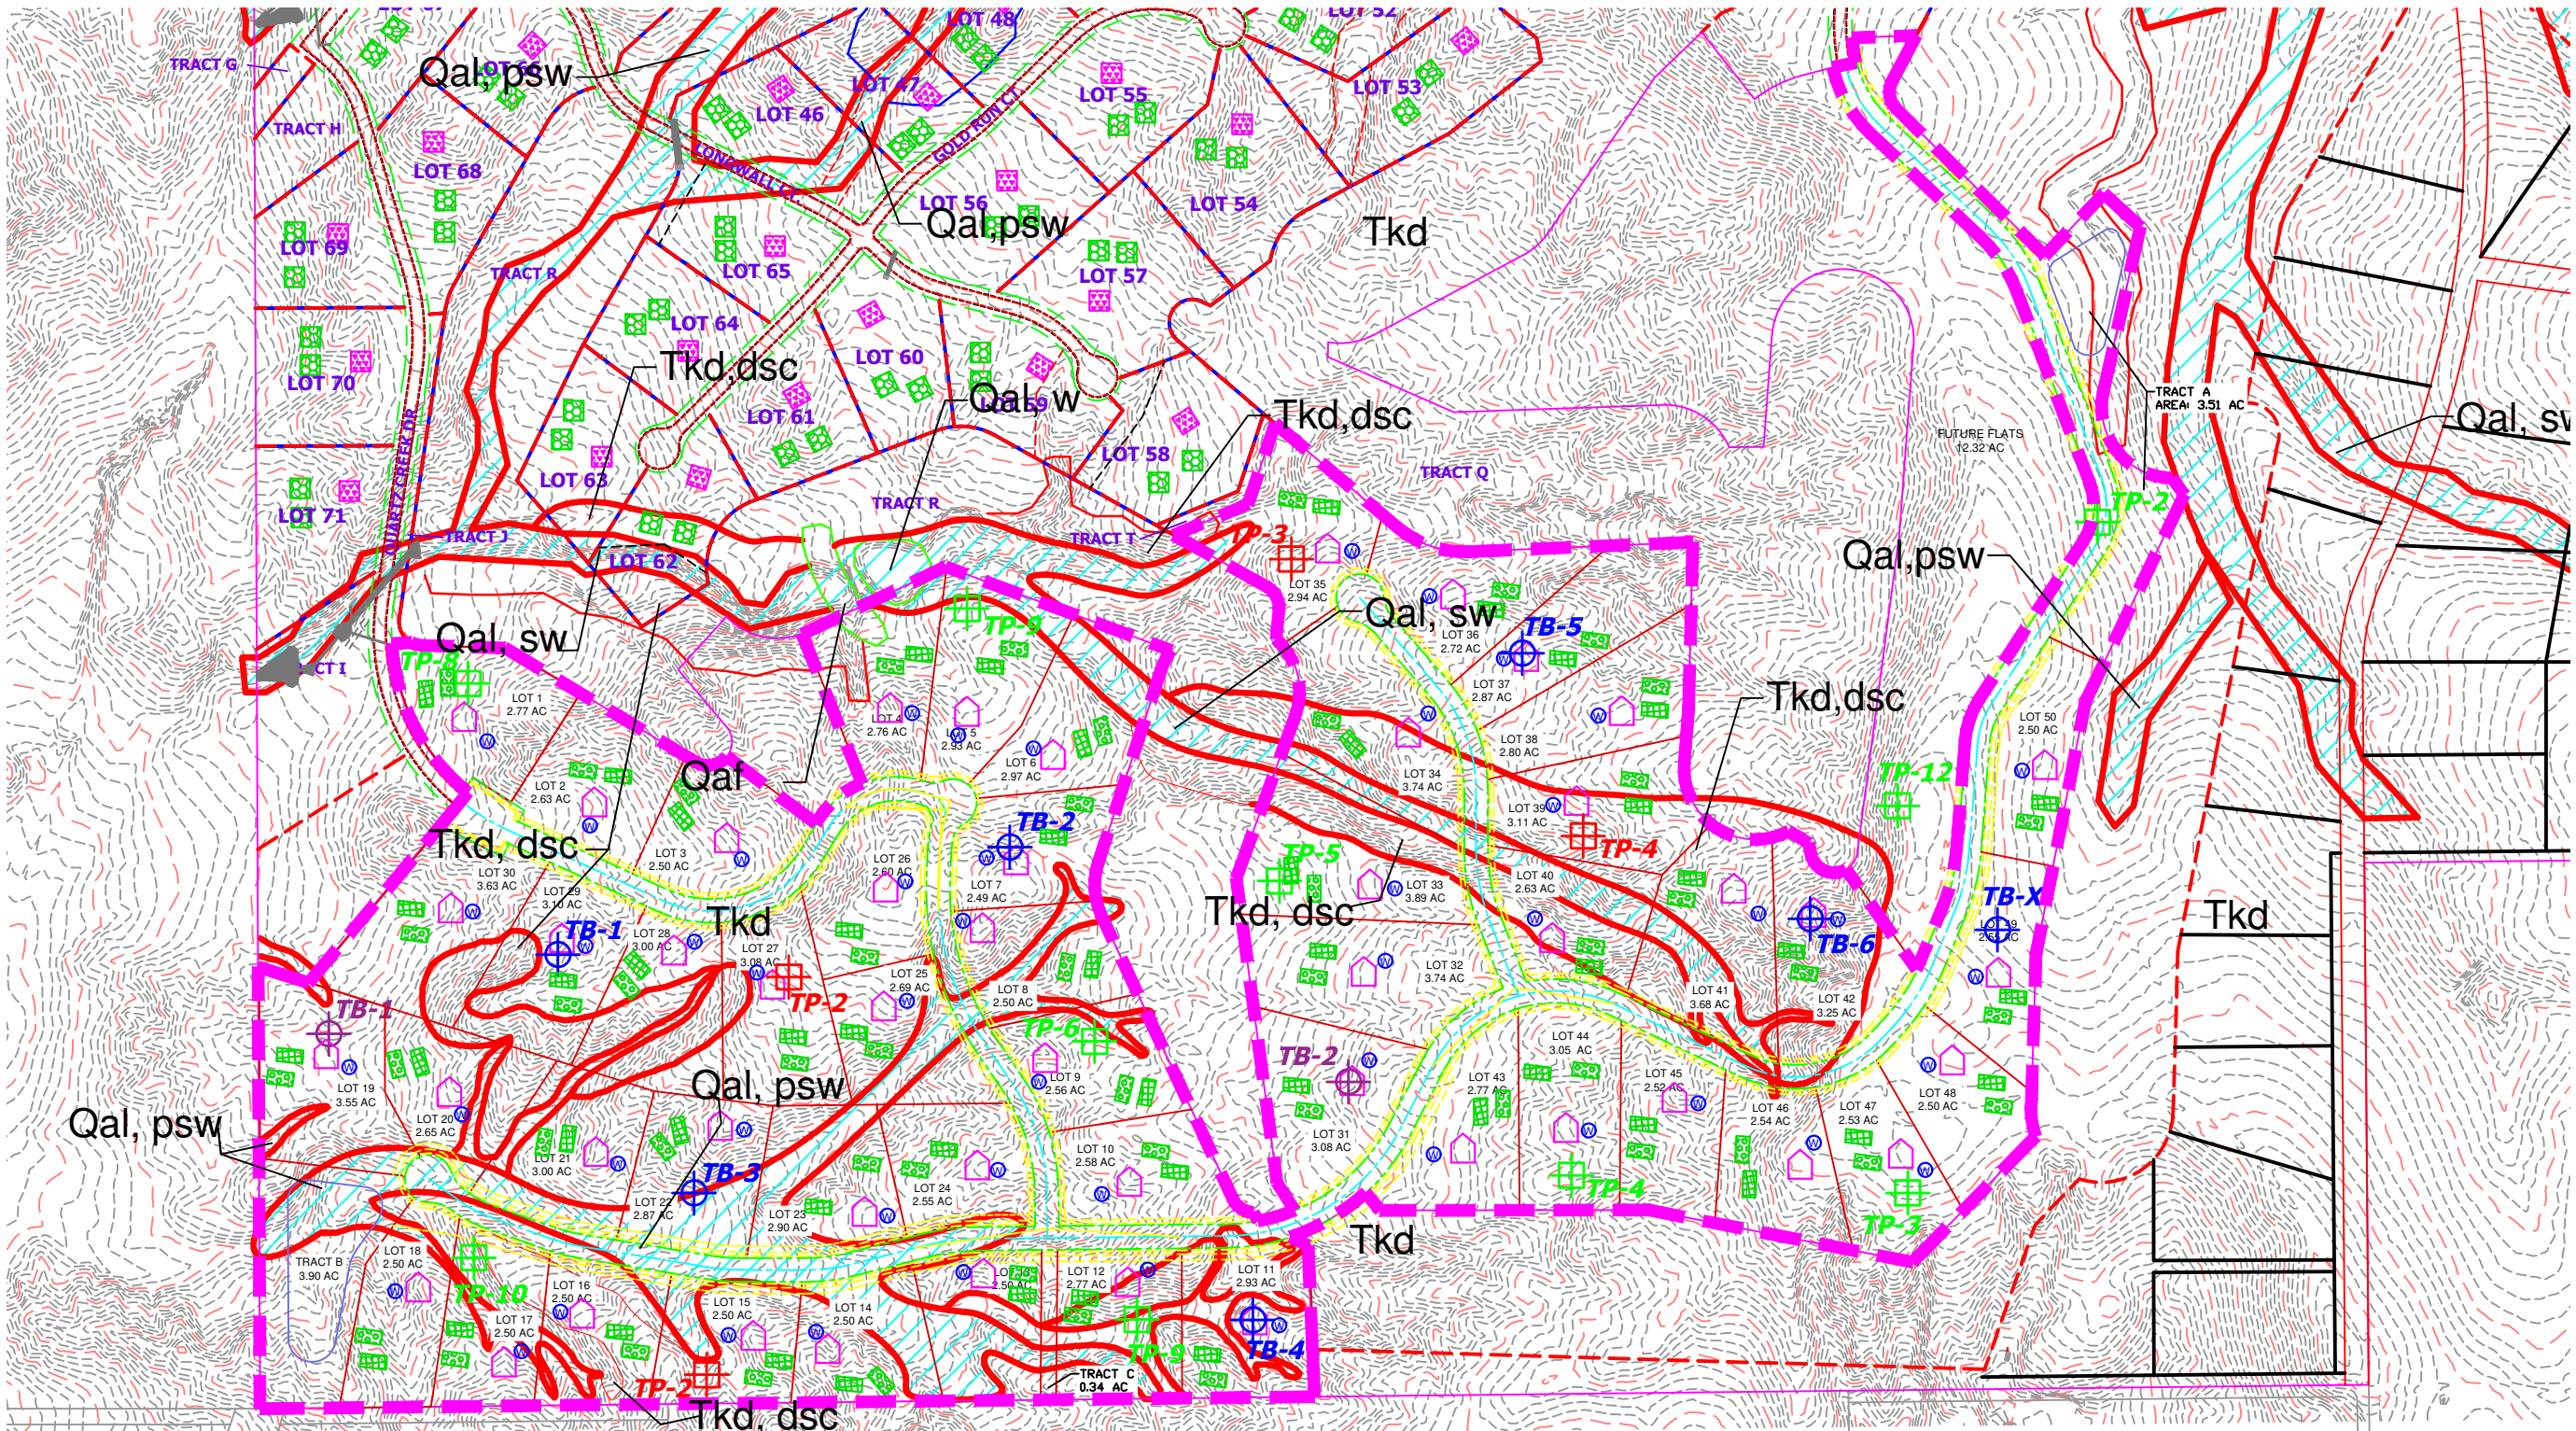
FIG. 8

OWTS SUITABILITY MAP
 FLYING HORSE NORTH FILING NO. 3
 EL PASO COUNTY, COLORADO
 FLYING HORSE NORTH, LLC

- LEGEND:**
- POSSIBLE OWTS LOCATIONS
 - POSSIBLE OWTS ALTERNATE LOCATIONS
 - POSSIBLE HOUSE LOCATIONS
 - WATER WELLS MUST BE A MINIMUM OF 100 FT FROM OWTS ABSORPTION FIELDS
 - OWTS SHOULD NOT BE LOCATED WITHIN ANY DRAINAGES, DEFINED DRAINAGE SWALES

In summary, it is our opinion the site is suitable for individual on-site wastewater treatment systems (OWTS) and that contamination of surface and subsurface water resources should not occur provided the OWTS sites are evaluated and installed according to El Paso County and State Guidelines and properly maintained. Based on the testing performed as part of this investigation designed systems will likely be required for the majority of the lots. A Septic Suitability Map is presented in Figure 8. OWTS sites should not be located within defined drainages. Individual soil testing is required on the lots prior to construction. Absorption fields must be located a minimum of 100 feet from any well, including those on adjacent properties. Absorption fields must also be located a minimum of 50 feet from any drainages, floodplains or ponded areas and 25 feet from dry gulches.

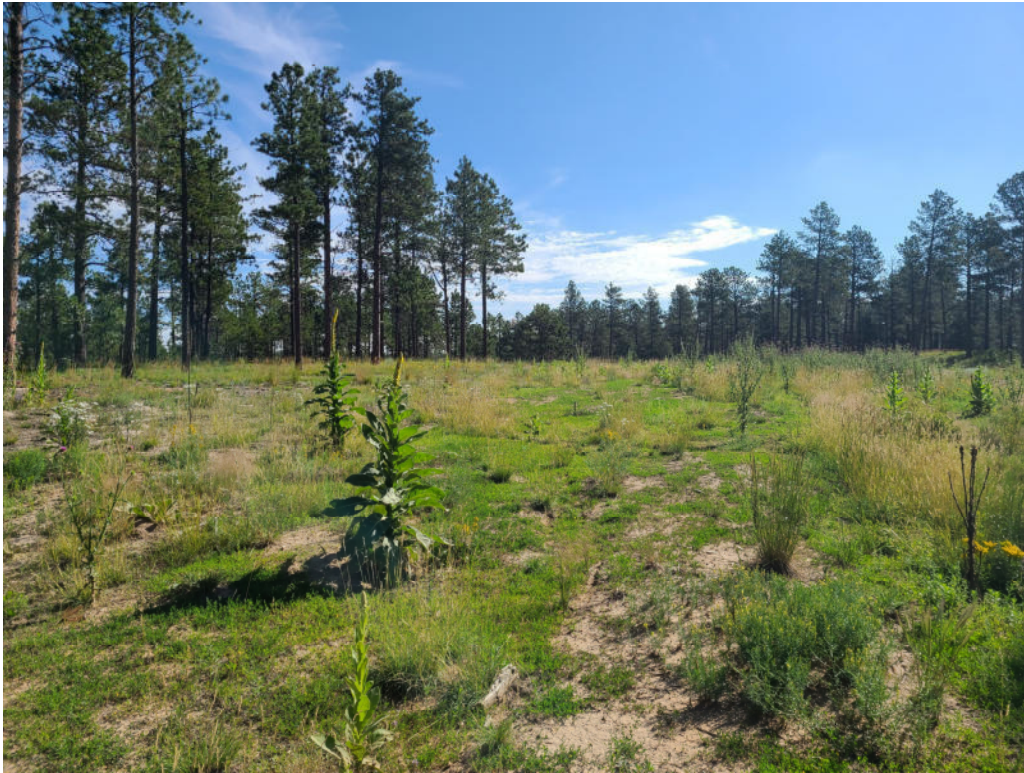
Looking west from the west-central portion of the site.

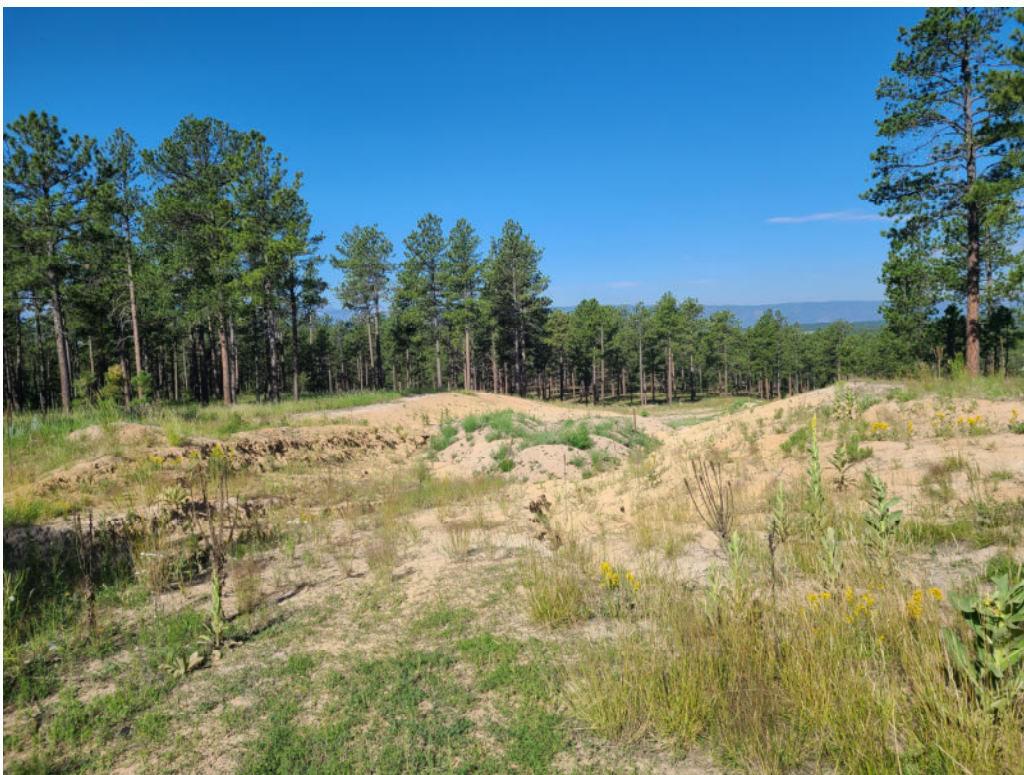
Looking east from the southwestern side of the site.

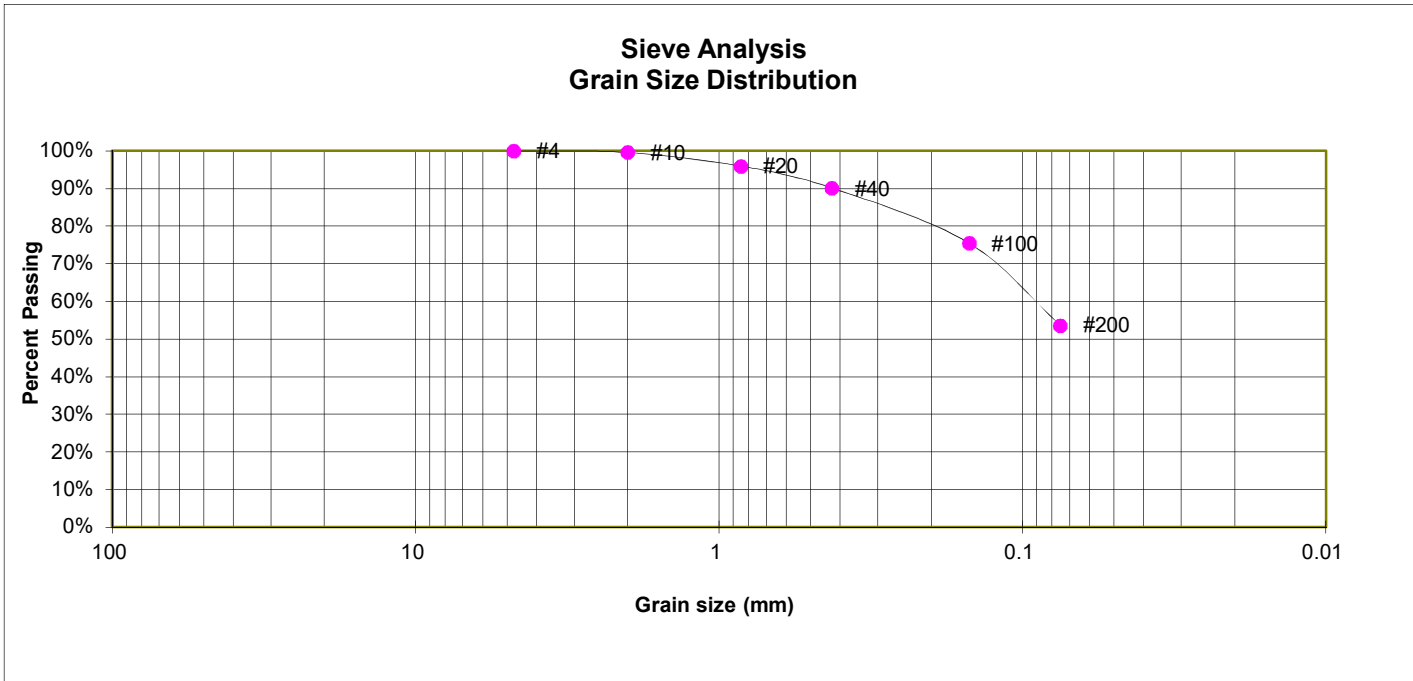
TEST PIT	TP-1	SOIL DESCRIPTION	CLAY, SANDY
DEPTH (FT)	3

GRAIN SIZE ANALYSIS

U.S. Sieve #	Percent Finer
3"	
1 1/2"	
3/4"	
1/2"	
3/8"	
4	100.0%
10	99.6%
20	96.0%
40	90.1%
100	75.5%
200	53.6%

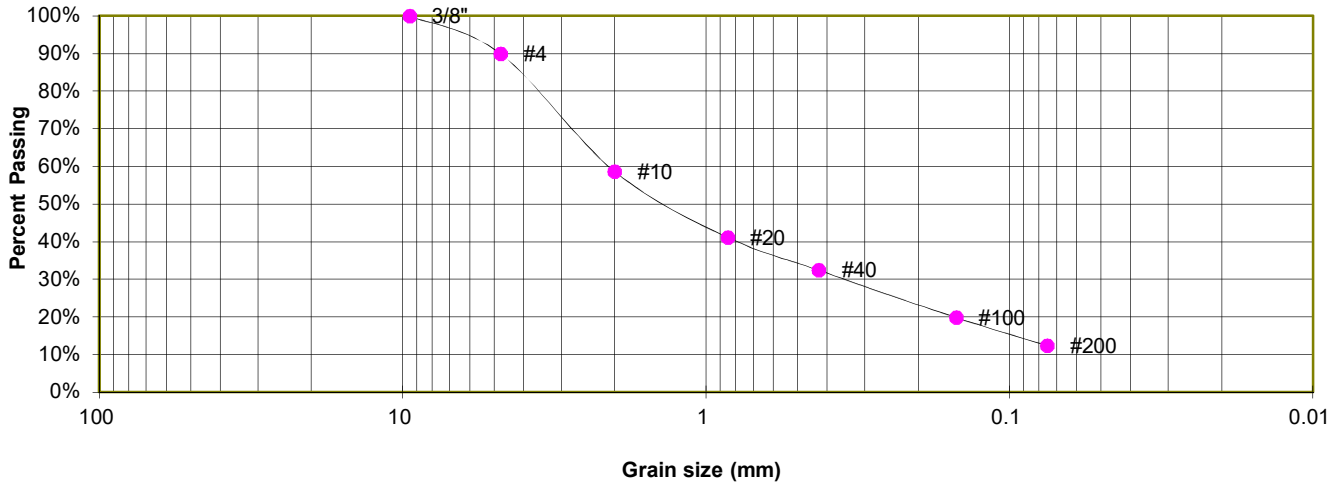
SOIL DESCRIPTION SANDSTONE, SILTY

Sieve Analysis Grain Size Distribution

GRAIN SIZE ANALYSIS

U.S. Sieve #	Percent Finer
3"	
1 1/2"	
3/4"	
1/2"	
3/8"	100.0%
4	89.9%
10	58.6%
20	41.2%
40	32.4%
100	19.8%
200	12.4%

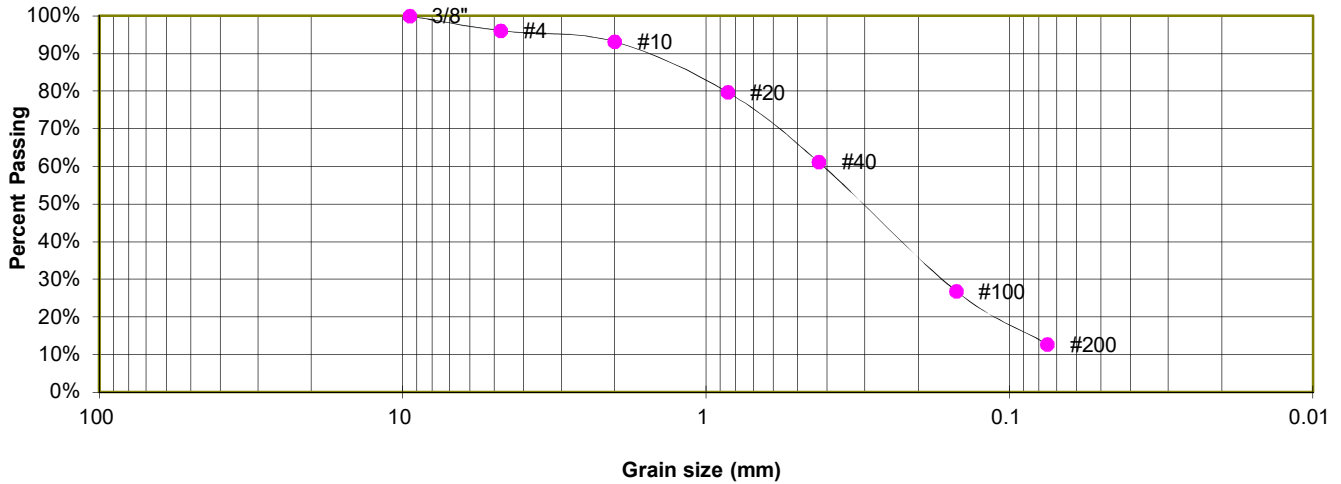
SOIL DESCRIPTION SAND, SILTY

Sieve Analysis Grain Size Distribution

GRAIN SIZE ANALYSIS

U.S. Sieve #	Percent Finer
3"	
1 1/2"	
3/4"	
1/2"	
3/8"	100.0%
4	96.1%
10	93.2%
20	79.7%
40	61.1%
100	26.9%
200	12.8%
